# **A Retrospective Evaluation of Cured-in-Place Pipe (CIPP) Used in Municipal Gravity Sewers**

**Contract No. EP-C-05-057  
Task Order No. 58**

**U.S. Environmental Protection Agency  
Urban Watershed Branch  
National Risk Management Research Laboratory  
Water Supply and Water Resources Division  
2890 Woodbridge Avenue (MS-104)  
Edison, NJ 08837**

**September 2011**

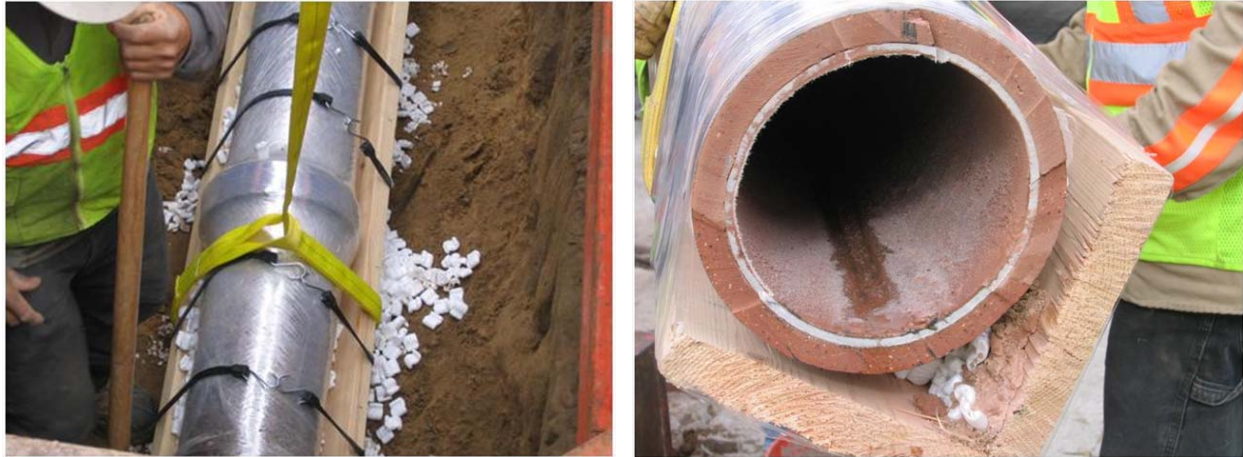
**Figure 4-1. Images of the Recovered Specimen**

**4.2.3 Visual Inspection of the Liner.** Overall the liner appeared to be in good shape. The polyurethane coating seemed to be eroded away at the invert of the pipe. Upon discussion with the vendor (Insituform), it was established that the polyurethane laminate coating was intended to serve as a sacrificial layer and act as a barrier for preventing resin from entering the interior of the tube. It was expected that this coating would hydrolyze over time (a chemical reaction causing the breakdown of certain polymers). The vendor was surprised to find out that most of the polyurethane layer remained intact (modern CIPP liners typically utilize a PE or a more durable polyurethane coating, which is considered to be a permanent layer). In locations where the polyurethane coating hydrolyzed, the fibers into which the polyurethane coating dissolved were exposed and somewhat loose. However, the resin-impregnated felt beneath it was solid and intact. The stitched seam holding together the CIPP tube was found to be in good condition. Signs of wear were restricted to the bottom third of the tube. A deposit made up of silt and what appeared to be residue of an organic matter was found at the invert of the CIPP liner (Figure 4-2).

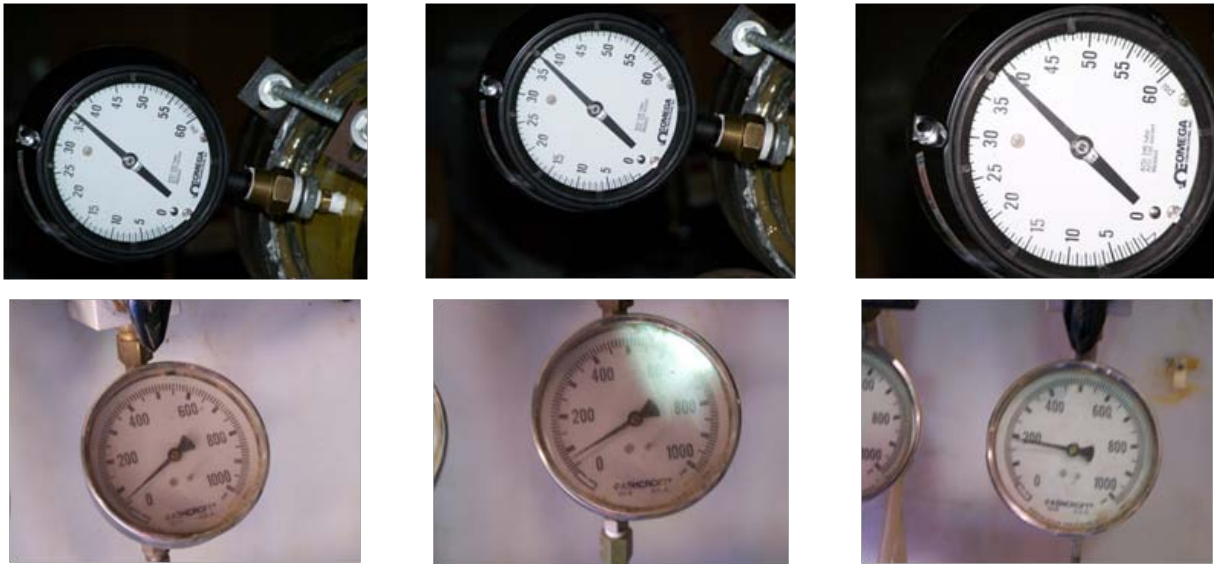
**Figure 4-21. Pressure on the Liner at Intervals During the Test**

Although there were some leaks during the test, the liner held 40 to 45 psi (equivalent to 92 to 104 ft of water head) for approximately 1 hour in total. The applied pressure spiked during the test to a value of 200 psi, but was quickly reduced again to the 40 to 45 psi range (Figure 4-21).

Even with the brief peak at 200 psi pressure, visible evidence did not show a buckling failure of the liner although there was evidence of water leaks through the liner that indicated some localized failures (Figure 4-22).

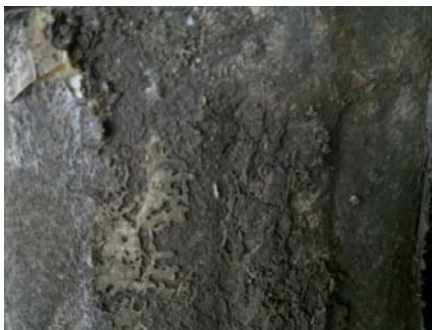
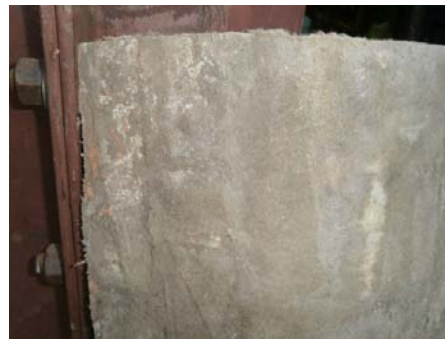
**Figure 4-27. Images of the Recovered Samples from the Denver 48-in. Liner**

**4.3.3 Sample Retrieval in 2010.** Two samples, each approximately 2 ft × 2 ft, were exhumed from the installed liner on May 20, 2010, by Wildcat Civil Services of Kiowa, CO with Jack Row, the General Superintendent, on site. (The liner age at this time was 23 years.) Both samples were taken from the crown of the pipe at a distance about 4 ft from manhole B-3 (one upstream and the other downstream of the manhole). The samples were sent to TTC for testing. Figure 4-27 shows images of the recovered specimens.

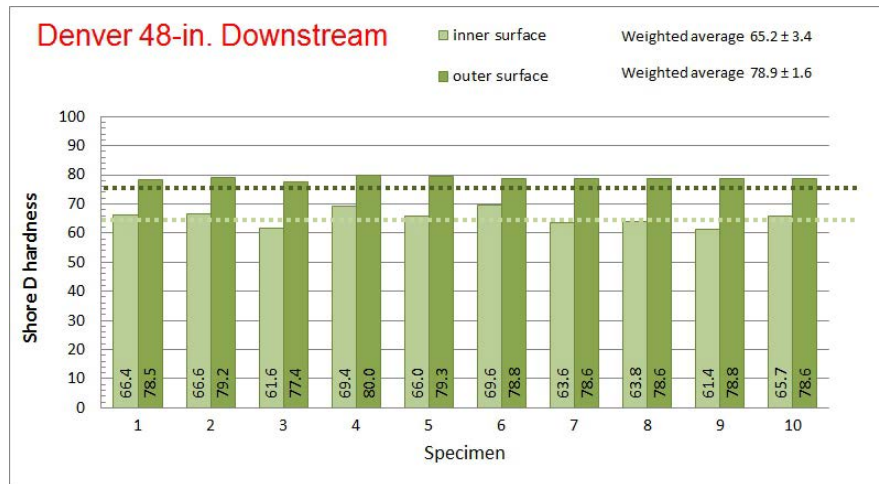
**Figure 4-40. Shore D Hardness for Denver 48-in. Downstream Sample**

**4.3.9.2 Downstream Sample.** Specimens measuring approximately 1 in. × 1 in. were cut from the retrieved downstream sample of the CIPP liner using a band saw. A total of 10 specimens were prepared and tested. A total of 36 tests were conducted on each sample: 18 tests on the inner surfaces and 18 tests on the outer surfaces. The average calculated values and their standard deviations are shown in Figure 4-40. The average and standard deviation of the Shore D hardness for the sample inner surface was calculated to be  $65 \pm 3$  and for the outer surface  $79 \pm 2$ . The differences between the inner and outer surfaces of the liner follow the same pattern as the reading for the Denver 8-in. liner. The outer side of the liner enclosed by the host pipe was neither in contact with the soil nor with the waste stream. The significance of this result is explored in Section 6.

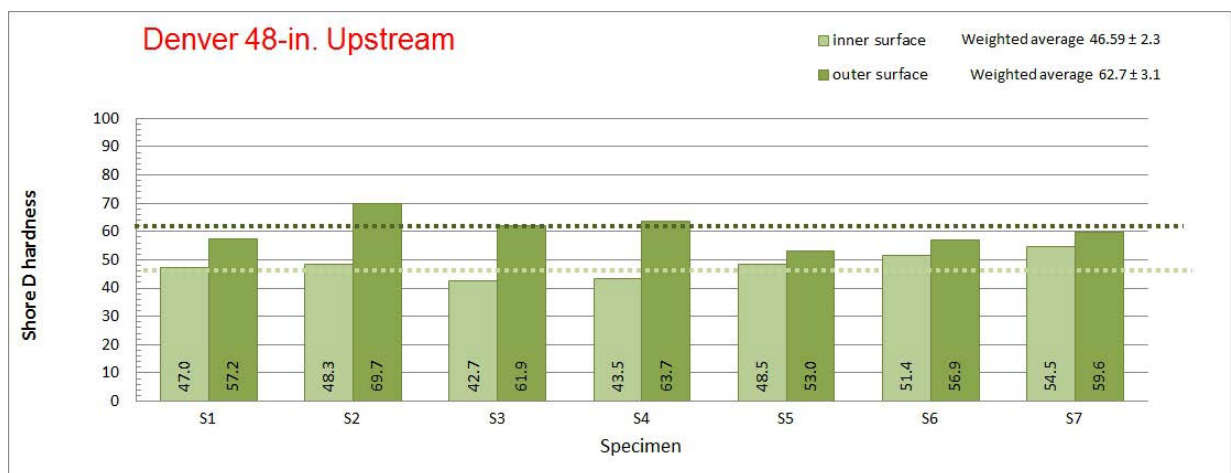
**Figure 4-41. Shore D Hardness for Denver 48-in. Upstream Sample**

**4.3.9.3 Upstream Sample.** A total of seven specimens were prepared and tested. A total of 50 tests were conducted on each sample: 25 tests on the inner surfaces and 25 tests on the outer surfaces. The average calculated values and their standard deviations are shown in Figure 4-41. An average of 25 readings at both the inner and outer surface of each of seven specimens is shown. The weighted average and standard deviation of the Shore D hardness for the sample inner surface was calculated to be  $47 \pm 2$  and for the outer surface  $63 \pm 3$ .

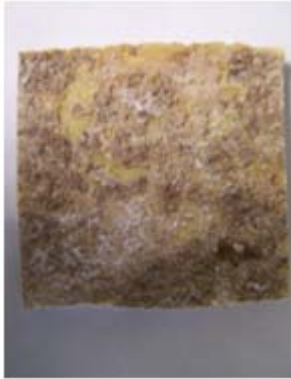
**Figure 4-42. Original Outer Surface (Denver 48-in. Downstream Sample)**

**4.3.10.1 Downstream Sample.** Seven specimens from the exhumed downstream sample were subjected to the Barcol test (ASTM D2583). Due to the presence of dust and debris on the outer wall of the exhumed CIPP slabs (Figure 4-42), a belt sander was used to achieve a smooth surface. The inner surface of each sample was kept unaltered (Figure 4-43). A wooden base was prepared to match the thickness of the specimens, and the Barcol hardness tester (Figure 4-44) was placed on that platform to conduct the test (Figure 4-45).

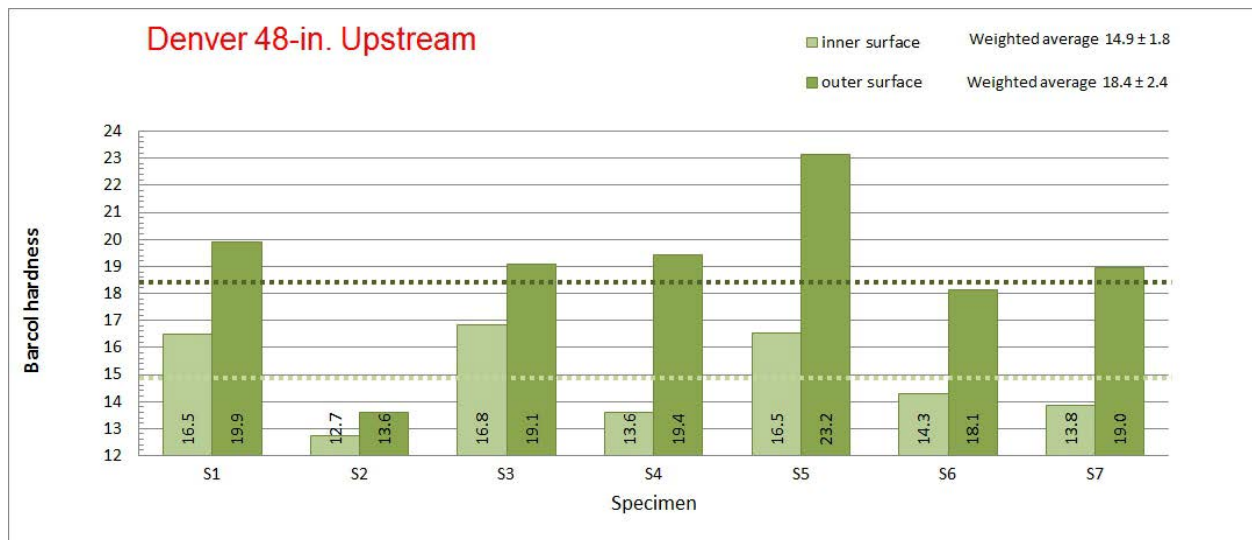
**Figure 4-47. Barcol Hardness of Denver 48-in. Upstream Sample**

**4.3.10.2 Upstream Sample.** Twenty-five hardness readings on the inner and outer side of seven samples were taken. The average calculated values and their standard deviations are shown in Figure 4-47. An average of 25 readings at both the inner and outer surface of each of seven specimens is shown. The weighted average and standard deviation of the Barcol hardness for the sample inner surface was calculated to be  $14.9 \pm 1.8$  and for the outer surface  $18.4 \pm 2.4$ .

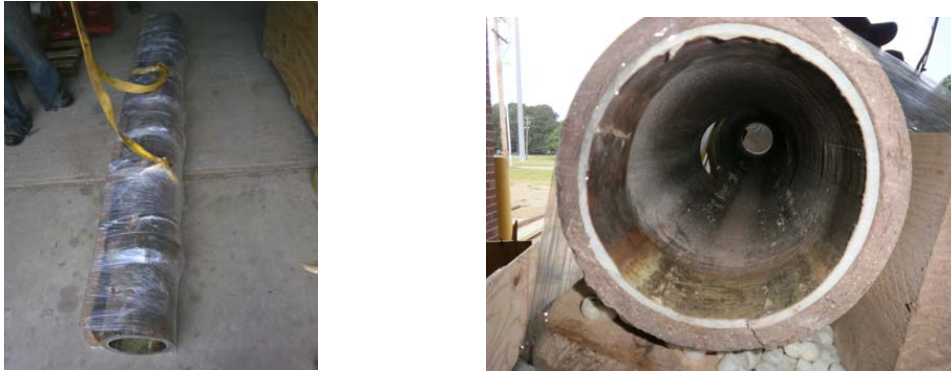
**Figure 5-1. Images of the Recovered Specimen (Columbus 8-in. Liner)**

The specimen was received at TTC (see Figure 5-1).

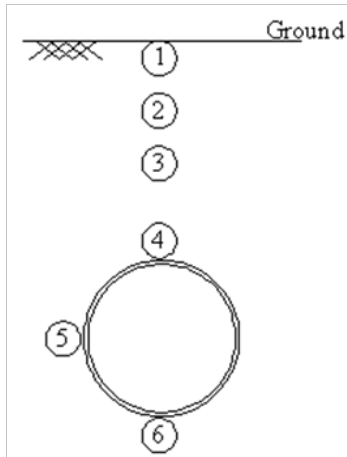
**Figure 5-3. Location of Soil Samples (Columbus 8-in. Site)**

**5.2.4 Locations of Soil Samples.** The trench was divided into six regions (Figure 5-3). Soil samples collected from each region were placed in airtight bags to avoid foreign contamination and/or loss of moisture. The samples were numbered as shown in Table 5-1.

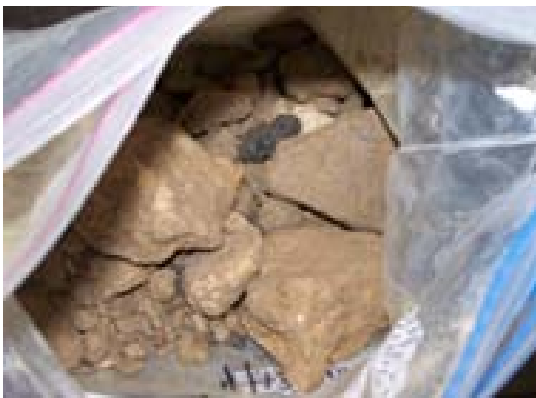
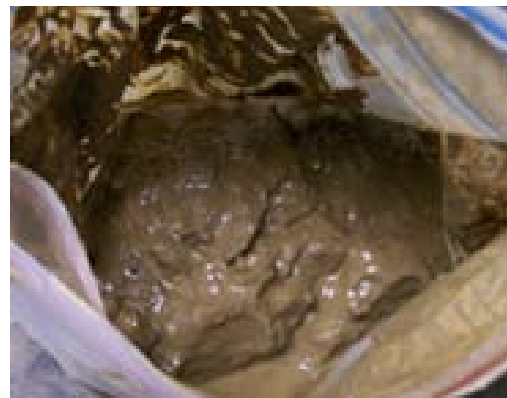
**Figure 5-4. Collected In-Situ Soil Samples (Columbus 8-in. Site)**

**5.2.5.1 Particle Size Distribution.** The soil gradation analysis followed ASTM C136. Based on visual inspection, the soil samples were categorized as fine aggregates. Some large particles (e.g., asphalt, rocks) (see Figure 5-4) were also present, but were considered a foreign material and were excluded from the sieve analysis. For the analysis, 500 g of soil material was taken from each of the six soil samples and placed on a No. 4 sieve (4.76 mm). For all samples (excluding the large foreign material), 85 to 95% of the particles passed through the No. 4 sieve.

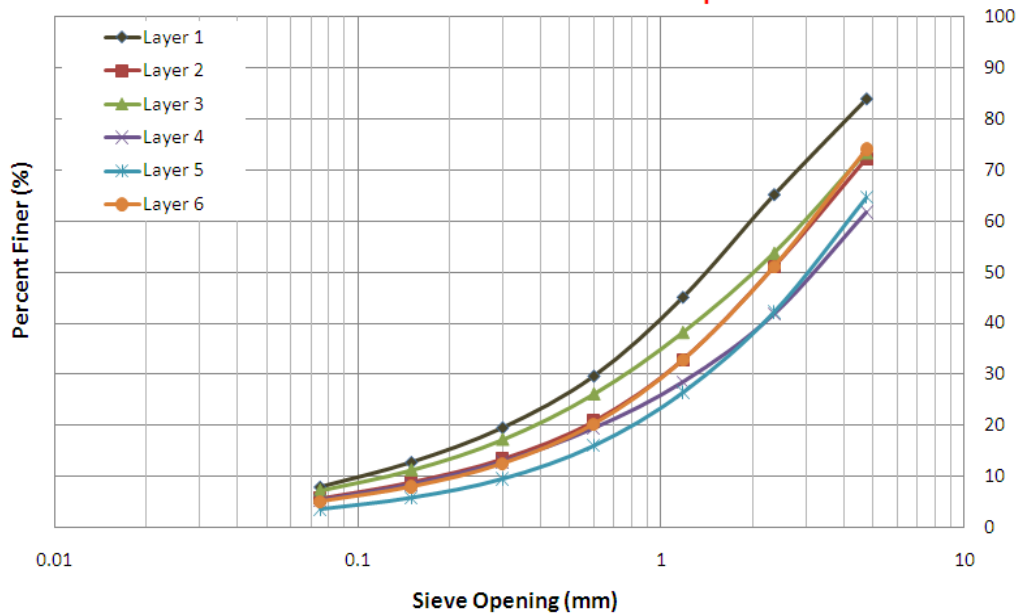
**Figure 5-5. Grain Size Distribution of Soil Samples (Columbus 8-in. Liner Site)**

Based on the grain size distribution, both the backfill and bedding soils can be considered to be sandy soils. The flatter slopes of the resulting gradation curves suggest that the bedding and surrounding soil are well-graded.

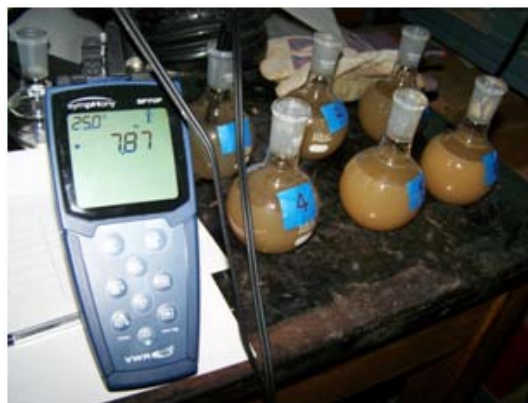
**Figure 5-6. Measurement of pH (Columbus 8-in. Soil Samples)**

**5.2.6 Measurement of Acidity, Alkalinity, and pH.** The pH of the soil embedment and the solid sediments collected from the pipe invert were measured using a Thermo Orion and a sympHony SP70P pH meter (see Figure 5-6). The soil samples were placed in a pan (which was rinsed using distilled water) and distilled water was added to the samples. The soil sample was then stirred, and the pH probe was inserted into the soil-water mixture. The process was repeated for the sediments collected from the bottom of the liner on the inside of the pipe. The pH values of the bedding soil, backfill soil, and the sediments are listed in Table 5-4.

The pH of soil samples collected from around the pipe (bedding material) and the backfill soil were found to be somewhat alkaline ranging from 7.3 to 8.9. The sediments inside the pipe were also found to be slightly alkaline (with an average pH of 7.6) as expected from a residential wastewater stream. These measurements do not provide any indication of a severe service environment for the liner.

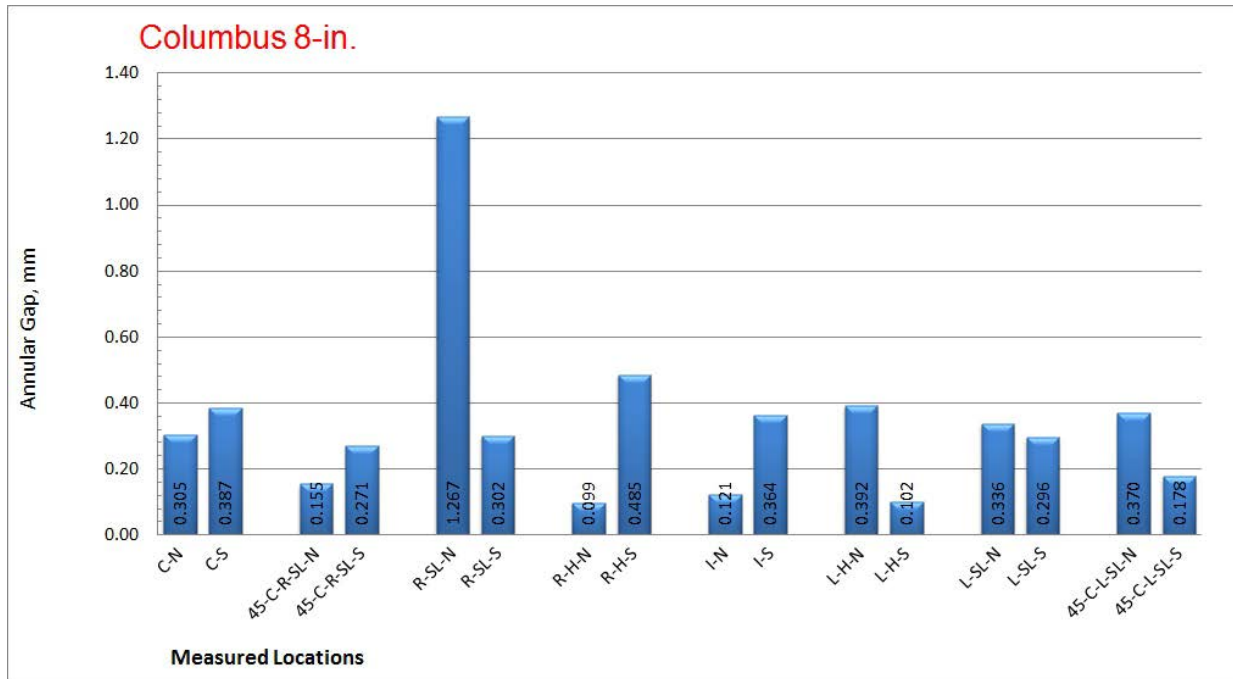
**Figure 5-7. Histogram of Annular Gap Measurements (Columbus 8-in. Liner)**

**5.2.8 Annular Gap.** The gap between the CIPP liner and the host pipe was measured at 45 degree increments around the circumference of the liner at both ends of the exhumed sample, as well as exposed ends of the remaining pipe sections. In the laboratory, nine separate measurements were made at each of the eight circumferential locations and averaged for the value at that location. The CIPP liner was found to tightly fit with the inner wall of the host pipe, with the average and standard deviation for the gap being  $0.35 \pm 0.26$  mm. The measurements are summarized in Table 5-6 and Figure 5-7.

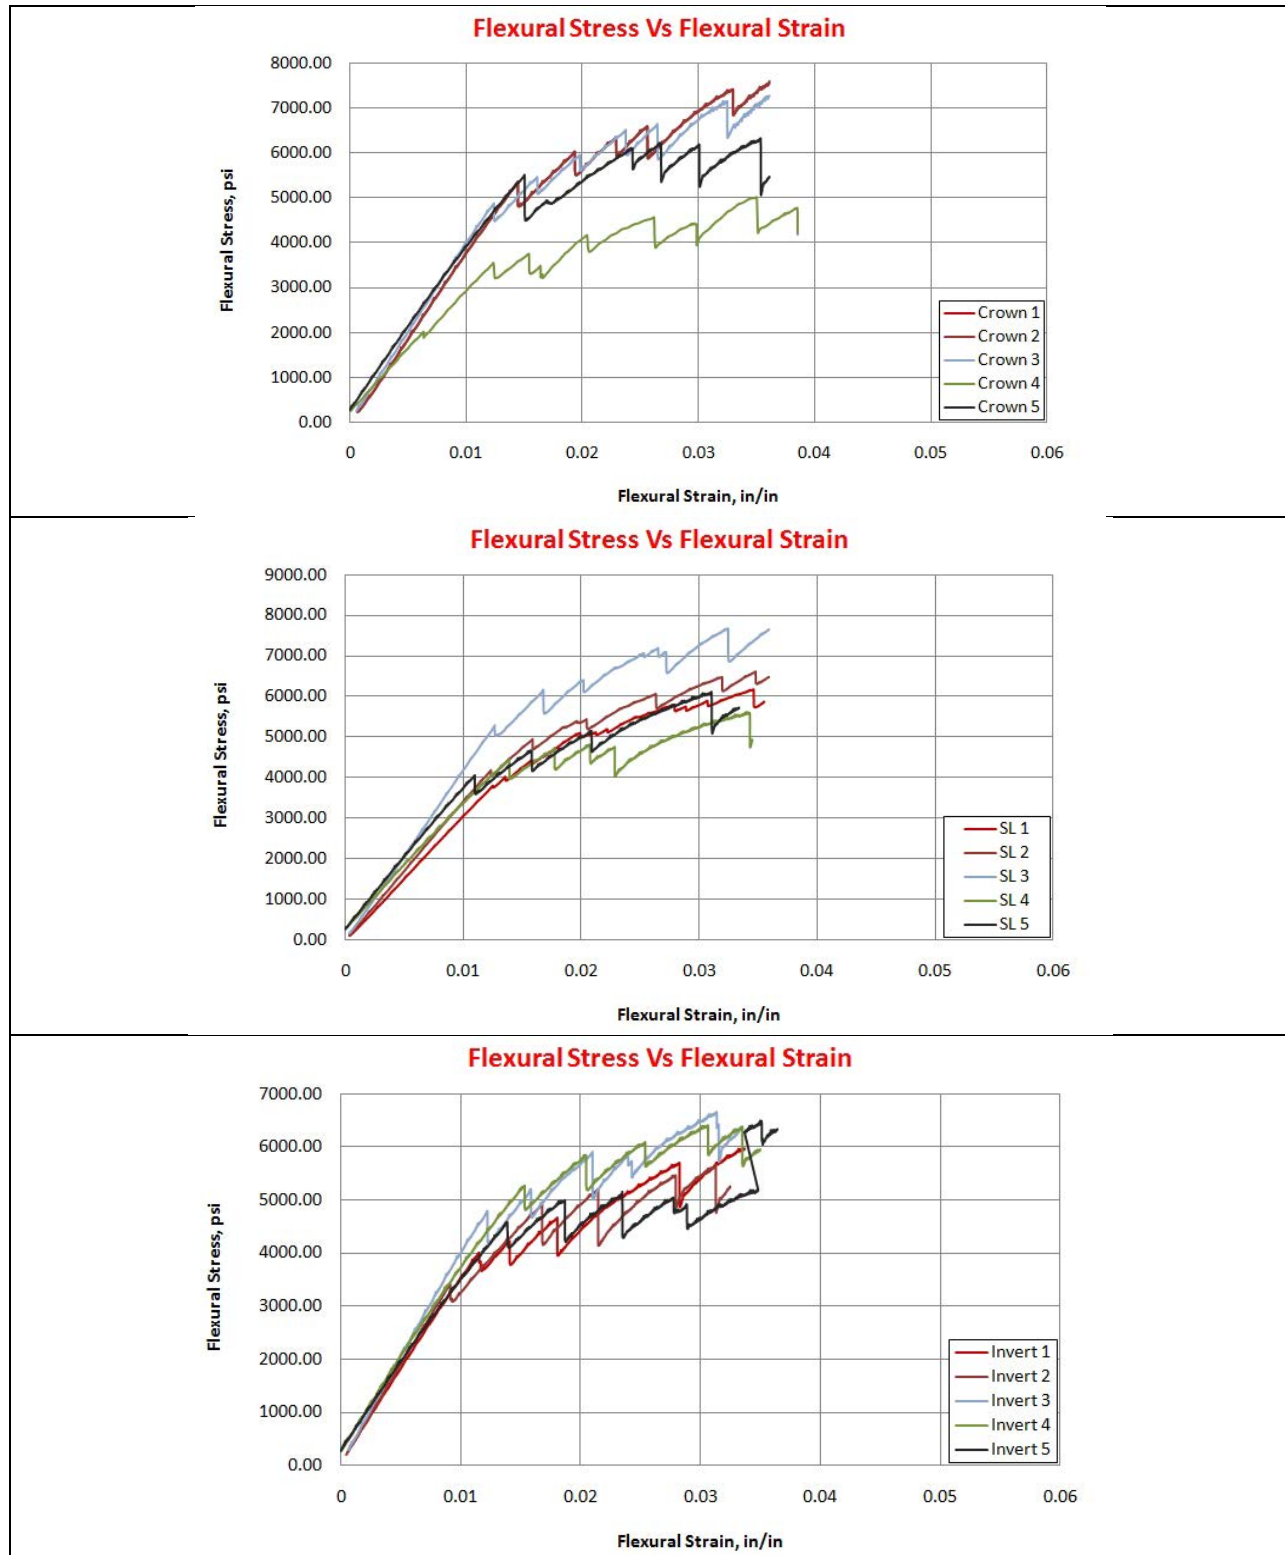
**Figure 5-14. Flexural Stress-Strain Curves for Crown, Spring Line, and Invert Samples (Columbus 8-in. Liner)**

Table 5-11 presents the results for ASTM D790 and ASTM D638 testing of the exhumed section of the same liner measured by TTC. The overall flexural strength of the liner ( $6,416 \pm 2,038$  psi) was found to be well above the design value of 4,500 psi, but lower than the value reported by DLZ in 2005 ( $7,264 \pm 500$  psi). The modulus of elasticity of the specimens taken from the exhumed liner was found in all cases to exceed the design value of 250,000 psi by a significant margin (see Table 5-11) with an average modulus of  $346,050 \pm 49,748$  psi. The flexural strength and the flexural modulus of the specimens taken from the spring line and invert of the liner were found to be below the respective values at the crown. The flexural strength of the exhumed liner is 12% below the value reported for the as-installed liner. Likewise, the flexural modulus of the exhumed liner is 25% below the value reported for the as-installed liner. These values may be expected to have some differences because the as-installed samples are not taken from the liner run itself, but rather from an extended portion of the liner within a manhole. The variation of data across all the retrospective specimens is examined further in Section 6.

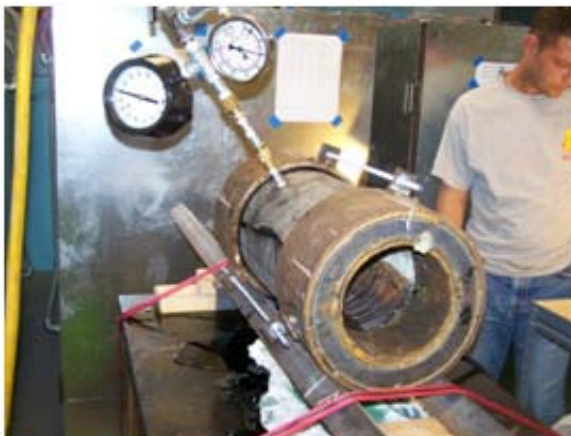
**Figure 5-22. Pressure on the Liner During Buckling Test**

Once the setup was completed, the buckling test commenced (Figure 5-22). The liner held a pressure of over 50 psi (corresponding to around 115 ft depth of immersion in water) for nearly 15 minutes (Figure 5-23). Leakage of water was observed through the liner material on the inner wall of the CIPP liner. These leaks suggest the presence of some migration paths through the resin matrix (Figure 5-24) at this elevated pressure. The cross-sectional profile of the liner before and after buckling is shown in Figure 5-11.

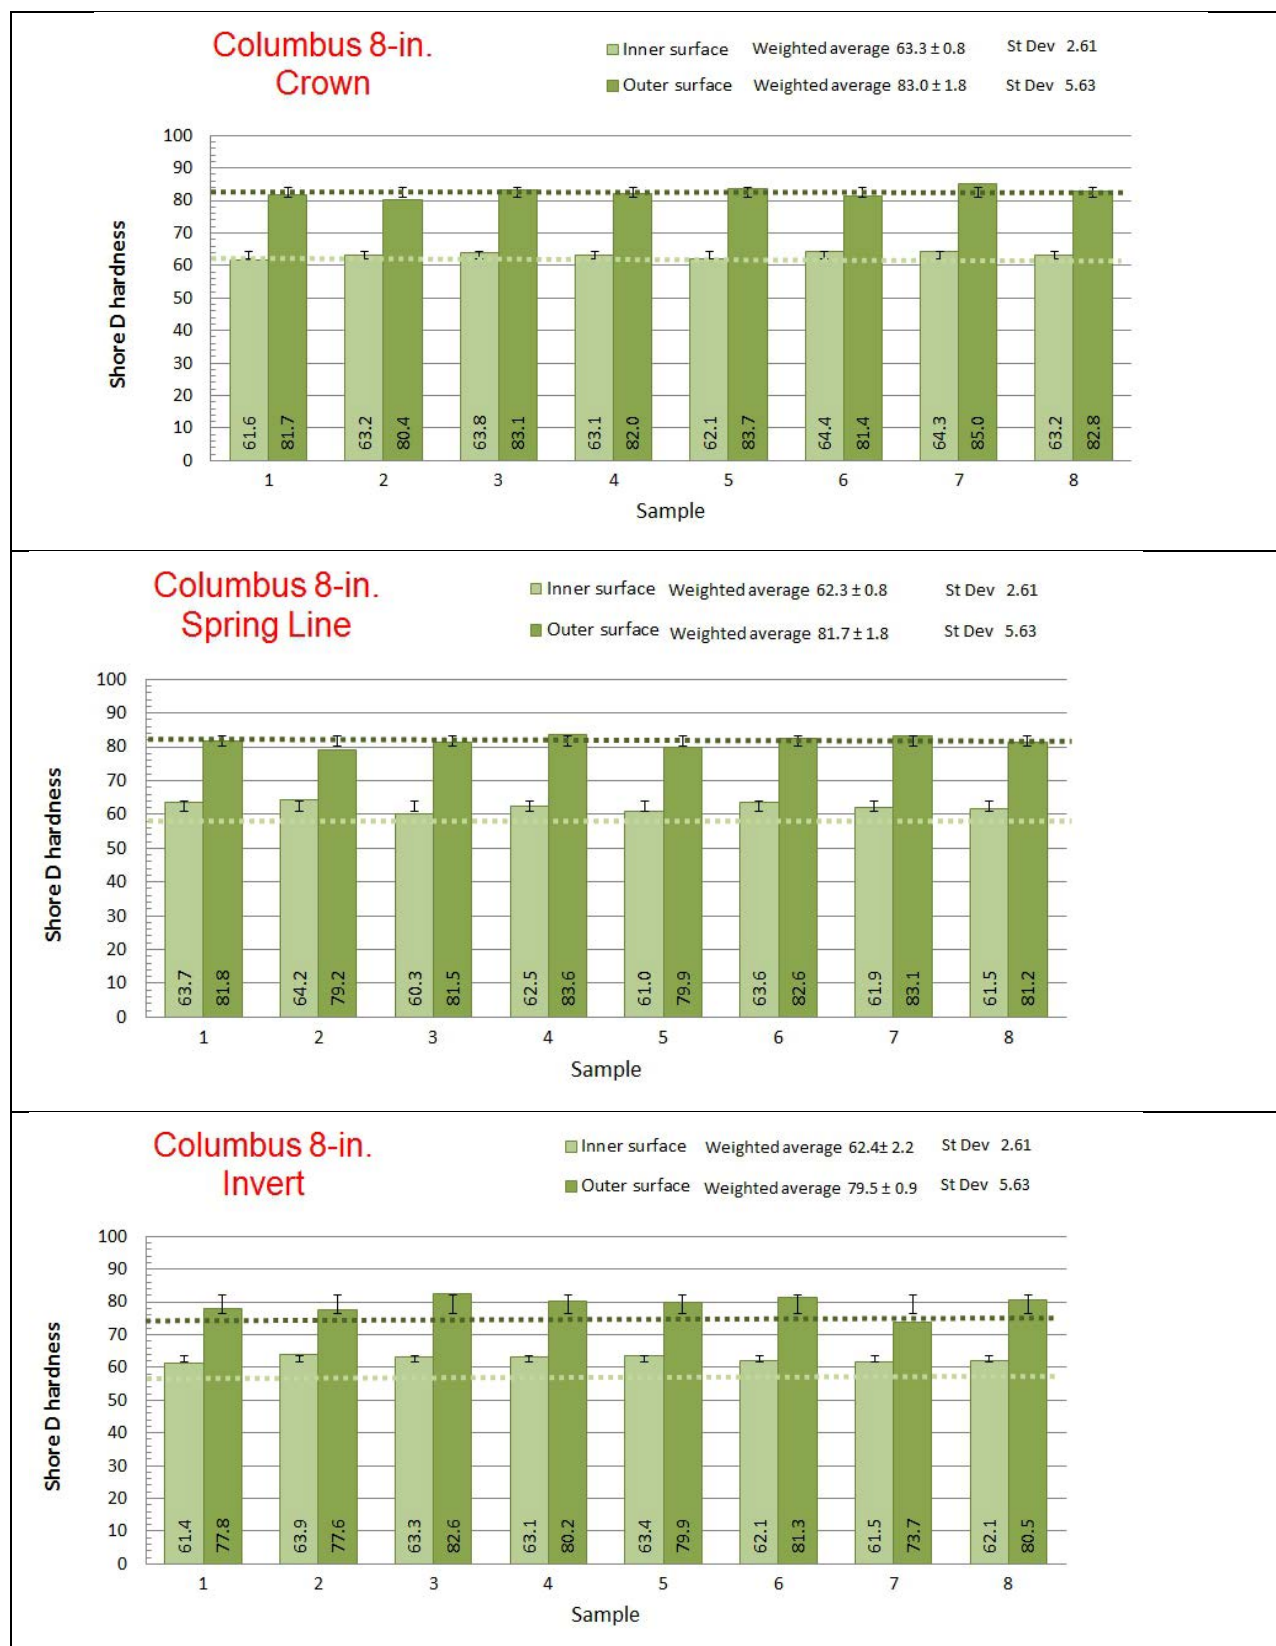
**Figure 5-25. Shore D Hardness Readings on Inner and Outer Surfaces (Columbus 8-in. Liner)**

All tests were performed using the Shore D hardness scale, which utilizes a weight of 10 lb (4,536 g) and a tip diameter of 0.1 mm. Tests were conducted on the inner and outer surfaces and a total of 1,440 readings were performed on samples taken from all of the locations. The recorded values are shown in Figure 5-25. As was noted in the Denver studies, it can be seen that the inner surface readings are approximately 23% softer (63.3, 62.3, and 62.4) compared with outer surfaces of the liner (79.5, 81.7, and 83.0). However, it is difficult to separate any effects of exposure to the waste stream from differences due to the presence of the interior surface coating.

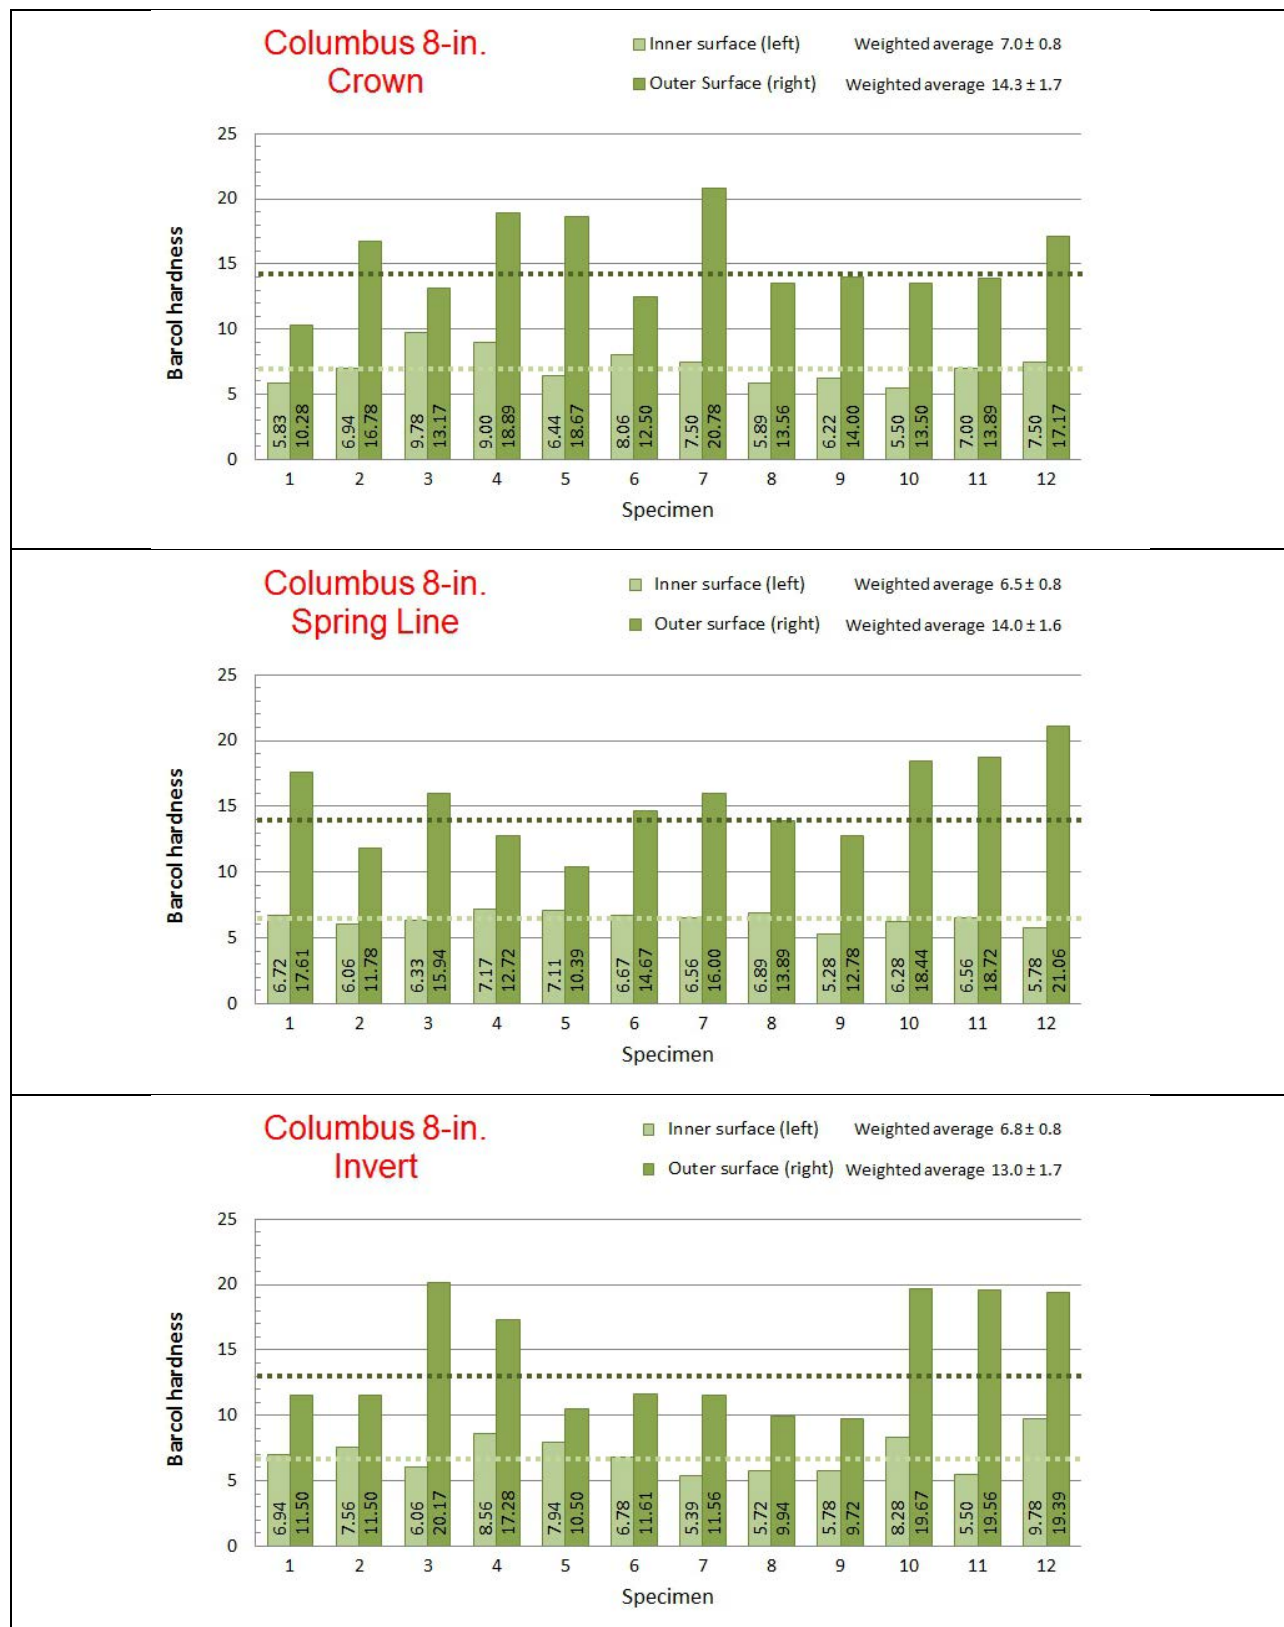
**5.2.17 Barcol Hardness.** Specimens were also subjected to the Barcol hardness test (ASTM D2583) as described for the Denver samples in Section 4. The results of the Barcol hardness testing for this liner are shown in Figure 5-26. The values (average of 6.77 for the inner surface and 13.76 for the outer surface) are much lower than for the equivalent testing for the Denver samples. For the inner surface, this may be a result of the different coating material used in recent liners than was used in the earlier liners retrieved from the Denver sites. Differences of similar magnitude are not seen in the Shore D hardness values between the Columbus and Denver 8-in. liners. While there is no correlation between these two hardness measurements methods, Barcol hardness is the more commonly utilized method in the CIPP industry. The Barcol hardness values for the 5-year old Columbus 8-in. liner show little difference between the inner and outer surfaces or between the invert readings and the crown readings. This may be due to the relatively short exposure of the liner to service conditions.

Figure 5-26. Barcol Hardness Readings on Inner and Outer Surfaces (Columbus 8-in. Liner)

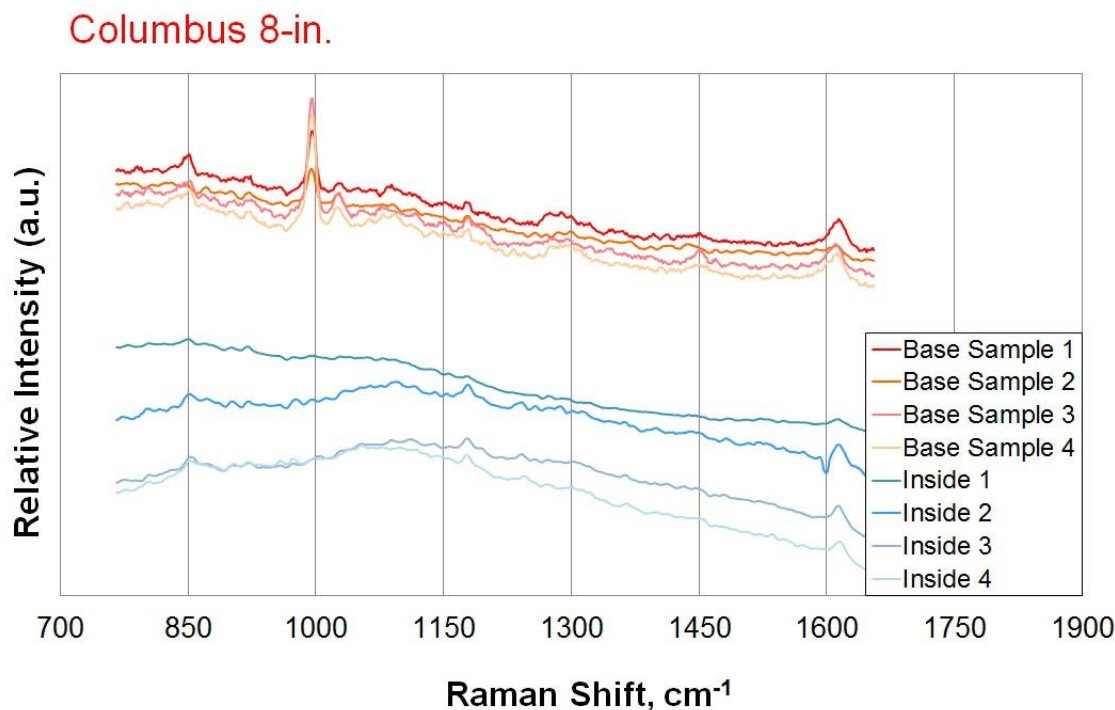
**5.2.18 Raman Spectroscopy.** The Raman spectroscopy plots for the Columbus 8-in. liner sample are shown in Figure 5-27. Plots are shown for the virgin resin, and several locations on the inside and outside liner surfaces. There is one clear difference in the presence of peaks between the base resin samples and the exhumed specimens, which was not seen in the Denver samples. A discussion of the possibilities for using Raman spectroscopy for liner evaluation is given in Section 6.

**Figure 5-27. Raman Spectra for the Columbus 8-in. Liner**

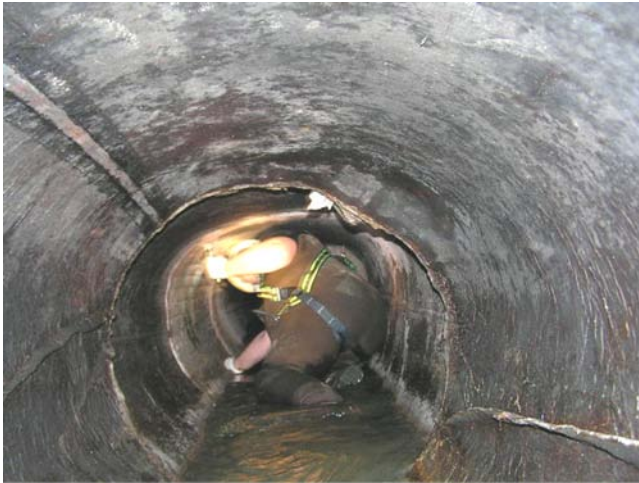
**5.3.2 Sample Recovery.** On-site personnel were present from the City of Columbus, Battelle, Jason Consulting, and Reynolds Inliner, Inc. The Reynolds personnel entered the pipeline, cut out a 52 in. × 24 in. rectangular sample (Figure 5-28) and prepared it for shipment. The sample was collected from approximately 2 ft upstream (south) of the access manhole (MH 0003C0008) at the 1 to 4 o'clock position approximately 2 in. above the flow line.

**Figure 5-28. Cutting Out the Columbus 36-in. Liner Sample**

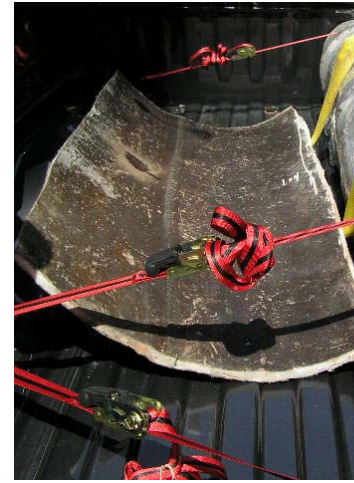
**5.3.3 Visual Inspection of Liner.** Images of the recovered specimen are shown in Figures 5-29 and 5-30. A visual inspection found the CIPP liner to be in good condition. The polymeric film (polyurethane) was essentially hydrolyzed except for the area where the seam was sealed. This is expected as the polyurethane was added as a sacrificial layer for confining the resin during the installation and curing process. The surface when rubbed clean of debris had a “fibrous finish”. This also is to be expected as the polyester fibers that were formerly embedded in the polyurethane are now exposed.

**Figure 5-29. The Exhumed Sample, 24-in. x 52-in. (Columbus 36-in. Liner)**

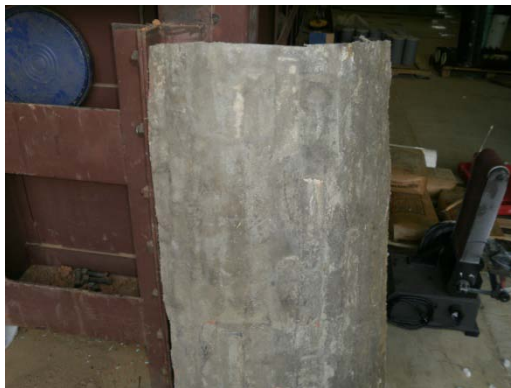
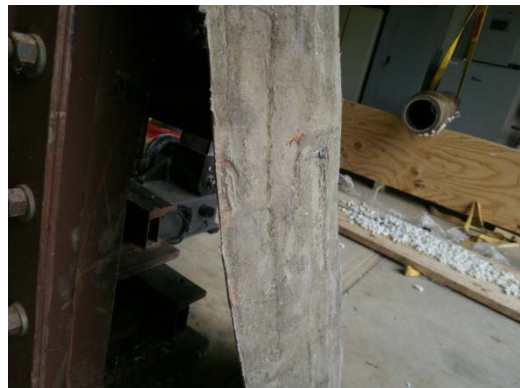
**Figure 5-30. Images of the Recovered Columbus 36-in. Specimen**

The outer surface of extracted sample mirrored the surface of the brick sewer in which it was installed. After removing the sample, some evidence of resin migration into the mortar joints was noticed. The CIPP did not appear to be chemically bonded to the sewer wall; in fact, a portion of the sample area had a compressed “clay-like” material on its surface, which would have prevented any such bonding. The mechanical bonding, however, was very good. The liner appeared to be positioned tight against the host pipe up to approximately the 11:00 o’clock position where an annulus began forming. Sounding the top of the CIPP indicated that this annulus continued around to the 1:00 o’clock position. This could be possibly attributable to an inadequate amount of head applied during the inversion process or inadequate cooling of the liner.

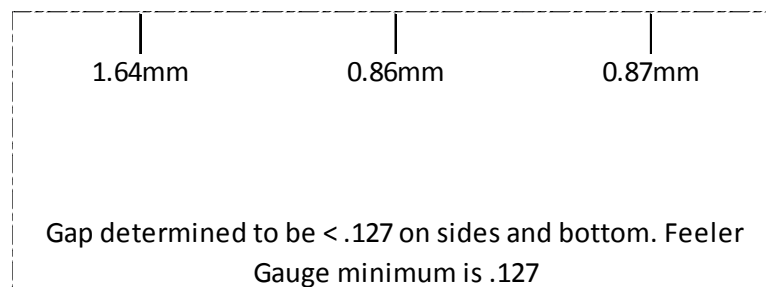
**5.3.5 Annular Gap.** A feeler gauge was used to measure the annular space around the perimeter where the sample was removed. The liner appeared to be very tight along the sides and bottom of the sample and a spacing greater than 0.127 mm was measured at only three locations (see Figure 5-31) – all along the top side of the sample removal area (see note on crown annulus gap in Section 5.3.3). The end measurements shown in Figure 5-31 were taken at approximately 4 in. from each end of the cutout and the middle measurement was taken at its center. Since the liner sample was removed from the host pipe, no laboratory annular space measurements were possible.

**Figure 5-31. Annular Space Measurements Around the Sample Removal Area (Columbus 36-in. Liner)**

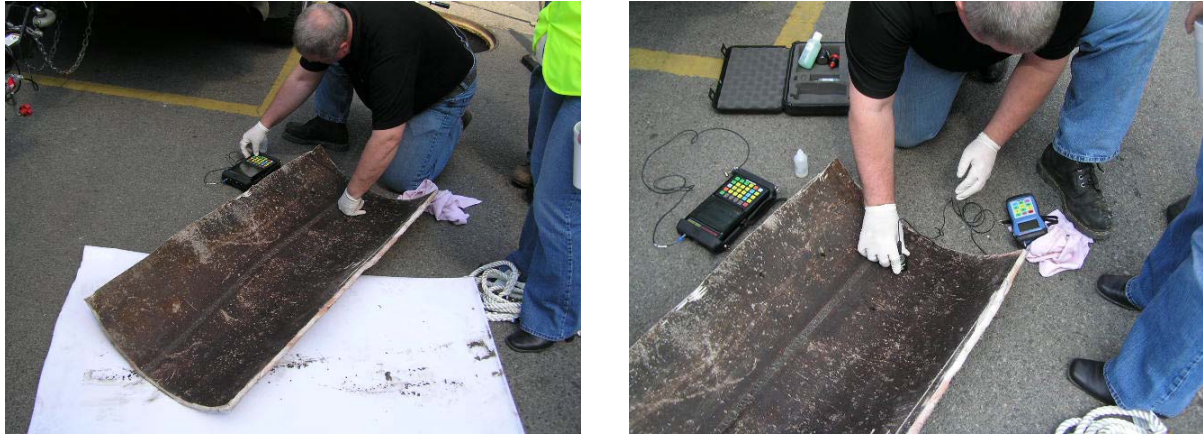
**5.3.6.1 Ultrasound Testing.** An ultrasonic meter (Olympus 37DL Plus) with a 2.25 MHz contact transducer was utilized in the field in an attempt to measure the thickness of the CIPP liner (Figure 5-32). However, the ultrasound testing for thickness did not produce any readings (apparently due to the thickness of this liner). This issue is discussed further in Section 6.

**Figure 5-32. Ultrasonic Testing for Measuring Liner Thickness in the Field**

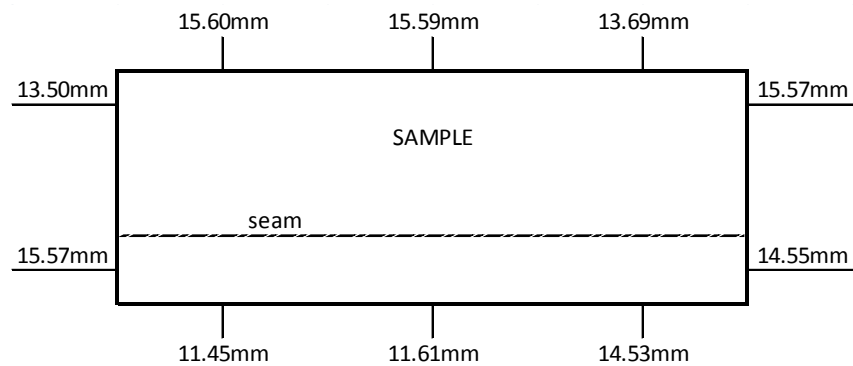
**5.3.6.2 Field Measurements.** Caliper measurements of the exhumed liner thickness were recorded around the edges of the extracted sample in the field as shown in Figure 5-33. The liner thickness measurements taken in the field are shown in Figure 5-34. The average thickness for the sample was calculated to be 14.2 mm and standard deviation was 1.5 mm. The original design thickness was not known, but it was assumed to be 15 mm (i.e., the same as the liner used for the adjacent line).

**Figure 5-33. Caliper Measurements of Columbus 36-in. Sample**

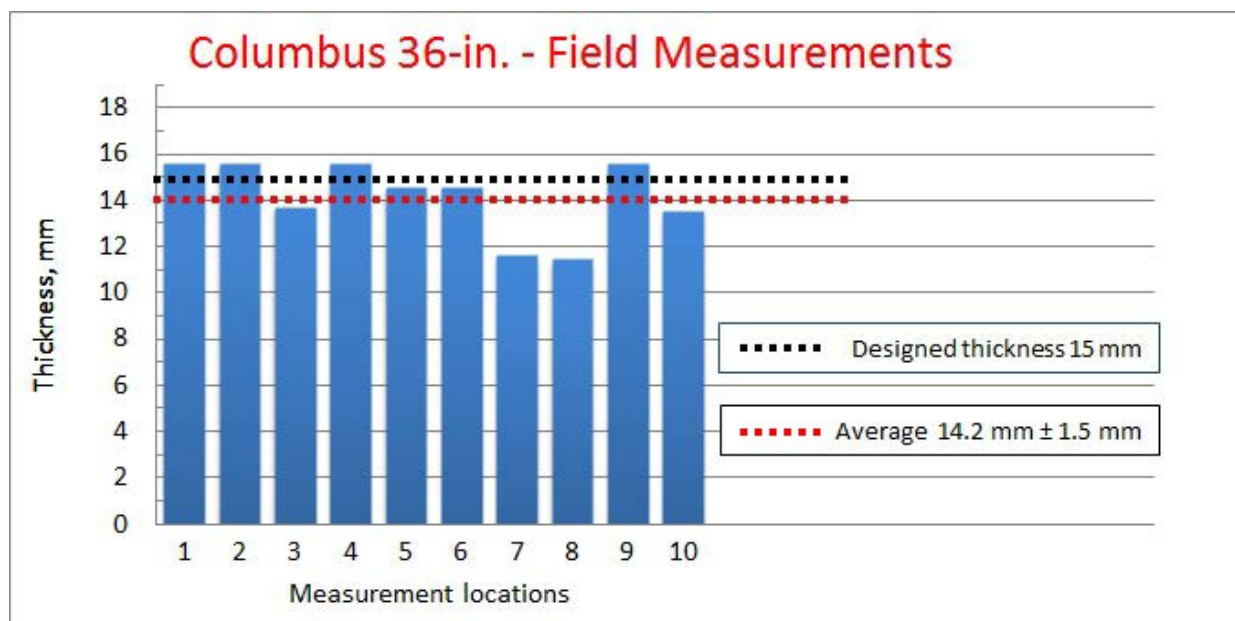
**Figure 5-34. Field Measurements of Thickness for Columbus 36-in. Liner**

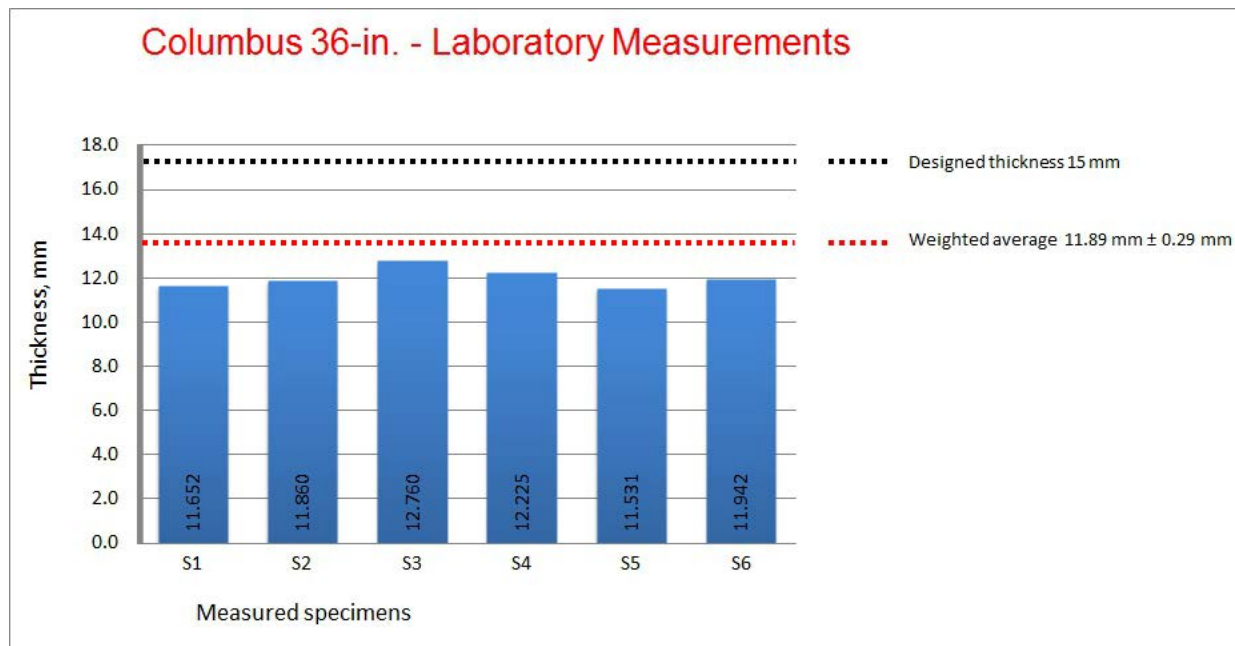
**5.3.6.3 Laboratory Measurements.** For determining the liner thickness in the laboratory, specimens cut out from the liner sample for the ASTM tensile and flexural tests were used. Six specimens were used and five readings were taken for each of the specimens using a micrometer. The average calculated values and their standard deviations are shown in Figure 5-35. The original design thickness stated in the figure was not known, but it was assumed to be 15 mm based on the thickness used for the adjacent liner. The weighted average for the sample thickness measurements was calculated to be 11.9 mm and the weighted error  $\pm 0.3$  mm. The laboratory measured values were 16% lower than the field measured values.

**Figure 5-35. Laboratory Measurements of Thickness for the Columbus 36-in. Liner**

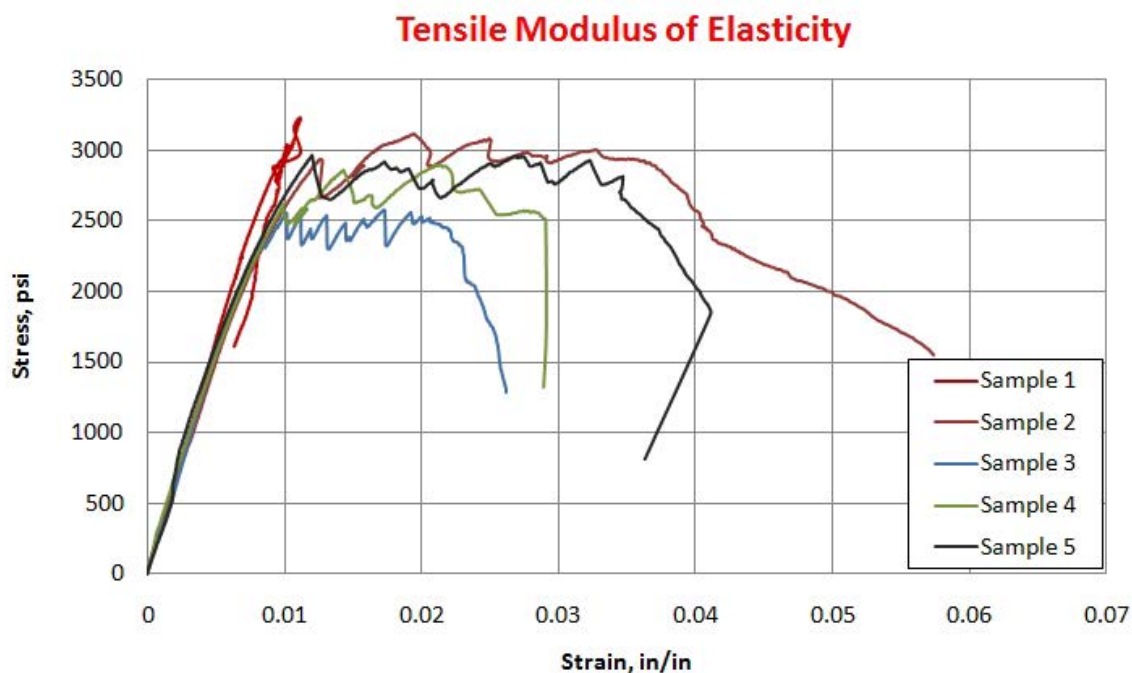
**5.3.9 Tensile Testing.** Specimen cutting and preparation for testing in accordance with ASTM D638 followed the procedures described earlier for the other retrospective samples. Table 5-15 provides the results from tensile testing. Using the information given in Table 5-15, the tensile stress-strain curves for all samples were developed and are presented in Figure 5-37.

**Figure 5-37. Tensile Stress-Strain Curves (Columbus 36-in. Liner)**
