# **A Retrospective Evaluation of Cured-in-Place Pipe (CIPP) Used in Municipal Gravity Sewers**

**Contract No. EP-C-05-057  
Task Order No. 58**

**U.S. Environmental Protection Agency  
Urban Watershed Branch  
National Risk Management Research Laboratory  
Water Supply and Water Resources Division  
2890 Woodbridge Avenue (MS-104)  
Edison, NJ 08837**

**September 2011**

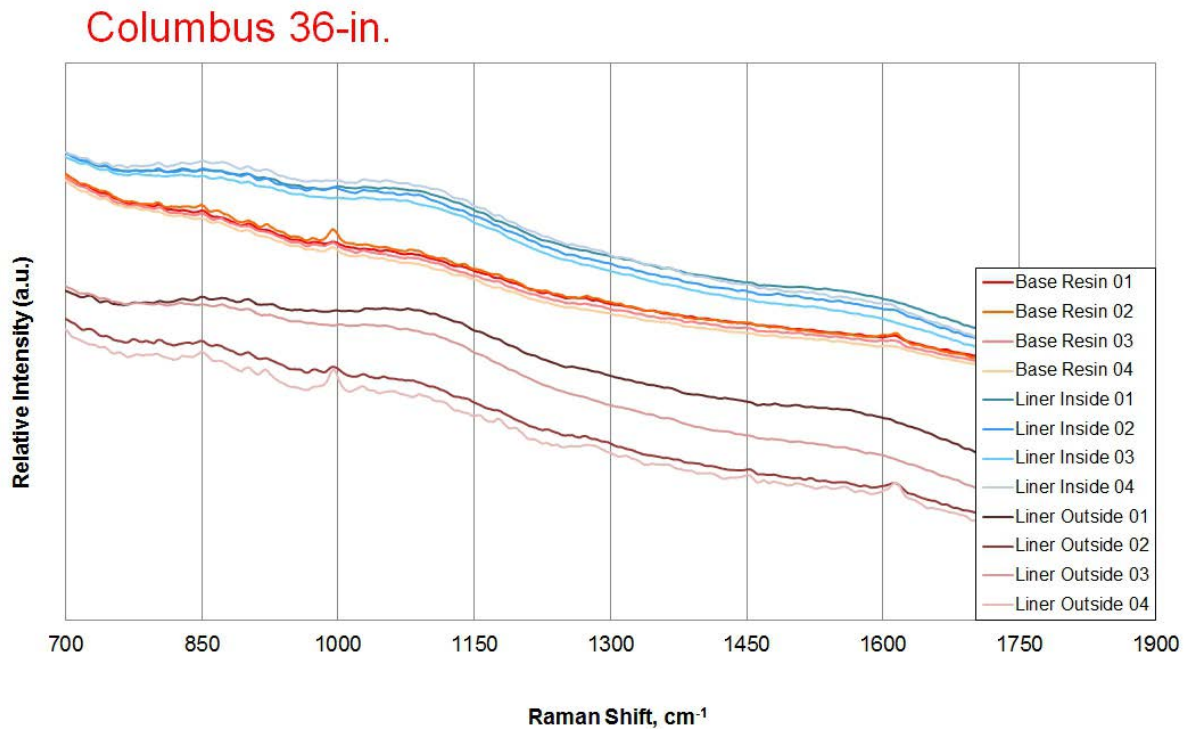
**5.3.12 Raman Spectroscopy.** The Raman spectroscopy plots for the Columbus 36-in. liner sample are shown in Figure 5-40. Plots are shown for the virgin resin, and several locations on the inside and outside liner surfaces. There are no clear differences in the shapes of the curves or the presence of peaks between the base resin samples and the exhumed specimens. This is similar to the results from most of the retrospective liner samples. A discussion of the possibilities for using Raman spectroscopy for liner evaluation is given in Section 6.

**Figure 5-40. Raman Spectroscopy Plots (Columbus 36-in. Liner)**

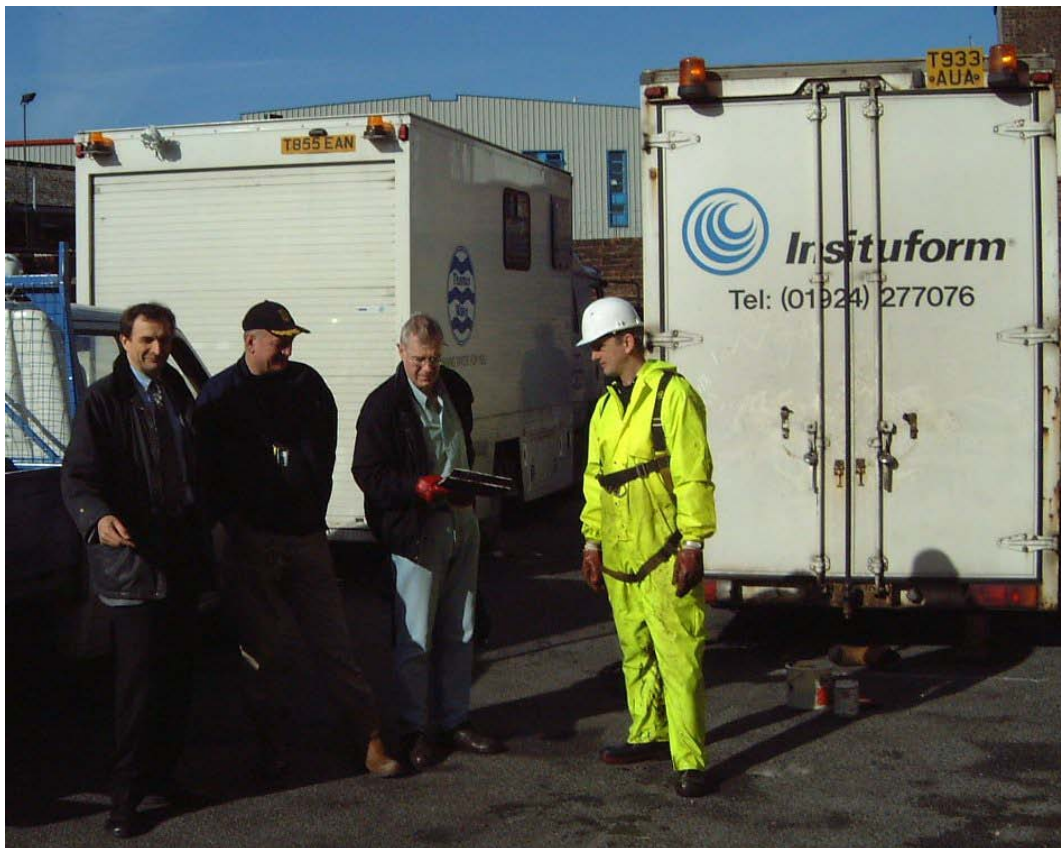
The original Insituform liner installed in the Brick Lane Sewer was examined in June 1991 and two sample panels were removed from the lining by Insituform Permaline, Ltd., and placed in the custody of MTS Pendar, Ltd., under the scrutiny of TW. The panels were cut from the sidewall of the liner along the spring line of the sewer about 3 ft (900 mm) from the access manhole located in Riverside Close. The location was revisited in October 2001 and two sample panels about 1 foot (300 mm) square were removed from an area of the sidewall about 6 ft (1.83 m) into the sewer (Figure C-1). The second set of samples was placed in the custody of Bodycote Materials Testing, Ltd. (owners of MTS Pendar). In each instance, test pieces were machined from the test panels and tested for flexural strength and modulus in accordance with the relevant testing specifications: BS 2782 Part 3 Method 335A:1978 in 1991 and U.K.WIS 4-34-04/BS EN ISO 178 in 2001. The results of this retrospective evaluation spanning 20 to 30 years after the original CIPP installation are summarized in Table C-1.

**Figure C-1. Sample Retrieval at the Brick Lane Sewer CIPP Project in Hackney, U.K.**
