Field Demonstration of Innovative Condition Assessment Technologies for Water Mains: Acoustic Pipe Wall Assessment, Internal Inspection, and External Inspection

**FIELD DEMONSTRATION OF INNOVATIVE CONDITION ASSESSMENT TECHNOLOGIES
FOR WATER MAINS: ACOUSTIC PIPE WALL ASSESSMENT, INTERNAL INSPECTION,
AND EXTERNAL INSPECTION**

VOLUME 1: TECHNICAL REPORT

September 2013

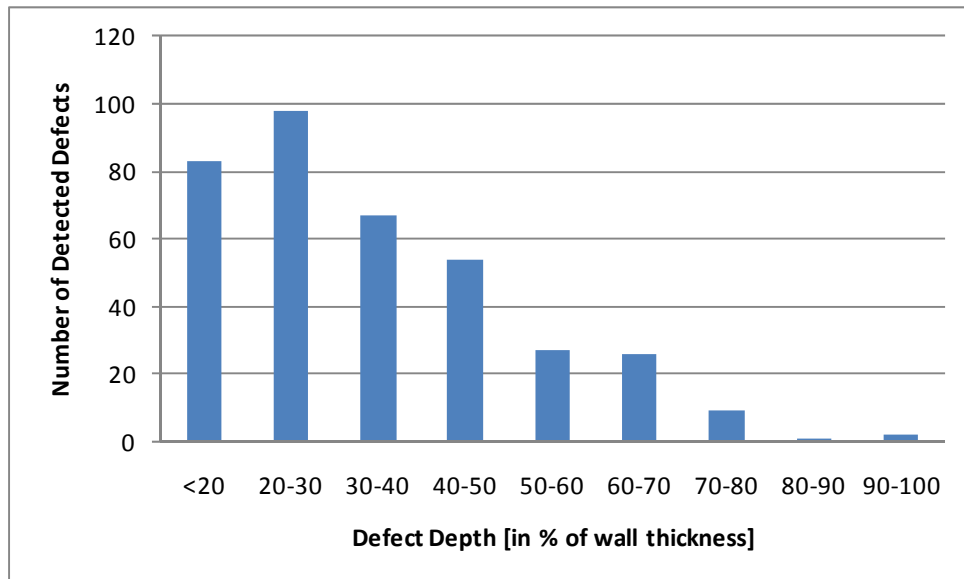
Figure 2-1. Defect Histogram

See Snake[®]. The See Snake[®] detected 367 wall loss indications. Figure 2-1 shows that a majority of the defects are less than or equal to 50% deep, with a much smaller group in the 60% to 80% range, and only a few defects 90% or deeper. More importantly, the results from See Snake[®] show that the deep defects are concentrated within the first half of the line, leaving about half of the line with approximately original wall thickness.

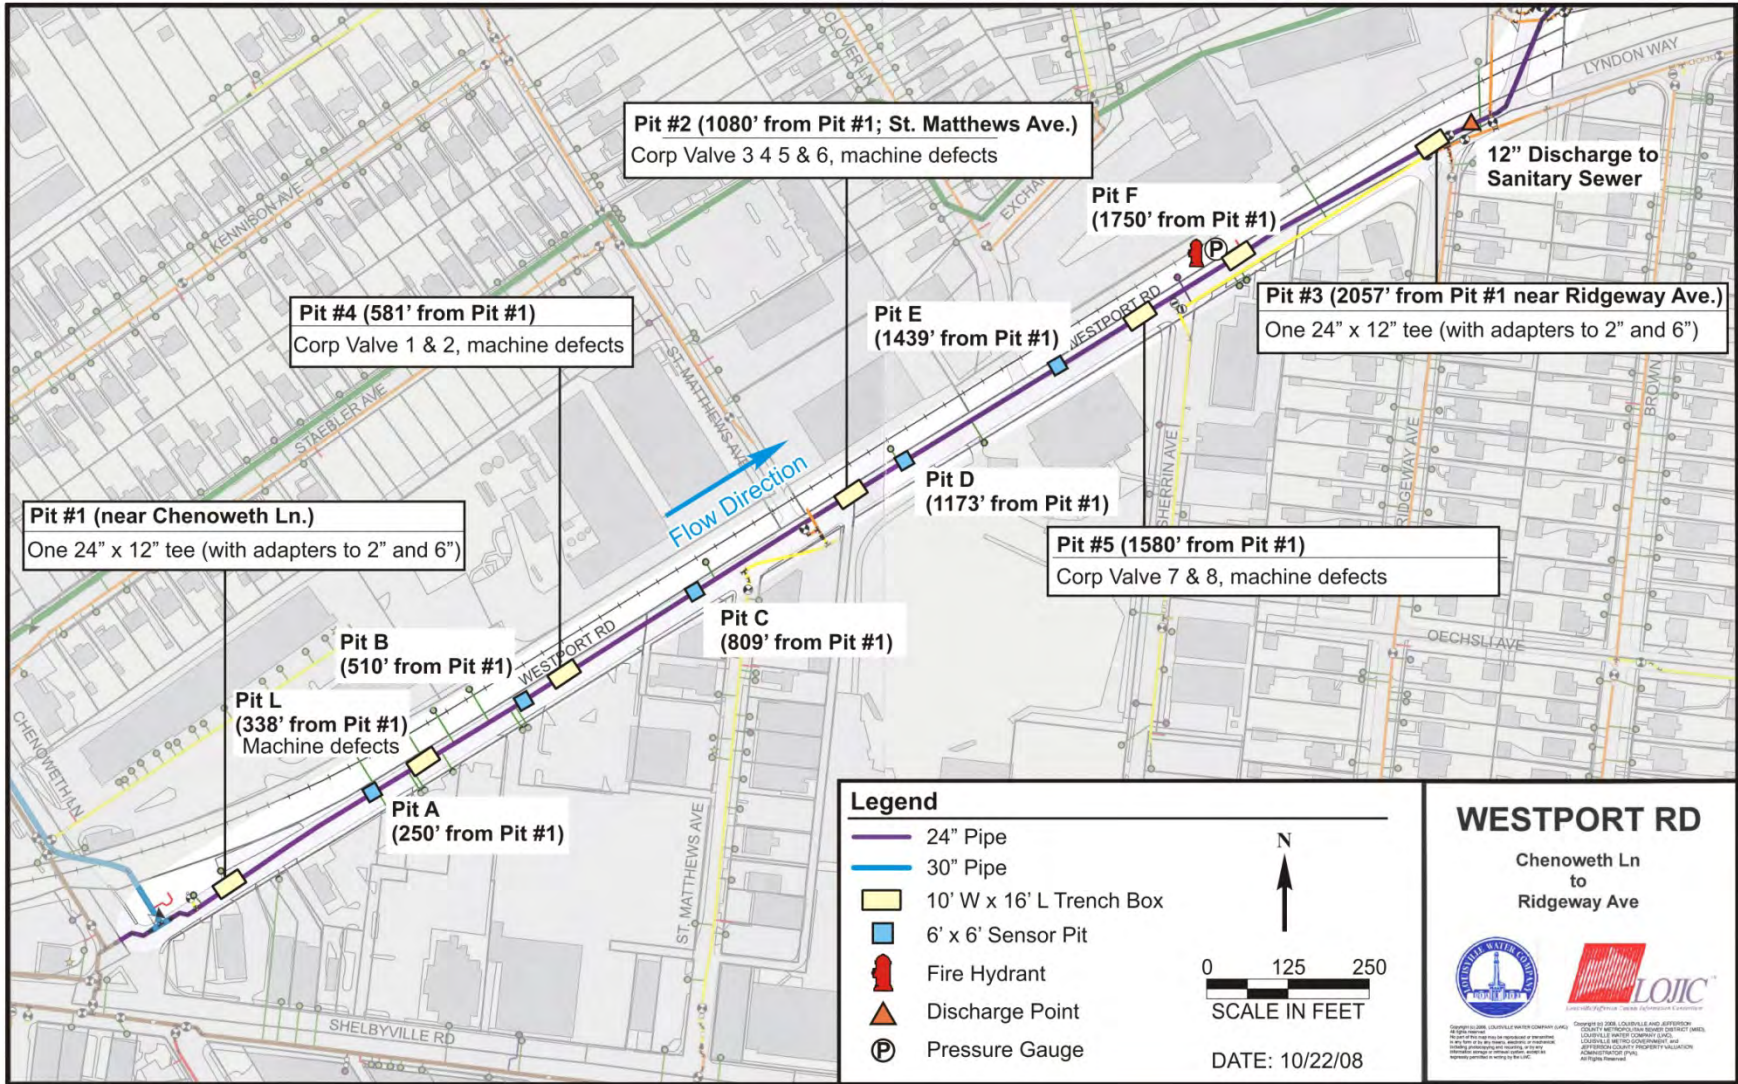
Figure 3-23. Location of Pits for Demonstration

Excavation. Five large excavations were used for the various technologies during the demonstration; these included Pits 1 through 5 as shown in Figure 3-23 and described in Table 3-5. These sites were selected based solely on location along the test pipe. Since the condition of the pipe was initially unknown, EPA’s contractor machined several metal loss defects within Pits 2, 4, 5, and F¹⁰ to facilitate tool calibration and to ensure defects were available to find during inspection. Six small excavations, identified as Pits A, B, C, D, E, and F in Figure 3-23, were used to demonstrate one leak detection system and several other condition assessment technologies. Pictures of pre-excavation locations for Pits 1, 2, and 3 are shown in Figures 3-24 through 3-26.

Three large excavations were used for the external condition assessment technologies during the demonstration including Pits L, 2, and F as shown in Figure 3-23 and described in Table 3-5. These sites were selected based on location constraints; Pit L was near an excavation to confirm the largest leak detected in first few weeks of the demonstration. Since the condition of the pipe was initially unknown, EPA’s contractor machined several metal loss defects within Pit 2 and Pit F to facilitate tool calibration and to ensure defects were available to find during inspection. Also, small pit-like metal-loss defects were installed in Pit 4 and 5.

Pit L	<ul style="list-style-type: none"> 326 ft from first 24-in. × 12-in. tee in Pit 1 ~14 ft of pipe exposed; ~2 ft circumferential clearance 	<ul style="list-style-type: none"> Large leak detected A large leak was verified at the bell and spigot joint.

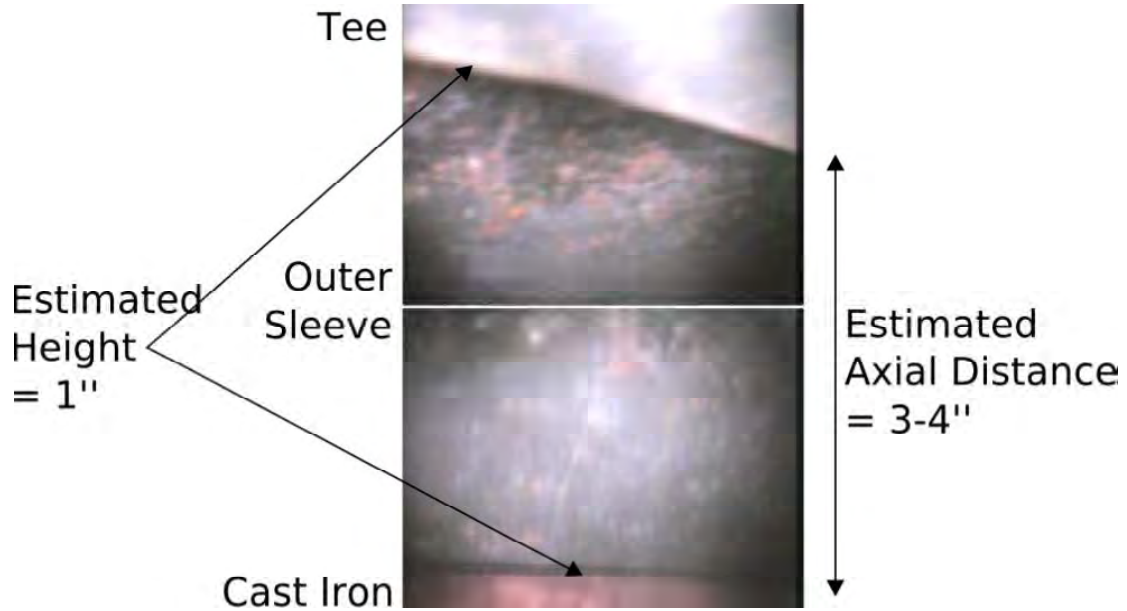
(Courtesy of vendor)
Figure 3-34. Sahara[®] Video of the Joint Gap

During the first insertion attempt on July 21, 2009, the PipeDiver[®] vehicle became stuck during the insertion process and therefore the launch had to be aborted. Video data was recorded during the Sahara[®] Video (Figure 3-34) inspection to investigate what was causing the PipeDiver[®] vehicle to become stuck in the line. The inspection vendor's conclusion was that the front of the PipeDiver[®] vehicle had become stuck in a 3- to 4-in. wide, unfilled gap between joints just downstream of the insertion point (see schematic in Figure 3-35).

Modification of the tool was designed and implemented allowing for the completion of four inspection runs. PipeDiver[®] is designed for live inspections using standard accesses including 12-in. diameter hot

taps, tees with minimum joint gaps, or similar features. For certain accesses such as tees with large unfilled joint gaps or accesses with unknown internal conditions, the vendor recommends using Sahara[®] Video prior to the inspection to identify the exact layout of the insertion point. The insertion design and process can then be modified for a successful insertion if required.

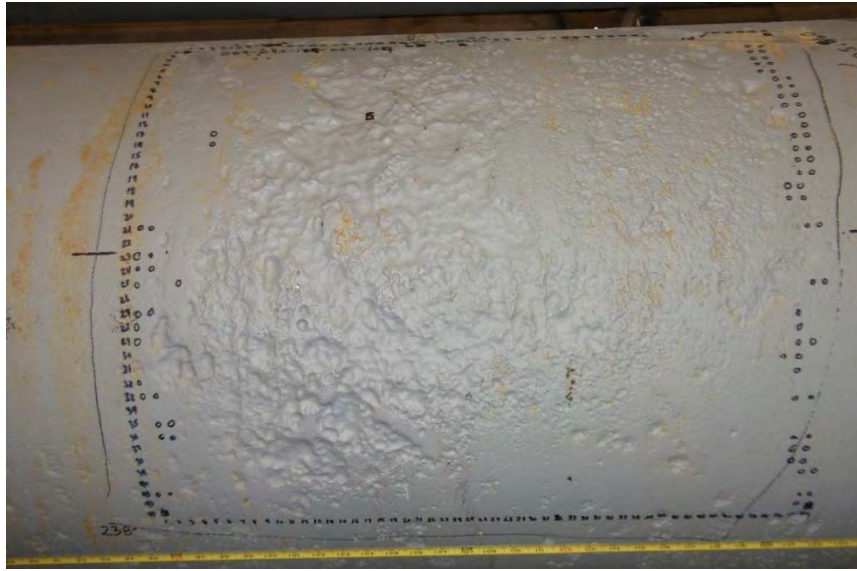
Figure 4-4. Corrosion Area on Pipe 69: 95-in. from the spigot, 129-degrees from the top of the pipe, 27-in. in axial extent and 109-degrees in circumferential extent

A typical result of the metal loss evaluation is shown in Figures 4-4 and 4-5. Figure 4-4 shows the corrosion area on pipe 69 (at 95-in. from the spigot, 129-degrees from the top of the pipe, 27-in. in axial extent, and 109-degrees in circumferential extent). Figure 4-5 shows a color coded depth area contour map. Each color change corresponds to a change in depth of 0.05-in. While corrosion is present throughout the region, the deepest corrosion is more severe on the left side of the anomalous region shown. The deepest pit is between 0.35- and 0.40-in., or 50% of the pipe wall thickness.

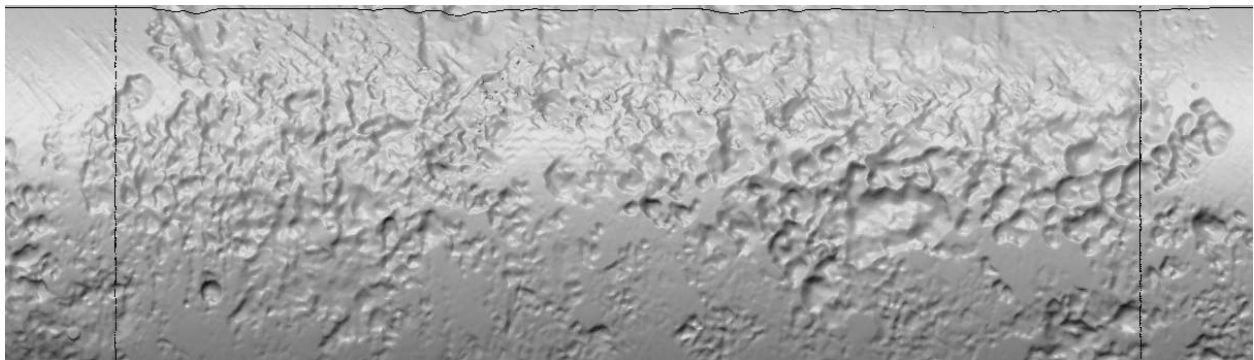
Figure 4-7. CMM Laser Scan Image of Pipe 63

Figure 4-6 shows the laser scanning of Pipe 63. The handheld CMM unit is in the upper left hand corner. The white dots, referred to as targets, are applied to areas of the pipe without metal loss. The coordinates of these points enables the establishment of a reference cylinder for estimating corrosion depth. A typical result is seen via laser scan in Figure 4-7 and via normal photography in Figure 4-8.

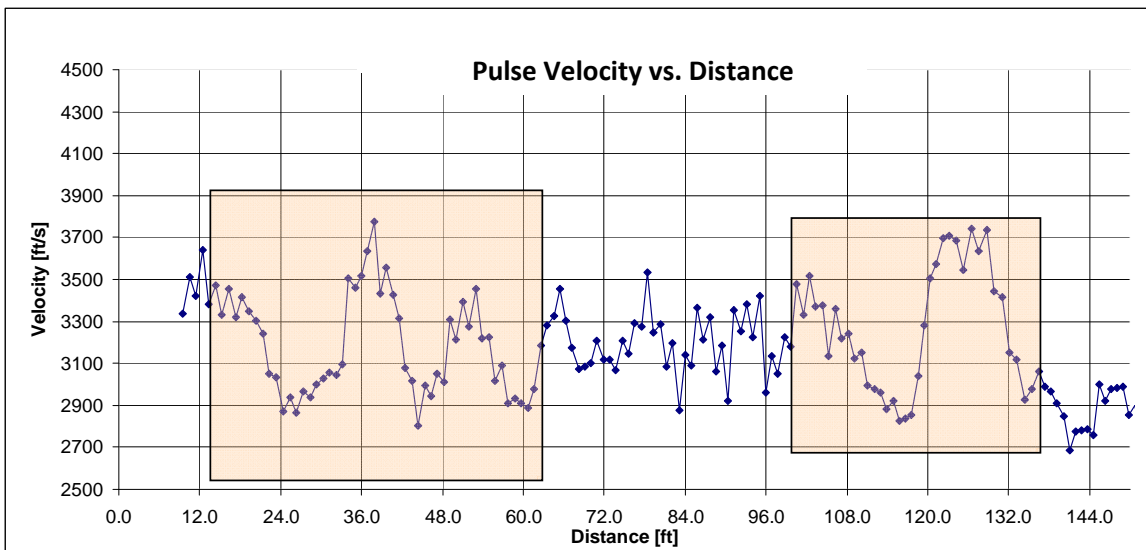
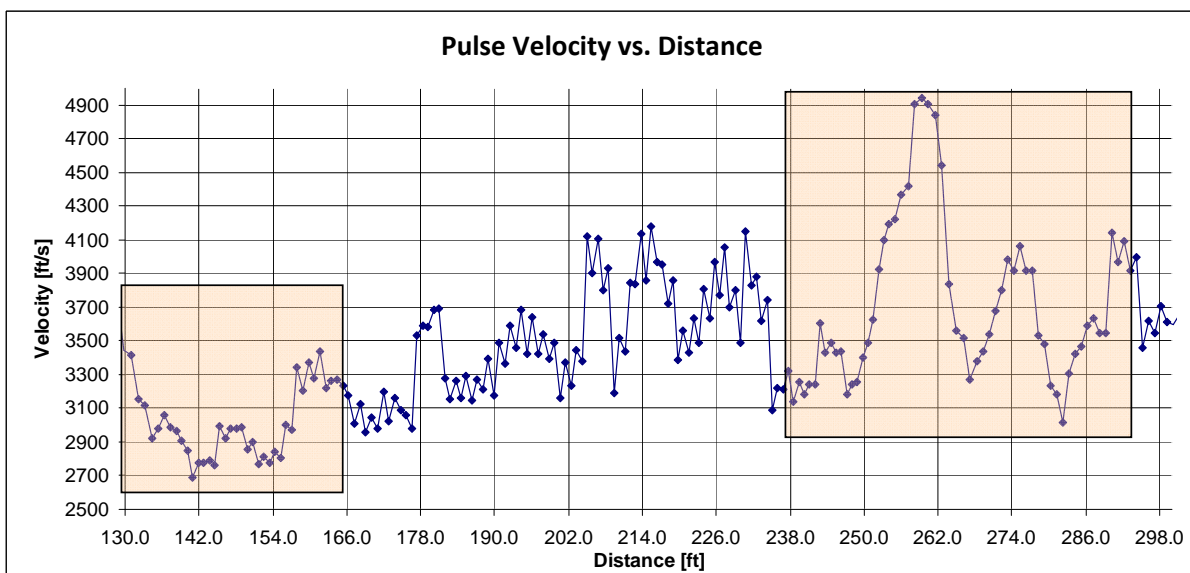
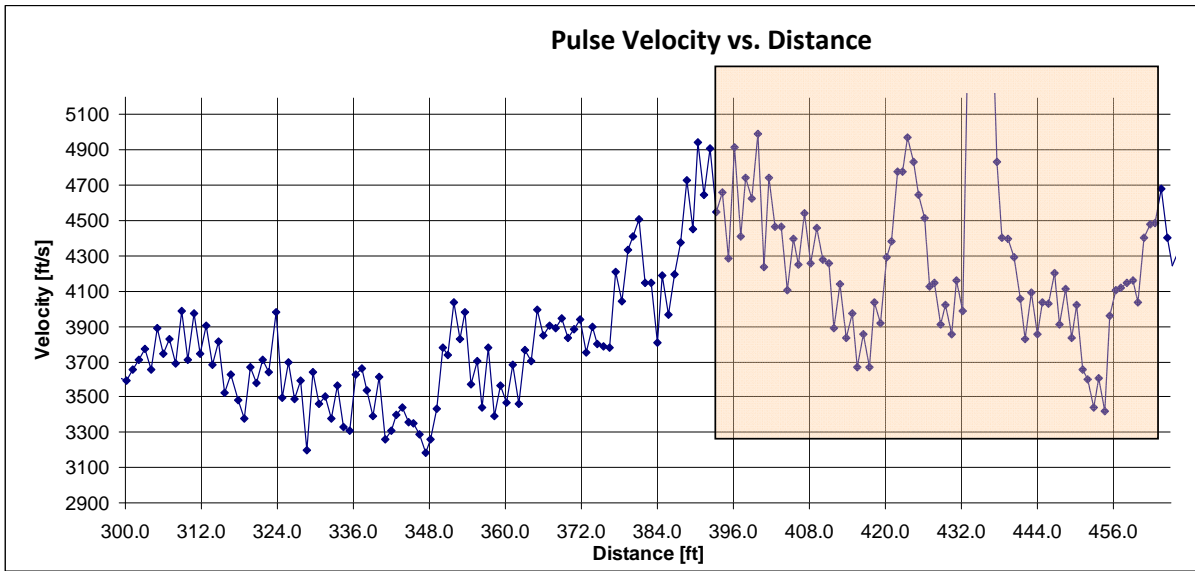
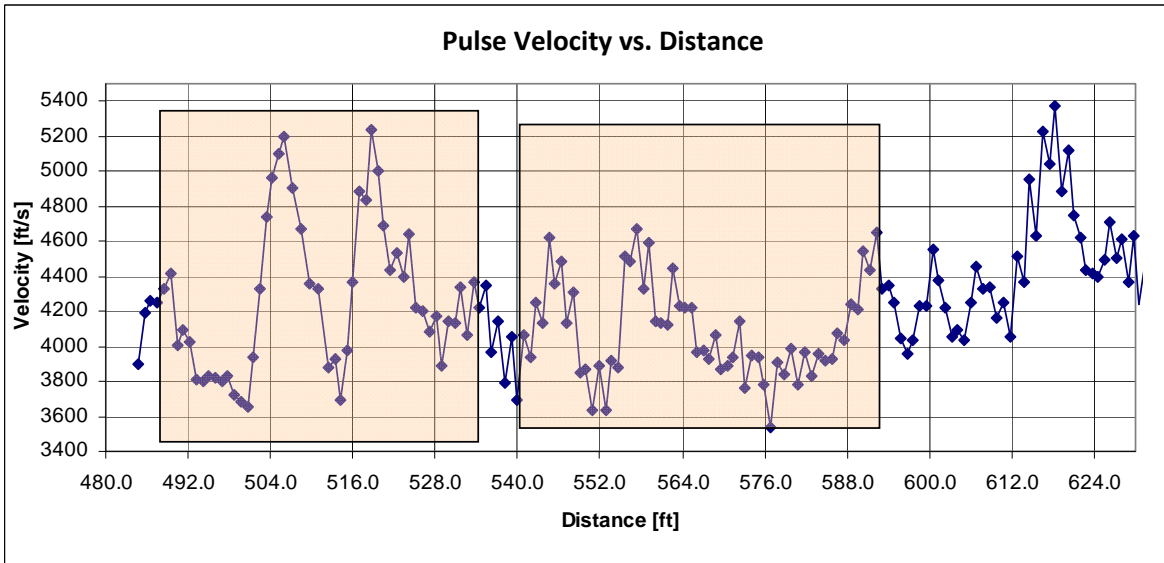
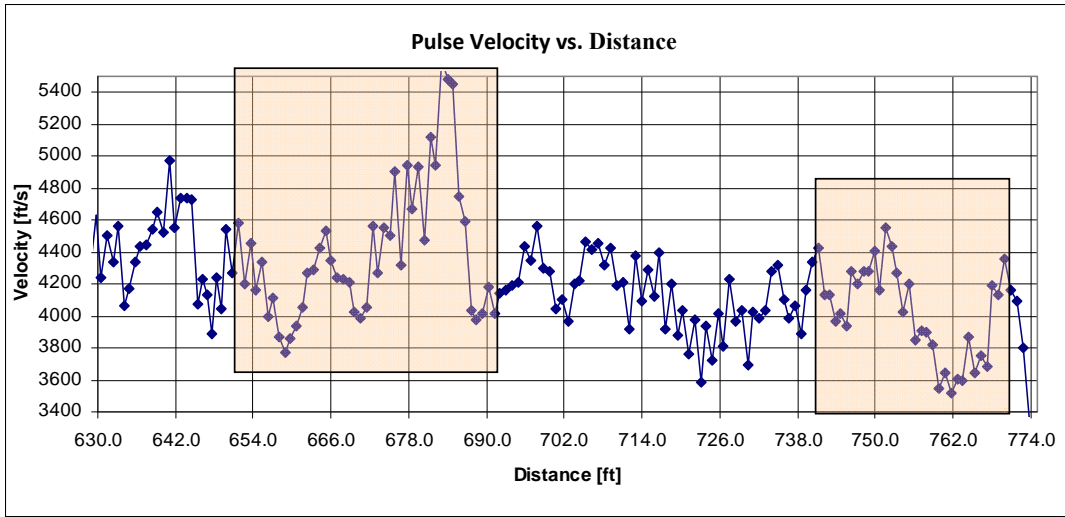
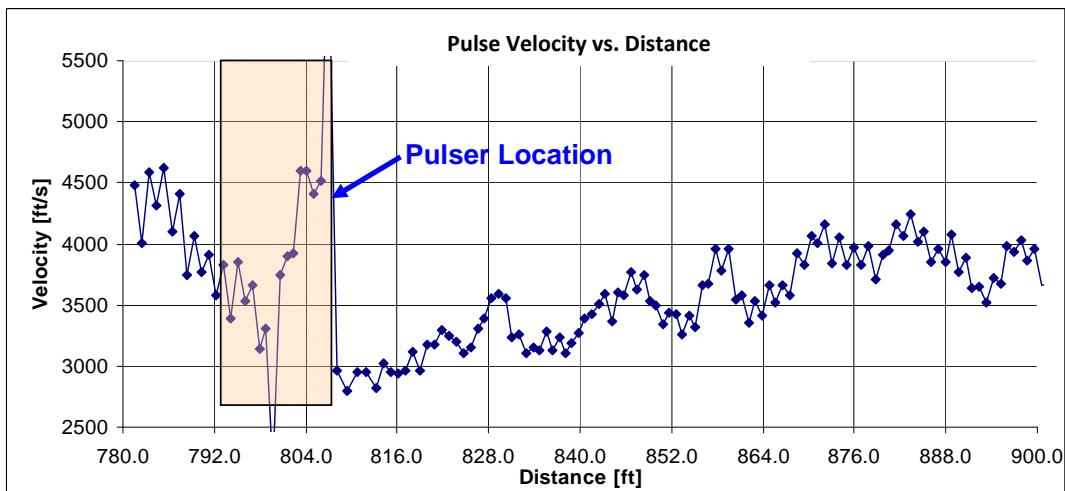
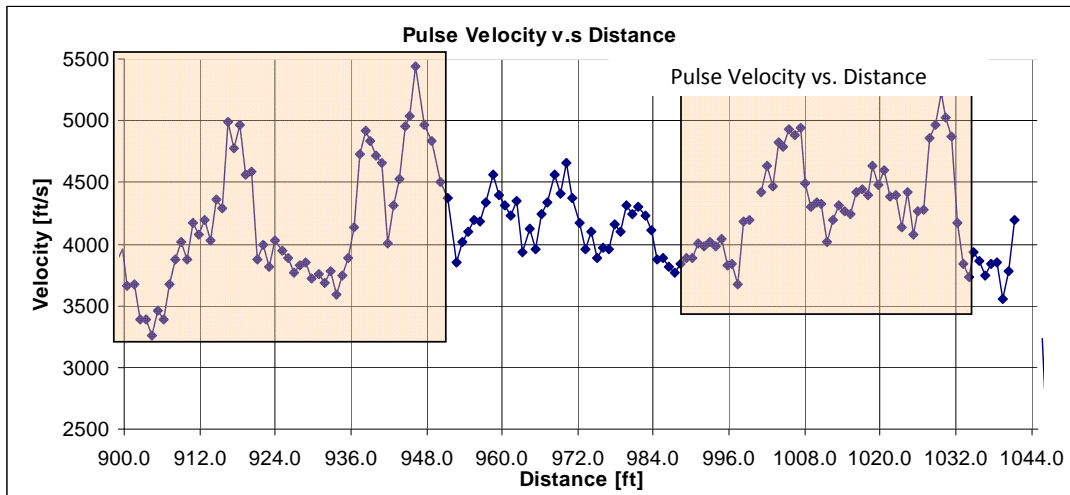
The graphs in Figure 5-1 through Figure 5-7 show the condition of the pipe as detected by the SmartBall[™] PWA with respect to its distance along the pipeline. Since the pipe wall thickness is directly proportional to the velocity of the signal as it propagates through a water filled pipe, these graphs indicate that there is some evidence of pipe wall stiffness changes within the highlighted areas. However, although the data suggests that several interesting variations exist in the pulse velocity at different points along the pipeline, it was unclear whether the data revealed actual changes in the hoop stiffness of the pipe wall, or if the data had been affected by the presence or condition of the mortar lining or other pipe stiffness enhancements (such as previous repairs on the pipe). This is a common issue for acoustic-based technologies.

Table 5-3 provides a summary of the locations with evidence of pipe wall weakness up to the second pulser location. In addition, the SmartBall™ PWA was able, in some portions of the pipeline, to detect features such as valves and joints based on increased acoustic velocity. For example, the acoustic profile showed increased acoustic velocities at, or in the vicinity of, the 12-ft intervals of the joints (see Figure 5-8) and at a drain valve approximately 260 ft from the insertion location (see Figure 5-9). The spatial resolution of the tool factored in the flow velocity and was at least one data point every two ft along the line. This technique is not designed to detect individual pits, but may reveal areas where clusters of pitting or thinning produce weakening over several feet along the pipe.

Location of Interest	Sections of Interest Downstream from Launch Point
1	14 ft to 63 ft
2	100 ft to 138 ft
3	130 ft to 165 ft
4	237 ft to 292ft
5	393 ft to 465 ft
6	488 ft to 535 ft
7	540 ft to 592 ft
8	650 ft to 692 ft
9	742 ft to 770 ft
10	794 ft to 808 ft
11	900 ft to 950 ft
12	990 ft to 1,034 ft

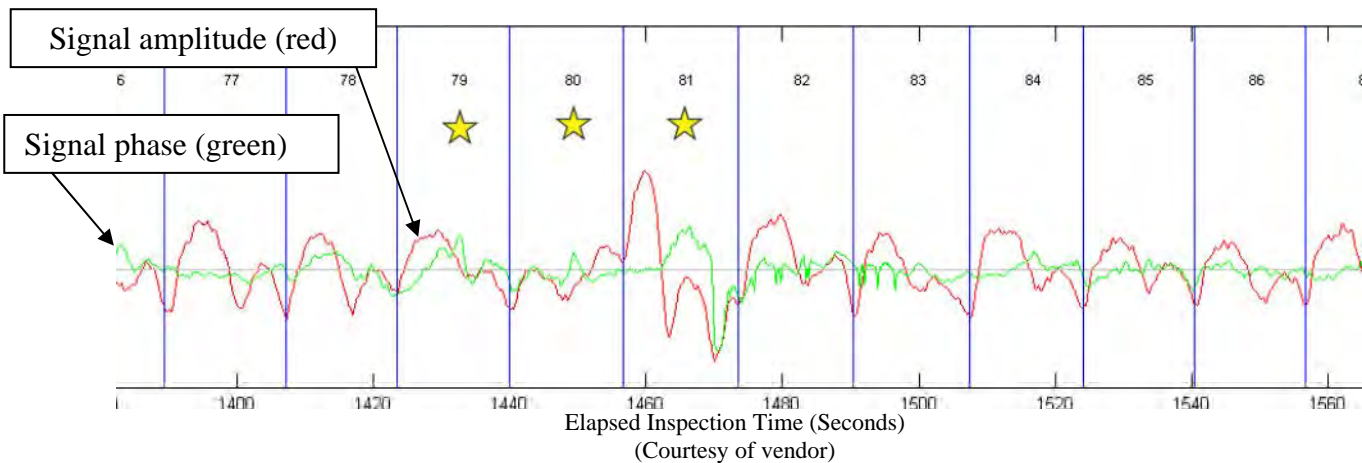
Figure 5-10. PipeDiver RFEC Anomalous Pipes (for Reference Elapsed Inspection Time (sec) and Pipe Length Number are Given)

Figure 5-10 shows an example of several pipes classified as anomalous from their RFEC signal. The proprietary processing routine produced two separate outputs, signal amplitude (red curve) and signal phase (green curve). When assessing the red signal, the two hump pattern with the first higher than the second is considered normal. The entire signal in pipe 81 is larger and different from the normal pipe signal and could be due to wall thickness loss or from an unidentified pipe feature. Pipe 80 is missing the pattern altogether, which could be due to a wall thickness loss. For pipe 79, the dip is missing, but this may be due to degradation in pipe 80. The green signal was not useful in characterizing pipe.

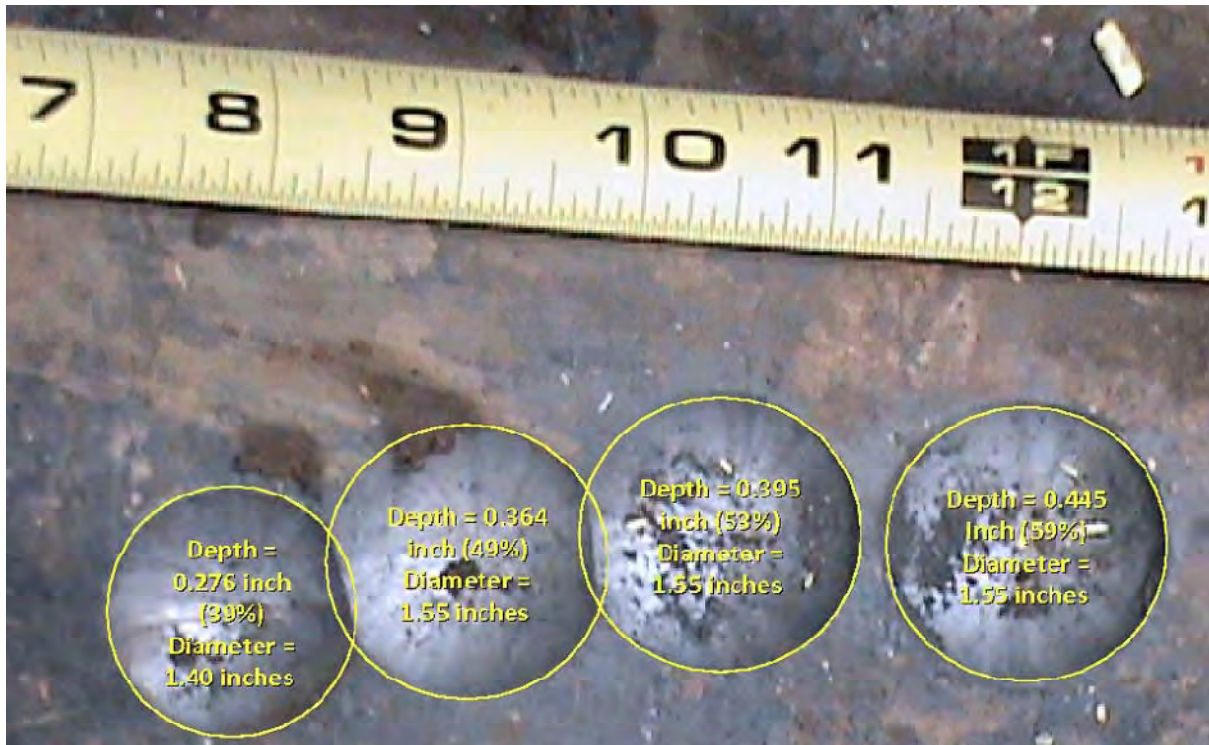
Figure 5-11. Calibration Defects in Pit F

Four manufactured defects were machined into Pit F on July 28th (see Figure 5-11). By comparing the RFEC signals from the data before and after the defects were created gave PipeDiver® data analysts the

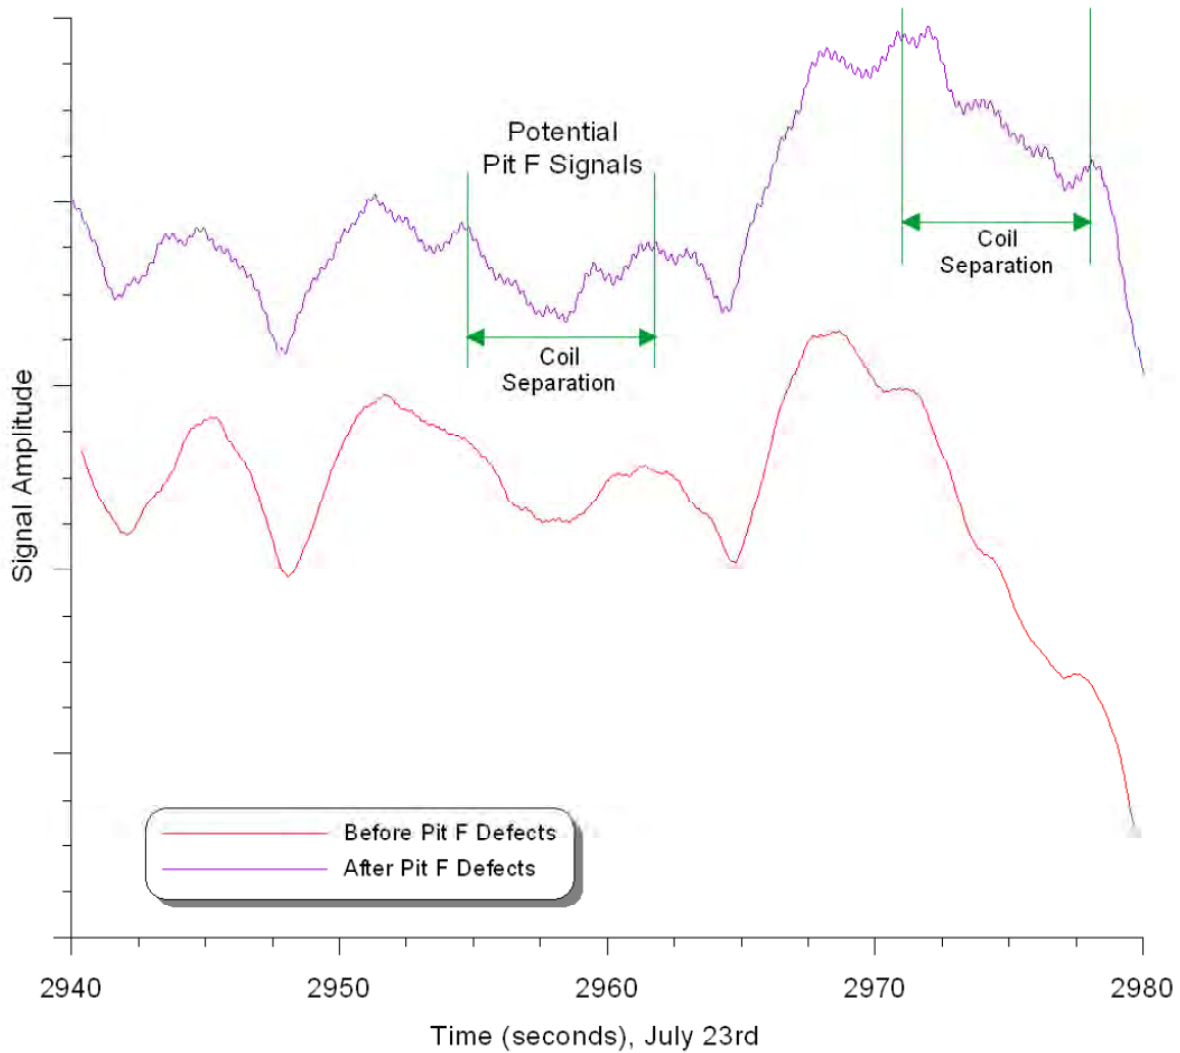
Figure 5-12. Comparing RFEC Data Before and After Defects

best possible chance of seeing the relatively small amount of wall thickness loss in the data (see Figure 5-12).

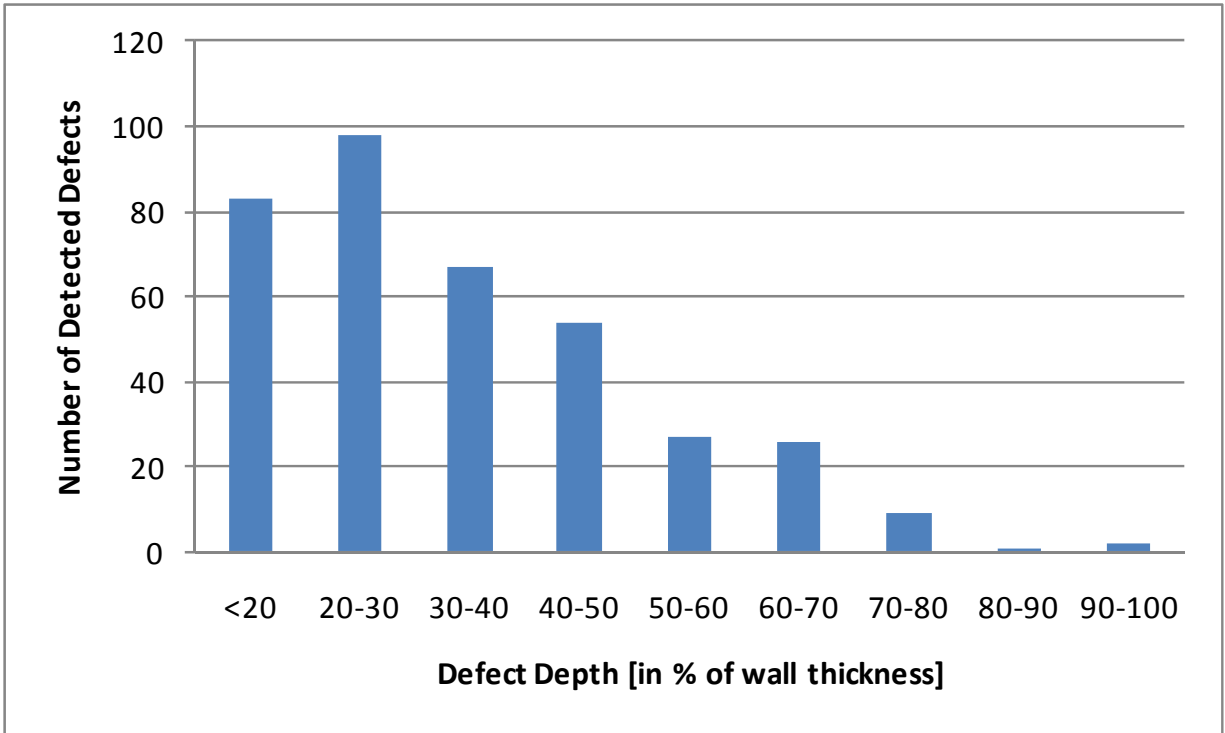
(Adapted from vendor report)
Figure 5-13. See Snake[®] Defect Histogram

The inspection of the water line resulted in 367 wall loss indications. A histogram of the results shows that a majority of the defects were less than or equal to 50% deep, with a much smaller group in the 60-80% range, and only a few defects 90% or deeper. More importantly, the results from the See Snake[®] tool show that the deep defects are concentrated within the first half of the line, leaving about half the line in relatively good shape. A histogram of the number of defects by wall loss percentage is provided in Figure 5-13, while the defect depth as a function of distance along the pipeline is provided in Figure 5-14.

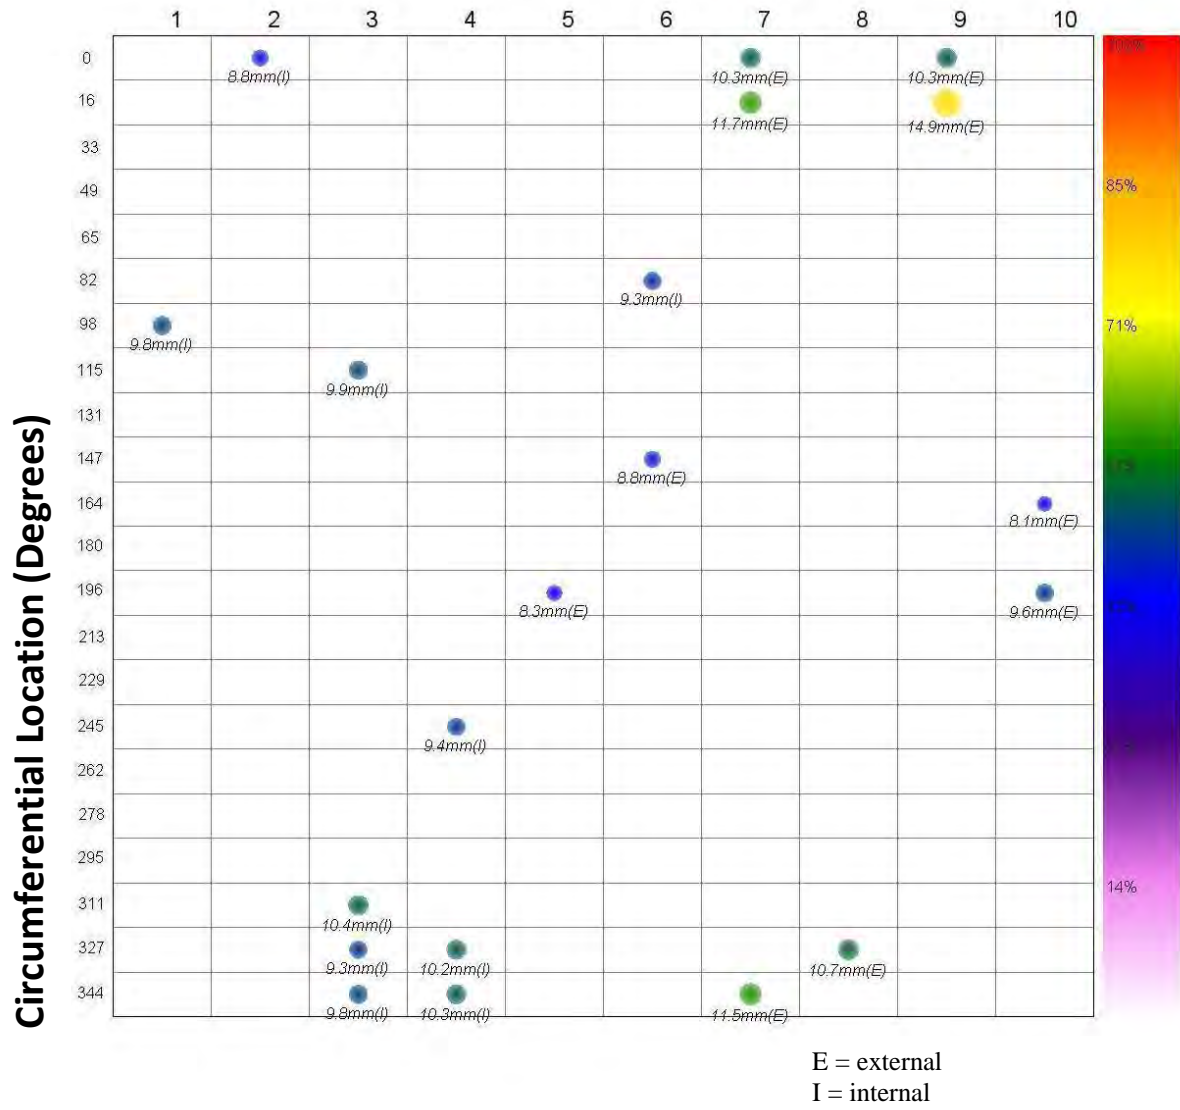
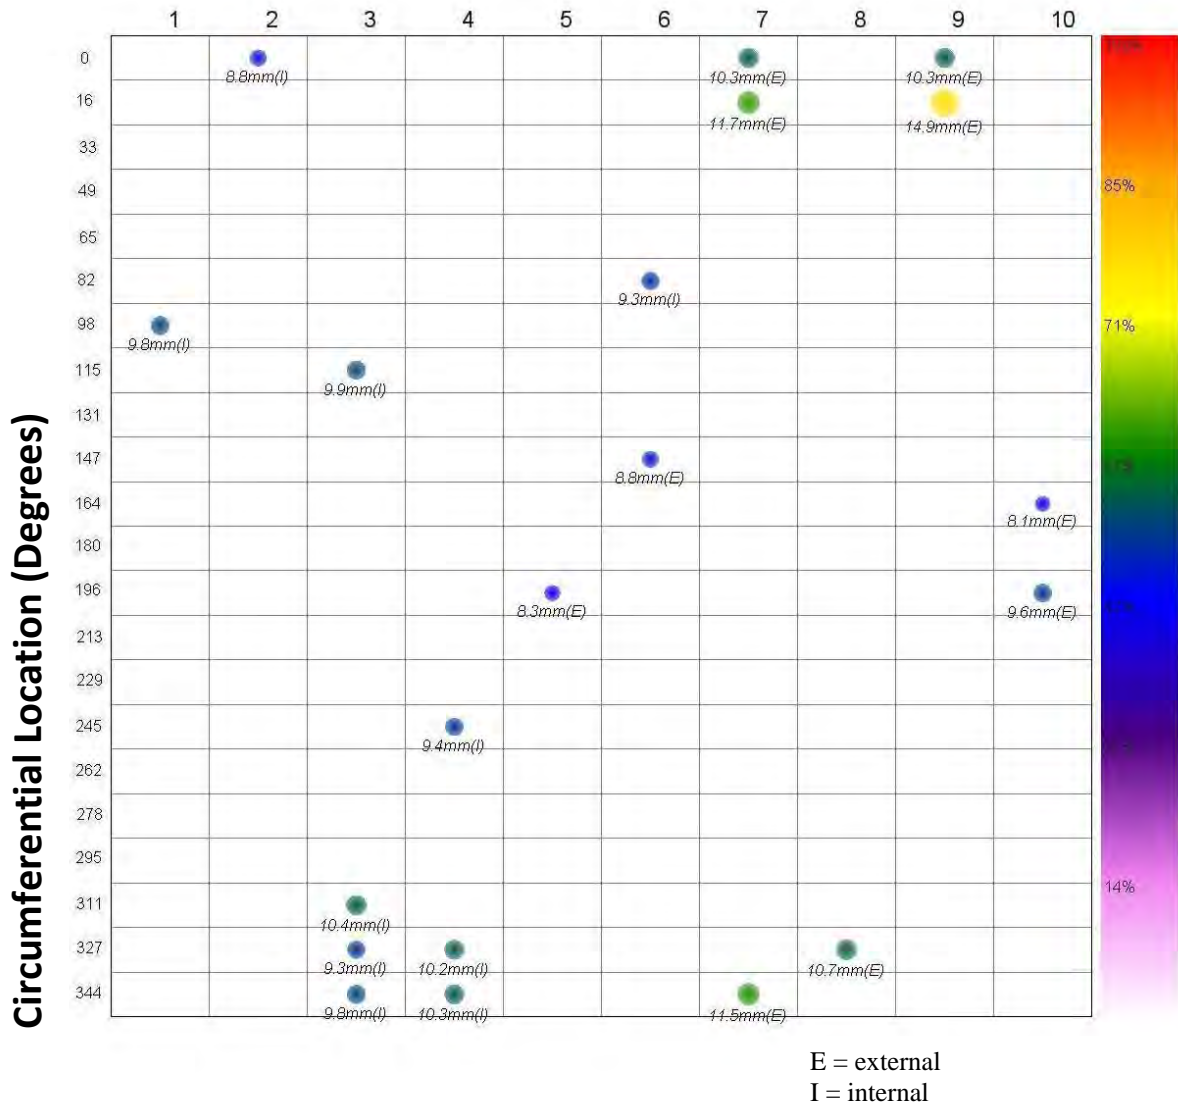
(Courtesy of AESL)
Figure 5-19. Defect Plot for Pit 2 (20 Largest Defect Depths)

AESL conducted a detailed pipe wall condition assessment using the ECAT for Pit F, Pit 2, and Pit L over a 1 m length and full pipe circumference. Table 5-13 summarizes the condition assessment results for the three excavation pits. The vast majority of the defects were external (~ 800), but ~ 23 internal defects were identified. The internal and external defects were differentiated with a proximity sensor. Some mechanical damage was also identified in Pits F and L. Figure 5-18 through Figure 5-21 graphically depict the size and location of specific metal loss defects. Because of the sheer number of defects identified in each excavation location only the 20 largest defects are presented in the figures. AESL also determined wall thickness with an ultrasonic device. The wall thickness for all three excavation locations ranged from a minimum of 17.6 mm (0.69 in.) to a maximum of 20.8 mm (0.82 in.).

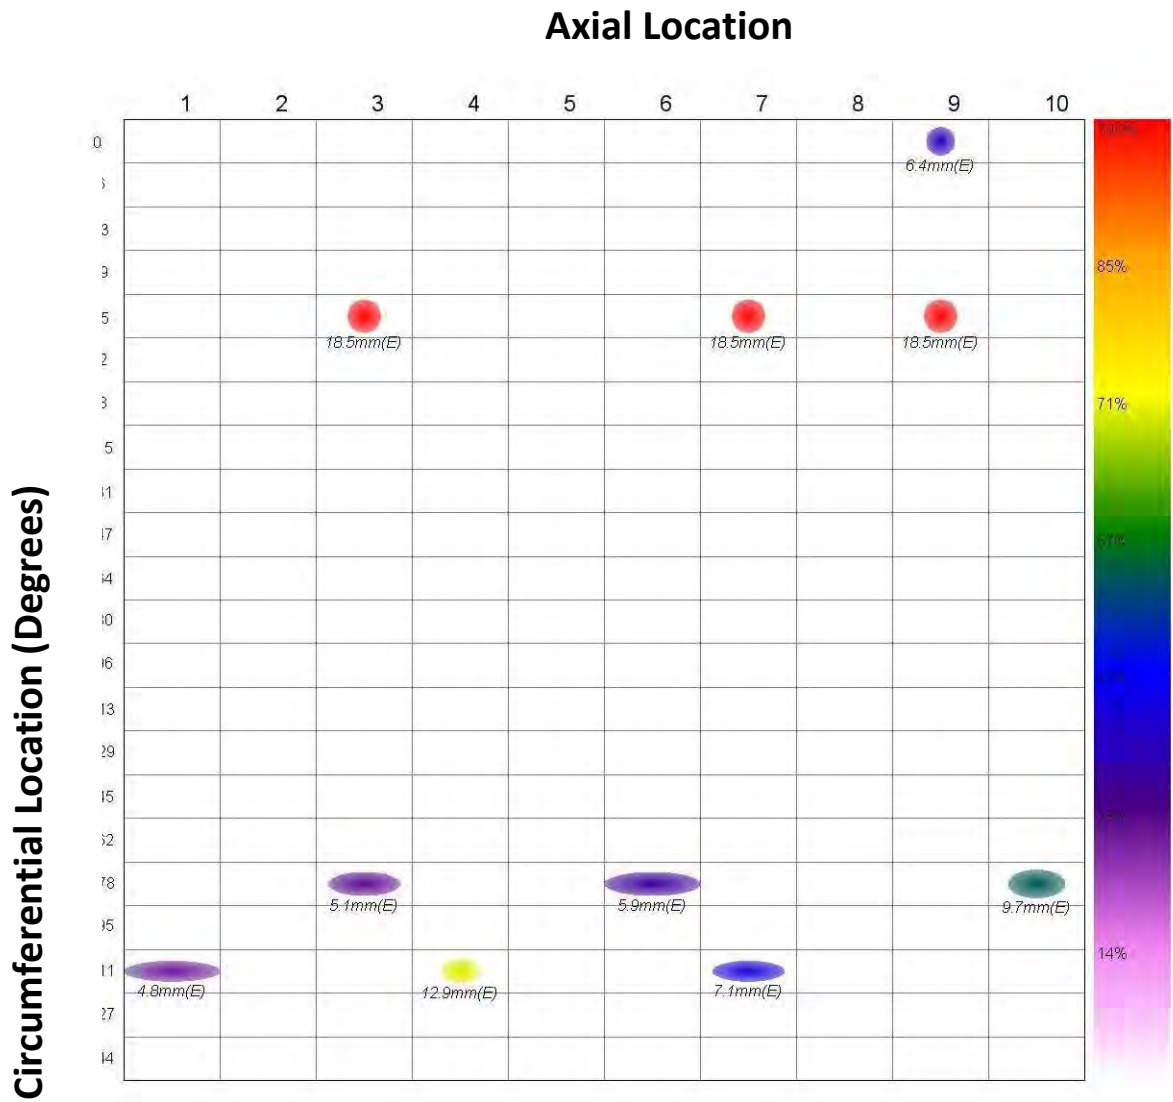
Courtesy of AESL
Figure 5-20. Machined Defect Plot for Pit 2

The machined defects in Pit 2 were distributed over a length of pipe greater than the 1 m that AESL scanned, so the verification had to be limited to those machined defects that AESL was able to scan in Pit 2. The AESL ECAT detection rate for the machined defects in Pit 2 was 100%, detecting six of six of the machined defects within their scan range. On average, AESL located anomalies within a small distance (2.6 inches) of the recorded defect location, but this apparent error may be attributed to differences between AESL's and EPA contractor's coordinate reference systems. ECAT's sizing accuracy is depicted in Figure 5-22 and Figure 5-23 in which the predicted and measured anomaly depths and lengths are presented. Ideally, the ECAT predicted values and the measured value should fall on the 45° line. The ±10 percent error is representative for MFL systems, and long skinny defects such as the ones in this pipe are difficult to accurately assess. The other 12 machined defects were not assessed by ECAT.

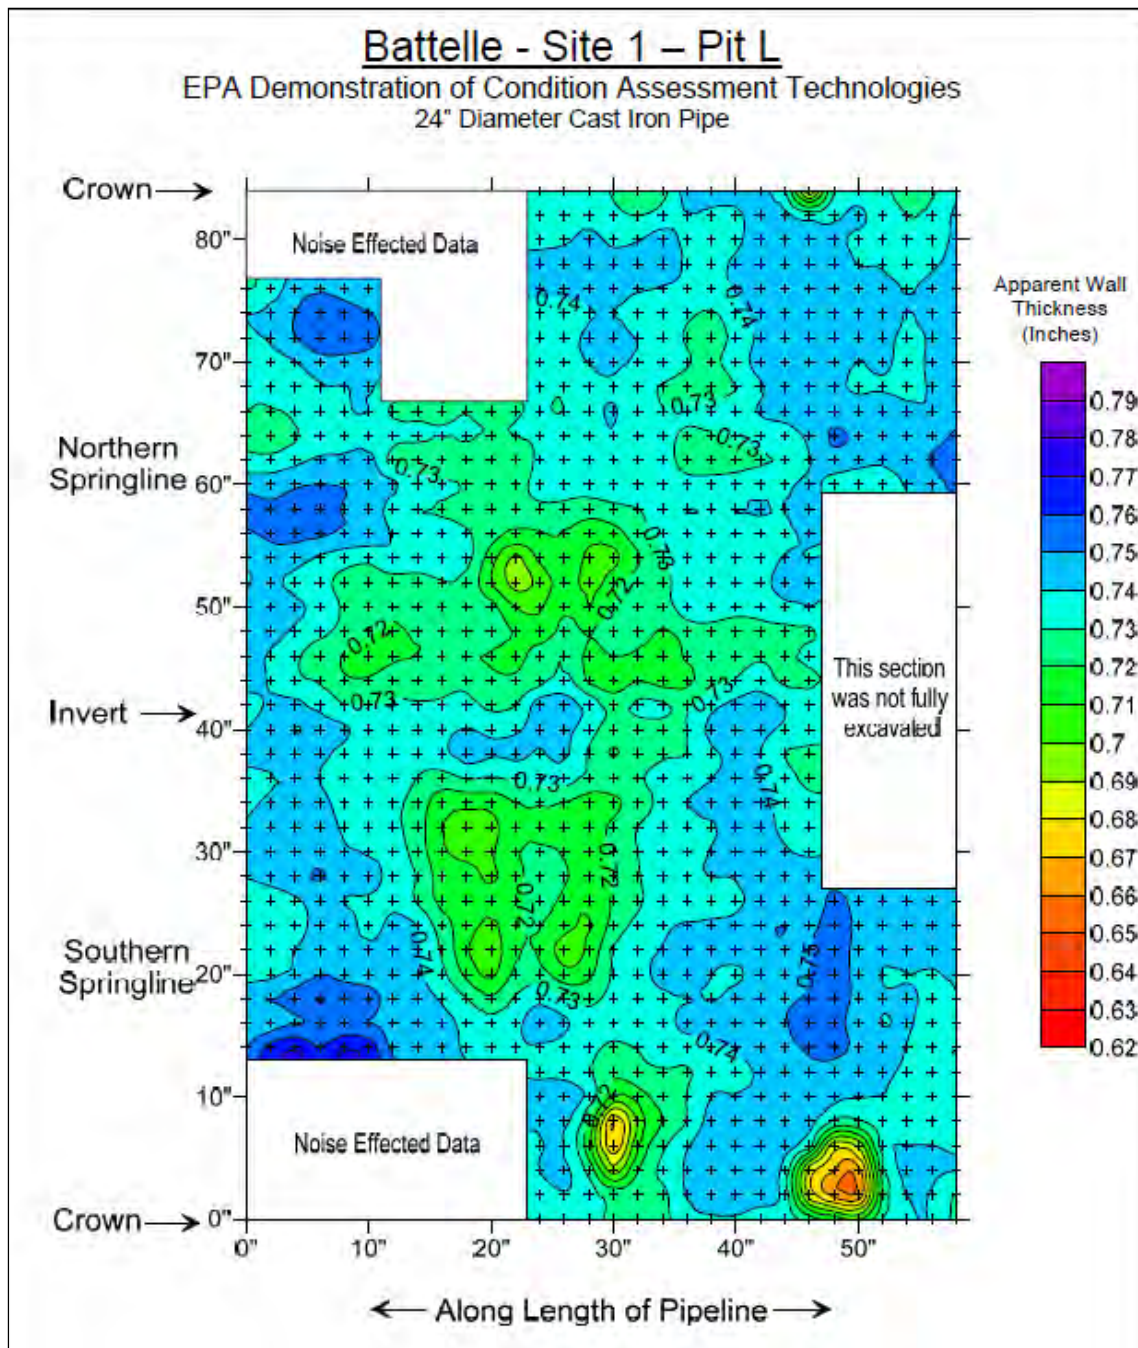
(Courtesy of RSG)
Figure 5-24. HSK Data Plot – Pit L

Location [ft]	Type of Scan	Minimum Wall Thickness [in.]	Average Wall Thickness [in.]	Summarized Condition Assessment Results
250 (Pit A)	CAP	0.662	0.737	* Moderate corrosion near the pipe crown (Fig. 5-26)
338 (Pit L)	HSK	0.654	0.735	* Higher degree of wall thinning near the pipe crown * Moderate degree of wall thinning at the pipe sides * One section could not be scanned due to access restrictions; BEM data could not be analyzed for two sections due to noise interference (Fig. 5-24)
510 (Pit B)	CAP	0.680	0.719	* Moderate corrosion near the pipe crown (Fig 5-27)
809 (Pit C)	CAP	0.627	0.703	* Most severe corrosion near the pipe crown (Fig. 5-28)
1,080 (Pit 2)	HSK	0.688	0.735	* Moderate to severe corrosion on the southern side of the pipe * Moderate corrosion at the bottom of the pipe (Fig. 5-30)
1,173 (Pit D)	CAP	0.666	0.689	* Moderate corrosion near the pipe crown (Fig. 5-29)
1,439 (Pit E)	CAP	0.704	0.709	* Negligible wall thickness variation (Fig. 5-32)

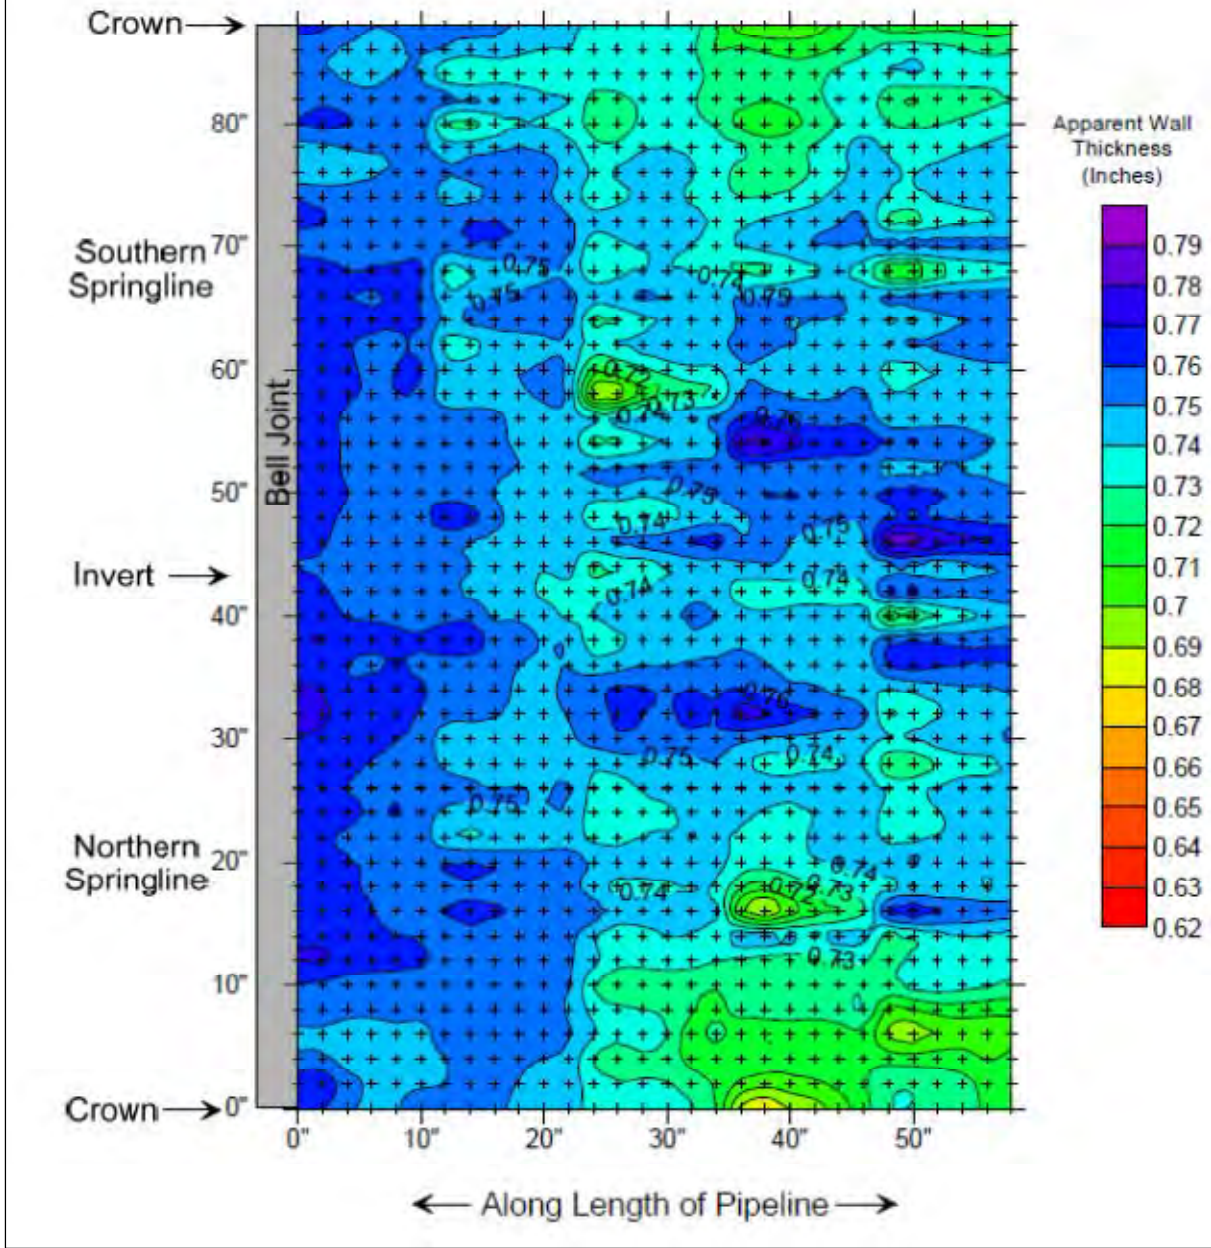
Figure 5-25. HSK Data Plot – Pit F

Location [ft]	Type of Scan	Minimum Wall Thickness [in.]	Average Wall Thickness [in.]	Summarized Condition Assessment Results
1,750 (Pit F)	HSK	0.678 to 0.711	0.745 to 0.748	<ul style="list-style-type: none"> * Higher degree of wall thinning near pipe crown * Moderate degree of wall thinning at the pipe sides; more prevalent on northern side * Thinning in isolated areas; therefore likely due to pitting clusters or graphitization * (Fig 5-25 and 5-31; two different lengths of pipe in the same pit, separated by b/s joint).
