Field Demonstration of Innovative Condition Assessment Technologies for Water Mains: Acoustic Pipe Wall Assessment, Internal Inspection, and External Inspection

**FIELD DEMONSTRATION OF INNOVATIVE CONDITION ASSESSMENT TECHNOLOGIES
FOR WATER MAINS: ACOUSTIC PIPE WALL ASSESSMENT, INTERNAL INSPECTION,
AND EXTERNAL INSPECTION**

VOLUME 1: TECHNICAL REPORT

September 2013

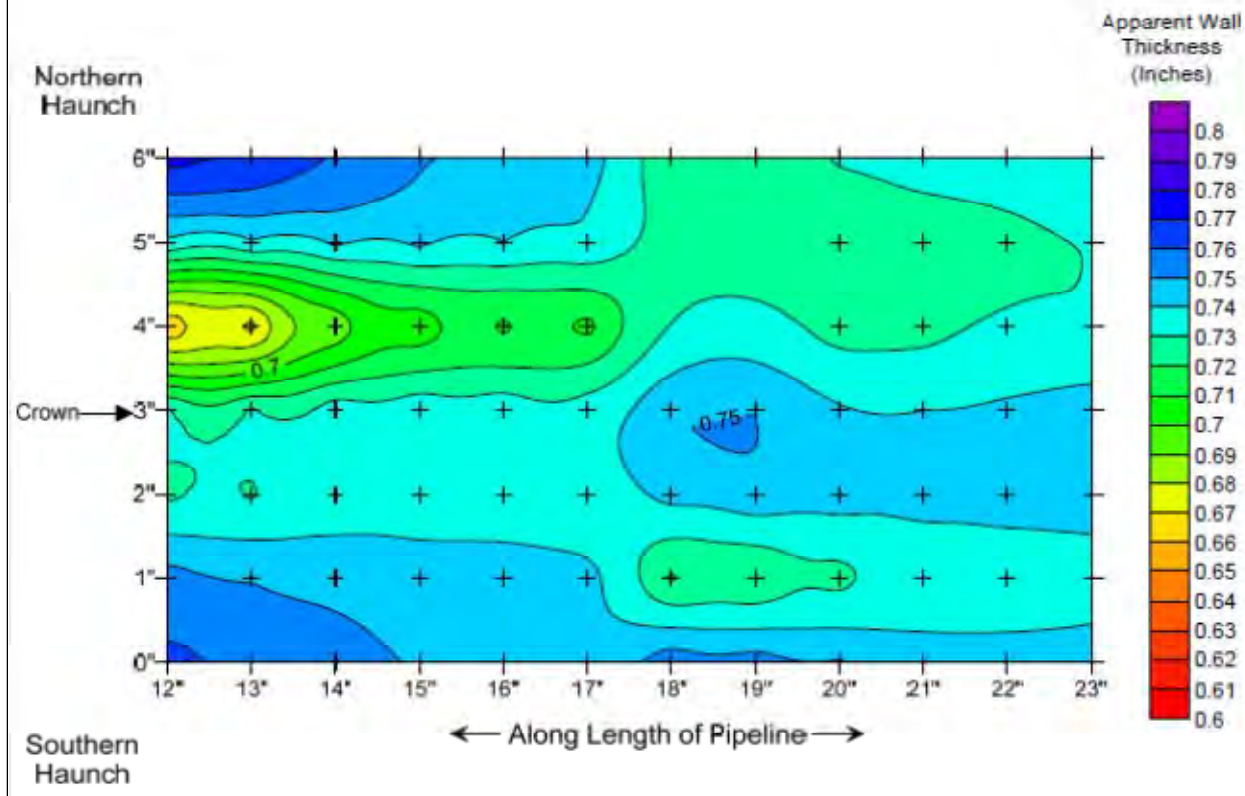
(Courtesy of RSG)
 Figure 5-26. CAP Data Plot – Pit A

Location [ft]	Type of Scan	Minimum Wall Thickness [in.]	Average Wall Thickness [in.]	Summarized Condition Assessment Results
250 (Pit A)	CAP	0.662	0.737	* Moderate corrosion near the pipe crown (Fig. 5-26)
338 (Pit L)	HSK	0.654	0.735	* Higher degree of wall thinning near the pipe crown * Moderate degree of wall thinning at the pipe sides * One section could not be scanned due to access restrictions; BEM data could not be analyzed for two sections due to noise interference (Fig. 5-24)
510 (Pit B)	CAP	0.680	0.719	* Moderate corrosion near the pipe crown (Fig 5-27)
809 (Pit C)	CAP	0.627	0.703	* Most severe corrosion near the pipe crown (Fig. 5-28)
1,080 (Pit 2)	HSK	0.688	0.735	* Moderate to severe corrosion on the southern side of the pipe * Moderate corrosion at the bottom of the pipe (Fig. 5-30)
1,173 (Pit D)	CAP	0.666	0.689	* Moderate corrosion near the pipe crown (Fig. 5-29)
1,439 (Pit E)	CAP	0.704	0.709	* Negligible wall thickness variation (Fig. 5-32)

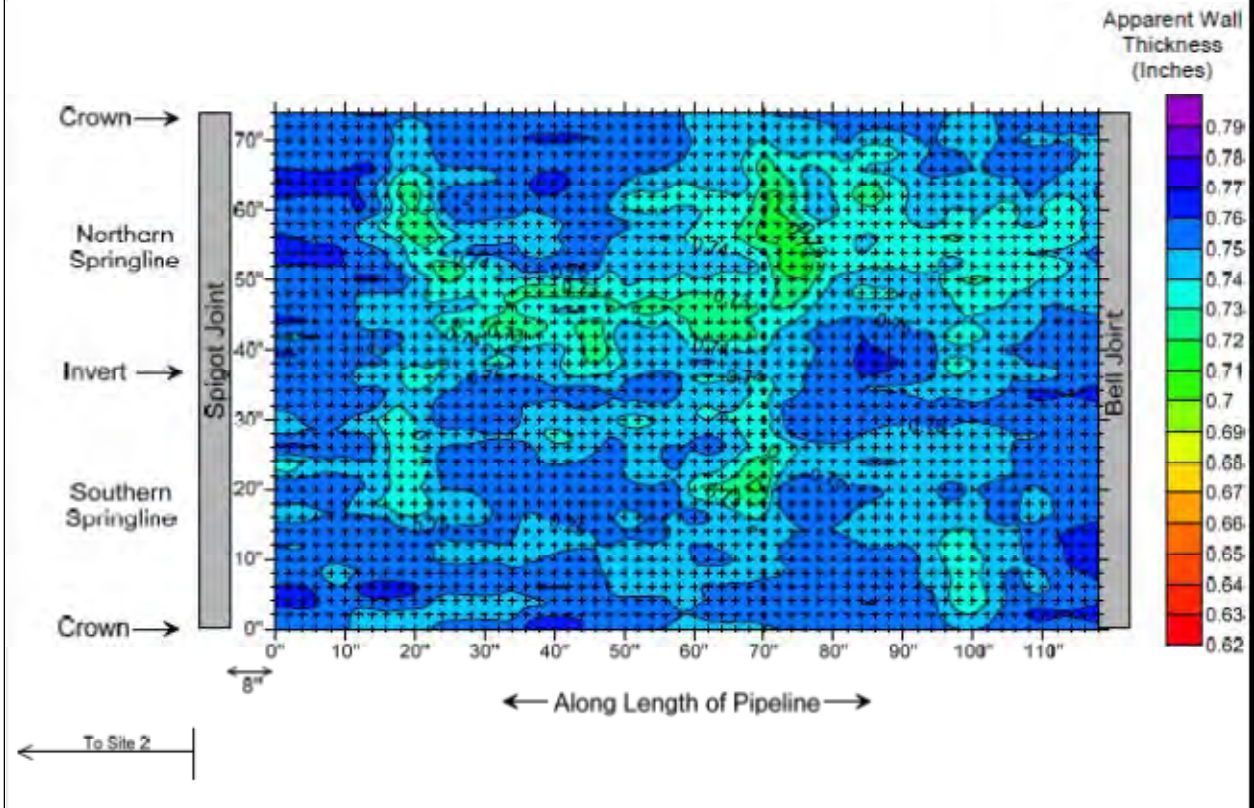
Figure 5-31. HSK Data Plot – Pit F

Location [ft]	Type of Scan	Minimum Wall Thickness [in.]	Average Wall Thickness [in.]	Summarized Condition Assessment Results
1,750 (Pit F)	HSK	0.678 to 0.711	0.745 to 0.748	<ul style="list-style-type: none"> * Higher degree of wall thinning near pipe crown * Moderate degree of wall thinning at the pipe sides; more prevalent on northern side * Thinning in isolated areas; therefore likely due to pitting clusters or graphitization * (Fig 5-25 and 5-31; two different lengths of pipe in the same pit, separated by b/s joint).

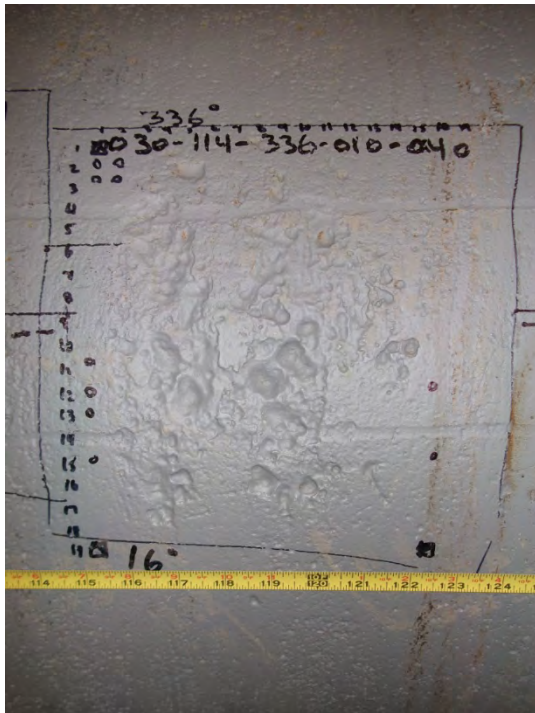
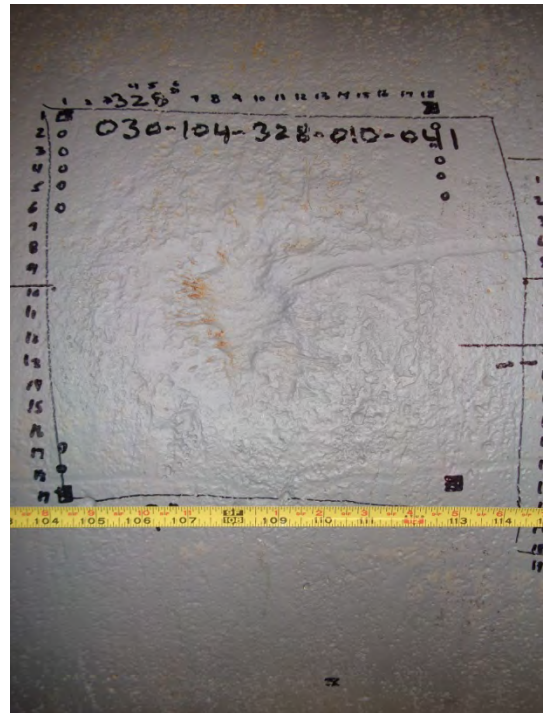
Figure A-30(1). Pipe 30, area 030-114-336-010-040

Defect Area	Total Volume Loss (in. ³)	Dist From Bell (in.)	Maximum Depths In Defect Area (in.)	% Loss	Remaining (in.)	% Remaining	Clock (Degrees)	Clock (12hr)
030-114-336-010-040	3.5	32.0	0.279	36%	0.50	64%	2	0:04
		34.5	0.217	28%	0.56	72%	2	0:04
		31.0	0.198	25%	0.58	75%	13	0:26
		32.0	0.173	22%	0.61	78%	355	11:50
030-104-328-010-041	7.3	42.0	0.531	68%	0.25	32%	10	0:20
		40.5	0.276	35%	0.50	65%	16	0:32
030-087-308-011-047	5.9	60.0	0.367	47%	0.41	53%	30	1:00
		58.5	0.257	33%	0.52	67%	36	1:12
		54.5	0.185	24%	0.60	76%	39	1:18
030-045-340-007-042	3.9	102.0	0.362	46%	0.42	54%	353	11:46

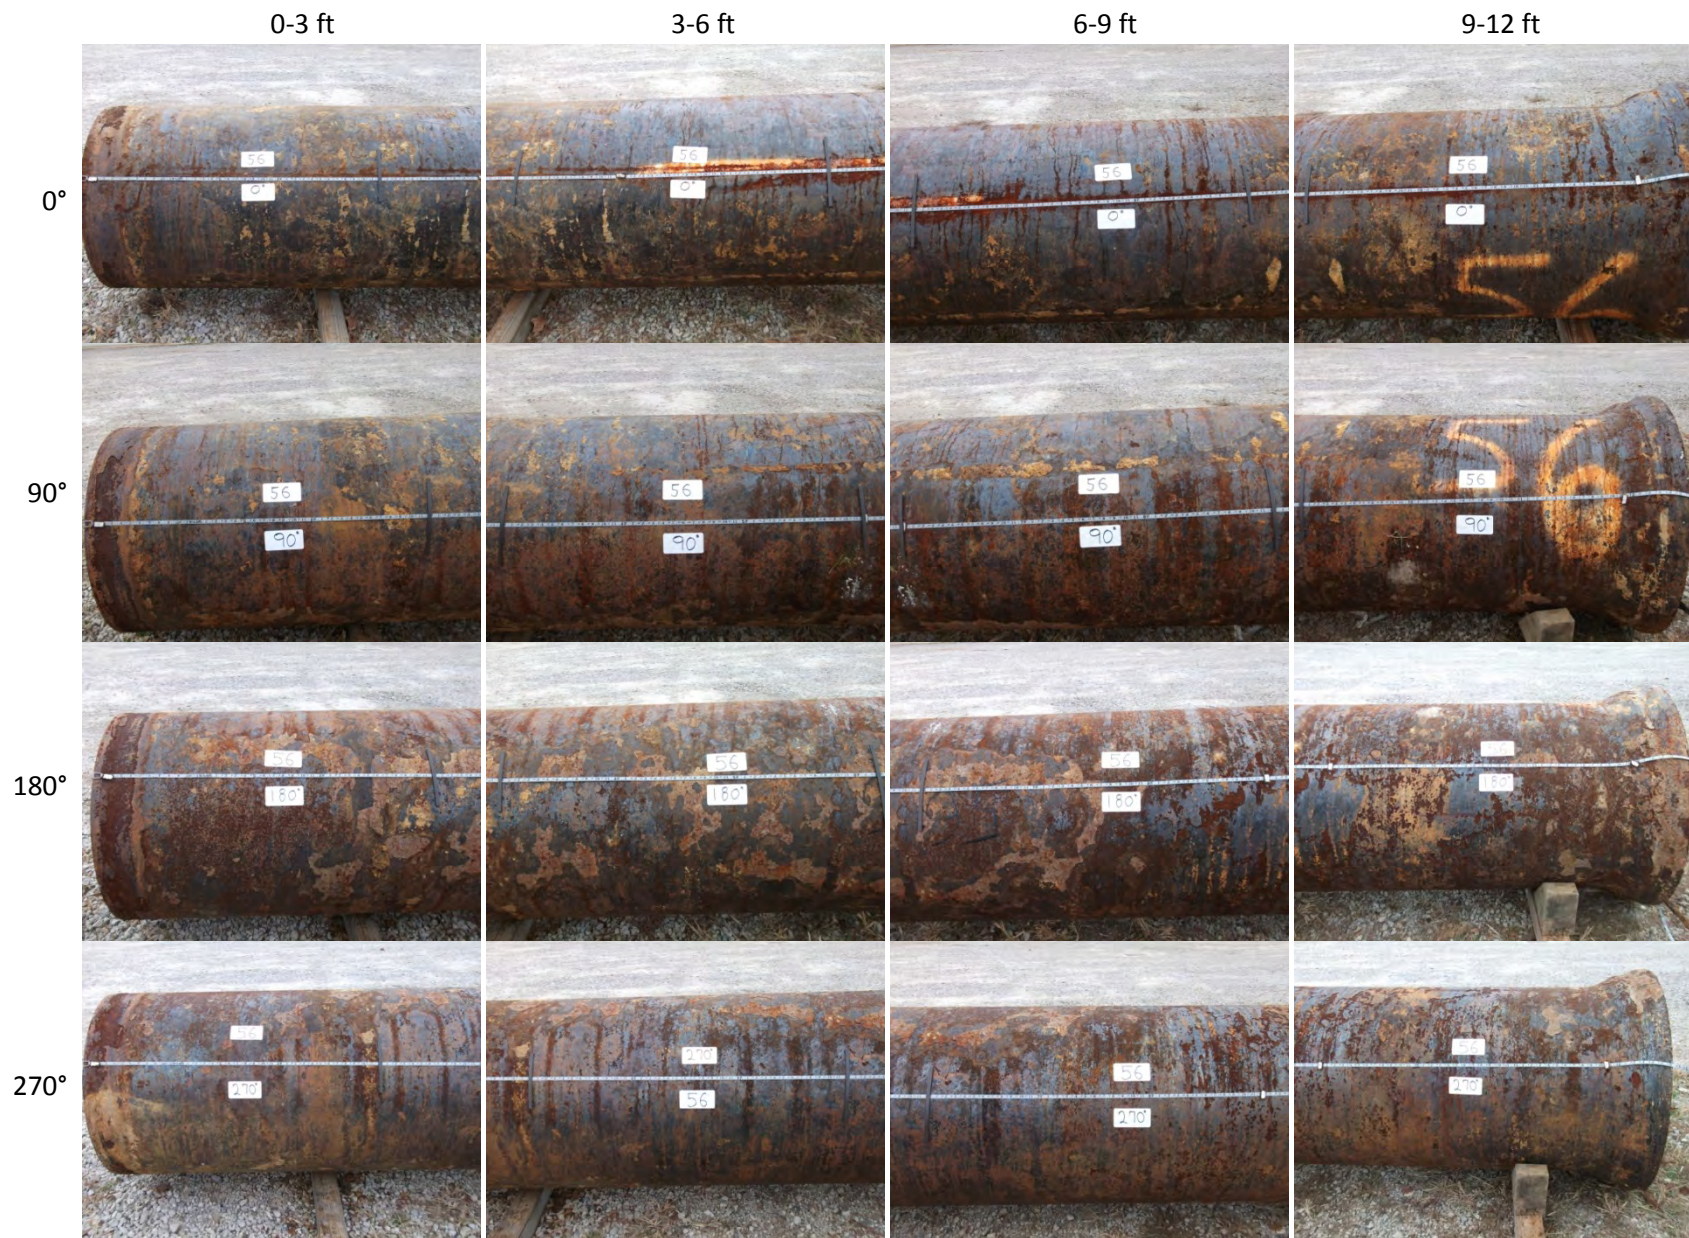
Figure A-56(1). Pipe 56 as Removed from Site

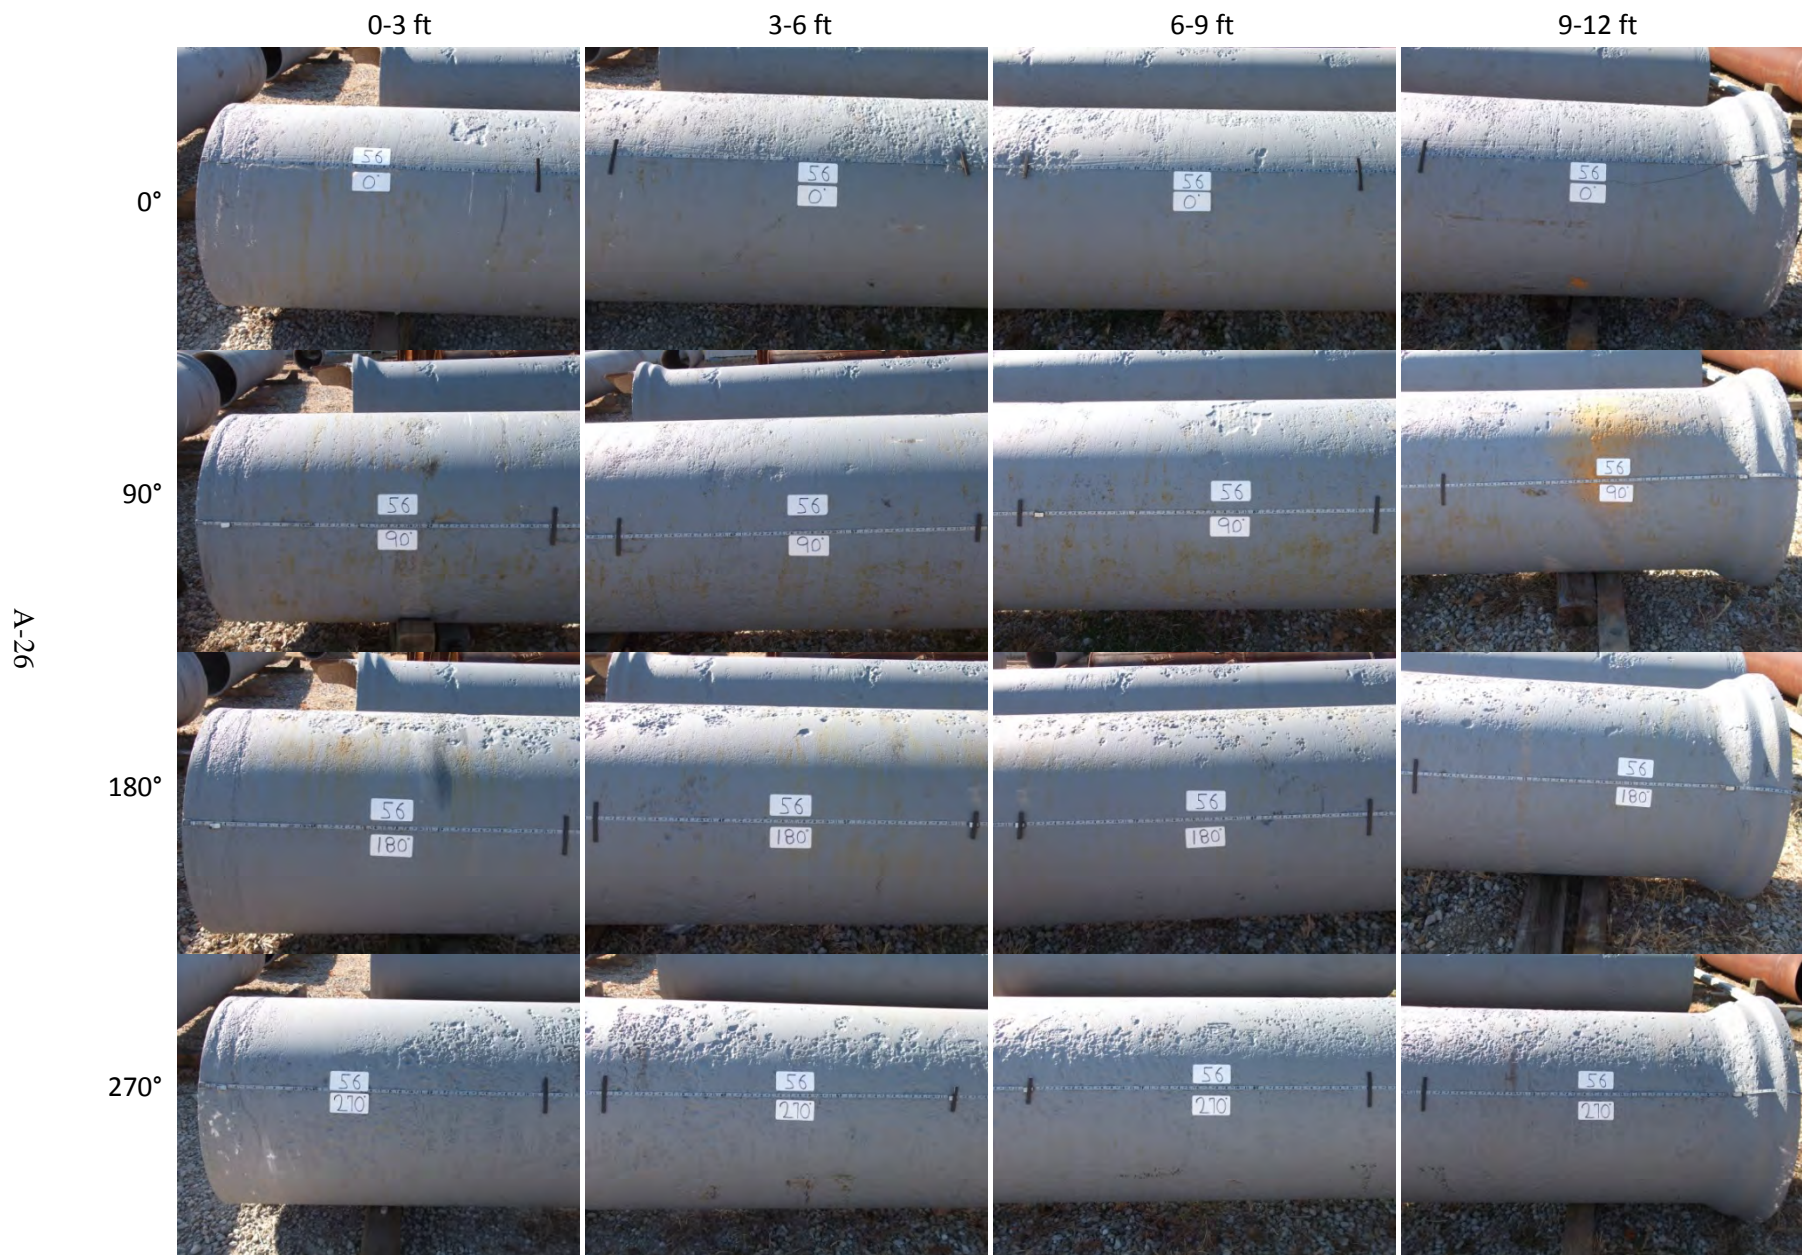
Figure A-56(2). Pipe 56 after Sandblasting

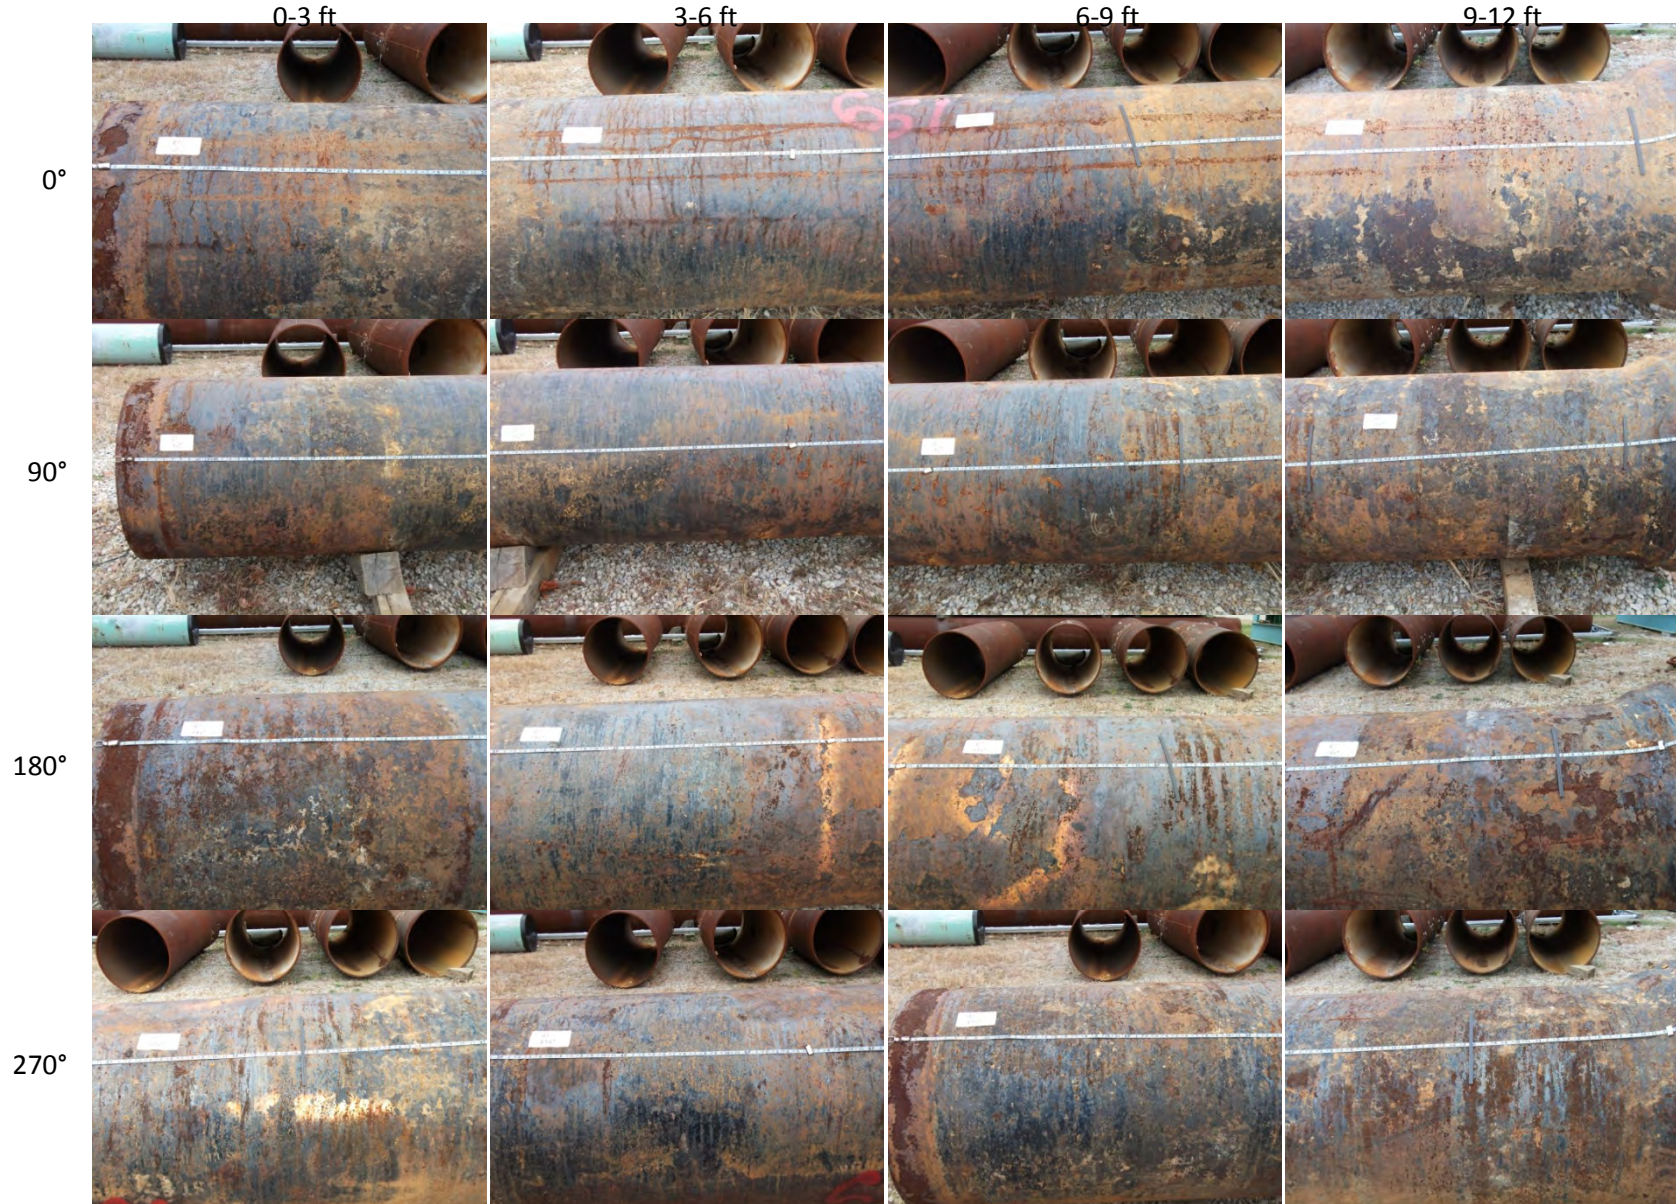
Figure A-61(1). Pipe 61 as Removed from Site

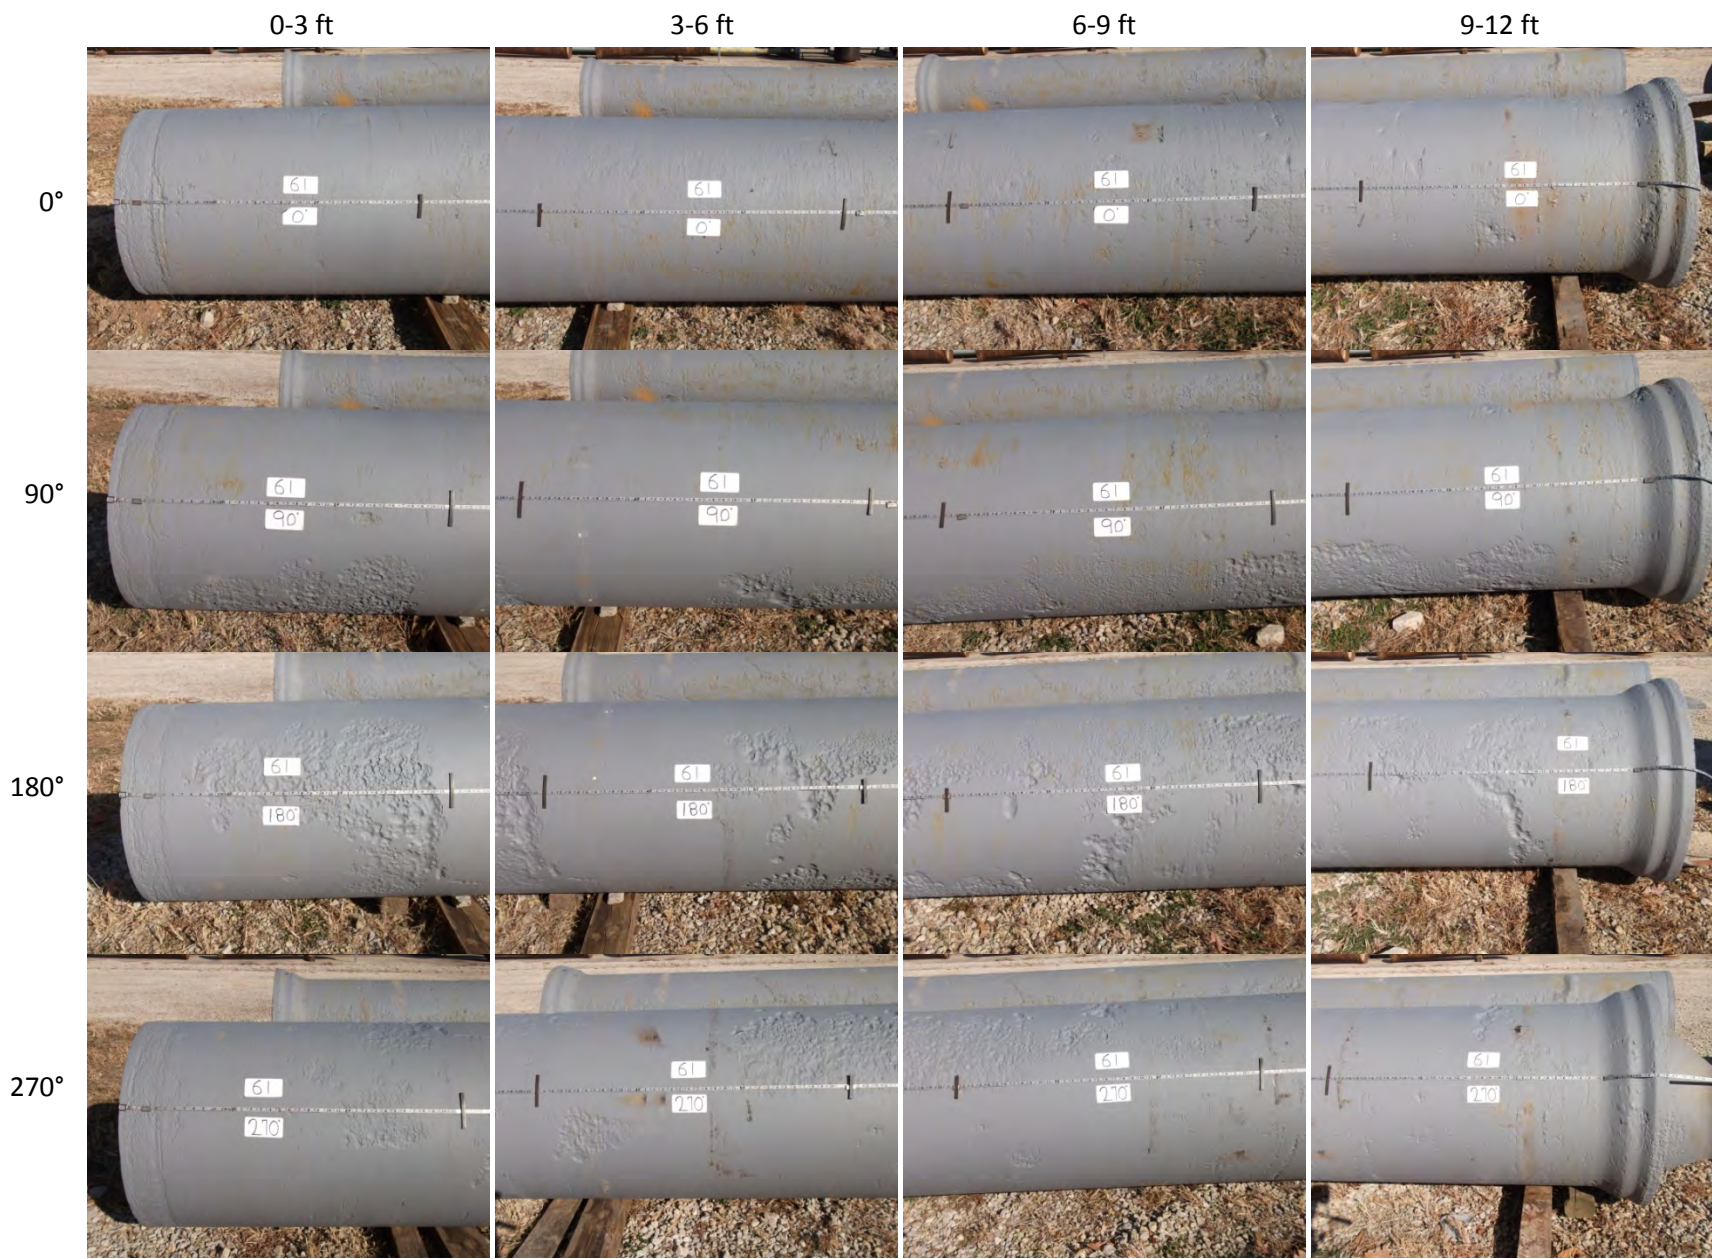
Figure A-61(2). Pipe 61 after Sandblasting

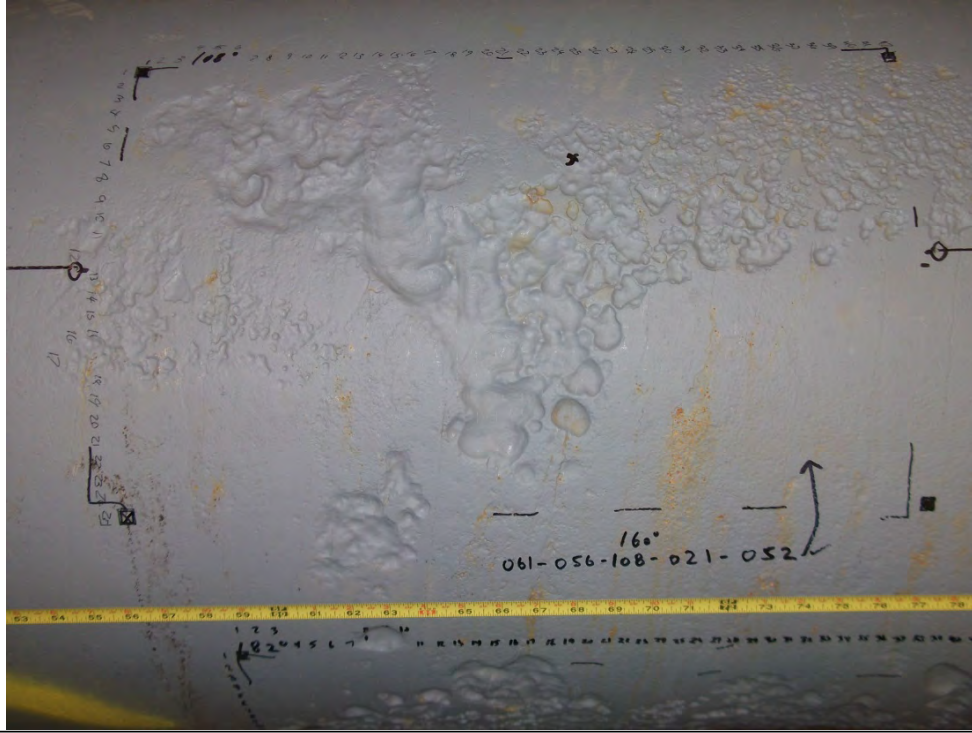
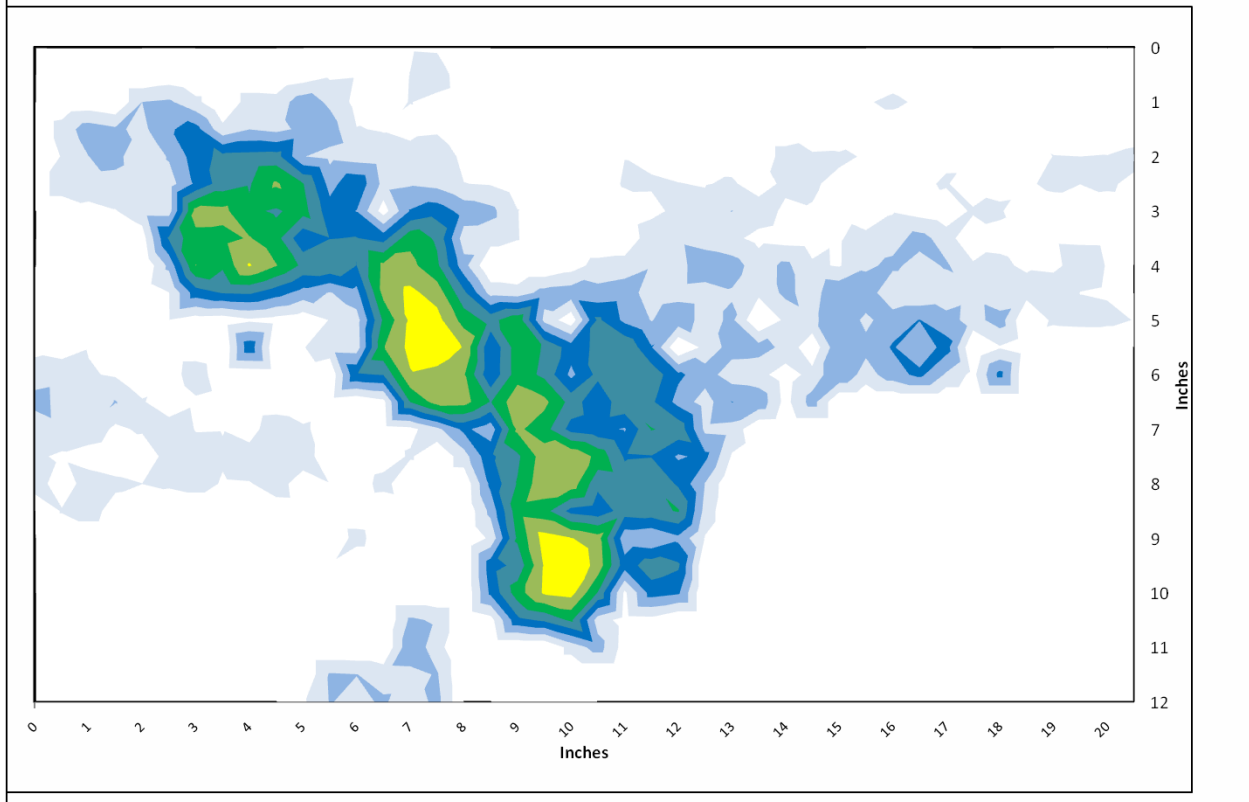
Figure A-61(2). .Pipe 61, area 061-056-108-021-052

118.0	0.346	44%	0.43	56%	209	6:58
		116.5	0.335	43%	0.45	57%	216	7:12
		116.5	0.311	40%	0.47	60%	185	6:10
		119.5	0.304	39%	0.48	61%	207	6:54
061-056-108-021-052	15.6	90.0	0.399	51%	0.38	49%	210	7:00

91.0	0.385	49%	0.40	51%	228	7:36
		87.0	0.355	45%	0.43	55%	234	7:48
		85.0	0.346	44%	0.43	56%	219	7:18
		84.0	0.338	43%	0.44	57%	223	7:26
		84.0	0.318	41%	0.46	59%	239	7:58

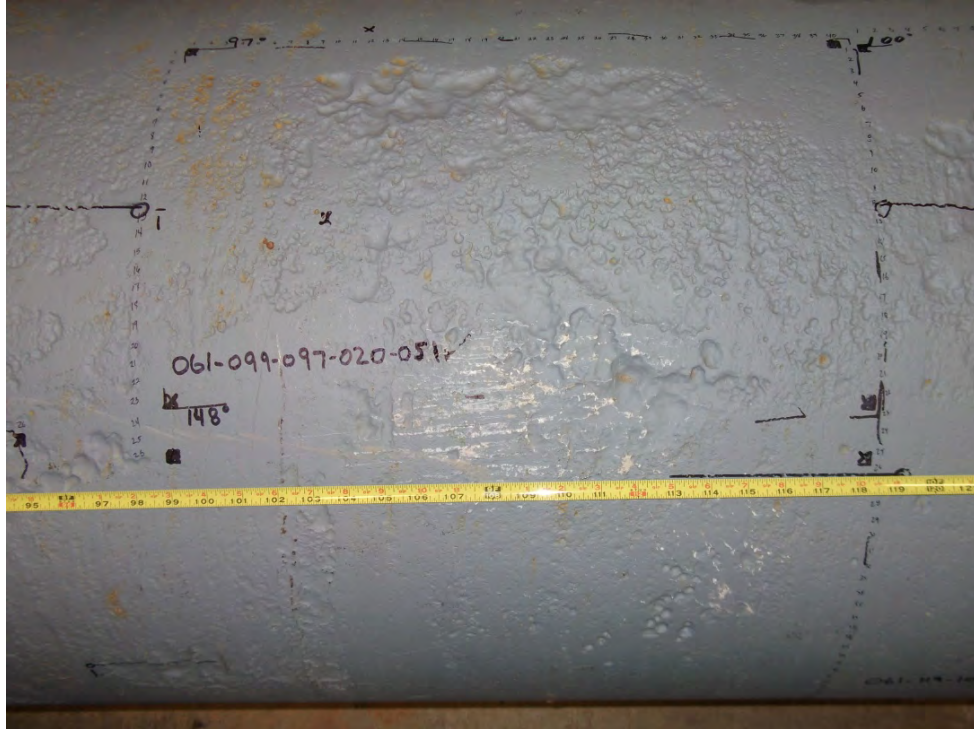
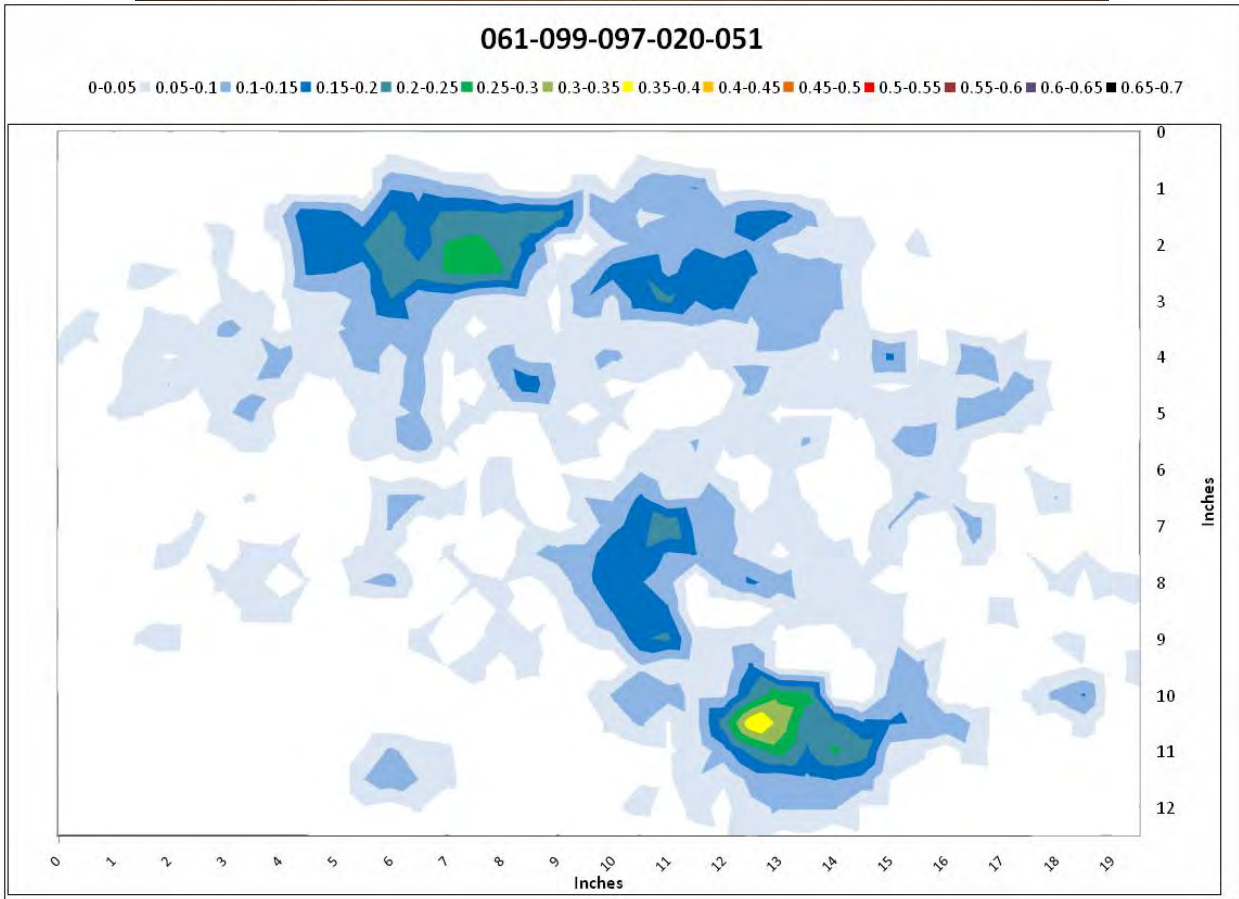
Figure A-61(3). Pipe 61, area 061-099-097-020-051

Defect Area	Total Volume Loss (in.³)	Dist From Bell (in.)	Maximum Depths In Defect Area (in.)	% Loss	Remaining (in.)	% Remaining	Clock (Degrees)	Clock (12hr)
061-099-097-020-051	12.8	38.5	0.396	51%	0.38	49%	216	7:12

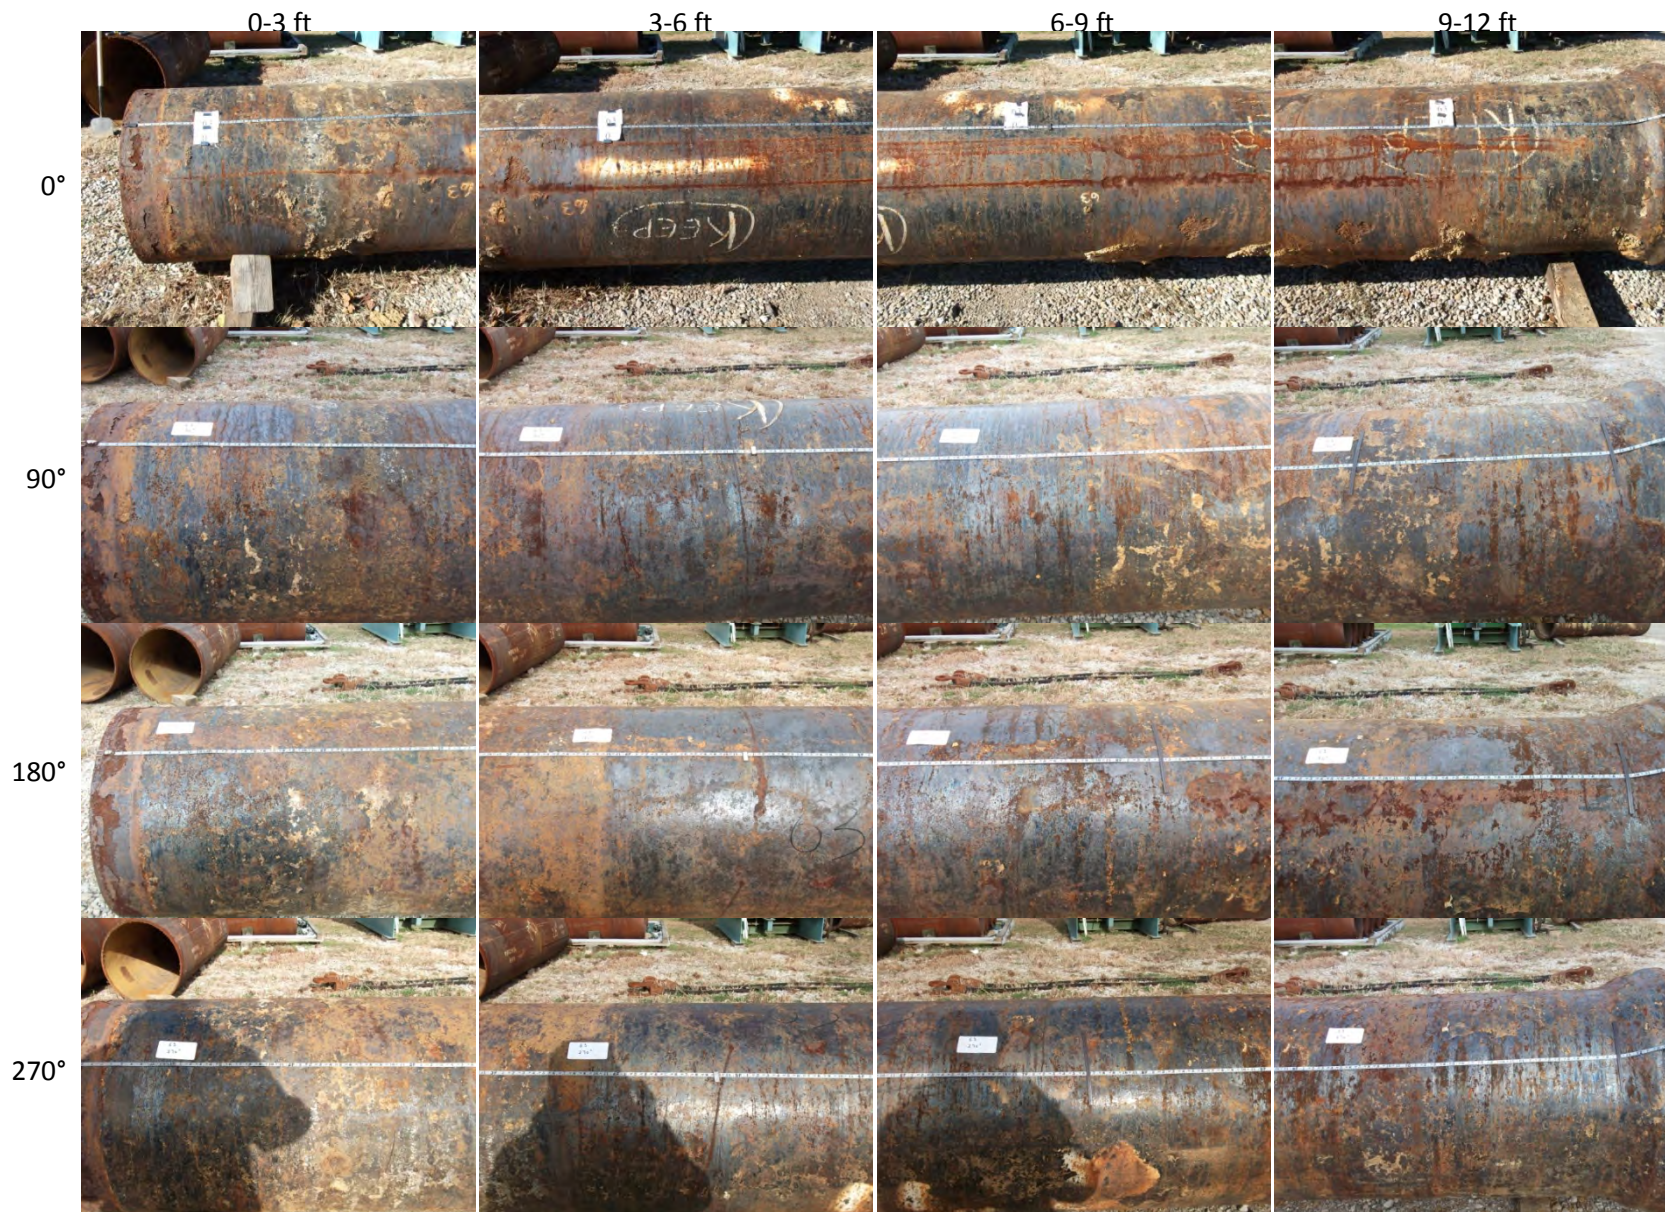
Figure A-63(1). Pipe 63 as Removed from Site

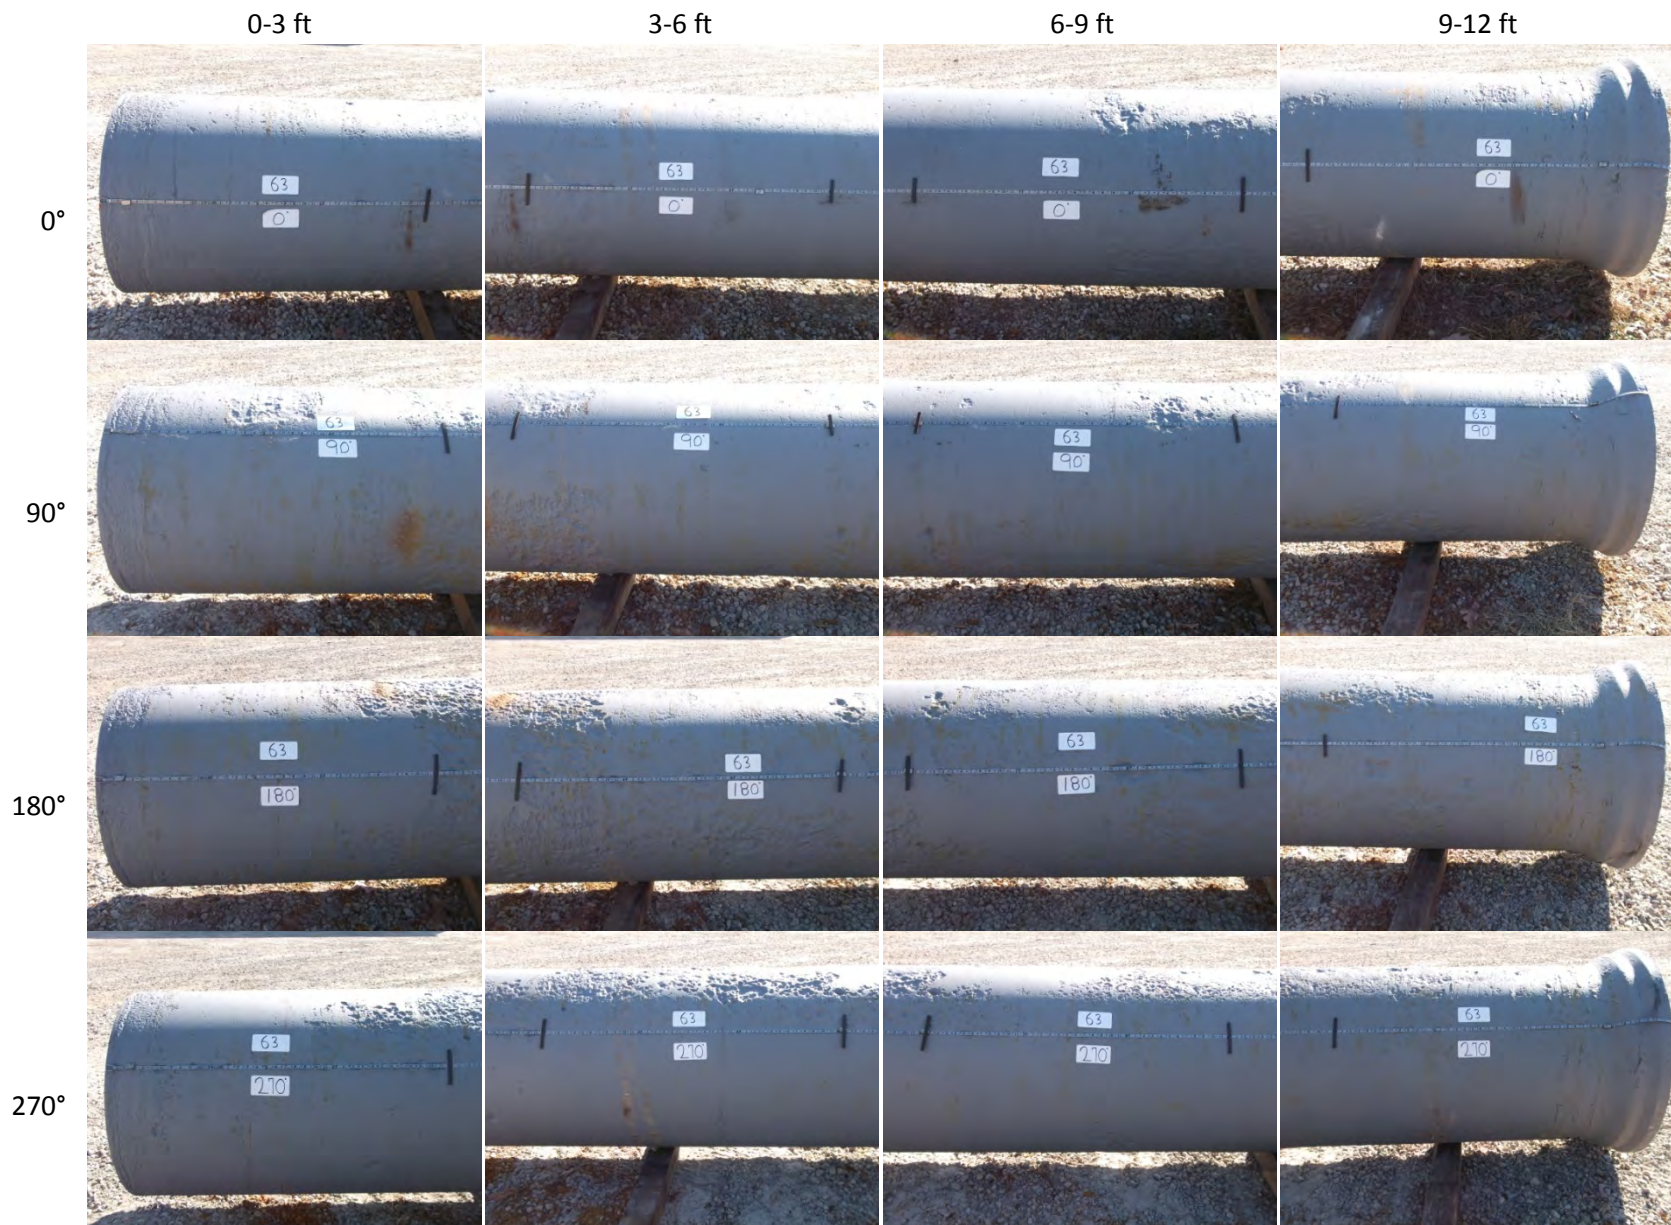
Figure A-63(2). Pipe 63 after Sandblasting

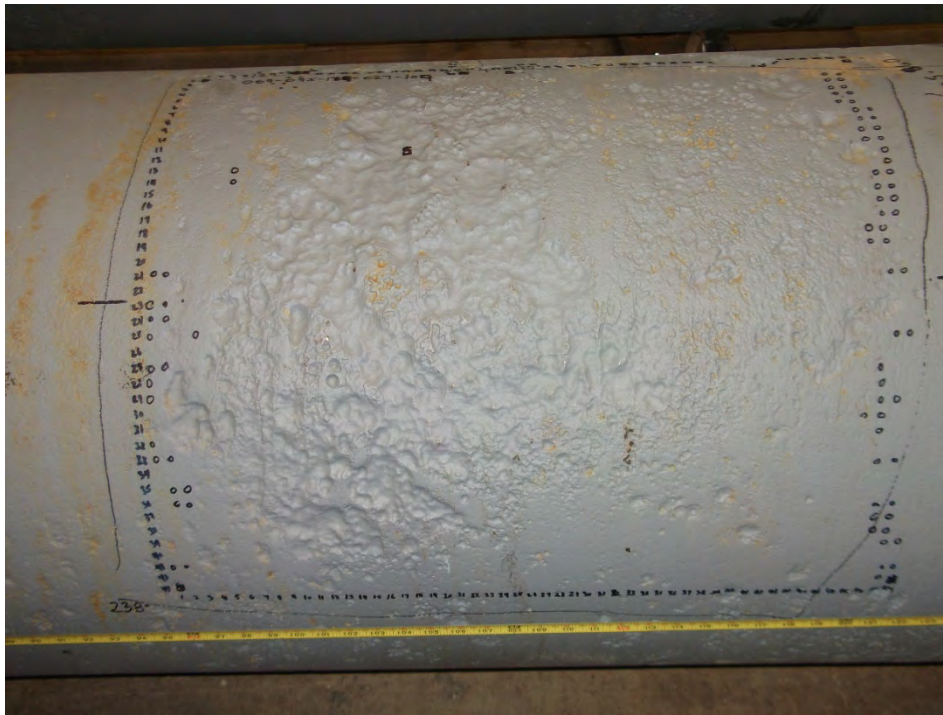
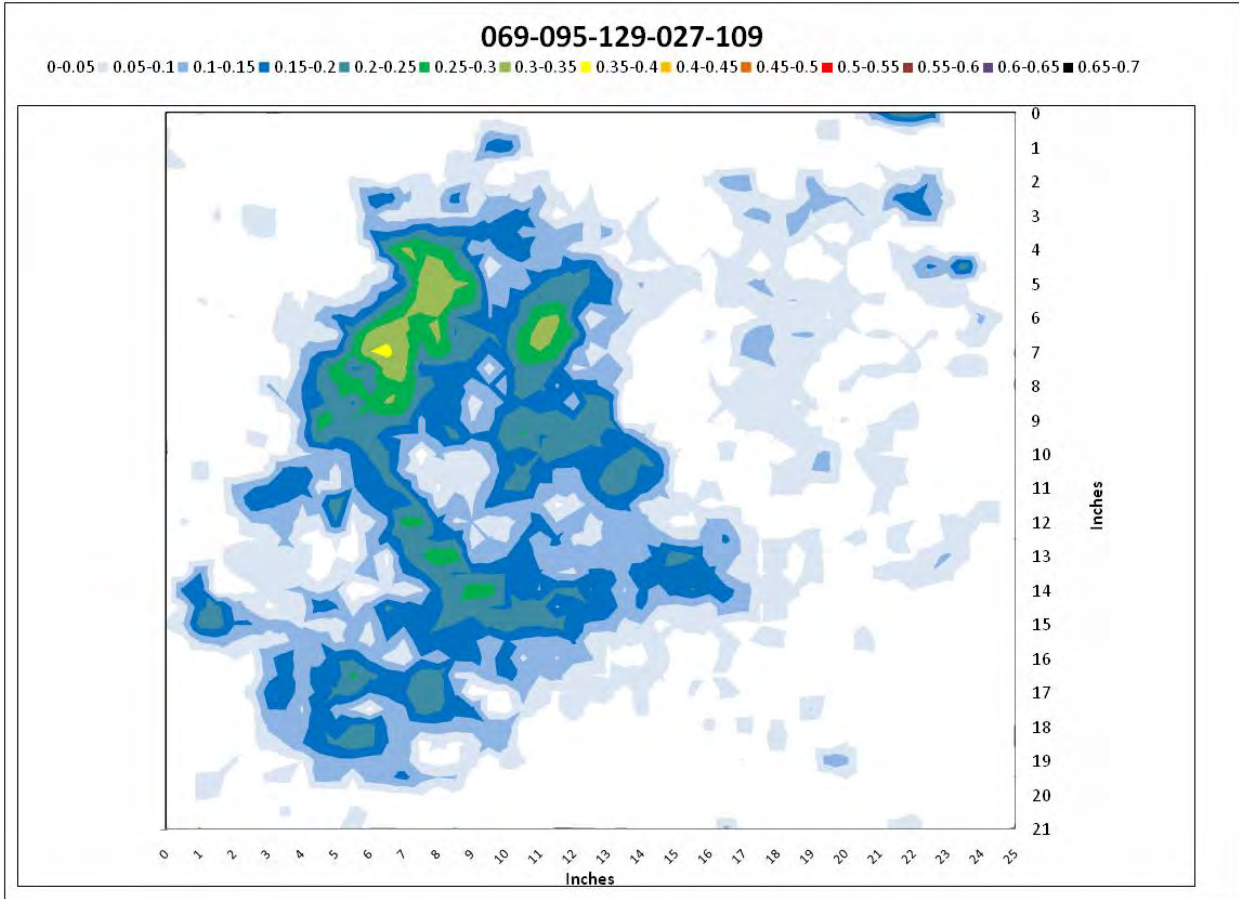
Figure A-69(1). Pipe 69, area 069-095-129-027-109

Defect Area	Total Volume Loss (in.³)	Dist From Bell (in.)	Maximum Depths In Defect Area (in.)	% Loss	Remaining (in.)	% Remaining	Clock (Degrees)	Clock (12hr)
069-095-129-027-109	38.1	48.5	0.362	46%	0.42	54%	200	6:40

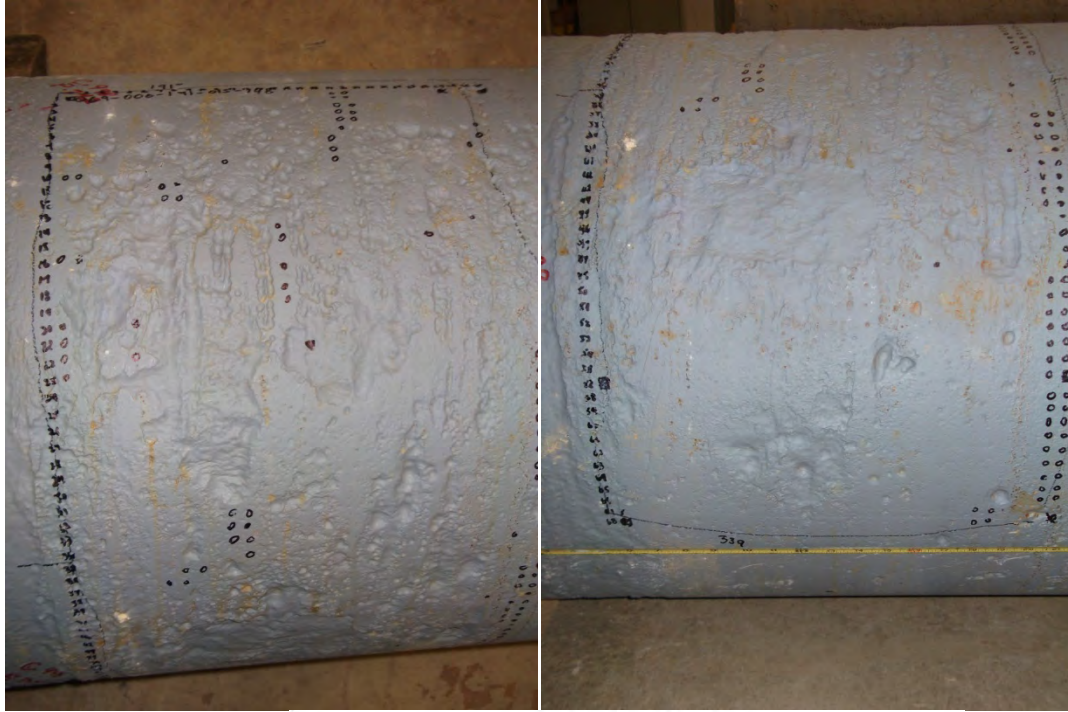
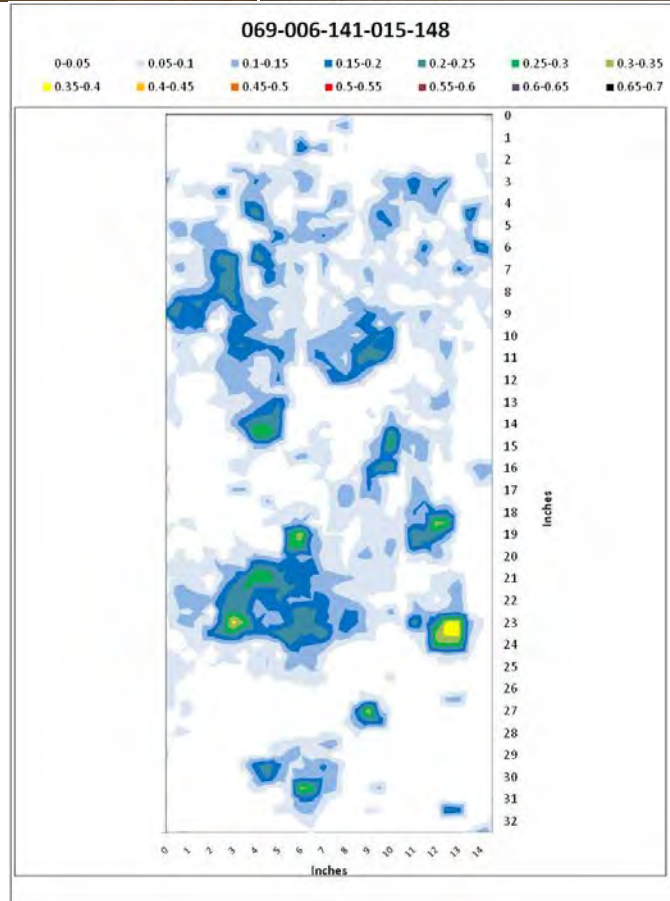
Figure A-69(8). Pipe 69, area 069-006-141-015-148

29.0	0.241	31%	0.54	69%	358	11:56
069-006-141-015-148	30.0	131.0	0.368	47%	0.41	53%	115	3:50
		141.0	0.367	47%	0.41	53%	117	3:54
		135.0	0.338	43%	0.44	57%	99	3:18
