Field Demonstration of Innovative Condition Assessment Technologies for Water Mains: Acoustic Pipe Wall Assessment, Internal Inspection, and External Inspection

**FIELD DEMONSTRATION OF INNOVATIVE CONDITION ASSESSMENT TECHNOLOGIES
FOR WATER MAINS: ACOUSTIC PIPE WALL ASSESSMENT, INTERNAL INSPECTION,
AND EXTERNAL INSPECTION**

VOLUME 1: TECHNICAL REPORT

September 2013

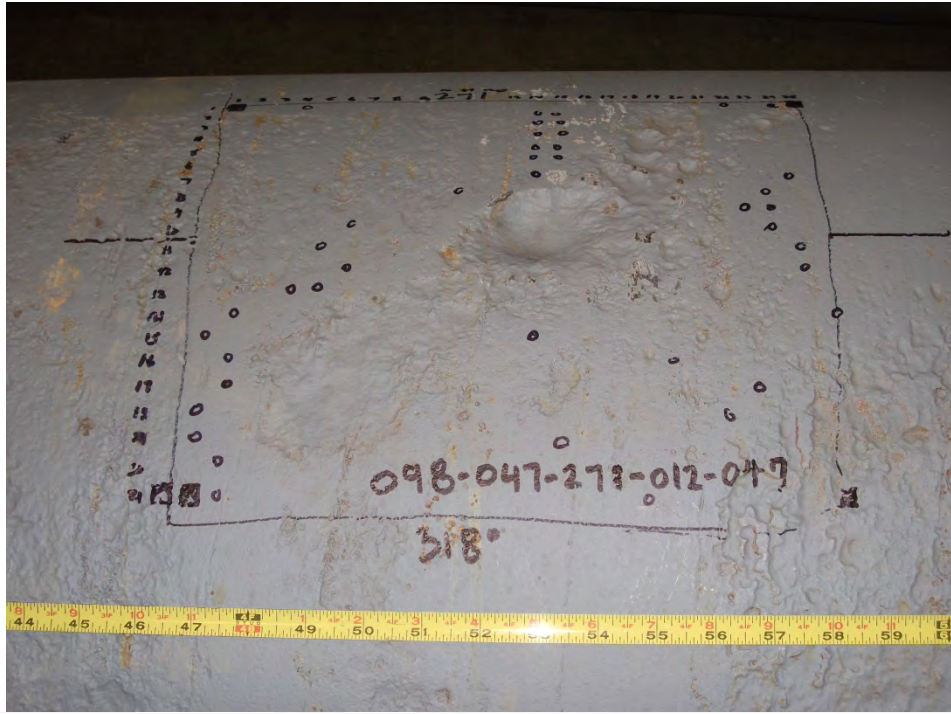
Figure A-98(1). Pipe 98, area 098-047-271-012-047

Defect Area	Total Volume Loss (in. ³)	Dist From Bell (in.)	Maximum Depths In Defect Area (in.)	% Loss	Remaining (in.)	% Remaining	Clock (Degrees)	Clock (12hr)
098-047-271-012-047	5.0	96.5	0.493	63%	0.29	37%	69	2:18
098-066-282-024-066	13.4	62.0	0.379	49%	0.40	51%	23	0:46
		81.0	0.339	43%	0.44	57%	54	1:48
098-109-337-010-121	39.5	36.5	0.299	38%	0.48	62%	1	0:02
		39.5	0.252	32%	0.53	68%	288	9:36
		38.5	0.236	30%	0.54	70%	310	10:20
098-103-168-029-039	24.4	21.0	0.328	42%	0.45	58%	174	5:48
		25.0	0.314	40%	0.47	60%	163	5:26
		23.0	0.298	38%	0.48	62%	172	5:44
		36.0	0.295	38%	0.49	62%	163	5:26
		44.0	0.251	32%	0.53	68%	176	5:52
		32.0	0.224	29%	0.56	71%	161	5:22

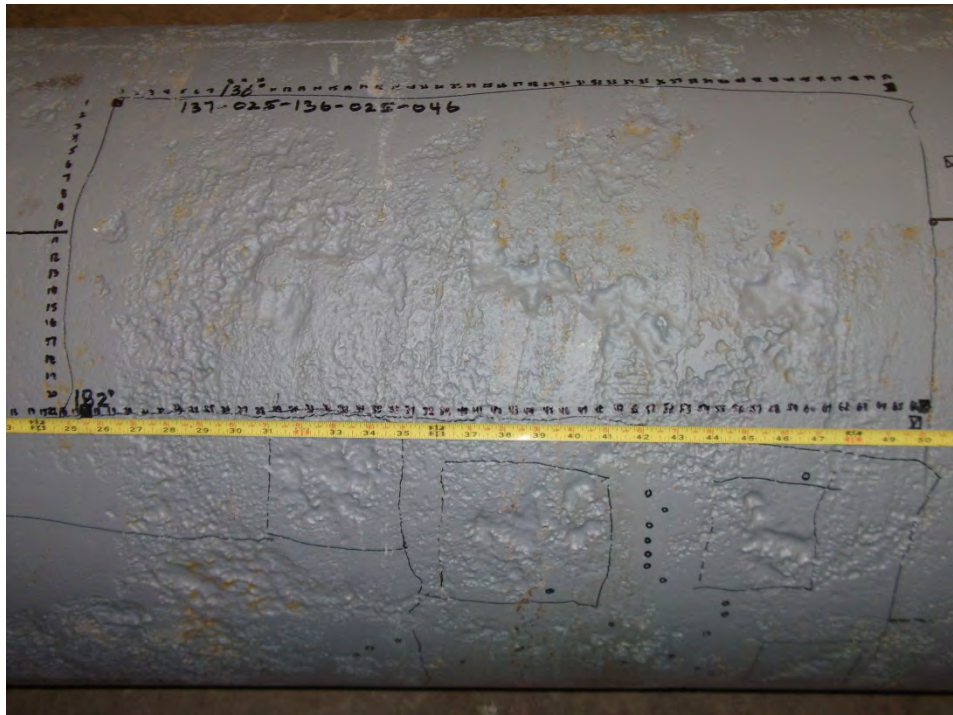
Figure A-137(1). Pipe 137, area 137-025-136-025-046

Defect Area	Total Volume Loss (in.³)	Dist From Bell (in.)	Maximum Depths In Defect Area (in.)	% Loss	Remaining (in.)	% Remaining	Clock (Degrees)	Clock (12hr)
137-025-136-025-046	10.7	111.5	0.243	31%	0.54	69%	195	6:30
		109.5	0.239	31%	0.54	69%	193	6:26
		120.0	0.231	30%	0.55	70%	197	6:34
137-017-182-033-059	16.9	103.5	0.238	31%	0.54	69%	160	5:20
		122.0	0.206	26%	0.57	74%	145	4:50
		113.0	0.202	26%	0.58	74%	165	5:30
137-010-299-040-094	18.8	113.0	0.207	27%	0.57	73%	357	11:54
		109.5	0.189	24%	0.59	76%	5	0:10
		124.0	0.181	23%	0.60	77%	34	1:08
137-000-000-010-360	52.7	146.5	0.361	46%	0.42	54%	253	8:26
		146.0	0.328	42%	0.45	58%	213	7:06
		146.0	0.324	42%	0.46	58%	200	6:40
		146.5	0.321	41%	0.46	59%	160	5:20
		146.5	0.320	41%	0.46	59%	260	8:40

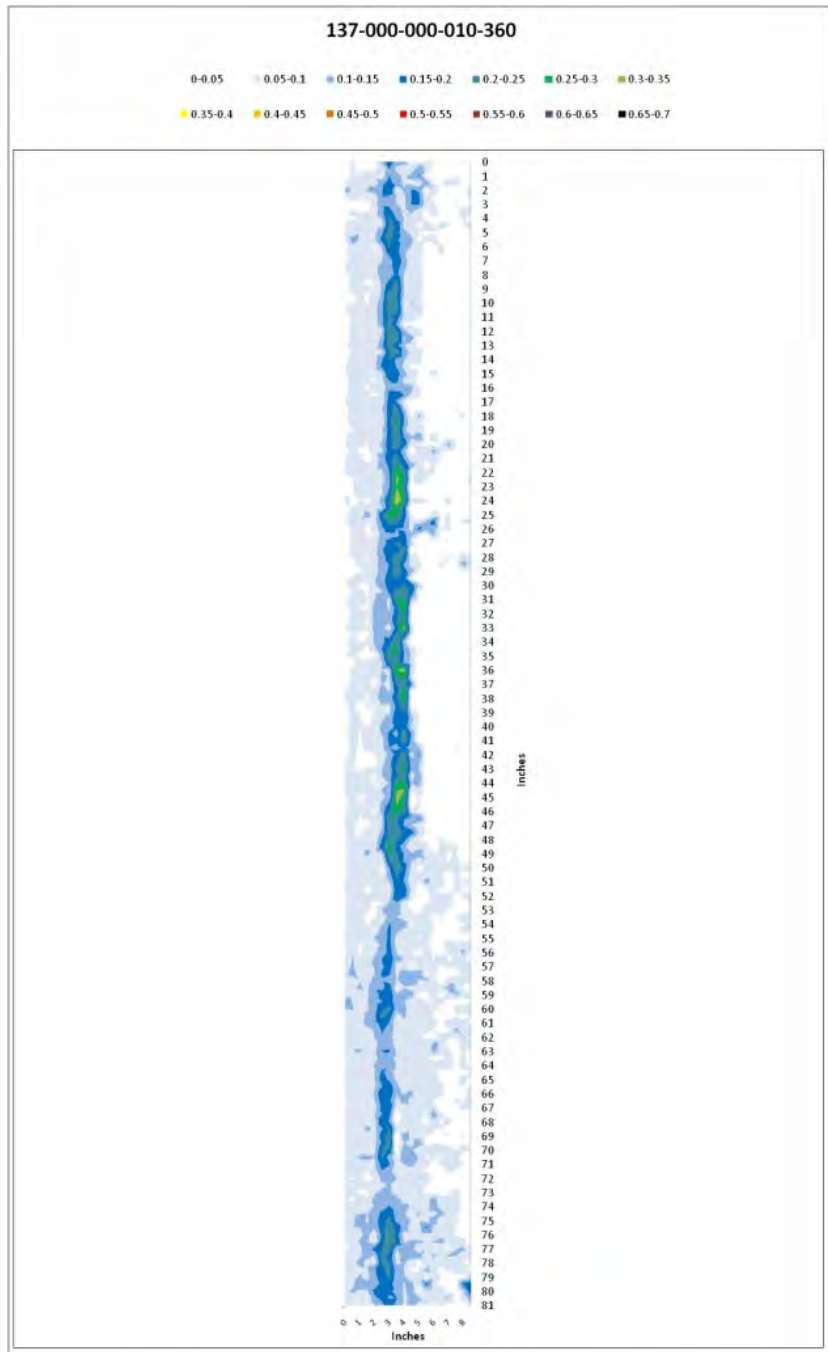
Figure A-137(7). All depths at the spigot for Pipe 137 from 0° to 360° combined into one image, area 137-000-000-010-360

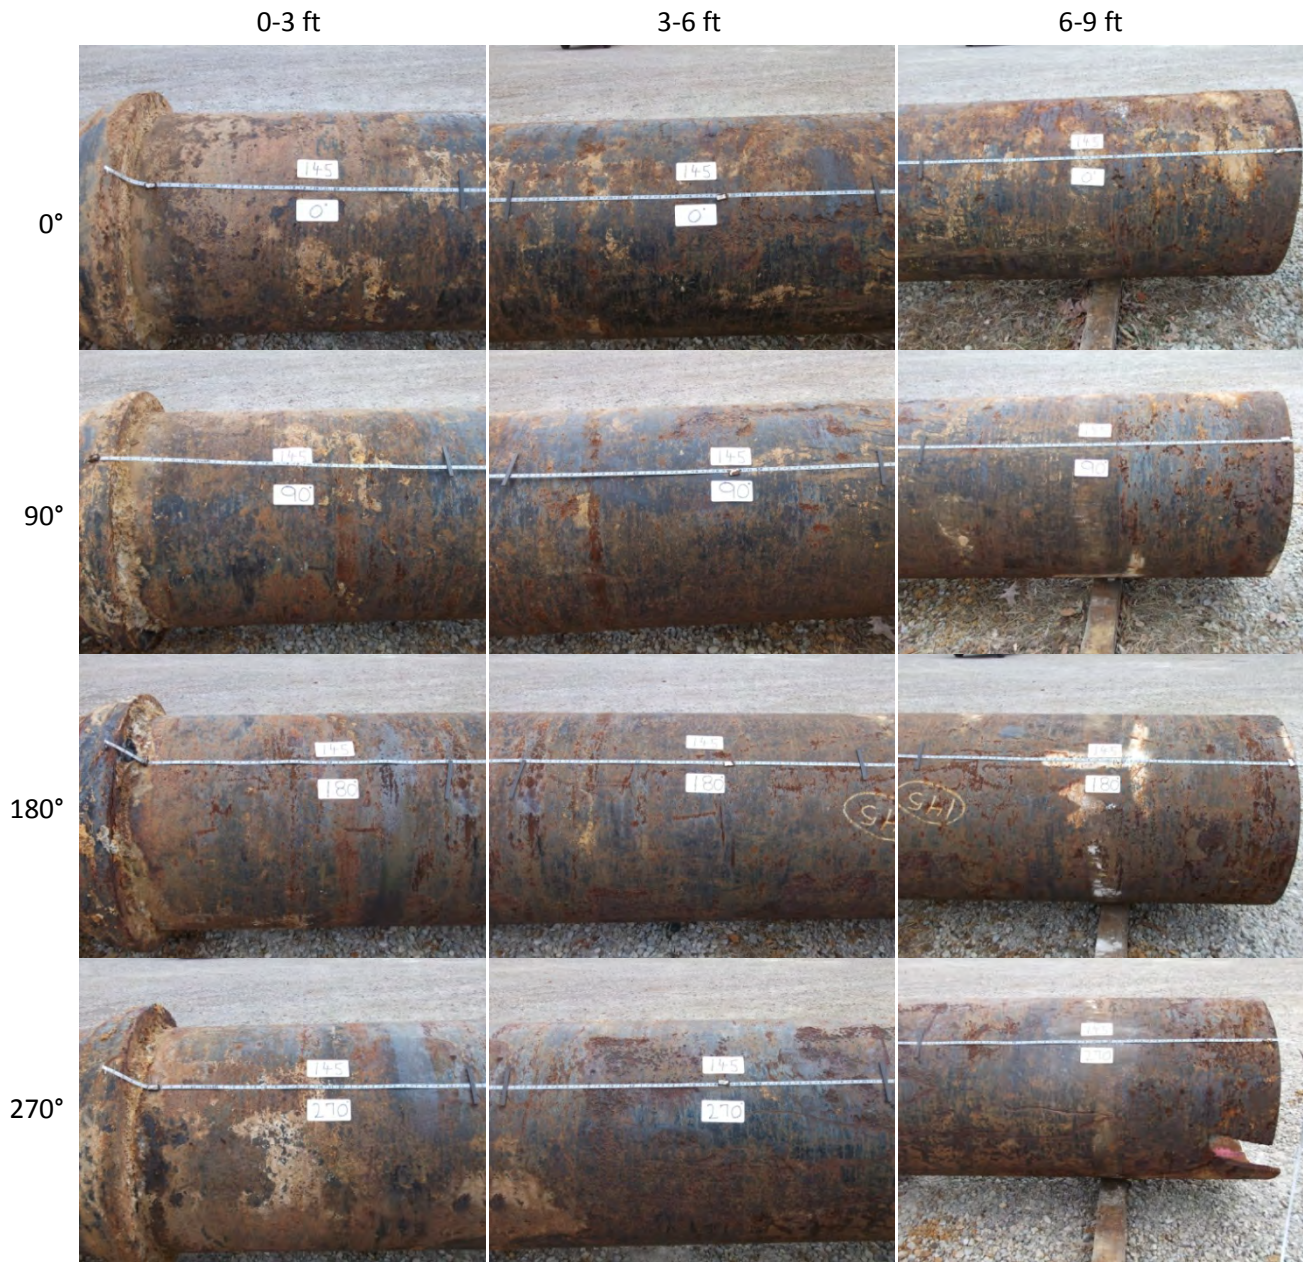
Figure A-145(1). Pipe 145 as Removed from Site

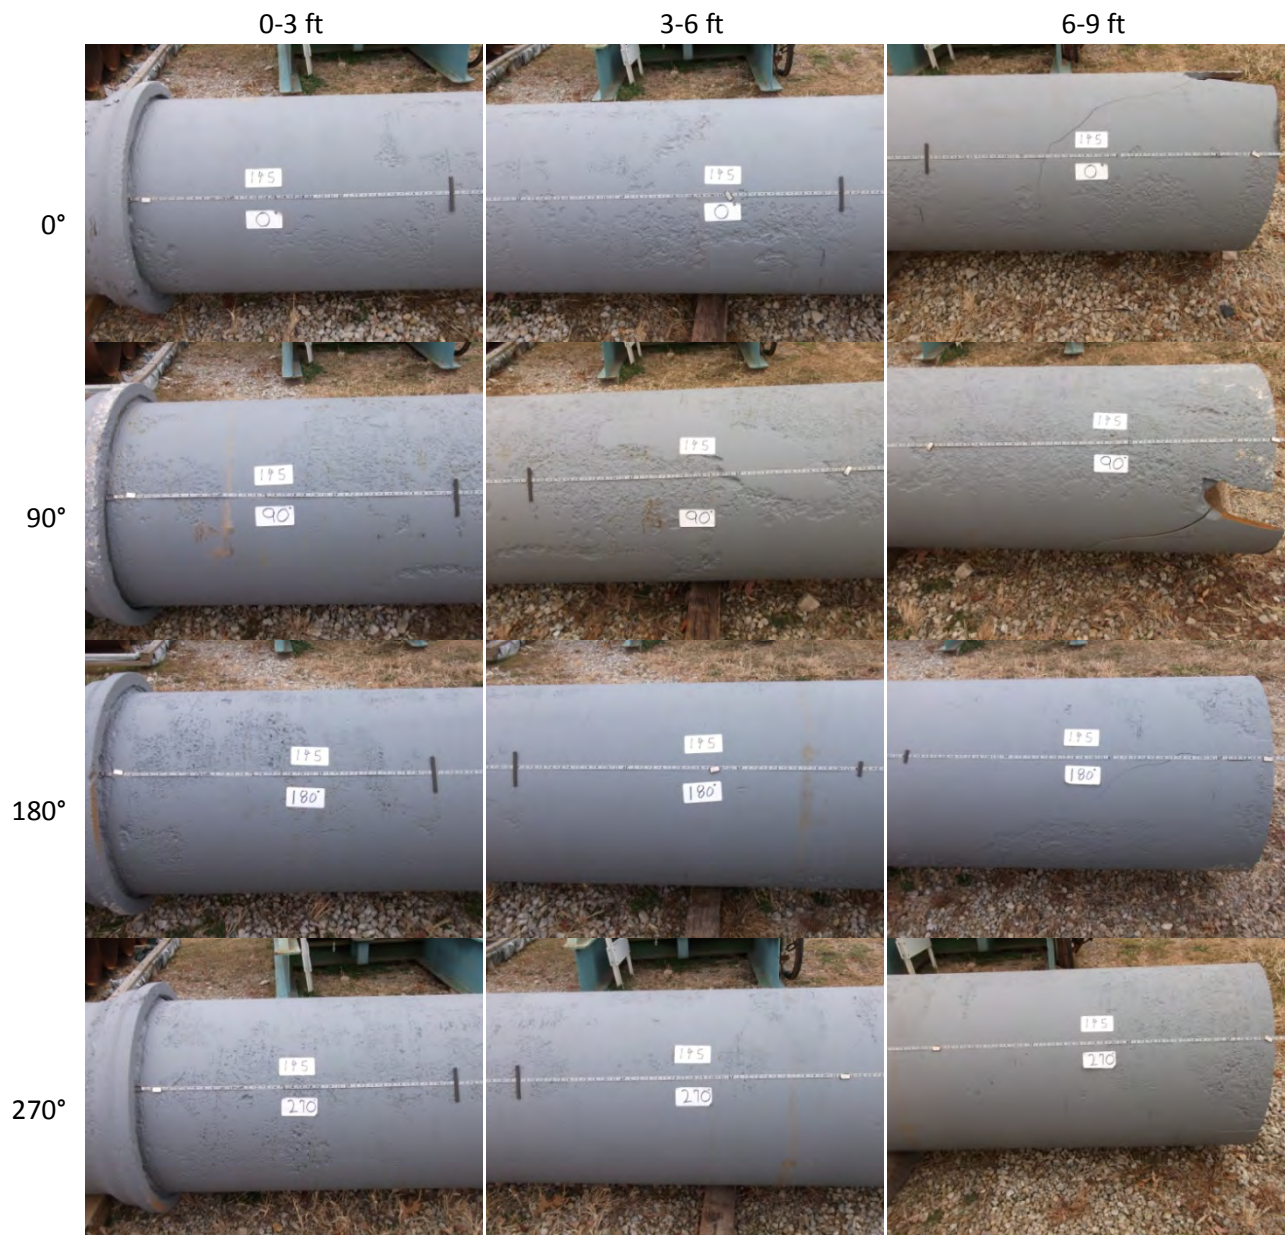
Figure A-145(2). Pipe 145 after Sandblasting

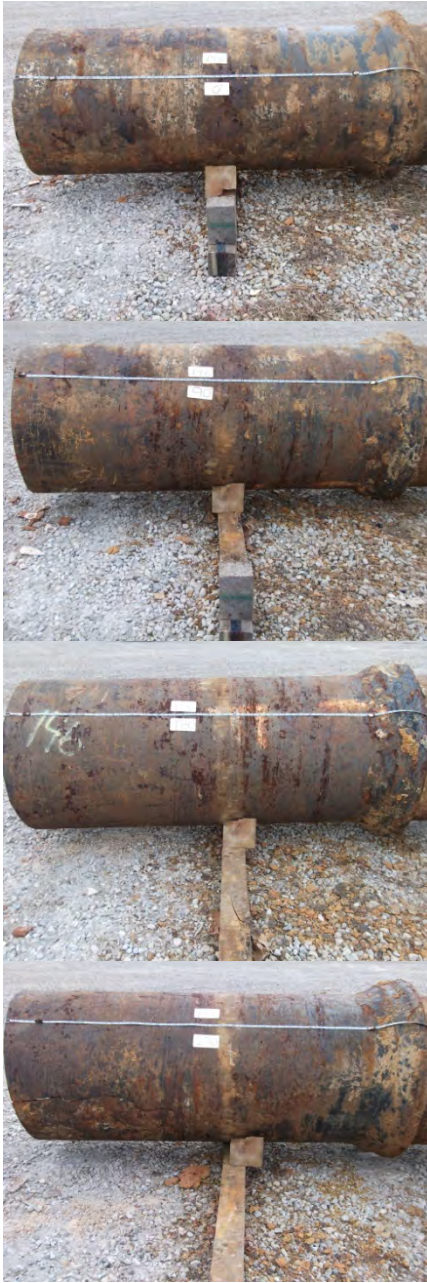
**Figure A-146(1). Pipe 146 as
Removed from Site**

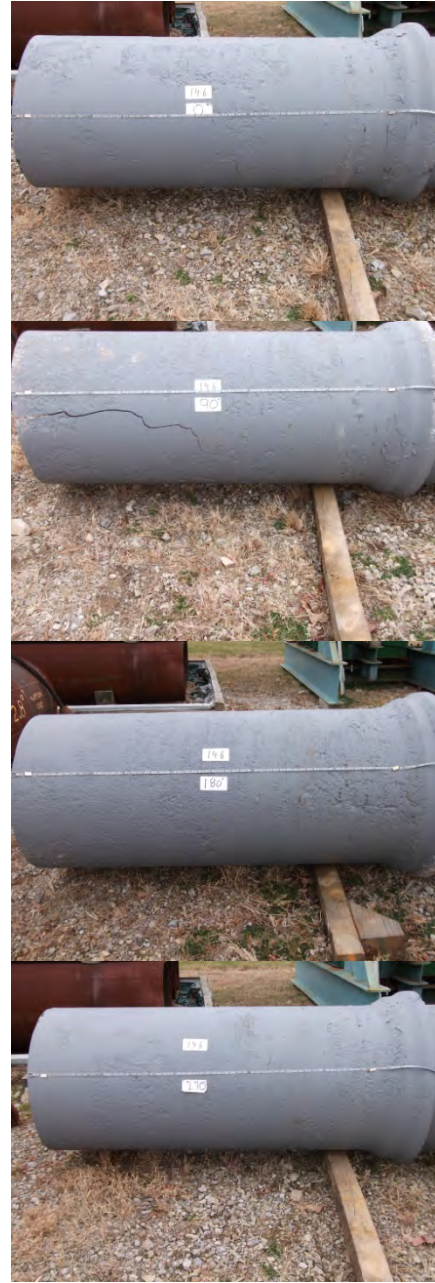
Figure A-146(2). Pipe 146 after Sandblasting

Note that Pipe 146 was a cutout and not a complete pipe. Therefore, only partial measurements were made and are presented next.

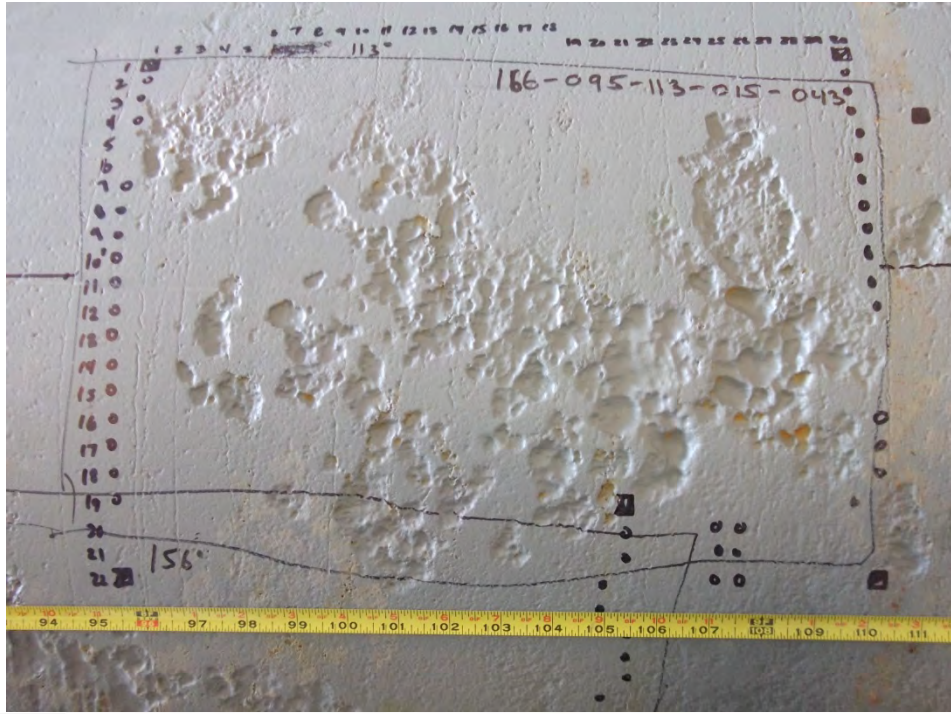
Figure A-166(1). Pipe 166, area 166-095-113-015-043

Defect Area	Total Volume Loss (in. ³)	Dist From Bell (in.)	Maximum Depths In Defect Area (in.)	% Loss	Remaining (in.)	% Remaining	Clock (Degrees)	Clock (12hr)
166-095-113-015-043	5.5	45.0	0.260	33%	0.52	67%	211	7:02
		43.0	0.223	29%	0.56	71%	216	7:12
166-080-156-026-055	12.6	67.5	0.291	37%	0.49	63%	162	5:24
		68.5	0.246	31%	0.53	69%	155	5:10
		65.0	0.206	26%	0.57	74%	151	5:02
166-026-092-038-058	9.5	111.0	0.256	33%	0.52	67%	228	7:36
		101.5	0.196	25%	0.58	75%	230	7:40
		101.5	0.189	24%	0.59	76%	248	8:16
		113.0	0.166	21%	0.61	79%	237	7:54

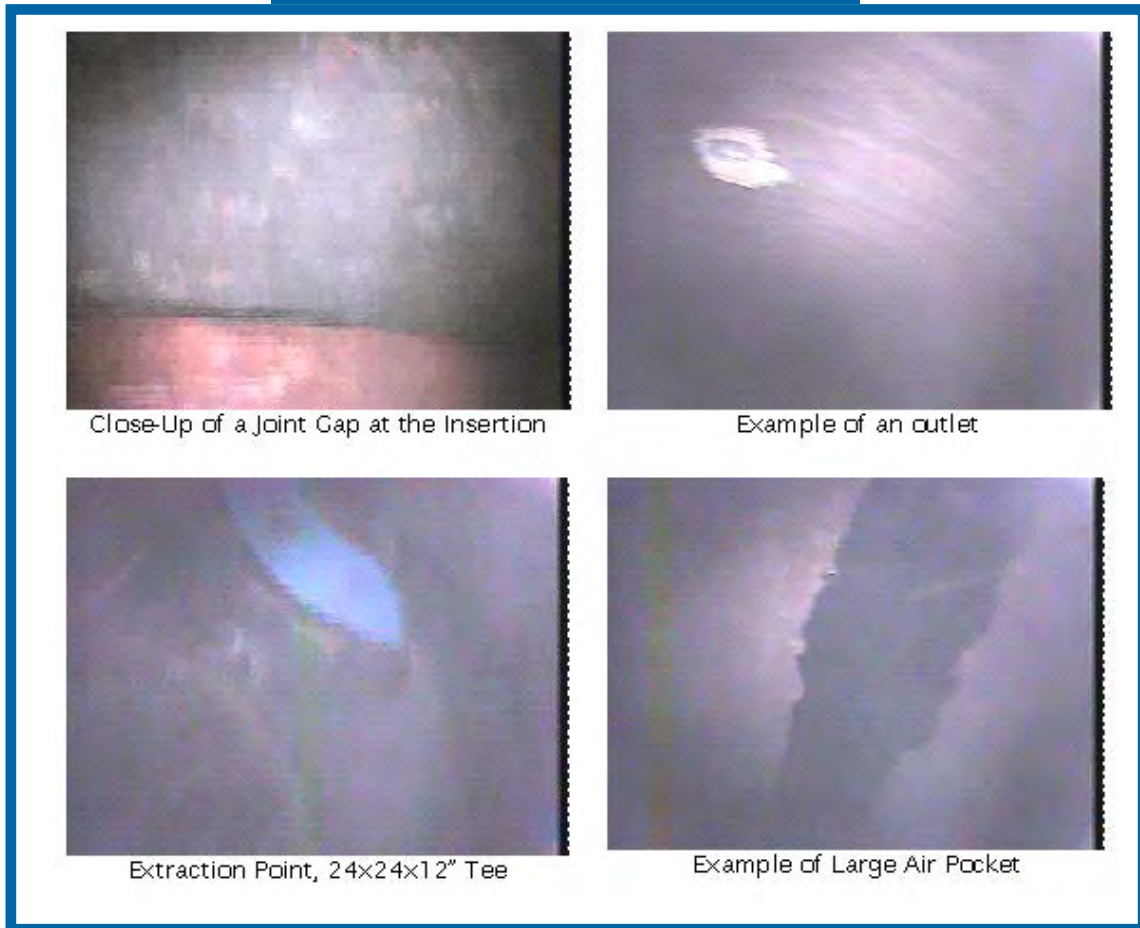
Figure 3.5 Sahara Video Examples

Many additional air pockets, ranging from small to large in size, were discovered during the video inspection. Both air pockets and wall corrosion could be clearly distinguished in the video inspection.

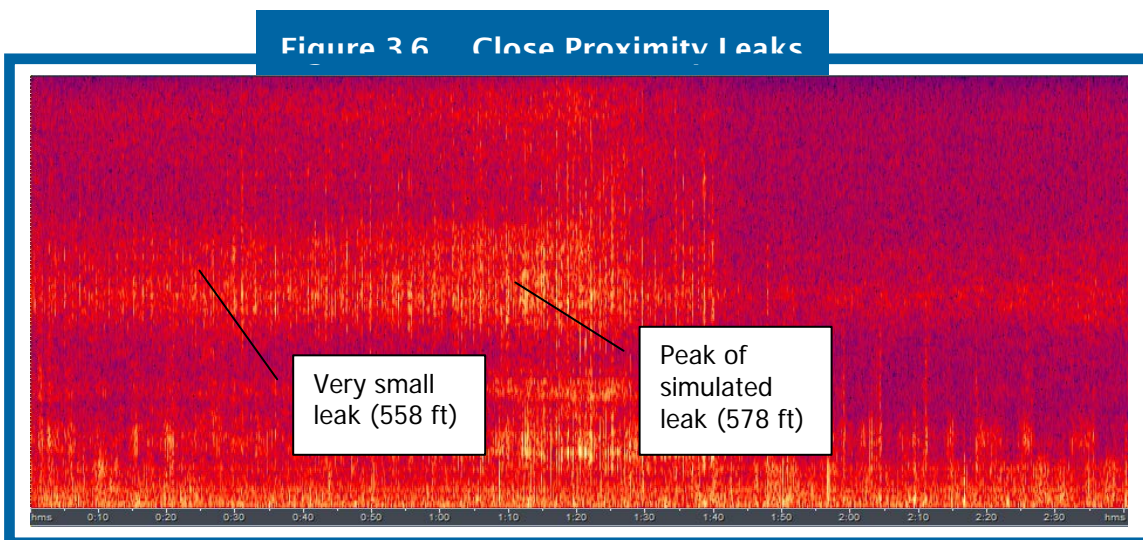
The following screen capture is from the simulated leak recording located at pit 4, from 541 ft to 607 ft. A small peak around 558ft shows a very small natural leak. Signatures of both leaks are combined and are difficult to report in real-time.

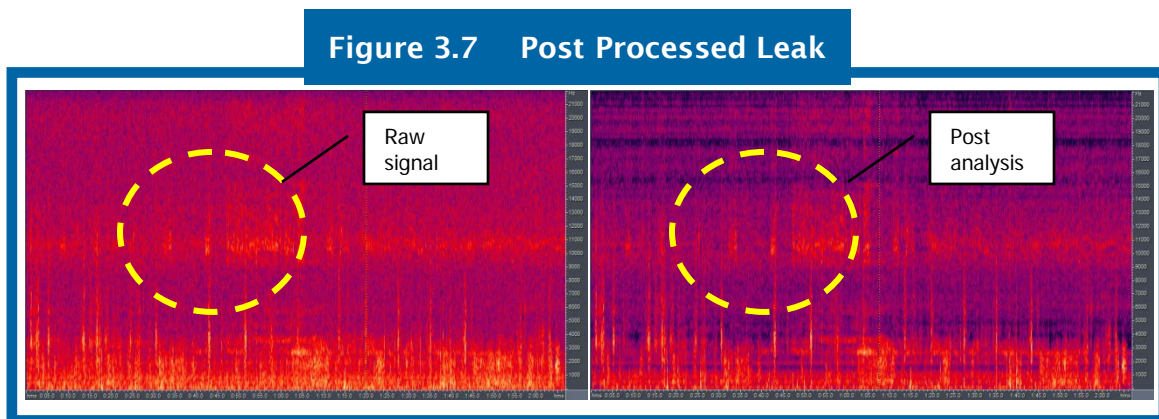
After recording signals from inspections, PPIC used post analysis to filter noise and improve leak detection. The signals were filtered and show that post analysis can make leak signals more distinguishable.

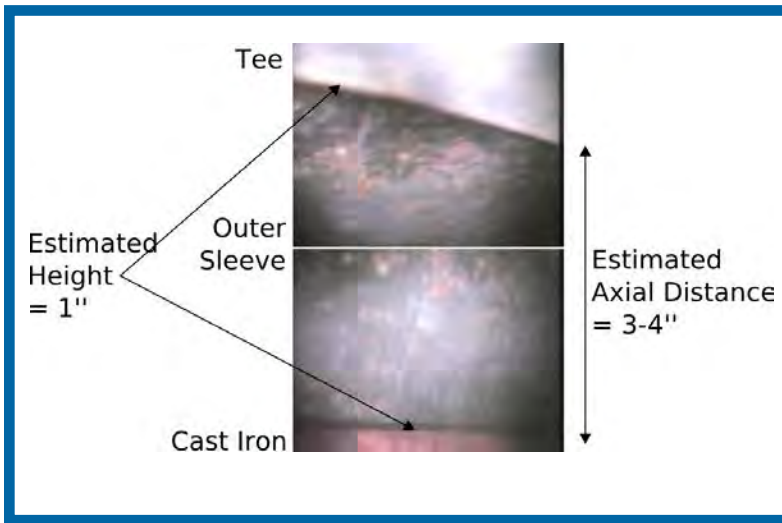
Figure 4.5 Sahara Video of the Joint Gap

On July 21st, the first insertion attempt, the PipeDiver vehicle became stuck during the insertion process and that day's inspection had to be stopped and the vehicle retrieved from the pipe. An investigation of the issue with the help of Sahara video (Figure 4.5 and 4.6) led to the conclusion that the front of the PipeDiver has become stuck in a large, unfilled gap estimated to be 3 to 4 inches in width between joints just downstream of the insertion point.

An alternate insertion process was designed and implemented and the following four insertions were successful.

PipeDiver is designed for live inspections using standard accesses including 12 inch diameter hot taps, tees with minimum joint gaps, or similar features. For certain accesses such as tees with large unfilled joint gaps or accesses with unknown internal conditions Sahara Video is recommended to identify the exact layout of the insertion

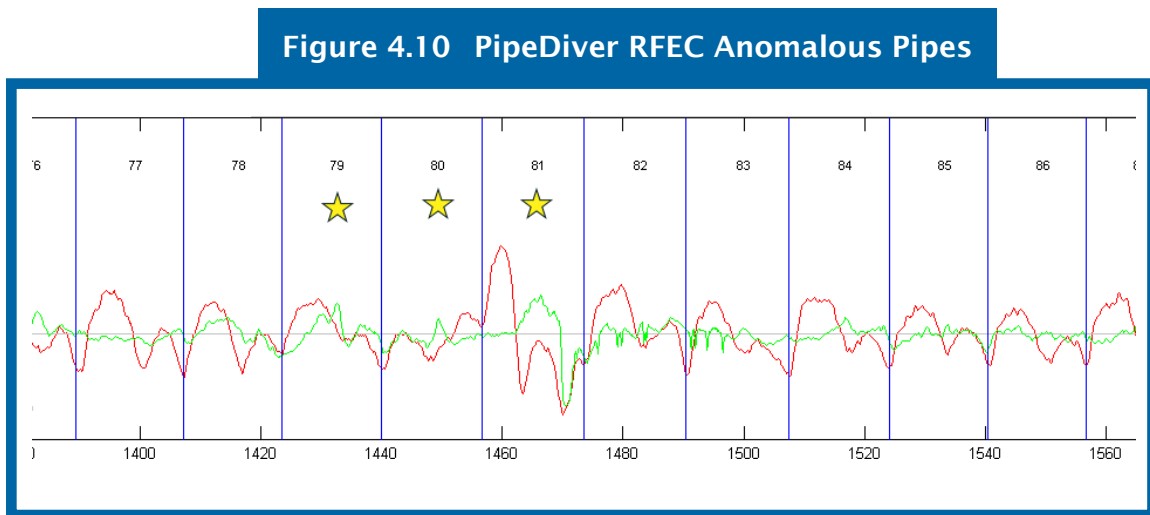
Figure 4.10 below shows an example of several pipes classified as anomalous from their RFEC signal. The second half of pipe 79 and the first half of pipe 80 show an anomalous signal which could be due to a wall thickness loss from pipe 80. The entire signal in pipe 81 differs largely from the nominal pipe signal and could be due to wall thickness loss or from an unidentified pipe feature.

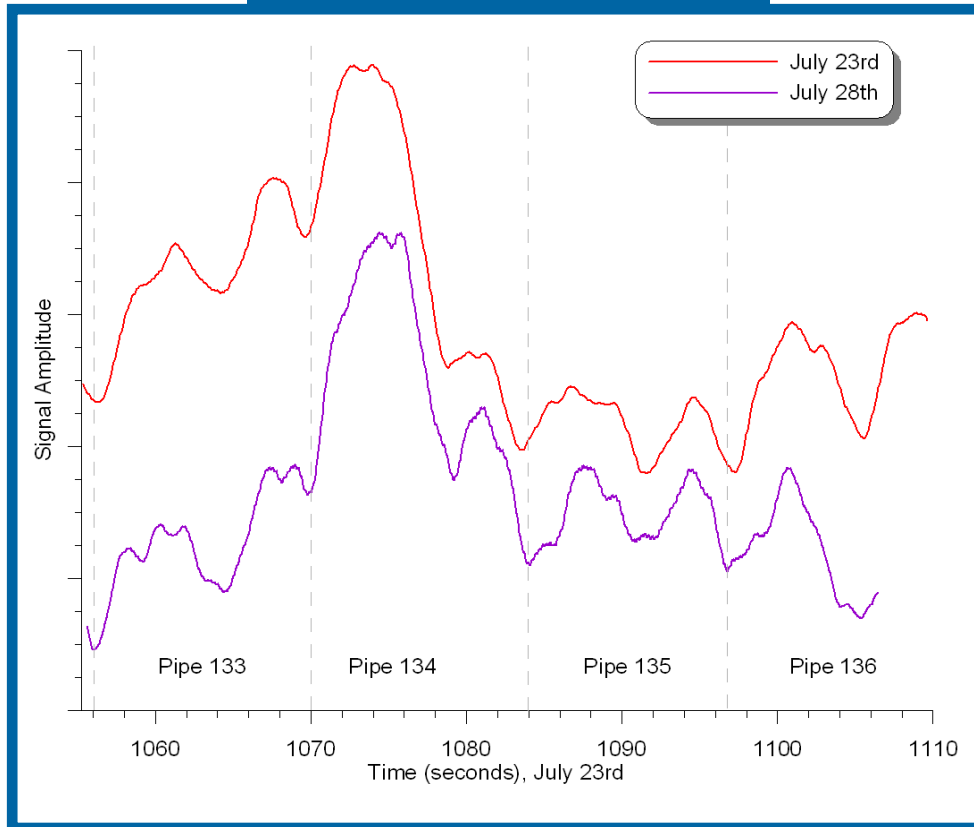
Figure 4.11 RFEC Repeatability

The PipeDiver configuration used on the July 23rd and 28th inspections were almost identical which allows a direct comparison of the signals. Figure 4.11 below shows a comparison for a section of four pipes from the center detector. One of the objectives of this inspection was to verify the validity of the PipeDiver RFEC technology by performing such repeatability tests. The results from the multiple PipeDiver scans show good repeatability.

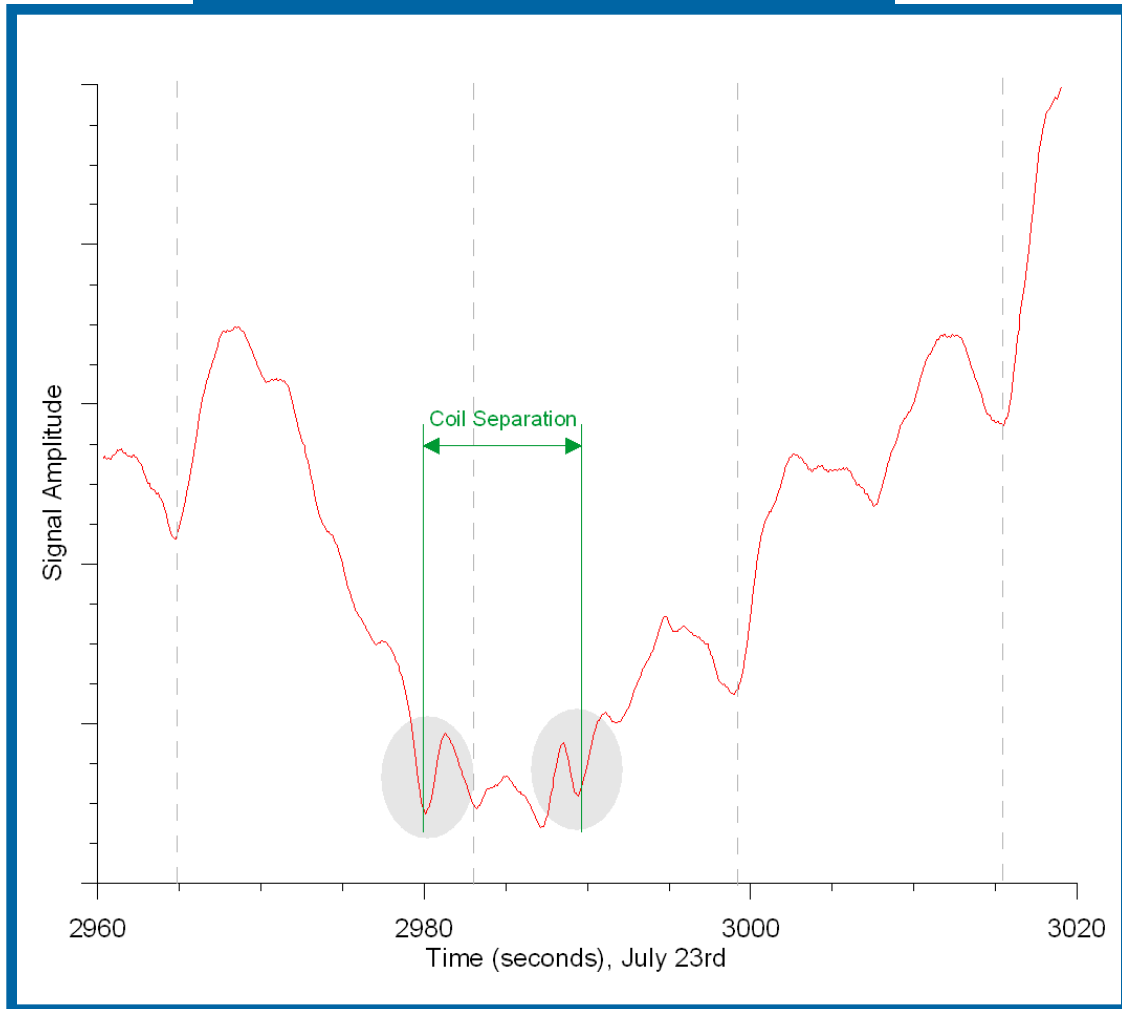
Figure 4.12 PipeDiver RFEC Hydrant Signal

A known feature from the pipeline that is readily seen in the PipeDiver RFEC data is the hydrant outlet that is located near Pit F (Figure 4.12). While the signal is relatively small as compared to the joint signal it can be distinguished by having a double signal occurring the exact distance as the PipeDiver's detector-exciter coil separation distance.

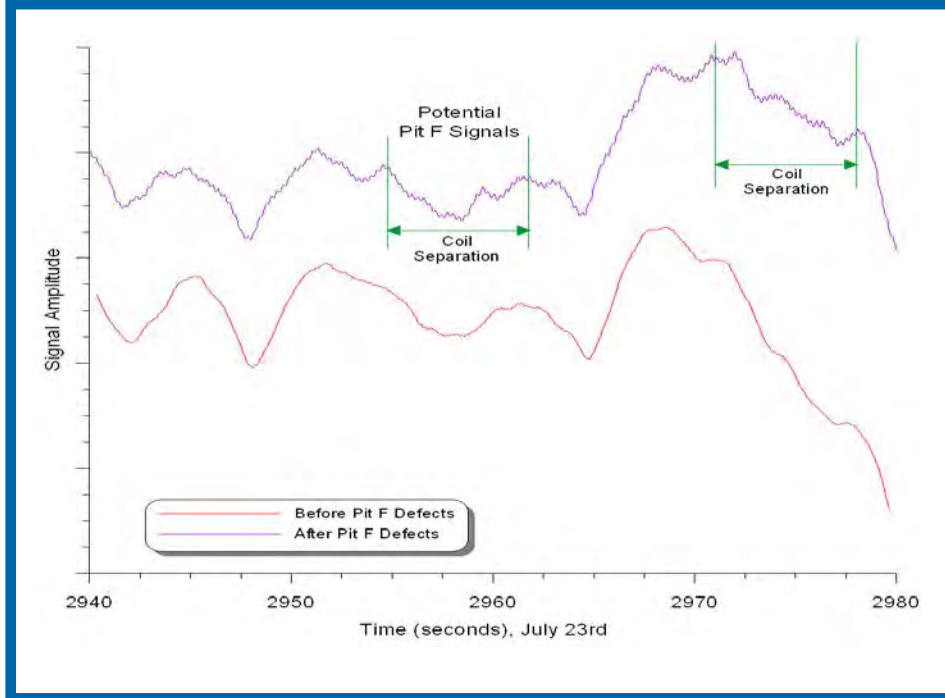
Figure 4.14 Comparing RFEC Data Before and After Defects

Four new defects were machined into Pit F on July 28th (Figure 4.13). By comparing the RFEC signals from the data before and after the defects were created we have the best possible chance of seeing this relatively small amount of wall thickness loss in the data (Figure 4.14).

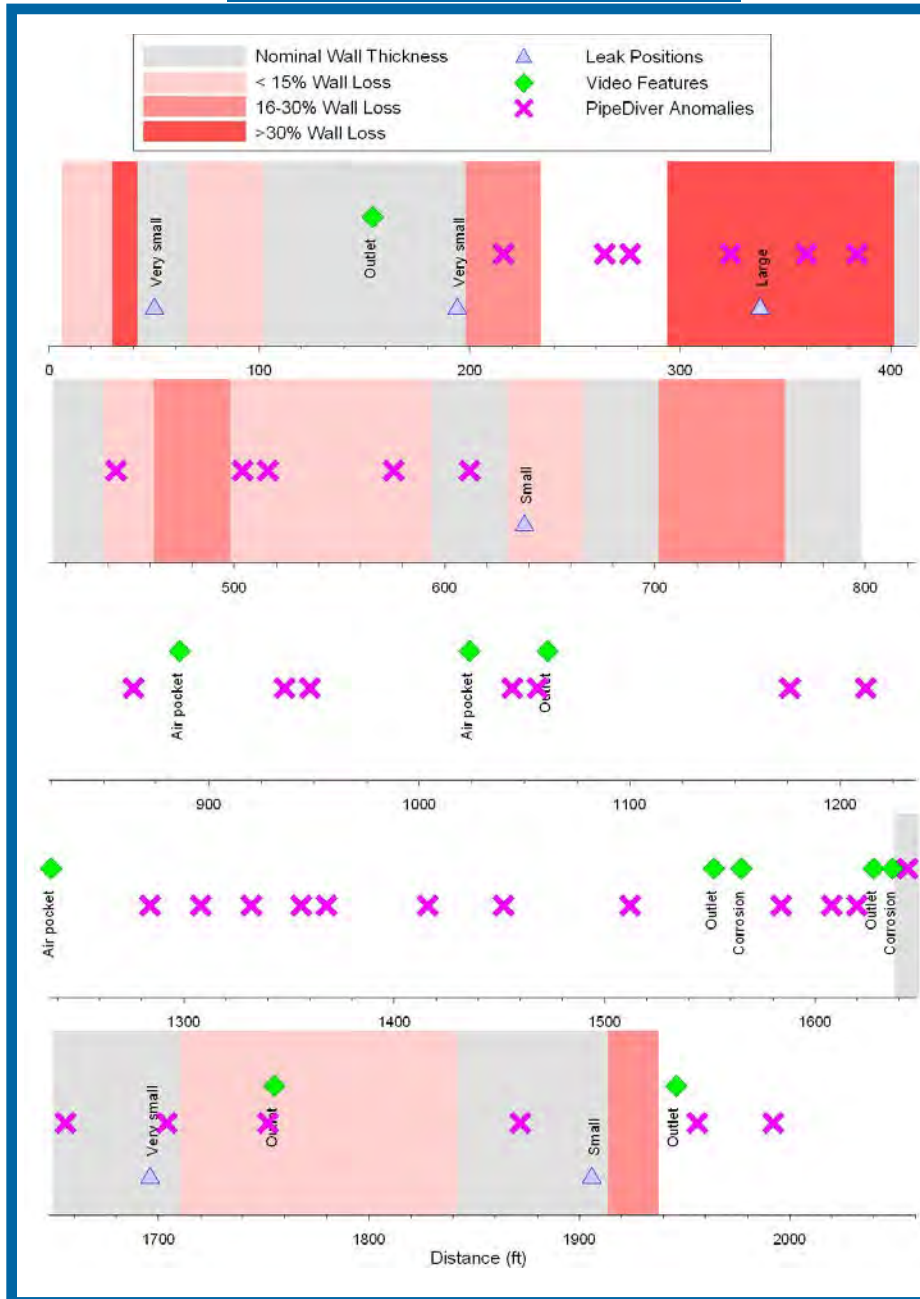
Figure 5.1 Combined Results

The combined results make it easier to identify potential areas of interest within the pipe. For example, the section between 300 to 400 ft contains a large leak, several PipeDiver RFEC anomalies and has a high average wall thickness loss and is one of the areas recommended for further verification and calibration. Similarly, the area between 1560 to 1640 ft contains several identified corrosion spots and PipeDiver RFEC anomalies.

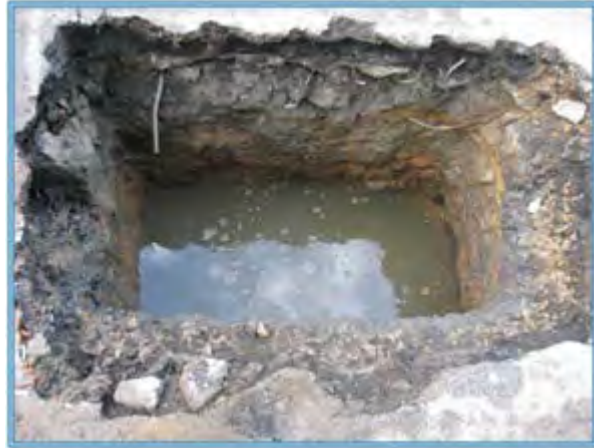
Pits were constantly flooded due to ground water and rain storms.

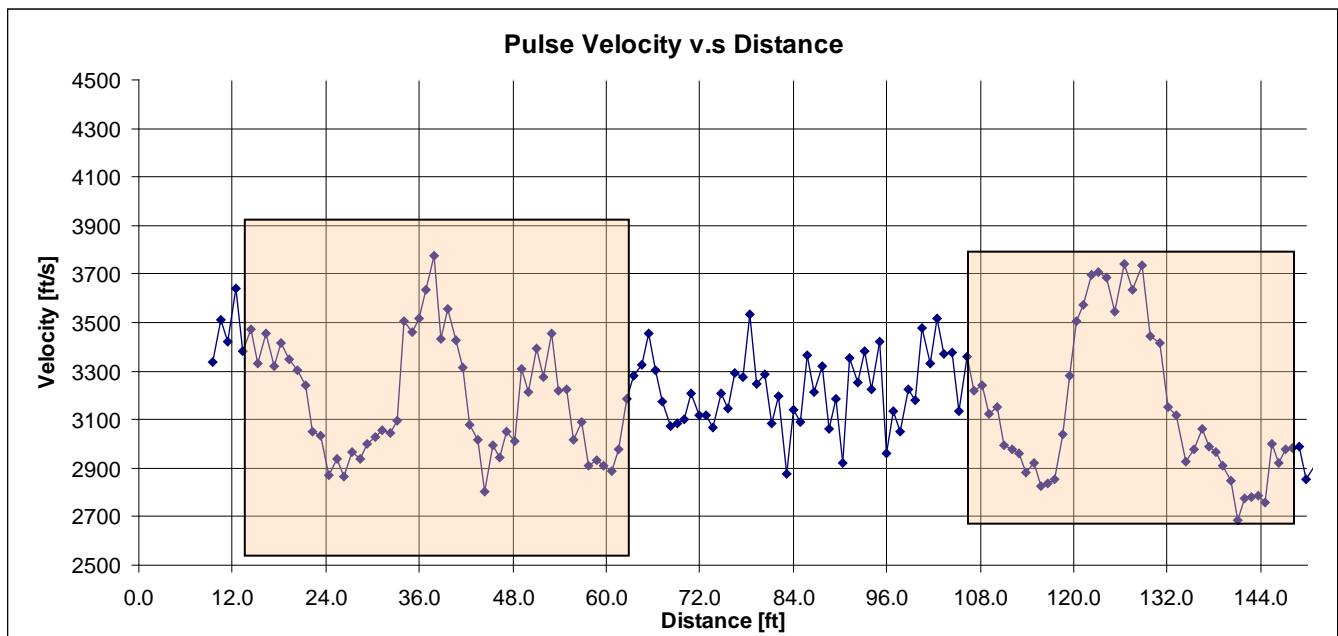
Figure 5.1: Acoustic Profiles from 0ft – 150ft

The graphs below show the condition of the pipe as detected by the SmartBall™ with respect to the position of the SmartBall™ along the pipeline. Since the pipe wall thickness affects the velocity of the signal as it propagates through a water filled pipe, it is therefore concluded that there is some evidence of pipe wall weakness at highlighted areas.

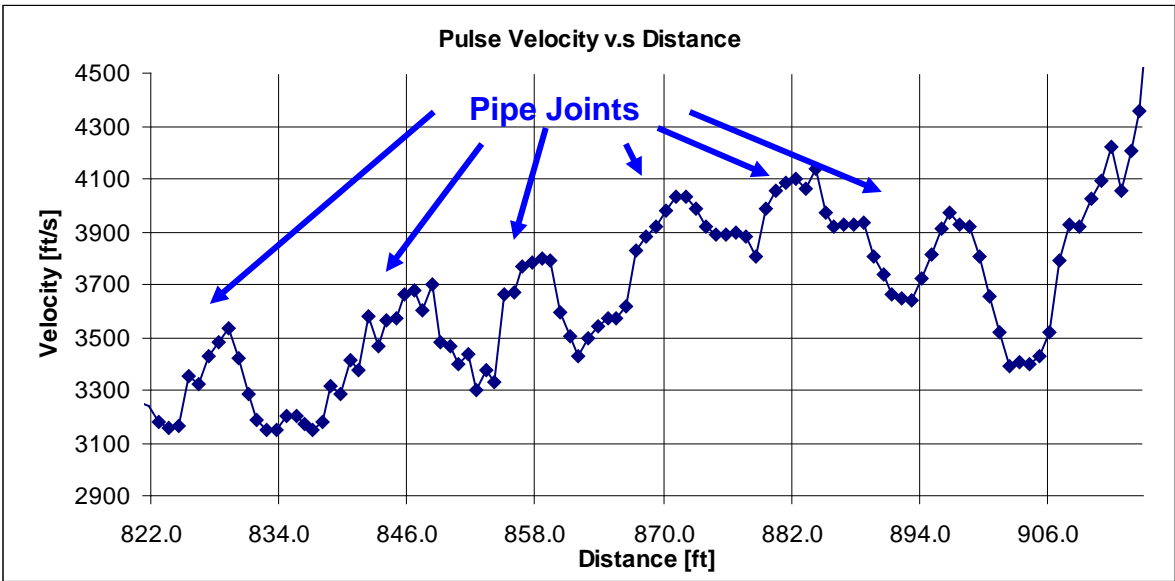
Figure 5.8: Joint Locations

The data obtain from the SmartBall PWA tool also suggests that it is capable of detecting features on the pipeline such as valves and joints. The peaks presented in Figure 5.8 illustrate the location of the joints. As shown, a typical joint section for this pipeline is approximately 12ft.

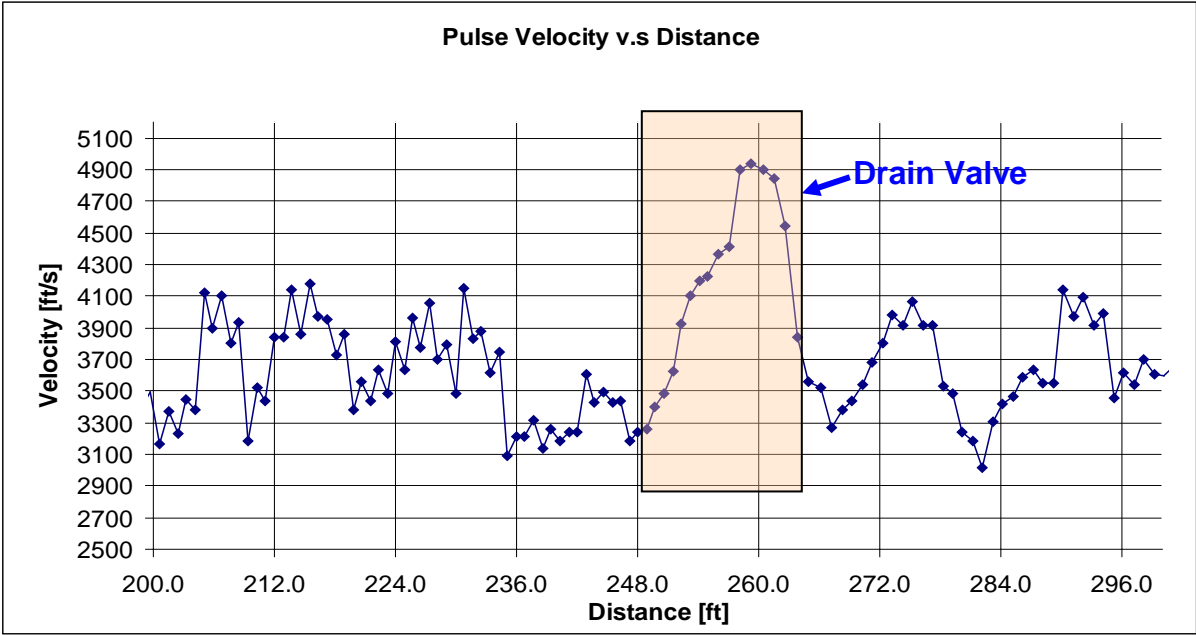
The anomaly shown in Figure 5.9 illustrates the acoustic representation of the drain valve found at approximately 260 ft from the insertion location.

Figure 5.9: Drain Valve Location as Seen By Acoustic Pulses

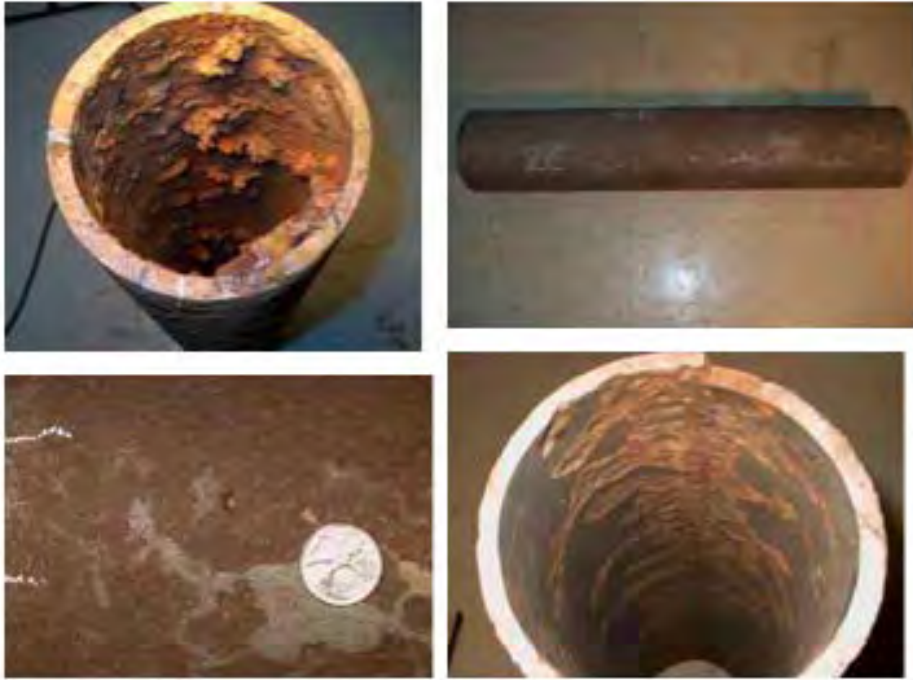
Figure 1: Photos of pipe with 4.2% measured loss

A section of pipe where 4.7% measured loss is shown in Figure 1. The nominal thickness of this pipe was 12mm (0.47in), whereas the lab measured physical thickness at either end of the sample was 11.4+/-2.7mm (0.45in +/-0.1in). The average pit depth was 1.5mm / 1.9mm. The pipe was qualitatively described as very good / very good. This again is an indication that the acoustic wave velocity from the acoustic mode of the

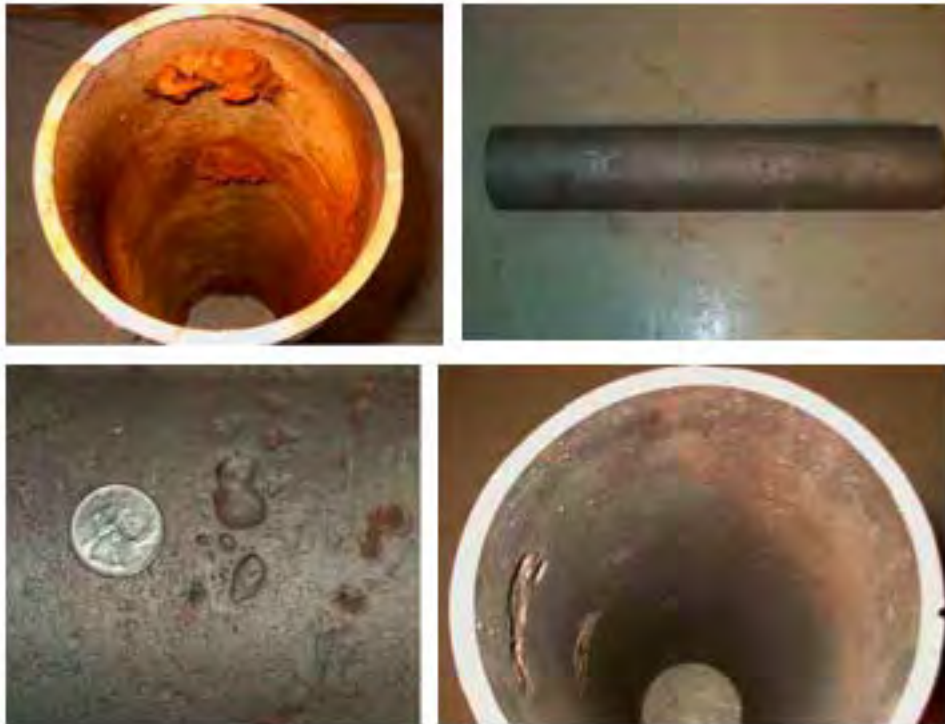
Figure 2: Photos of pipe with 8.9% measured loss

Figure 2 shows photographs of a section of pipe measured at 8.9% average loss. The physical thickness of this pipe was measured at 8.8 \pm 0.8mm (0.35in \pm 0.03in)(nominal was 9mm), with average pit depth at 2.5mm / 3.0mm. The condition of the pipe was rated as very good / moderate. The corrosion of this pipe was primarily localized internally on the bottom of the pipe as can be seen in the right photo. The corrosion appeared in this case more continuous perhaps due to sediment build up at the bottom of the pipe. Overall the structural integrity of the pipe is good.

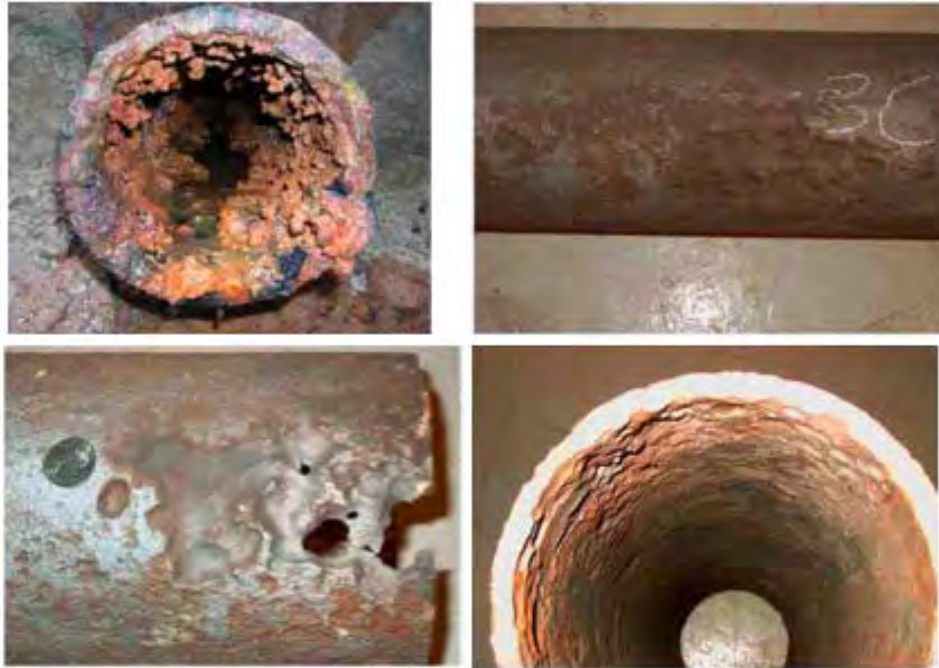
Figure 3: Photos of pipe with 47.3% measured loss

Figure 3 provides photographs of a pipe with a measured 47.3% average loss of pipe wall thickness (11.0mm, 0.43in nominal). In the lab the average physical thickness was measured as 11.6 \pm 3.3mm (0.456in, \pm 0.13in) and an average pit depth of 3.8mm / 2.5mm. The physical condition of the pipe was described as very poor / poor. Note that there were also numerous through holes in the pipe evident after sand blasting. It is interesting to note that the pipe was not leaking when measured, probably due to the build up of tuberculation.

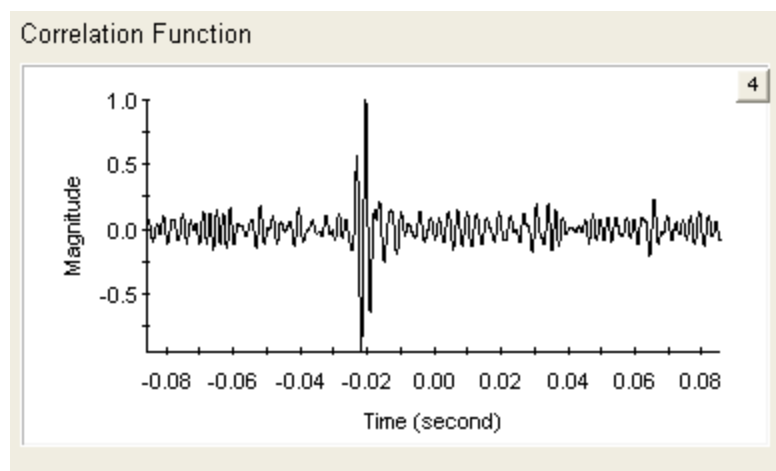
Figure 4: Correlation result for File #2

File 2a was recorded with the Blue station on the pipe in Pit B and the White station in Pit A with sensor spacing of 260.5ft. The correlation function shown for this file indicates a leak at a position was 91.5ft from the White sensor. A sharp correlation peak and moderate levels of coherence indicates a flow rate of 2.5 – 5.0 Gpm for this leak.

The evidence presented here strongly indicates the presence of a leak and if this pipe were to remain in service, it would be suggested to perform remedial action.

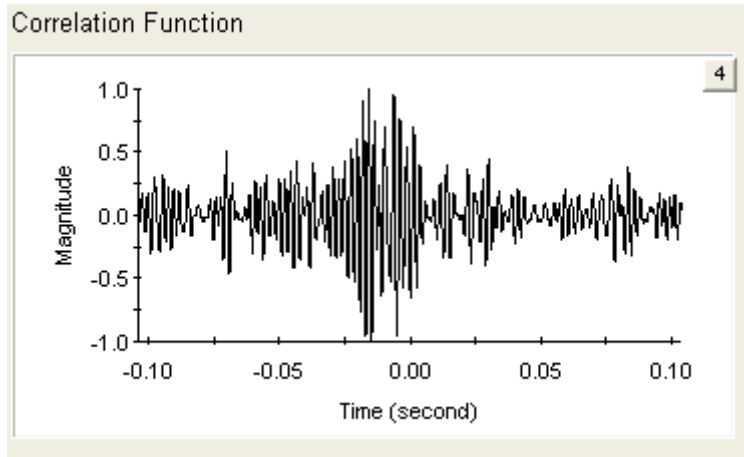
Figure 5: Correlation Result for File #7

The correlation function shown for File 7c was recorded with the Blue station mounted to the pipe in Pit F and the White station mounted to the pipe in Pit #3 with a sensor-to-sensor spacing of 312.7ft. The character of the signal suggests that there may be two leaks at this location at a distance of 126.6ft and 144.6ft from the White station. The weaker signal and wider correlation peak indicates a small leak, which sets the estimated flow rate at 1.0 – 2.5 Gpm for each leak.

The evidence presented here is not entirely conclusive because the correlation peak is not defined. If this pipe were to remain in service, it would be suggested to perform further investigation by either using a ground-microphone to confirm a noise source or potholing to confirm the presence of water.
