Field Demonstration of Innovative Condition Assessment Technologies for Water Mains: Acoustic Pipe Wall Assessment, Internal Inspection, and External Inspection

**FIELD DEMONSTRATION OF INNOVATIVE CONDITION ASSESSMENT TECHNOLOGIES
FOR WATER MAINS: ACOUSTIC PIPE WALL ASSESSMENT, INTERNAL INSPECTION,
AND EXTERNAL INSPECTION**

VOLUME 1: TECHNICAL REPORT

September 2013

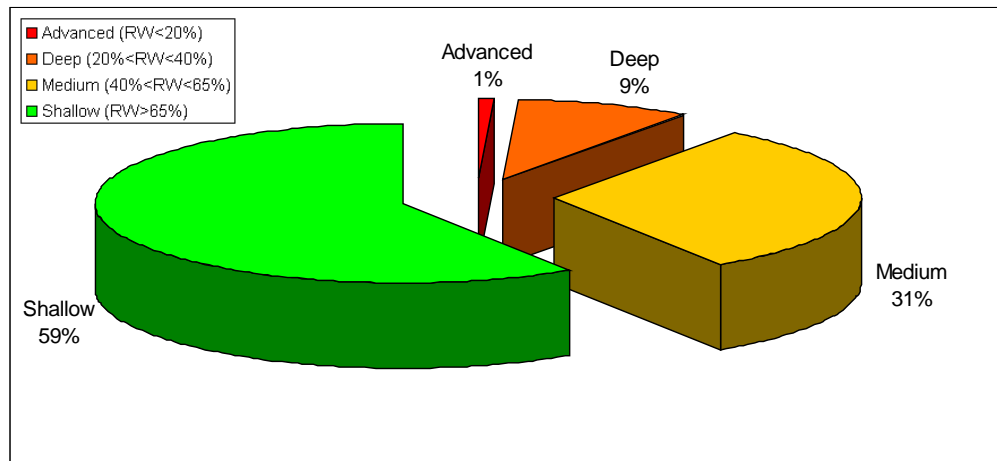
This report documents the RFT findings for the 24-inch Westport Rd main in Louisville. A total of 367 wall loss indications were found along the 2059ft main. A majority of these defects are less than or equal to 60% deep, with a much smaller group in the 60-80% range. Only a few localized indications sized 80% or deeper. In addition, the results from the 24-inch See Snake tool show that the deep defects are concentrated within the first half of the line, leaving about half the line in relatively good shape. The Pie chart and Table 1 provide a summary overview of the RFT findings and the measured remaining wall thickness.

• Figure 1. Defect break down according to minimum Local Remaining Wall.

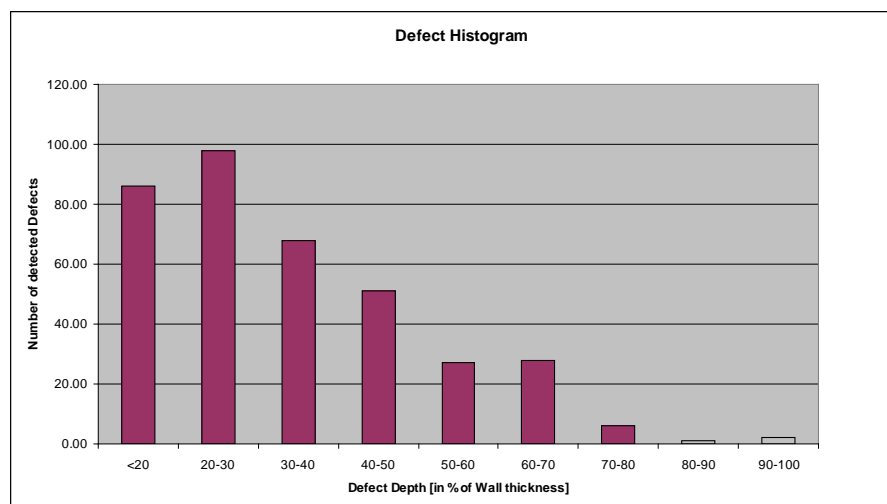
The inspection of the water line resulted in 367 wall loss indications. A histogram of the results show that a majority of the defects are less than or equal to 50% deep, with a much smaller group in the 60-80% range, and only a few defects 90% or deeper. More importantly the results from the See Snake tool show that the deep defects are concentrated within the first half of the line, leaving about half the line in relatively good shape.

• Figure 6. Defect Histogram (for example the count at 70% deep are defects that are deeper than 60% but less than 70%).

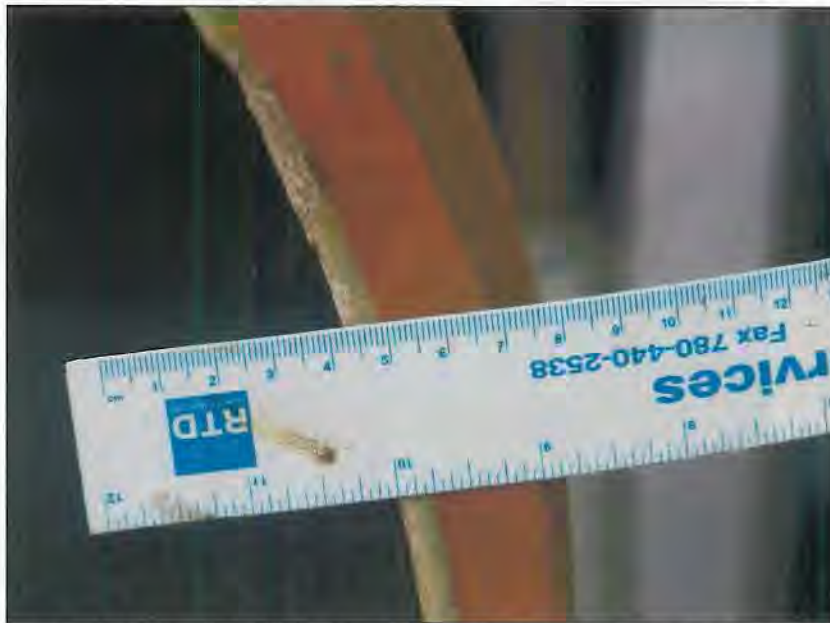
The pipe internal surface is lined with cement mortar approximately 5mm in thickness. This was identified by Battelle upon the removal of pipe sections as shown in Figure 4.1. The pipe's external surface was coated in bitumen paint.

FIGURE 4.1 - PHOTOGRAPH PROVIDED BY BATTELLE OF PIPE CROSS SECTION

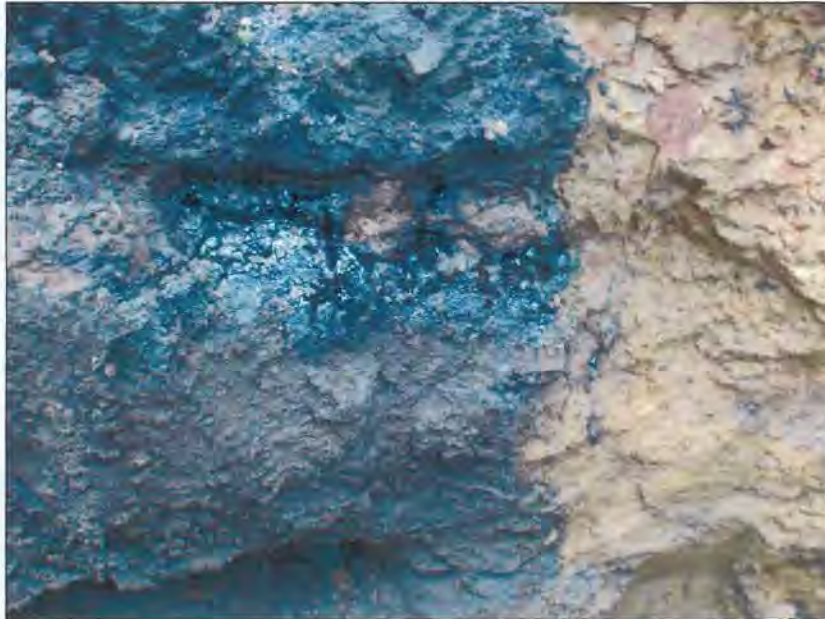
FIGURE 4.2 - BLACK CONTAMINANTS IN THE GROUND

Black and green contaminants in the soil were evident within the sidewalls at some of the excavations as seen in Figure 4.2.

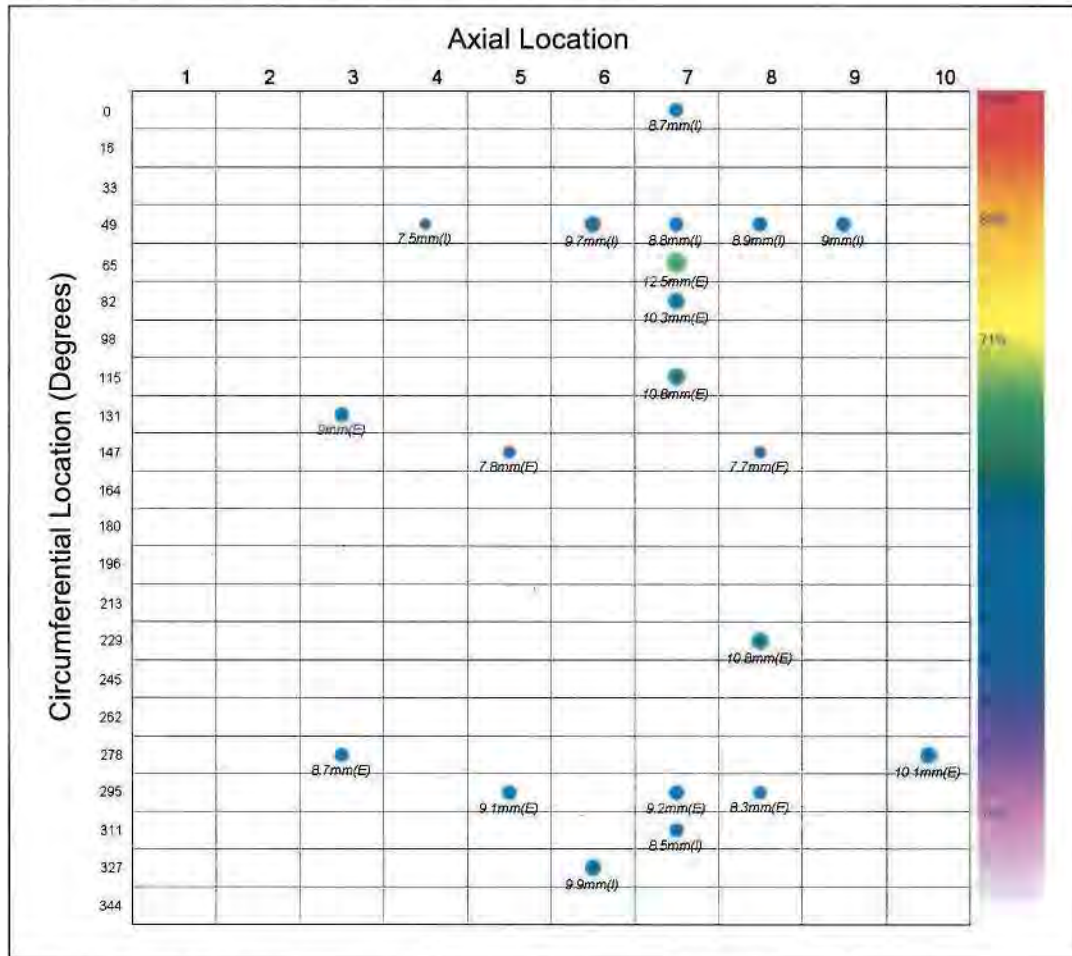
FIGURE 4.4 – DEFECT PLOT FOR SITE F (20 LARGEST DEFECT DEPTHS)

corrosion grid has been reported and displayed. Therefore where there is more than one defect located in the same cell the smaller of the two will not be displayed. As a large amount of defects were identified at Site F only the largest 20 defects have been chosen to be displayed on the grid in Figure 4.4. Internal and external defects have been distinguished with an "I" and "E" following the defect depth. The defects have been assumed to be hemispherical in shape.

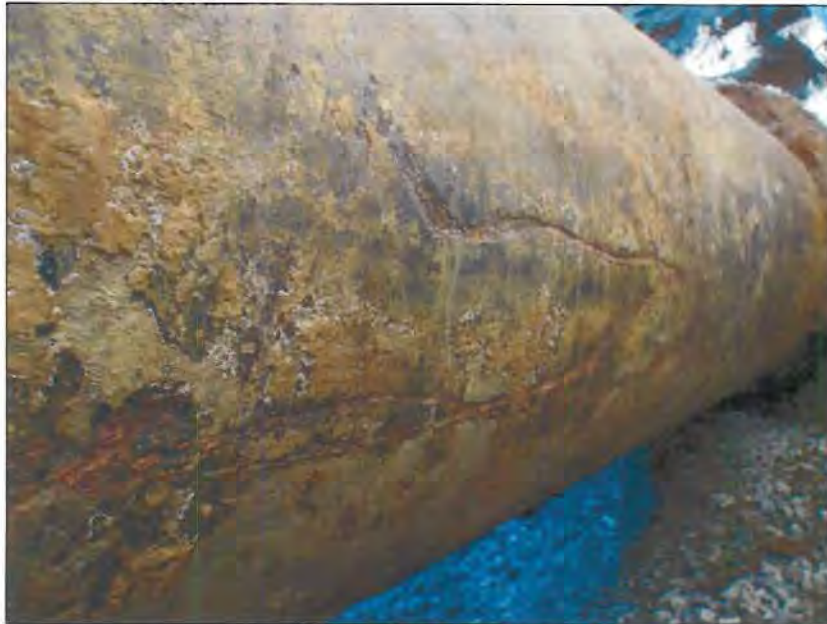
FIGURE 4.5 - AREA OF MECHANICAL DAMAGE

Mechanical damage was identified on the pipe between 180° and 270°. Evidence suggests that the mechanical damage had not occurred recently because corrosion was identified within the damaged area as shown in Figure 4.5 below.

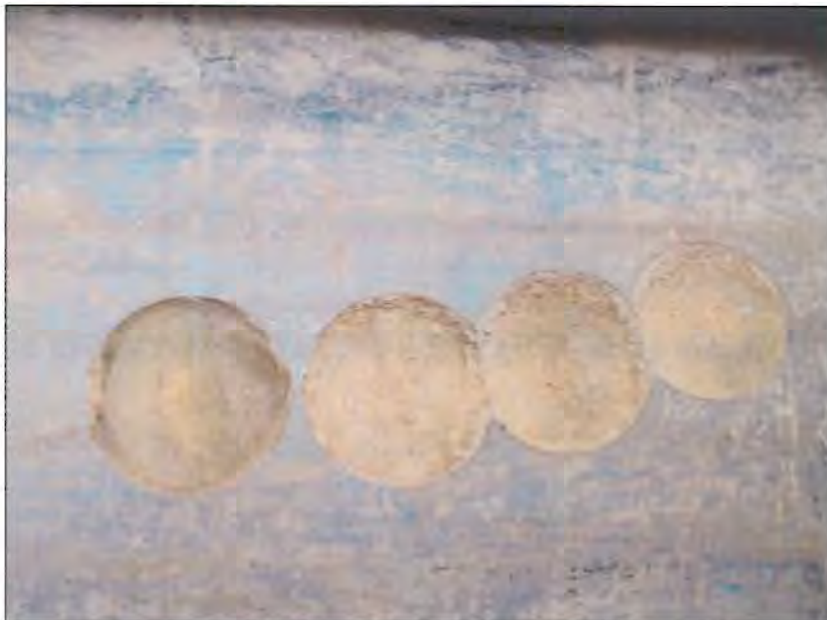
FIGURE 4.6 - MACHINED HEMISPHERICAL DEFECTS

Hemispherical machined defects were indicated by the client on an adjacent spool to the one which was scanned by the ECAT at Site F, as shown in Figure 4.6. These defects were scanned and sized for calibration purposes.

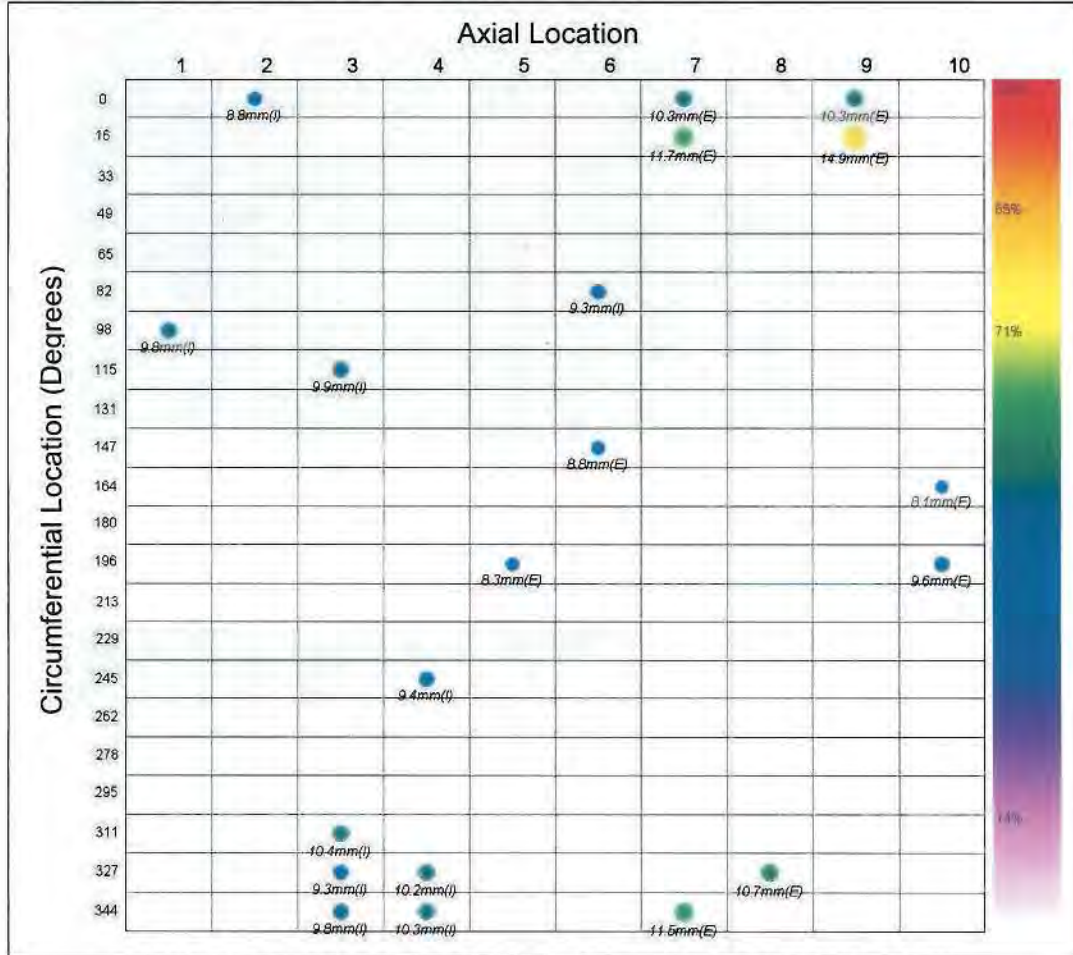
FIGURE 4.7 DEFECT PLOT FOR SITE 2 (20 LARGEST DEFECT DEPTHS)

this scanned length were sized using AESL's algorithms. Analysis of the MFL scans identified approximately 225 localised external defects and 11 localised internal defects at Site 2. Using the data collected from the ECAT magnetic inspection corrosion defects have been identified and quantified. Only the largest 20 defects have been chosen to be displayed on the grid in Figure 4.7.

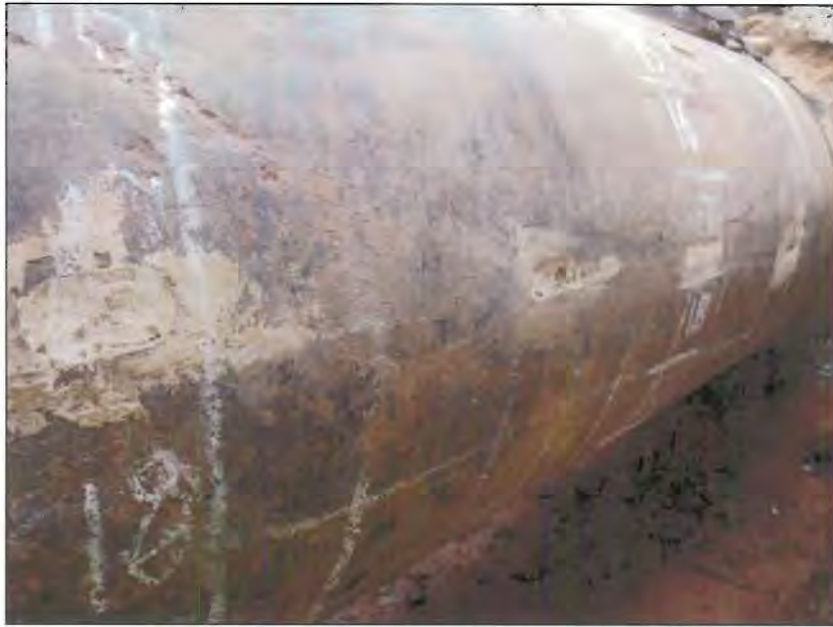
FIGURE 4.8 - EXTERNAL MACHINED DEFECTS

As shown in Figure 4.8, some of the machined defects were located beyond the 1m scanned length. In total, seven machined defects were scanned using the MFL tool.

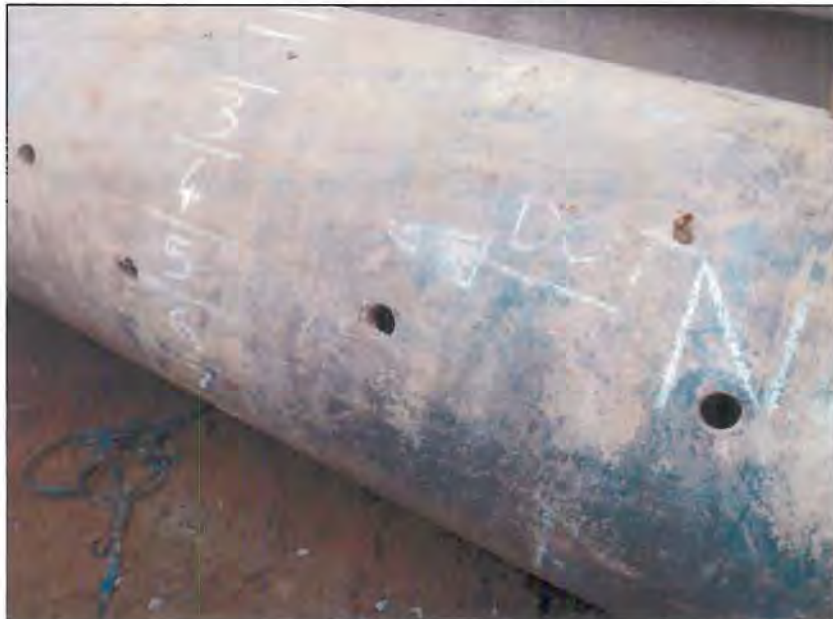
FIGURE 4.9 - THREADED HOLES

Threaded holes were machined into the pipe between an orientation of 45° and 90° as shown in Figure 4.9 above. These holes were created for connections to be fitted. The connections were required to simulate pipe leakage for other companies who were testing leakage technology the following week. Three through wall threaded holes were within the 1m scanned location during the inspection. The position of the machined defects can be seen on the plot in Figure 4.10.

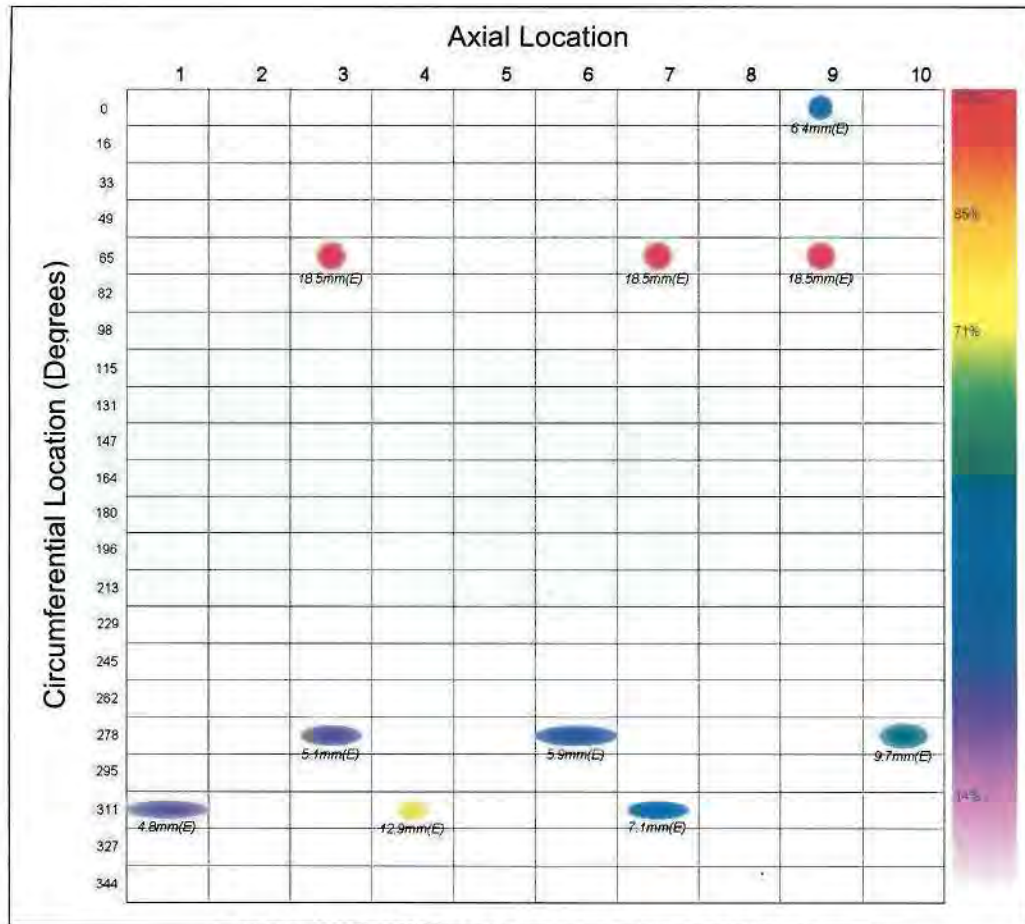
FIGURE 4.10 MACHINED DEFECT PLOT FOR SITE 2

Although, on-site two machined defects were identified at an orientation of approximately 290° (5.9mm external defect) when analysing using AESL algorithms the defects appears as a singular defect as the physical proximity between each defect was too small and the flux leakage output appeared as a singular defect.

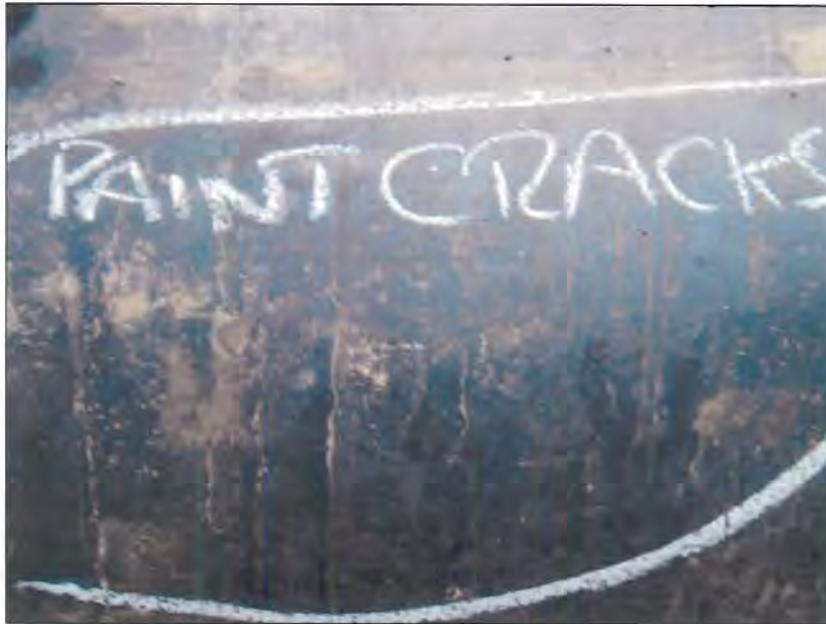
FIGURE 4.11 - PHOTOGRAPH OF COATING DAMAGE

Cracks were identified in the bitumen paint coating at an orientation of 270° as shown in Figure 4.11.

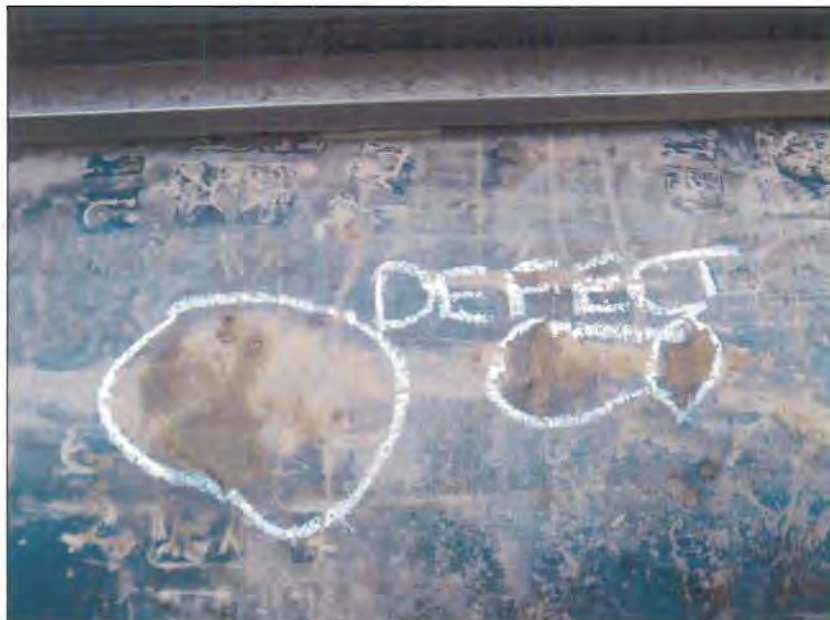
FIGURE 4.12 - PHOTOGRAPH OF EXTERNAL DEFECTS

Mechanical damage was also identified on the pipeline at approximately 90° and between 180°-280° at this inspection location. External defects were identified in the pipe wall using the MFL tool. Due to the extent of the corrosion some of the external defects could be verified visually without the need to remove corrosion product as shown in Figure 4.12.

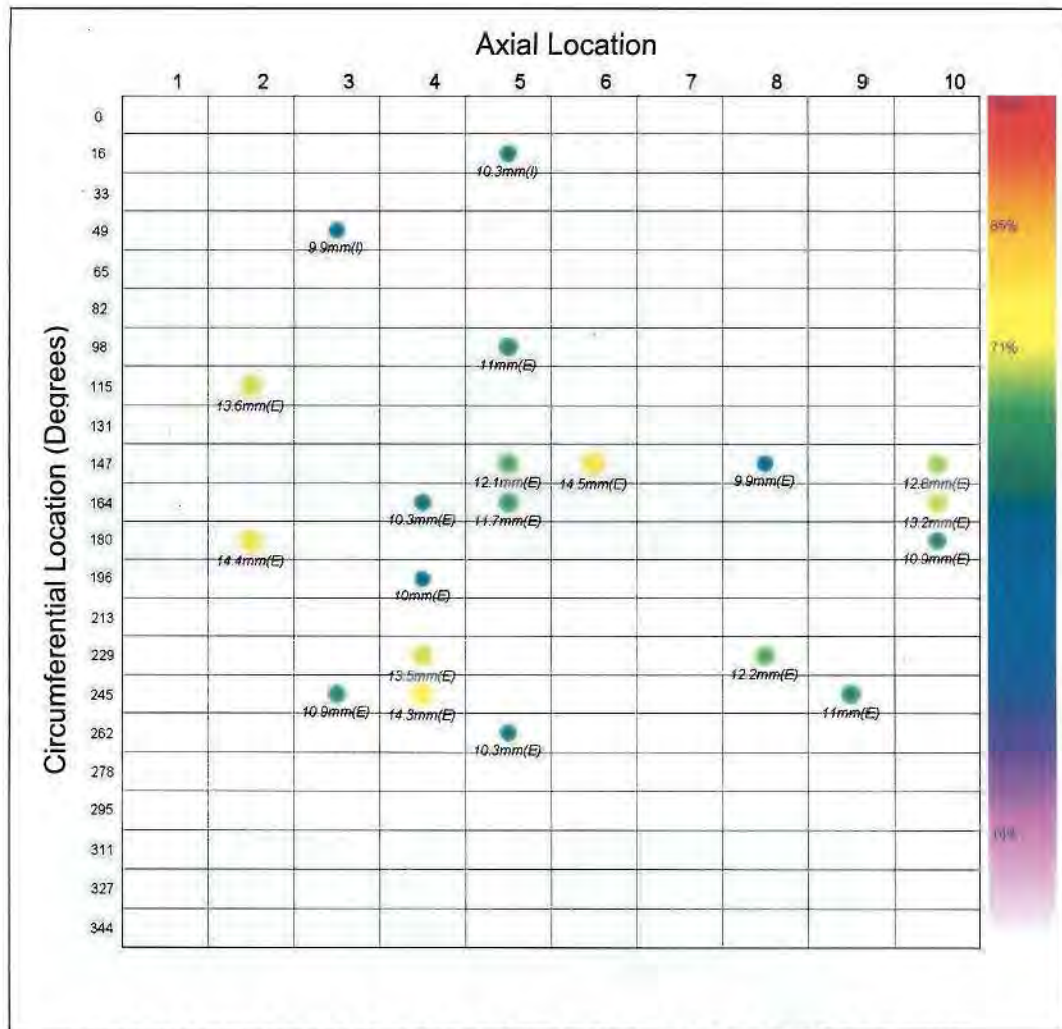
FIGURE 4.13 DEFECT GRID FOR SITE L (20 LARGEST DEFECT DEPTHS)

Analysis of the MFL scans identified approximately 330 localised external defects and 3 localised internal defects at site L. Using the data collected from the ECAT magnetic inspection corrosion defects have been identified and quantified. As in Site F and 2 a large amount of defects was identified at Site L therefore only the largest 20 defects have been chosen to be displayed on a corrosion grid (Figure 4.13).

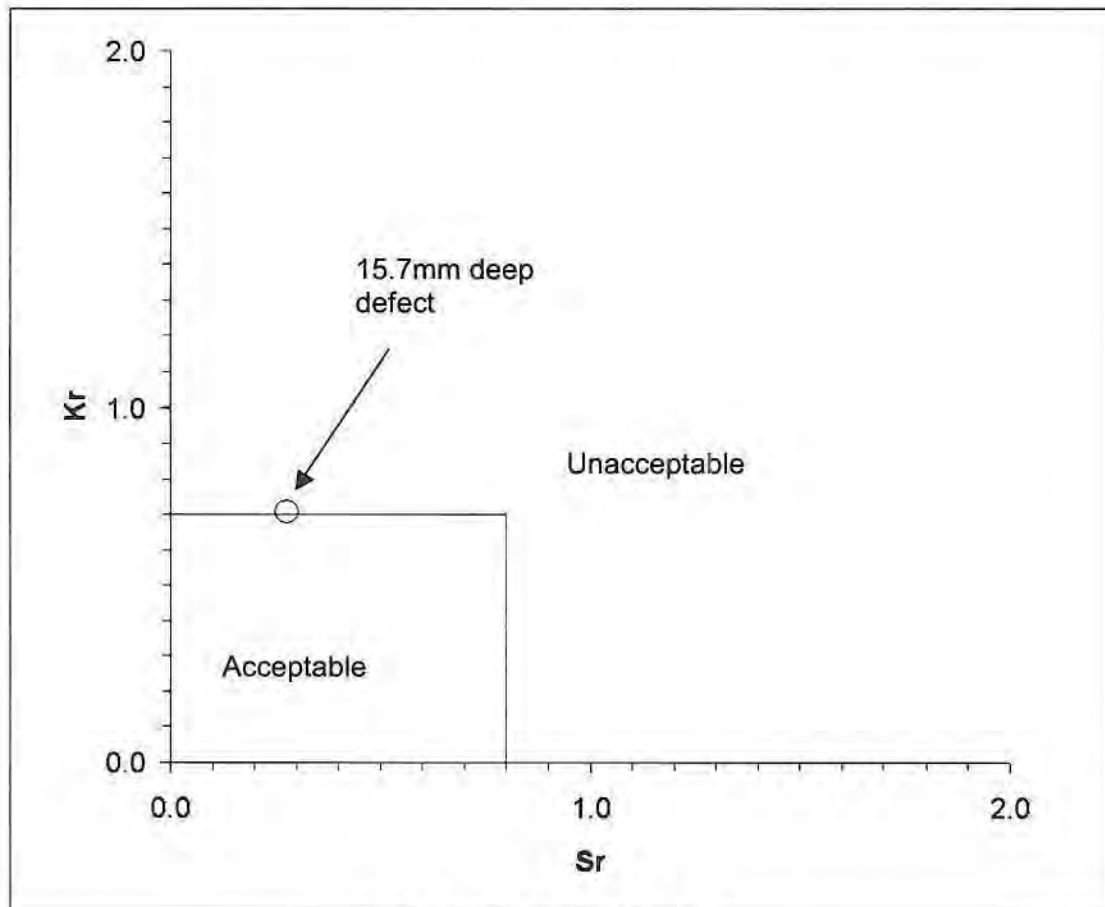
FIGURE 5.1- FAD FOR SITE F

The analysis showed that a 15.7mm deep defect of hemispherical geometry at Site F would not be acceptable in terms of the risk of structural failure resulting from its presence.

TABLE 5.4 – DEFECT DEPTH TO CAUSE FRACTURE		
SECTION	LOAD CASE	CRITICAL DEFECT DEPTH AT LOCATION OF MAXIMUM STRESS (MM)
F	Minor road	15.7
2	Minor road	14.6
L	Minor road	17.0

It must be noted that this estimation above is based on the presence of one singular defect forming at a point of maximum stress. Defects found in close proximity to each other are likely to give rise to a higher stress concentration and hence further increase the risk of structural failure.

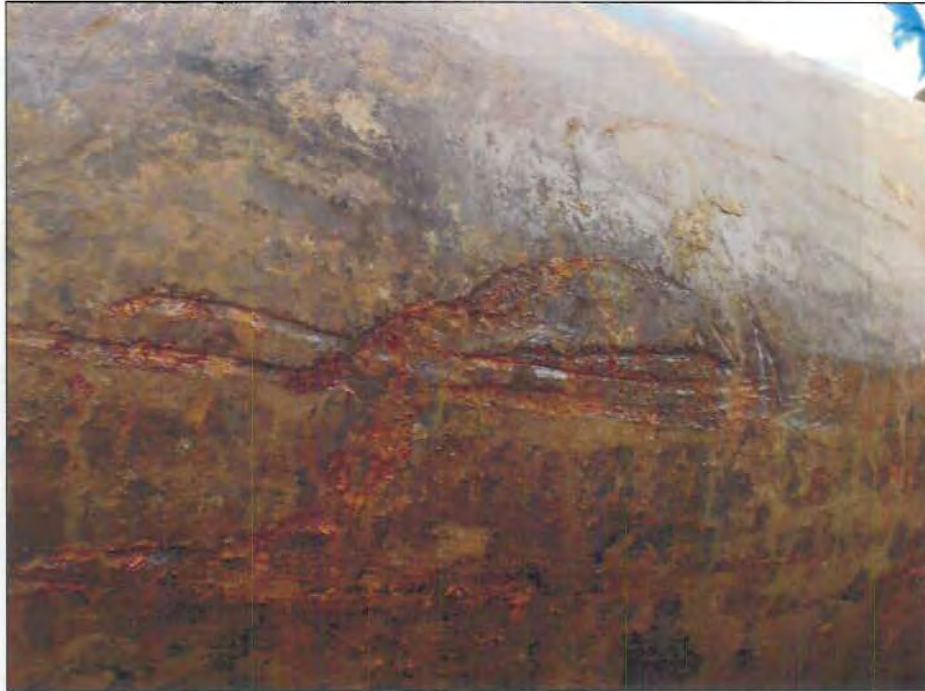
FIGURE A5.5 - PHOTOGRAPH OF MECHANICAL DAMAGE AND CORROSION

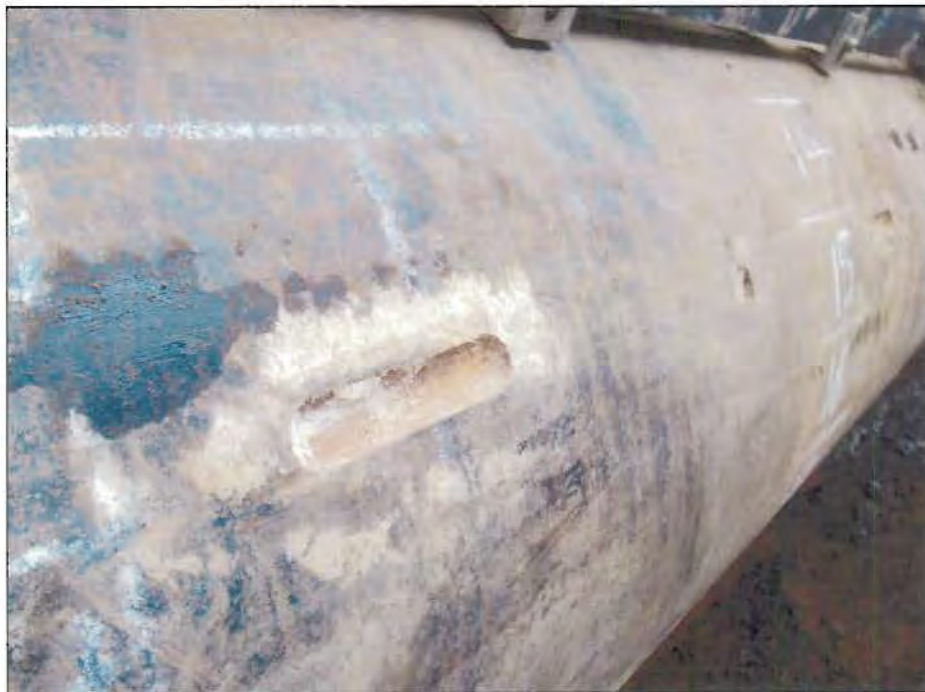
FIGURE A5.9 - PHOTOGRAPH OF MACHINED DEFECTS IN THE PIPE

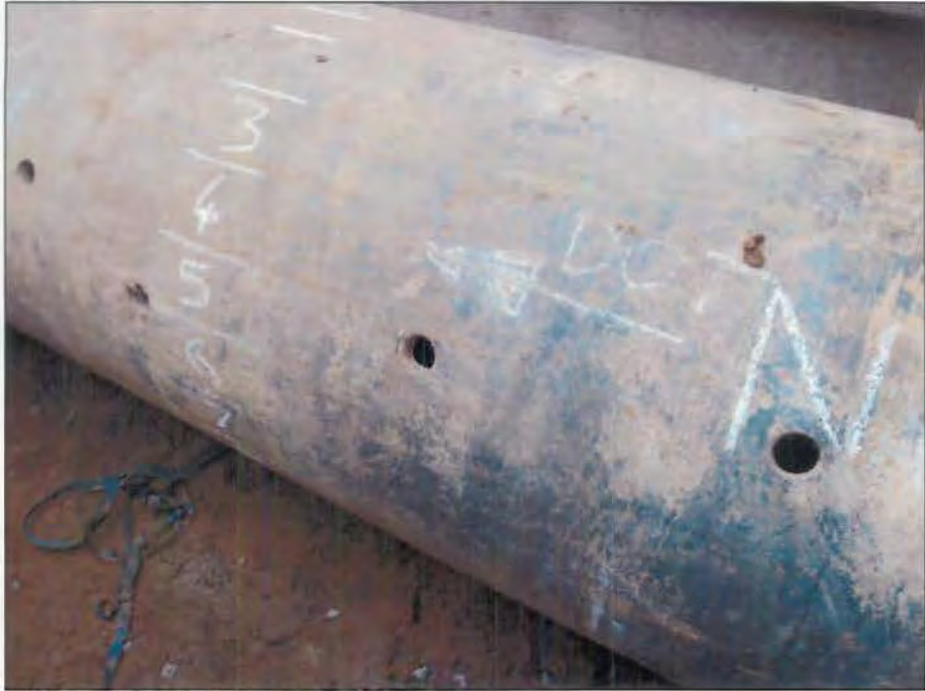
FIGURE A5.10 - PHOTOGRAPH OF MACHINED THREADED HOLES IN THE PIPE

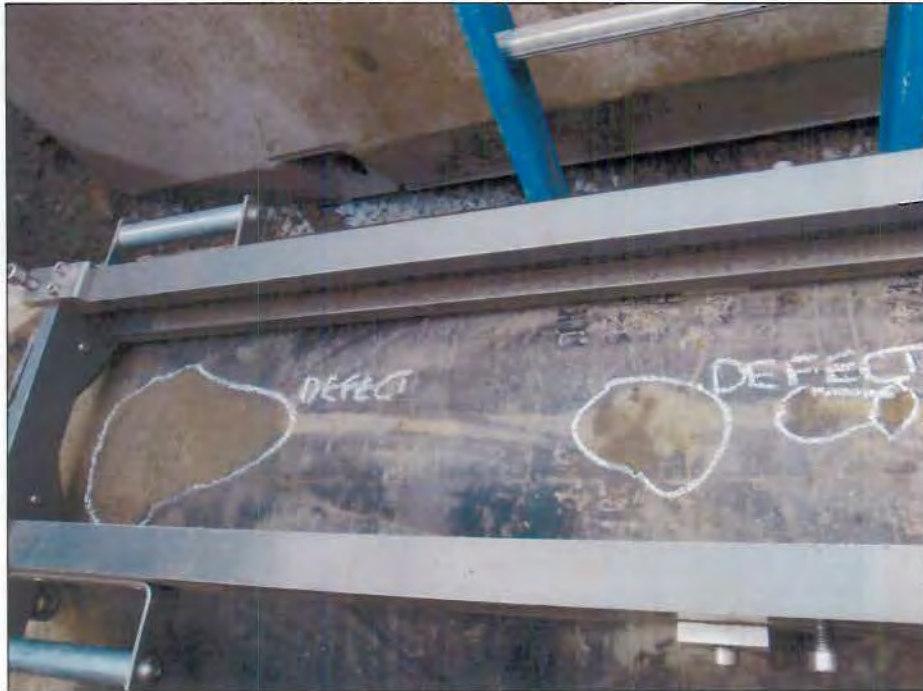
FIGURE A5.15 - PHOTOGRAPH OF DEFECTS IDENTIFIED ON THE PIPE

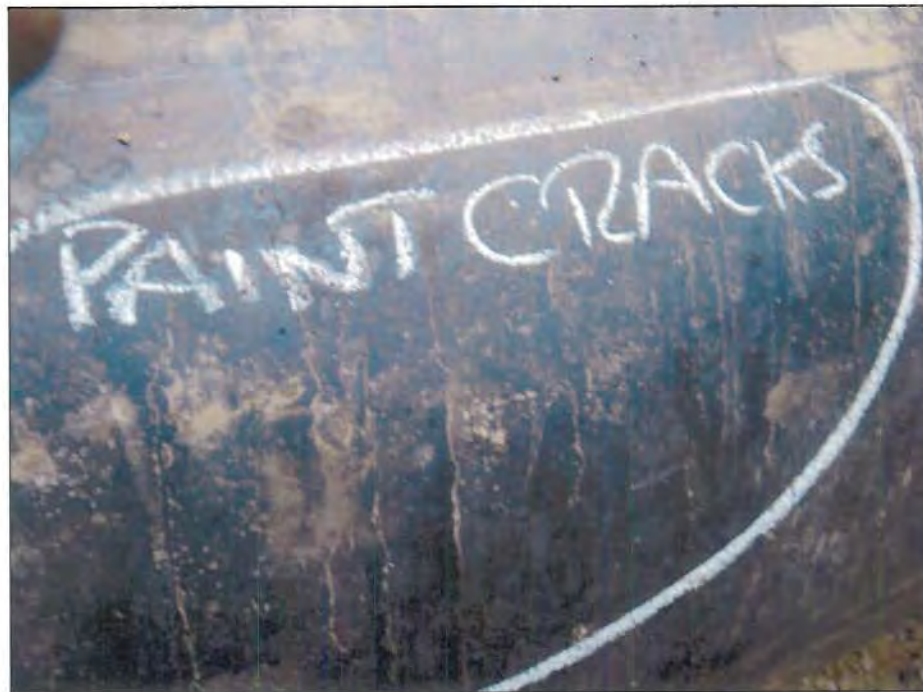
FIGURE A5.16 - PHOTOGRAPH OF COATING DEFECTS

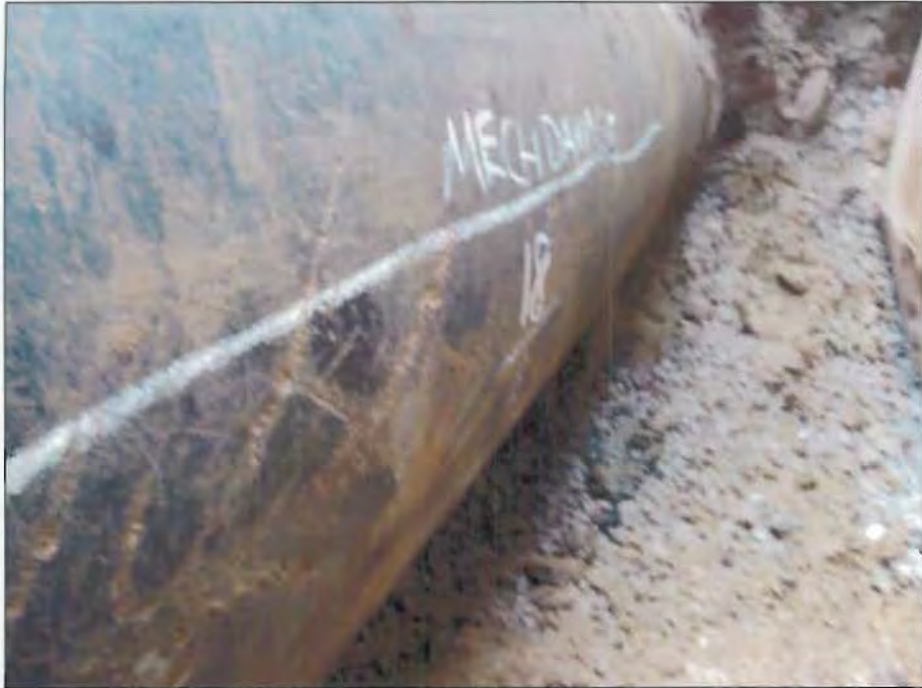
FIGURE A5.17 - PHOTOGRAPH OF MECHANICAL DAMAGE TO THE PIPE

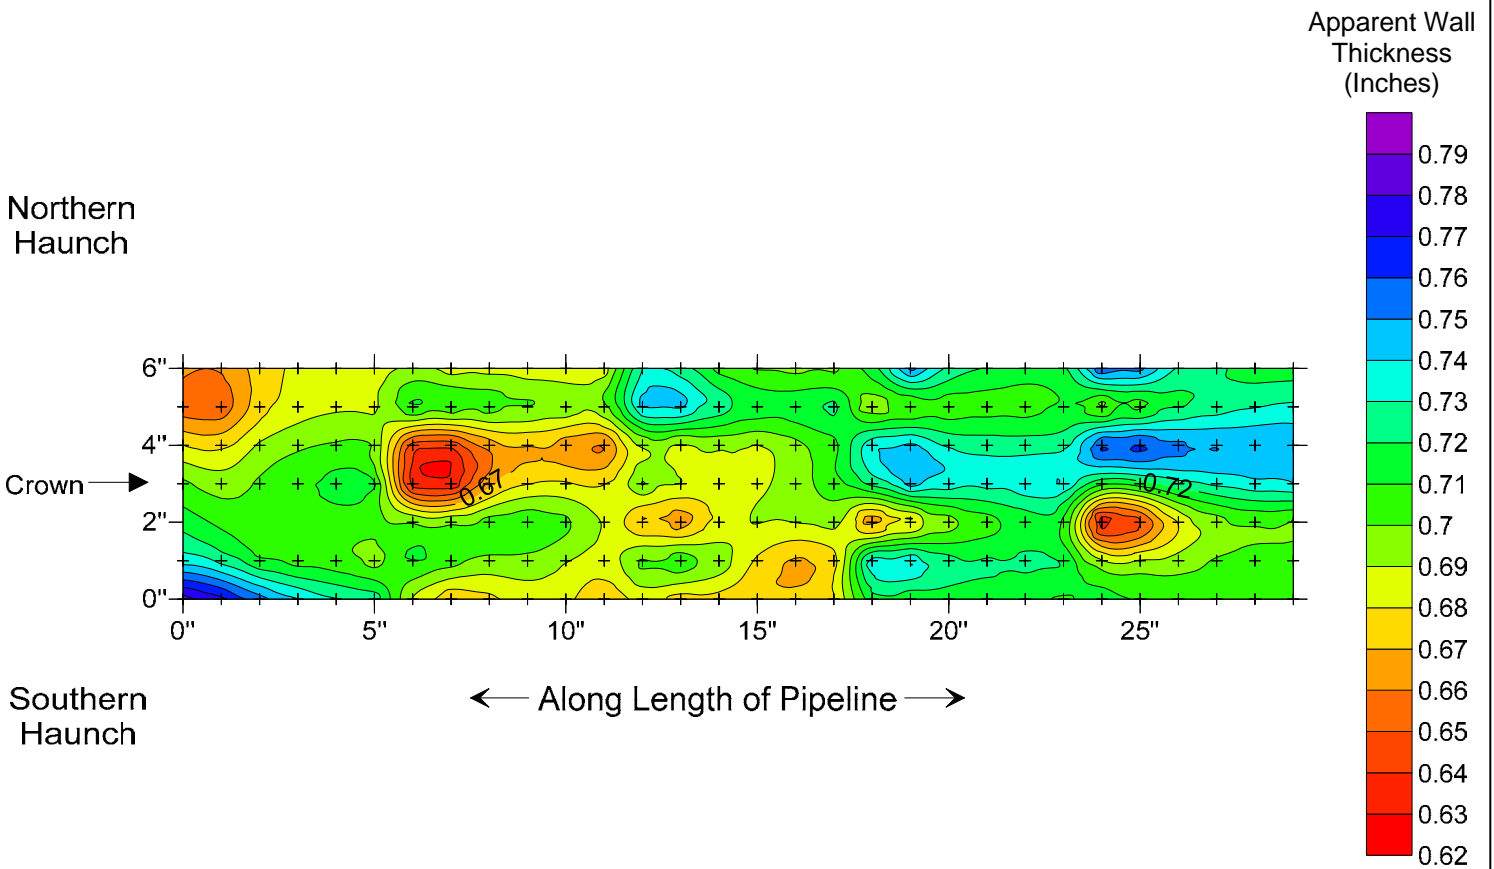
Battelle - Site 5 – Pit C

EPA Demonstration of Condition Assessment Technologies
 24" Diameter Cast Iron Pipe
 (CAP Scan Only)

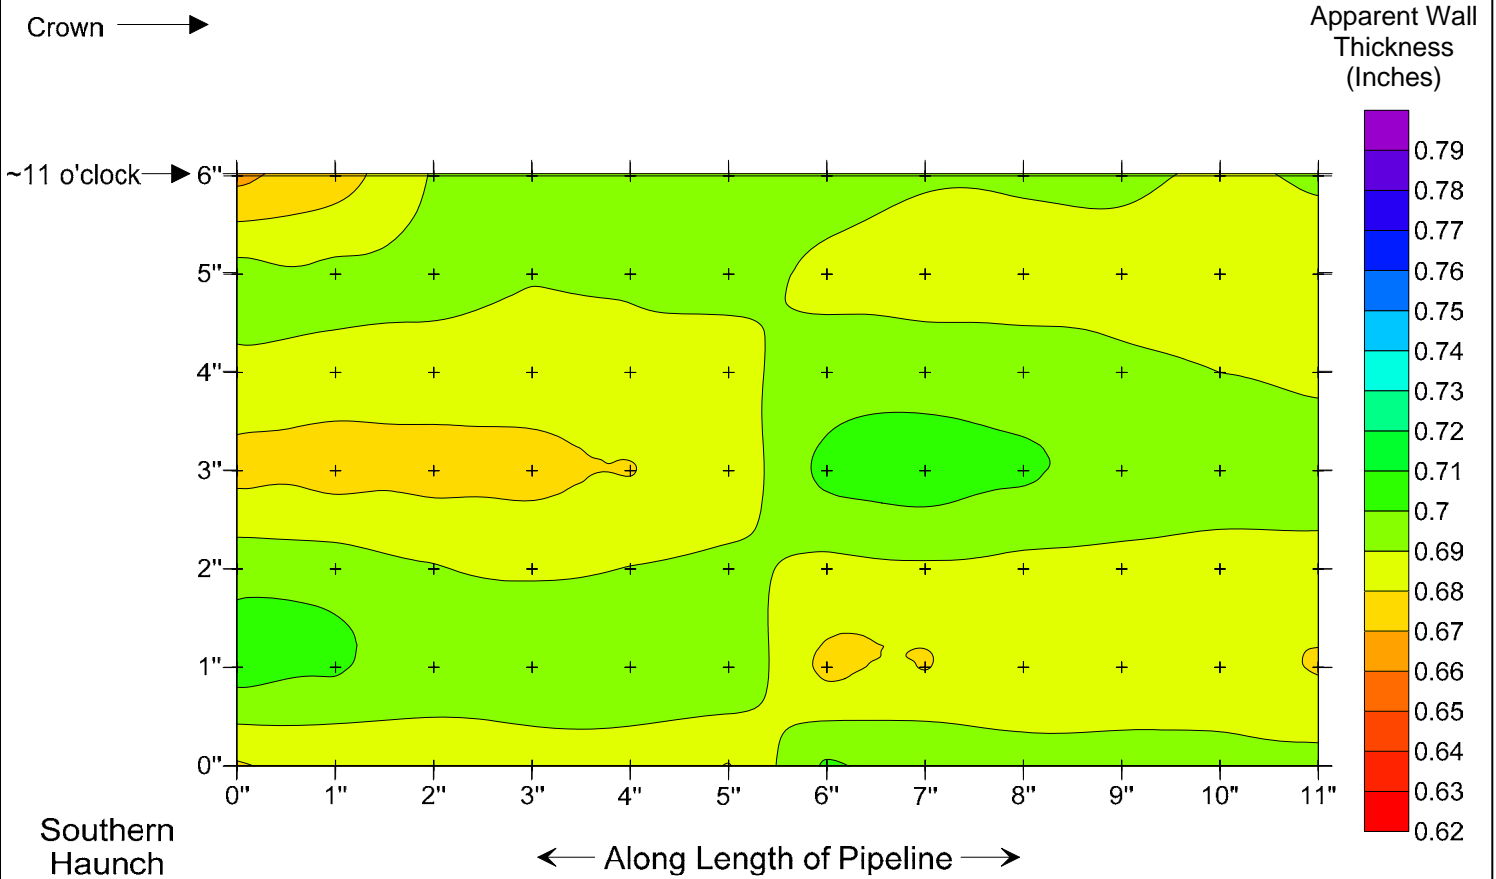
Battelle - Site 6 – Pit D

EPA Demonstration of Condition Assessment Technologies
 24" Diameter Cast Iron Pipe
 (CAP Scan Only)

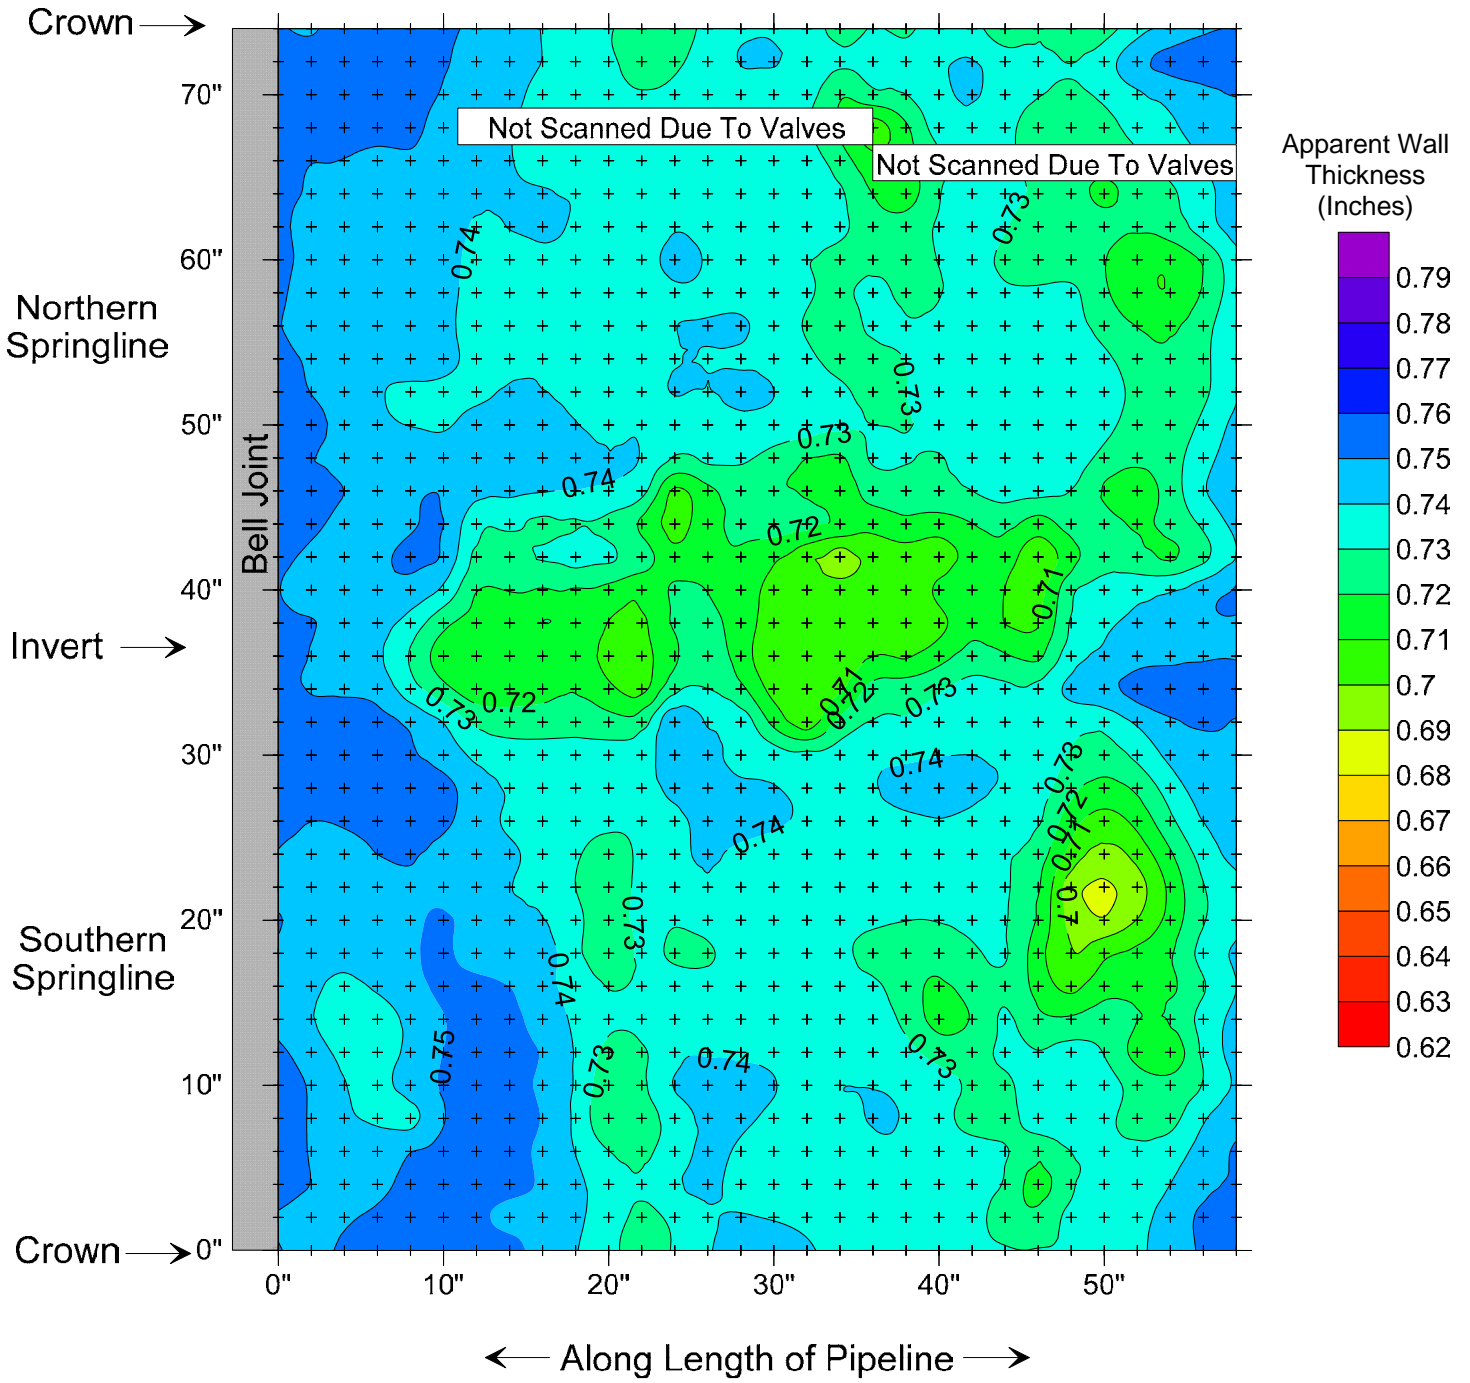
Battelle - Site 7 - Pit 2

EPA Demonstration of Condition Assessment Technologies
24" Diameter Cast Iron Pipe

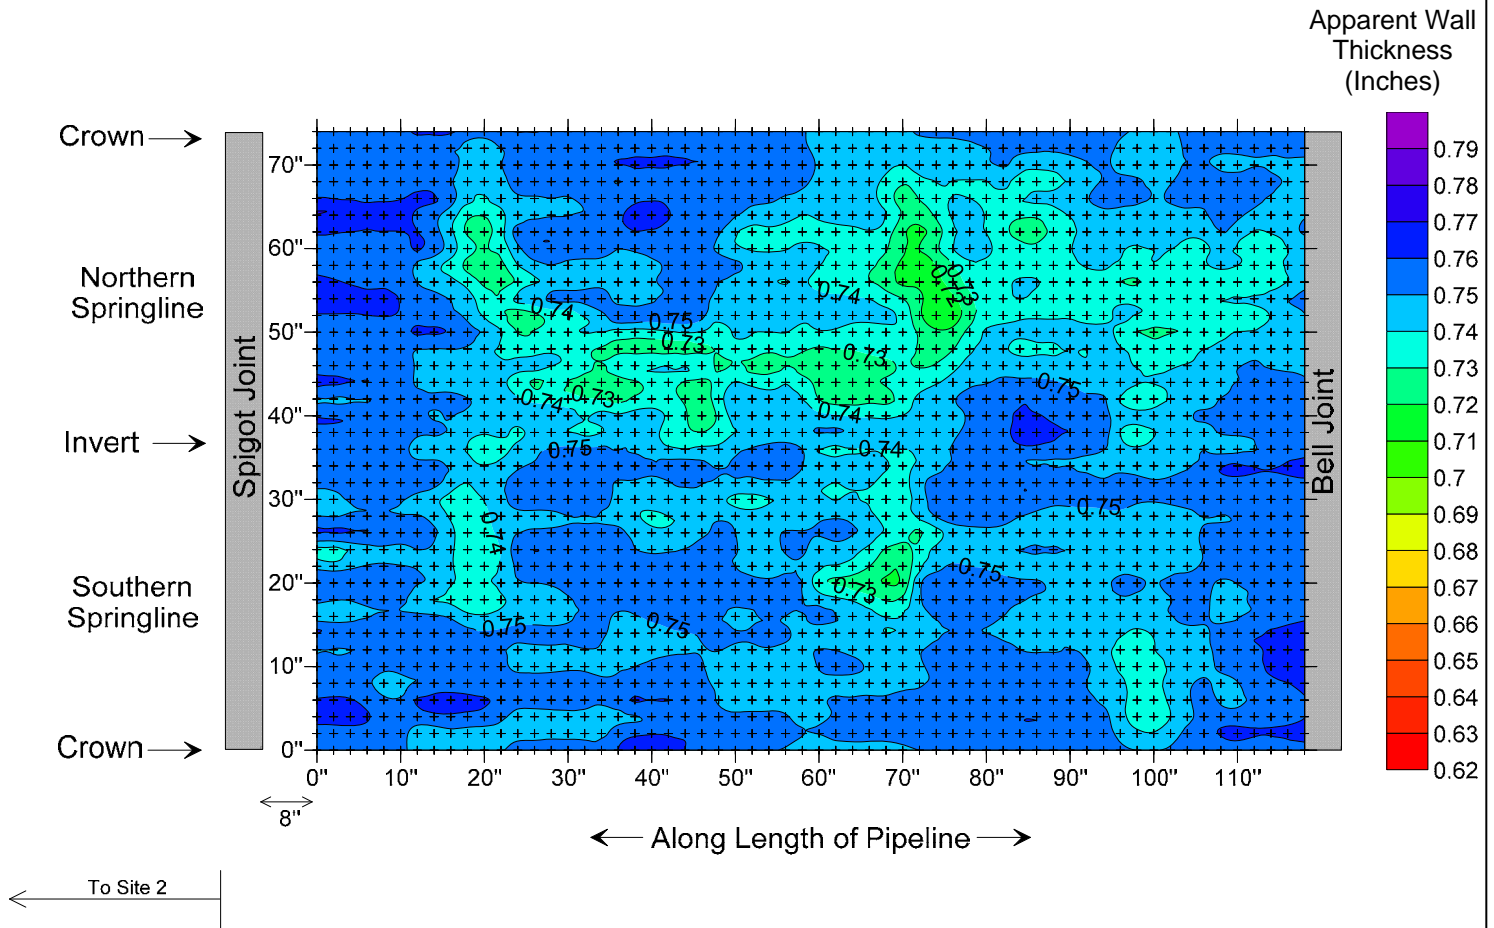
Battelle - Site 8 – Pit F

EPA Demonstration of Condition Assessment Technologies
24" Diameter Cast Iron Pipe
