Field Demonstration of Innovative Condition Assessment Technologies for Water Mains: Acoustic Pipe Wall Assessment, Internal Inspection, and External Inspection

**FIELD DEMONSTRATION OF INNOVATIVE CONDITION ASSESSMENT TECHNOLOGIES
FOR WATER MAINS: ACOUSTIC PIPE WALL ASSESSMENT, INTERNAL INSPECTION,
AND EXTERNAL INSPECTION**

VOLUME 1: TECHNICAL REPORT

September 2013

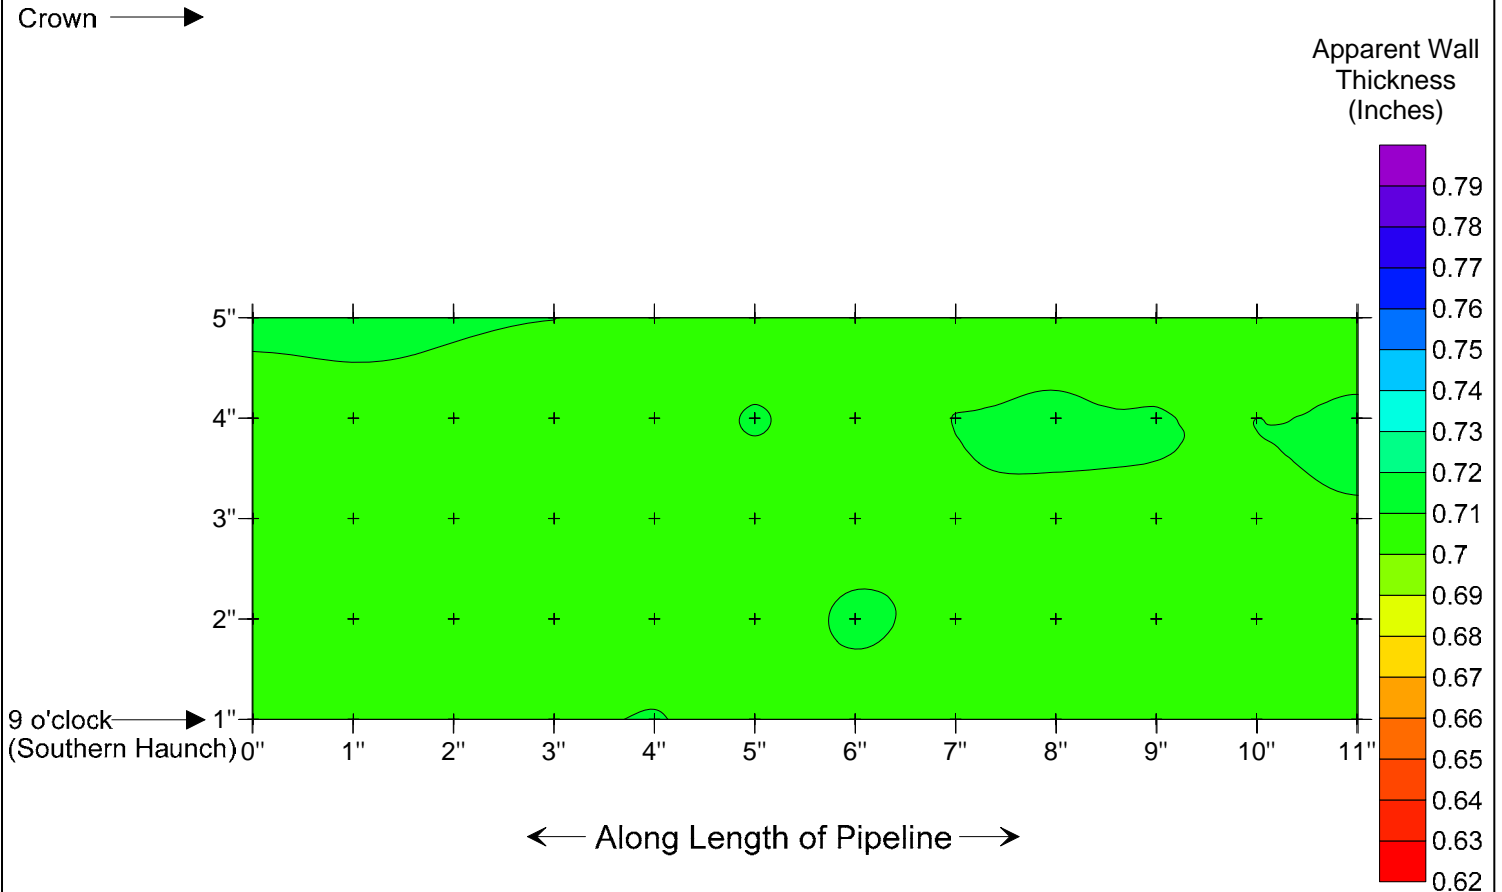
Battelle - Site 9 – Pit E

EPA Demonstration of Condition Assessment Technologies
 24" Diameter Cast Iron Pipe
 (CAP Scan Only)

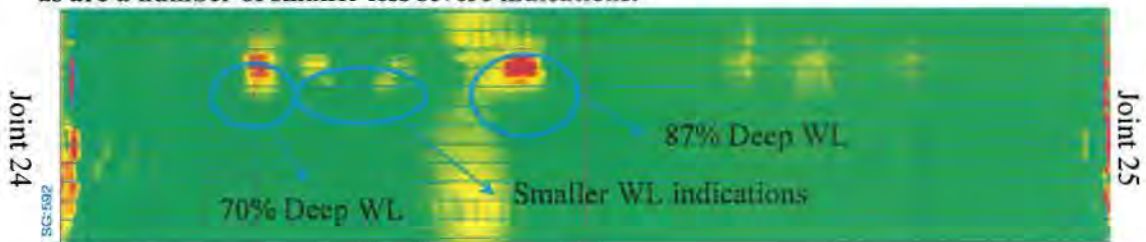
- 1) We are not surprised by the fact that PICA's 24" Tool provided the most accurate and informative information. Russell (PICA) has had over 20 years of developing this technology for a range of pipeline and other applications and, while this particular Tool size was brand new at the time, the fundamental technique has plenty of experience in similar materials and applications (just different pipe sizes). The colour map below shows an example of See Snake data. The image is the RFT wall thickness representation for the pipe length between joints 24 and 25. The reported 70% and 87% deep defect are clearly visible, as are a number of smaller less severe indications.

Figure 1. Colour map of See Snake RFT data for pipelength between joints 24 and 25. Red localized indications depict areas of substantial wall loss (WL).
