Demonstration of Innovative Sewer System Inspection Technology SewerBatt™

Srinivas Panguluri
Shaw Environmental & Infrastructure, Inc.
Cincinnati, OH

Contract No. EP-C-11-006

Daniel Murray
Water Supply and Water Resources Division
U.S. Environmental Protection Agency
Cincinnati, OH 45268

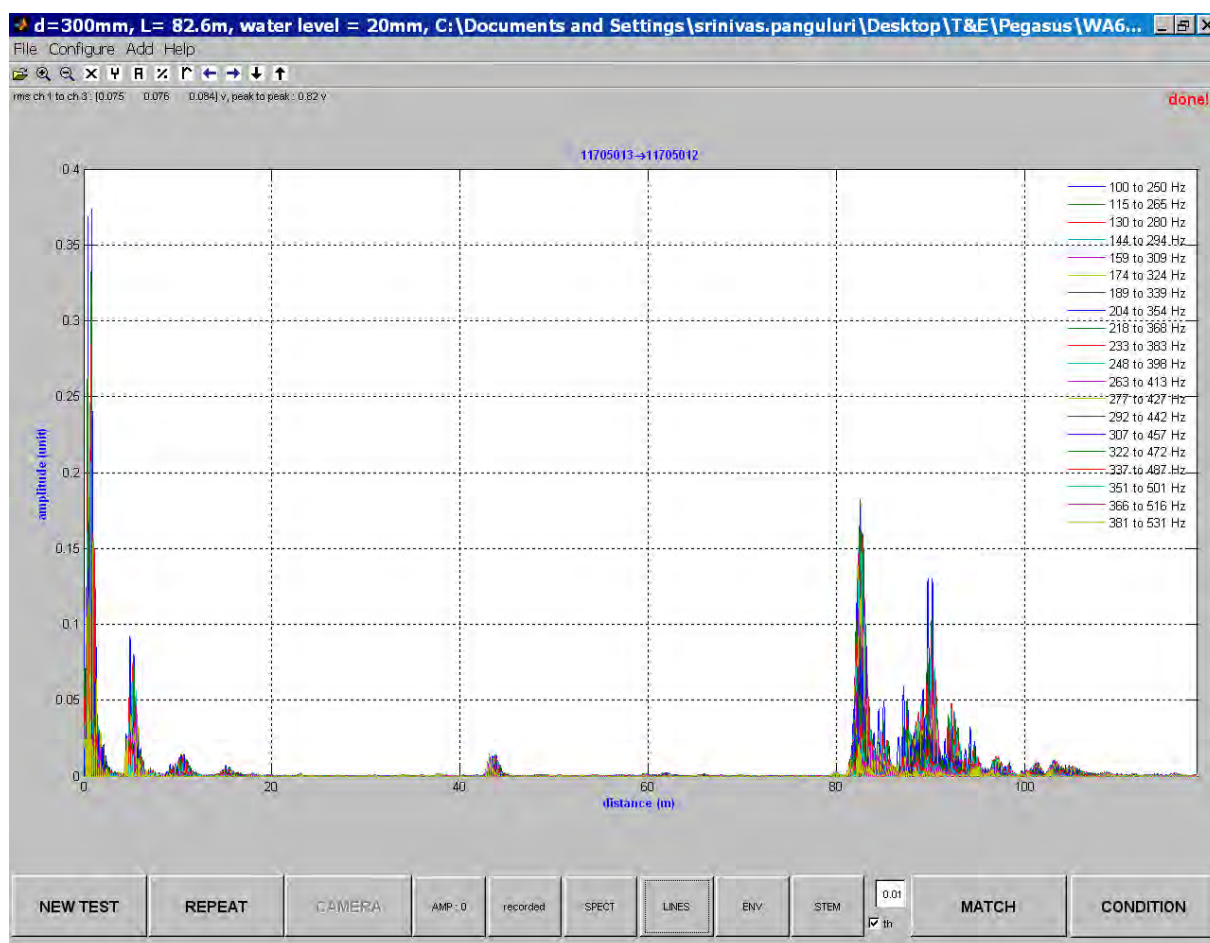
Figure 1-6. SewerBatt Acoustic Response Lines Plot

A review of the “Lines” plot presented above as Figure 1-6, indicates an initial “bump” or response (at the manhole insertion point) and other responses at approximately 5m, 10m, 44m and 82m (and beyond). The colored lines in this plot indicate the range of frequencies and the relative amplitude of the frequency-specific response from the pipe. Also, the level of detail

or “bumps” presented in the plot depends upon the set threshold. The threshold used to generate the “Lines” plot presented in Figure 1-6 was 0.01. This plot can be further reviewed by using the “Envelope” plot option in the Scanfield software presented as Figure 1-7. The level of signal response detail presented in this plot also depends upon the set threshold. For the purposes of discussion, to only highlight features of interest with high amplitude signal response, a different threshold level (0.039) was used to generate the “Envelope” plot presented as Figure 1-7.

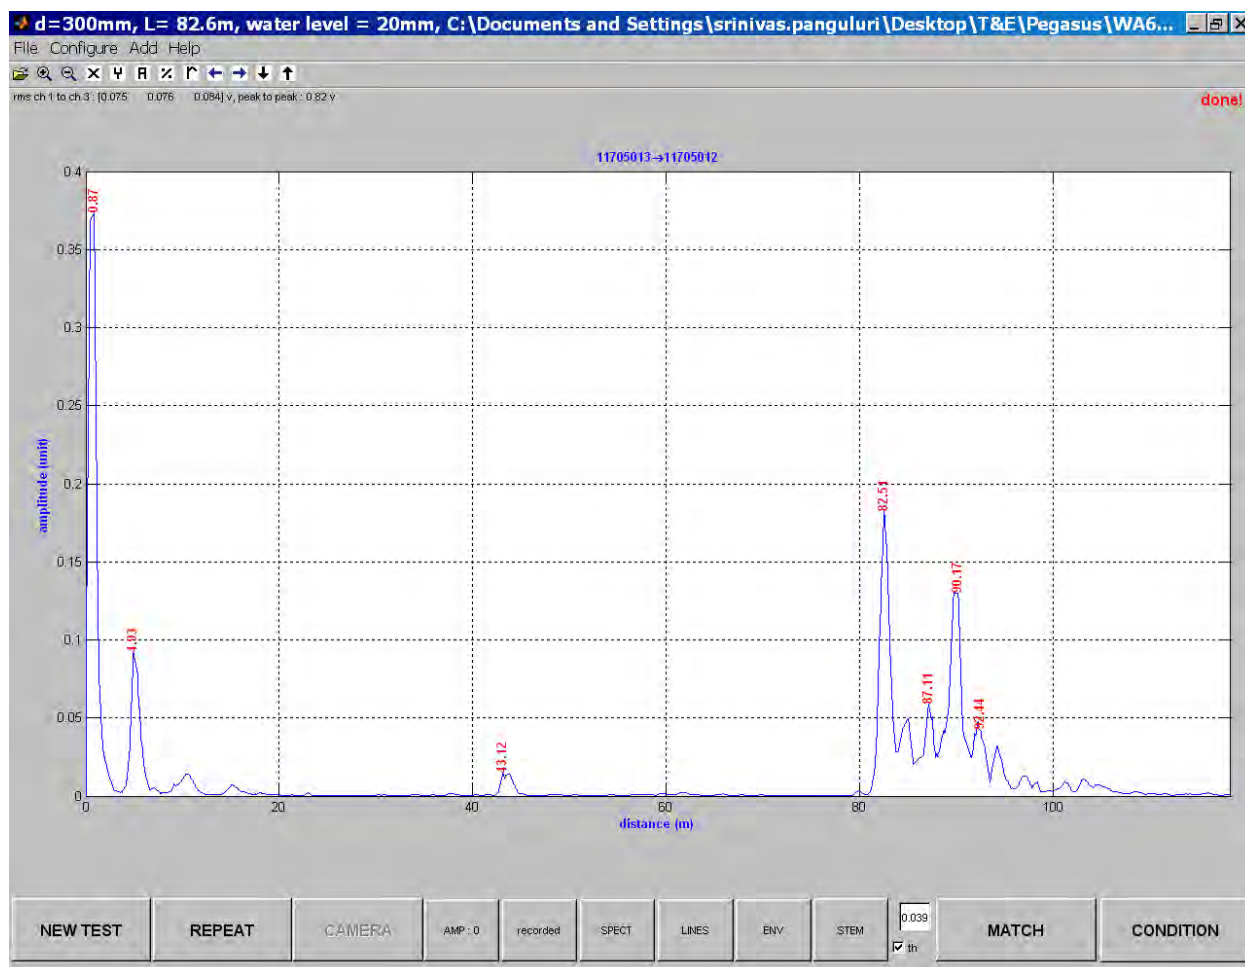
Figure 1-7. SewerBatt Acoustic Response Envelope Plot

At the set threshold-level for this pipe segment (1705013 – 1705012), the SewerBatt identified an initial response from the device insertion point (0.87m), some obstructions at 4.93m and 43.12m and the end of pipe response at 82.51m (the distances are indicated in the plot in red). In this case, the end-of-pipe acoustic response distance (~82 m) is matched based on known pipe length data from MSDGC’s Geographic Information System (GIS) database. When the match button is selected, based on the limited site specific acoustic match library, the software generates the impulse response “Match” plot presented as Figure 1-8.

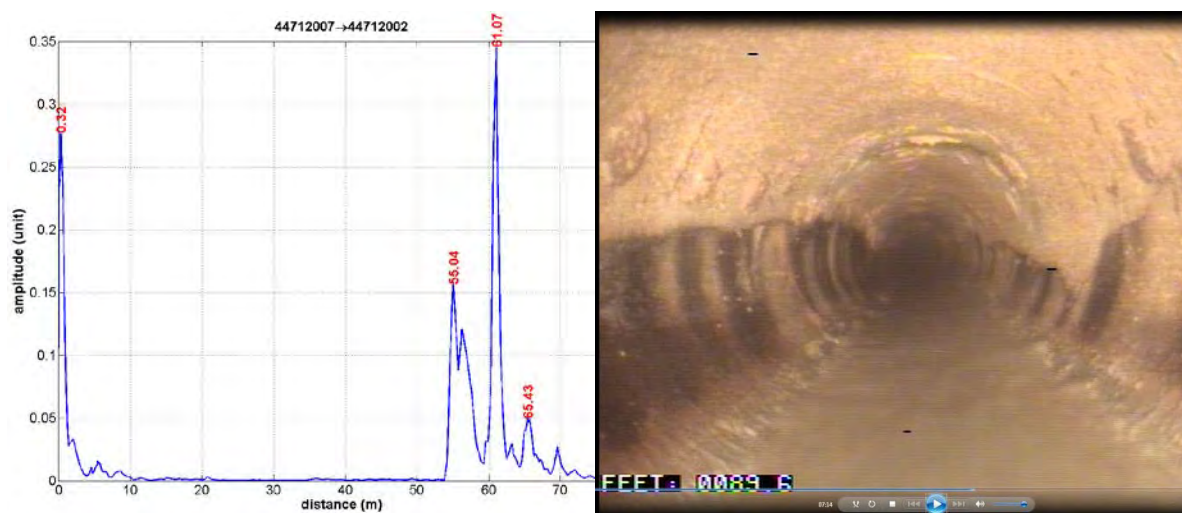
Figure 3-3. SewerBatt/CCTV Response Comparison (Segment ID 44712007-44712002)

Green Condition Grade Discussion - Of the selected locations, two (2) locations had final condition grades of green. One pipe segment (44712007-44712002) was assessed from the upstream manhole using SewerBatt, but was CCTV'd upstream or with a reverse setup. The SewerBatt inspection Envelope plot shows a slight response in the first 20 meters (end of pipe response is at 55.04m and beyond) and the CCTV inspection showed non-laminar flow and some cracked pipe with minor deposits (See Figure 3-3).

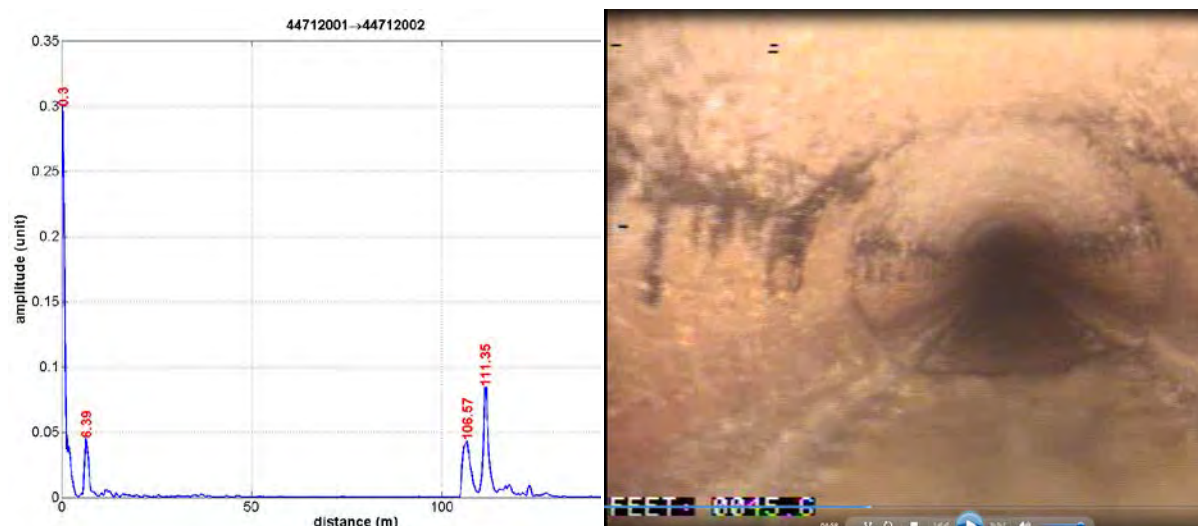
Figure 3-6. SewerBatt/CCTV Response Comparison (Segment ID 44712002-44712001)

The final section with a grade of red, 44712002-44712001, showed minor grease deposits throughout the entire section (Figure 3-6). Additionally, the review of the CCTV inspection showed the noticeably turbulent flow in the pipe.

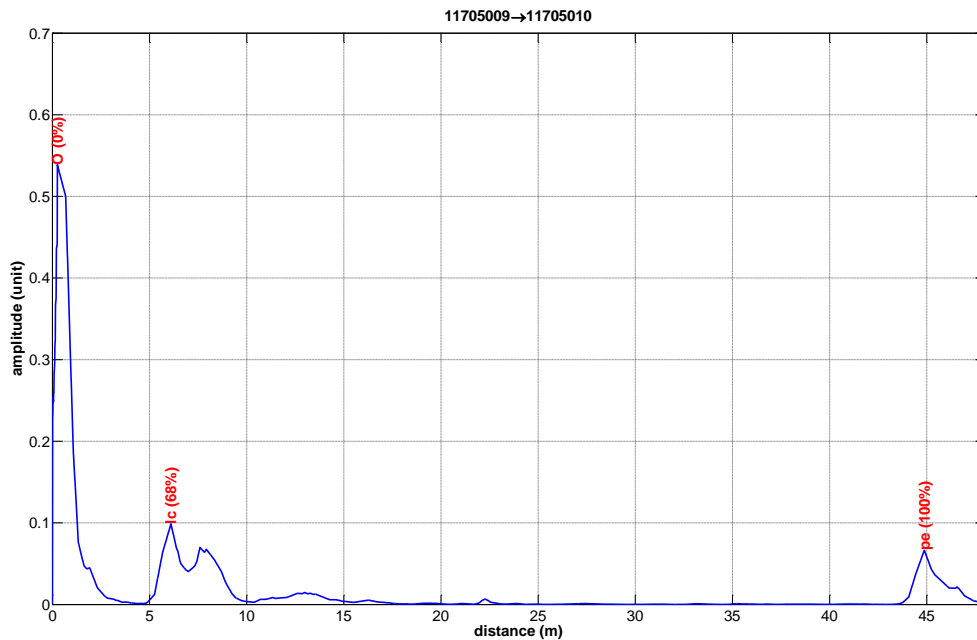
2 : lc (68%) at 6.1m

6.1 : lc (intruding, defective)

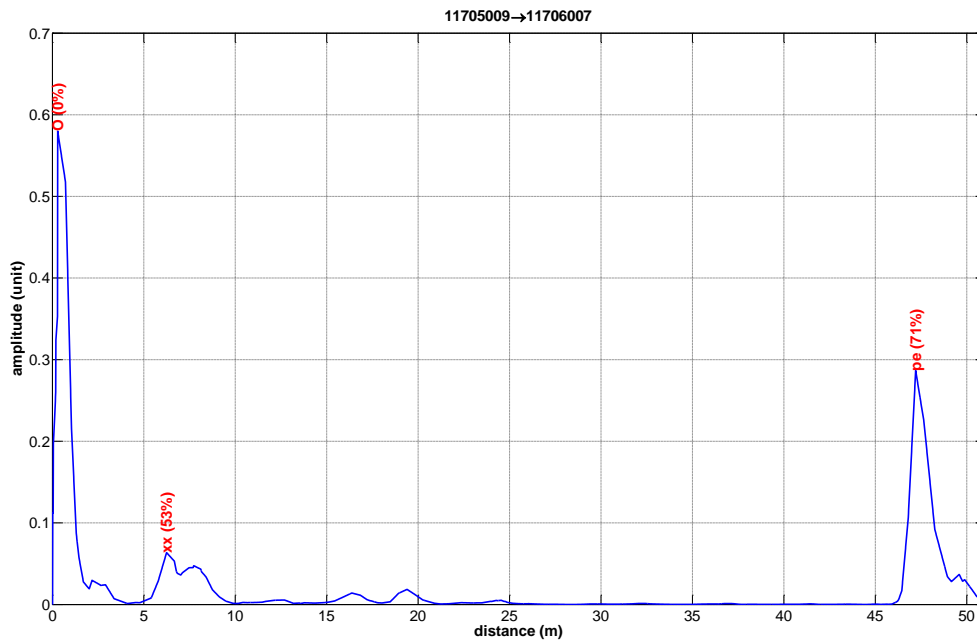
2 : xx (53%) at 6.24m

6.24 : xx

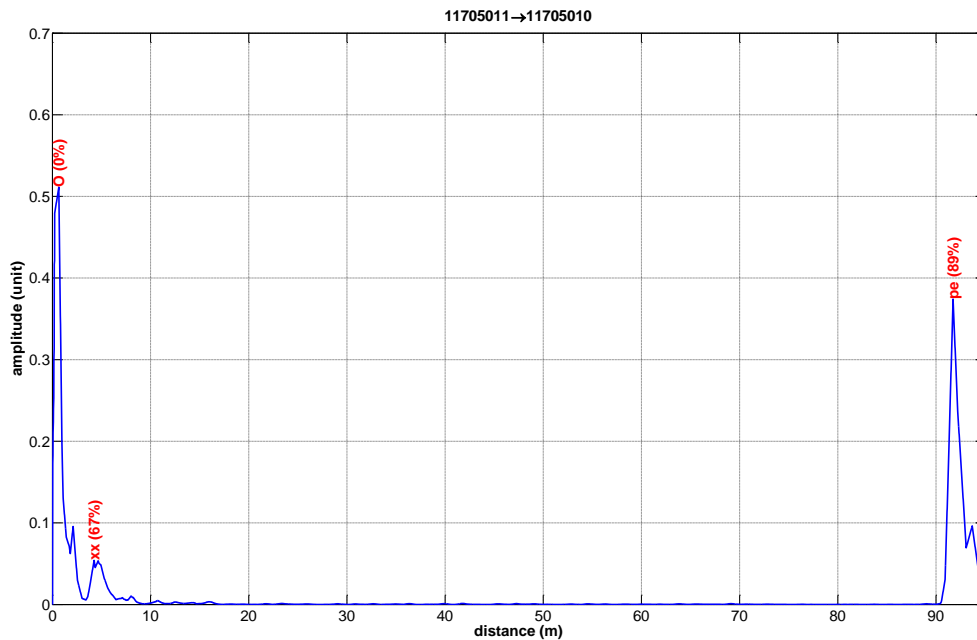
2 : xx (67%) at 4.25m

4.25 : xx

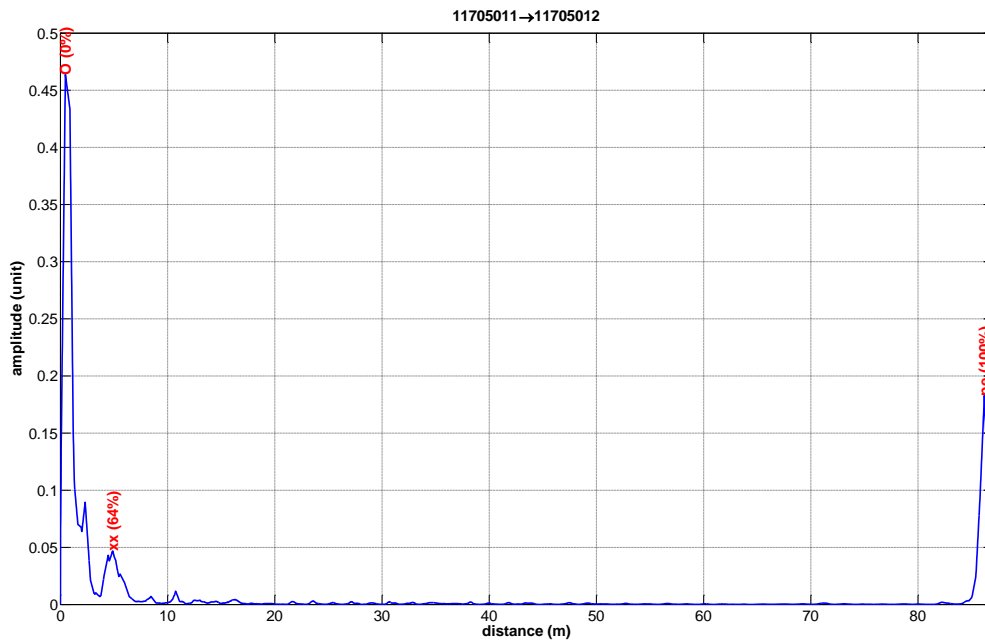
2 : xx (64%) at 4.88m

4.88 : xx

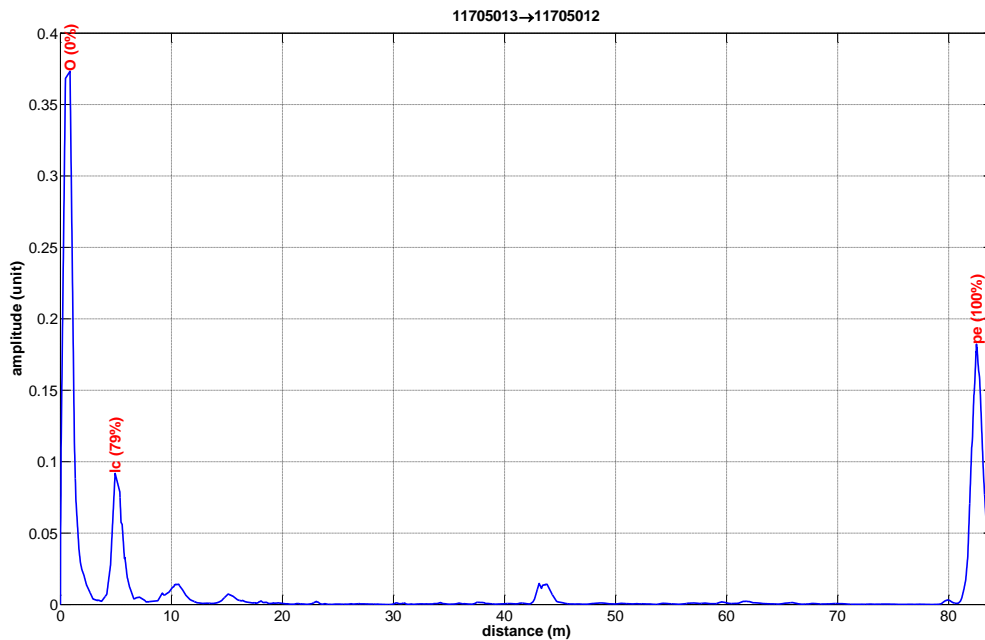
2 : lc (79%) at 4.93m

4.93 : lc (intruding, defective)

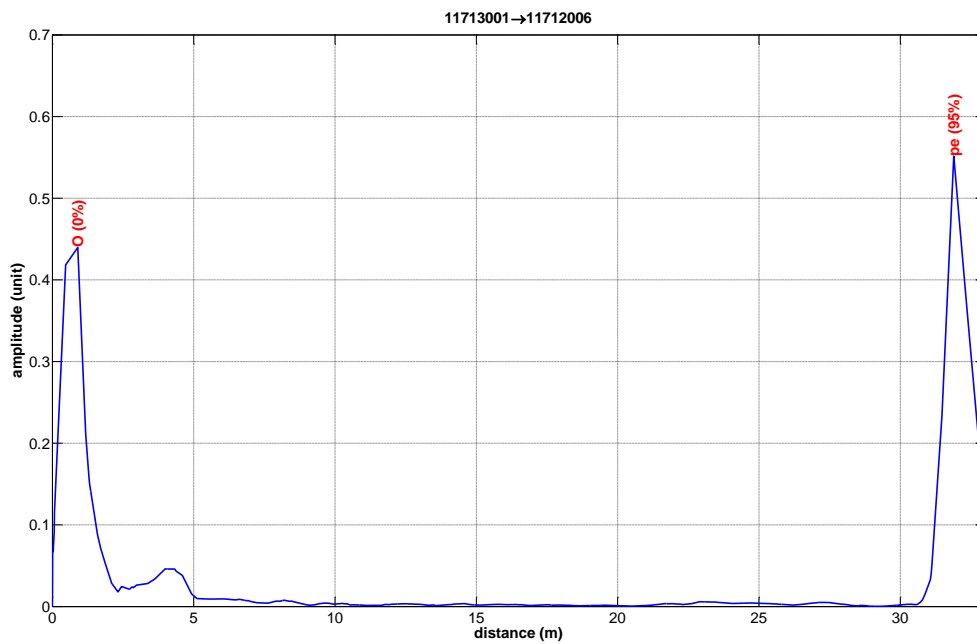
31.89 : pe (Good)

AUTO CONDITION GRADE – Green

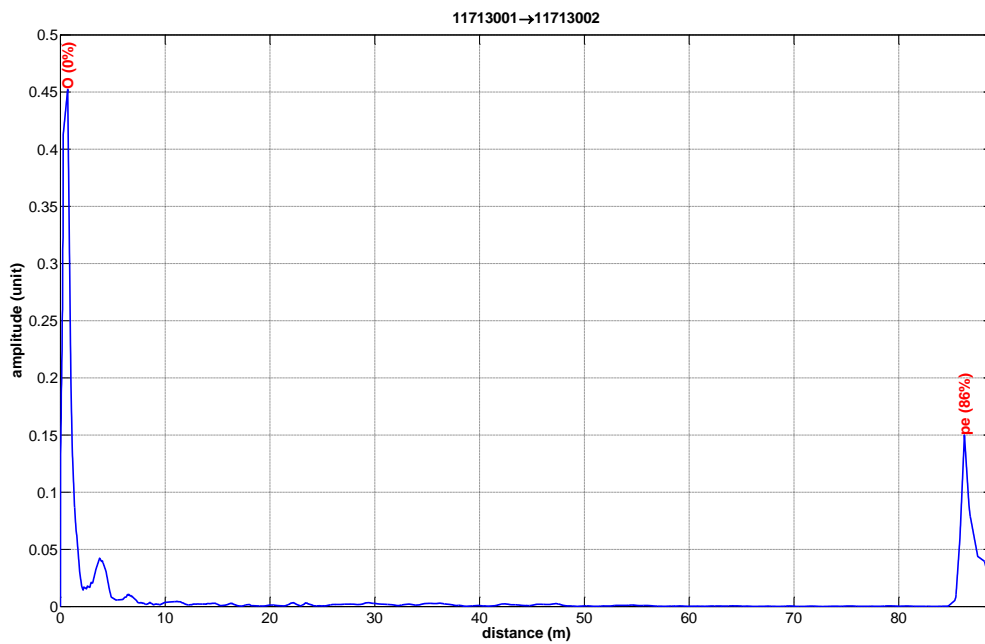
86.27 : pe (good)

AUTO CONDITION GRADE – Green

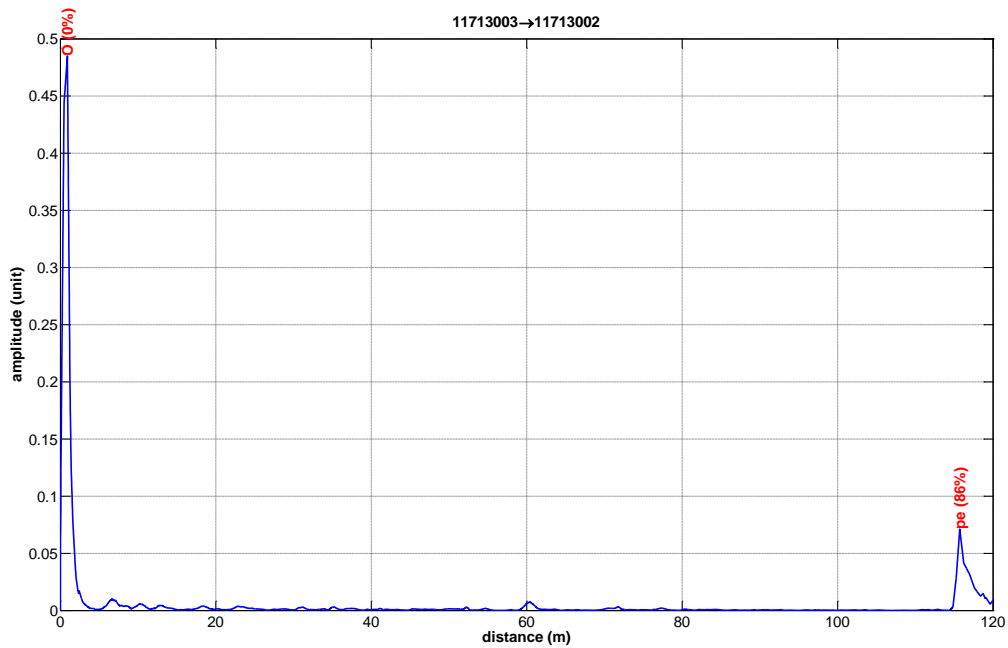
115.71 : pe

AUTO CONDITION GRADE – Green (manual override to Amber)

COMMENT – GIS pipe length = 115.5m. Significant attenuation of response from target manhole in the absence of responses along the pipe indicates defects that are absorbing the acoustic energy. Log for reinspection after an appropriate interval.

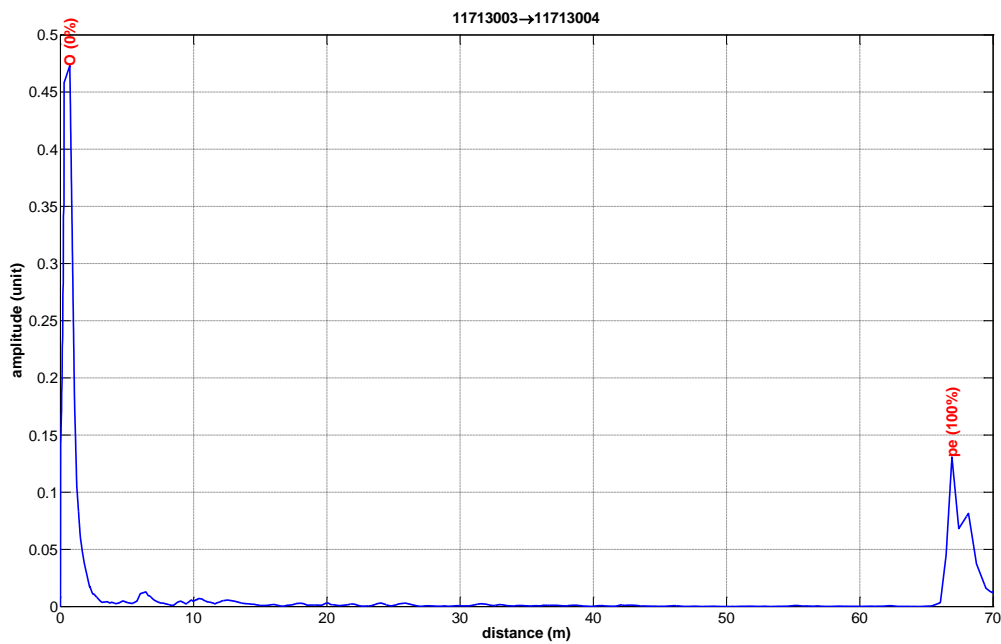
66.91 : pe

AUTO CONDITION GRADE – Green (manual override to Amber)

COMMENT – GIS Length = 66.9m. Pipe is currently serviceable but attenuation of target manhole response indicates potential for deterioration. Log for resurvey after an appropriate interval.

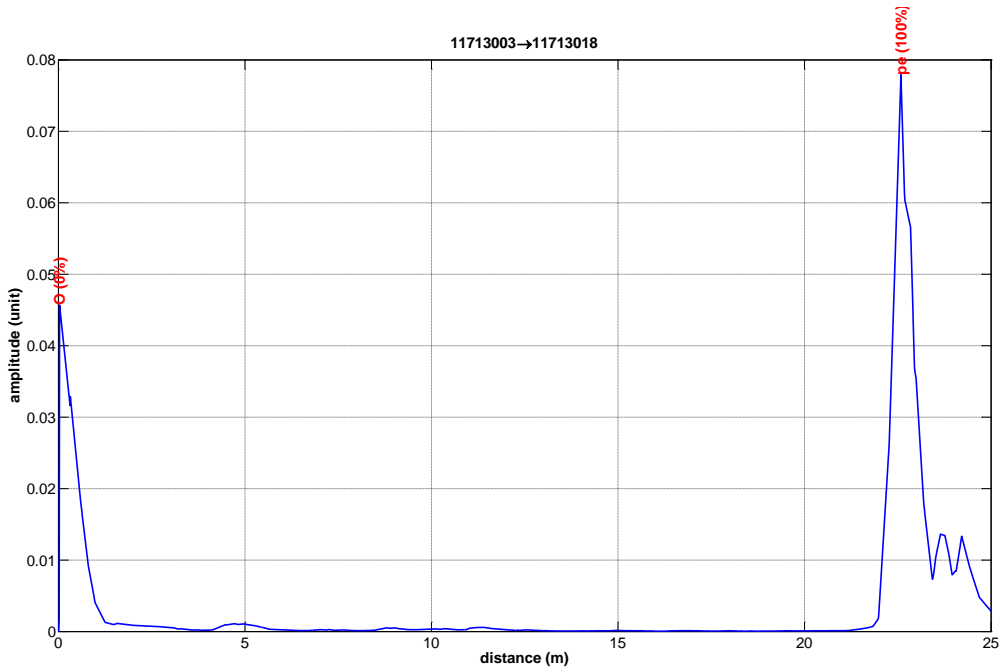
22.58 : pe (Good)

AUTO CONDITION GRADE – Green

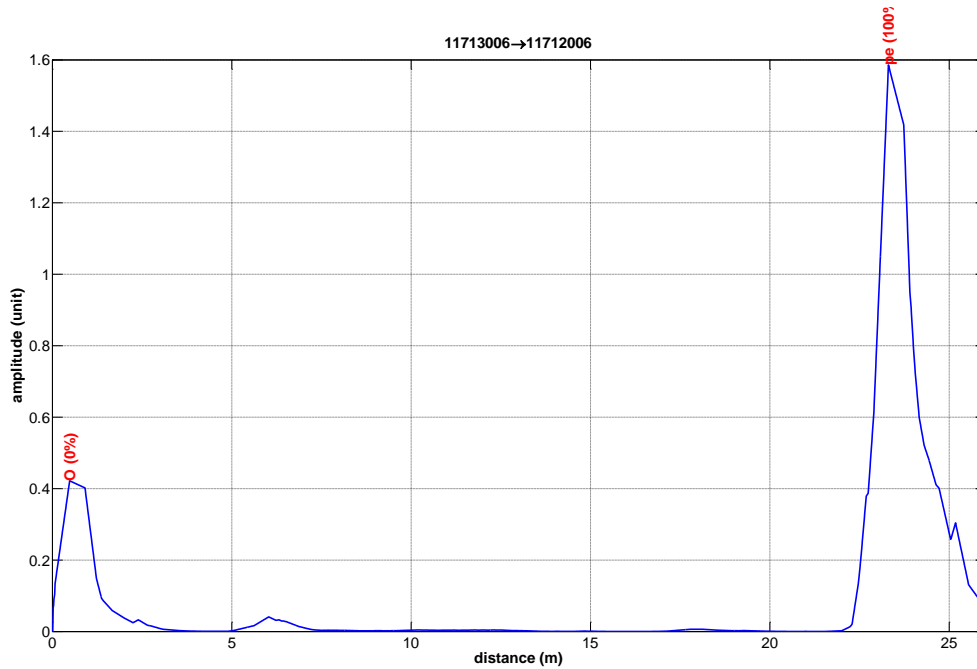
23.31 : pe (Good)

AUTO CONDITION GRADE – Green

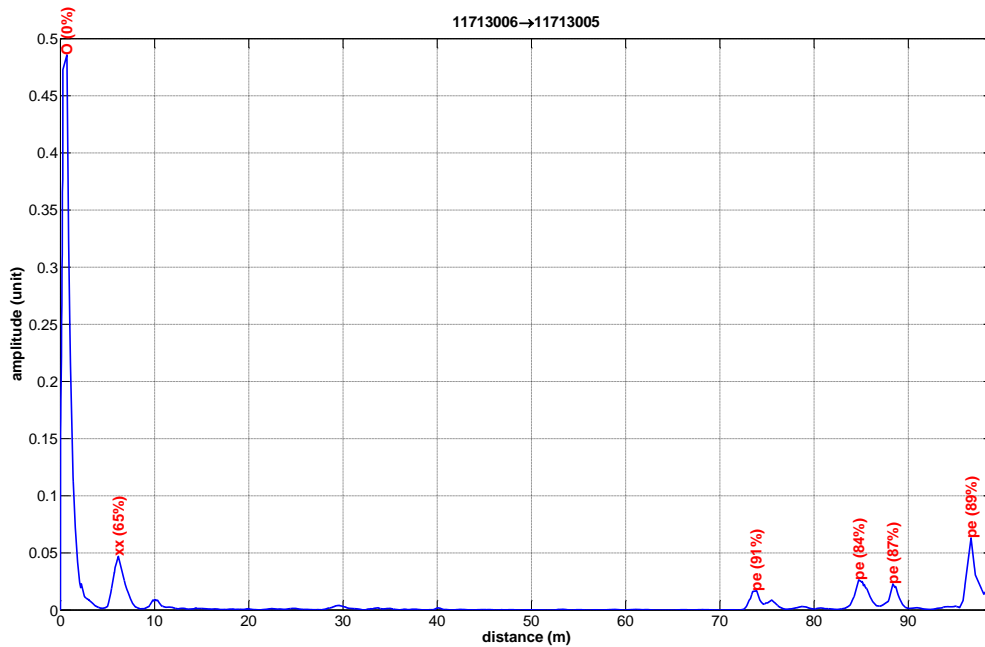
6.15 : xx

AUTO CONDITION GRADE – Red

COMMENT – GIS Length = 96.6m. Responses at 73.84m, 84.74m and 88.37m were initially identified as pipe ends, but subsequently reclassified by the system as lateral connections once the true pipe end at 96.66m had been confirmed through the interface. There is an unidentified response at 6.15m. The reason for the red classification in this case is the low level of response from the target manhole. CCTV is recommended in this case.

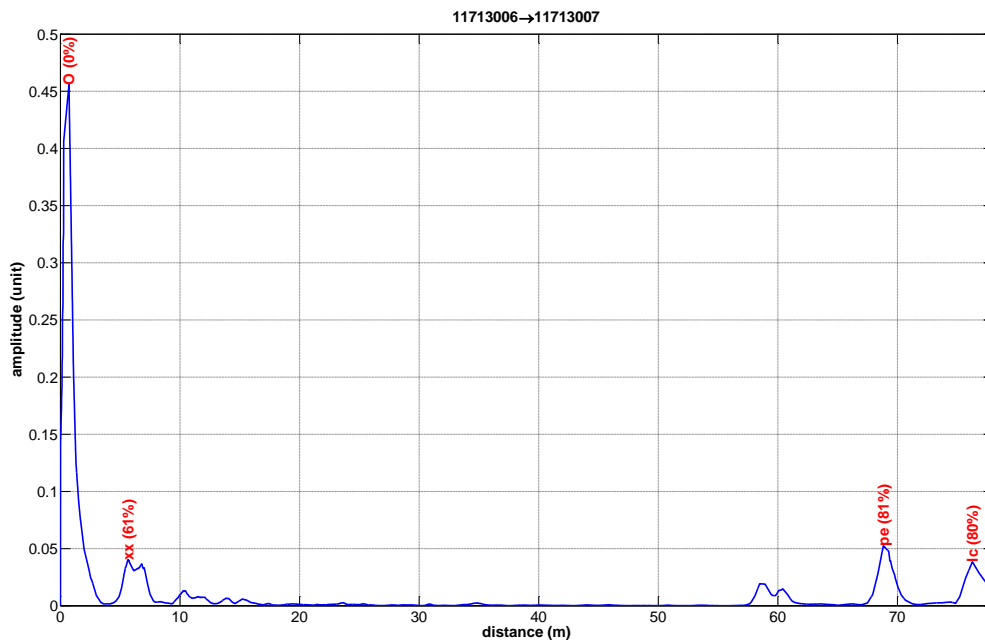
5.67 : xx

68.82 : lc (defective)

AUTO CONDITION GRADE - Red

been confirmed through the interface, after which the system reclassified the response at 68.82 as a defective connection. There is an unidentified response at 5.67m. CCTV is recommended in this case.

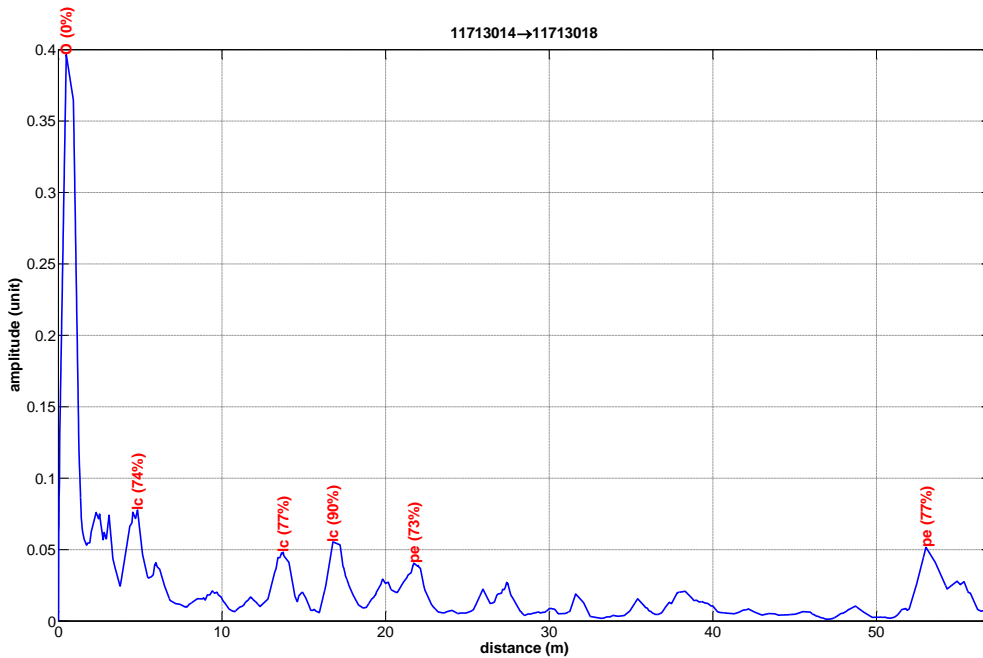
4.83 : xx

AUTO CONDITION GRADE – Red

COMMENT – GIS length = 52.6m. There are many responses along the length of the pipe and the energy loss is very high. CCTV is recommended.

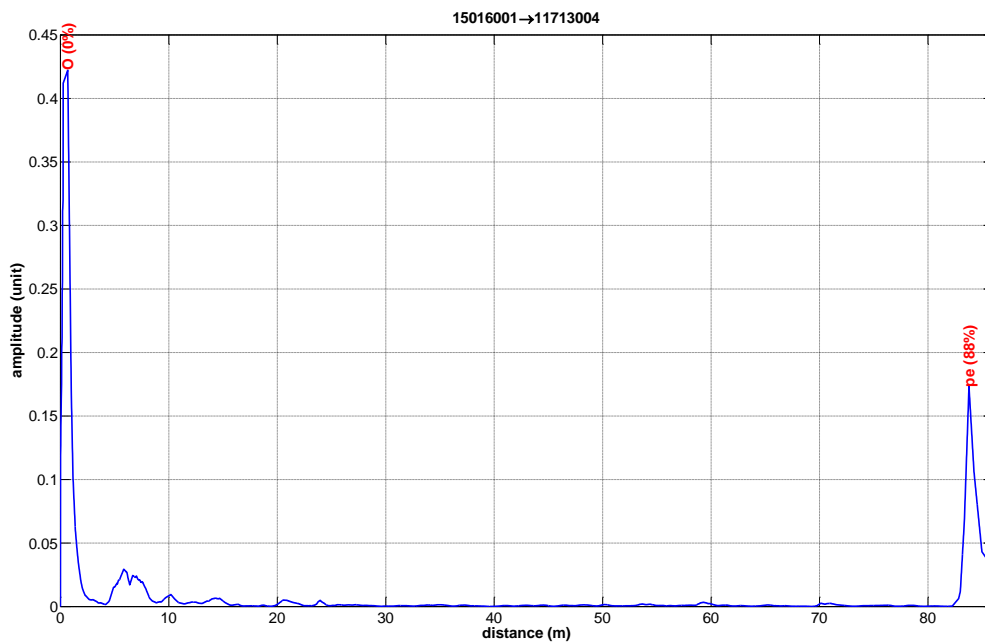
83.78 : pe

AUTO CONDITION GRADE – Green (manual override to Amber)

COMMENT – GIS Length = 83.4m. Pipe is currently serviceable but significant attenuation of response from remote manhole indicates potential for deterioration. Log for resurvey after an appropriate interval.

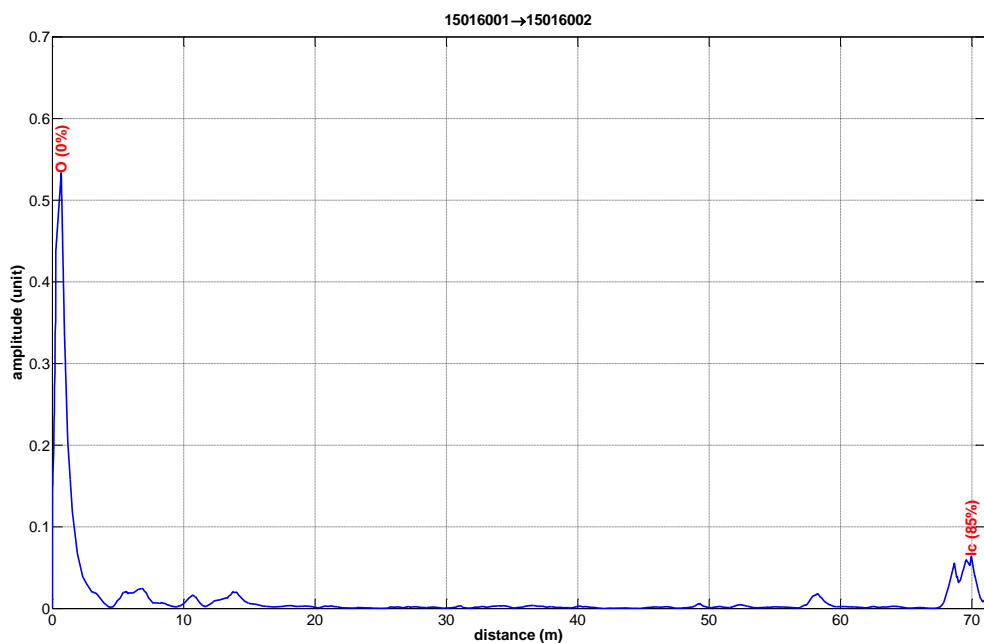
69.96 : pe

AUTO CONDITION GRADE – Green (manual override to Amber)

COMMENT – GIS pipe length = 68.2m. Pipe end was initially identified as a lateral connection. This was subsequently reclassified as a pipe end based on the GIS data. There are minor responses along the length of the pipe and the response from the target manhole is significantly attenuated. The energy level is approaching the amber threshold of 70, indicating that there are some serviceability issues with this pipe but CCTV is not recommended at the present time. Log for resurvey after an appropriate interval.

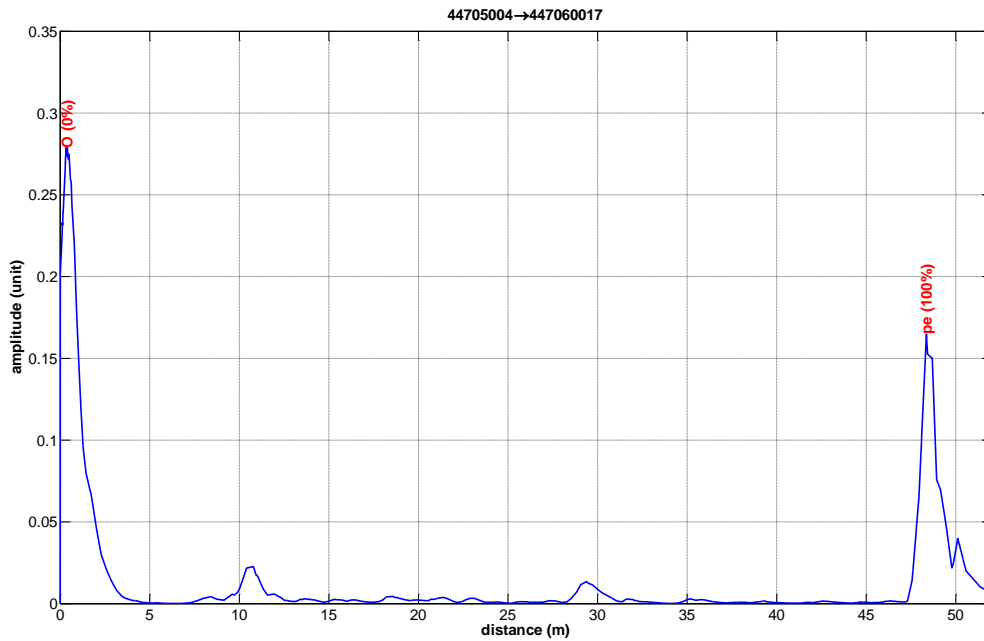
48.36 : pe (Good)

AUTO CONDITION GRADE – Green (manual override to Amber)

COMMENT – GIS length = 53.0m. The system reported a faulty microphone for this test. In the absence of a repeat test the available data from the other microphones has been used. The strong response at 48.36m may be a lateral or a defect. The pipe is serviceable but should be logged for reinspection after an appropriate interval on account of the significantly attenuated response from the target manhole and small responses at 11m and 19m that indicate a potential for deterioration.

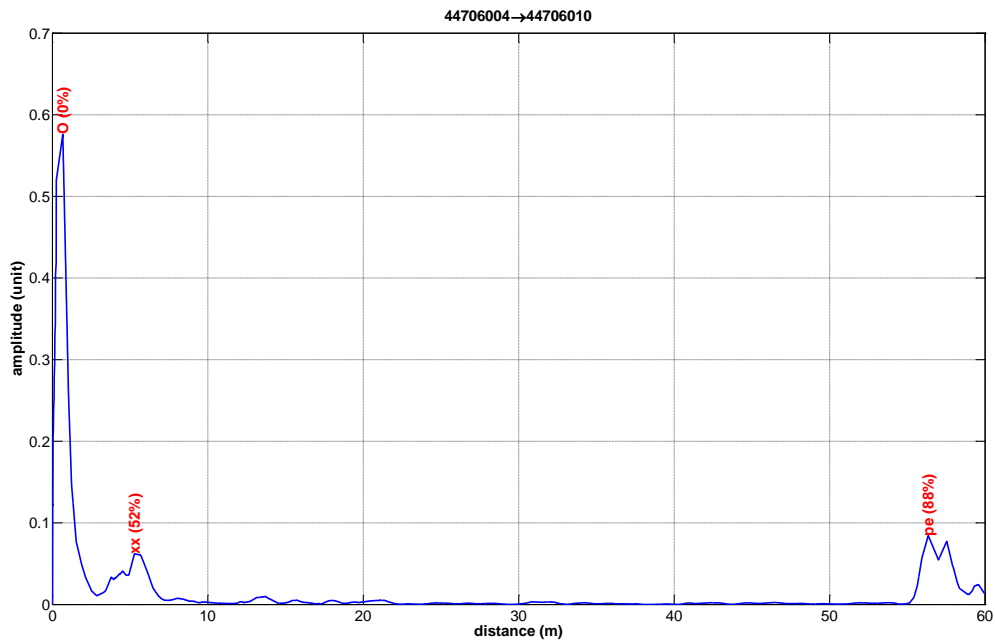
5.28 : xx

AUTO CONDITION GRADE – Red

COMMENT – GIS length = 58.2m. The energy loss is within the 'Green' zone but a 'Red' classification has been applied by the system due to the significant attenuation of the response from the target manhole. This may be due to issues such as sediment or roots and CCTV is recommended.

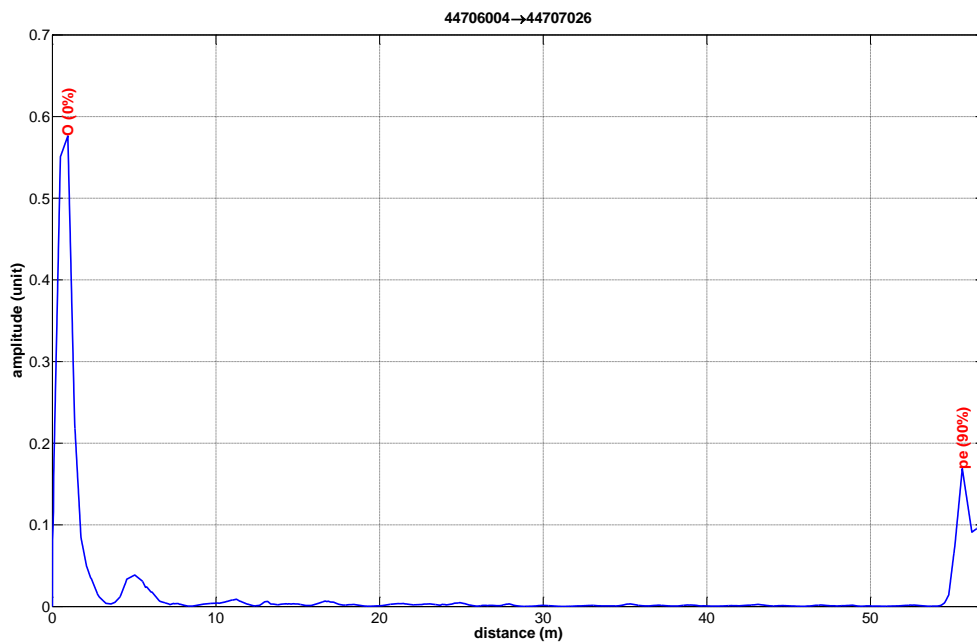
55.61 : pe (Good)

AUTO CONDITION GRADE – Green (manual override to Amber)

COMMENT – GIS Pipe length = 54.0m. Pipe is currently serviceable but significant attenuation of response from remote manhole indicates potential for deterioration.

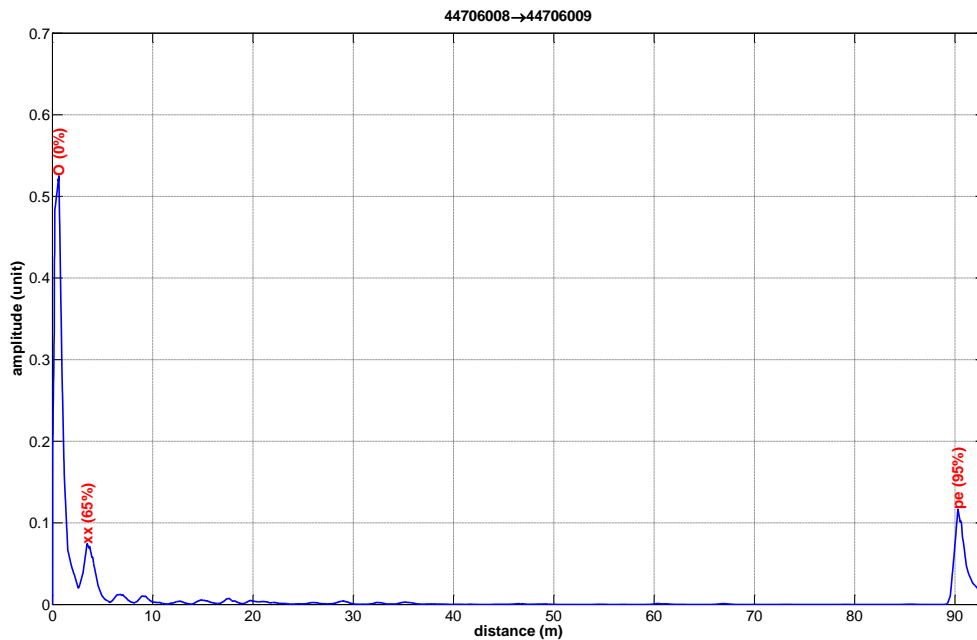
3.46 : xx

AUTO CONDITION GRADE – Amber

COMMENT – GIS Pipe length = 82.9m. SewerBatt output shows pipe length as 90.29m. It is recommended that the pipe should be logged up for reinspection after an appropriate period.

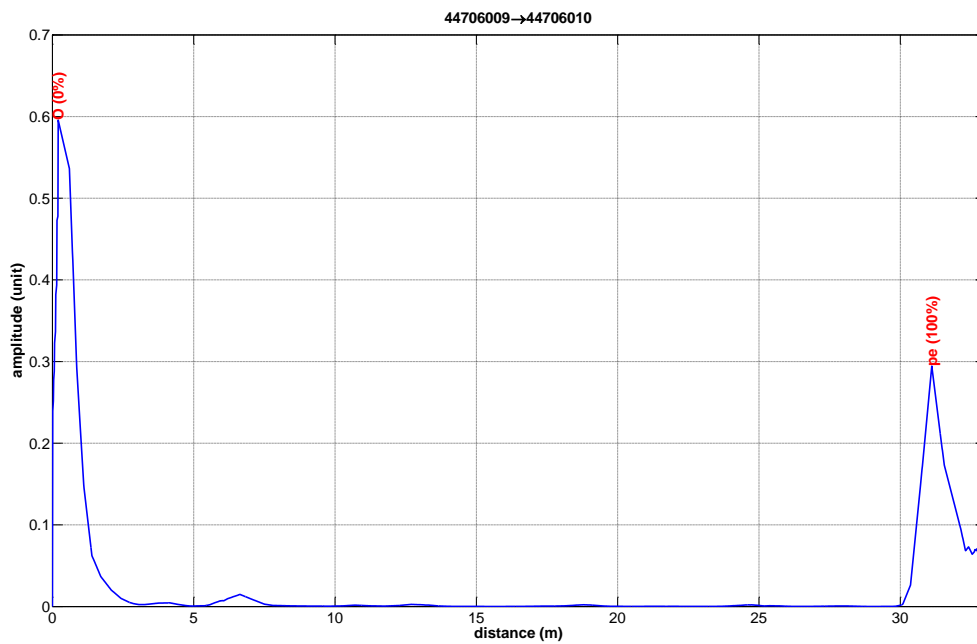
1.11 : pe (Good)

AUTO CONDITION GRADE – Green

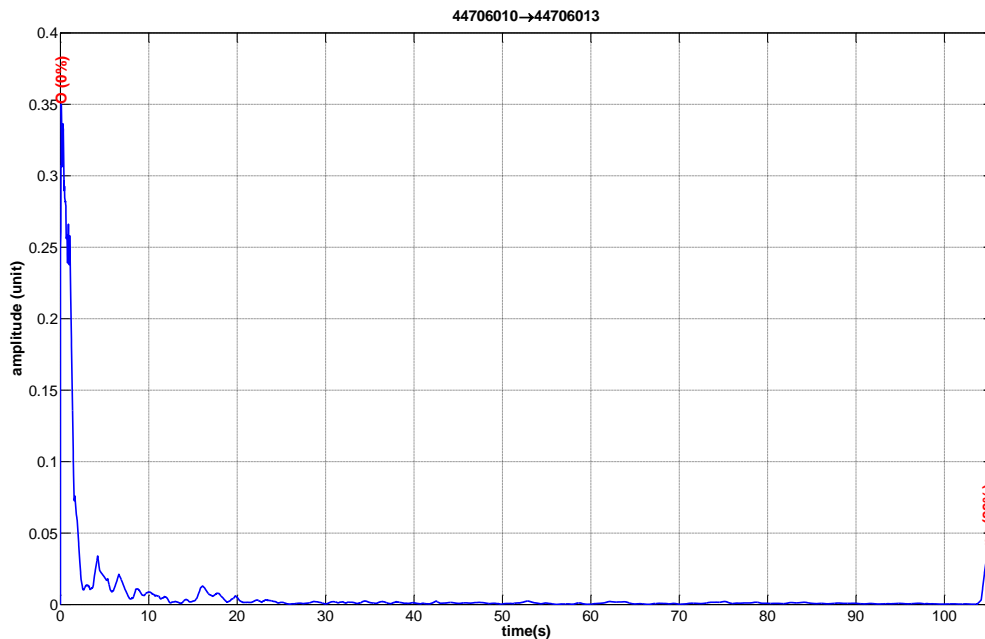
104.94 : pe (Good)

AUTO CONDITION GRADE – Green (manual override to Amber)

COMMENT – GIS Pipe length = 104.2m. Pipe is currently serviceable but significant attenuation of response from remote manhole indicates potential for deterioration.

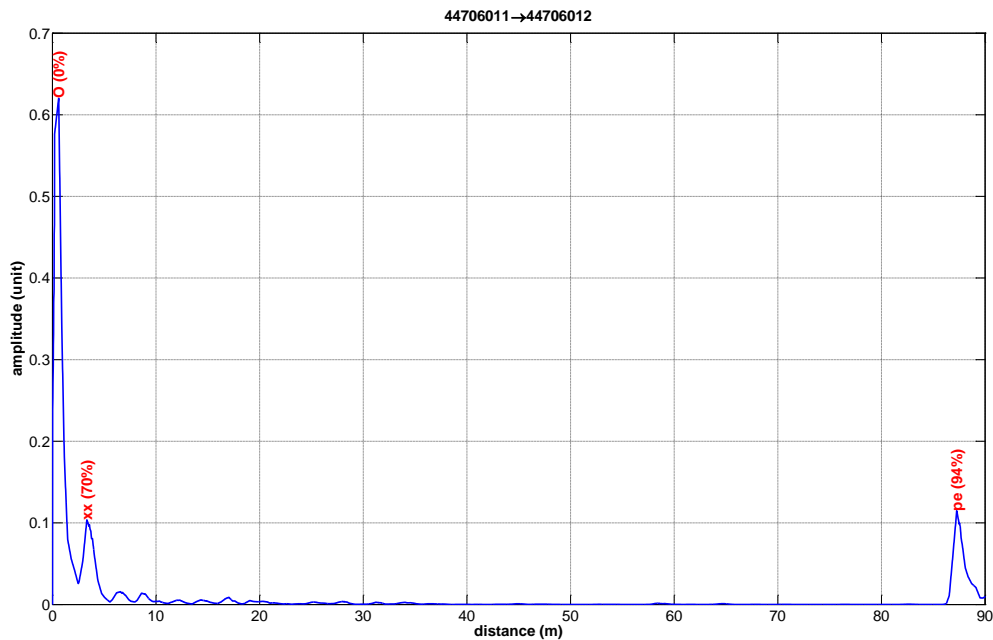
3.32 : xx

AUTO CONDITION GRADE – Red

COMMENT – GIS Pipe length = 87.4m. The energy loss is within the 'Green' zone but a 'Red' classification has been applied by the system due to the significant attenuation of the response from the target manhole. This may be due to issues such as sediment or roots and CCTV is recommended.

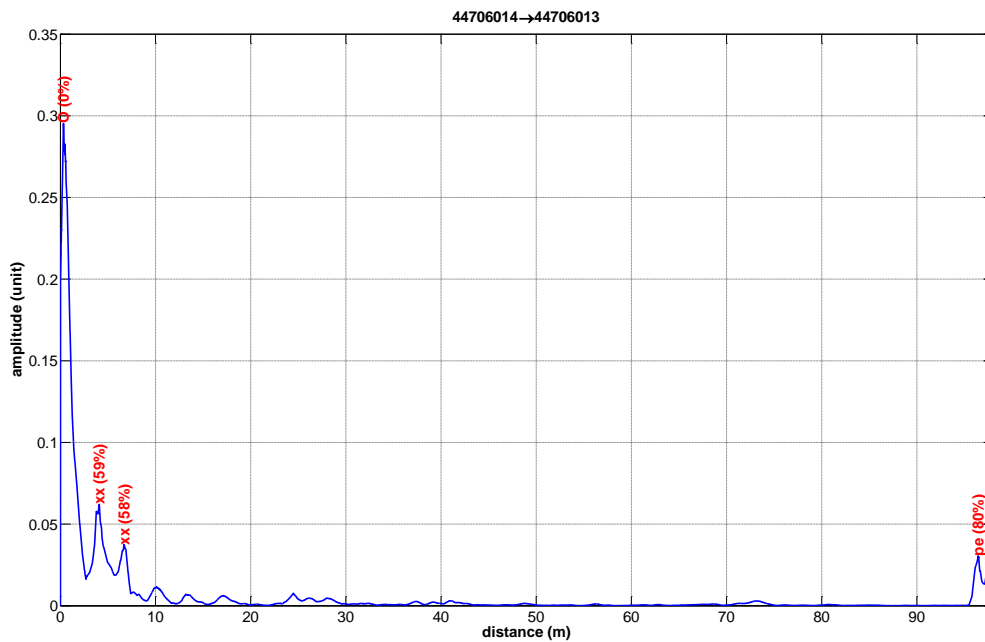
4.08 : xx

AUTO CONDITION GRADE – Red

Comment – GIS pipe length = 95.7m. The reflected energy is within the ‘Green’ zone but a ‘Red’ classification has been applied by the system due to the significant attenuation of the response from the target manhole. This may be due to issues such as sediment or roots and CCTV is recommended.

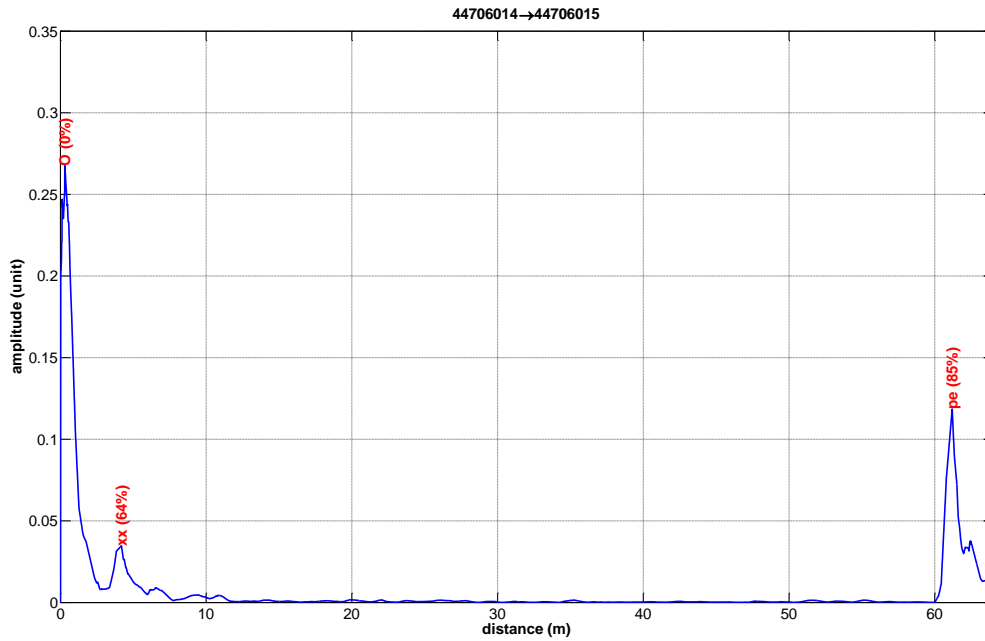
4.19 : xx

AUTO CONDITION GRADE – Green

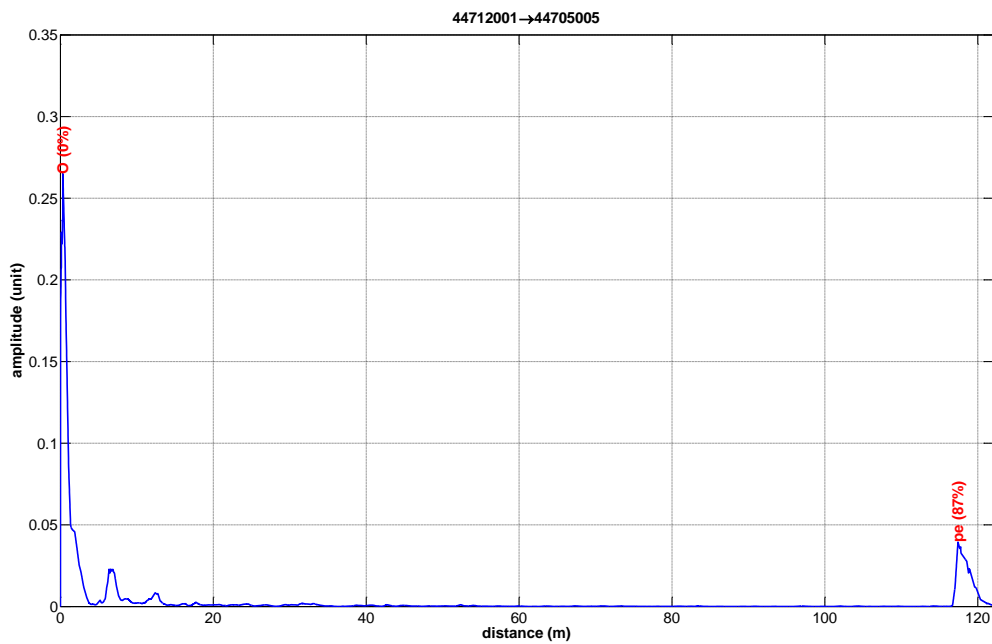
117.41 : pe (Good)

AUTO CONDITION GRADE – Green. (manual override to Amber)

COMMENT – GIS Pipe length = 115.8m. Pipe is currently serviceable but significant attenuation of response from remote manhole indicates potential for deterioration.

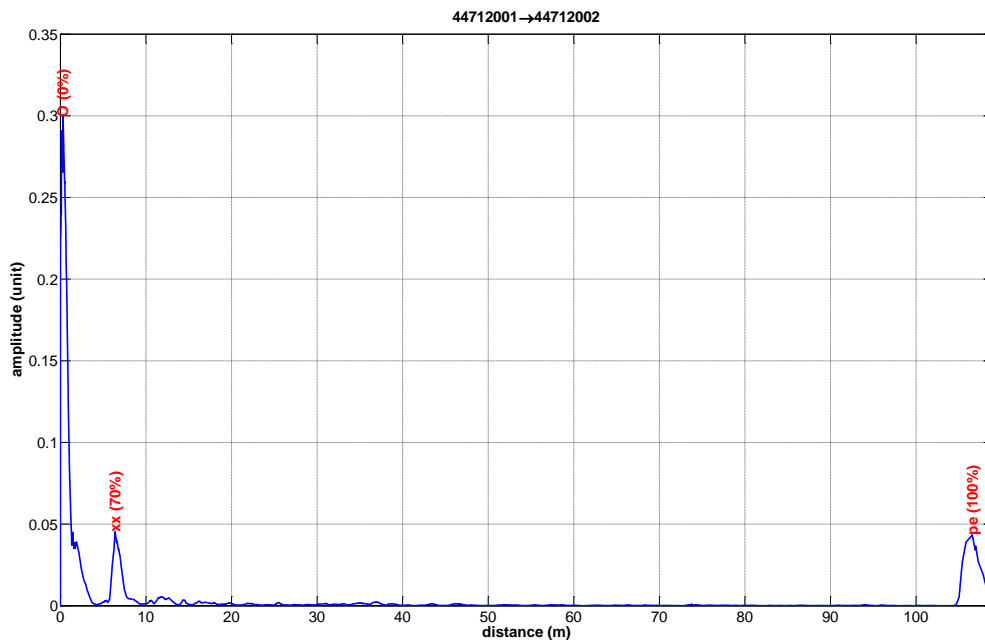
6.39 : xx

AUTO CONDITION GRADE – Red

Comment – GIS Pipe length = 105.3m The reflected energy is within the 'Green' zone but a 'Red' classification has been applied by the system due to the significant attenuation of the response from the target manhole. This may be due to issues such as sediment or roots and CCTV is recommended.
