Demonstration of Innovative Sewer System Inspection Technology SewerBatt™

Srinivas Panguluri
Shaw Environmental & Infrastructure, Inc.
Cincinnati, OH

Contract No. EP-C-11-006

Daniel Murray
Water Supply and Water Resources Division
U.S. Environmental Protection Agency
Cincinnati, OH 45268

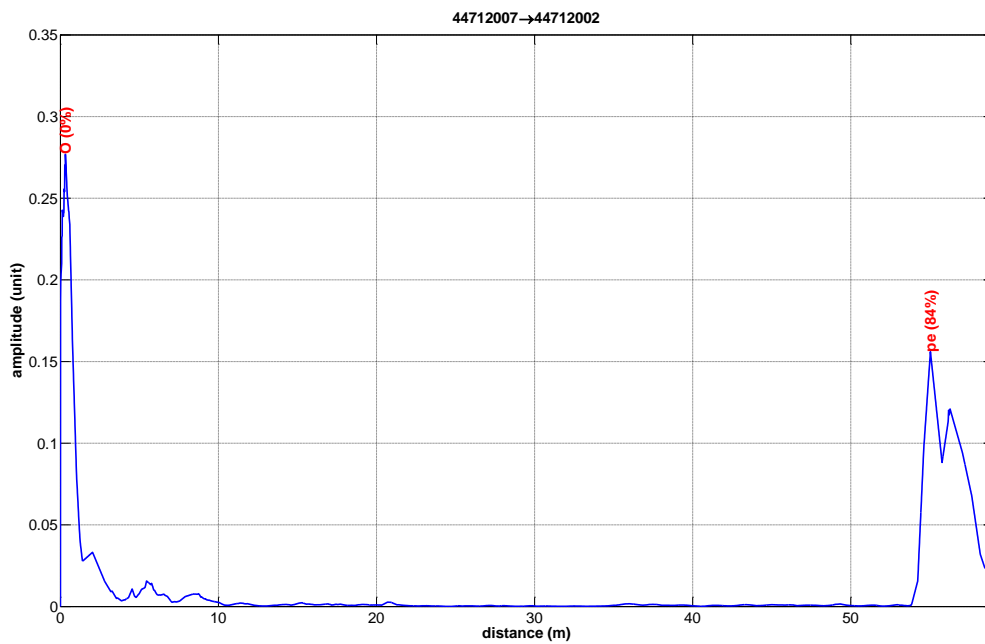
55.04 : pe (Good)

AUTO CONDITION GRADE – Green

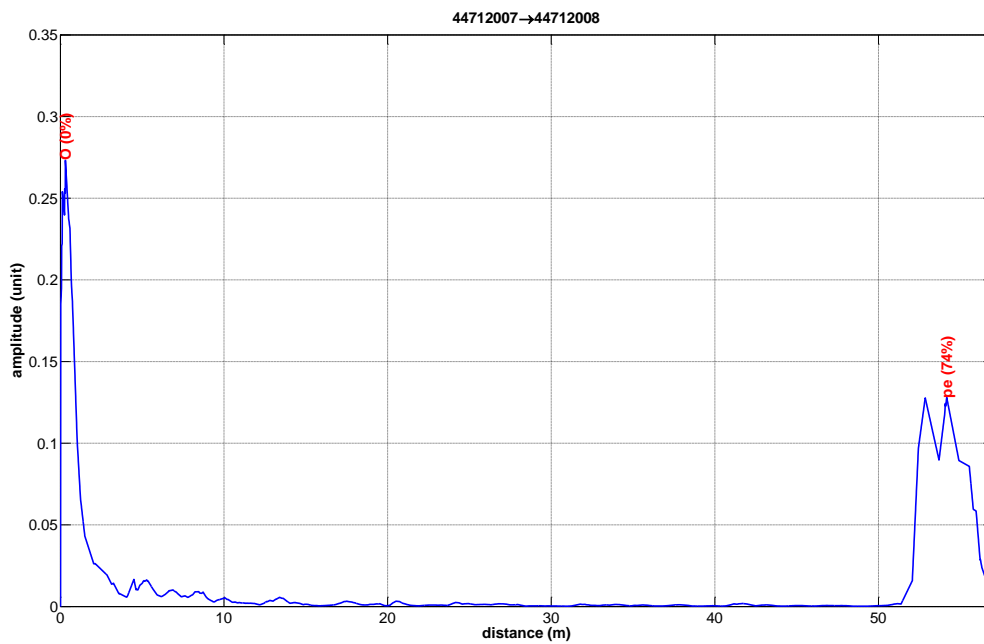
54.17 : pe (Good)

AUTO CONDITION GRADE – Amber (manual over-ride to Green – see below)

COMMENT – GIS pipe length = 52.7m. It is likely that the response from the target manhole is at 53m rather than the 54.17m derived by SewerBatt. This is due to the double-peaked response. This being the case, the condition would have been calculated as 'Green' and hence the pipe is considered to be serviceable, with no further action required.

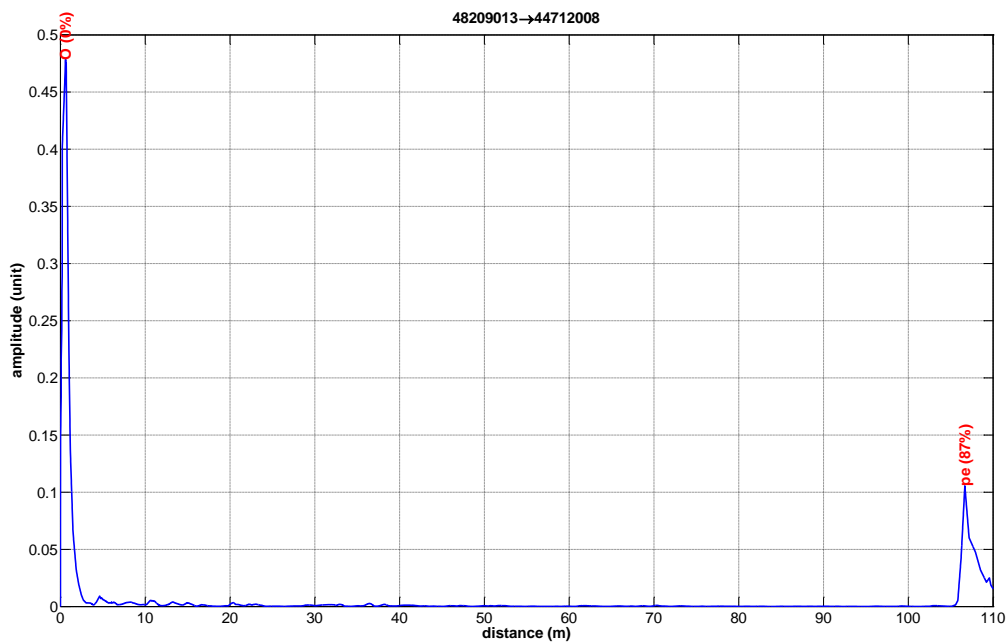
106.67 : pe

AUTO CONDITION GRADE – Green

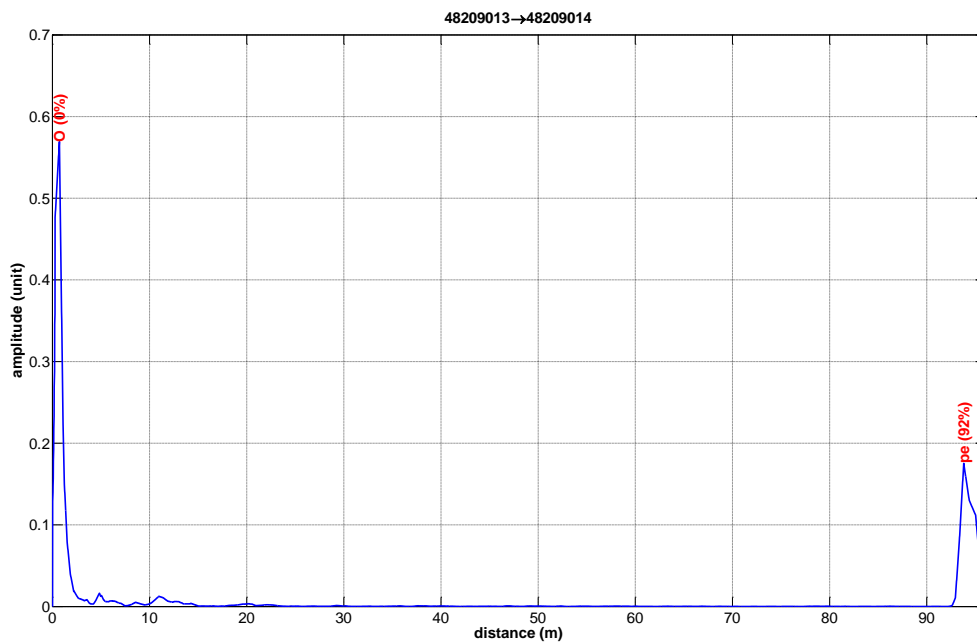
93.8 : pe

AUTO CONDITION GRADE – Green

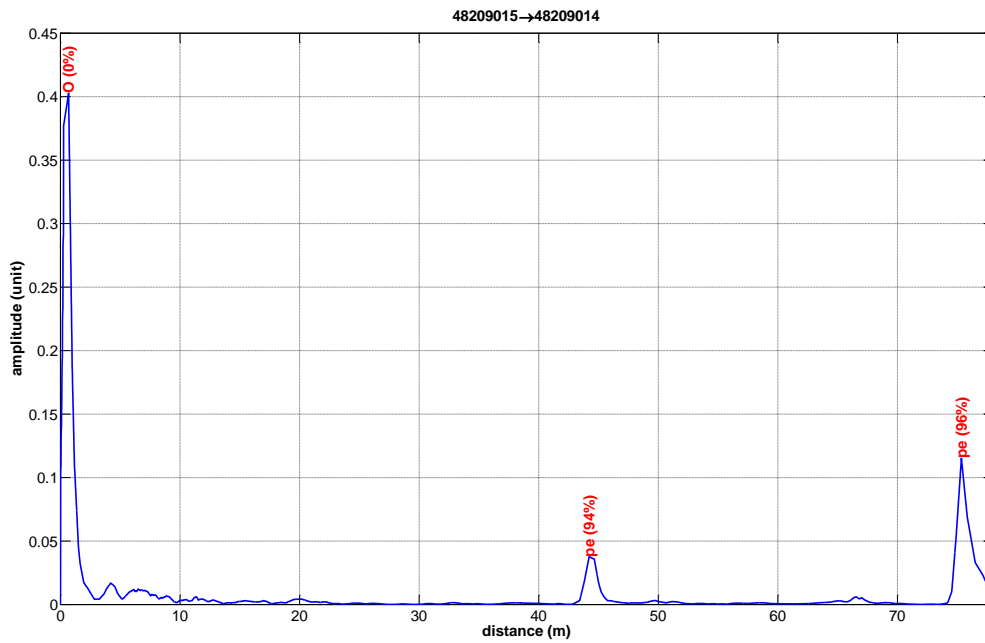
44.22 : lc (Good)

AUTO CONDITION GRADE – Green

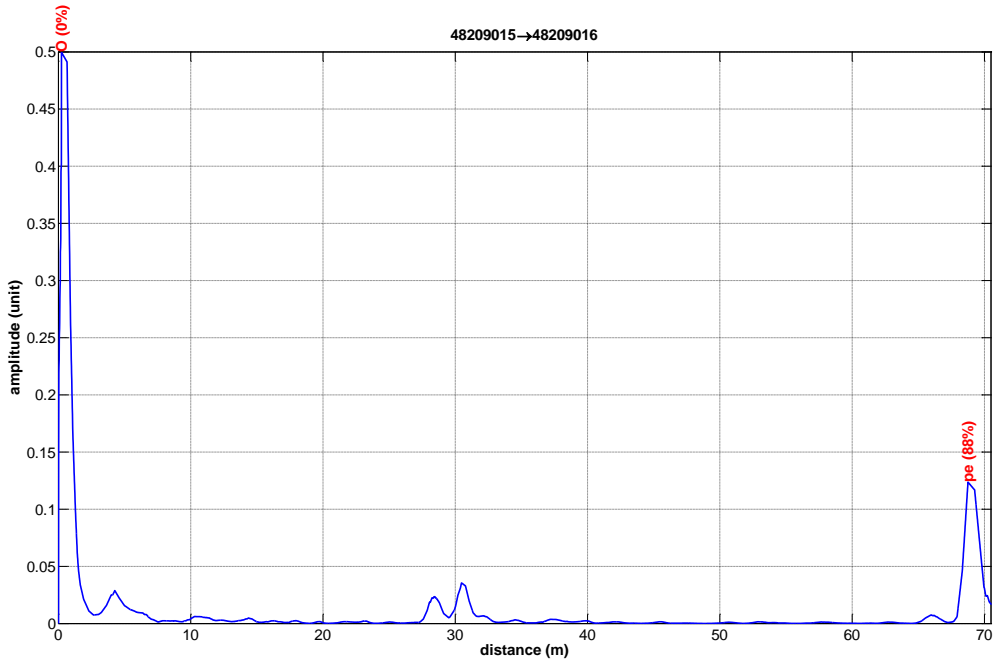
68.75 : pe

AUTO CONDITION GRADE – Green

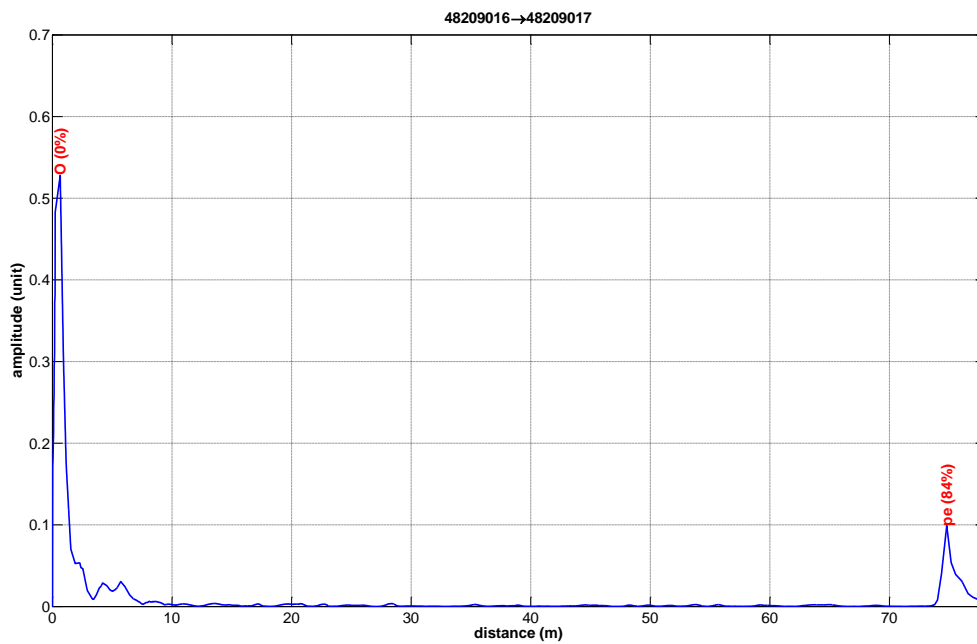
74.79 : pe

AUTO CONDITION GRADE – Green

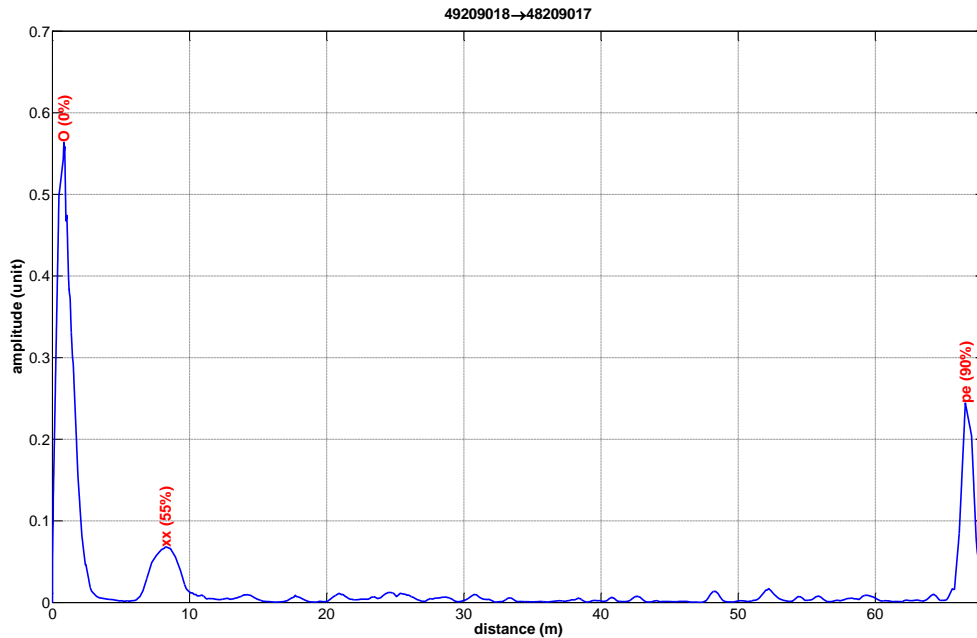
8.25 : xx

AUTO CONDITION GRADE – Amber

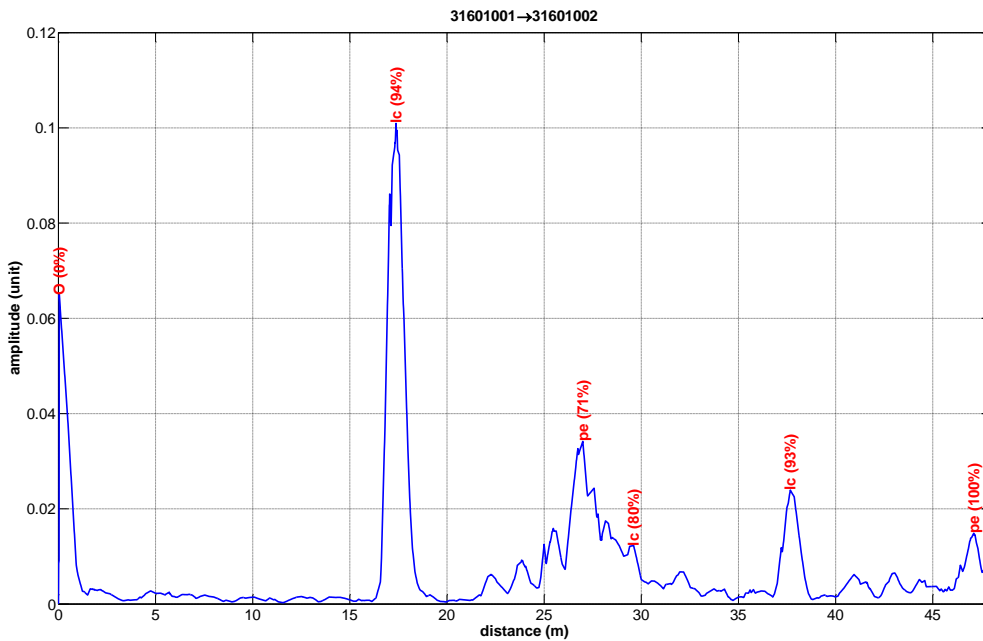
17.37 : lc

AUTO CONDITION GRADE – Red

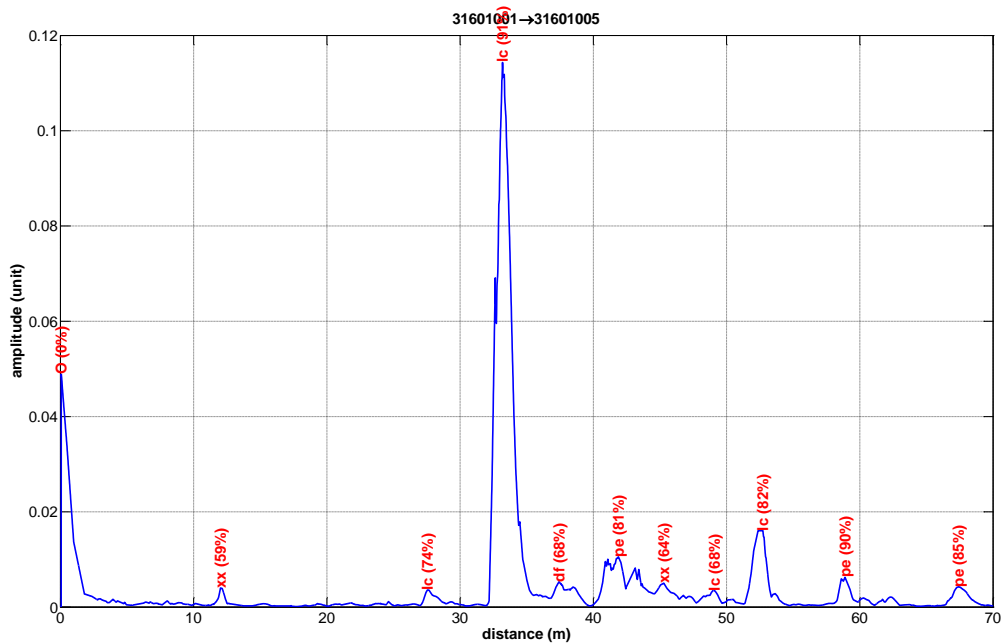
12.02 : xx

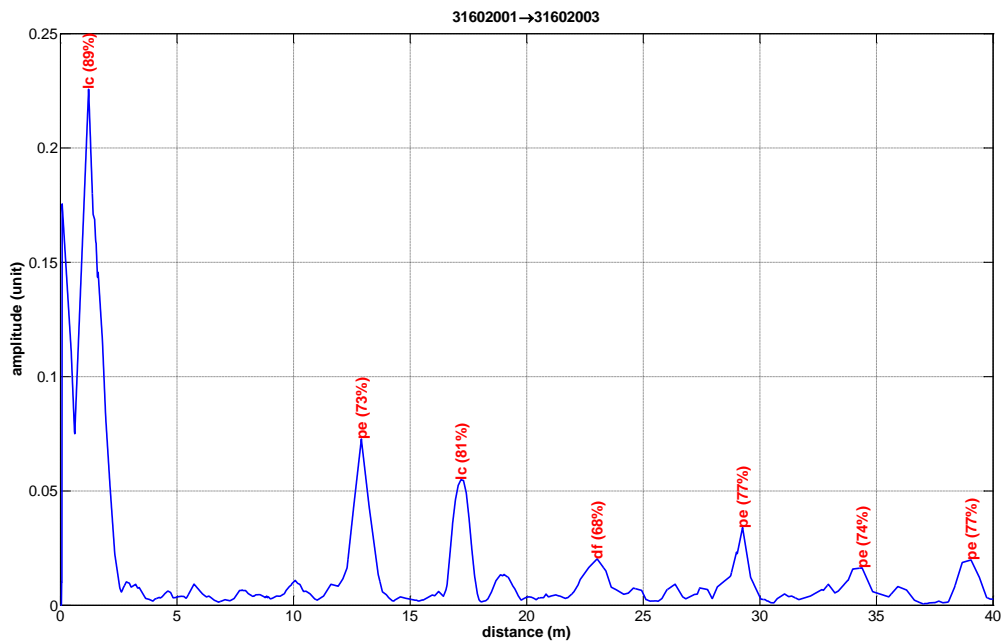
12.91 : xx

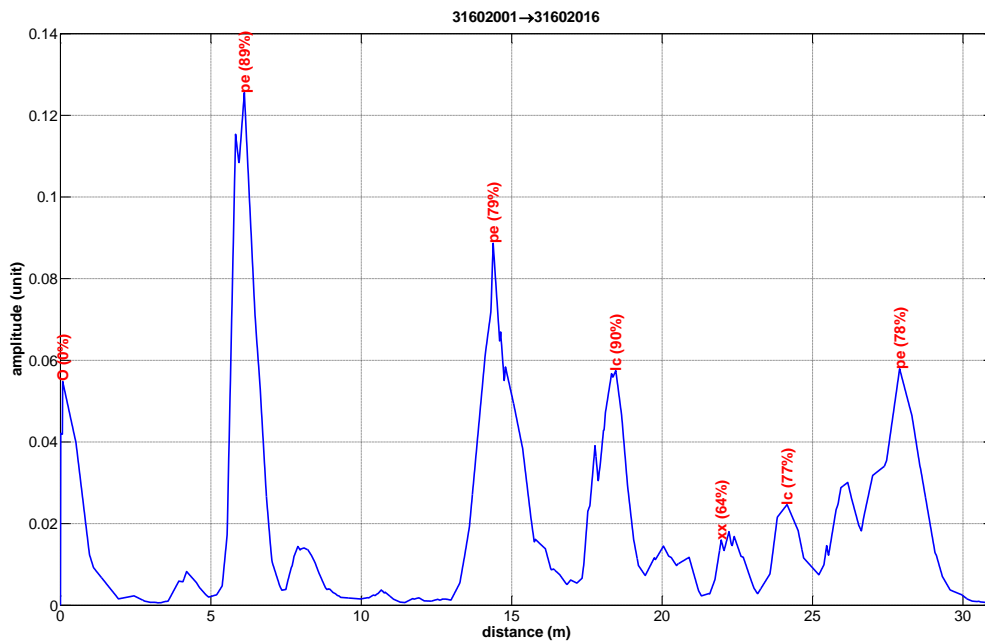
- 6.11 : lc (crack, infiltration)
- 14.38 : lc (crack, infiltration)
- 18.46 : lc
- 21.96 : xx
- 24.15 : xx
- 27.89 : pe

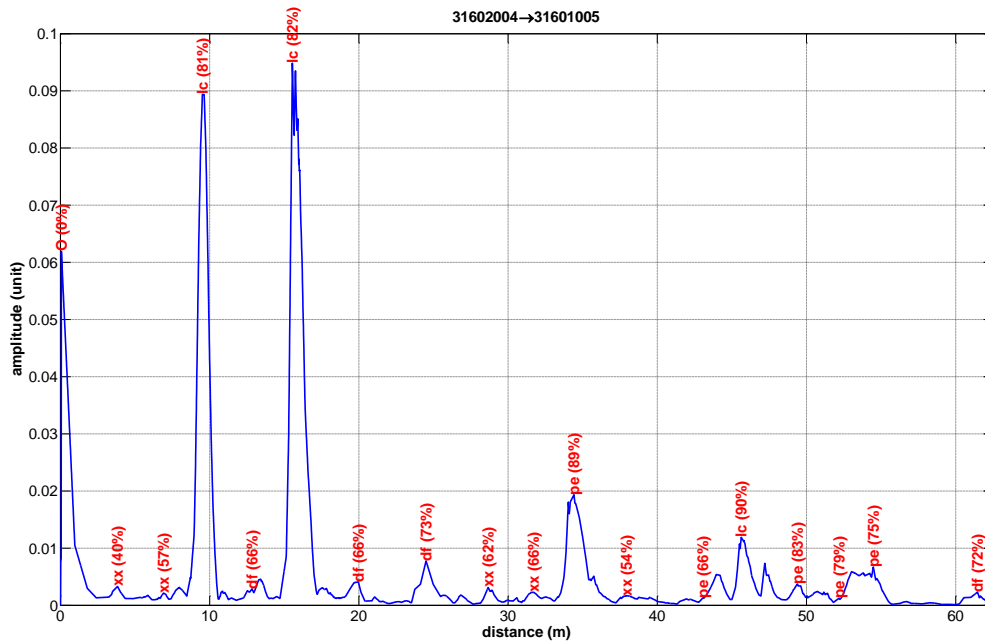
3.83 : xx
 6.91 : xx
 9.52 : lc (missing pieces, crack, displacement)
 12.84 : xx
 15.54 : lc (closed)
 19.96 : xx
 24.5 : xx
 28.66 : xx
 31.7 : xx
 34.41 : lc (closed)
 37.94 : xx
 43.06 : xx
 45.63 : lc (closed)
 49.38 : xx
 52.18 : xx
 54.48 : xx
 61.46 : pe
 ENERGY : 17
 PE : 0
 DE ratio : 3.35
 AUTO CONDITION GRADE – Red

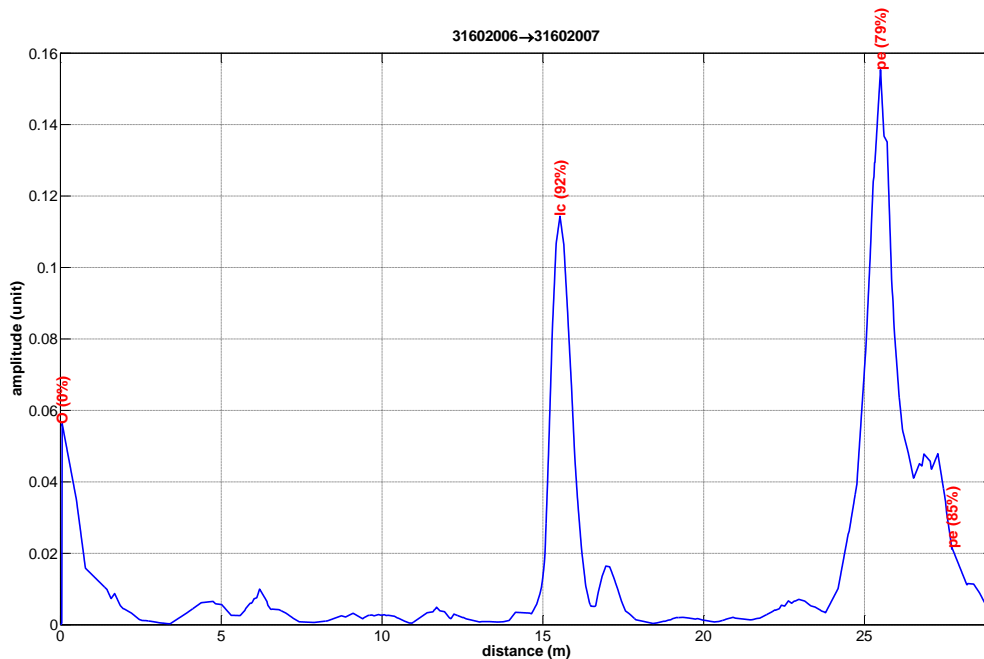
15.53 : lc

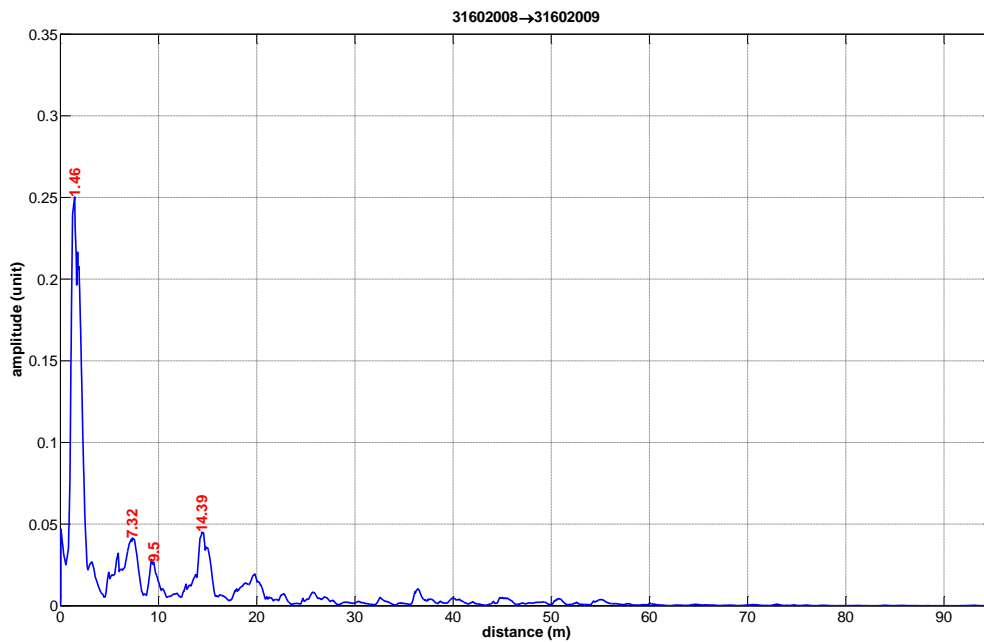
AUTO CONDITION GRADE – Red by manual assessment.

COMMENT – GIS pipe length = 91.5m. CCTV is recommended.

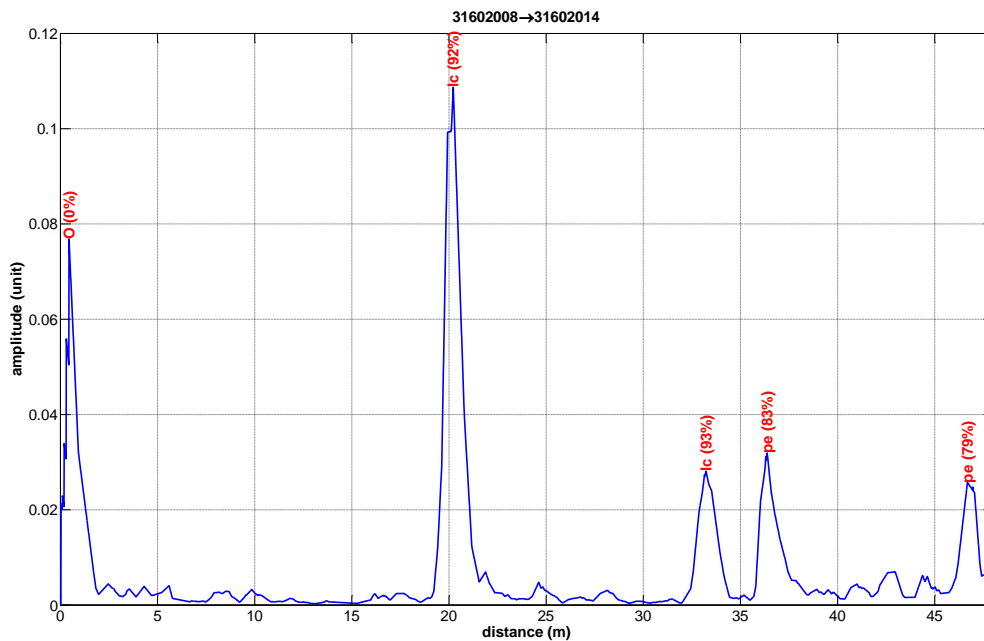
20.22 : lc (crack, infiltration)

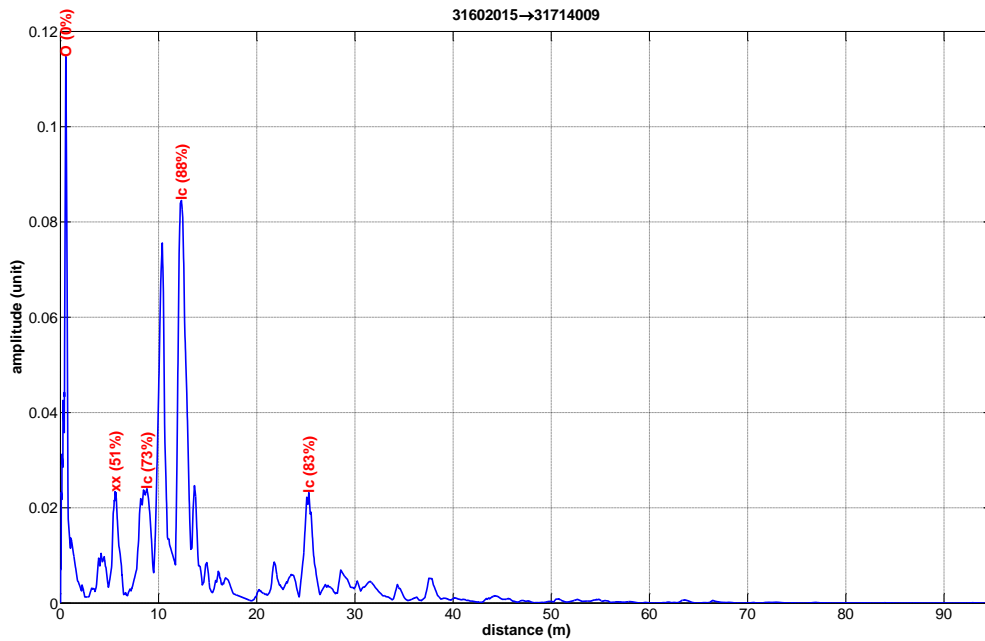
AUTO CONDITION GRADE – Red by manual assessment.

COMMENT – GIS pipe length = 92m. CCTV is recommended.

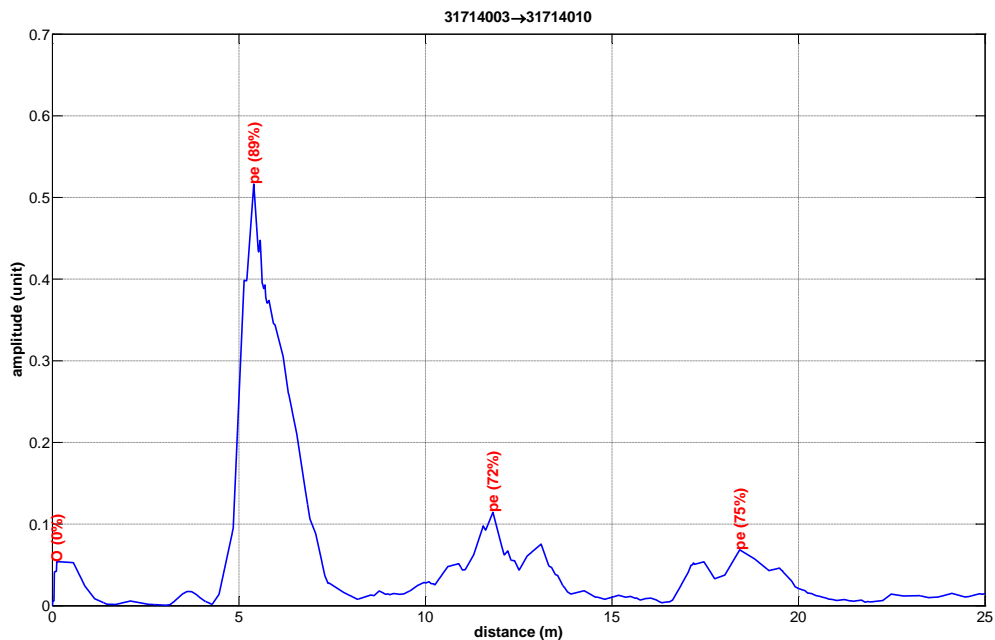
CONDITION REPORT :

11.81 : xx

AUTO CONDITION GRADE – Red

COMMENT – GIS pipe length = 26m. CCTV recommended.

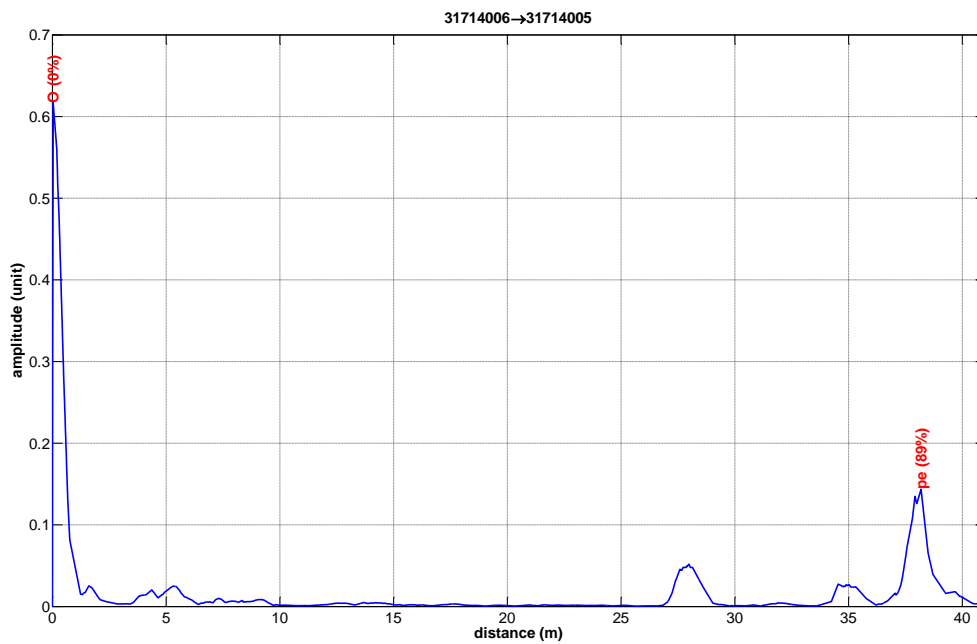
CONDITION REPORT :

38.19 : pe

AUTO CONDITION GRADE – Amber

COMMENT – GIS pipe length = 39m. The pipe is serviceable but shows signs of deterioration. It is recommended that the pipe should be logged for reinspection after an appropriate interval.

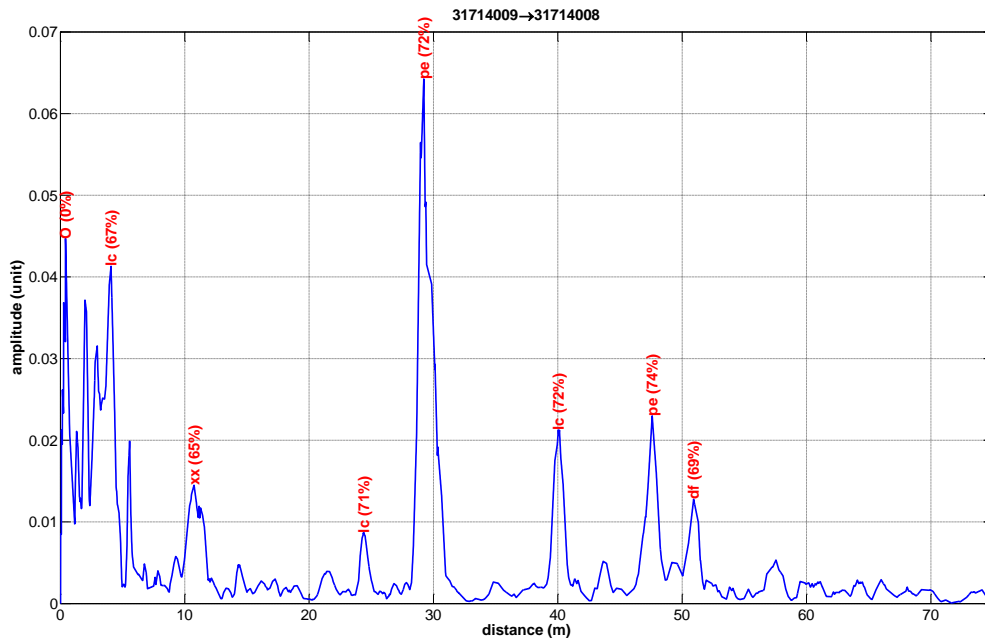
- 1 : O (0%) at 0.41m
- 2 : lc (67%) at 4.07m
- 3 : xx (65%) at 10.75m
- 4 : lc (71%) at 24.4m
- 5 : pe (72%) at 29.22m
- 6 : lc (72%) at 40.04m
- 7 : pe (74%) at 47.59m
- 8 : df (69%) at 50.92m

AUTO CONDITION GRADE – Red by manual assessment.

COMMENT – GIS pipe length = 73m. CCTV is recommended.

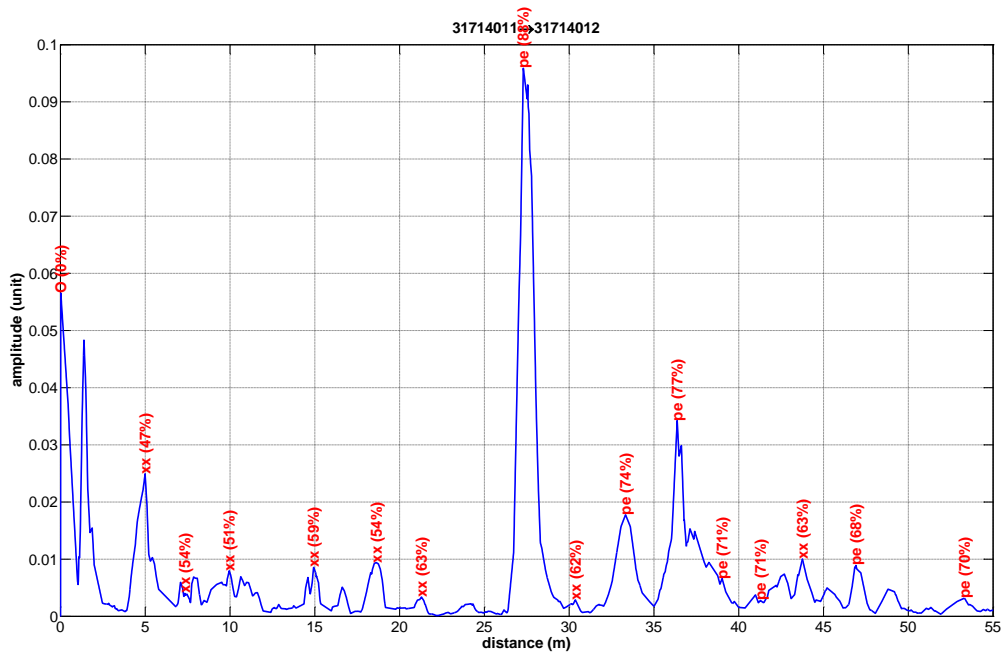
1 : O (0%) at 0.02m
2 : xx (47%) at 4.99m
3 : xx (54%) at 7.34m
4 : xx (51%) at 9.96m
5 : xx (59%) at 14.93m
6 : xx (54%) at 18.63m
7 : xx (63%) at 21.29m
8 : pe (88%) at 27.3m
9 : xx (62%) at 30.37m
10 : pe (74%) at 33.33m
11 : pe (77%) at 36.37m
12 : pe (71%) at 39.02m
13 : pe (71%) at 41.28m
14 : xx (63%) at 43.76m
15 : pe (68%) at 46.91m
16 : pe (70%) at 53.32m

4.99 : xx
 7.34 : xx
 9.96 : xx
 14.93 : xx
 18.63 : xx
 21.29 : xx
 27.3 : lc (crack, infiltration)
 30.37 : xx
 33.33 : xx
 36.37 : xx
 39.02 : xx
 41.28 : xx
 43.76 : xx
 46.91 : xx
 53.32 : pe
 ENERGY : 42
 PE : 0
 DE ratio : 10.77
 AUTO CONDITION GRADE – Red
 COMMENT – GIS pipe length = 53m. CCTV recommended.

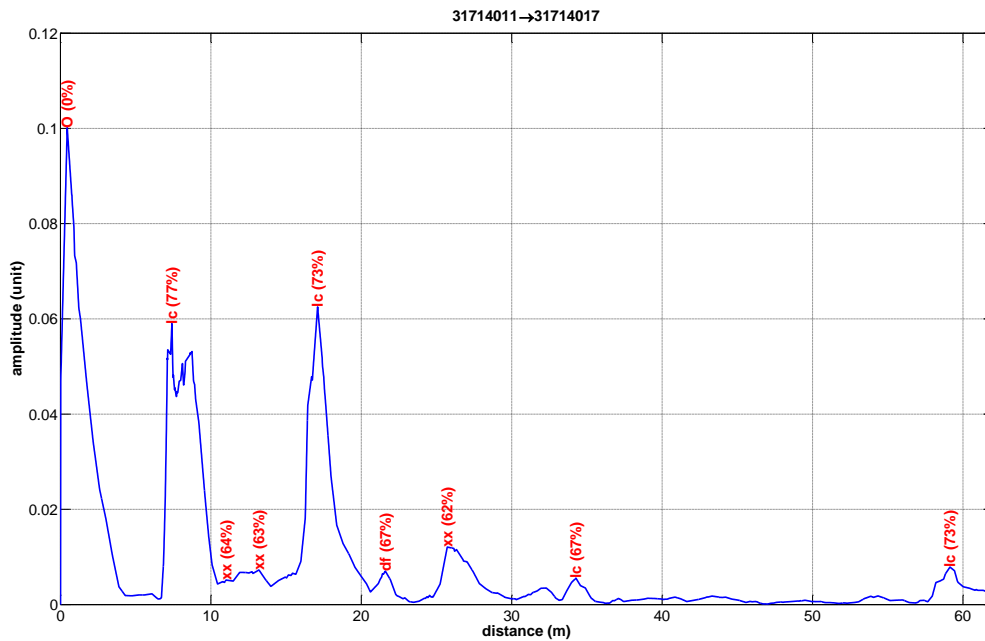
- 1 : O (0%) at 0.45m
- 2 : lc (77%) at 7.41m
- 3 : xx (64%) at 11.01m
- 4 : xx (63%) at 13.2m
- 5 : lc (73%) at 17.1m
- 6 : df (67%) at 21.6m
- 7 : xx (62%) at 25.72m
- 8 : lc (67%) at 34.27m
- 9 : lc (73%) at 59.14m

7.41 : xx

17.1 : lc (crack, infiltration)

59.14 : pe (crack, infiltration)

AUTO CONDITION GRADE – Red

COMMENT – GIS pipe length = 59m. Analysis based on mics 2 and 3 only. Energy level is in the 'Amber' zone but given the nature of several of the identified defects and the level of attenuation of the response from the target manhole CCTV is recommended.

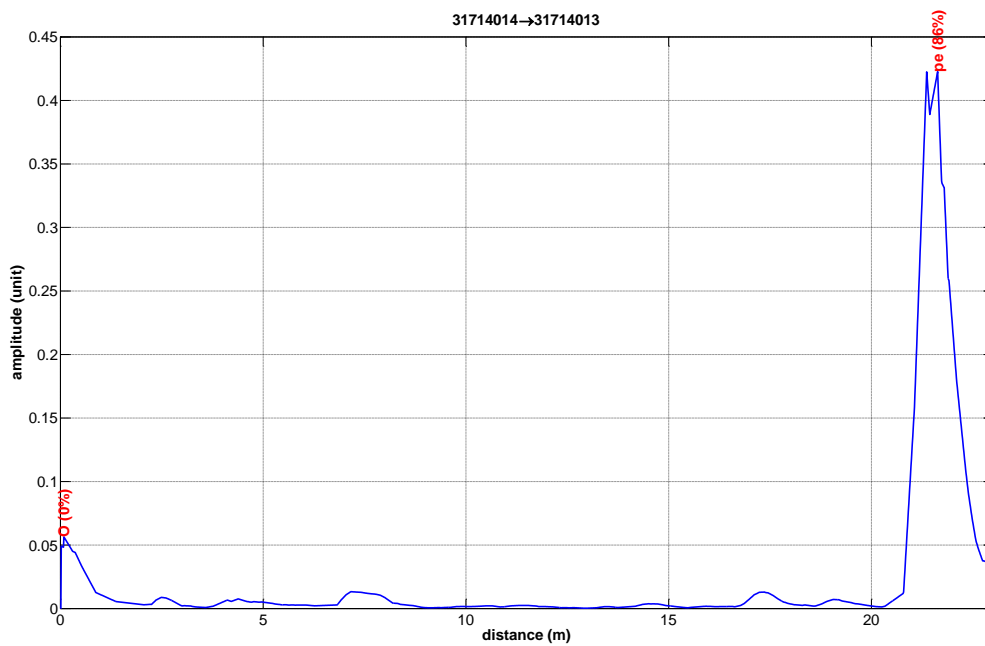
21.63 : pe

AUTO CONDITION GRADE – Green

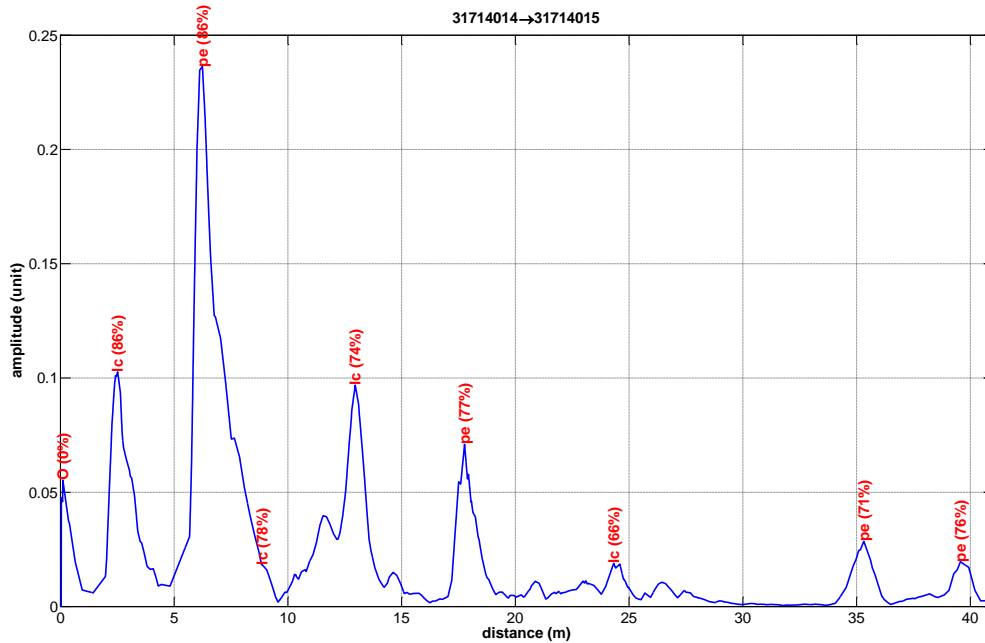
- 1 : O (0%) at 0.11m
- 2 : lc (86%) at 2.52m
- 3 : pe (86%) at 6.24m
- 4 : lc (78%) at 8.87m
- 5 : lc (74%) at 12.96m
- 6 : pe (77%) at 17.77m
- 7 : lc (66%) at 24.32m
- 8 : pe (71%) at 35.32m
- 9 : pe (76%) at 39.56m

2.52 : lc (crack, infiltration)

AUTO CONDITION GRADE – Red

COMMENT – GIS pipe length = 40m. If the many peaks could be identified as lateral connections then an 'Amber' or 'Green' classification could be given to this pipe, but with the present signature library CCTV is recommended on a precautionary basis.

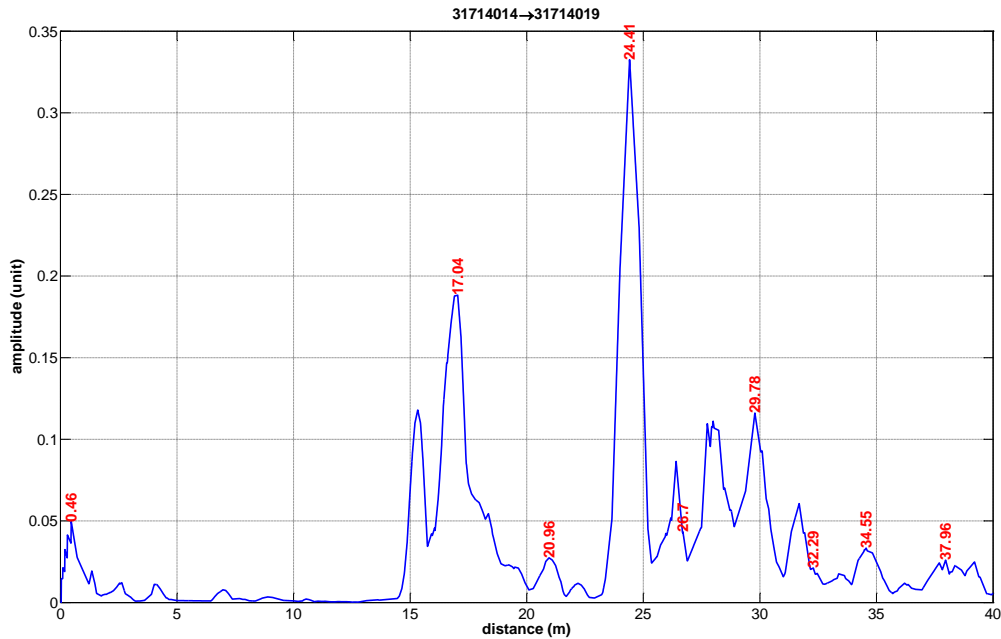
17.04 : lc (crack, infiltration)

20.96 : lc (crack, infiltration)

26.7 : lc (crack, infiltration)

32.29 : lc (crack, infiltration)

34.55 : lc (crack, infiltration)

AUTO CONDITION GRADE – Red

COMMENT – GIS pipe length = 40m. CCTV is recommended.

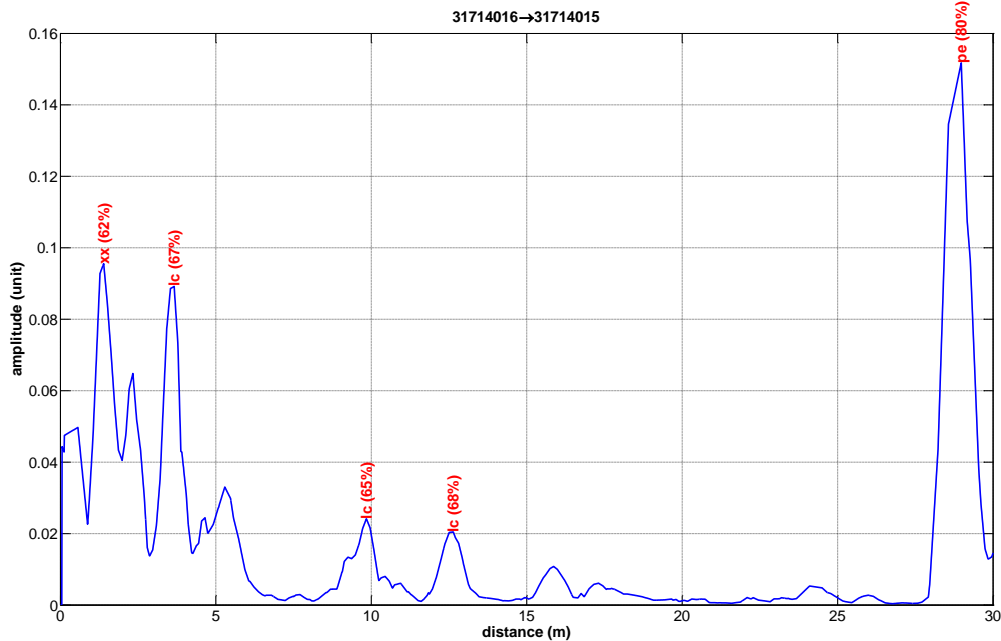
3.66 : lc (crack, infiltration)

9.84 : lc (crack, infiltration)

12.64 : lc (missing pieces, crack, displacement)

AUTO CONDITION GRADE – Red

Comment – GIS pipe length = 32m. CCTV recommended to investigate poor conditions reported to be associated with lateral connections and multiple responses in first 5m.

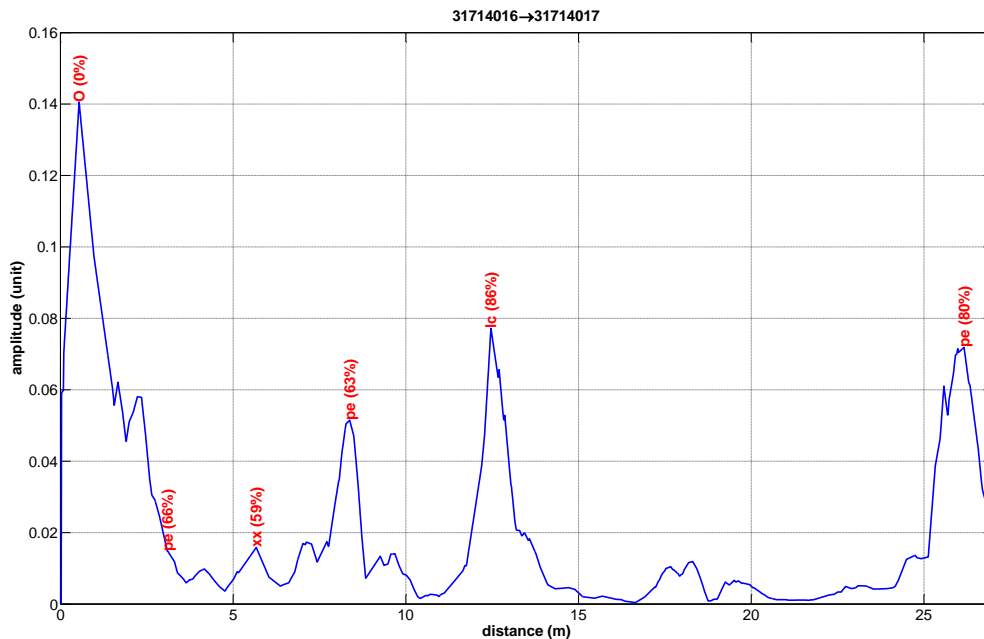
12.46 : lc (crack, infiltration)

AUTO CONDITION GRADE – Red (manual override to Amber)

COMMENT – GIS pipe length 29.5m. Condition is just into the 'Red' zone but appears serviceable. Re-survey after 1 year is recommended to assess whether pipe has deteriorated further.

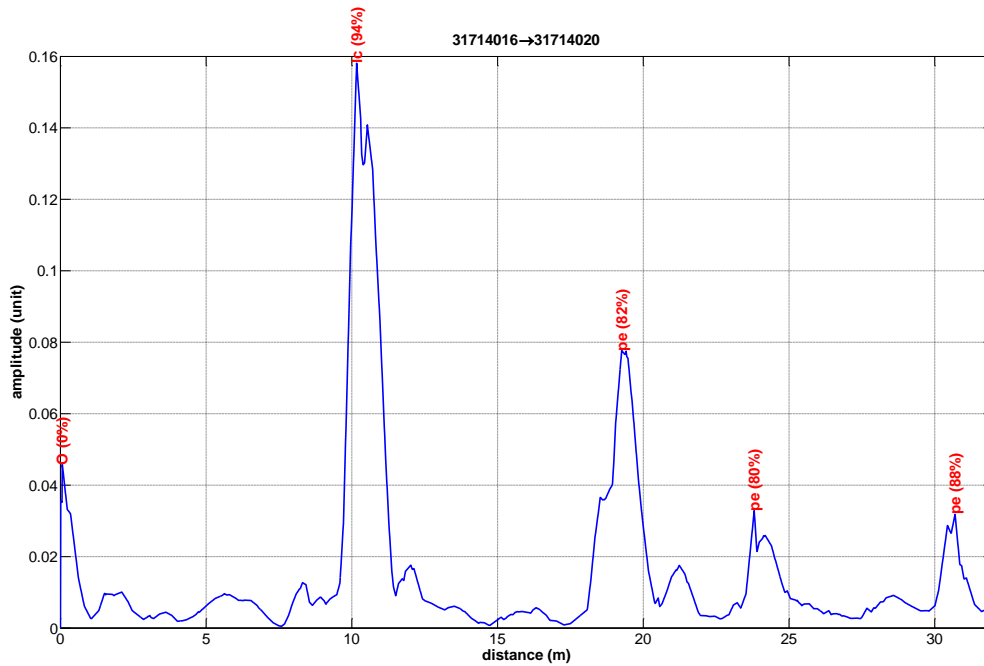
10.16 : lc

AUTO CONDITION GRADE – Green

COMMENT – GIS pipe length = 31m. The response from the target manhole is significantly attenuated and there are continuous low-level responses along the pipe. However the pipe appears serviceable and further survey is not recommended.

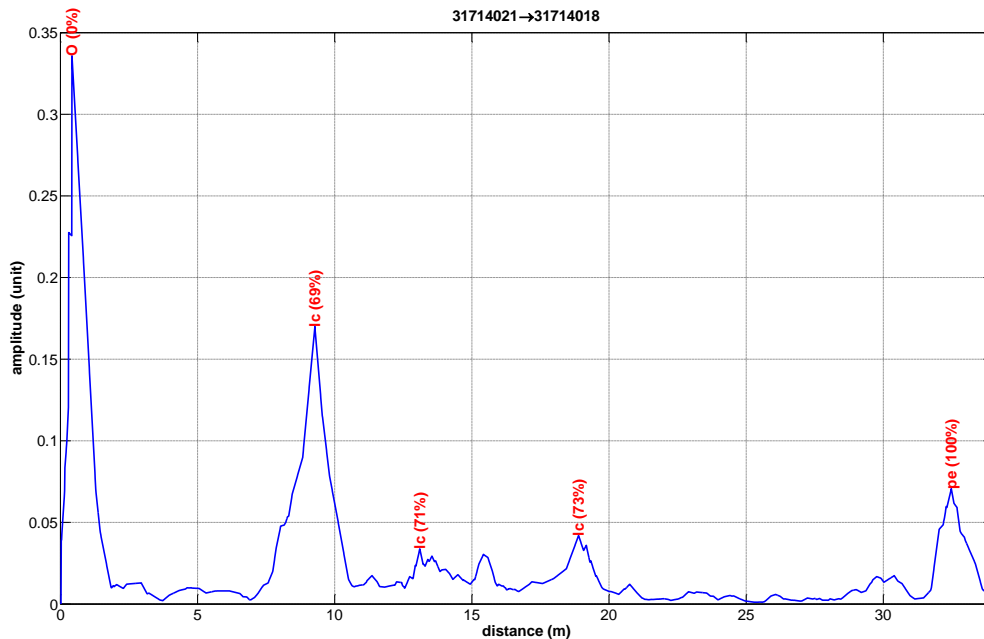
9.28 : lc (crack, infiltration)

18.89 : lc (crack, infiltration)

AUTO CONDITION GRADE – Red (manual override to Amber)

COMMENT – GIS pipe length = 35m. Energy level calculated by the system is marginally in the red zone but this is affected by the large incident pulse and an ‘Amber’ classification has been applied. It is recommended that the pipe should be logged for resurvey after an appropriate interval.

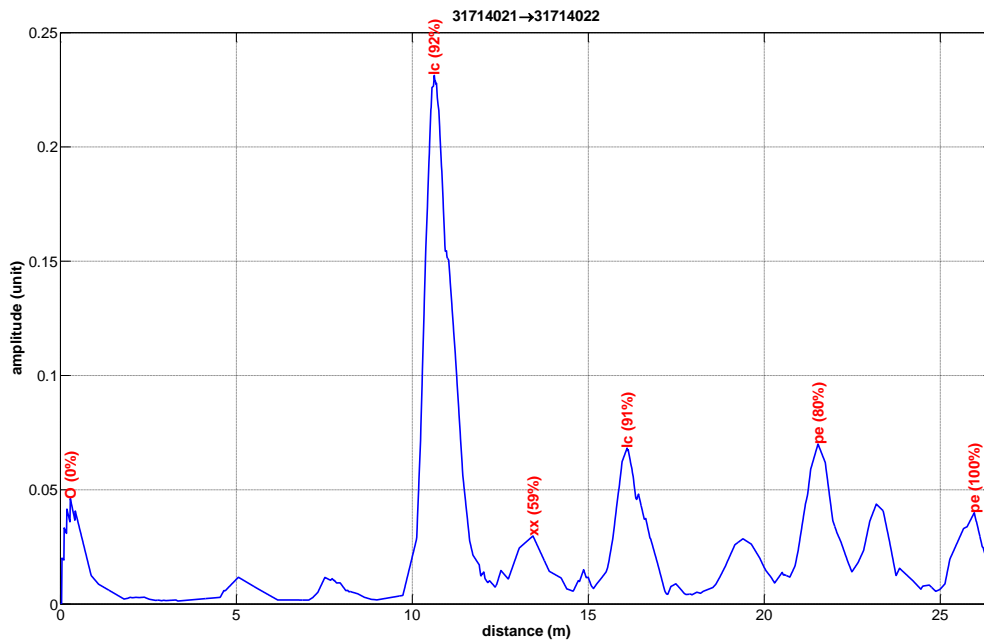
10.62 : lc (crack, infiltration)

16.1 : lc (crack, infiltration)

AUTO CONDITION GRADE – Red

COMMENT – GIS pipe length = 26m. CCTV is recommended.

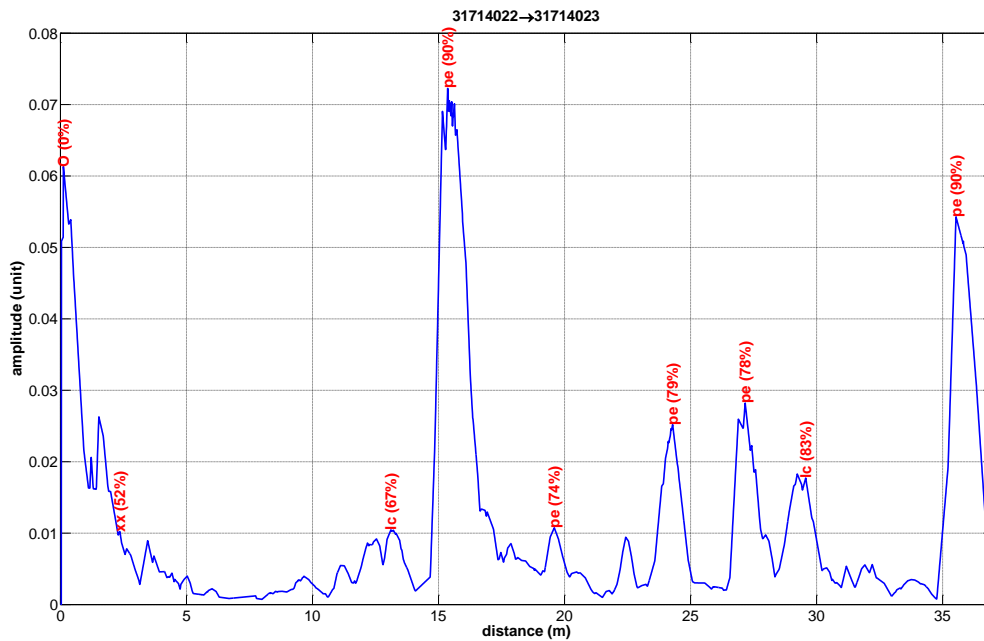
- 1 : O (0%) at 0.12m
- 2 : xx (52%) at 2.36m
- 3 : lc (67%) at 13.11m
- 4 : pe (90%) at 15.36m
- 5 : pe (74%) at 19.59m
- 6 : pe (79%) at 24.29m
- 7 : pe (78%) at 27.17m
- 8 : lc (83%) at 29.57m
- 9 : pe (90%) at 35.53m

15.36 : lc (crack, infiltration)

AUTO CONDITION GRADE – Amber

COMMENT – GIS pipe length = 36m. Pipe appears serviceable but with potential for deterioration. Log for reinspection after an appropriate interval.

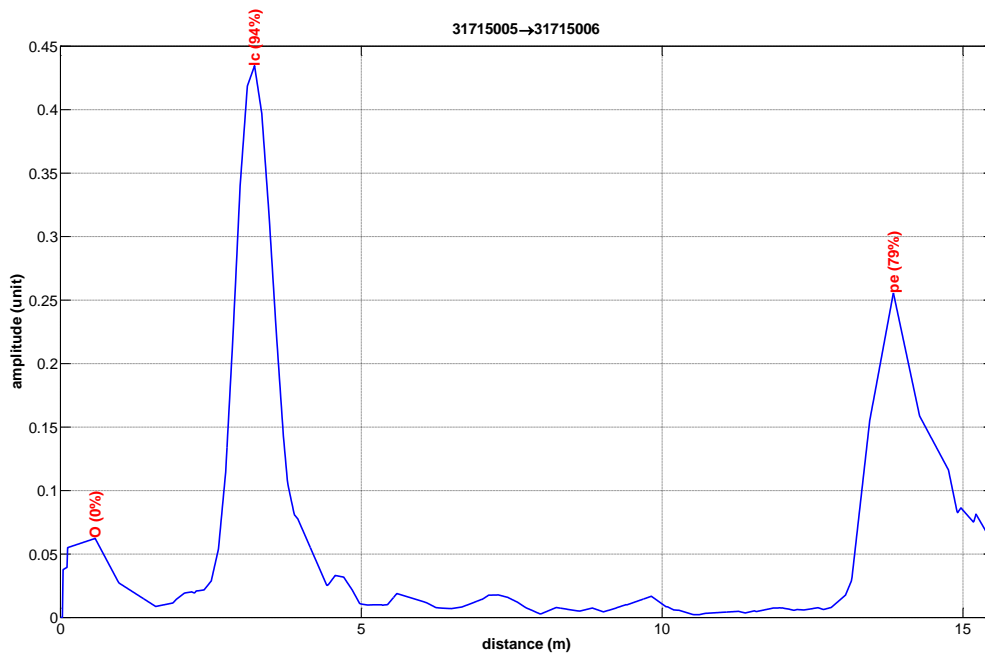
3.23 : lc (crack, infiltration)

AUTO CONDITION GRADE – Amber

COMMENT – GIS pipe length = 14.5m. Pipe appears serviceable but is deteriorating. Log for resurvey after an appropriate period.

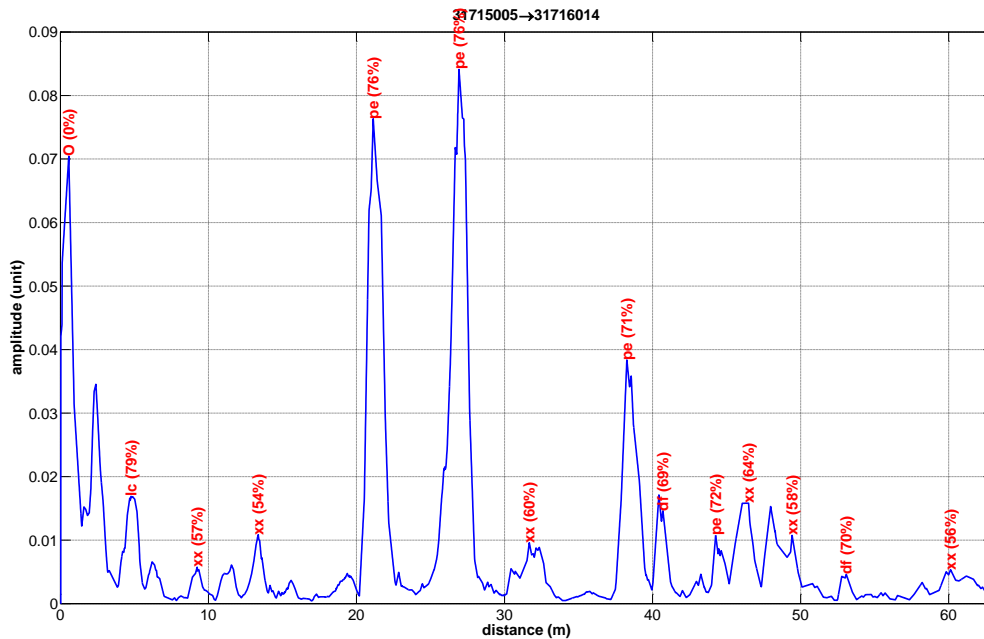
- 1 : O (0%) at 0.57m
- 2 : lc (79%) at 4.77m
- 3 : xx (57%) at 9.24m
- 4 : xx (54%) at 13.36m
- 5 : pe (76%) at 21.13m
- 6 : pe (76%) at 26.92m
- 7 : xx (60%) at 31.67m
- 8 : pe (71%) at 38.26m
- 9 : df (69%) at 40.7m
- 10 : pe (72%) at 44.26m
- 11 : xx (64%) at 46.48m
- 12 : xx (58%) at 49.42m
- 13 : df (70%) at 53.08m
- 14 : xx (56%) at 60.13m

4.77 : lc
9.24 : xx
13.36 : xx
21.13 : lc (crack, infiltration)
26.92 : lc (crack, infiltration)
31.67 : xx
38.26 : lc (crack, infiltration)
40.7 : lc (crack, infiltration)
44.26 : lc (crack, infiltration)
46.48 : xx
49.42 : xx
53.08 : lc (crack, infiltration)
60.13 : pe
ENERGY : 25
PE : 0.01
DE ratio : 2.96
AUTO CONDITION GRADE – Red

COMMENT – GIS pipe length = 61m. CCTV is recommended.
