Demonstration of Innovative Sewer System Inspection Technology SewerBatt™

Srinivas Panguluri
Shaw Environmental & Infrastructure, Inc.
Cincinnati, OH

Contract No. EP-C-11-006

Daniel Murray
Water Supply and Water Resources Division
U.S. Environmental Protection Agency
Cincinnati, OH 45268

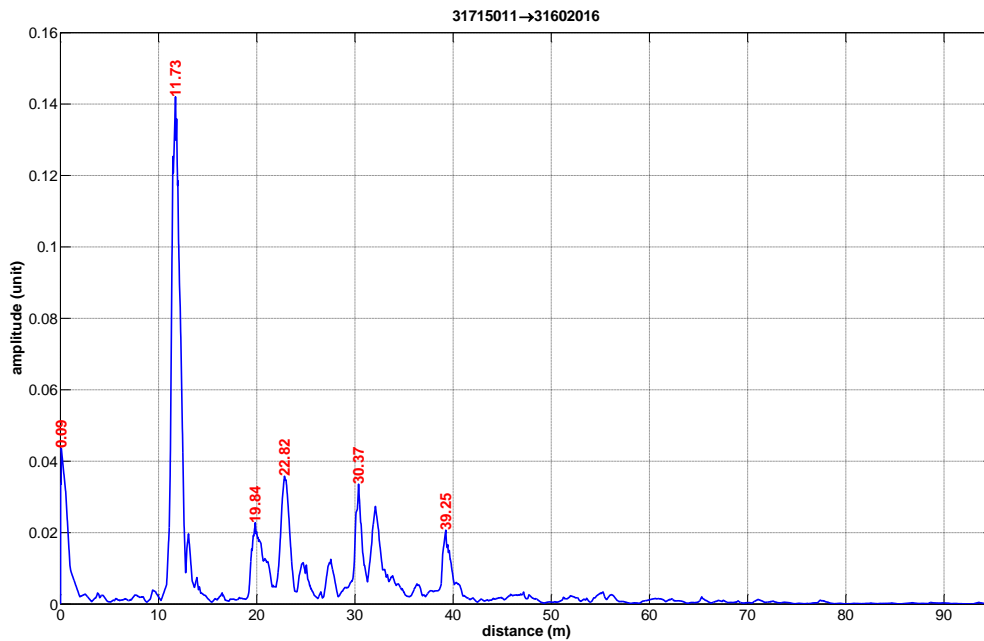
AUTO CONDITION GRADE – Red by manual assessment.

COMMENT – GIS pipe length = 92m. CCTV is recommended.

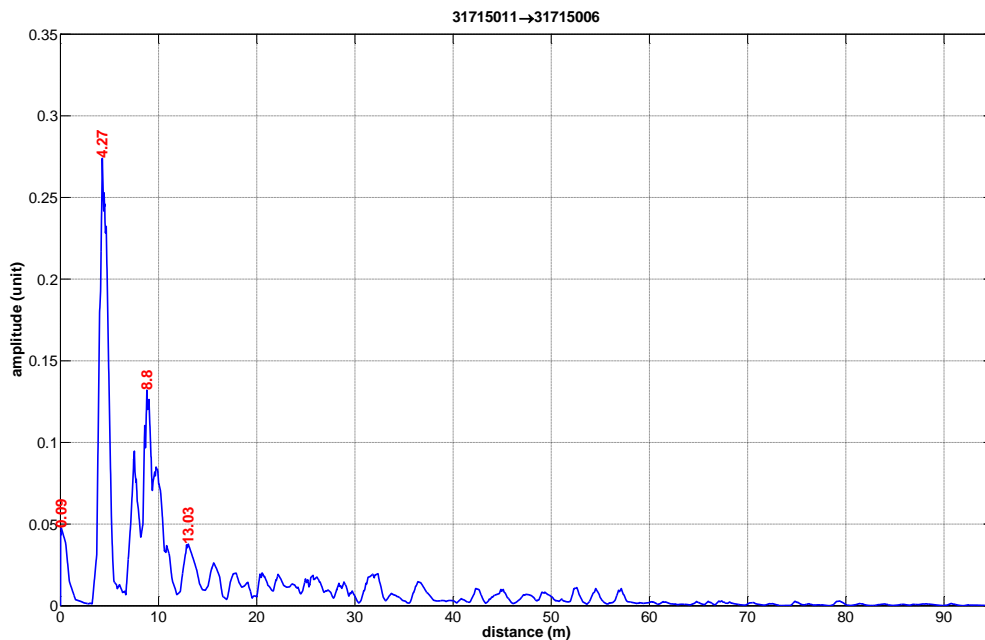
AUTO CONDITION GRADE – Red by manual assessment.

COMMENT – GIS pipe length = 92m. CCTV is recommended.

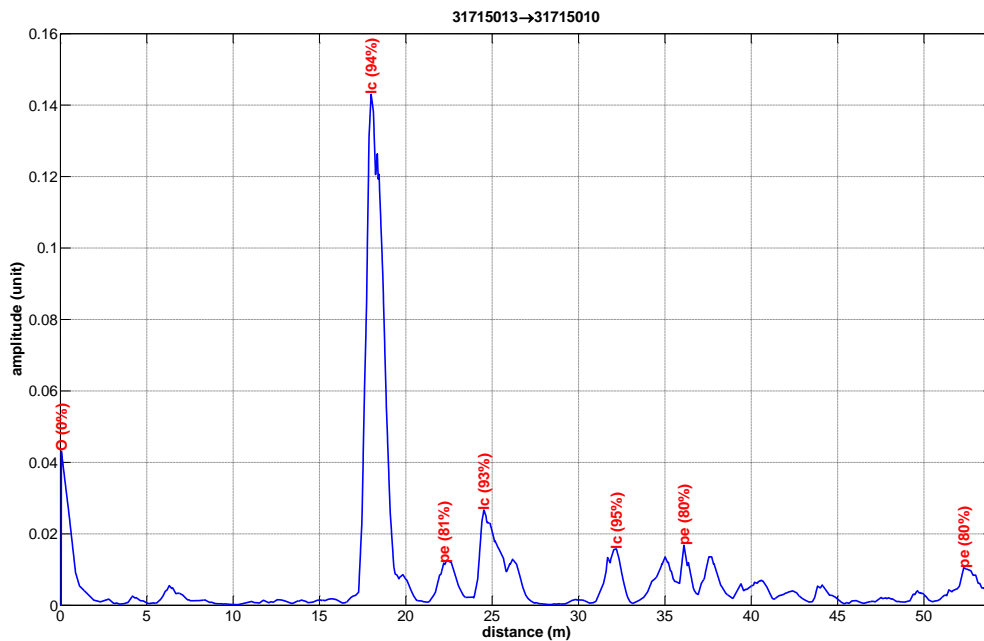
- 1 : O (0%) at 0.05m
- 2 : lc (94%) at 17.99m
- 3 : pe (81%) at 22.2m
- 4 : lc (93%) at 24.52m
- 5 : lc (95%) at 32.19m
- 6 : pe (80%) at 36.1m
- 7 : pe (80%) at 52.3m

17.99 : lc

22.2 : lc (crack, infiltration)

24.52 : lc (crack, infiltration)

32.19 : lc (crack, infiltration)

AUTO CONDITION GRADE – Red

COMMENT – GIS pipe length = 52m. CCTV is recommended.

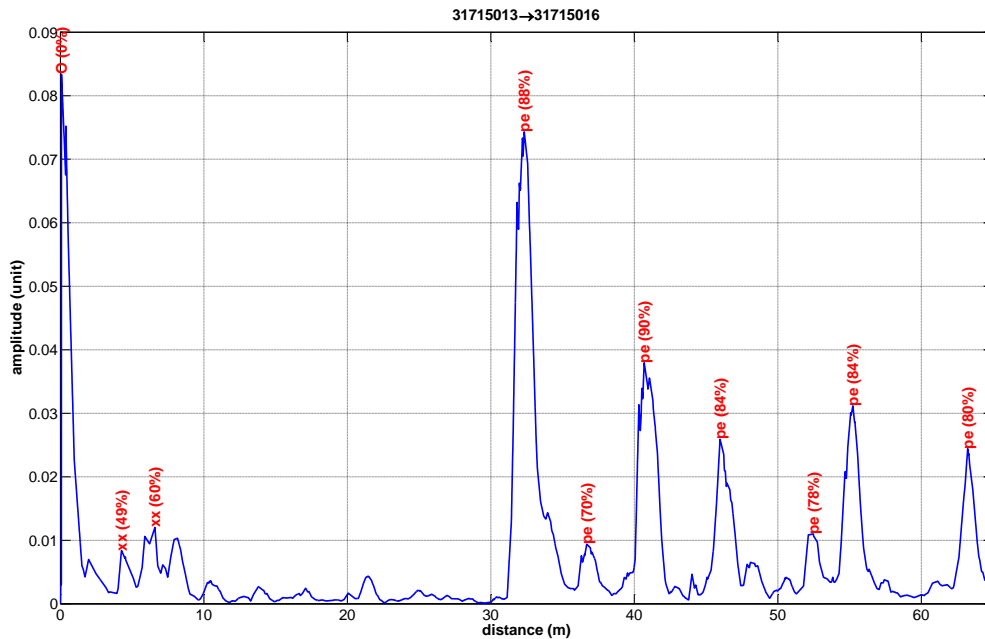
- 1 : O (0%) at 0.08m
- 2 : xx (49%) at 4.26m
- 3 : xx (60%) at 6.59m
- 4 : pe (88%) at 32.33m
- 5 : pe (70%) at 36.68m
- 6 : pe (90%) at 40.68m
- 7 : pe (84%) at 45.97m
- 8 : pe (78%) at 52.47m
- 9 : pe (84%) at 55.23m
- 10 : pe (80%) at 63.23m

40.68 : lc
45.97 : lc
52.47 : xx
55.23 : lc
63.23 : pe (Good)
ENERGY : 31
PE : 0.02
DE ratio : 0.49
AUTO CONDITION GRADE – Amber

COMMENT – GIS pipe length = 63m. The pipe is serviceable but has potential to deteriorate. It is recommended that the pipe be logged for reinspection after an appropriate interval.

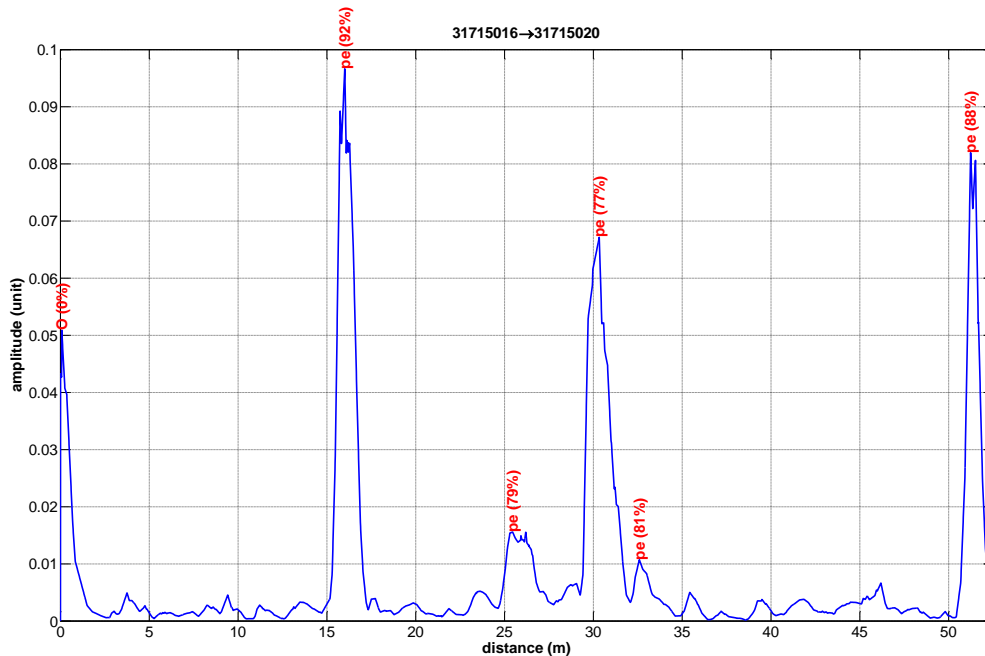
16.01 : lc (crack, infiltration)

30.33 : lc (crack, infiltration)

AUTO CONDITION GRADE – Green (manual override to Amber due nature of reported defects)

COMMENT – GIS pipe length = 50.5m. Pipe is serviceable but has potential to deteriorate. It is recommended that it should be logged for reinspection after an appropriate interval.

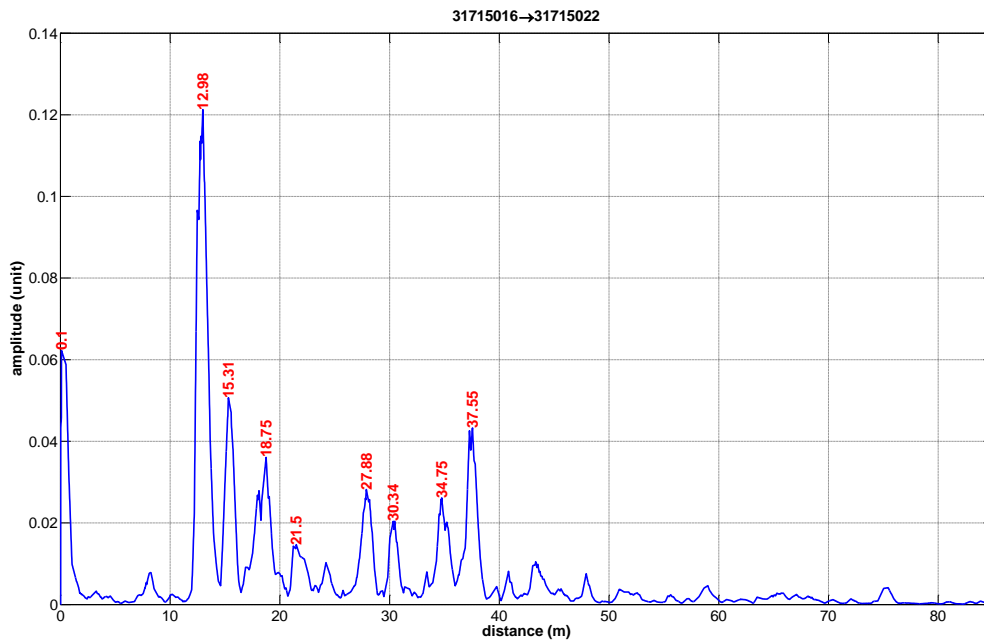
AUTO CONDITION GRADE – Red by manual assessment.

COMMENT – GIS pipe length = 83m. CCTV is recommended.

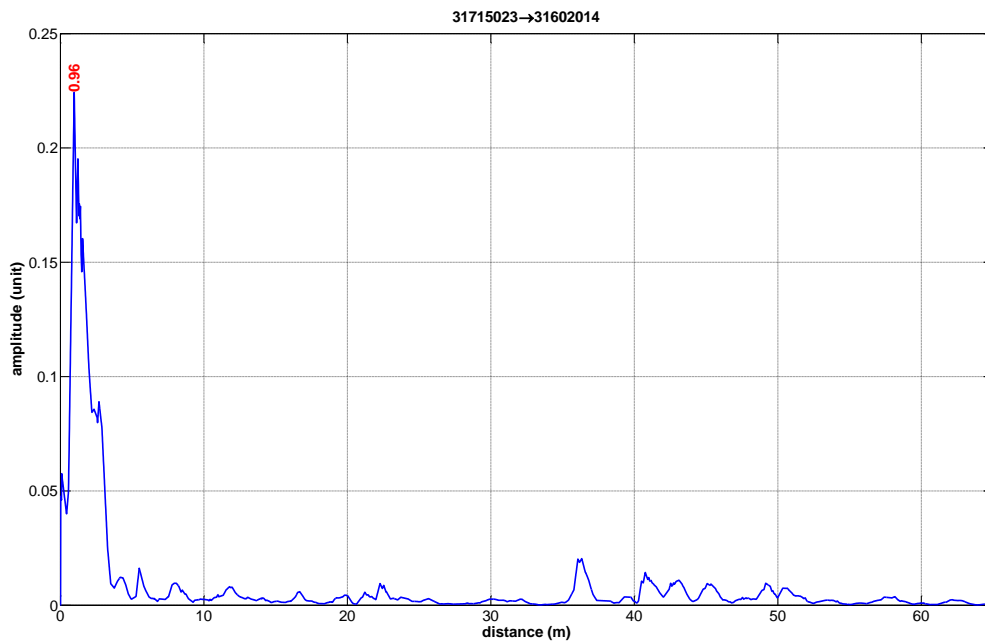
AUTO CONDITION GRADE – Red by manual assessment.

COMMENT – GIS pipe length = 62m. CCTV is recommended.

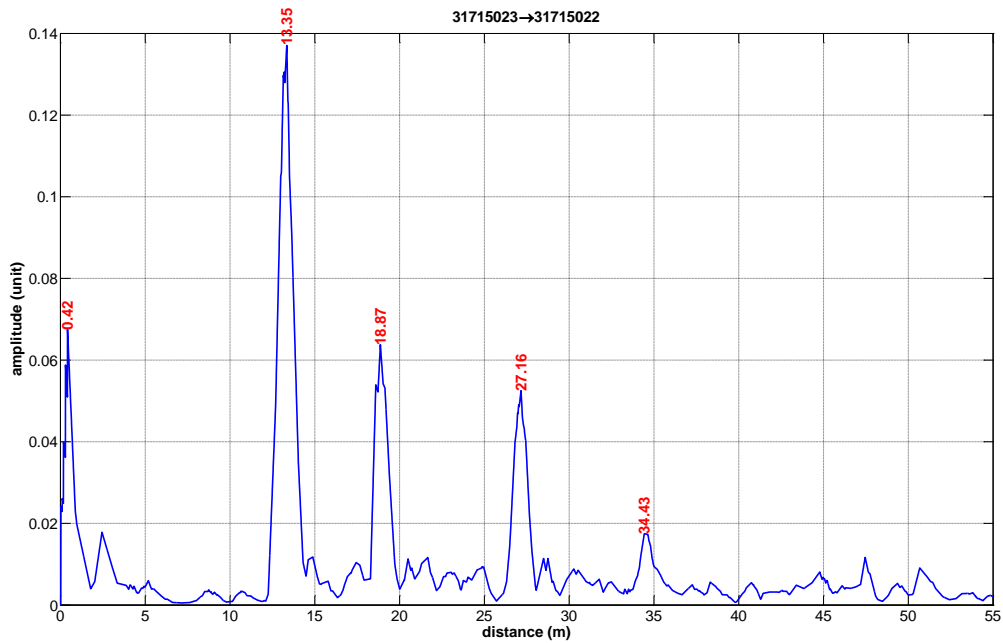
AUTO CONDITION GRADE – Red by manual assessment.

COMMENT – GIS pipe length = 51.5m. CCTV is recommended.

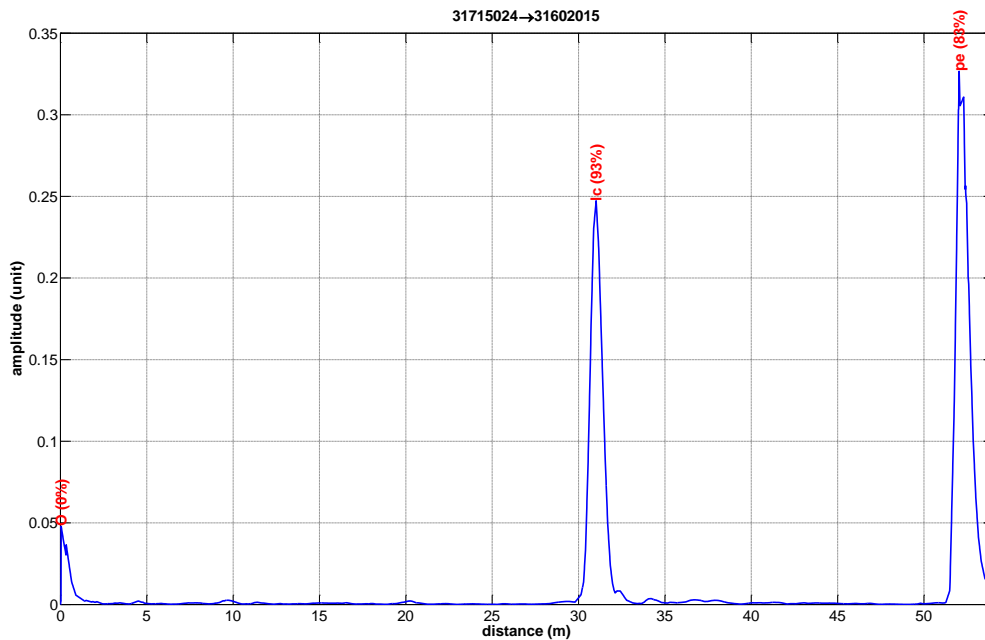
31.02 : lc

AUTO CONDITION GRADE – Green

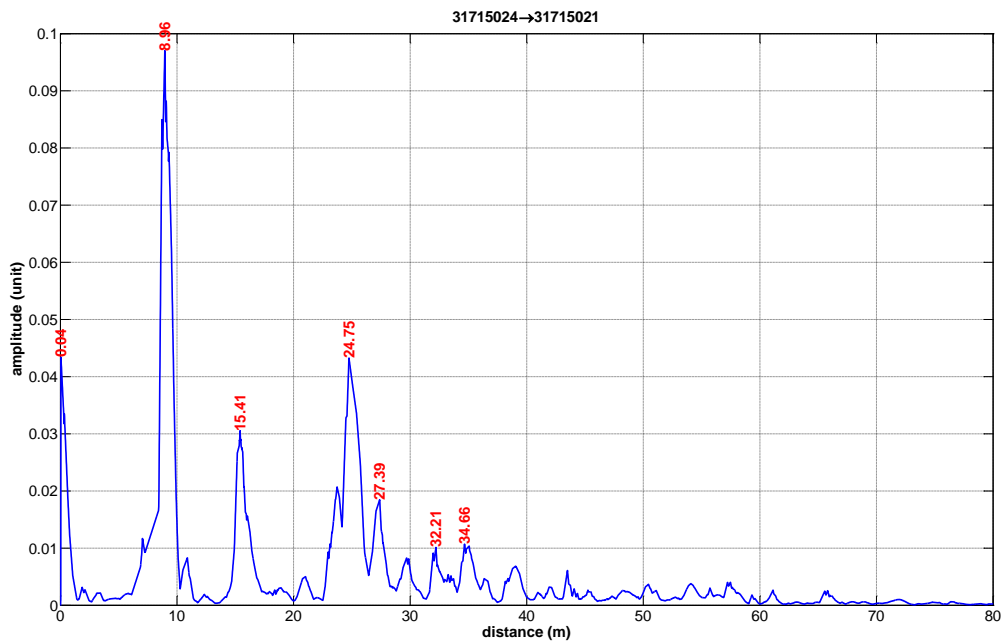
AUTO CONDITION GRADE – Red by manual assessment.

COMMENT – GIS pipe length = 75.5m. CCTV is recommended.

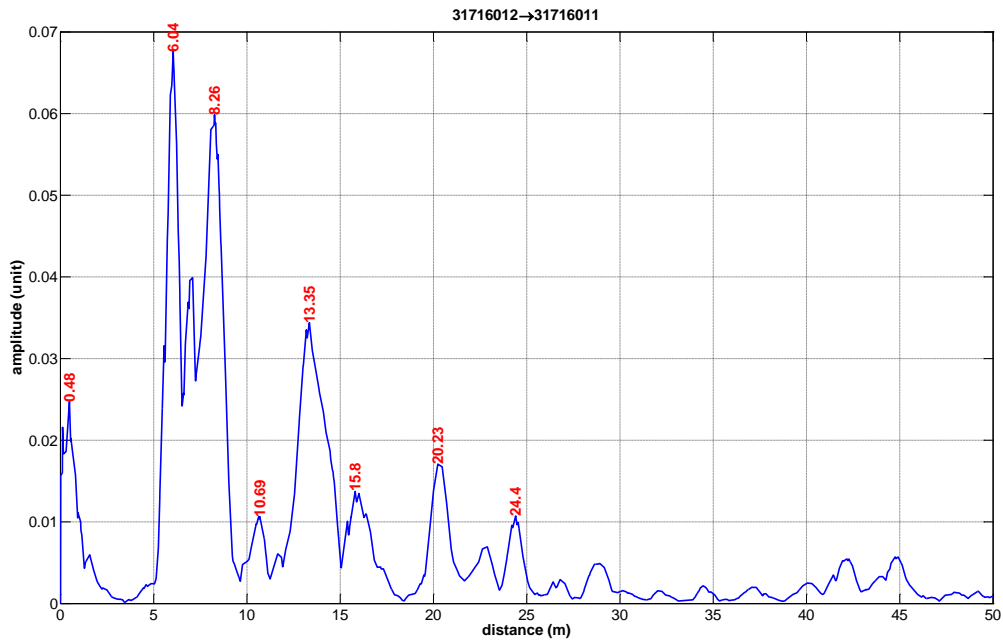
AUTO CONDITION GRADE – Red by manual assessment.

COMMENT – GIS pipe length = 46m. CCTV is recommended.

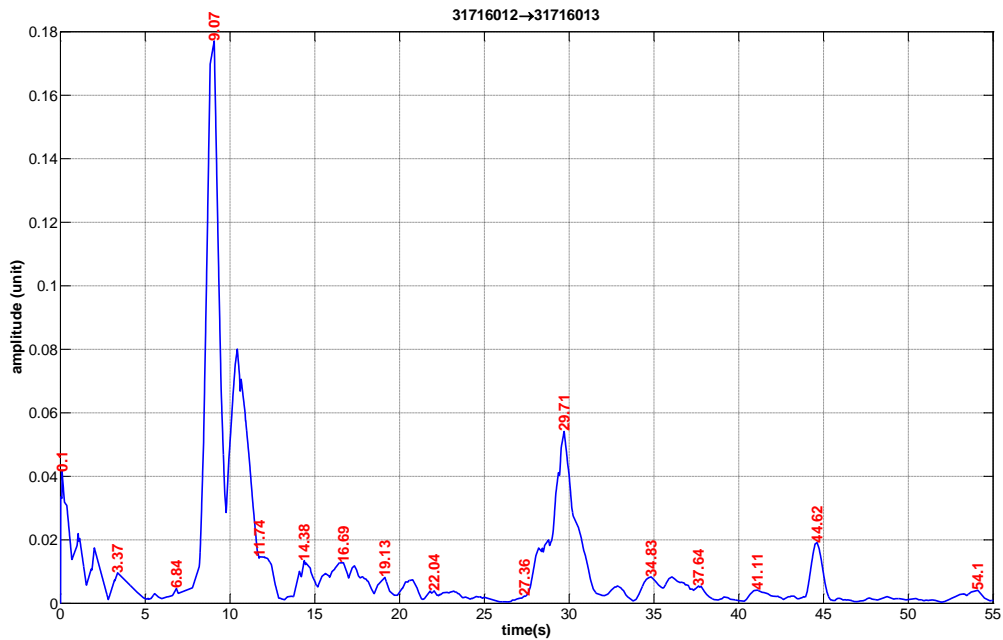
- 3.37 : xx
- 6.84 : xx
- 9.07 : lc (good)
- 11.74 : lc (Good)
- 14.38 : xx
- 16.69 : xx
- 19.13 : xx
- 22.04 : xx
- 27.36 : xx
- 29.71 : xx
- 34.83 : xx
- 37.64 : xx
- 41.11 : xx
- 44.62 : xx
- 54.1 : pe (Good)

AUTO CONDITION GRADE – Red (Energy is only just in the ‘Red’ zone and the energy loss appears to be caused mainly by low level distributed defects but CCTV is recommended on a precautionary basis)

COMMENT – GIS length = 53.5m. CCTV is recommended.

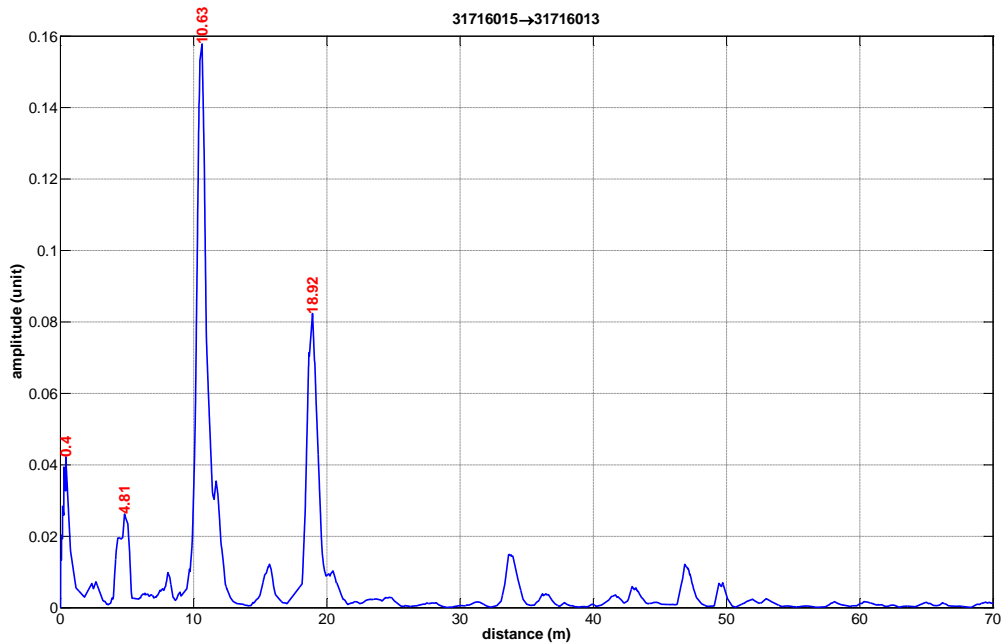
AUTO CONDITION GRADE – Red by manual assessment.

COMMENT – GIS pipe length = 68m. CCTV is recommended.

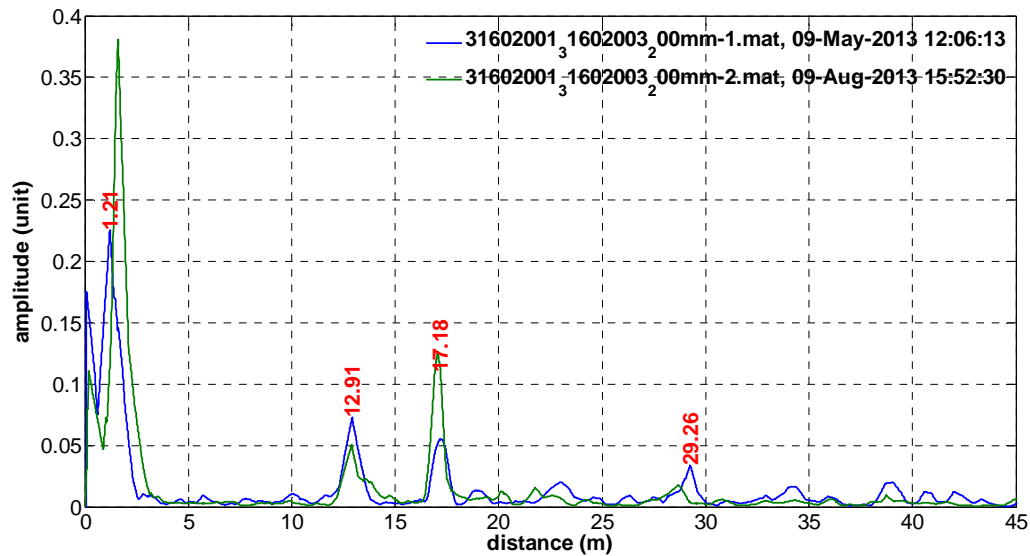
Figure 1

The subsequent test was performed using the production unit and small sensor head and a chirp excitation signal. It displays a large response at 1.57m. This may be due to a connection close to the location of the sensor head. This appears to have given a strong response, reducing the energy available for onward transmission; hence most subsequent peaks are reduced in amplitude compared to the original test. In this case there is however sufficient energy recorded throughout the length of the pipe for a satisfactory assessment of condition to be made.

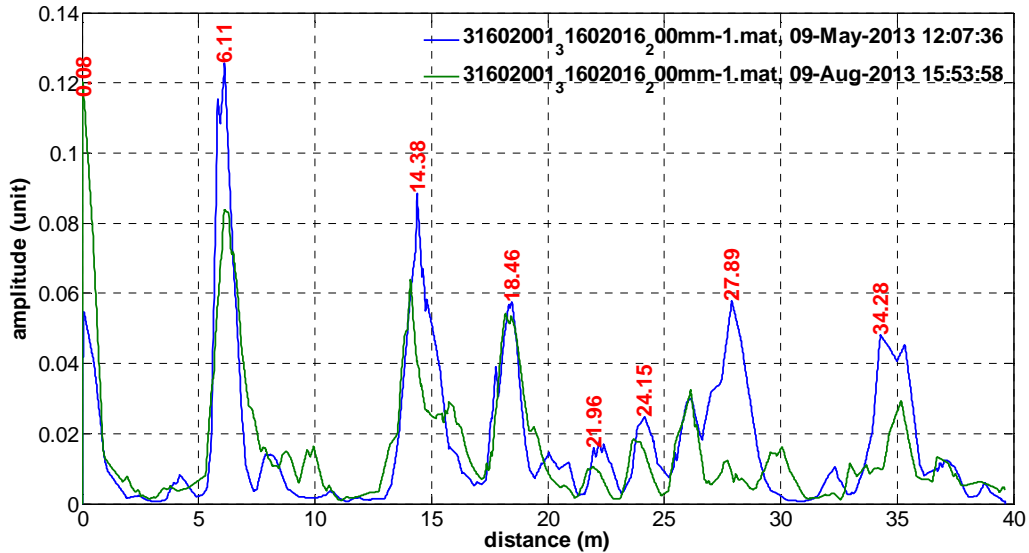
Figure 2

The subsequent test was performed using the production unit and small sensor head and a chirp excitation signal. It displays a large incident pulse at 0.03m, indicative of poor testing conditions. This has reduced the energy available for onward transmission, hence subsequent peaks are reduced in amplitude compared to the original test. In this case there is however sufficient energy recorded throughout the length of the pipe for a satisfactory assessment of condition to be made.

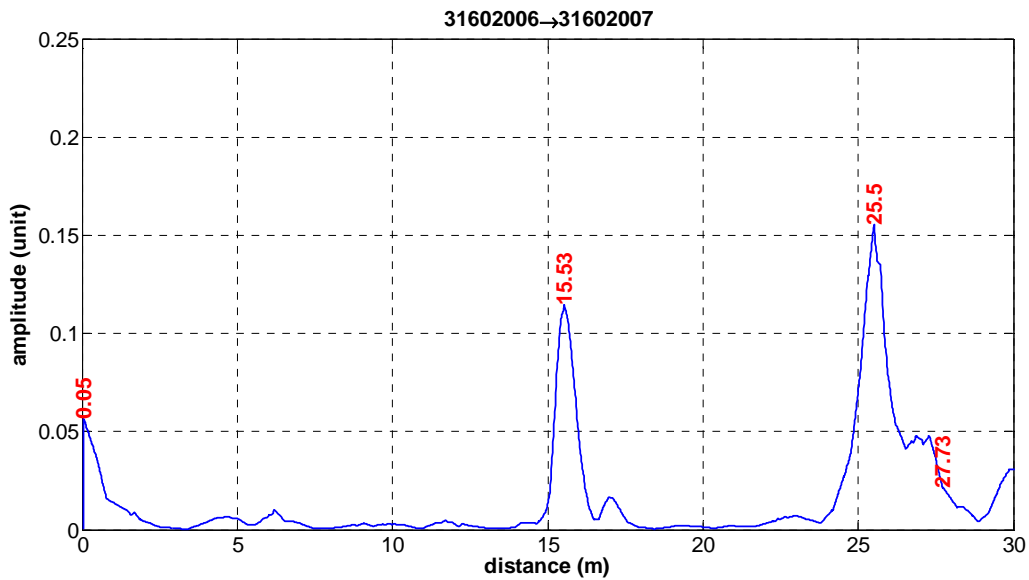
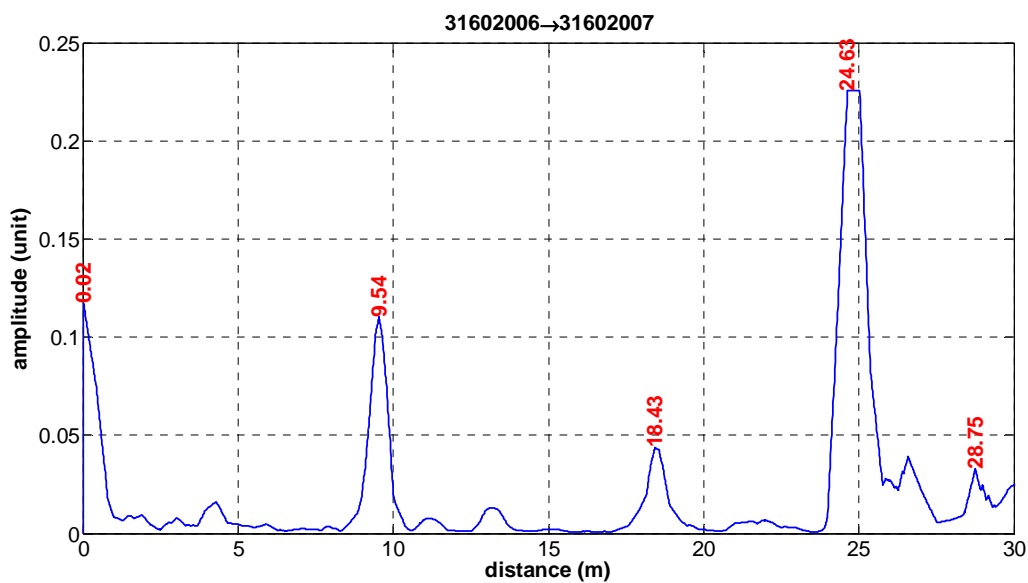
Figure 3 - Original test on May 9th 2013 (31602006_31602007_200mm-1)

Figure 4 - Subsequent test on August 9th 2013 (31602006_31602007_200mm-2)

The subsequent test was performed using the production unit and small sensor head and a chirp excitation signal. Although the file names indicate that the tests were carried out in the same direction, the results clearly show that the tests were done in opposite directions and are therefore not suitable for direct comparison (ref Comparison 4). This can be seen by noting that in the original test there was a strong response at 15.53m (9.97m from the target manhole) which correlates strongly with the strong response at 9.54m in the subsequent test, clearly demonstrating that the readings have been taken in opposite directions and therefore cannot be compared.

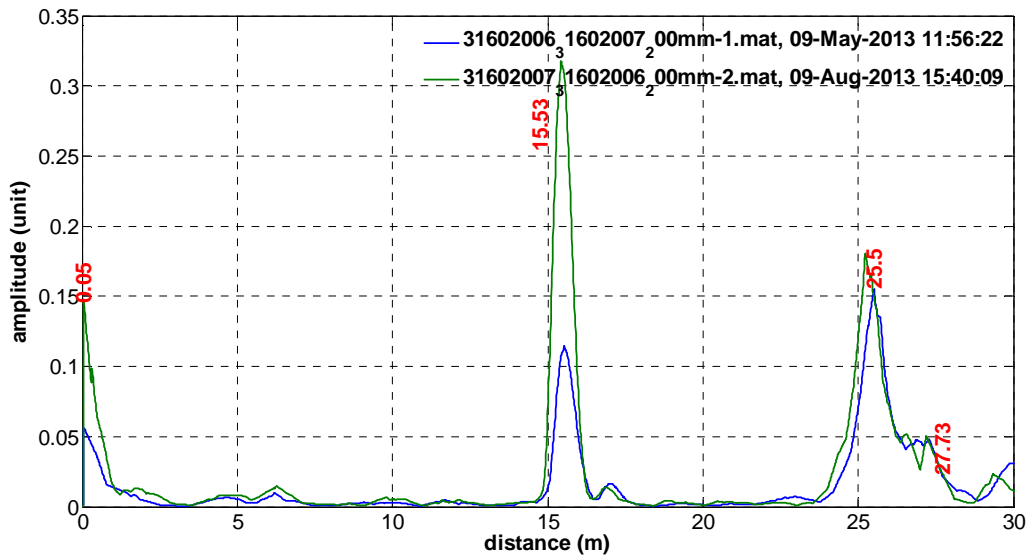
Figure 5

The subsequent test was performed using the production unit and small sensor head and a chirp excitation signal. Although the file references indicate the contrary, it is clear that these two tests were conducted in the same direction (ref Comparison 3). The strengths of the responses at 15.07m and from the pipe end at 24.64m are both greater than the original results, indicating that improved signal penetration has been achieved.

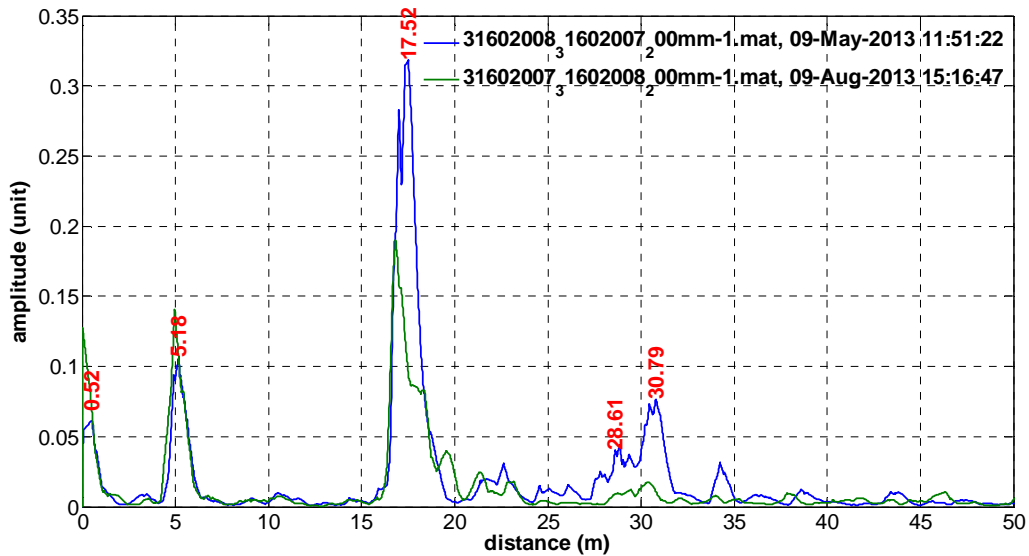
Figure 6

The subsequent test was performed using the production unit and small sensor head and a chirp excitation signal. Filenames show references reversed but inspection of the test results, with a close match in the distances of the observed peaks, shows that the tests were in fact carried out in the same direction. The larger incident pulse at 0.02m in the subsequent test indicates poor testing conditions and has absorbed acoustic energy, thus reducing the amplitude of the response from the rest of the pipe.

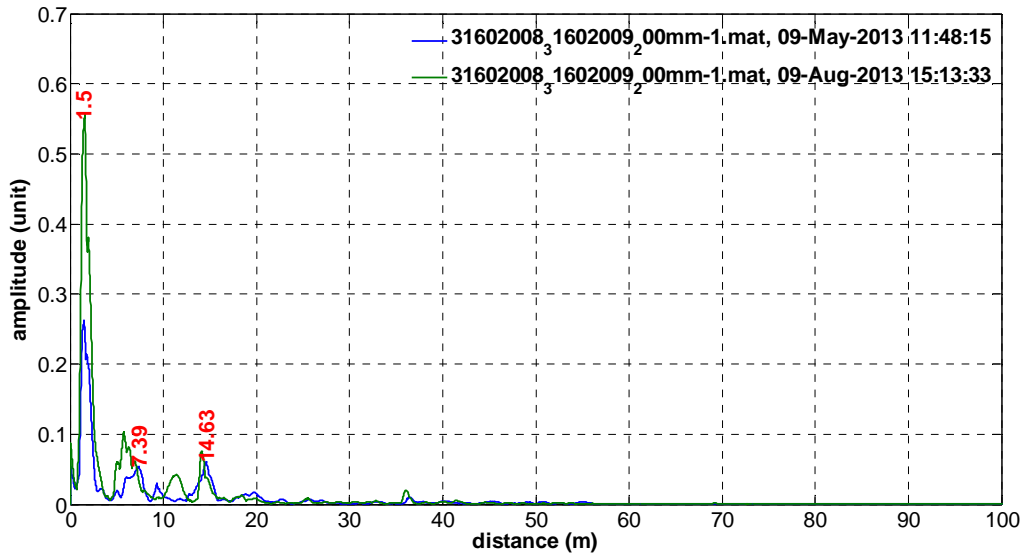
Figure 7

The subsequent test was performed using the production unit and small sensor head and a chirp excitation signal. It displays a large response at 1.54m. This may be due to a connection close to the location of the sensor head. This appears to have given a strong response, although energy available for onward transmission is still greater than the original test. The following figures compare the response from the target manhole 31602009.

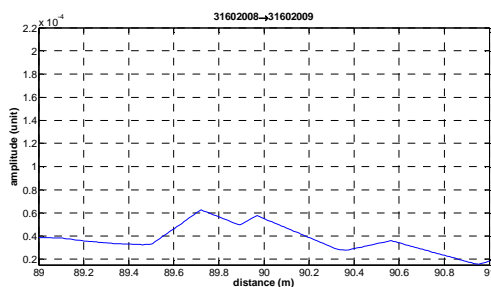
Figure 8

Response from target manhole 31602009 from the original test on May 9th 2013 (31602008_31602009_200mm-1)

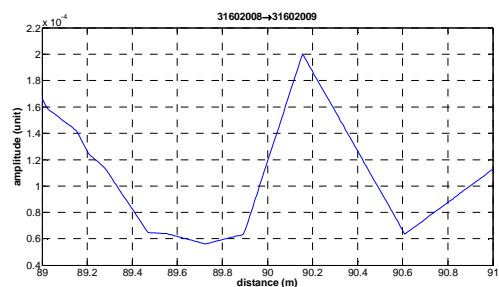
Figure 9

Response from target manhole 31602009 from the subsequent test on August 9th 2013 (31602008_31602009_200mm-1), showing improved definition of the response despite the low amplitude of the signal.

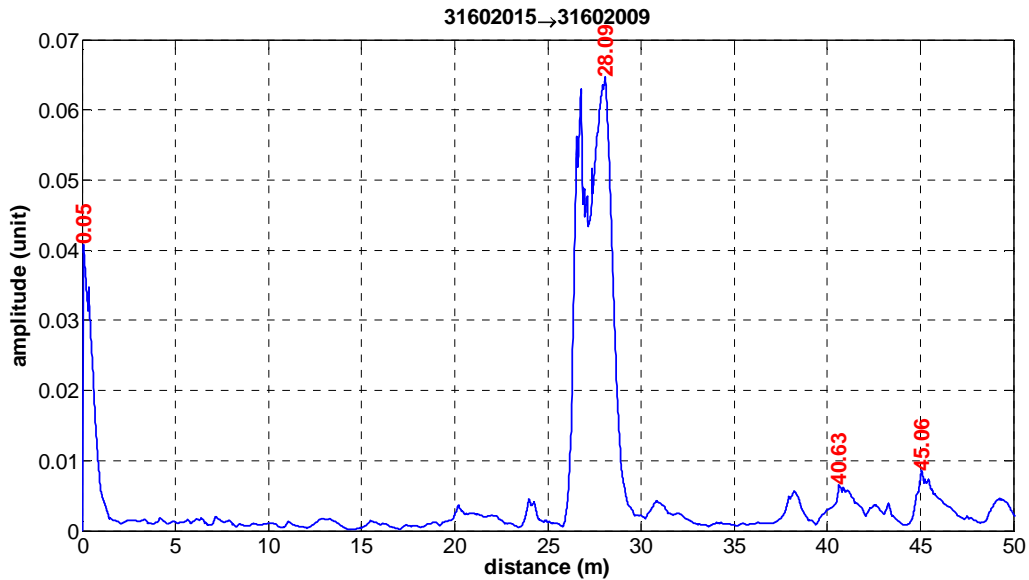
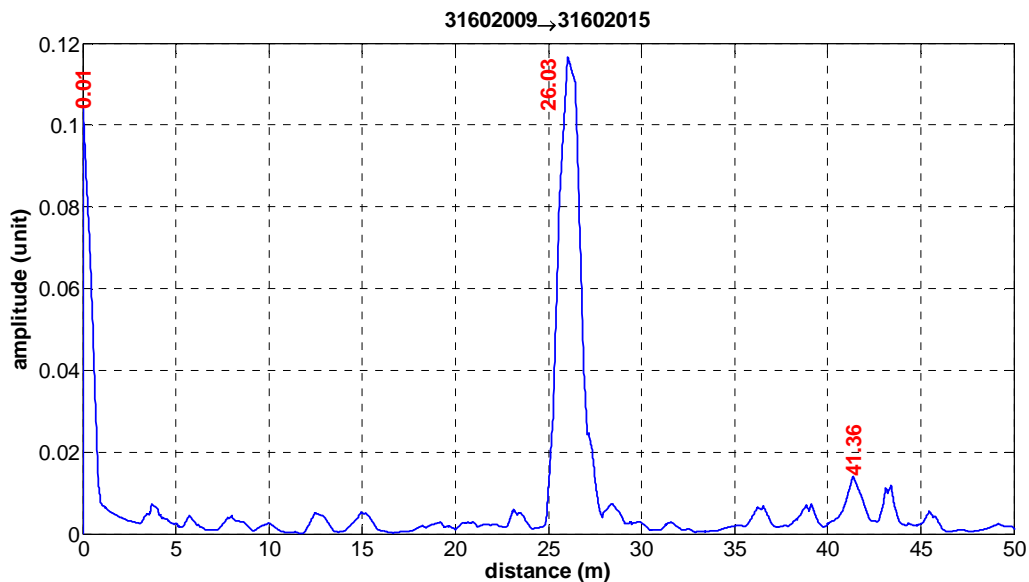
Figure 10 - Original test on May 9th 2013 (31602015_31602009_200mm-1)

Figure 11 - Subsequent test on August 9th 2013 (31602009_31602015_200mm-2)

Filenames show references reversed and the test results appear to confirm that the tests were in fact carried out in the opposite direction since the difference in distance to the large response at 28.09m/26.03m is too large to admit otherwise and the shapes are quite different also. Consequently the results are not suitable for comparison.

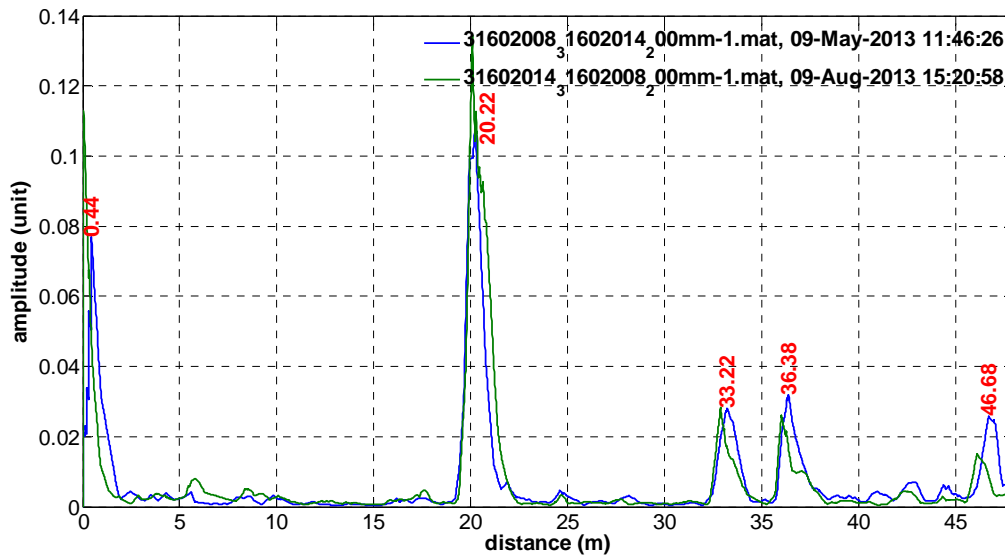
Figure 12

The subsequent test was performed using the production unit and small sensor head and a chirp excitation signal. Filenames show references reversed but test results appear to show the tests were in fact carried out in the same direction. This is evidenced by the close correlation of the various peaks and the distances between them, which are within 4%. The larger incident pulse at 0.04m in the subsequent test indicates poor testing conditions and has absorbed acoustic energy, thus reducing the amplitude of the response from most of the rest of the pipe.

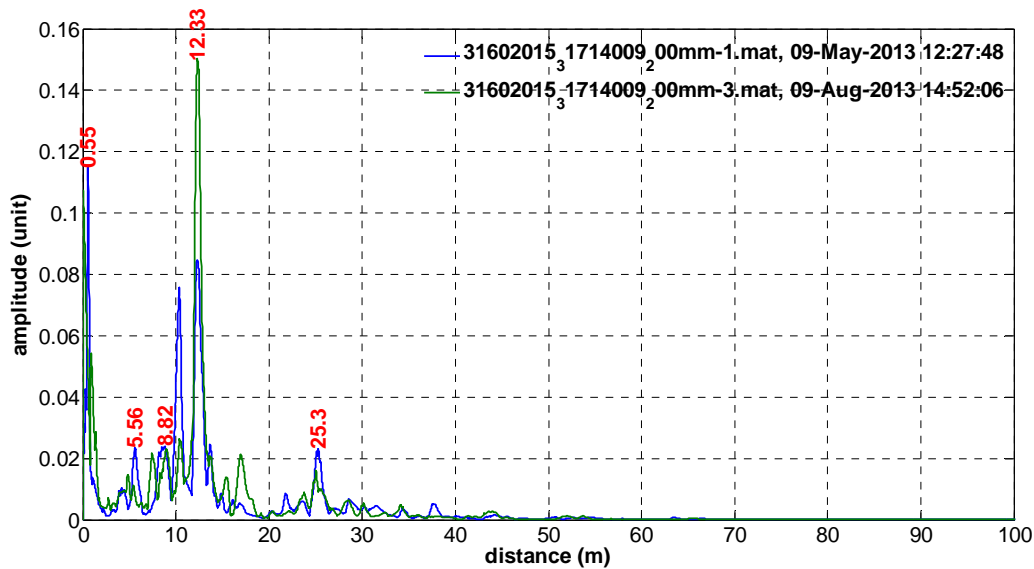
Figure 13

The subsequent test was performed using the production unit and small sensor head and a chirp excitation signal. There are some differences in the two results, and while the response at 12.33m in the subsequent test is larger than the original, the responses from the target manhole 31714009 as shown in the following figures show the subsequent test having a slightly reduced amplitude.

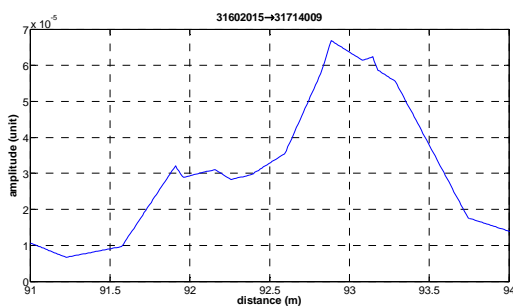
Figure 14

Response from target manhole 31714009 from original test on May 9th 2013 (31602015_31714009_200mm-1)

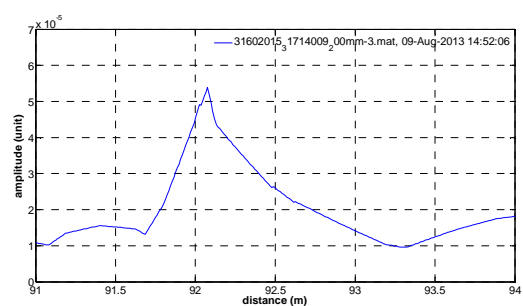
Figure 15

Response from target manhole 31714009 from subsequent test on August 9th 2013 (31602015_31714009_200mm-3)

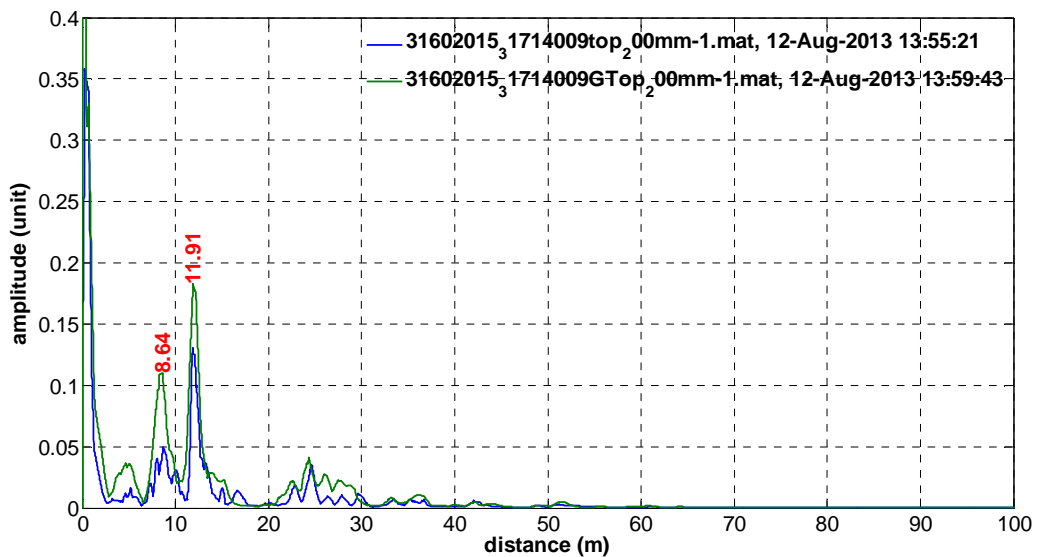
1. Subsequent test on August 12th 2013 using large sensor and chirp excitation (31602015_31714009top_200mm-1.mat)
2. Subsequent test on August 12th 2013 using large sensor and gauss excitation (31602015_31714009GTop_200mm-1.mat)

For these tests a large prototype sensor head with chirp and gauss excitation signal were used. The response is found to be higher in the case of gauss excitation.

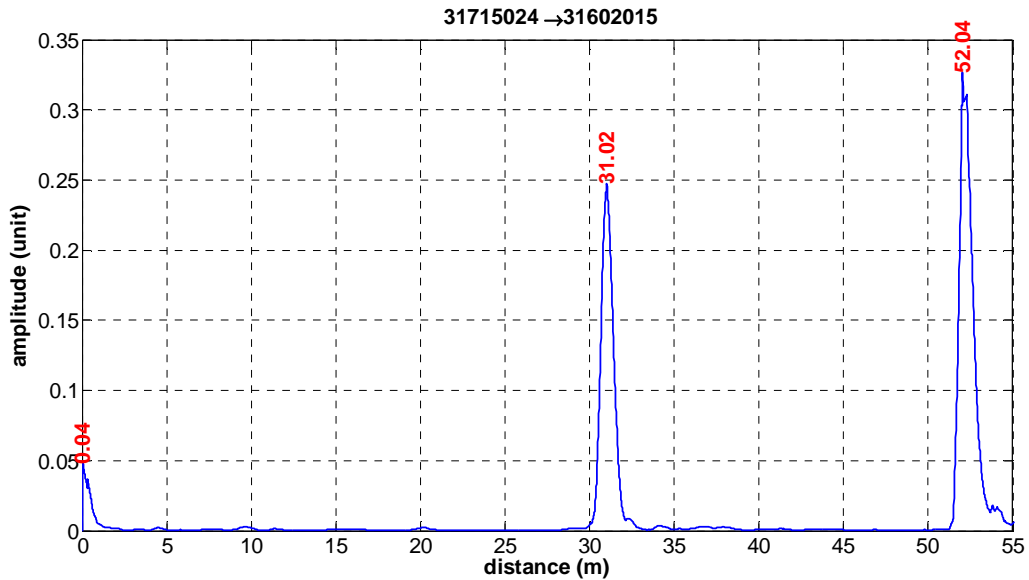
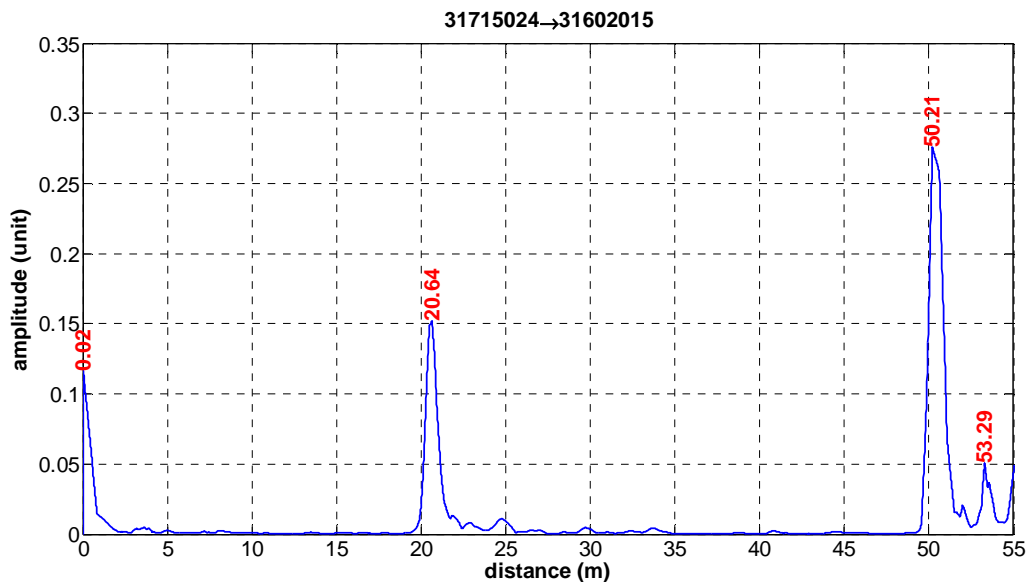
Figure 16 - Original test on May 9th 2013

Figure 17 - Subsequent test on August 9th 2013

It appears that pipe has been tested from the opposite direction. This may be inferred by the different location of the response at 31.02m in the original test and 20.64m in the subsequent test, which are almost identical locations if the tests were reversed as surmised. Since the tests have not been taken in the same direction the results are not comparable.

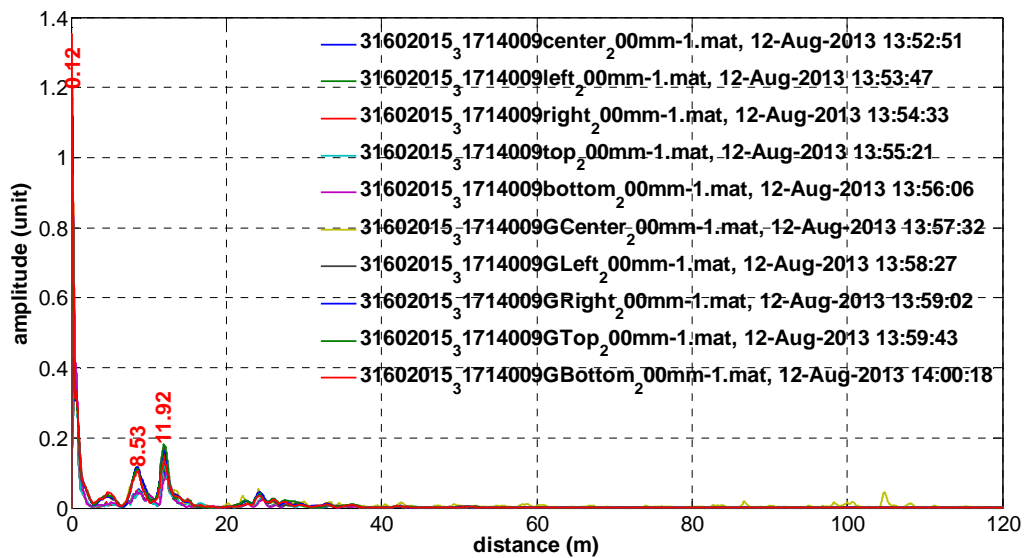
Figure 18 Acoustic responses from pipe section 31602015_31714009 for different sensor position using chirp (first five) and gauss (last five) excitation signal.

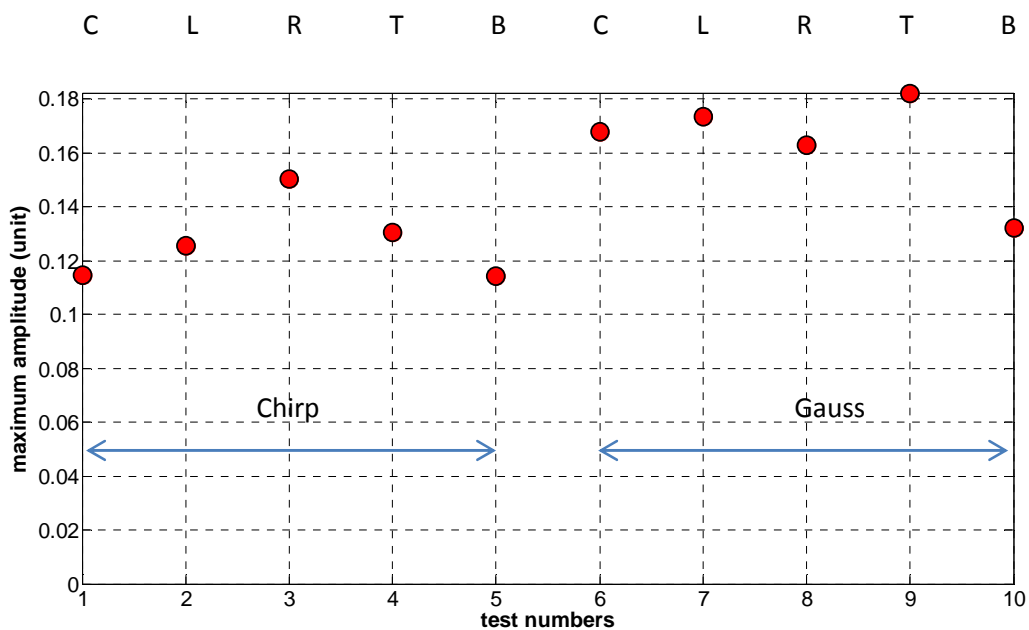
Figure 19 - 31602015_31714009 maximum amplitudes at 11.92m

It can be seen that the responses from the Gauss pulse excitation are slightly higher and generally more consistent than those from the chirp.

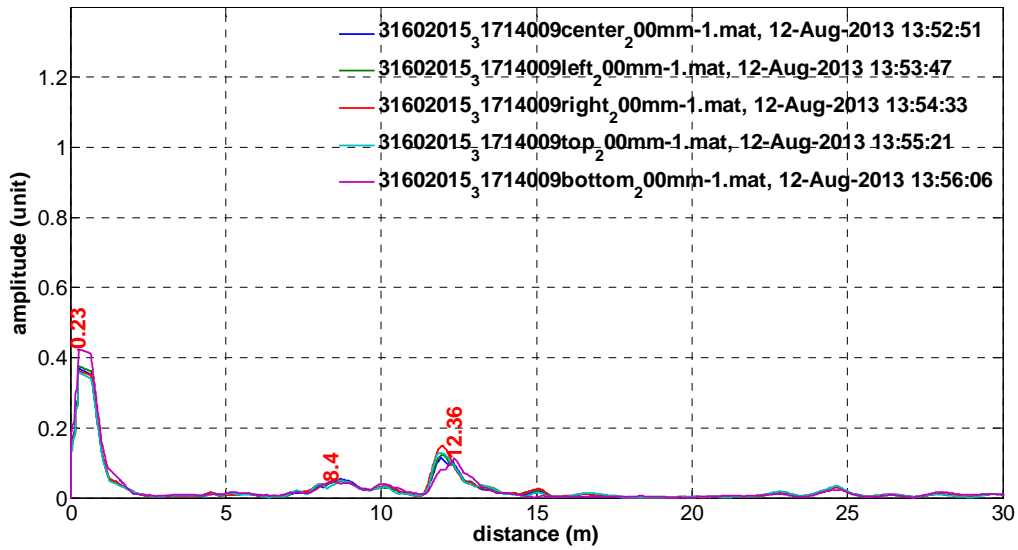
Figure 20 - 31602015_31714009 Chirp excitation, different sensor positions

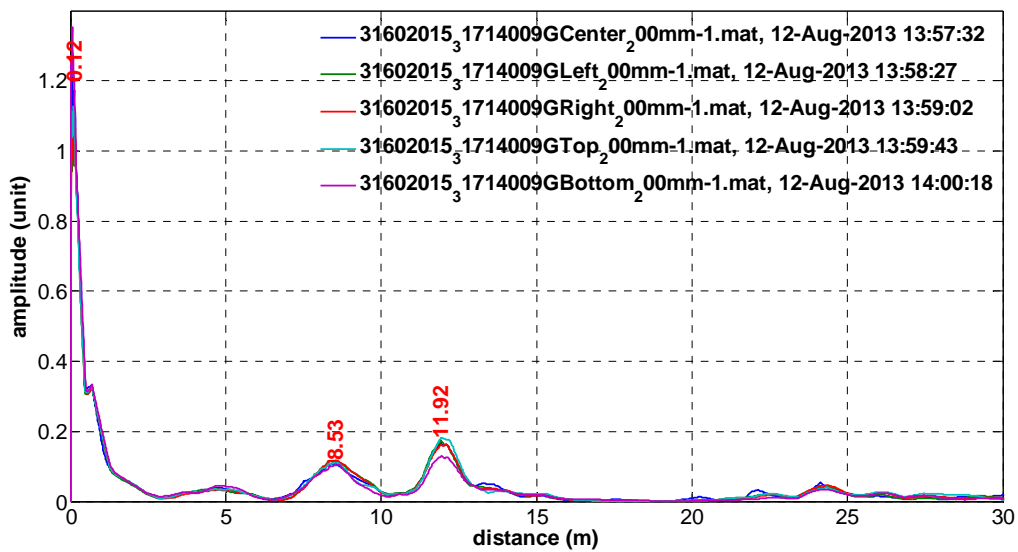
Figure 21 - 31602015_31714009 Gauss pulse excitation signal, different sensor positions

It can be seen that the incident pulse (close to the origin) has greater amplitude when the Gauss pulse is used but the amplitude of the responses at around 8.5m and 12m are stronger for the Gauss pulse too.

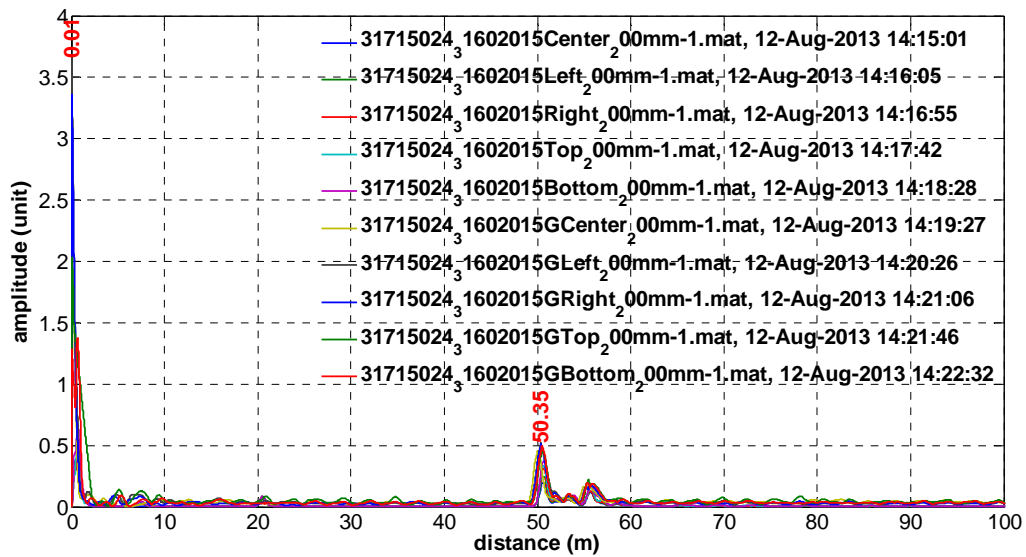
Figure 22 Figure 18 Acoustic responses from pipe section 31715024_31602015 for different sensor position using chirp (first five) and gauss (last five) excitation signal.
