Demonstration of Innovative Sewer System Inspection Technology SewerBatt™

Srinivas Panguluri
Shaw Environmental & Infrastructure, Inc.
Cincinnati, OH

Contract No. EP-C-11-006

Daniel Murray
Water Supply and Water Resources Division
U.S. Environmental Protection Agency
Cincinnati, OH 45268

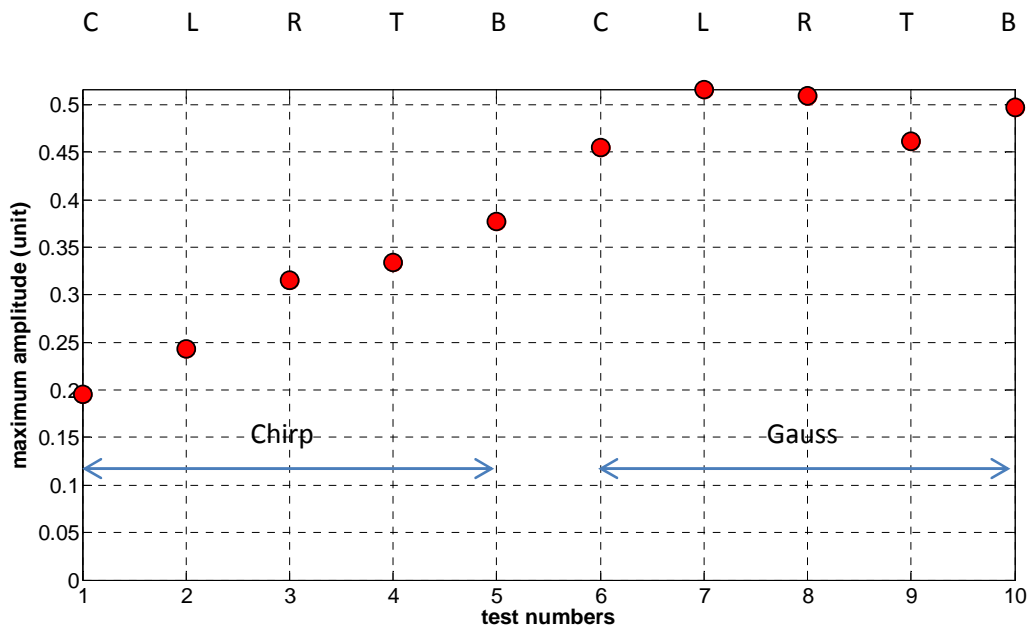
Figure 23 - 31715024_31602015 maximum amplitudes at 50.35m

It can be seen that the responses from the Gauss pulse excitation are higher and more consistent than those from the chirp.

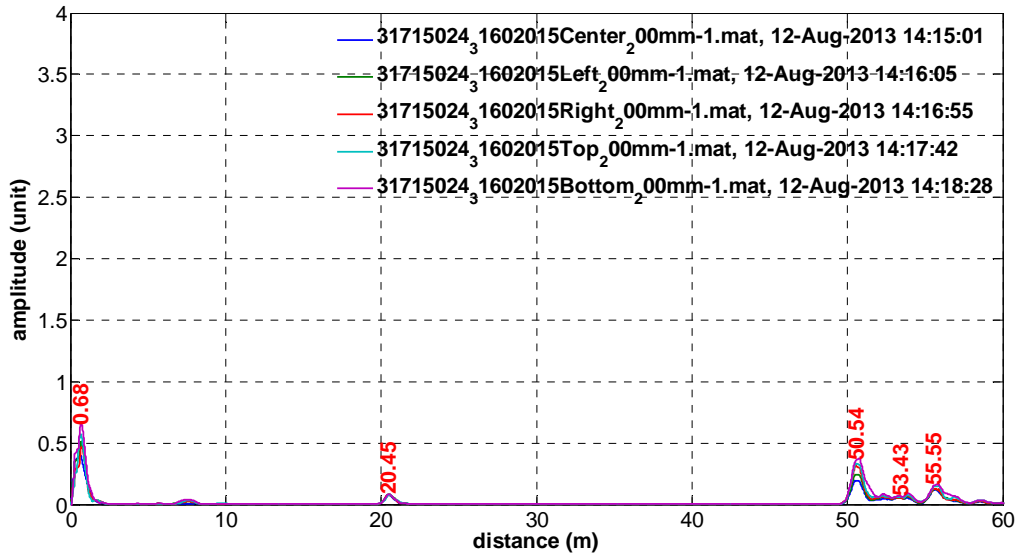
Figure 24 - 31715024_31602015 Chirp excitation, different sensor positions

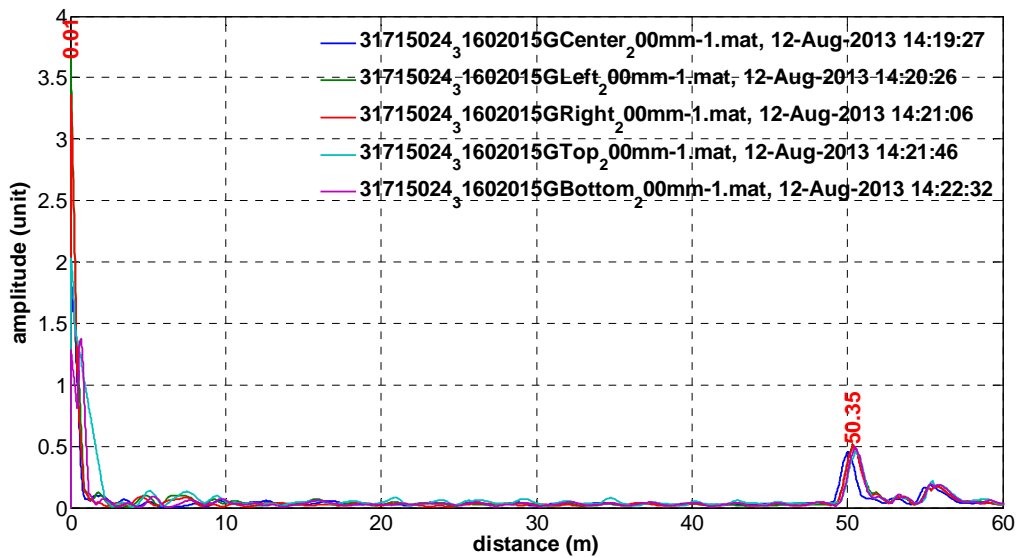
Figure 25 - 31715024_31602015 Gauss pulse excitation signal, different sensor positions

It can be seen that the incident pulse (close to the origin) has greater amplitude when the Gauss pulse is used but the amplitude of the response at around 50m is slightly stronger for the Gauss pulse too.
