# **EPA CHEMICAL ACCIDENT INVESTIGATION REPORT**

**Accra Pac Group, Inc.  
North Plant  
Elkhart, Indiana**

## **The EPA Chemical Accident Investigation Program**

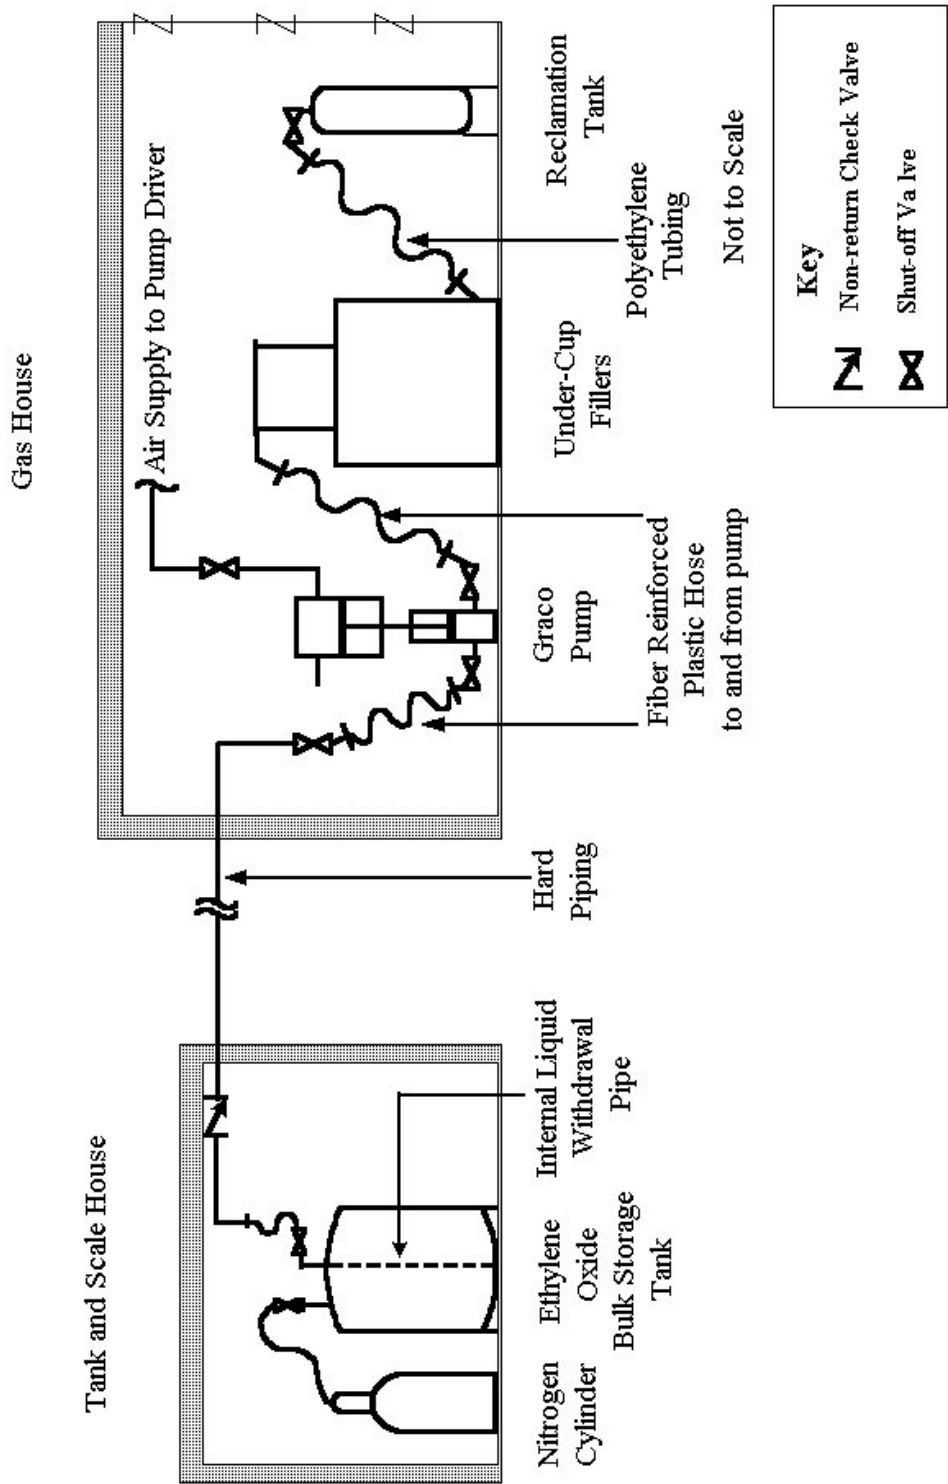
**Exhibit 3. Ethylene Oxide - Simplified Filling Configuration**

Nitrogen at 55-65 psig pressure is used to push the liquid ethylene oxide out of the 400-pound ethylene oxide storage tank into a one-inch diameter stainless steel pipe leading to the Gas House. The stainless steel pipe enters the Gas House on the west side of the building. (See Exhibit 3 )

In the Gas House, the stainless steel pipe is connected to a flexible fiber-reinforced plastic hose through which ethylene oxide is fed into the Graco pump. The Graco pump is a pneumatically driven, reciprocating pump. The Graco pump raises the ethylene oxide pressure to 600-650 psig. The ethylene oxide then travels through another flexible fiber reinforced plastic hose to the under-the-cup filler machine.

- The valves on the ethylene oxide feed line were left open when the filling process was shut down. In the event of a leak in the feed line or valves connected to the feed line within the Gas House, the ethylene oxide in the storage tank would discharge into the Gas House.

- While the ethylene oxide feed line outside the Gas House was made out of stainless steel, some of the ethylene oxide feed lines inside the Gas House were flexible fiber reinforced plastic hoses. These were not as strong as the “hard”(not flexible) stainless steel pipes. There were also several connections and valves. These fittings are much more susceptible to leaks.

- The flexible lines inside the Gas House were damaged to the point where they could not be analyzed to determine an exact leak source. The “hard” steel piping was tested and showed no leaks. It is not clear whether the feed system failed and caused the explosion and fire or if the explosion and fire caused by ethylene oxide release from the

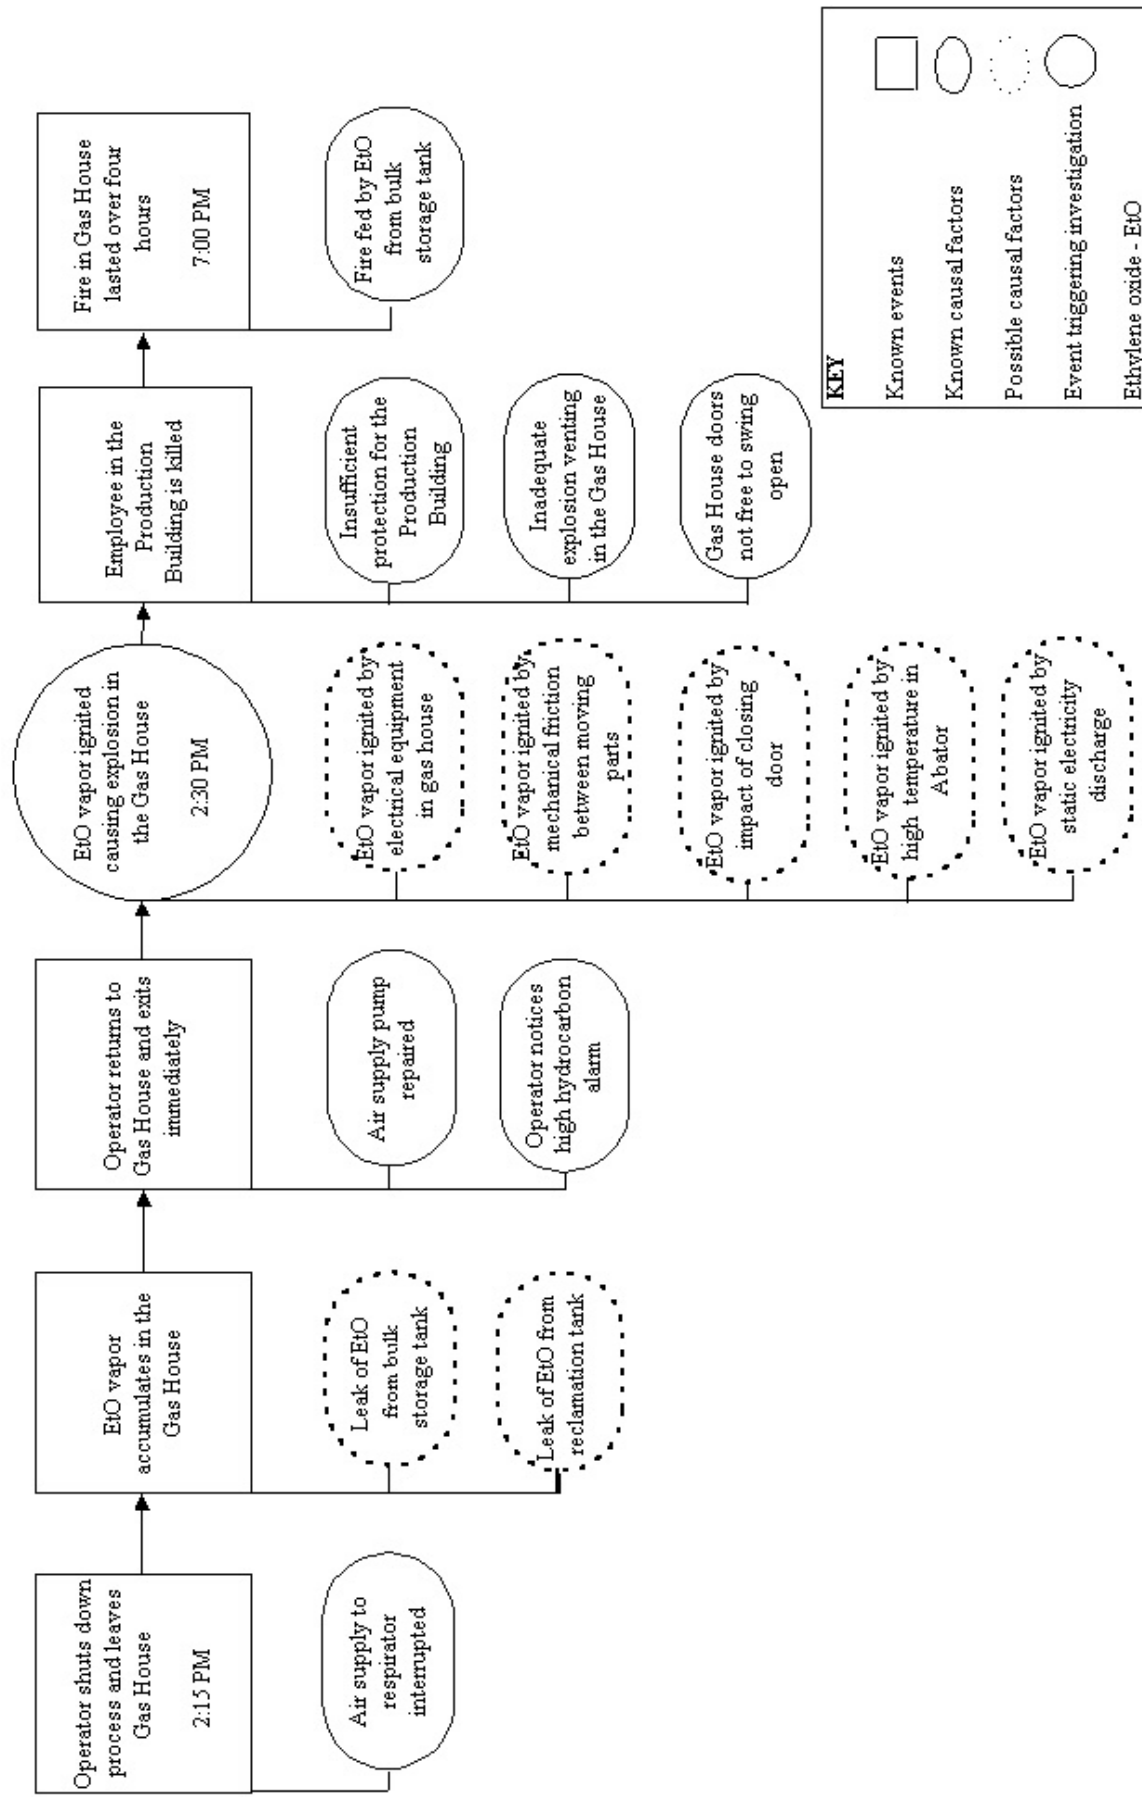
**Exhibit 6. Event and Causal Factors Diagram**

Accra Pac Inc. - Elkhart, Indiana  
June 24, 1997 Explosion and fire
