Technical Note
ORP/TAD-79-2

On Board Corrosion Analysis of a Recovered Nuclear Waste Container

Stephen C. Dexter
Assistant Professor
of Ocean Engineering
and Materials Science
College of Marine Studies
University of Delaware

August 1979

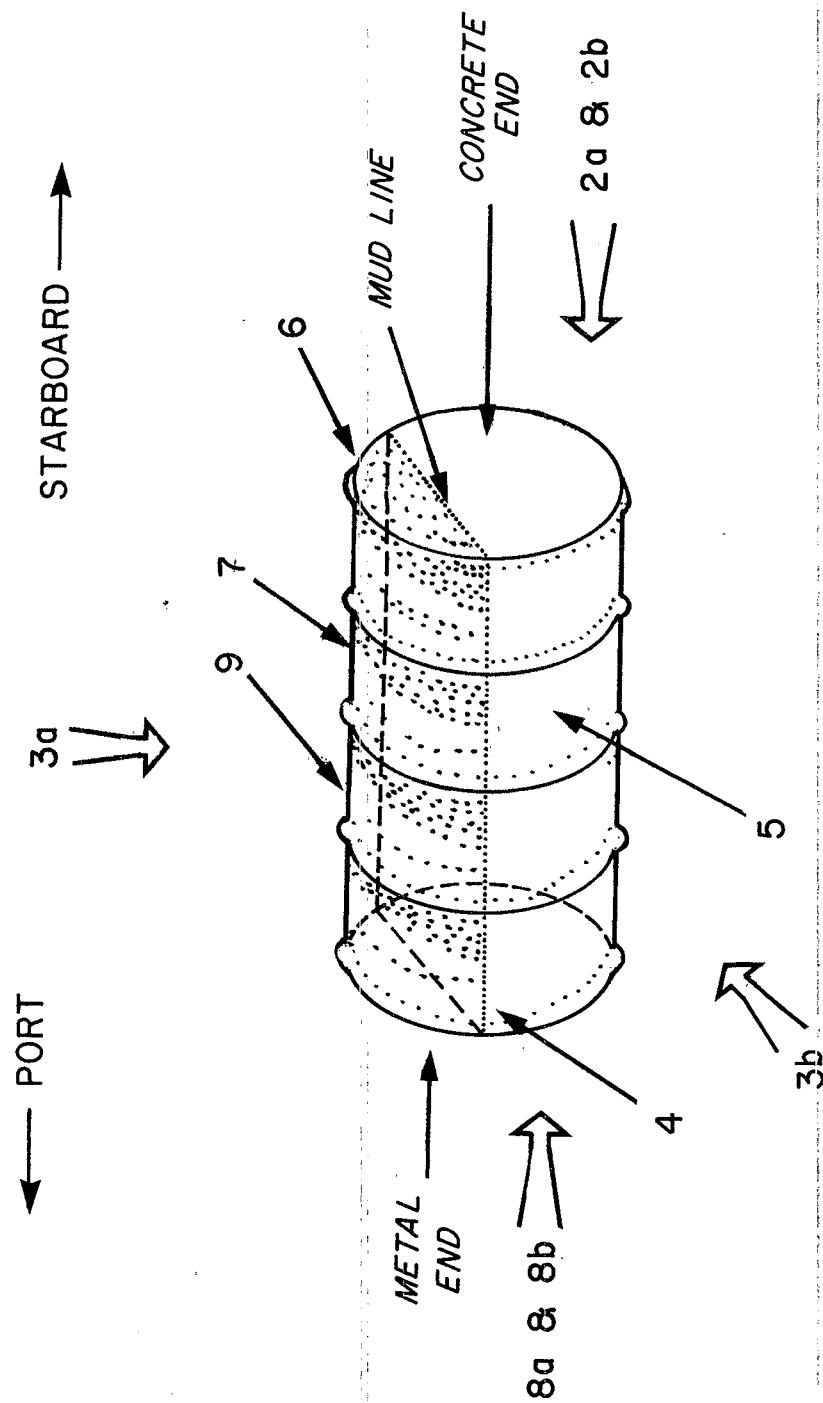
Figure 1 is a schematic diagram of the container showing the locations from which each of the photographs in Figures 2 through 9 were taken. Figures 2 through 9 show the general condition of the container immediately upon recovery. Note that the container as it sat on the deck was upside down compared to its position on the sea floor.

Figure 1. Schematic diagram of the recovered container showing the locations of the photographs in Figures 2 through 9. The container as it sat on the deck, and as pictured here is upside down compared to its position on the sea floor. The shaded portion was embedded in the sediments.
