On Board Corrosion Analysis of a Recovered Nuclear Waste Container

ON BOARD CORROSION ANALYSIS OF A RECOVERED
NUCLEAR WASTE CONTAINER

Stephen C. Dexter
Assistant Professor
of Ocean Engineering
and Materials Science
College of Marine Studies
University of Delaware

August 1979

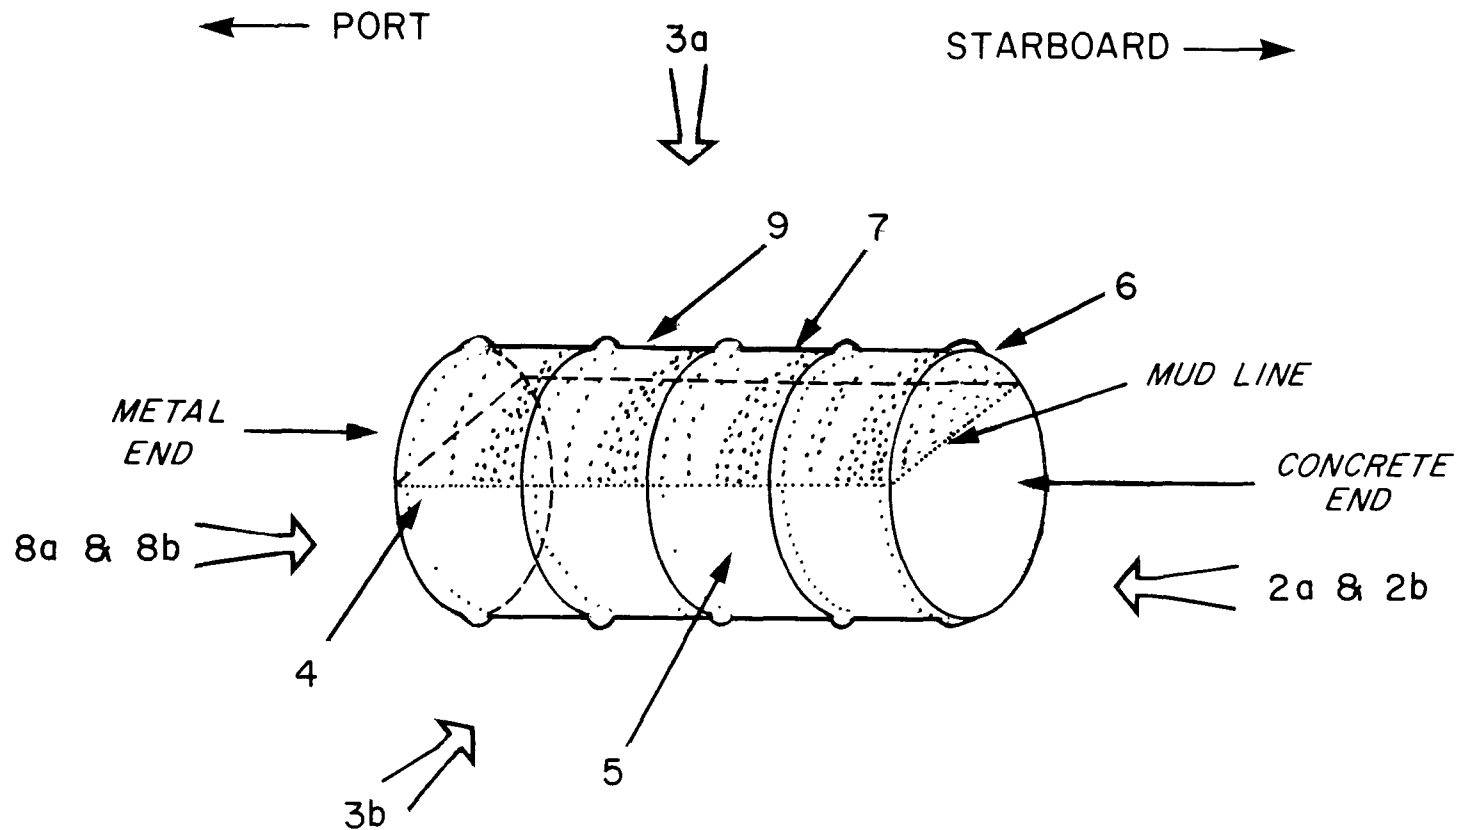
Figure 1 is a schematic diagram of the container showing the locations from which each of the photographs in Figures 2 through 9 were taken. Figures 2 through 9 show the general condition of the container immediately upon recovery. Note that the container as it sat on the deck was upside down compared to its position on the sea floor.

Figure 1. Schematic diagram of the recovered container showing the locations of the photographs in Figures 2 through 9. The container as it sat on the deck, and as pictured here is upside down compared to its position on the sea floor. The shaded portion was embedded in the sediments.
