OBSERVATIONAL STUDY OF FINAL CLEANING  
AND AHERA CLEARANCE SAMPLING AT  
ASBESTOS-ABATEMENT SITES IN NEW JERSEY

John R. Kominsky  
Ronald W. Freyberg  
PEI Associates, Inc.  
Cincinnati, Ohio 45246

James A. Brownlee  
James H. Lucas, Jr.  
Donald R. Gerber  
Asbestos Control Service  
New Jersey Department of Health  
Trenton, New Jersey 08625

EPA Contract No. 68-03-4006

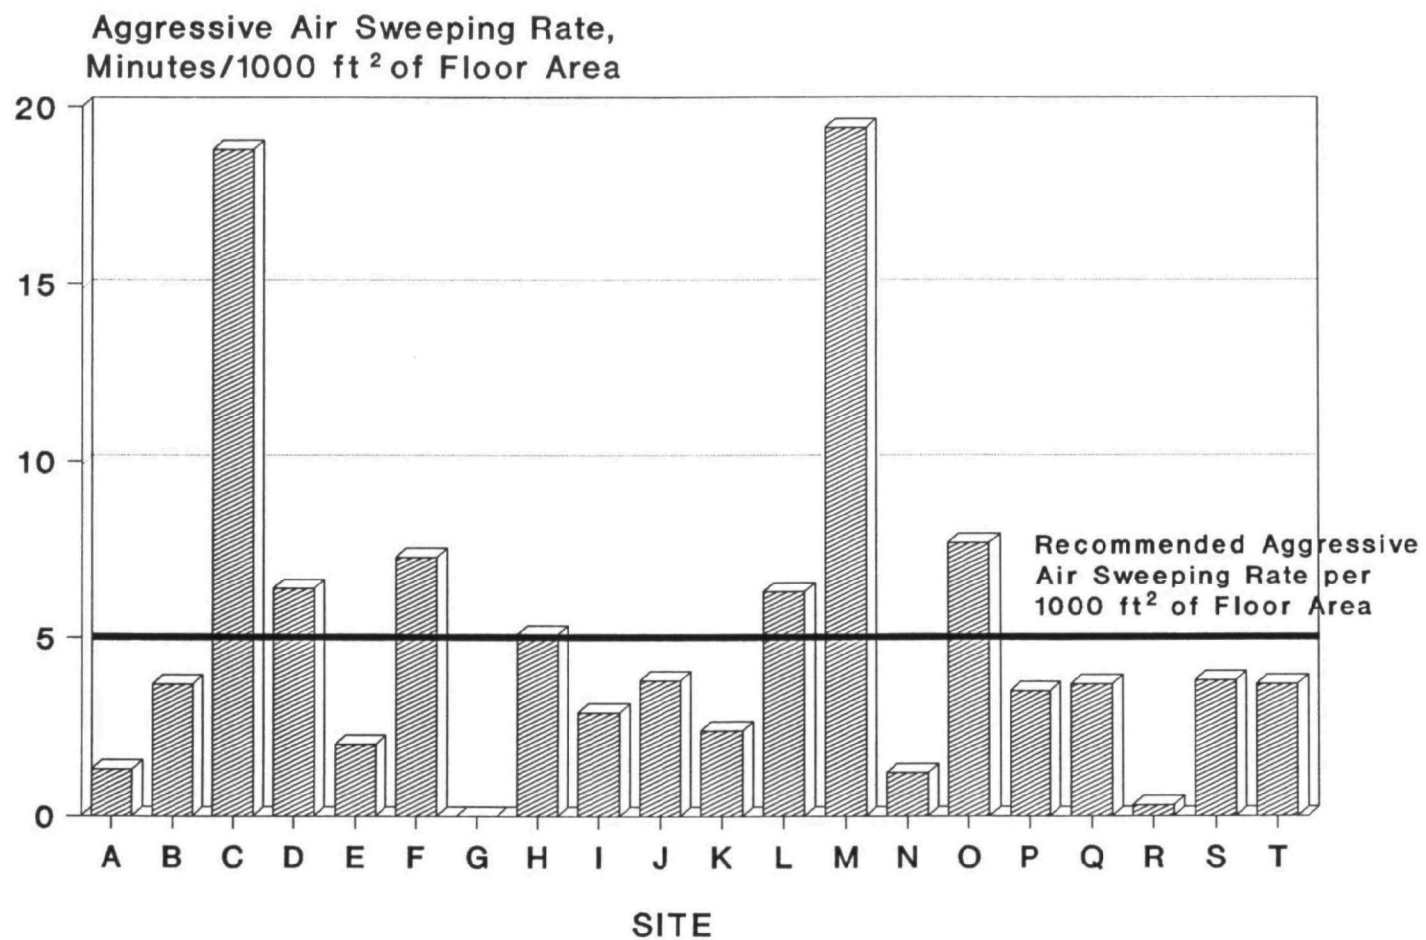
Nineteen of the 20 observed abatement sites used aggressive sampling techniques. Fourteen of these 19 sites failed to meet the recommended aggressive air-sweeping rate of at least 5 minutes per 1000 ft<sup>2</sup> of floor area. Table 8 presents actual and recommended aggressive sampling times for each observed site. Figure 4 shows the actual aggressive sampling rates per 1000 ft<sup>2</sup> of floor area for each of the 20 sites.

Figure 4. Observed aggressive sweeping times per 1000 square feet of floor area at 20 asbestos abatement sites.

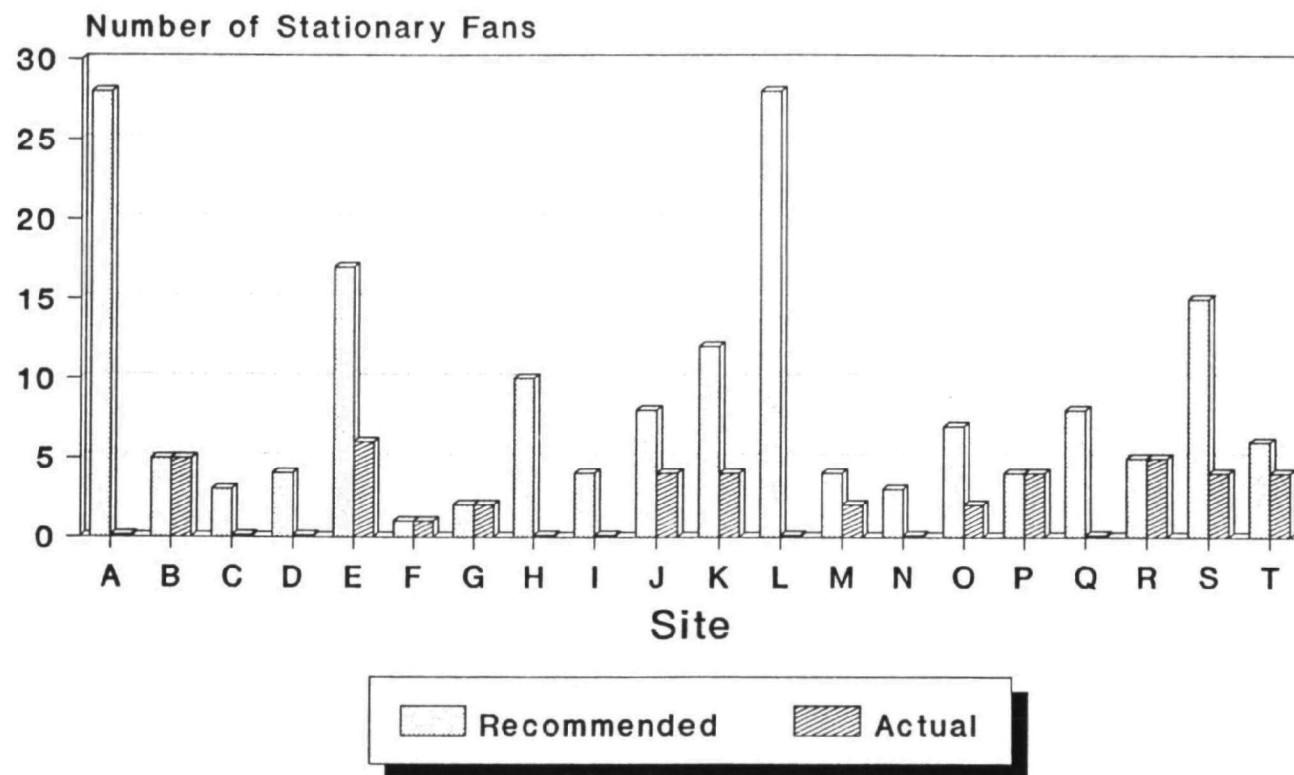
Only 12 of the 20 sites used stationary air fans to maintain a constant air movement during clearance air sampling. Box-type fans were used at nine of these sites, and pedestal-type fans were used at three sites. Fifteen of the observed sites failed to use the number of fans per given volume of workspace required by AHERA. The actual and required number of circulating fans for each site are presented in Table 8 and shown graphically in Figure 5.

Figure 5. Recommended and actual number of stationary fans used during AHERA clearance air monitoring.

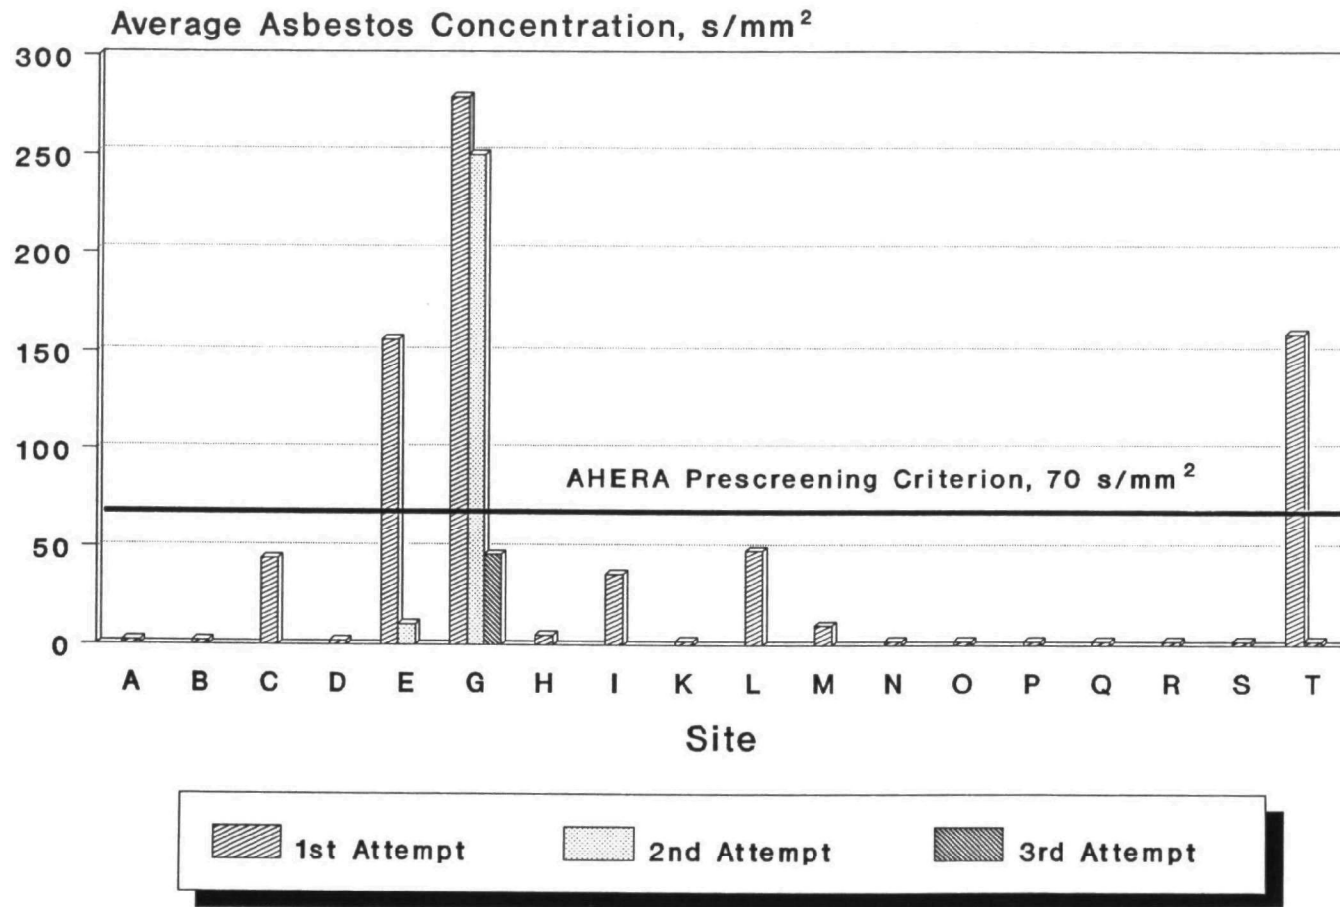
these sites subsequently tried to use the Z-Test to pass clearance. In each case, the site also failed the Z-Test and had to be recleaned. The Z-Test was used only twice at the 20 sites observed in this study, and it was never used to clear the abatement site. Figure 7 presents the average asbestos concentrations for each clearance attempt for the 18 sites that were cleared by TEM.

Figure 7. Average asbestos concentrations for each AHERA clearance attempt for the 18 sites cleared by TEM.

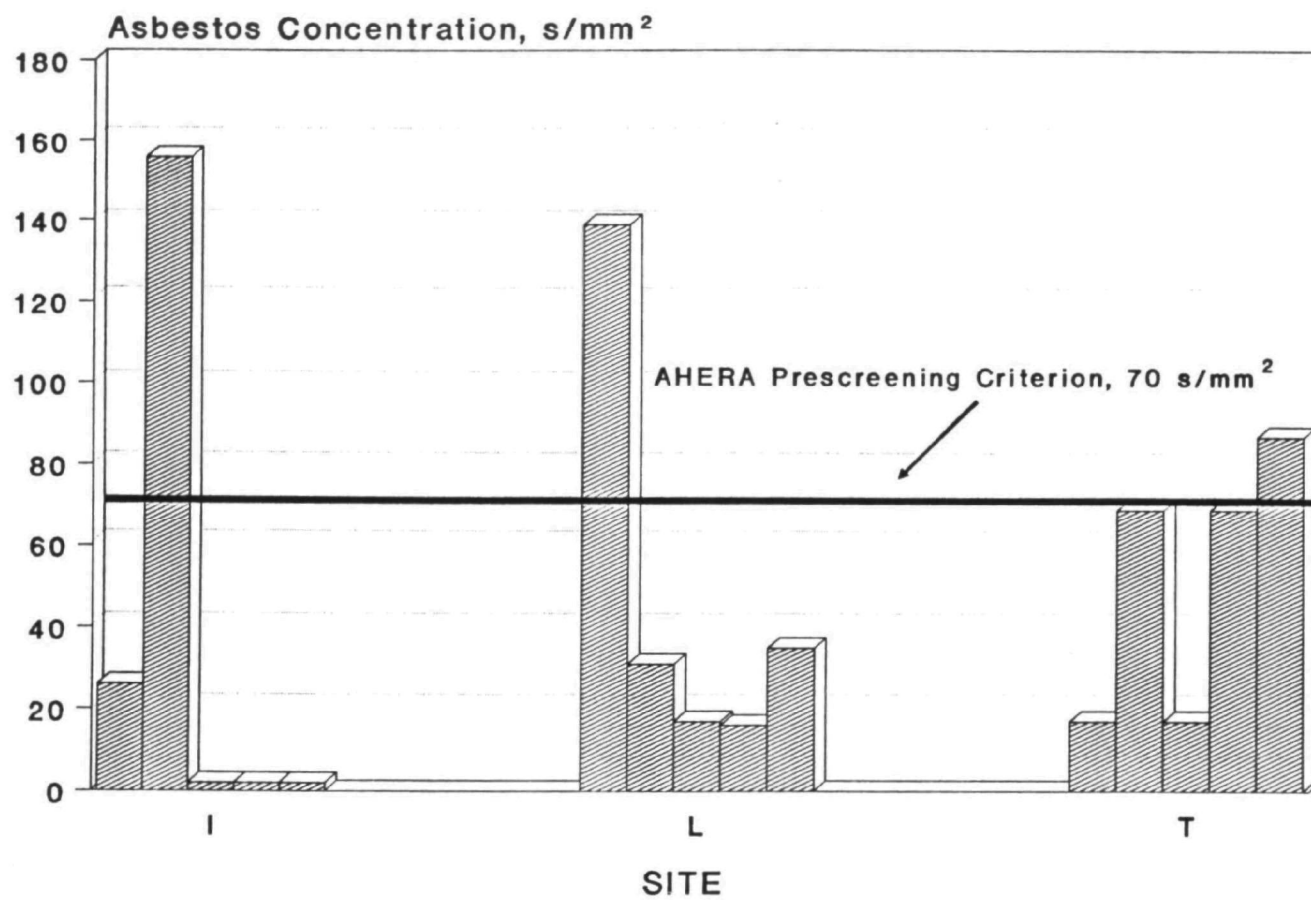
Occasionally, a site passed the initial prescreening test when one or more of the samples showed an asbestos concentration greater than or equal to 70 s/mm<sup>2</sup>. As shown in Figure 8, this occurred at three sites in this study.

Figure 8. AHERA clearance results for sites with individual sample concentrations greater than 70 s/mm<sup>2</sup>.

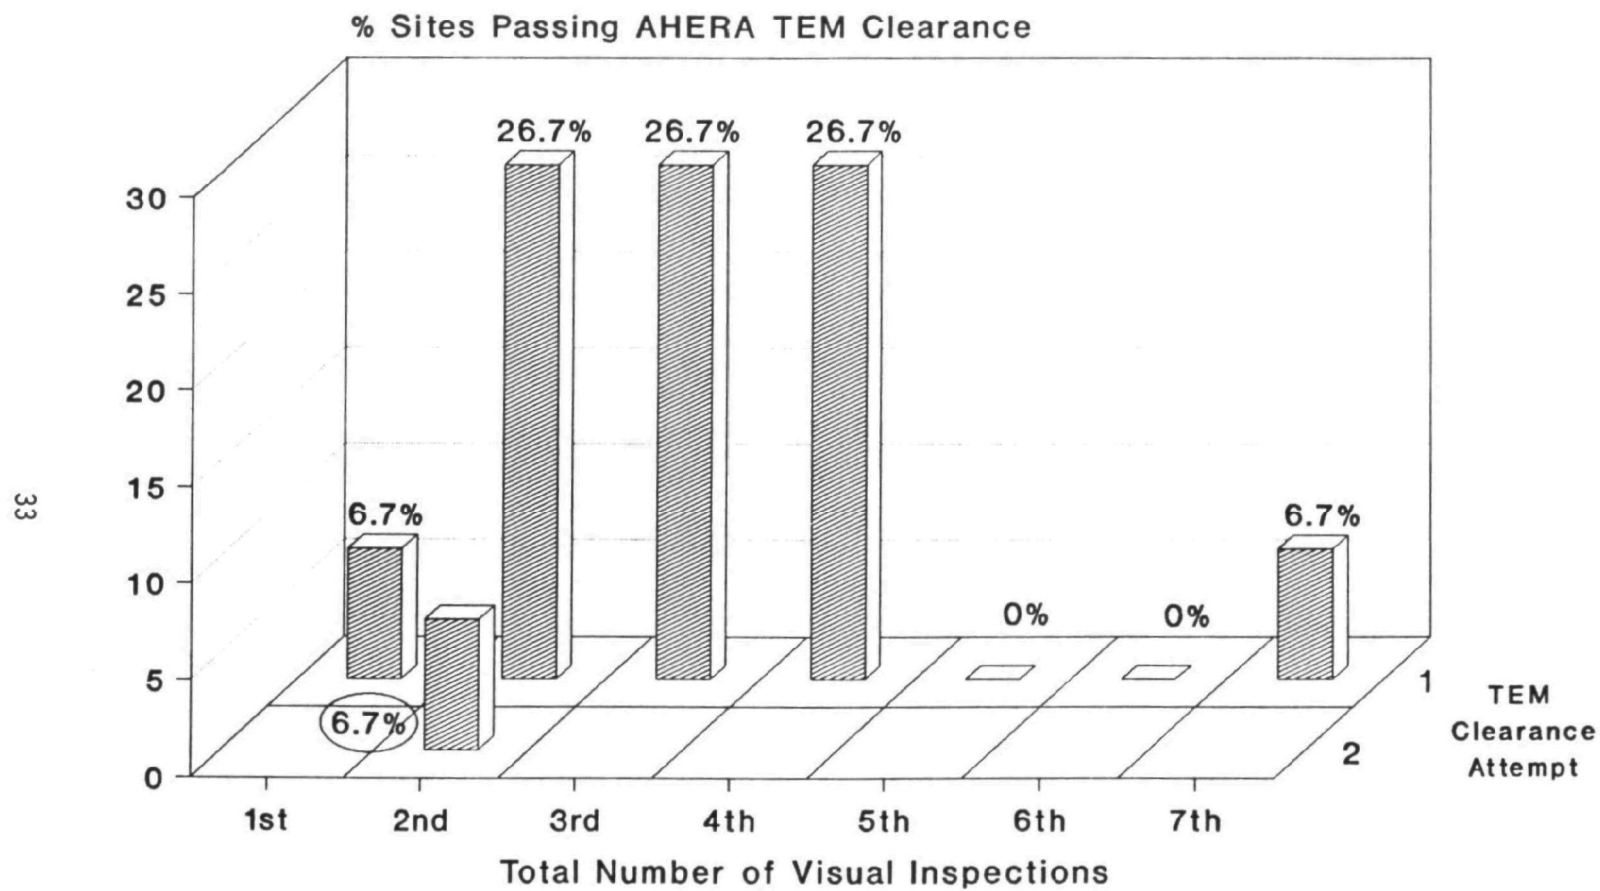
Figure 9 integrates the percentage of sites passing TEM clearance with the total number of NJDOH visual inspections and TEM clearance attempts. As shown, the largest percentage (93.5%) of these sites passed the AHERA TEM clearance on the first attempt after having passed a thorough visual inspection by the NJDOH. Only 6.7 percent (one site) failed the AHERA TEM clearance after passing a thorough visual inspection. These data support the premise that effective final cleaning practices that meet the standards of a thorough visual inspection strongly influence whether the AHERA clearance test or other TEM clearance tests will be passed.<sup>6</sup>

**Figure 9. Percentage of 15 sites passing AHERA TEM clearance by total number of ACS visual inspections and AHERA clearance attempt.**

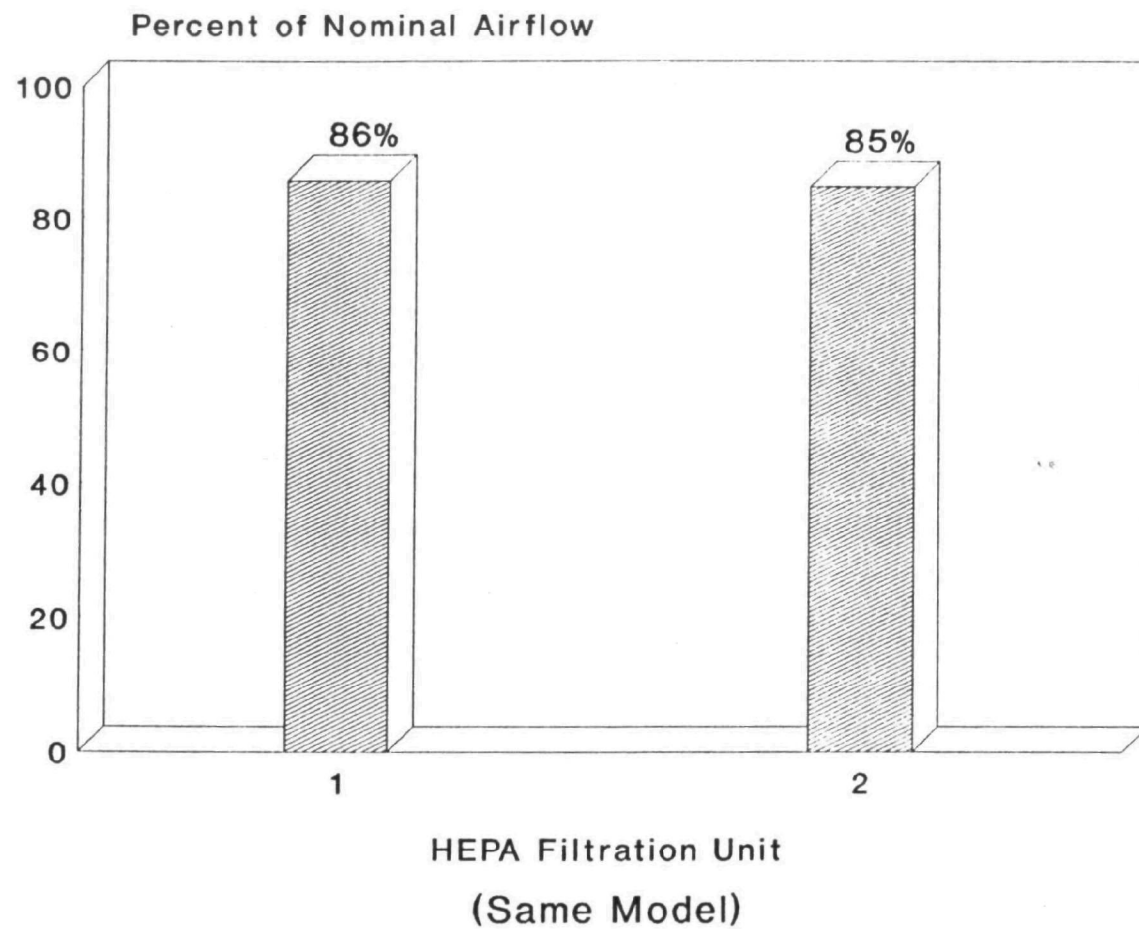
Figure B-1 compares the measured air-intake volume of each HEPA-filtration unit operating during AHERA clearance sampling with the unit's nominal airflow. The actual operating percentages of the nominal air flow were 85 and 86 during AHERA clearance sampling.

Figure B-1. Airflow performance for HEPA filtration systems operating during AHERA clearance.

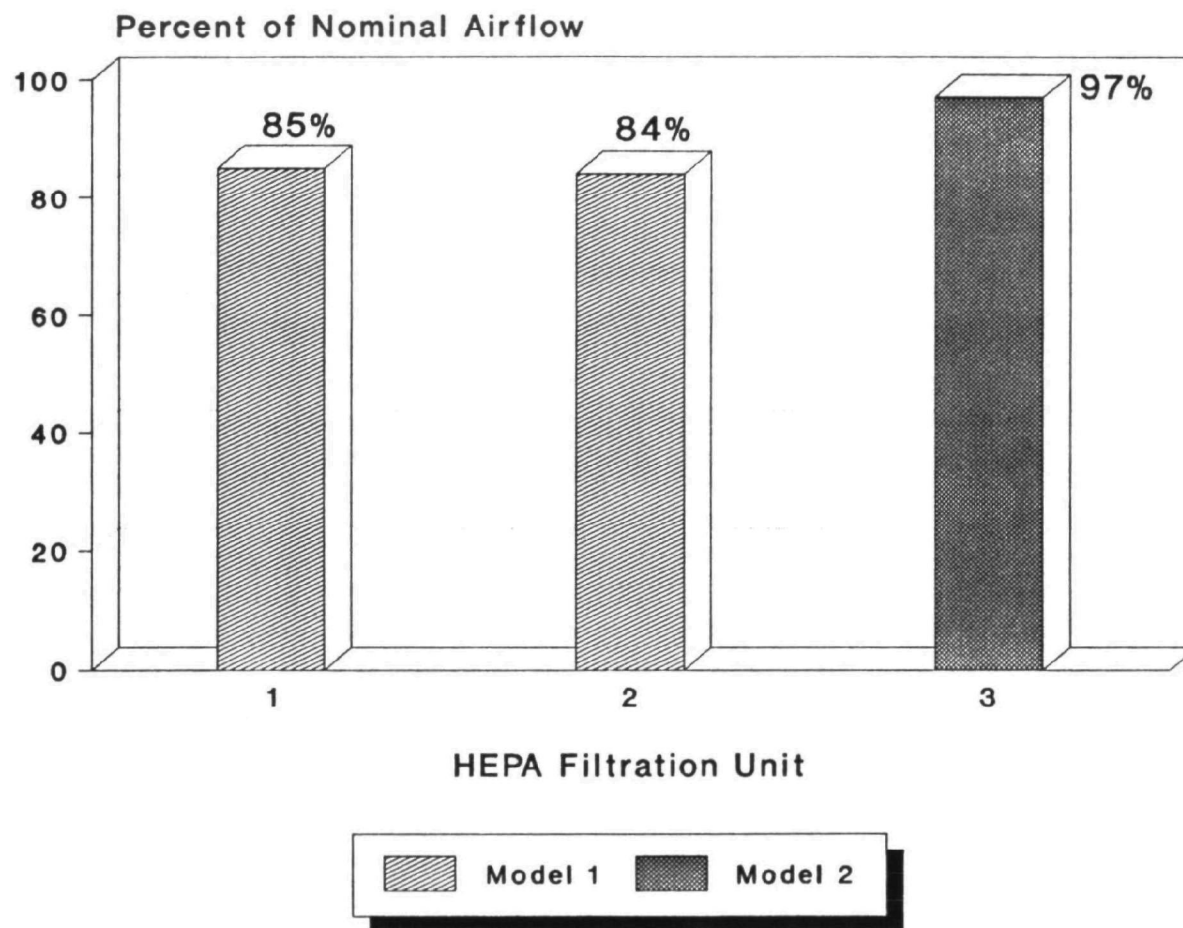
Figures D-1 and D-2 compare the measured air-intake volume of each HEPA-filtration unit operating during final cleaning and AHERA clearance sampling, respectively, with the unit's nominal airflow. The actual operating percentages of the nominal airflow ranged from 84 to 97 during final cleaning and 79 to 99 during AHERA clearance sampling. The reason for the significantly higher operating airflow performance of the third air filtration unit is not known.

Figure D-1. Airflow performance for HEPA filtration systems operating during final cleanup.

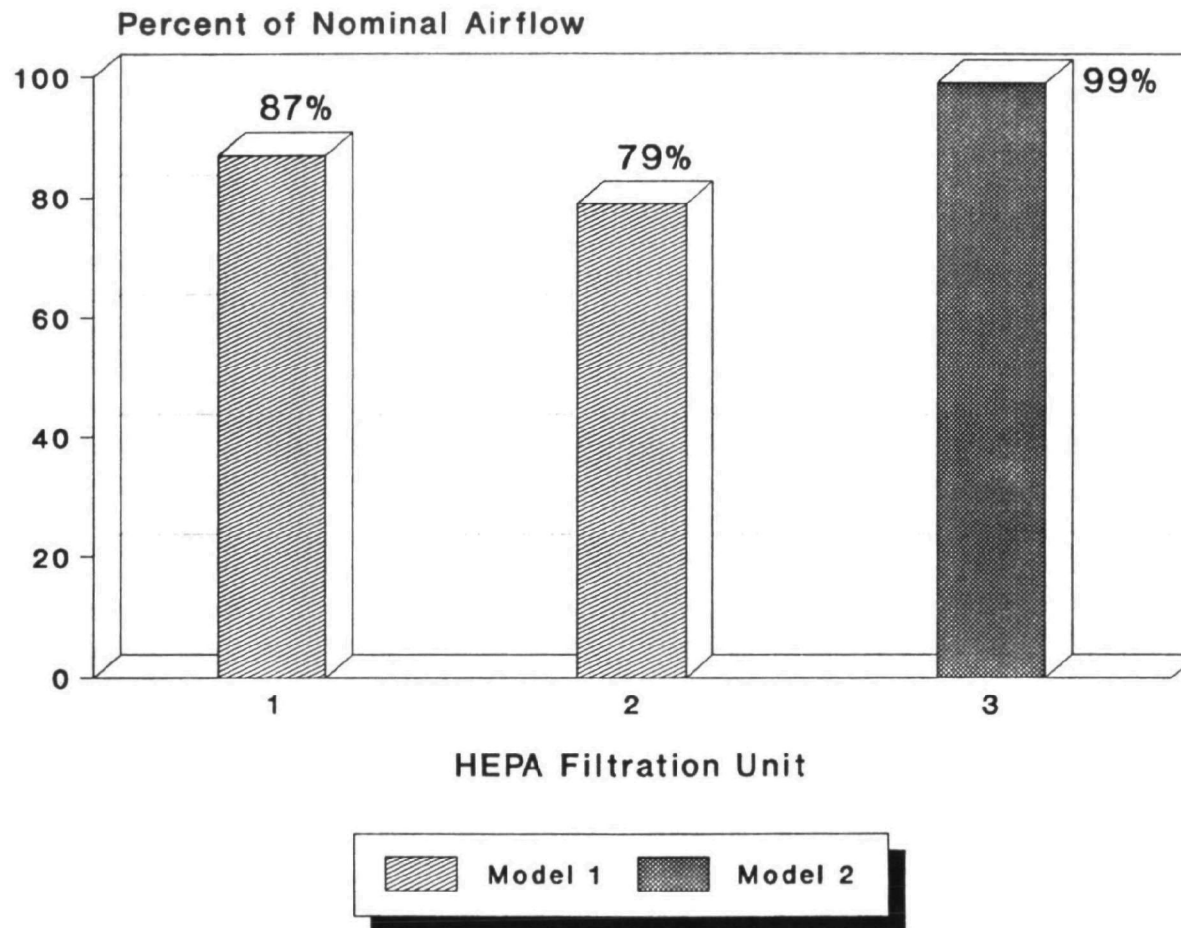
Figure D-2. Airflow performance for HEPA filtration systems operating during AHERA clearance.

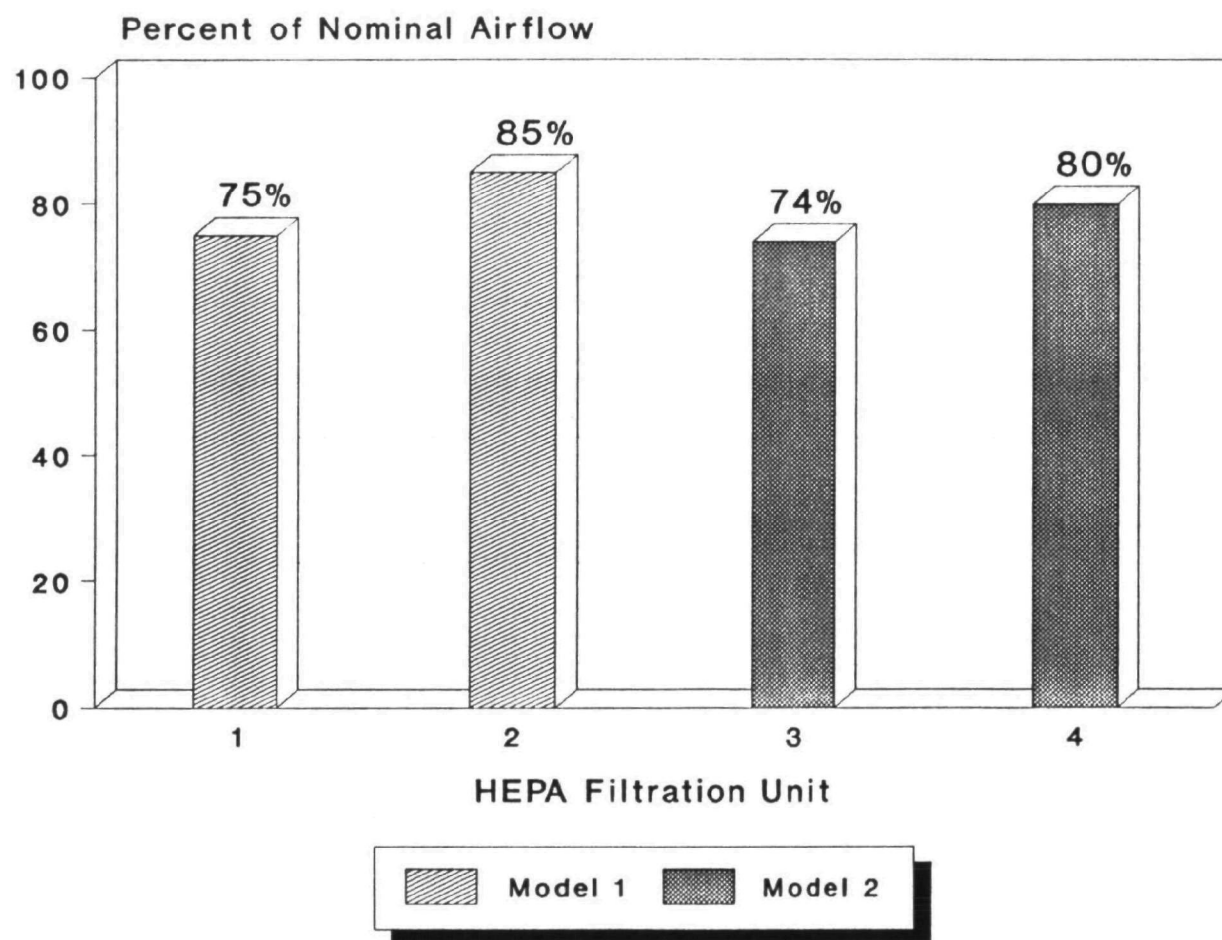
Figure P-2. Airflow performance for HEPA filtration systems operating during AHERA clearance.

The HEPA-filtration units were placed so that the makeup air entered the work area through the personnel decontamination facility and waste load-out port. Three of the five operating units were positioned along exterior walls, to facilitate venting the exhaust through windows via an interconnected flexible duct. The exhaust of two of the five units was vented through a doorway via an interconnected flexible duct that passed through a classroom outside of the abatement area. This is particularly noteworthy because the flexible duct for one of the two units was torn and a percentage of the exhaust air was released into the building. The discharge air from the HEPA-filtration units was not monitored for fiber content.

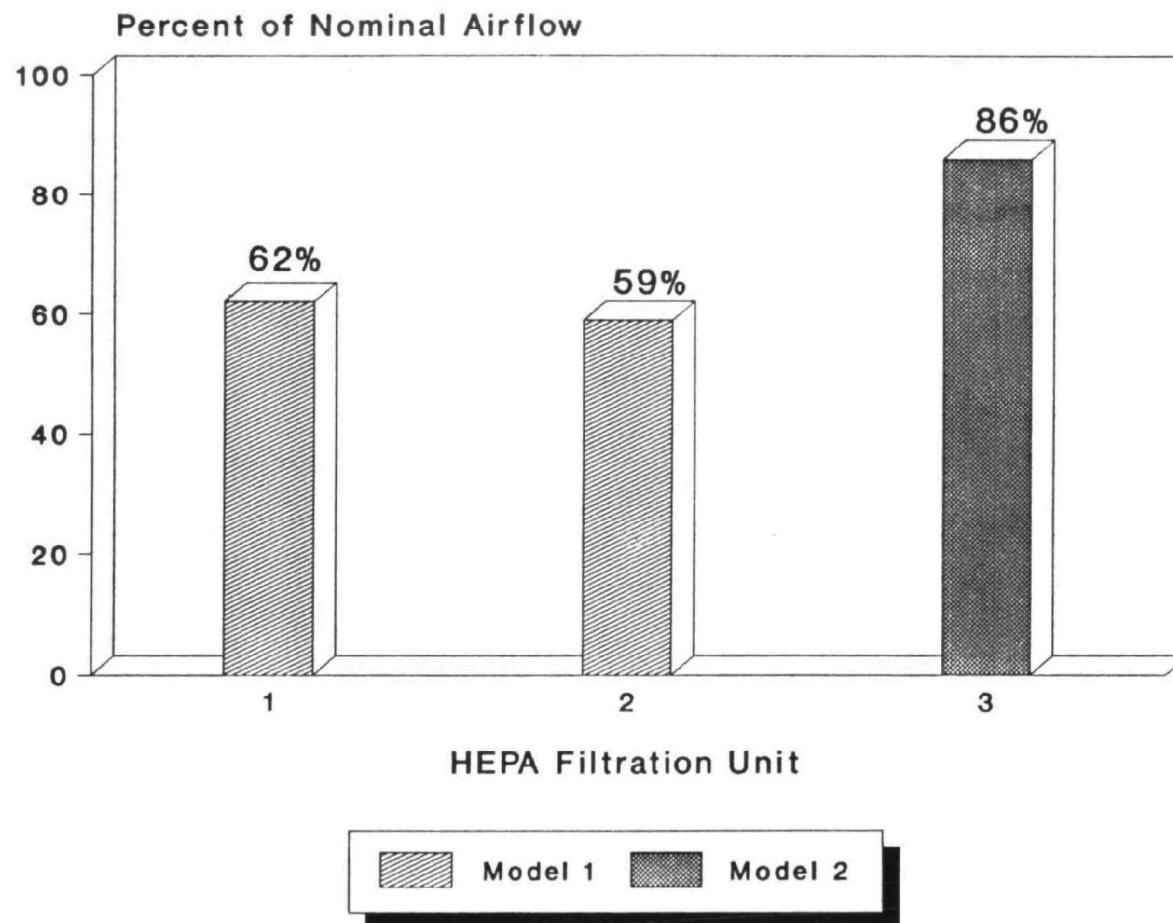
Figure Q-1. Airflow performance for HEPA filtration systems operating during final cleanup.

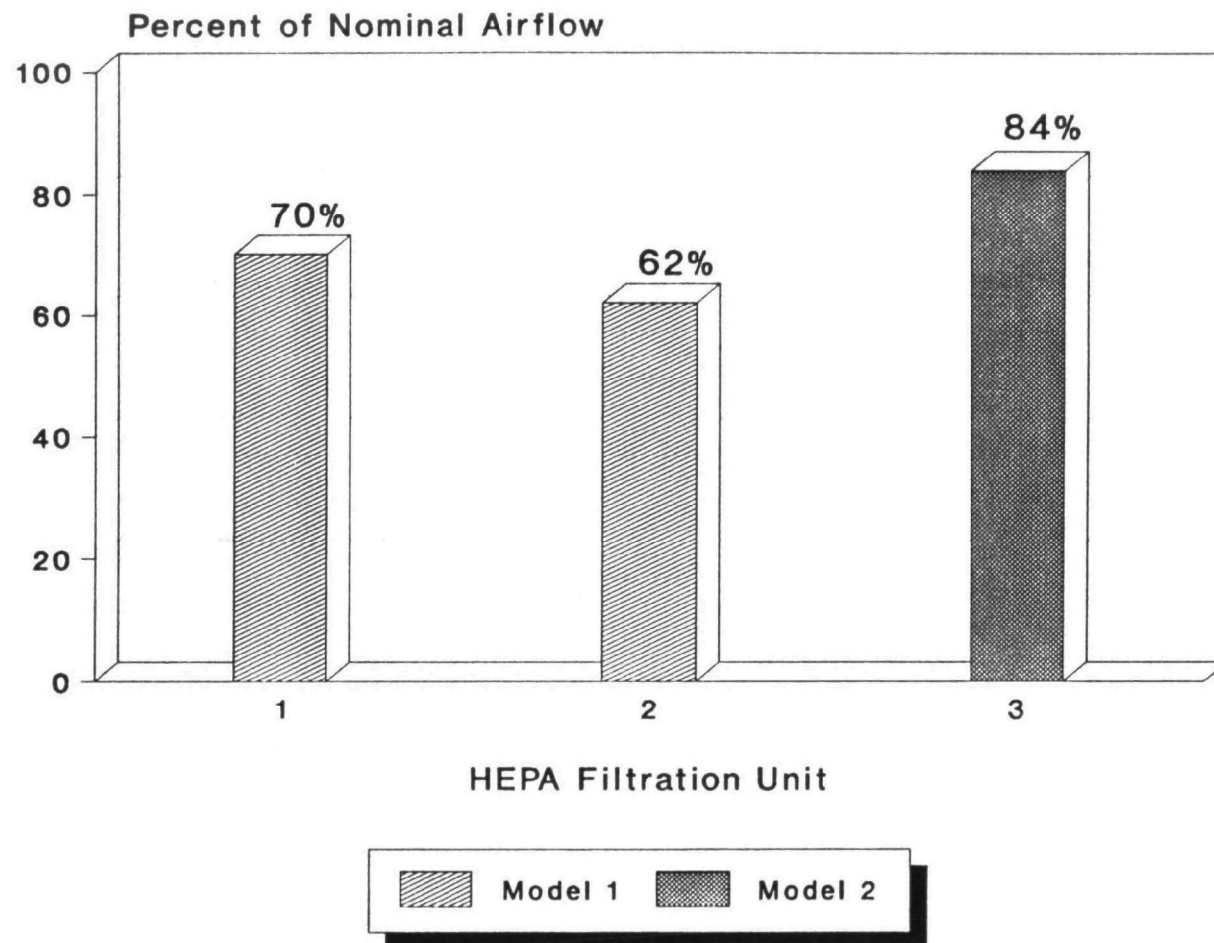
Figure Q-2. Airflow performance for HEPA filtration systems operating during AHERA clearance.

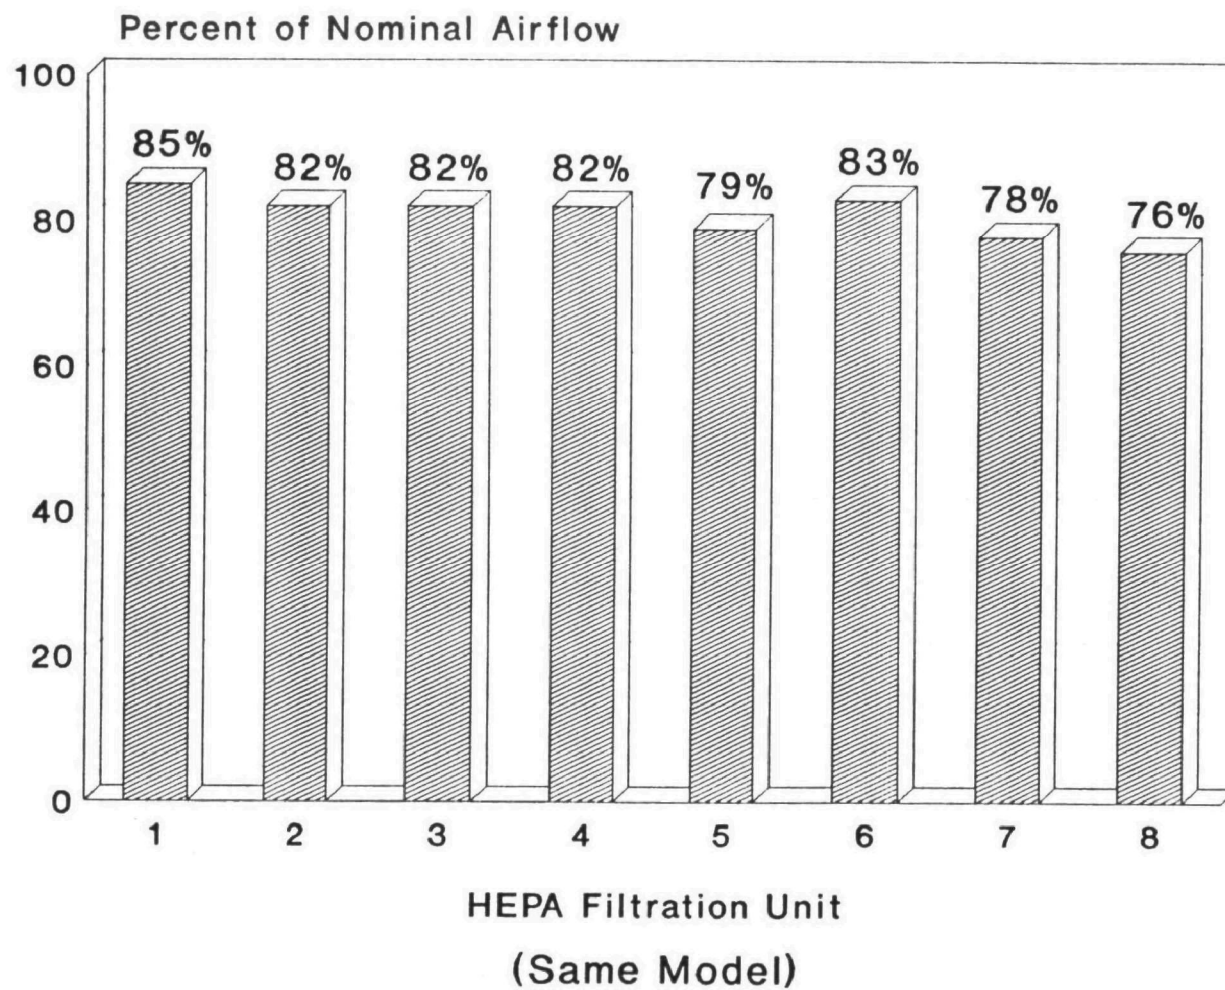
Figure R-1. Airflow performance for HEPA filtration systems operating during final cleanup.

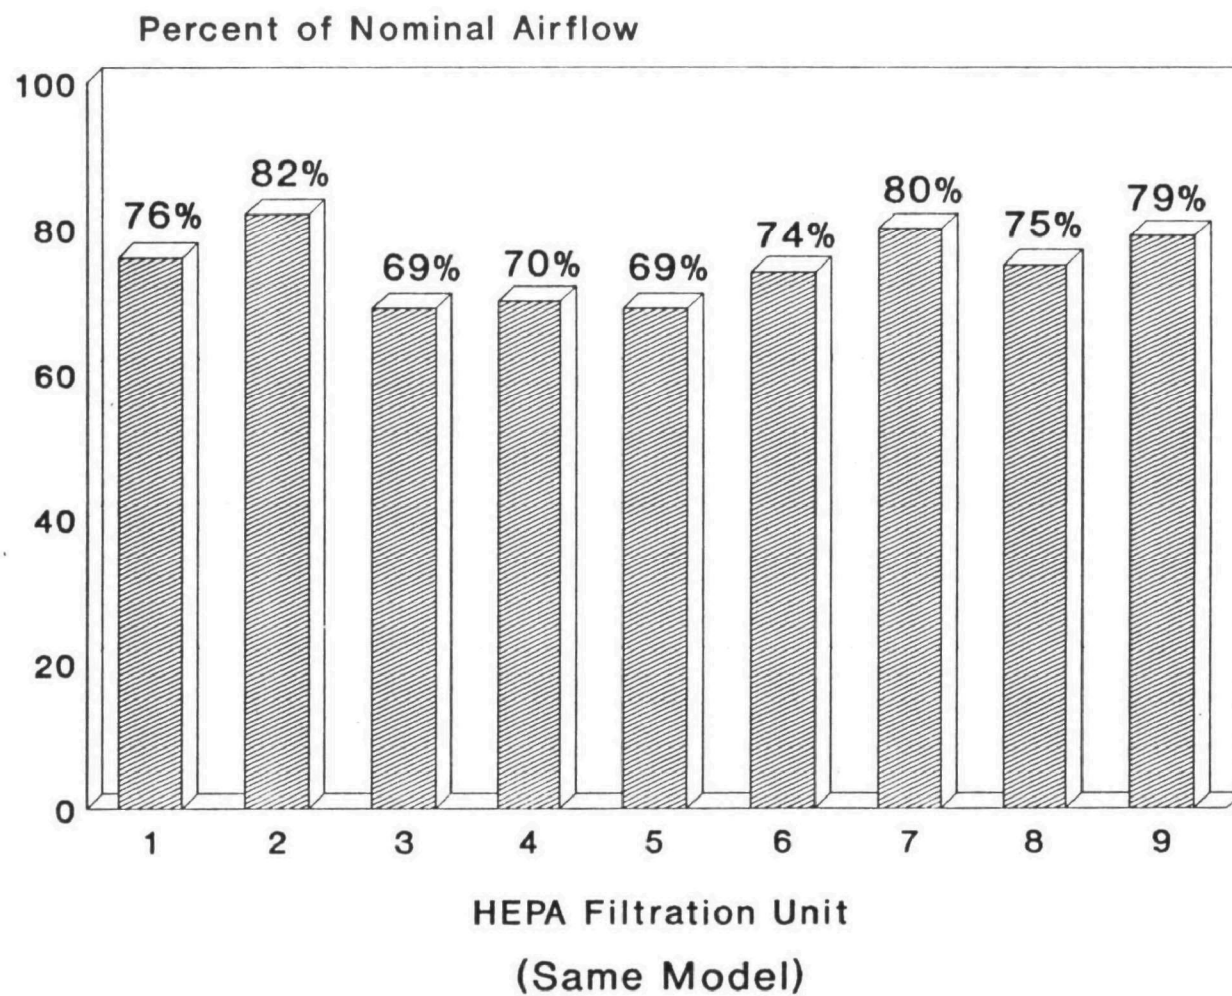
Figure R-2. Airflow performance for HEPA filtration systems operating during AHERA clearance.

The HEPA-filtration units were placed so that the makeup air entered the work area through the personnel decontamination facility. The nine operating units were positioned along exterior walls to facilitate venting the exhaust through windows via an interconnected flexible duct. The discharge air from the HEPA-filtration units was not monitored for fiber content.

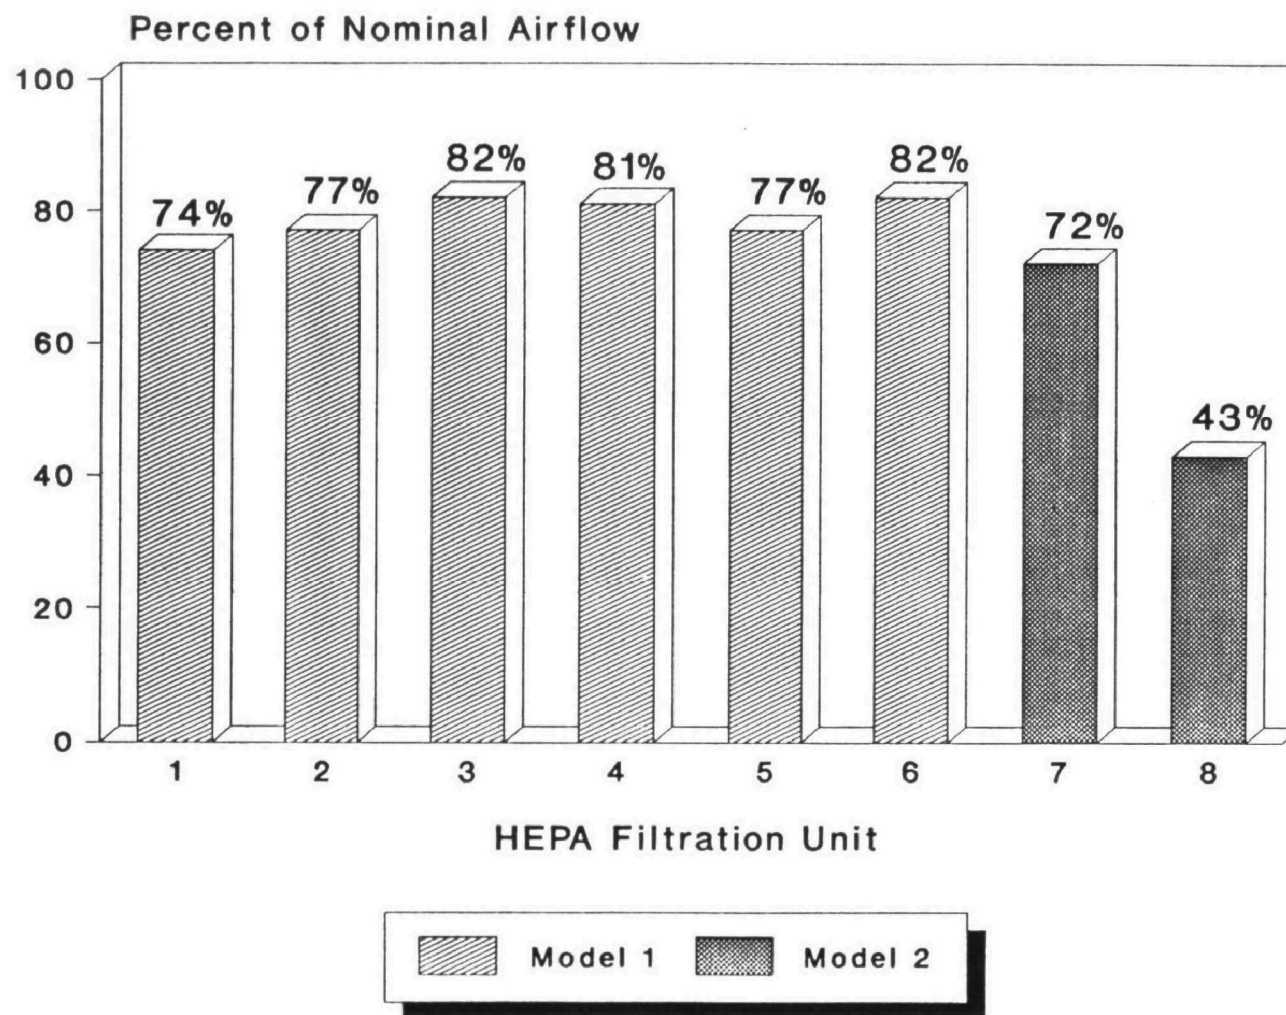
Figure S-1. Airflow performance for HEPA filtration systems operating during final cleanup.

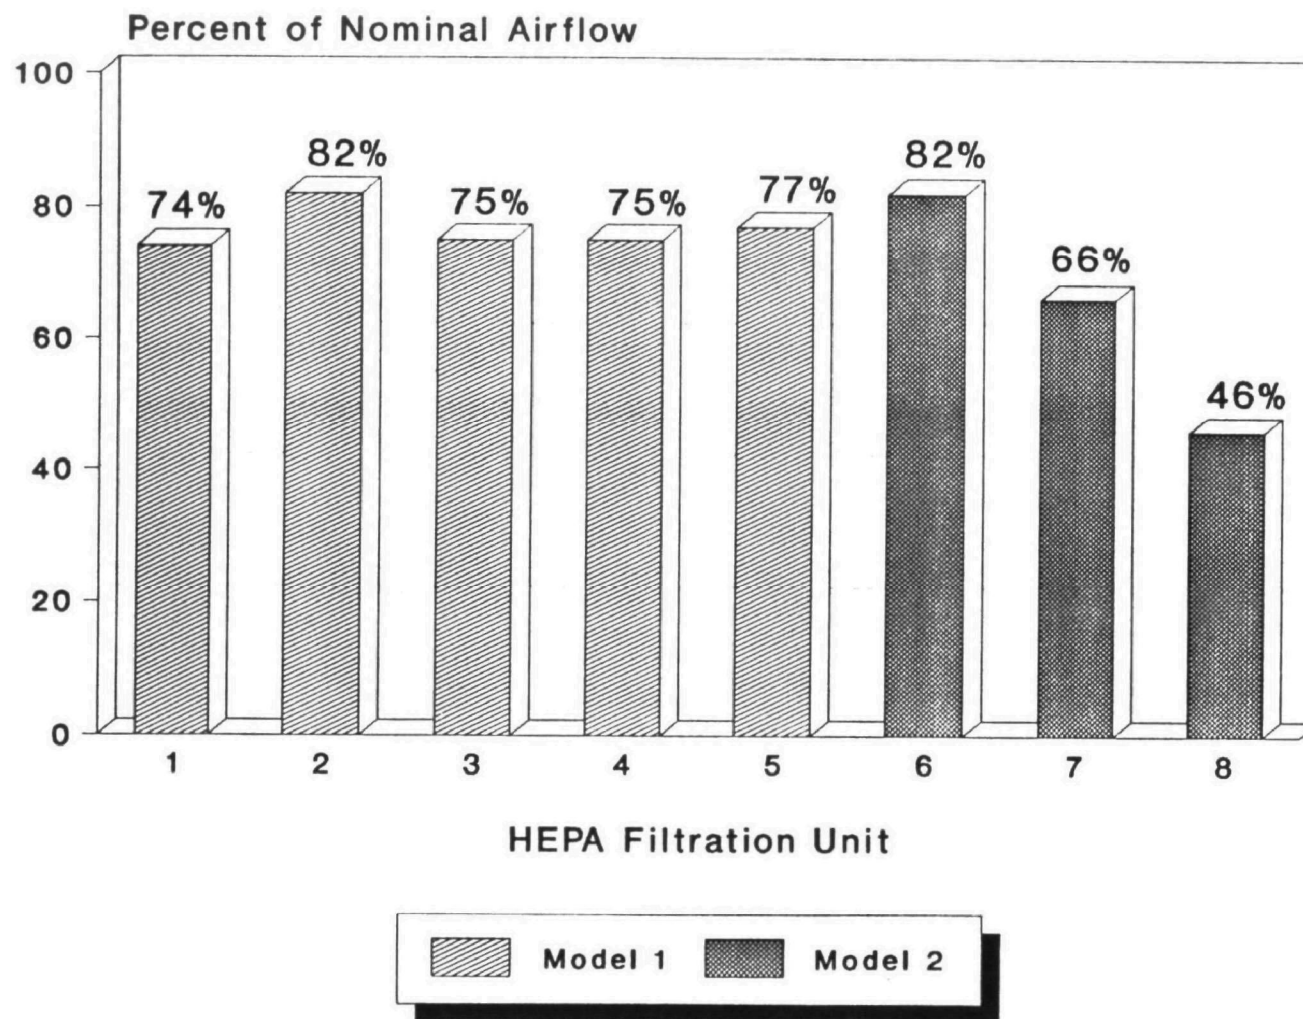
Figure S-2. Airflow performance for HEPA filtration systems operating during AHERA clearance.

The HEPA-filtration units were placed so that the makeup air entered the work area through the personnel decontamination facility. Eight of the nine operating units were positioned along exterior walls to facilitate venting the exhaust through windows via an interconnected flexible duct. The exhaust of one of the nine units was vented through a doorway via an interconnected flexible duct that passed through a classroom outside of the abatement area. This is particularly noteworthy because the flexible duct was torn and a percentage of the exhaust air was released into the building. The discharge air from the HEPA-filtration units was not monitored for fiber content.

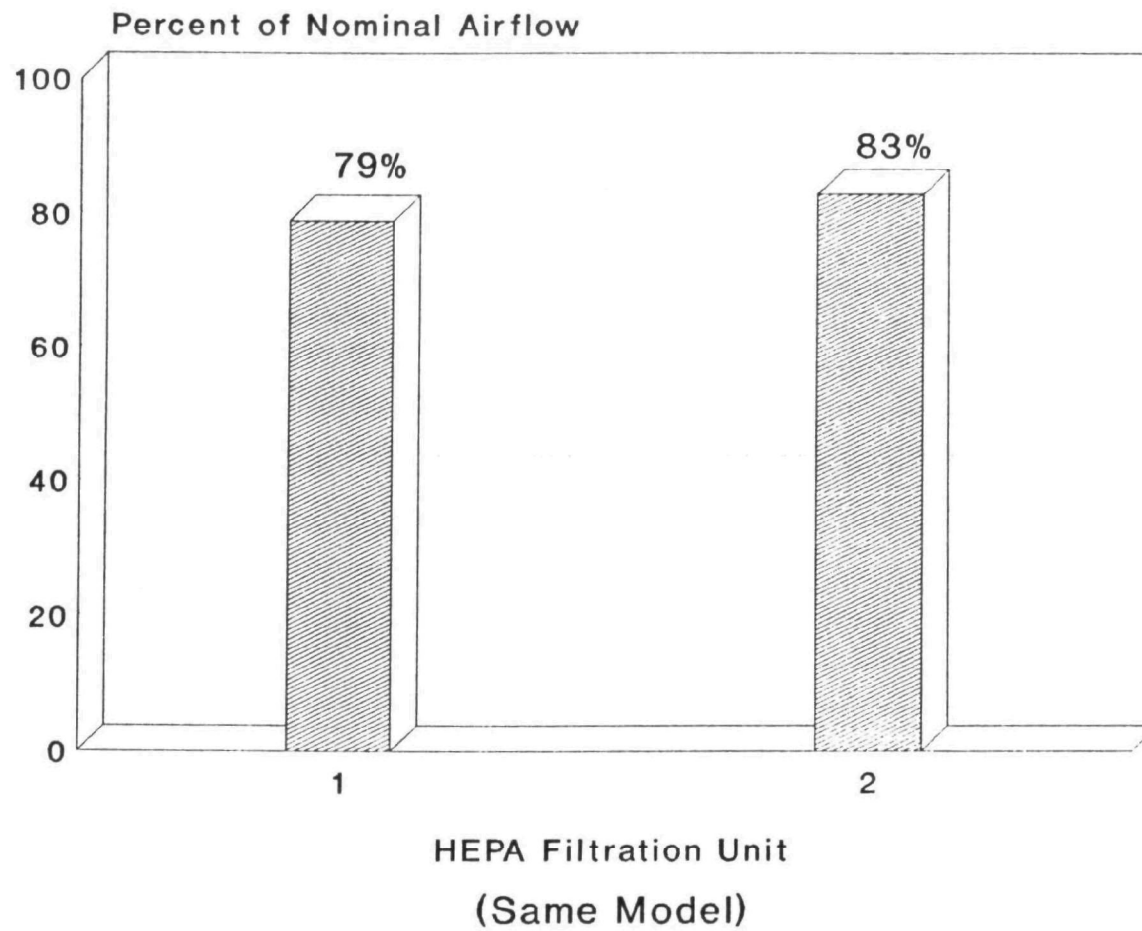
Figure T-1. Airflow performance for HEPA filtration systems operating during final cleanup.

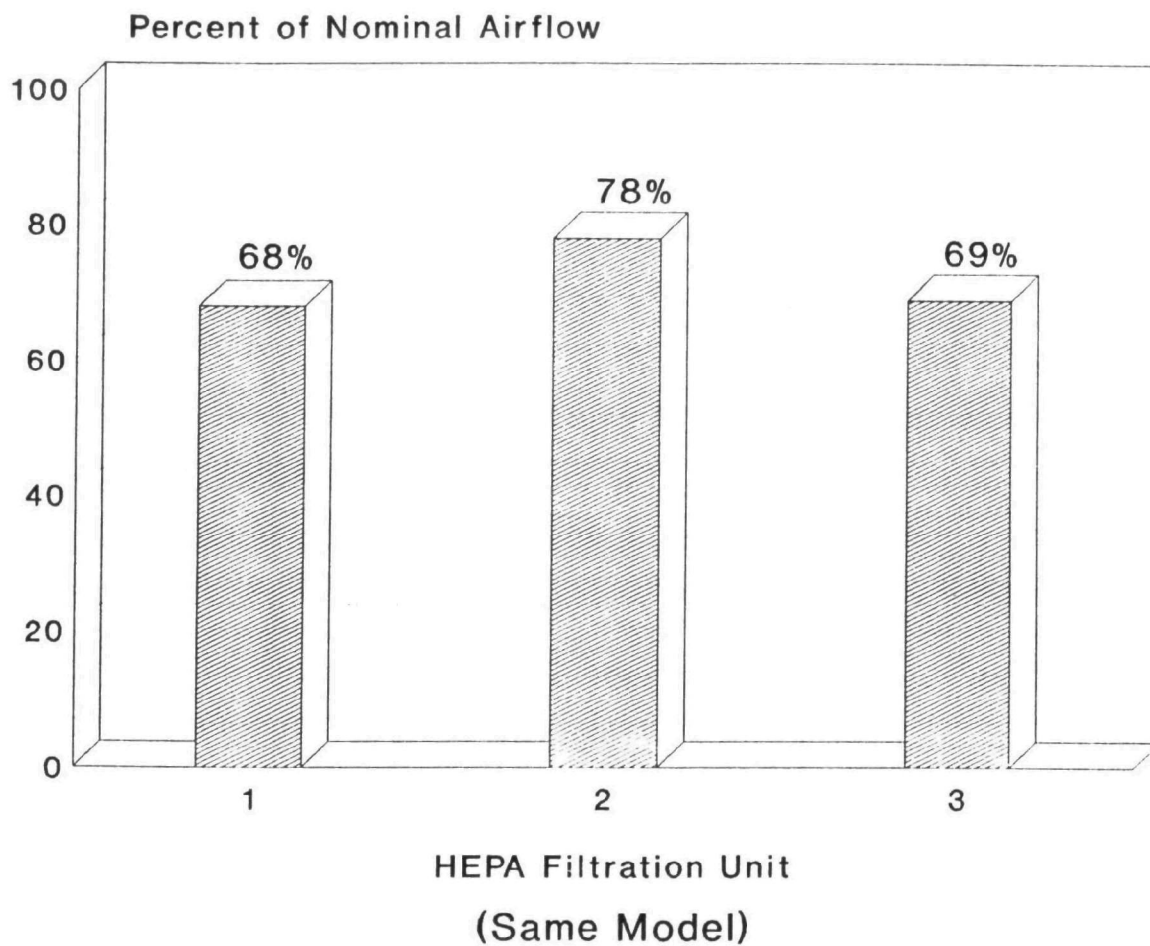
Figure T-2. Airflow performance for HEPA filtration systems operating during AHERA clearance.
