Materials for Oxygenated Wastewater Treatment Plant Construction

July 1978

H. K. Uyeda
B. V. Jones
T. E. Rutenbeck
J. W. Kaakinen

Division of General Research
Engineering and Research Center
Bureau of Reclamation
Denver, Colorado 80225

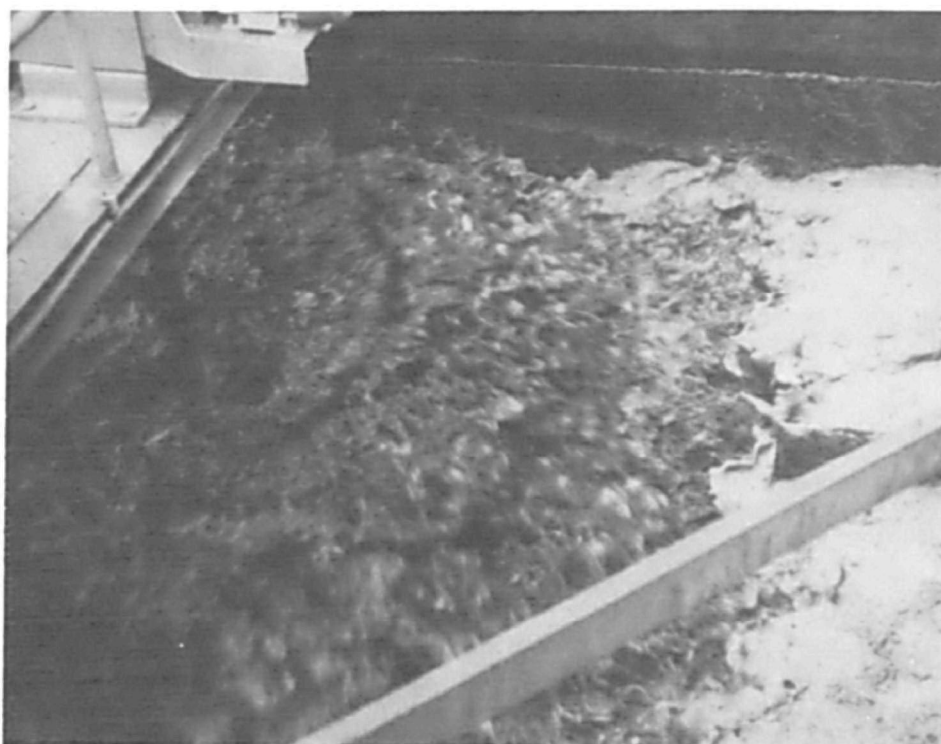
Figure 6. View of site 3 tank with cover removed to show splashing caused by the surface impeller. Test specimens were exposed to this splash zone effect.

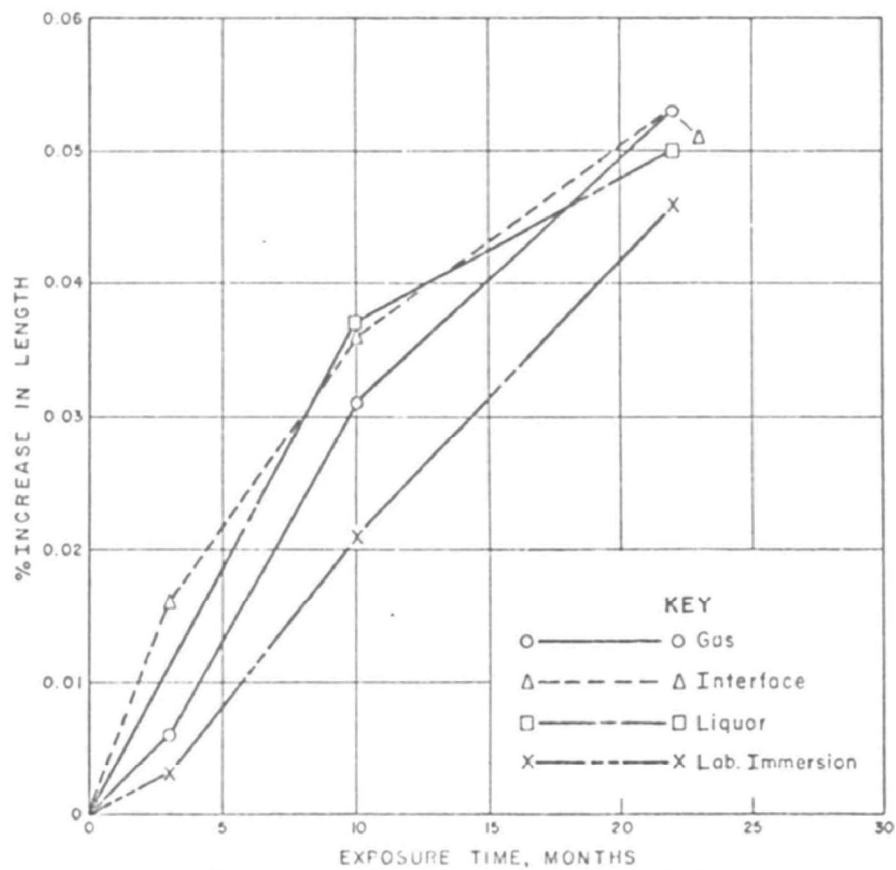
FIGURE 12. EFFECT OF SITE I EXPOSURE AND LABORATORY IMMERSION EXPOSURE ON LENGTH OF POLYMER IMPREGNATED CONCRETE

b. The effect of site exposures and laboratory immersion on the lengths of the PIC specimens are shown in figures 12, 13, and 14. The specimens continue to increase in length with duration of exposure. Although much less water is absorbed by the PIC specimens than the two conventional concretes, their increase in length after 22 and 28 months of exposure is of the same order of magnitude as the conventional concretes.
