# Field Demonstration of Innovative Condition Assessment Technologies for Water Mains: Leak Detection and Location

**FIELD DEMONSTRATION OF INNOVATIVE CONDITION ASSESSMENT TECHNOLOGIES  
FOR WATER MAINS: LEAK DETECTION AND LOCATION**

**Bruce Nestleroth, Stephanie Flamberg, Wendy Condit, and John Matthews  
Battelle**

**March 2012**

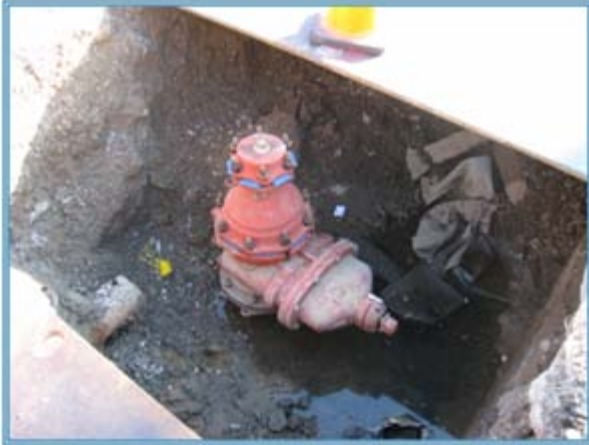
Sahara insertion site with valve and tap in Pit 1.

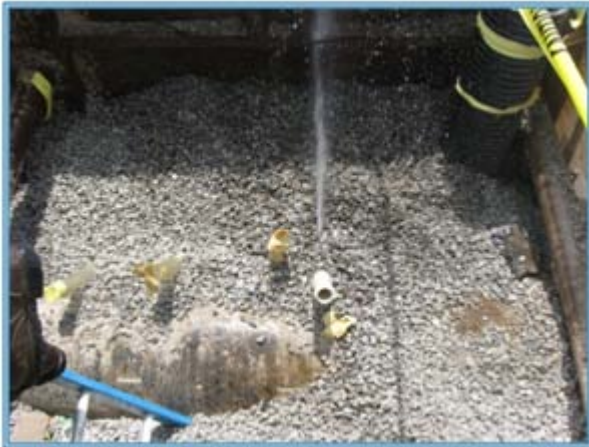
Valve creating a simulated leak in Pit 4.

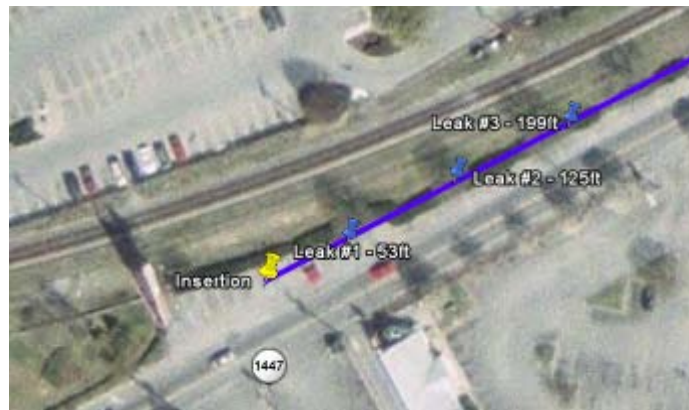
Figure 5.1c: Approximate Location of Leak

| Leak ID # | Distance from Start | Description | Approximate Size (US gpm) |
|---|---|---|---|
| 1 | 53ft | Leak (Small) | 0.15 |

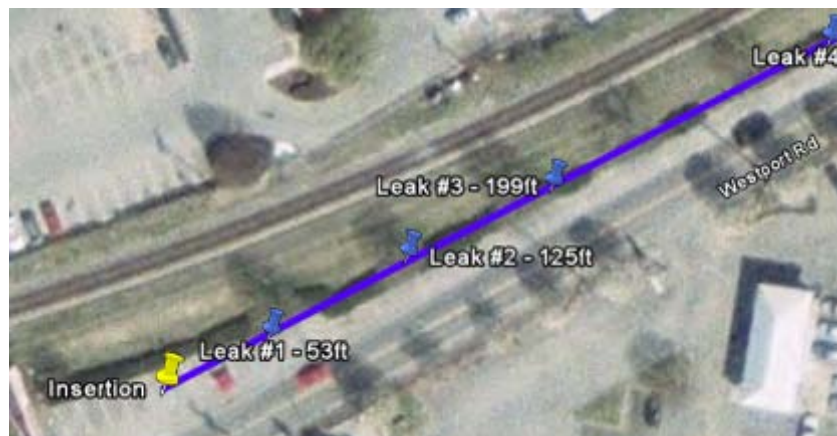
Figure 5.3c: Approximate Location of Leak

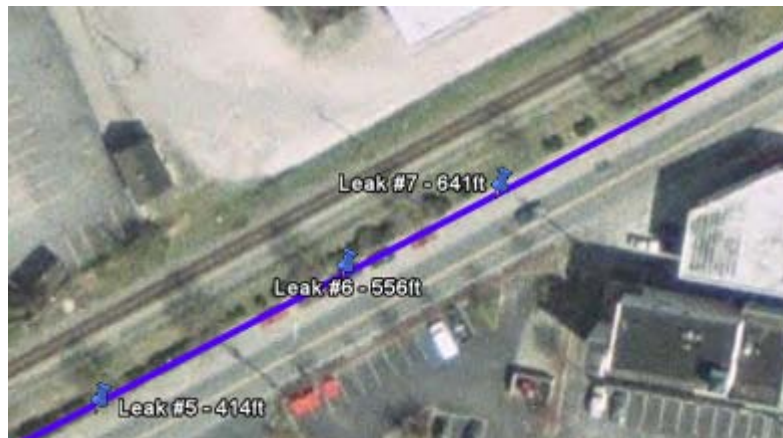
Figure 5.6c: Approximate Location of Leak

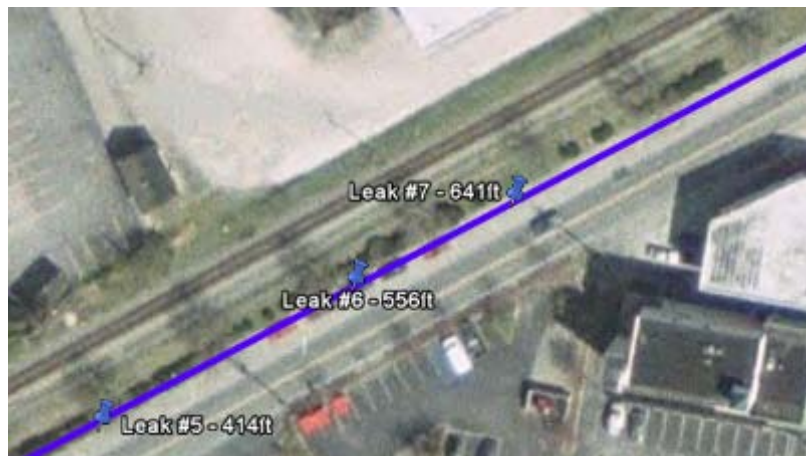
Figure 5.7c: Approximate Location of Leak

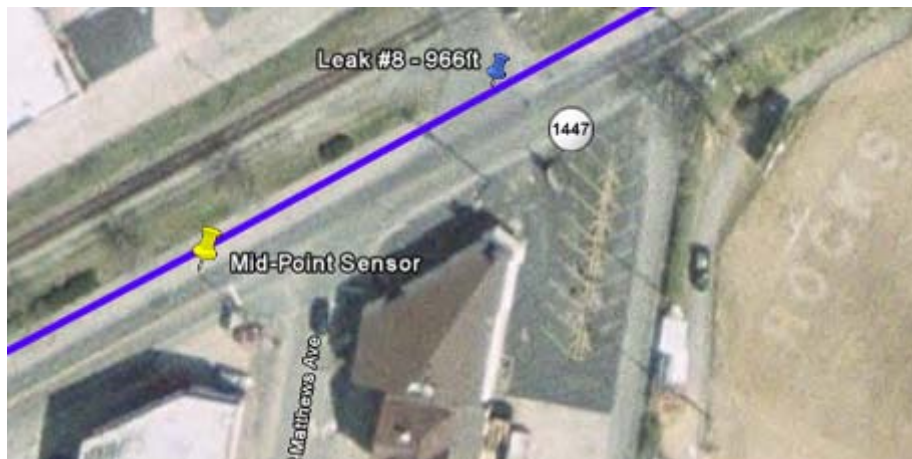
Figure 5.8c: Approximate Location of Leak

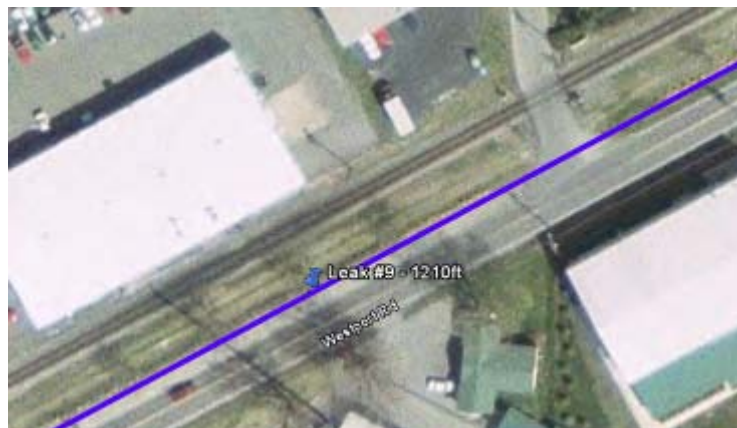
Figure 5.9c: Approximate Location of Leak

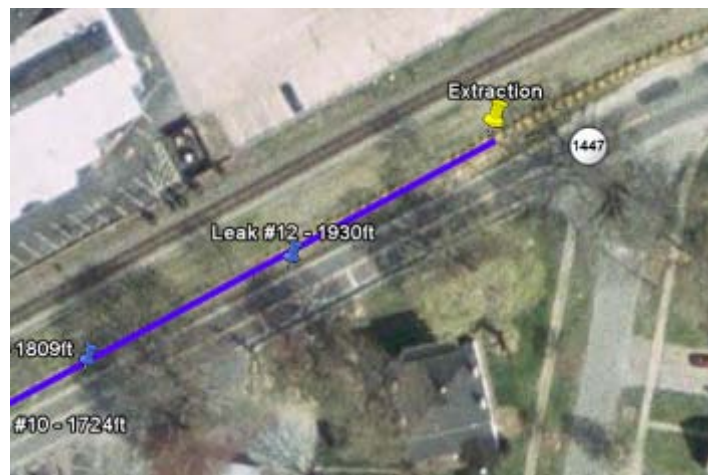
Figure 5.12c: Approximate Location of Leak

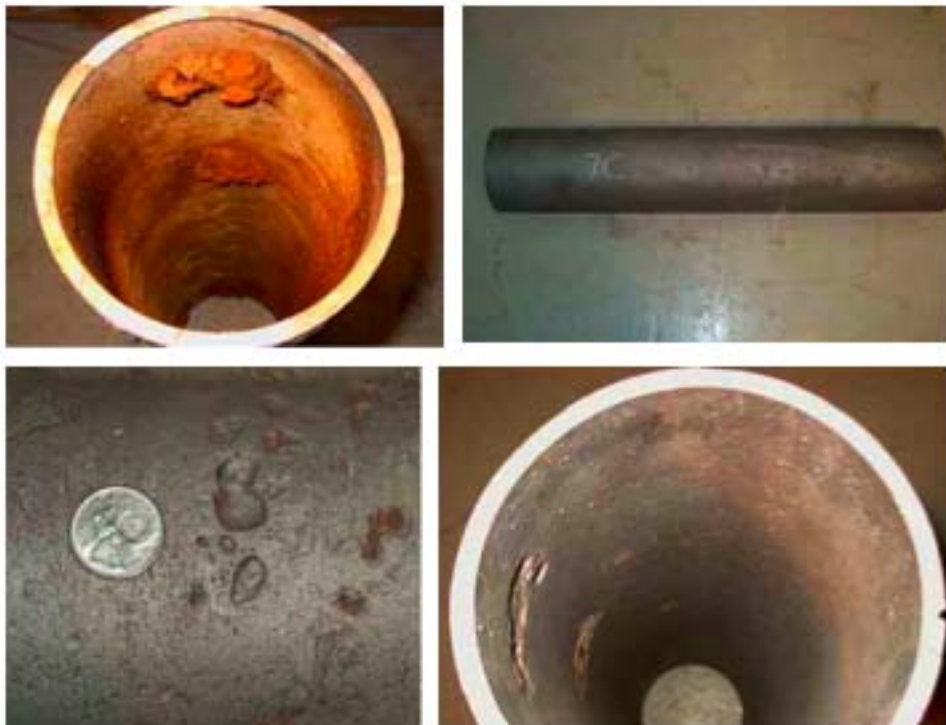
Figure 2: Photos of pipe with 8.9% measured loss

Figure 2 shows photographs of a section of pipe measured at 8.9% average loss. The physical thickness of this pipe was measured at  $8.8 \pm 0.8$ mm ( $0.35 \text{in} \pm 0.03 \text{in}$ ) (nominal was 9mm), with average pit depth at 2.5mm / 3.0mm. The condition of the pipe was rated as very good / moderate. The corrosion of this pipe was primarily localized internally on the bottom of the pipe as can be seen in the right photo. The corrosion appeared in this case more continuous perhaps due to sediment build up at the bottom of the pipe. Overall the structural integrity of the pipe is good.

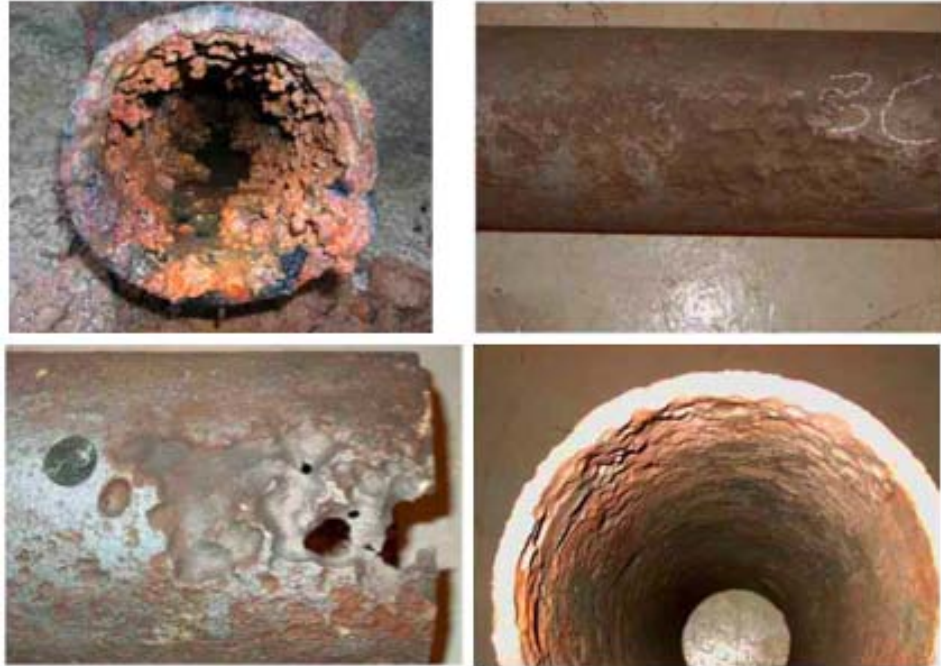
**Figure 3: Photos of pipe with 47.3% measured loss**

Figure 3 provides photographs of a pipe with a measured 47.3% average loss of pipe wall thickness (11.0mm, 0.43in nominal). In the lab the average physical thickness was measured as  $11.6 \pm 3.3$ mm ( $0.456 \text{in}, \pm 0.13 \text{in}$ ) and an average pit depth of 3.8mm / 2.5mm. The physical condition of the pipe was described as very poor / poor. Note that there were also numerous through holes in the pipe evident after sand blasting. It is interesting to note that the pipe was not leaking when measured, probably due to the build up of tuberculation.
