EPA/OSHA JOINT CHEMICAL ACCIDENT INVESTIGATION REPORT

Napp Technologies, Inc.
Lodi, New Jersey

The EPA/OSHA Accident Investigation Program

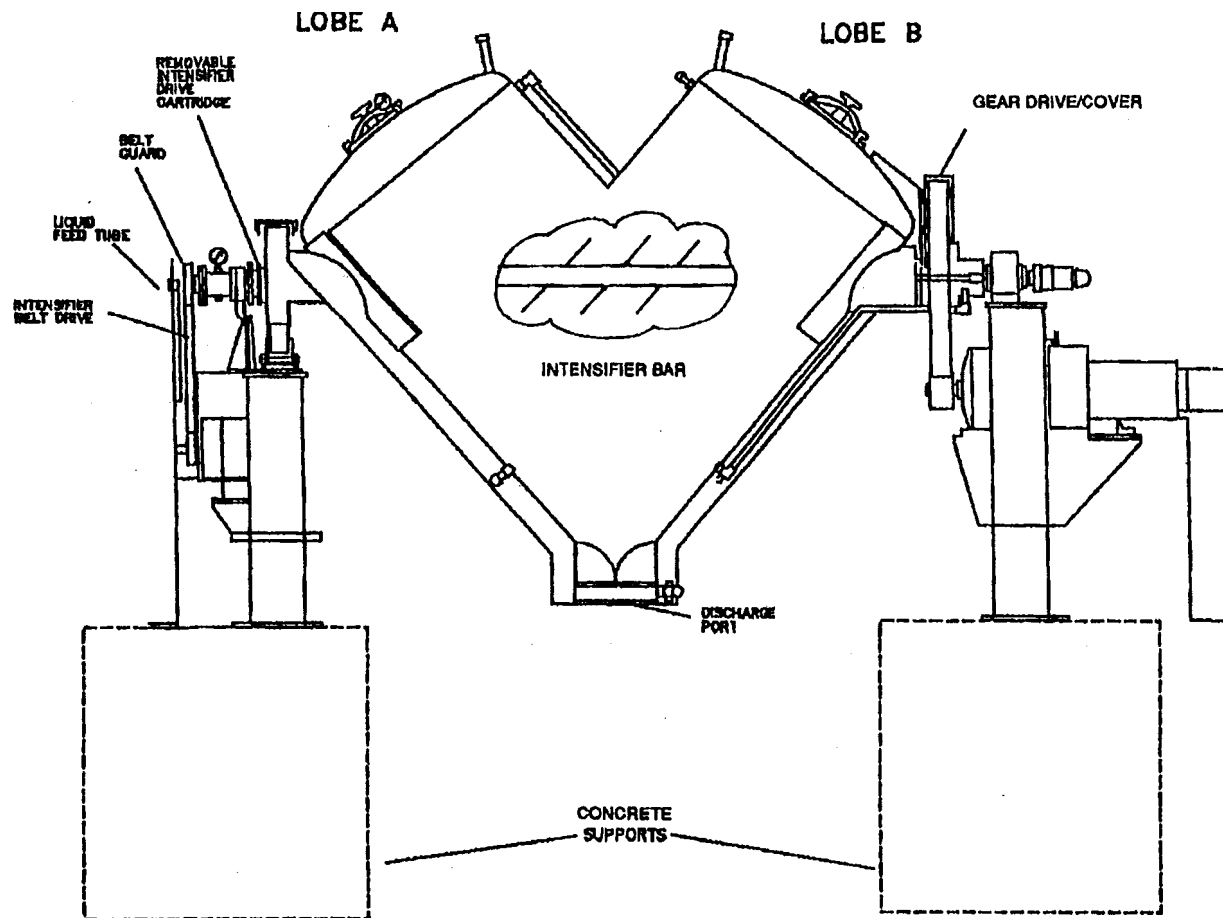
FIGURE 2

Figure 2 shows a typical Patterson-Kelley V-shaped blender. Patterson-Kelley builds each blender with options and features as specified by the purchaser. The blender at Napp had a working capacity of 6 cubic meters (125 cubic feet). It was approximately 6 meters wide (19 feet), including supports, and 3 meters (10 feet) high. The blender is a double-lobed stainless steel shell shaped like a heart. It is supported on its widest dimension by a horizontal trunnion attached to support tubes set in cement footings. It is insulated with a rigid foam material and encased in a steel jacket containing a water/glycol mixture for cooling and heating. The two access covers on top of the blender are used for loading raw materials, and one port is located at the bottom for off-loading product. A gear to one side of the blender (right side of Figure 2) rotates the shell of the blender through a 360-degree arc. Several water lines enter the jacket on this side. On the other side (left side of Figure 2) of the blender, a vacuum tube housing enters the blender. A graphite seal located inside the vacuum tube separates the seal's cooling water from the internal area of the vacuum tube and the blender. The purpose of the vacuum tube housing is to: (1) act as a conduit for establishing vacuum conditions when the blender is used for drying and other operations; and (2) contain other concentric lines, shafts, etc., including a liquid feed line (added by Napp) and the shaft used to rotate an intensifier bar (I-bar). The purpose of the I-bar is to enhance the mixing of materials being blended. The purpose of the feed line is to allow the controlled introduction of liquids to the materials being blended. The PK-125 blender can be used with or without the I-bar in service. The I-bar, Figure 3, transverses the inner walls of the blender connecting the inner sides of the blender on the same plane as the trunnion. See Figures 4-8 showing a larger but similar blender and associated equipment.

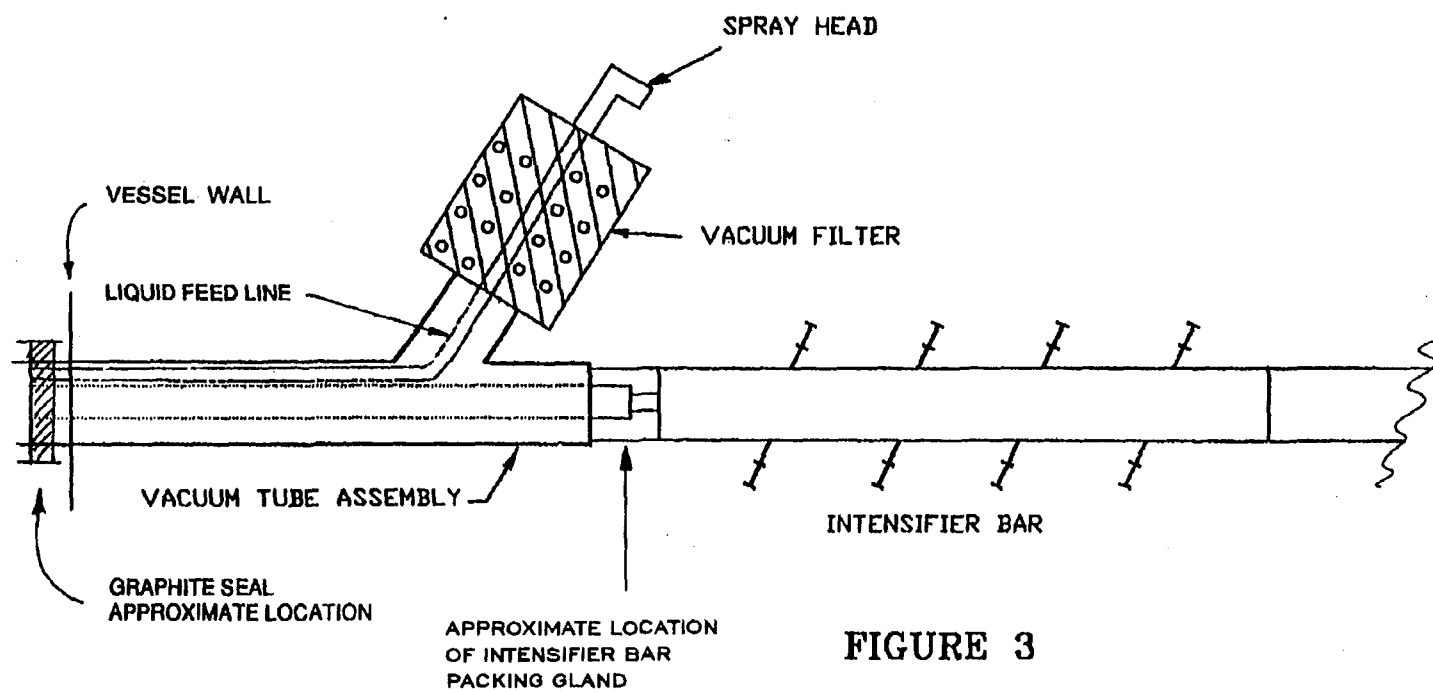
FIGURE 3

The maintenance foreman instructed a maintenance employee to remove and change the packing gland associated with the intensifier bar on the PK-125 blender. This activity was standard procedure whenever there was a scheduled product change for one of the Napp P-K blenders. After removing the old packing gland and its housing, the maintenance employee observed water next to a bearing. Based on this observation, the maintenance foreman instructed the maintenance employee

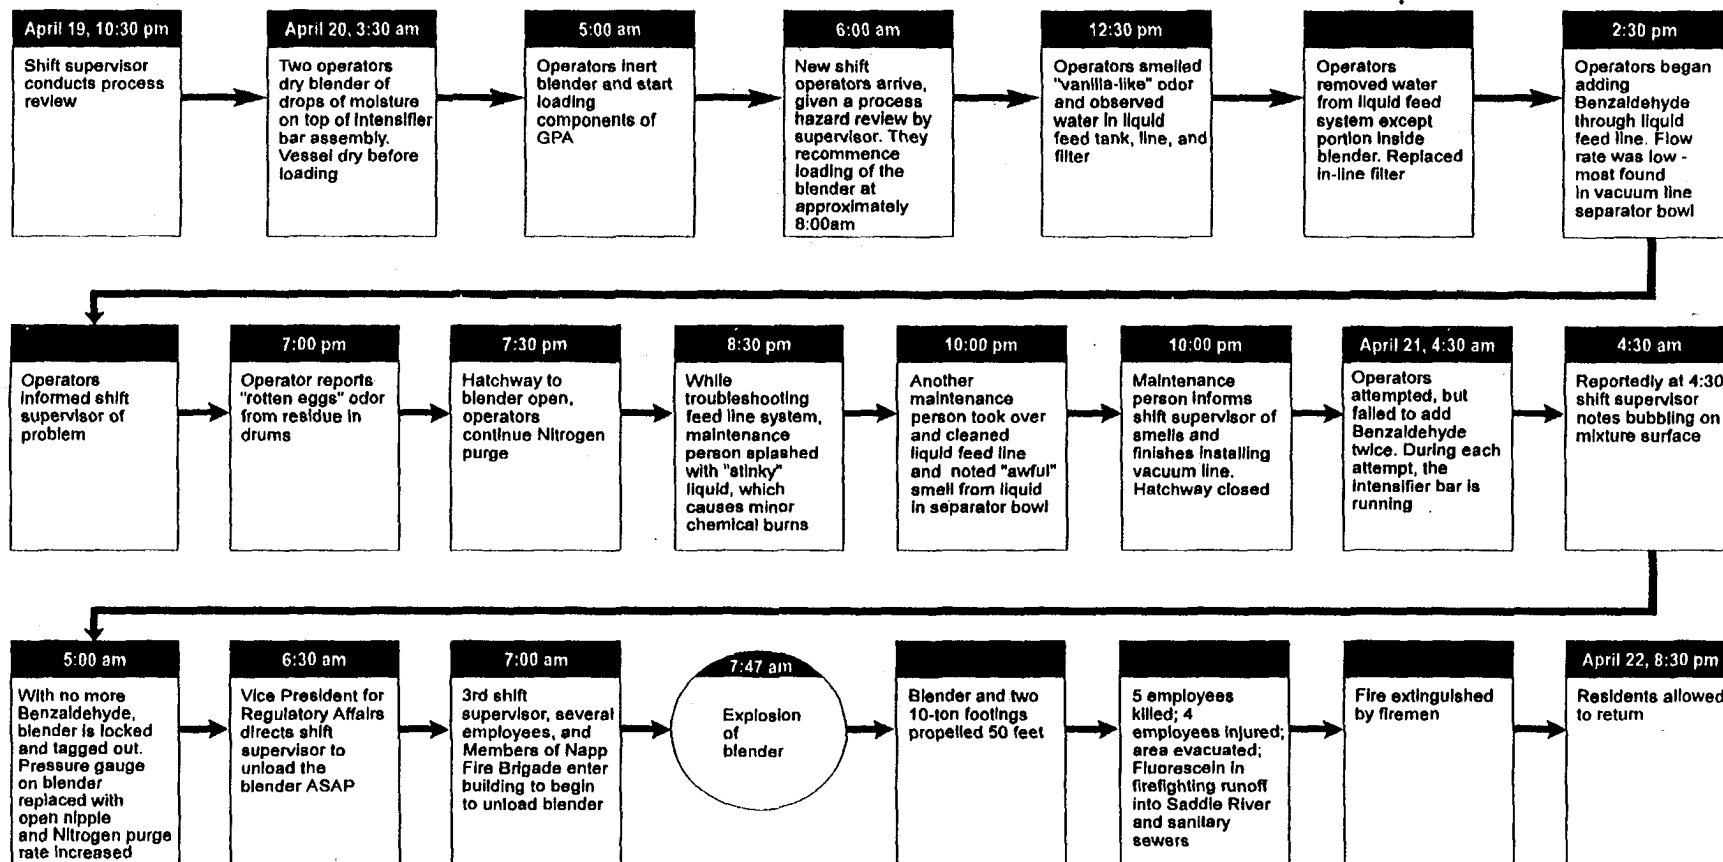
Timeline of Events

April 21, 1995 Explosion of Blender at Napp Technologies, Inc. - Lodi, NJ

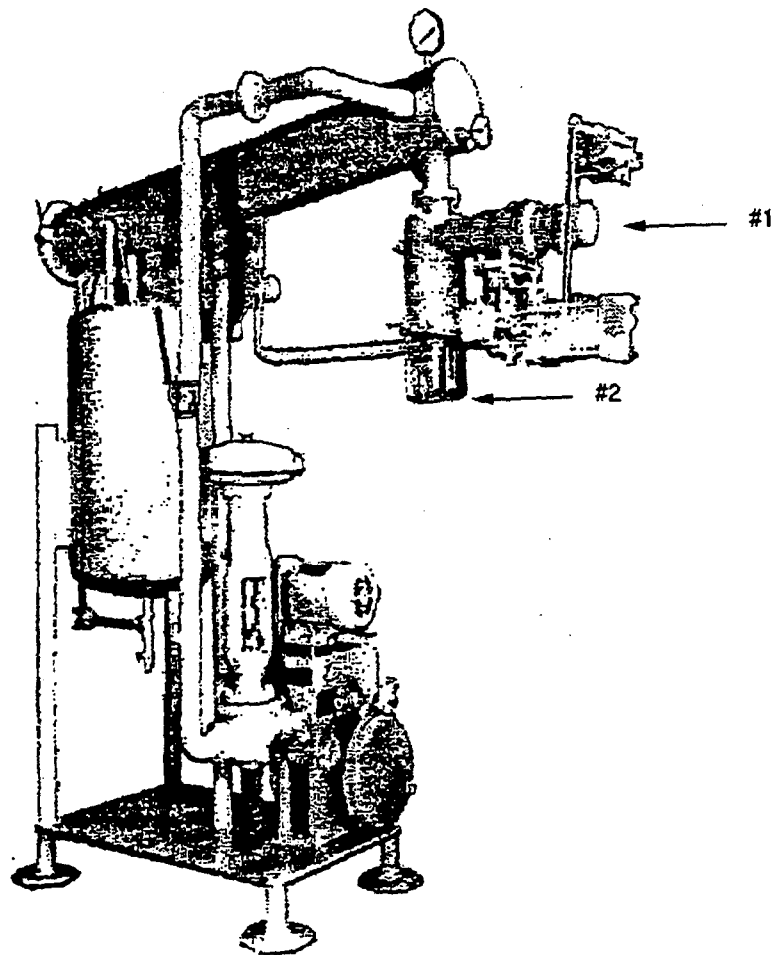
FIGURE 3A: TYPICAL VACUUM COLLECTION SYSTEM As SUPPLIED BY PATTERSON-KELLEY. # 1 SHOWS APPROXIMATE LOCATION OF INLET FROM BLENDER VACUUM LINE; # 2 SHOWS VACUUM SEPARATOR BOWL.

Between midnight and 4:30 a.m. on April 21, 1995, the third shift attempted to inject benzaldehyde into the batch on two occasions; each attempt failed. Operators observed the benzaldehyde running back into the vacuum separator. During each attempt to add the liquid, the blender was rotated for about two minutes with the intensifier bar running. Suspecting that product was blocking the spray tip of the nozzle and preventing the injection of the liquid, operators opened the blender twice and removed and washed the spray nozzle. Operators reportedly observed a slight dusty powder wafting within the head space of the blender. This was reported to the shift supervisor, who then checked the inside of the blender and directed the operators to remove and clean the nozzle. After the final attempt to charge benzaldehyde into the vessel it was determined that no fresh benzaldehyde remained. It was by then approximately 5:00 a.m. and coming to the end of the third shift. The shift supervisor told the operators to perform a lock and tagout of the blender.

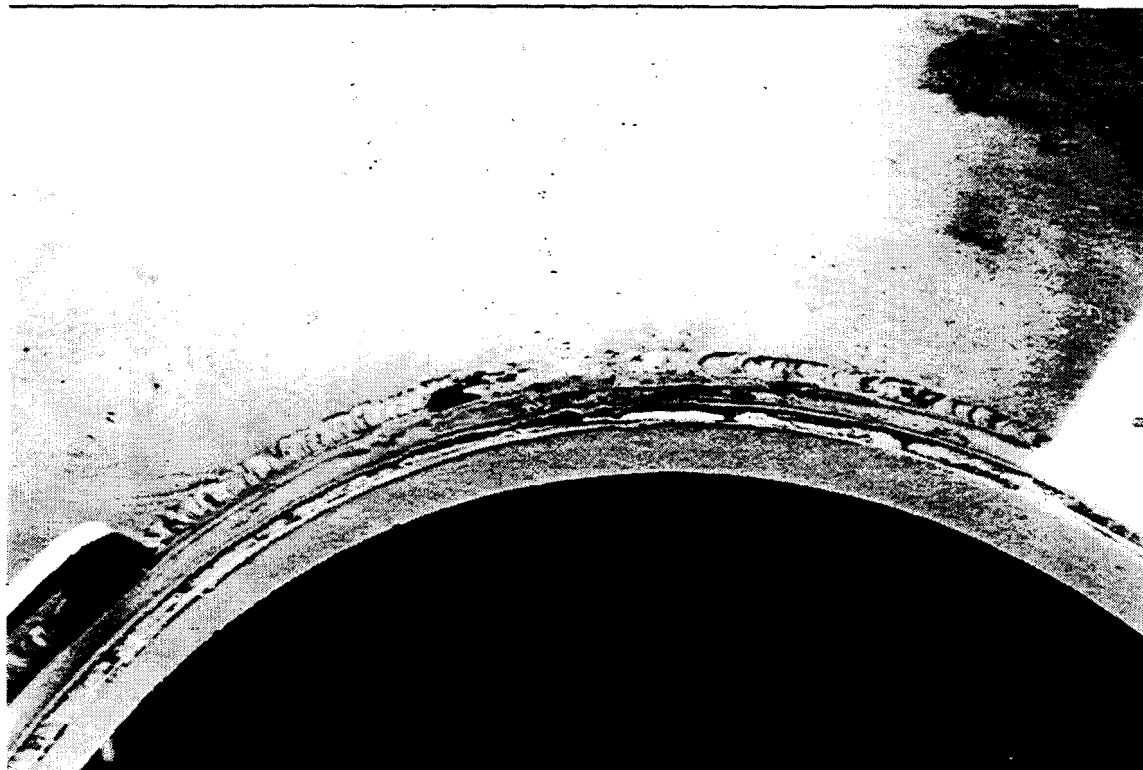
Figure 4: One of the top loading ports on the 150 cubic foot blender showing how the insulation jacket is attached (weld) and access door tabs.

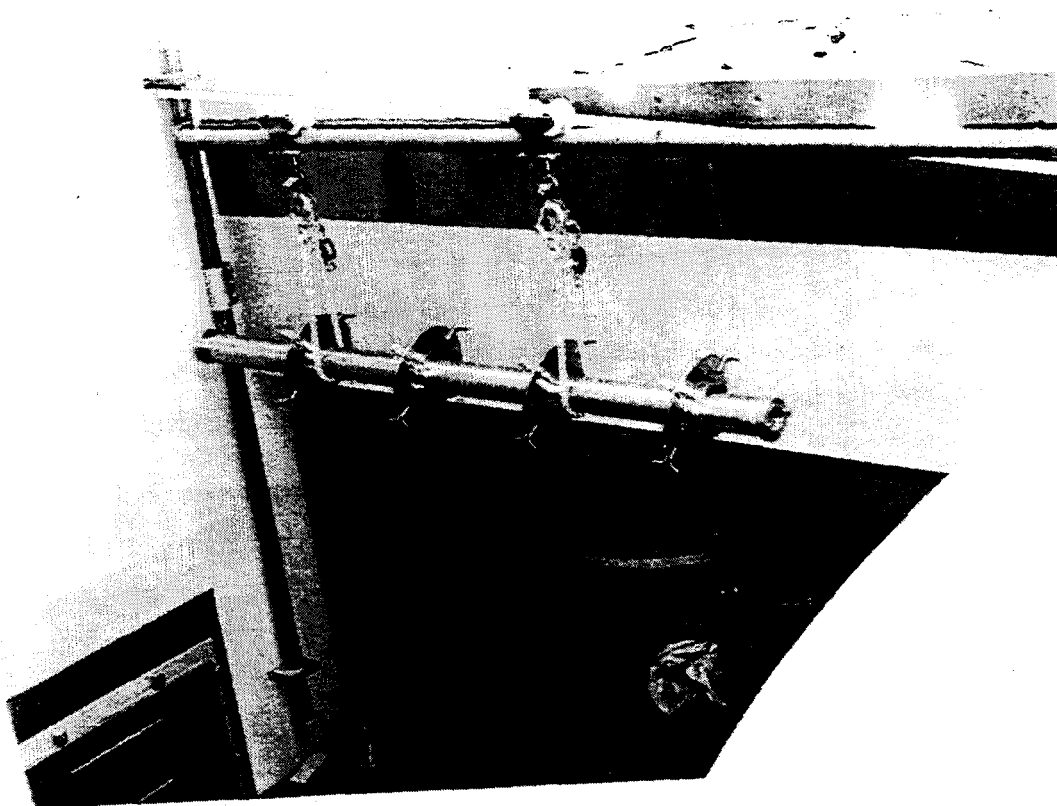
Figure 6: The intensifier bar for a PK-150 cubic foot blender shown in its storage position.

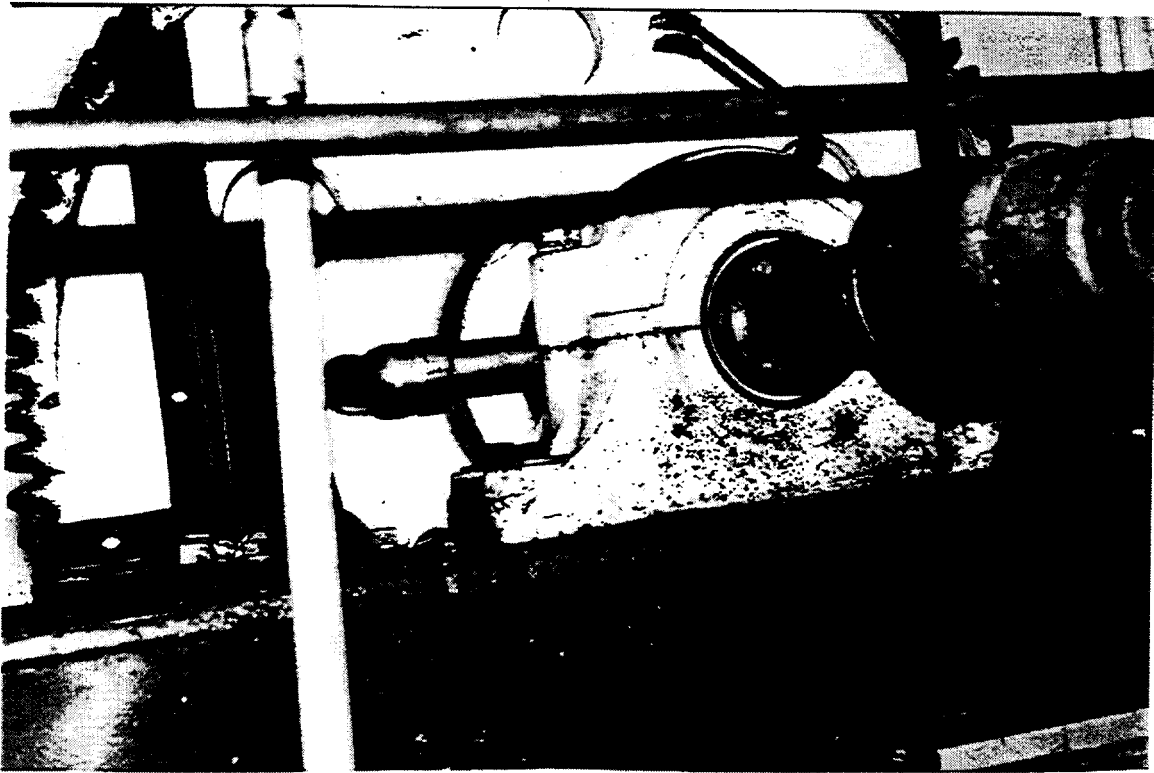
Figure 7: The gear drive and bearing that supports one side of a 150 cubic foot blender.

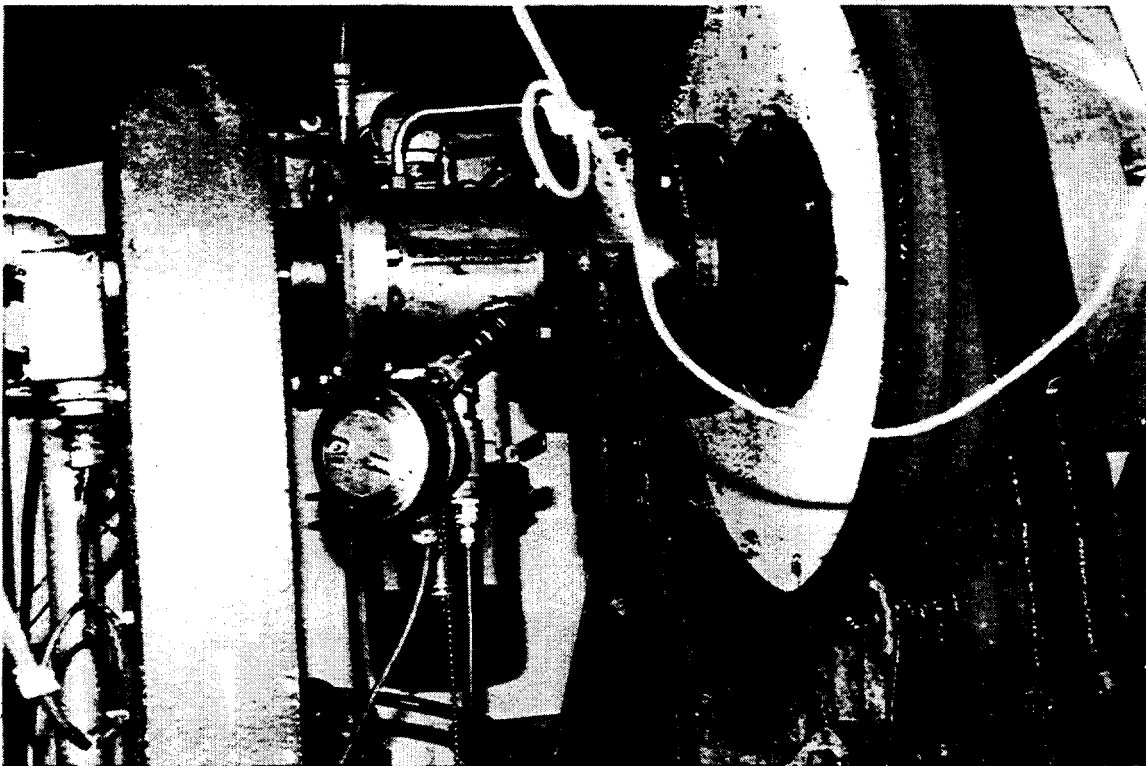
Figure 8: The other side support (intensifier bar drive side) of a 150 cubic foot blender.
