EPA CHEMICAL ACCIDENT INVESTIGATION REPORT

**Powell Duffryn
Terminals, Inc.
Savannah, Georgia**

EXECUTIVE SUMMARY

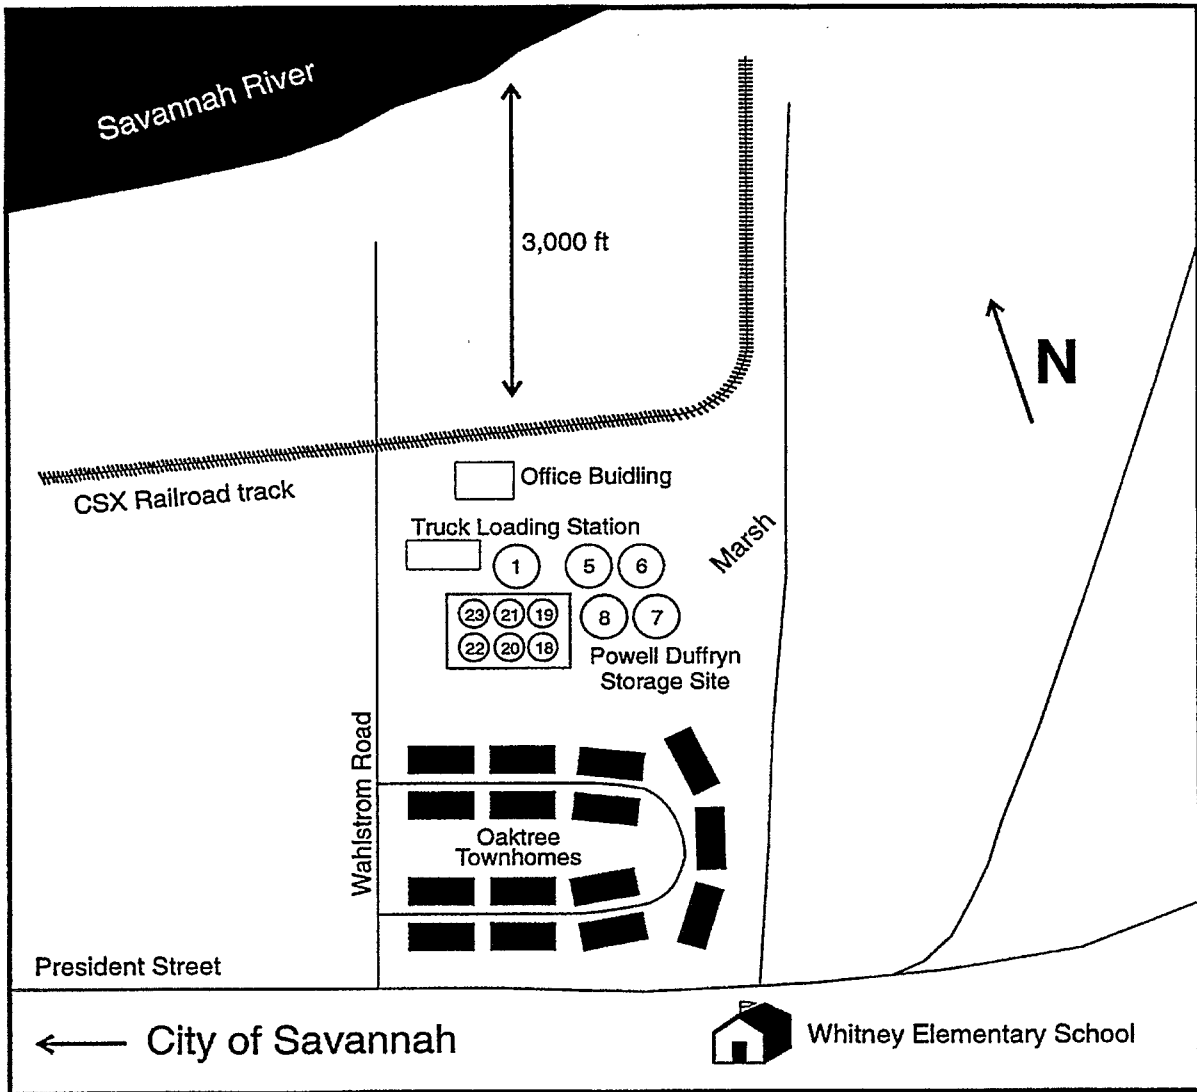
Exhibit 1 Powell Duffryn Terminal Site

The six-tank enclosure area is about 100 by 200 feet (20,000 square feet in area). A diagram of the enclosure area along with the approximate capacity and contents of each tank is presented in Exhibit 2. The enclosure area is located slightly north of the midpoint of Powell Duffryn's southern property line. Five other tanks, much larger than the tanks in the enclosure, are located to the north and east of the enclosure.^{8,9} (These other tanks are also shown in Exhibit 1.)

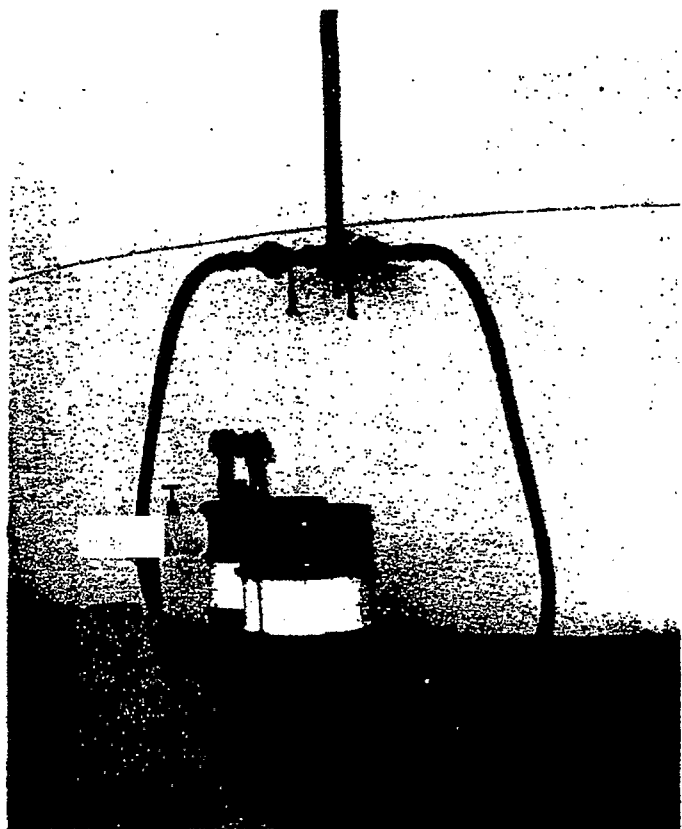
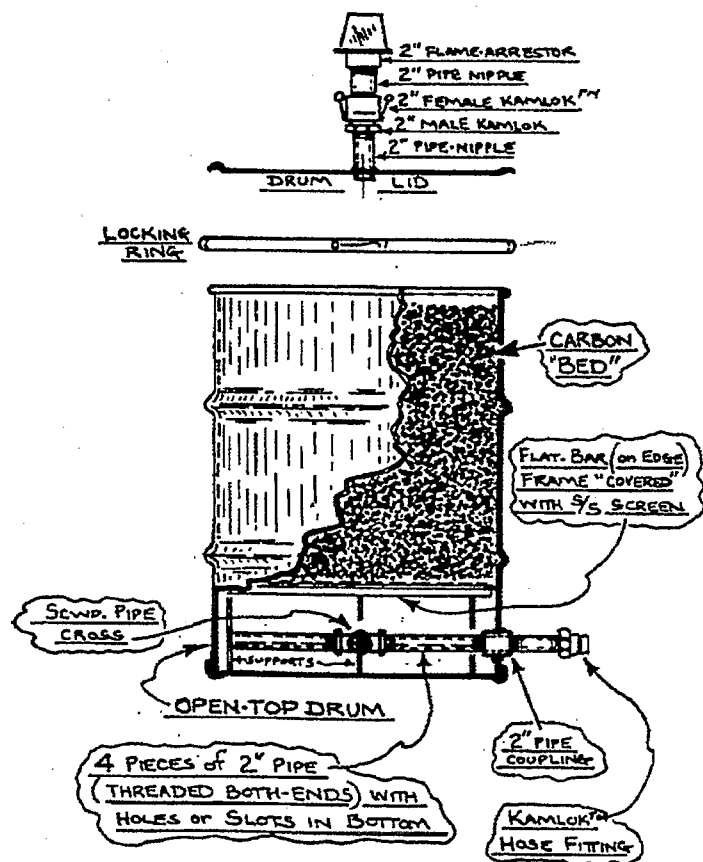
Figure 1. Details of carbon bed adsorber.

Now, this is typical. "10:45" was 10:45 p.m. The day had been hot, 95° or more, and the tank was exposed to full sunlight. We expect that within the crude sulfate tank the temperature rose to 135°F or more, the liquid expanded and vaporized, forcing vapor-laden air out through the tank vent. It is now evening, and cooling has

begun. Initially, vapor condenses creating a slight vacuum in the tank. Air is drawn in with oxygen to oxidize the hot adsorbed organic molecules spread in a thin layer on the carbon particles.

The adsorbers at Organic Chemicals are home-made from 55-gal. drums. Figure 1 shows the details of a typical drum. The carbon is confined between screens in a circular bed about 2 ft. deep. About 200 lb. of carbon are used in a bed. Flow through the bed is along the long axis of the drum. Flow is very slow. Where flow seems to be excessive two or four units are used in parallel.

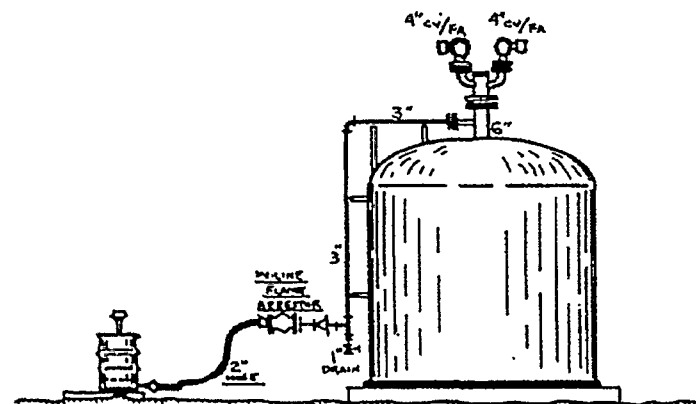
Figure 2. Typical single-drum adsorber connections to tank.

The typical installation of adsorbers, shown in Figure 2, indicates several important points:

Safety. The limited size of the module, the location of the installations, isolation of adsorbers from the source of odor that they control, and accessibility of the units are all factors that have protected the plant from fires and the
