# **EXPERT REVIEW OF EPA/OSHA JOINT CHEMICAL ACCIDENT INVESTIGATION REPORT**

**Napp Technologies, Inc.  
Lodi, New Jersey**

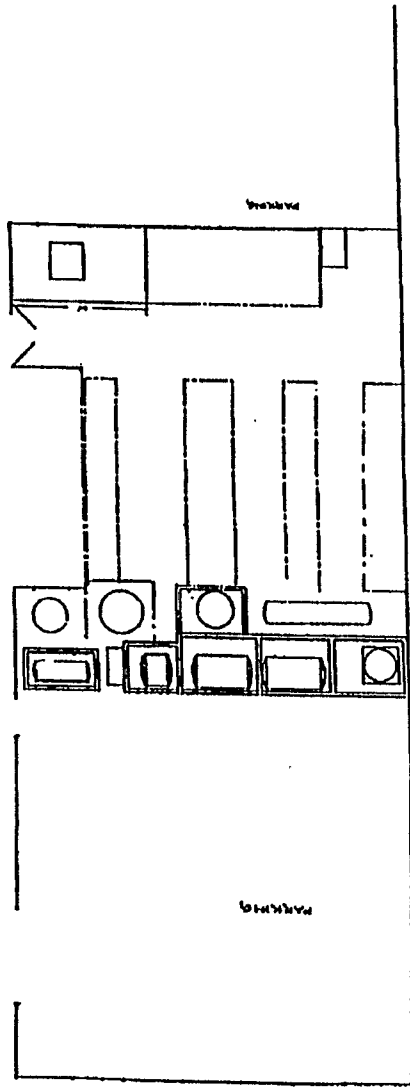
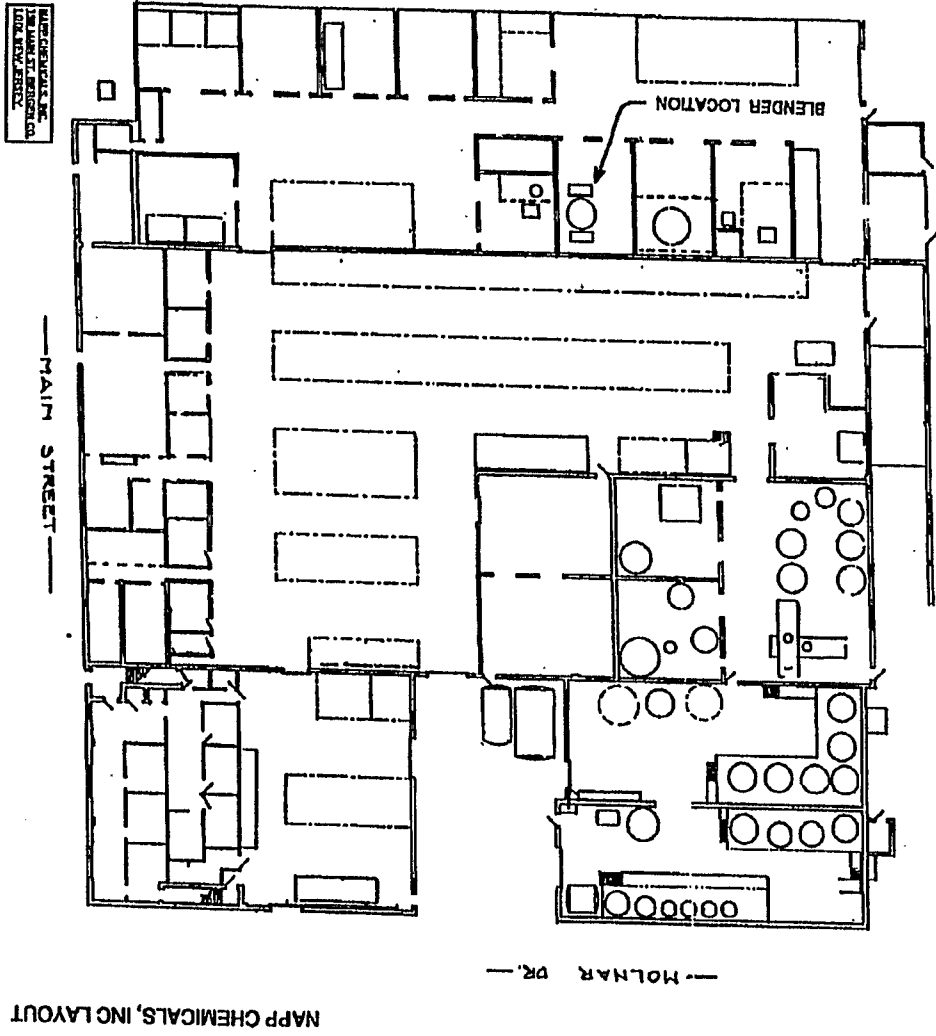
FIGURE 1

The Patterson-Kelley (PK) 125 blender used in the GPA blending operation was located in the PK-125 Blending Room, located in the Pulverizing and Blending Department on the South side of the facility, near the main warehouse area (see Figure 1).

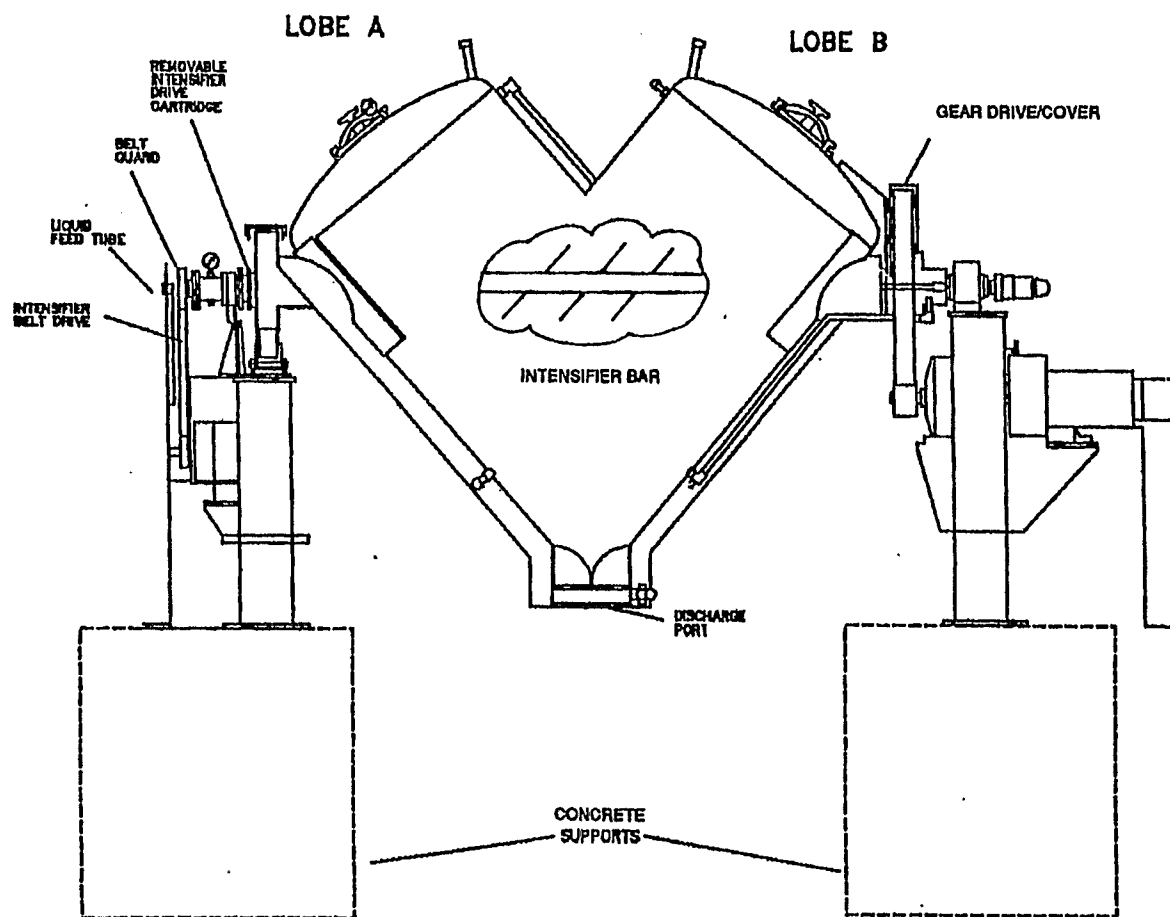
FIGURE 2

Figure 2 shows a typical Patterson-Kelley V-shaped blender. Patterson-Kelley builds each blender with options and features as specified by the purchaser. The blender at Napp had a working capacity of 6 cubic meters (125 cubic feet). It was approximately 6 meters wide (19 feet), including supports, and 3 meters (10 feet) high. The blender is a double-lobed stainless steel shell shaped like a heart. It is supported on its widest dimension by a horizontal trunnion attached to support tubes set in cement footings. It is insulated with a rigid foam material and encased in a steel jacket containing a water/glycol mixture for cooling and heating. The two access covers on top of the blender are used for loading raw materials, and one port is located at the bottom for off-loading product. A gear to one side of the blender (right side of Figure 2) rotates the shell of the blender through a 360-degree arc. Several water lines enter the jacket on this side. On the other side (left side of Figure 2) of the blender, a vacuum tube housing enters the blender. A graphite seal located inside the vacuum tube separates the seal's cooling water from the internal area of the vacuum tube and the blender. The purpose of the vacuum tube housing is to: (1) act as a conduit for establishing vacuum conditions when the blender is used for drying and other operations; and (2) contain other concentric lines, shafts, etc., including a liquid feed line (added by Napp) and the shaft used to rotate an intensifier bar (I-bar). The purpose of the I-bar is to enhance the mixing of materials being blended. The purpose of the feed line is to allow the controlled introduction of liquids to the materials being blended. The PK-125 blender can be used with or without the I-bar in service. The I-bar, Figure 3, transverses the inner walls of the blender connecting the inner sides of the blender on the same plane as the trunnion. See Figures 4-8 showing a larger but similar blender and associated equipment.

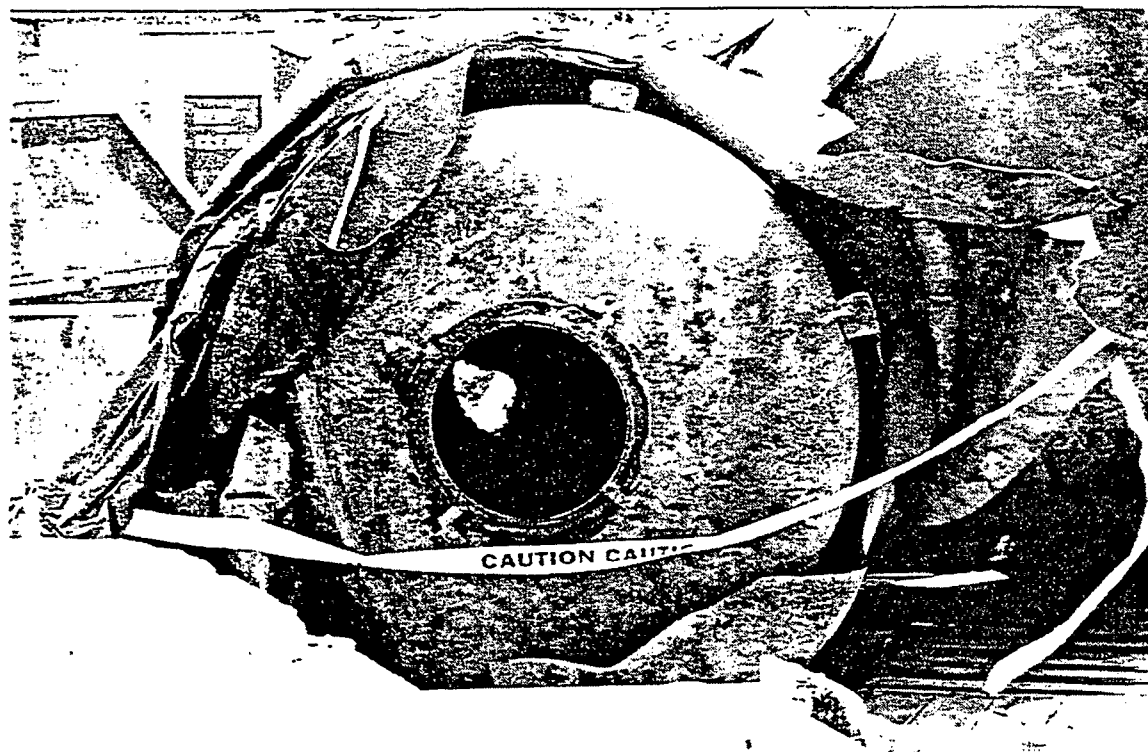
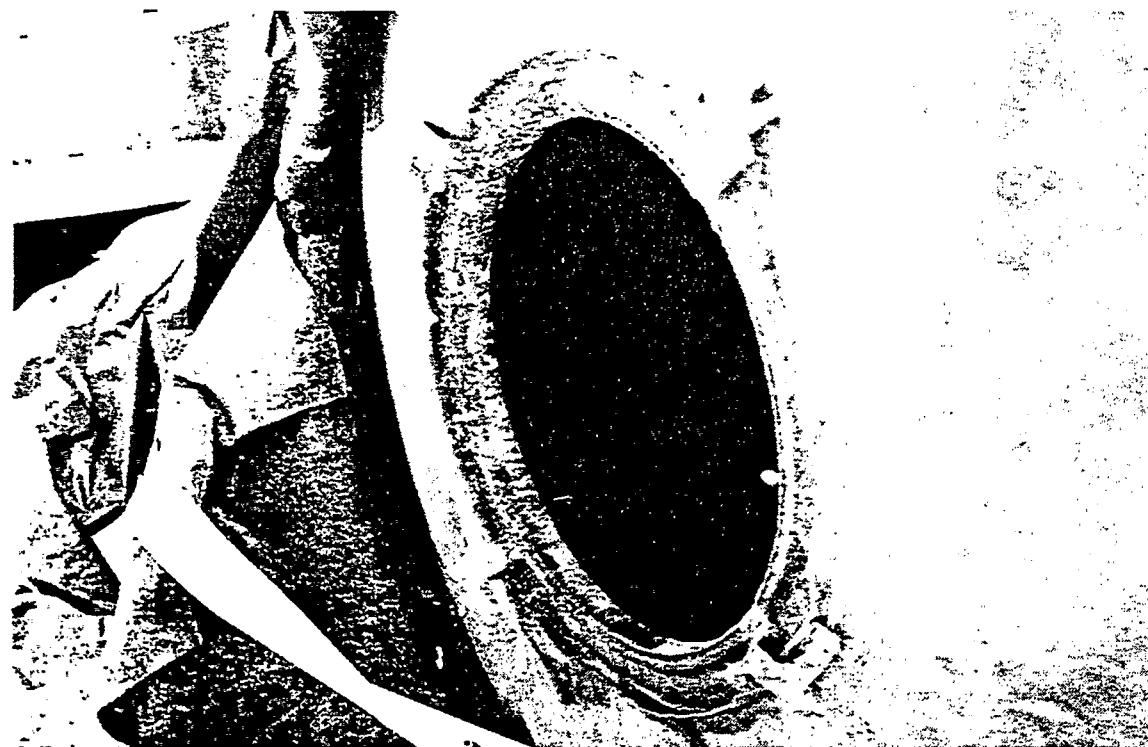
Figure 10: Top access port: a) looking through a top port and out the bottom off-load port, and b) close-up view of a top port.

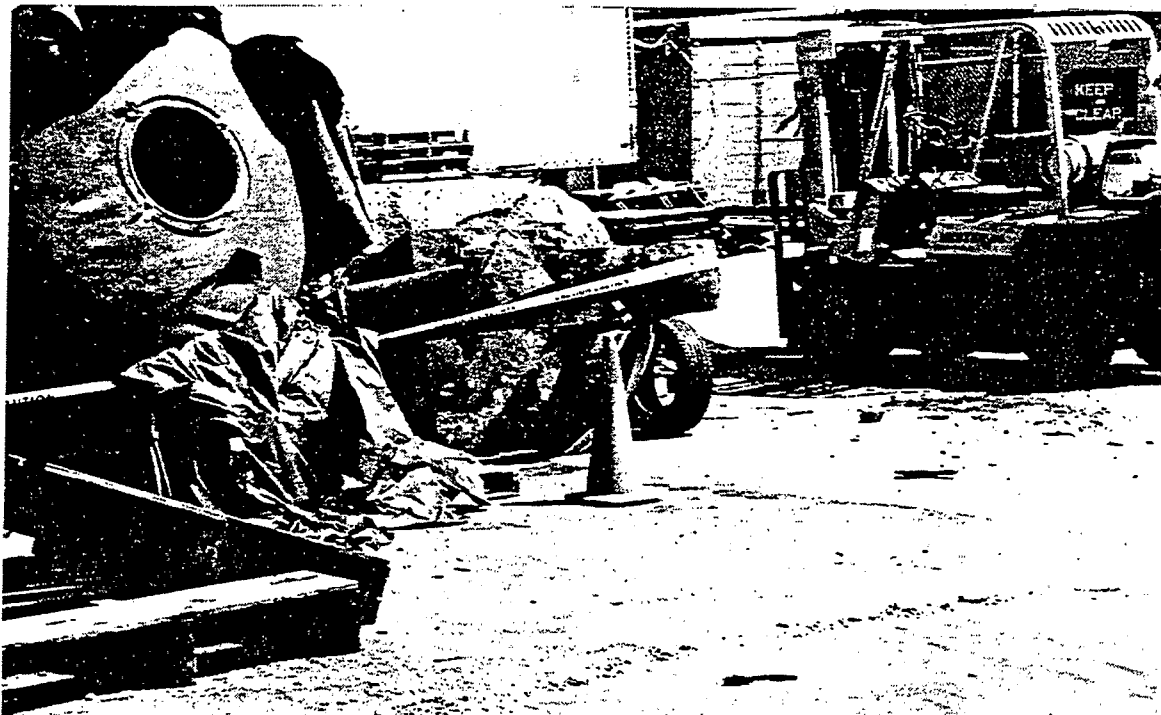
Figure 17: The concrete support and bracket that secured the bearing on the gear drive side of the blender.

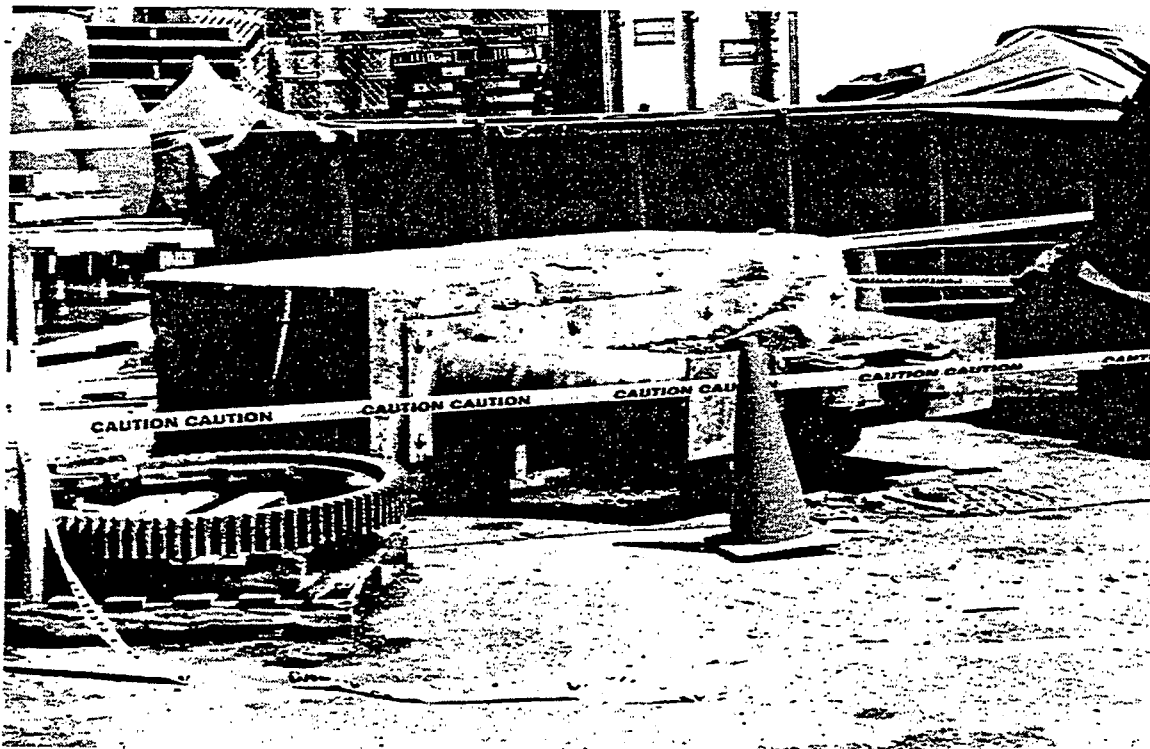
Figure 18: The concrete support and rollers that supported the belt drive side of the blender.

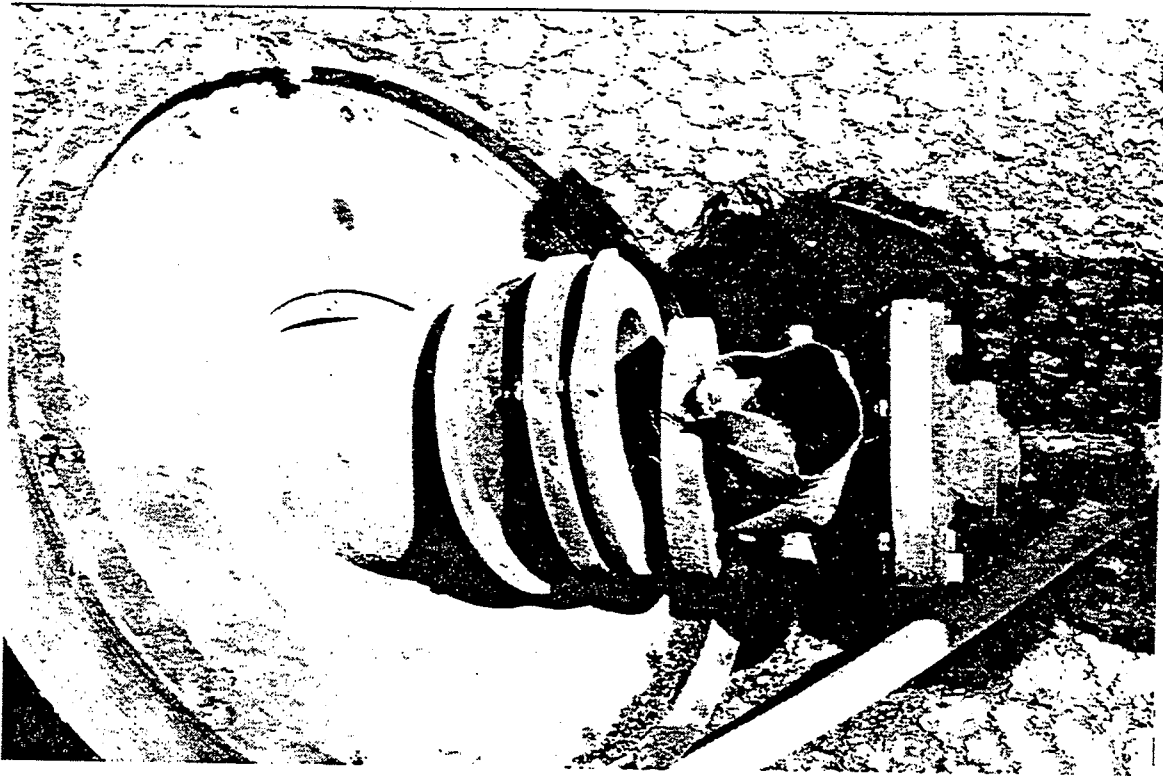
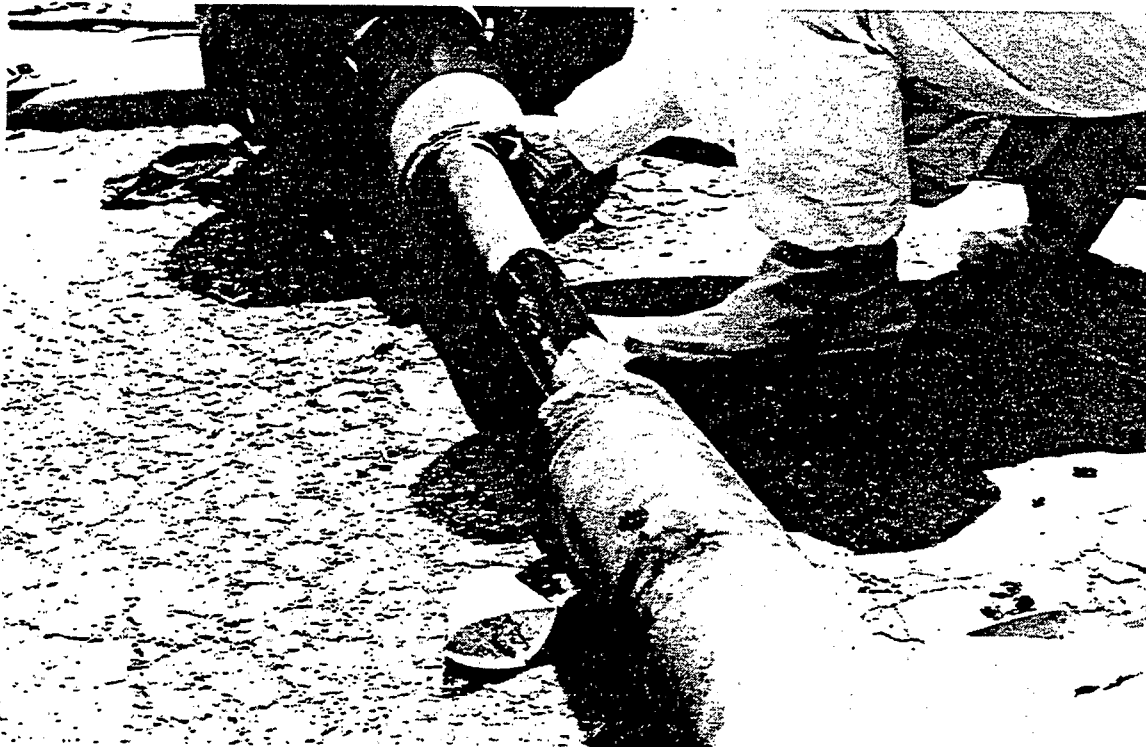
Figure 20: The wheel that supported the blender on the belt drive side and the shaft components: a) the wheel and shaft, b) the concentric shafts and tube that went into the interior of the blender.
