# **EPA/OSHA JOINT CHEMICAL ACCIDENT INVESTIGATION REPORT**

**Surpass Chemical Co., Inc.  
Albany, NY**

### **Surpass Chemical Company, Inc., Albany, New York, April 8, 1997**

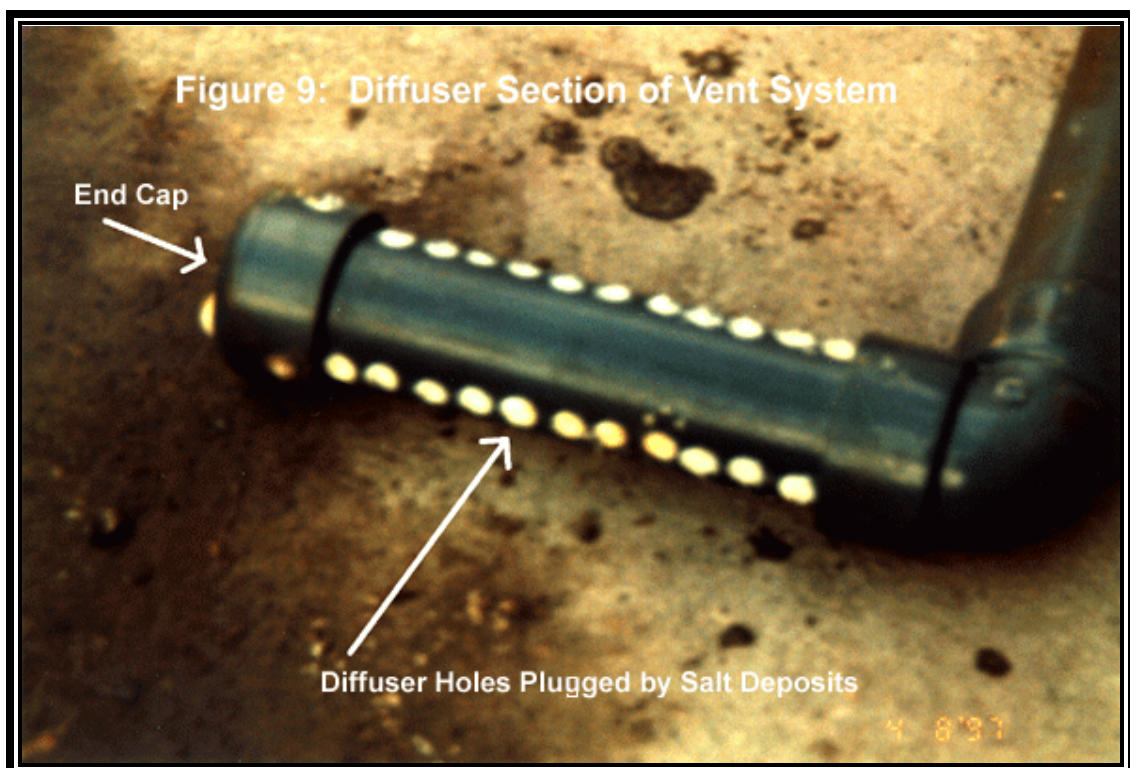
- The scrubber tank was not affected by the tank failure; it was found intact in its original position after the incident. (See **Figure 8**.)
- After the incident, the diffuser in the scrubbing tank was removed by disconnecting the vent line quick connect and removing the lid from the scrubber tank. The holes in the diffuser were found to be clogged with a white crystalline substance, as shown in **Figure 9**. This substance was sodium chloride, according to laboratory analysis.

- A layer of white crystalline material was also found in the bottom of the scrubber tank. This substance also was sodium chloride, according to laboratory analysis.
