# **EXPERT REVIEW OF EPA/OSHA JOINT CHEMICAL ACCIDENT INVESTIGATION REPORT**

**Napp Technologies, Inc.  
Lodi, New Jersey**

EPA  
550-  
R-  
98-008

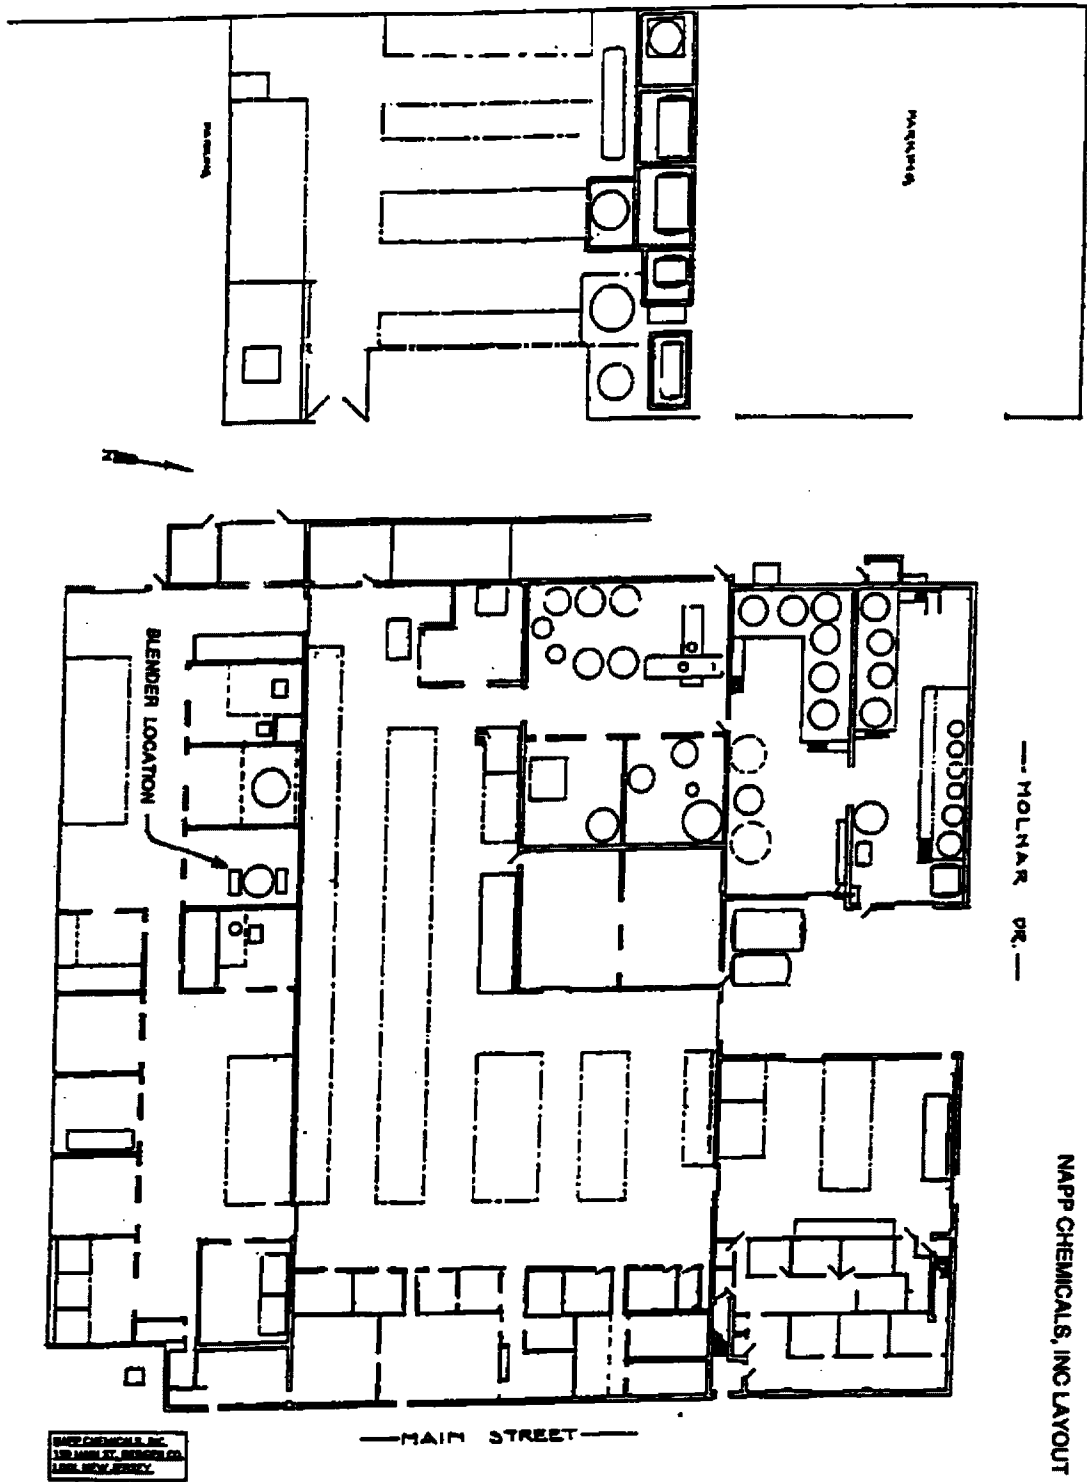
FIGURE 1

The Patterson-Kelley (PK) 125 blender used in the GPA blending operation was located in the PK-125 Blending Room, located in the Pulverizing and Blending Department on the South side of the facility, near the main warehouse area (see Figure 1).

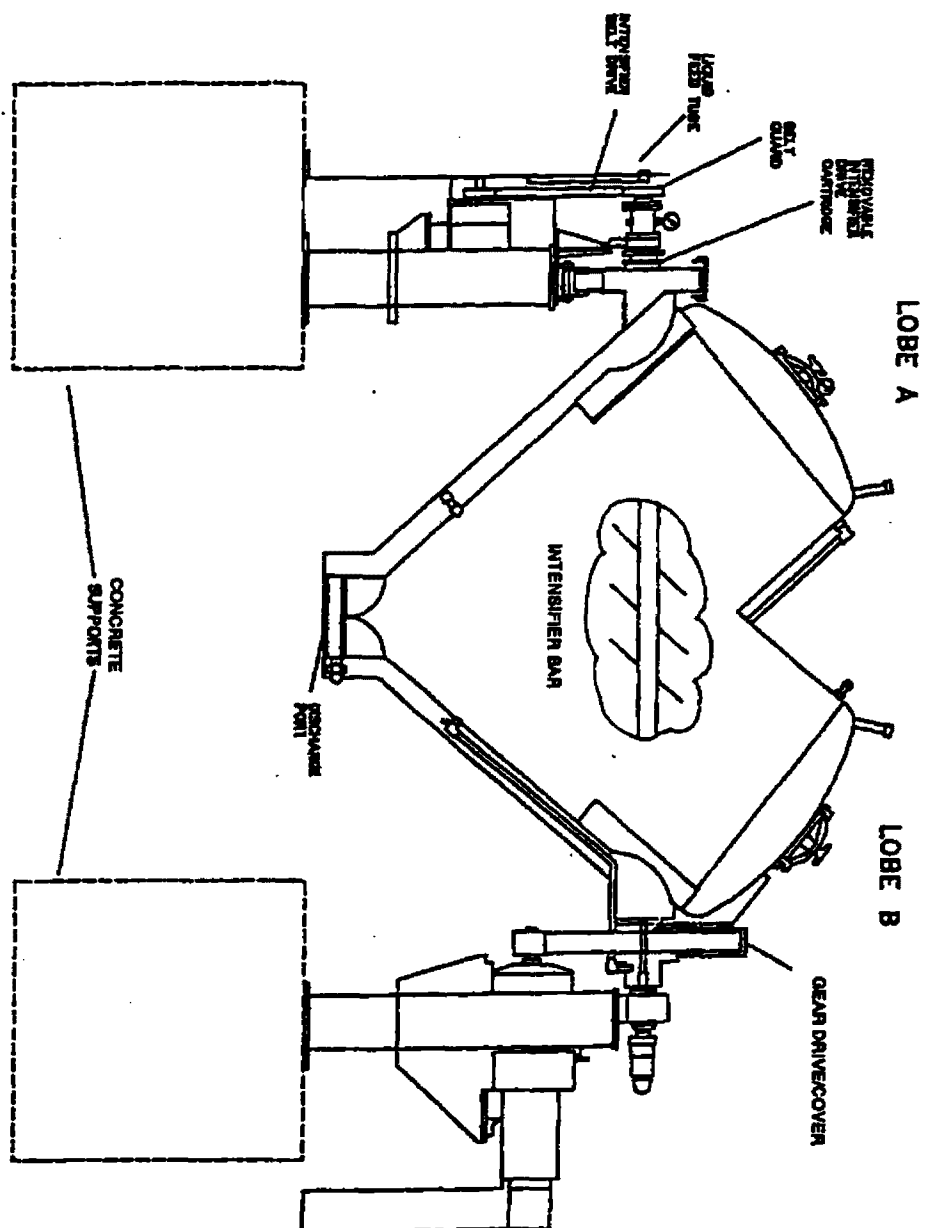
TYPICAL PATTERSON-KELLEY DRY SOLIDS BLENDER

Figure 2 shows a typical Patterson-Kelley V-shaped blender. Patterson-Kelley builds each blender with options and features as specified by the purchaser. The blender at Napp had a working capacity of 6 cubic meters (125 cubic feet). It was approximately 6 meters wide (19 feet), including supports, and 3 meters (10 feet) high. The blender is a double-lobed stainless steel shell shaped like a heart. It is supported on its widest dimension by a horizontal trunnion attached to support tubes set in cement footings. It is insulated with a rigid foam material and encased in a steel jacket containing a water/glycol mixture for cooling and heating. The two access covers on top of the blender are used for loading raw materials, and one port is located at the bottom for off-loading product. A gear to one side of the blender (right side of Figure 2) rotates the shell of the blender through a 360-degree arc. Several water lines enter the jacket on this side. On the other side (left side of Figure 2) of the blender, a vacuum tube housing enters the blender. A graphite seal located inside the vacuum tube separates the seal's cooling water from the internal area of the vacuum tube and the blender. The purpose of the vacuum tube housing is to: (1) act as a conduit for establishing vacuum conditions when the blender is used for drying and other operations; and (2) contain other concentric lines, shafts, etc., including a liquid feed line (added by Napp) and the shaft used to rotate an intensifier bar (I-bar). The purpose of the I-bar is to enhance the mixing of materials being blended. The purpose of the feed line is to allow the controlled introduction of liquids to the materials being blended. The PK-125 blender can be used with or without the I-bar in service. The I-bar, Figure 3, transverses the inner walls of the blender connecting the inner sides of the blender on the same plane as the trunnion. See Figures 4-8 showing a larger but similar blender and associated equipment.

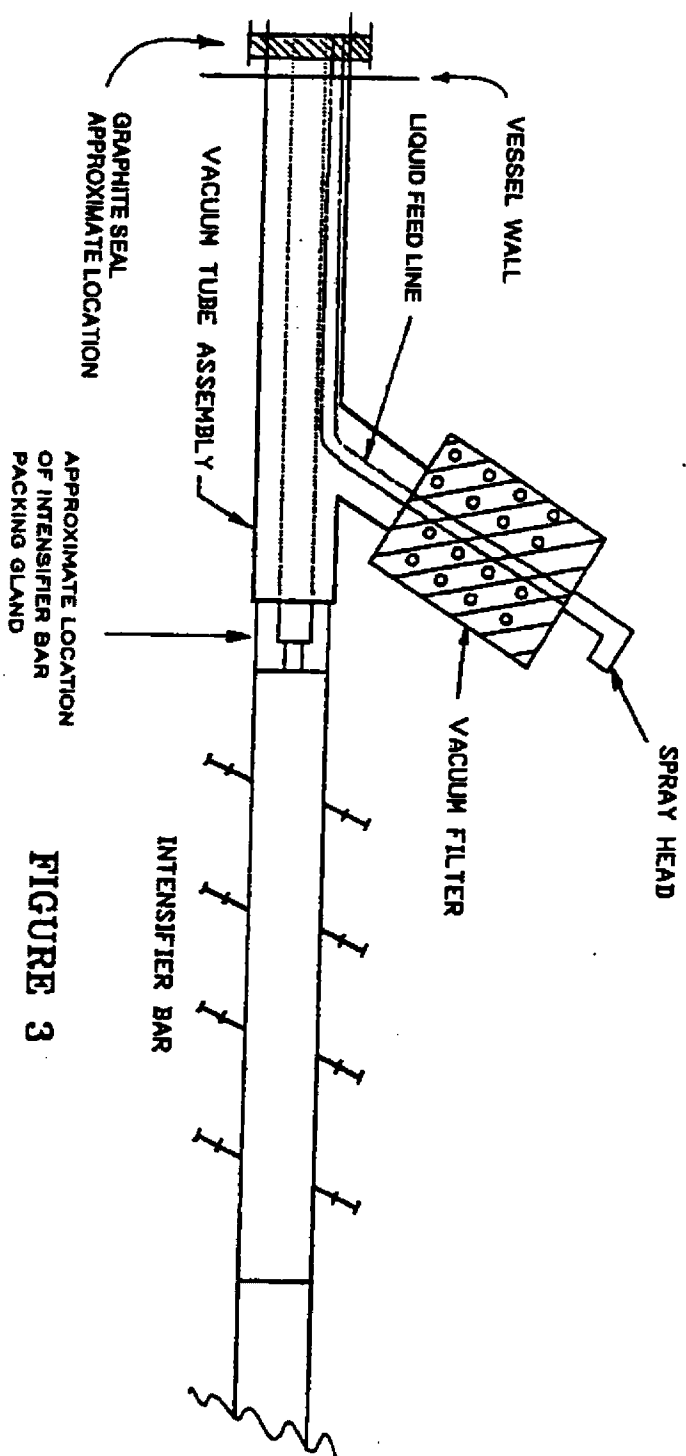
FIGURE 3

# INTENSIFIER BAR/VACUUM HEAD ASSEMBLY

At 3:30 a.m. on April 20, as part of the precharging verification, operators made a final check to assure the blender was ready (i.e., clean and dry) to be loaded. The two operators and a foreman discovered that the vacuum head area, inside the blender, was wet. They also observed water on the internal walls of the blender. Another employee saw a wet spot also described as "droplets of water on the stainless steel" at the intensifier bar shaft seal (connection). They believed this moisture was

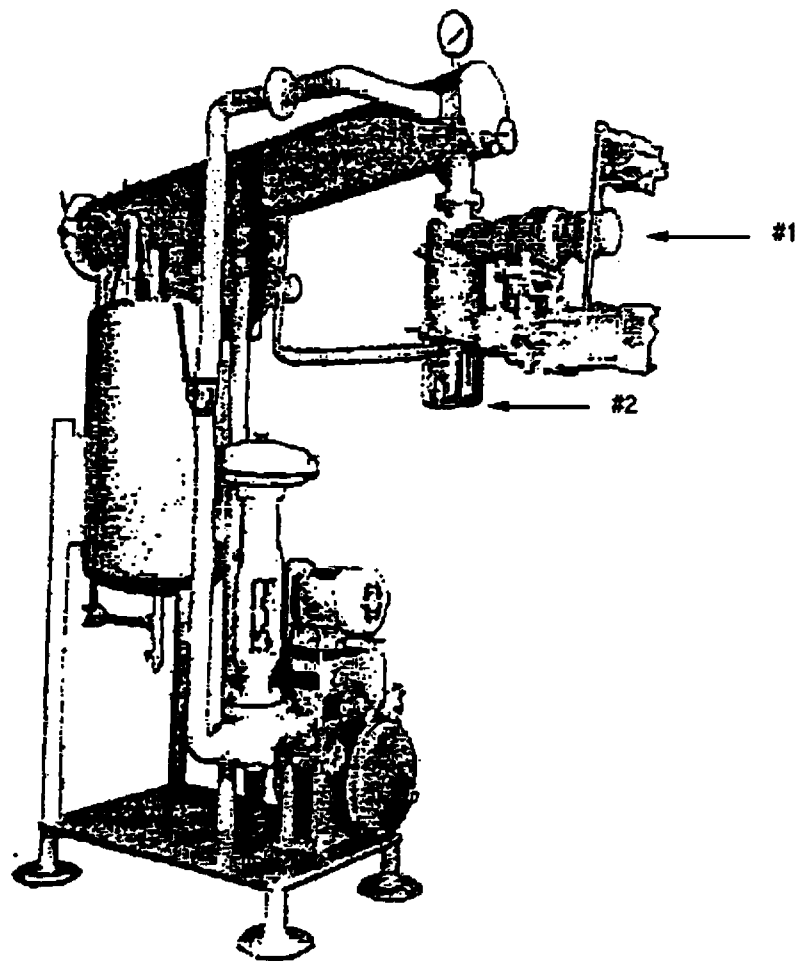
FIGURE 3A: TYPICAL VACUUM COLLECTION SYSTEM AS SUPPLIED BY PATTERSON-KELLEY. #1 SHOWS APPROXIMATE LOCATION OF INLET FROM BLENDER VACUUM LINE; #2 SHOWS VACUUM SEPARATOR BOWL.

Between midnight and 4:30 a.m. on April 21, 1995, the third shift attempted to inject benzaldehyde into the batch on two occasions; each attempt failed. Operators observed the benzaldehyde running back into the vacuum separator. During each attempt to add the liquid, the blender was rotated for about two minutes with the intensifier bar running. Suspecting that product was blocking the spray tip of the nozzle and preventing the injection of the liquid, operators opened the blender twice and removed and washed the spray nozzle. Operators reportedly observed a slight dusty powder wafting within the head space of the blender. This was reported to the shift supervisor, who then checked the inside of the blender and directed the operators to remove and clean the nozzle. After the final attempt to charge benzaldehyde into the vessel it was determined that no fresh benzaldehyde remained. It was by then approximately 5:00 a.m. and coming to the end of the third shift. The shift supervisor told the operators to perform a lock and tagout of the blender.

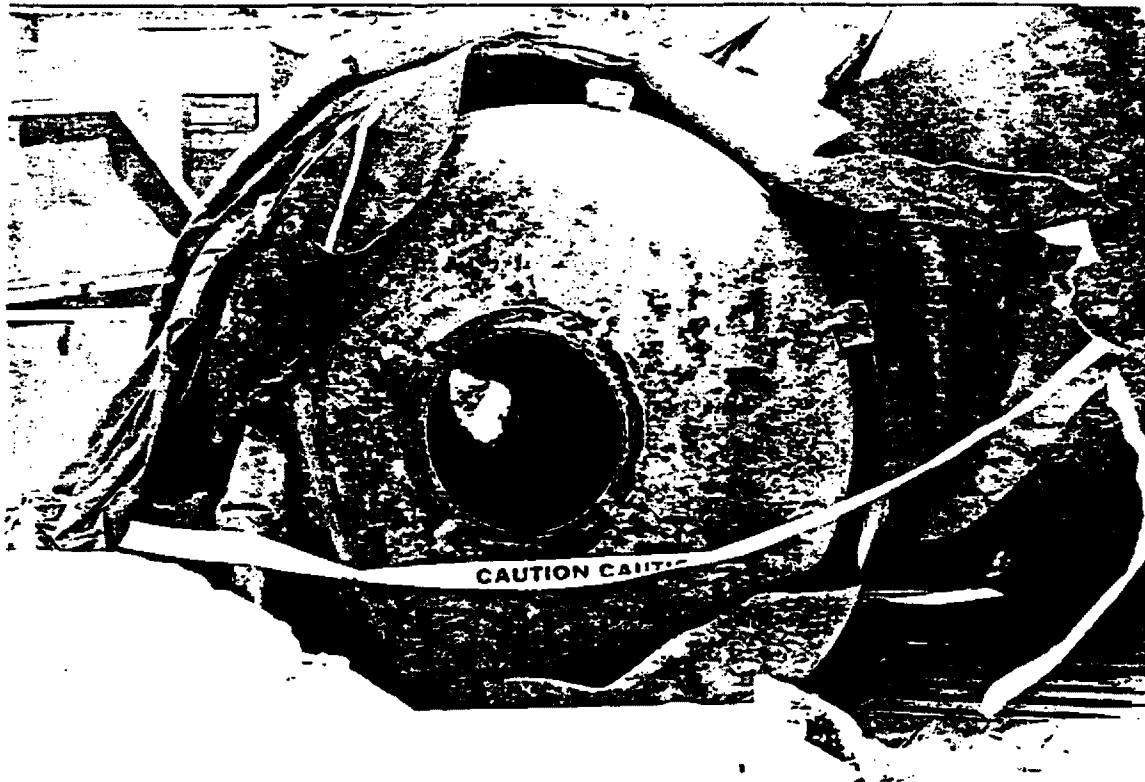
Figure 10: Top access port: a) looking through a top port and out the bottom off-load port, and b) close-up view of a top port.

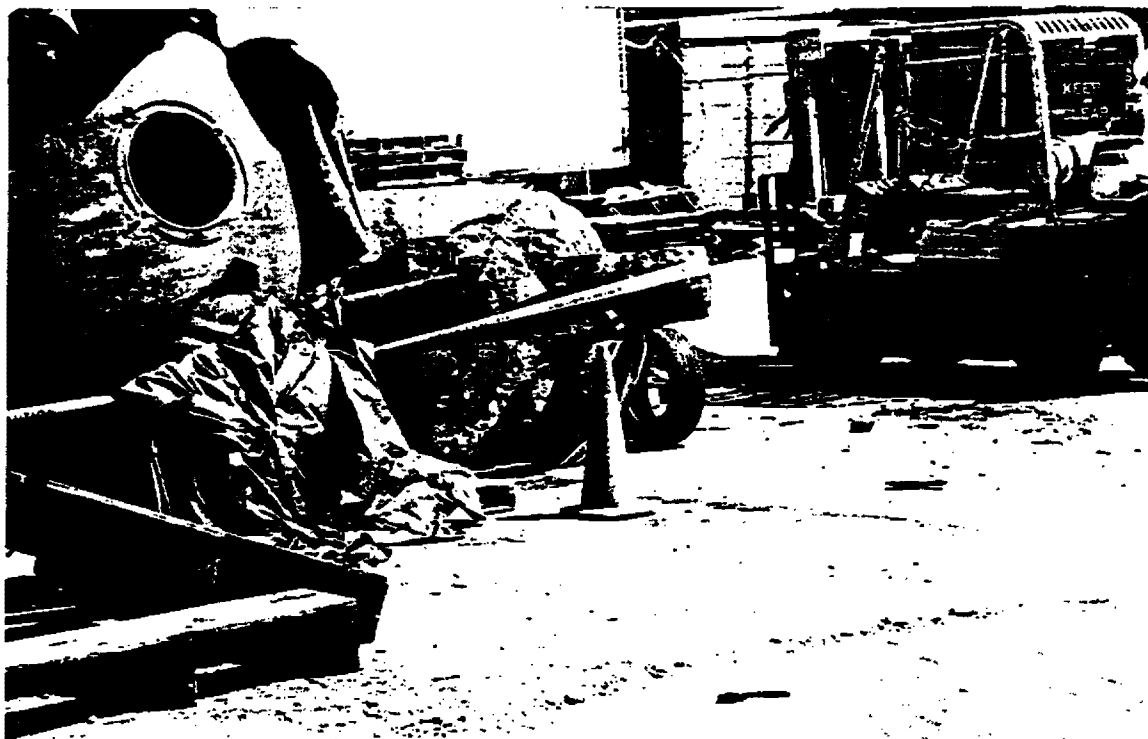
Figure 17: The concrete support and bracket that secured the bearing on the gear drive side of the blender.

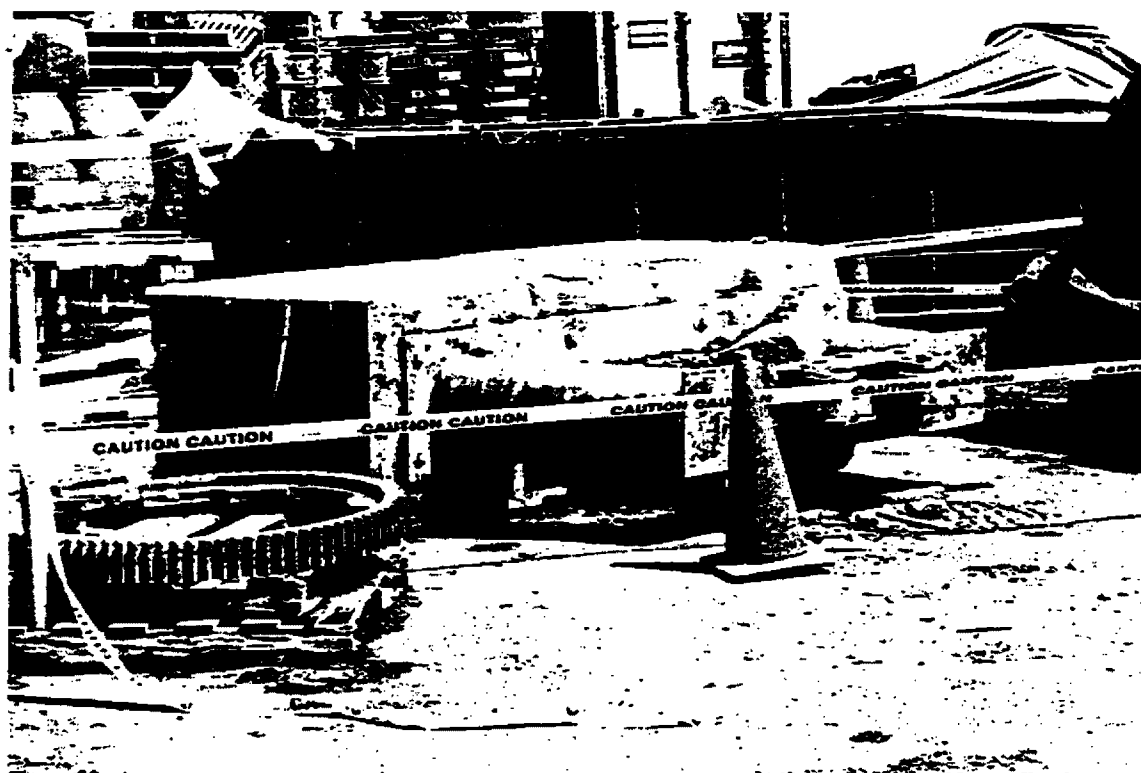
Figure 18: The concrete support and rollers that supported the belt drive side of the blender.
