S&A-TSB-21

TECHNICAL ASSISTANCE PROJECT  
VAIL WASTEWATER TREATMENT FACILITY

VAIL, COLORADO

MARCH - APRIL, 1973

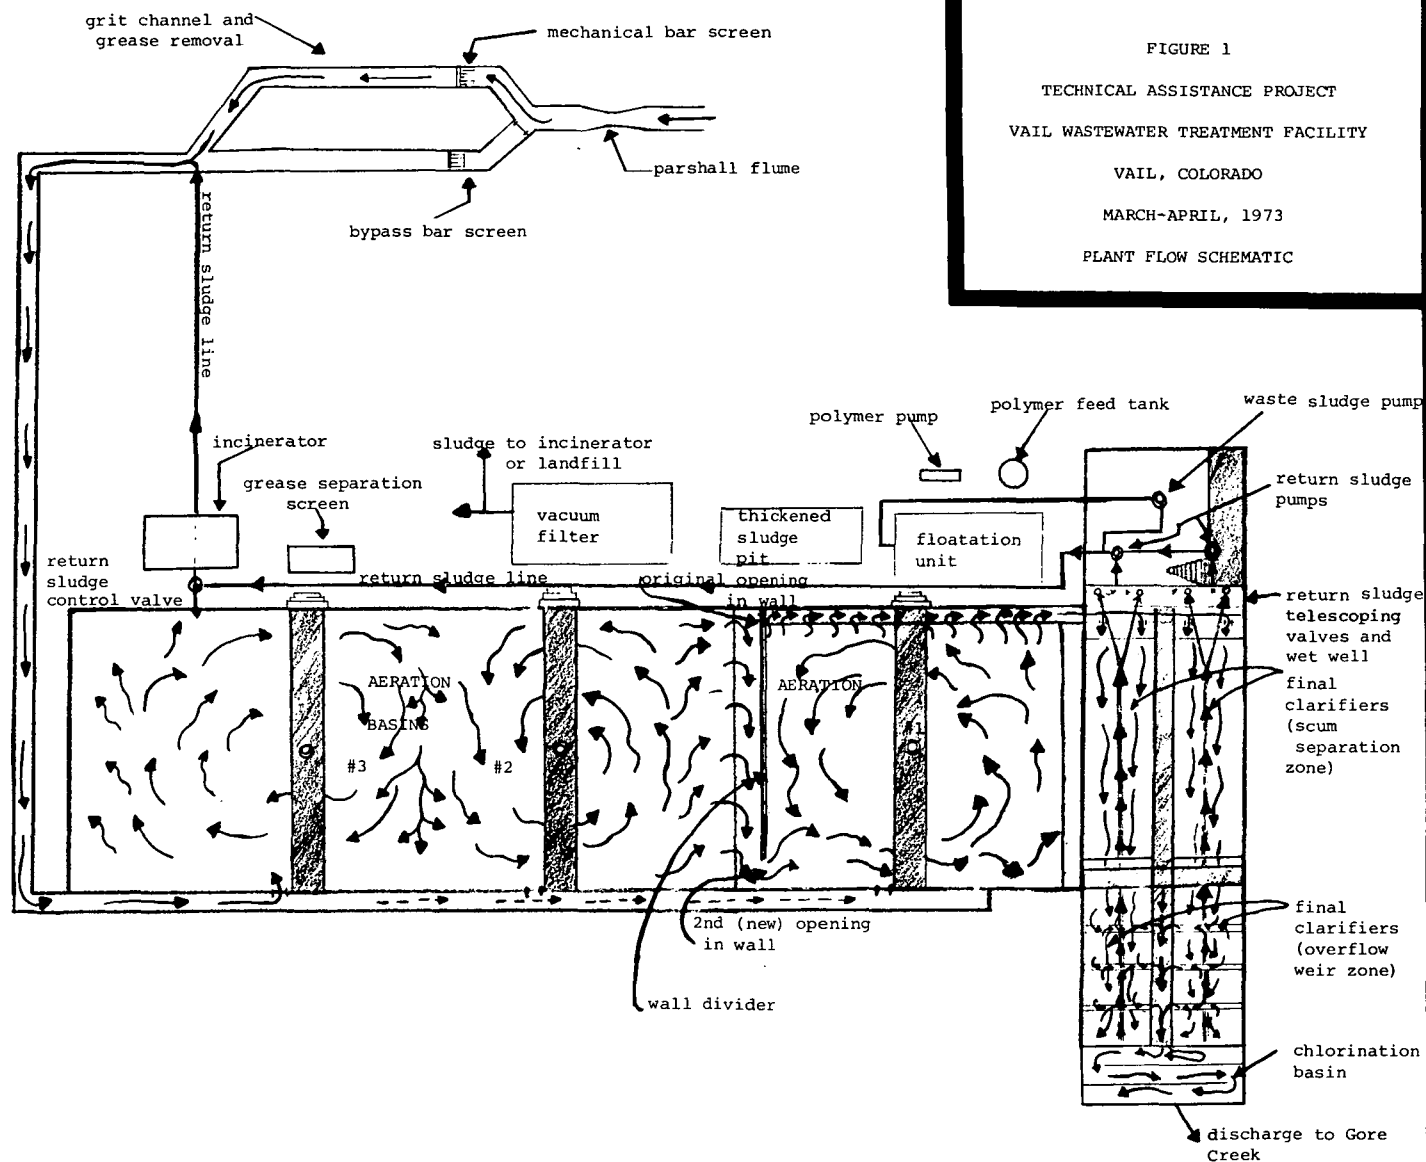
FIGURE 1

Flow enters the plant and is directed through a parshall flume, bar screen, and grit channel before entering the aeration basins. Flow may enter the aeration basins at the head end, near aerator #3, half way down, near aerator #2, or at the far end of the basin, near aerator #1. A concrete wall is located near the end of the aeration basins and physically separates aeration basin #1 from basins #2 and #3. During the initial EPA evaluation made at the Vail plant it was recommended that an opening be provided in the wall between basin #1 and basins #2 and #3 to allow for series operation.
