EPA-650/2-74-010

**EPA ALKALI  
SCRUBBING TEST FACILITY:  
LIMESTONE WET SCRUBBING  
TEST RESULTS**

Bechtel Corporation  
50 Beale Street  
San Francisco, California 94119

This report presents the results, through early January 1974, of limestone and lime reliability verification and long-term reliability testing at the Shawnee Prototype Facility.

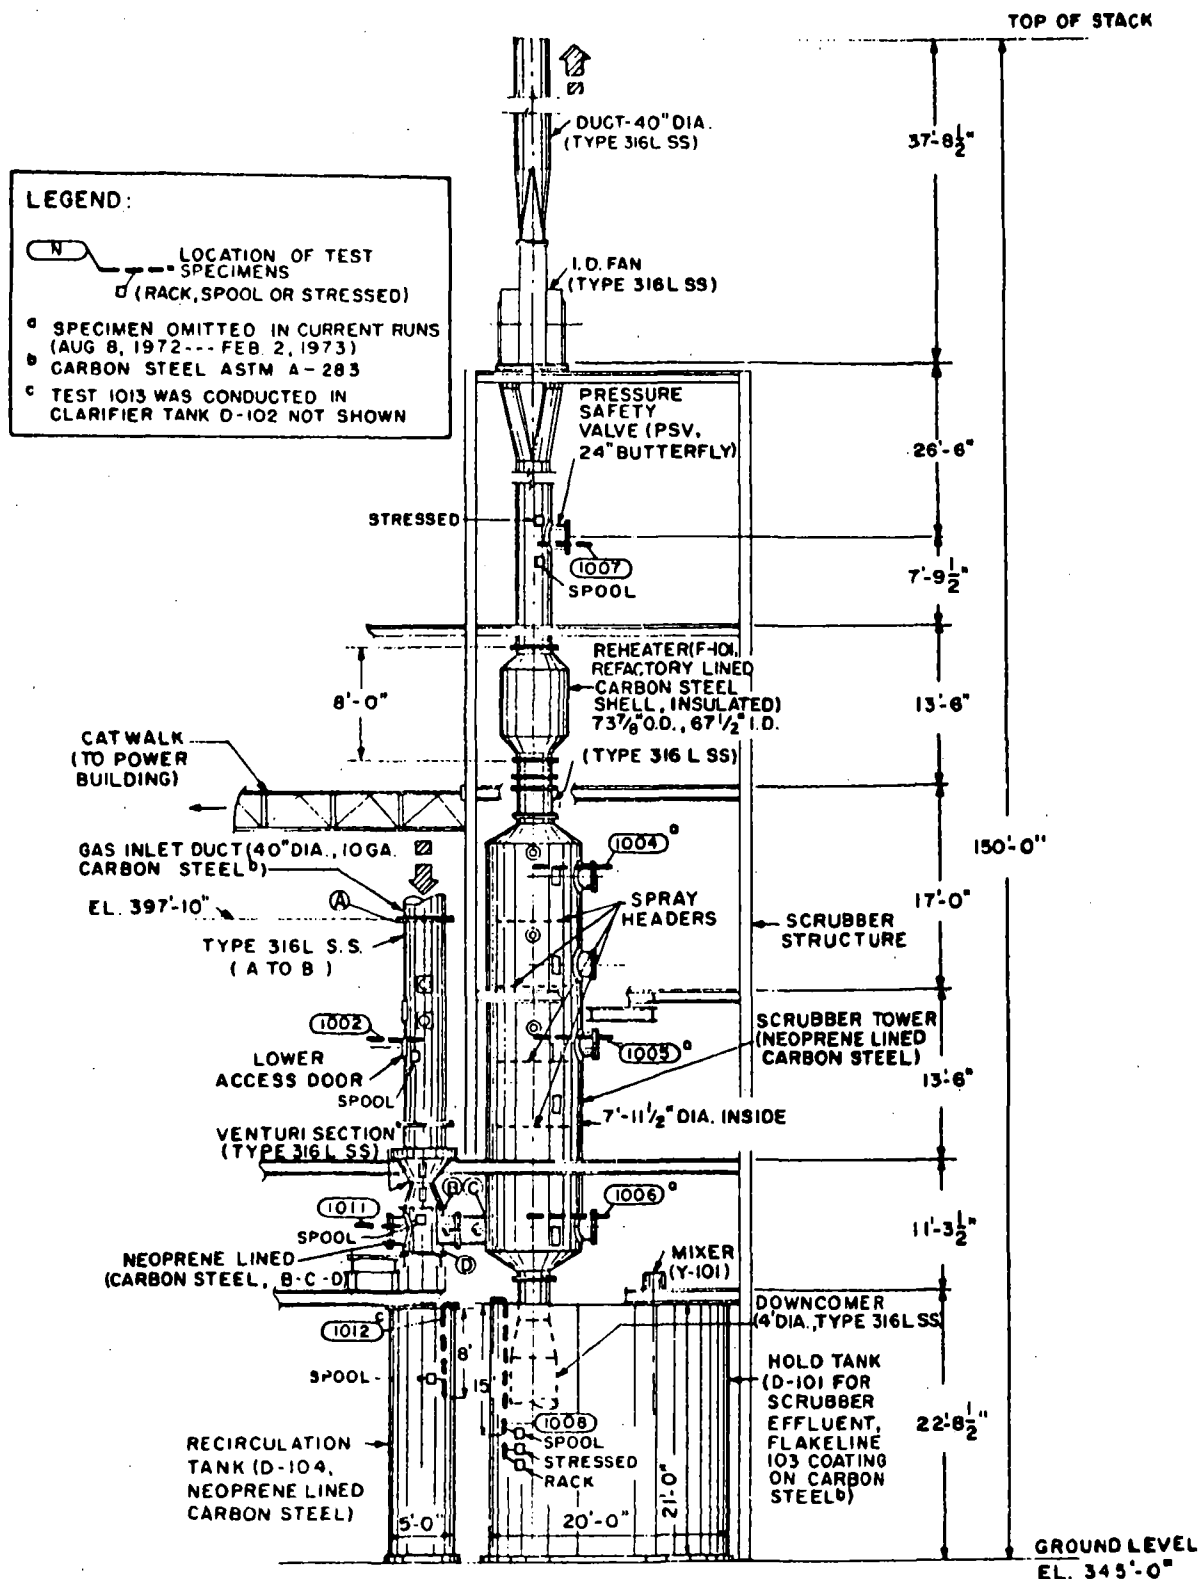
FIGURE 2  
VENTURI SCRUBBER SYSTEM, (C-101)

Venturi Scrubber--Corrosion of Test Specimens: The specimens were installed directly below the vertically mounted venturi as shown at point 1011 of Figure 2. Gas and slurry (laden with compounds of sulfur oxides) at a high velocity caused more severe corrosion and erosion damage to specimens in this location than in any other in the three systems. Specimens of nine alloys and three nonmetals failed. Figure 7 shows that spool 1011 was clean and only 8 of the 20 test specimens remained at the end of the 1840-hour test period. The five alloys that showed the lowest corrosion in mils per year were: Hastelloy C-276--5 mils, Inconel 625--5 mils, Incoloy 825--7 mils, Carpenter 20 Cb-3--14 mils, and Type 316L stainless steel--15 mils.

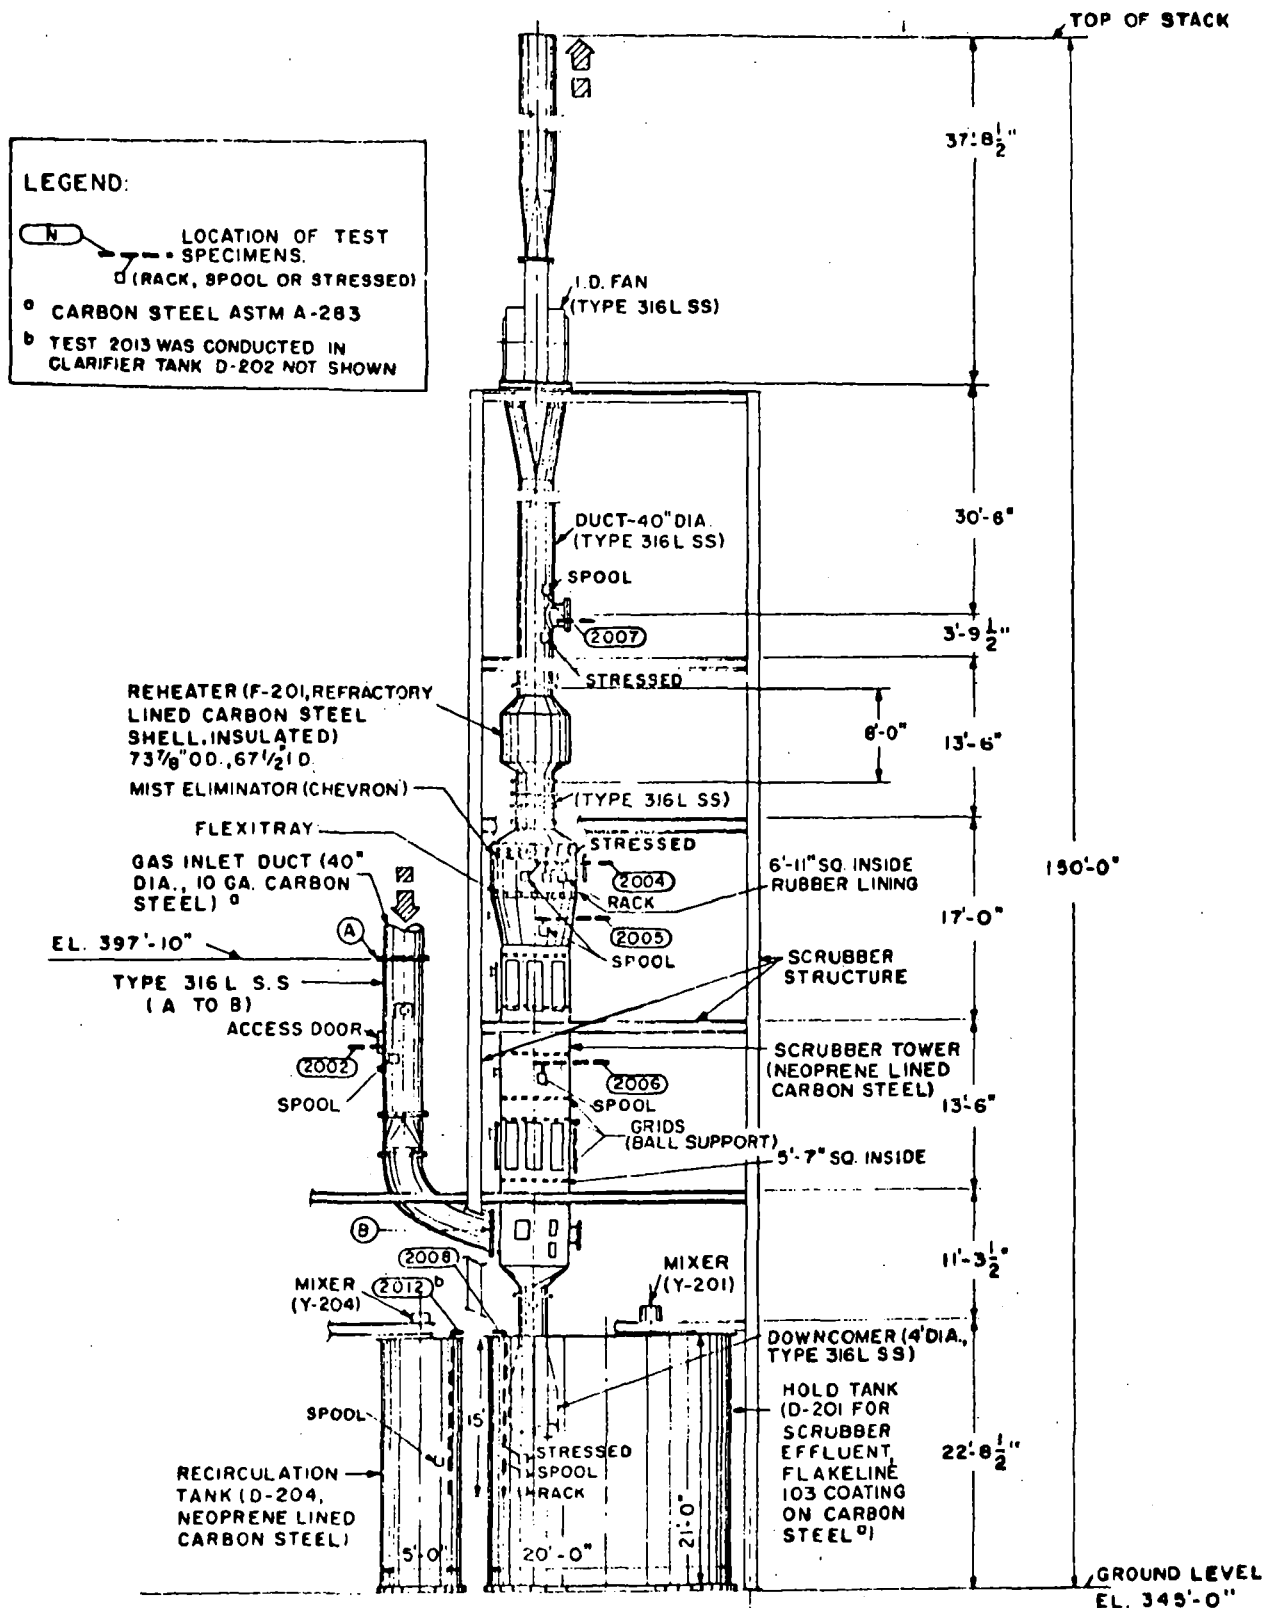
FIGURE 3  
TURBULENT CONTACT SCRUBBER SYSTEM, TCA-(C-201)  
(MOBILE BED, -- PING-PONG BALL)

In the TCA scrubber tower, test specimens were mounted at three elevations (see Figure 3 and Table II). Those above the third grid for holding mobile packing hollow plastic spheres at location 2006 were exposed to gas and liquor. Those below the FlexiTray at 2005 were exposed to gas and droplets, and those below the chevron mist eliminator at 2004 were exposed to gas and mist. Figure 9 shows that spools of specimens which had been exposed at 2006 and 2005 were partly covered by solids, but those at 2004 were clean. In the period August 12 through November 3, 1972, movement of the mobile bed had caused some erosion at 2006. The eroded specimens were replaced with new ones that were placed within a wire mesh container to protect them from erosion by the balls. At all three locations, the corrosion rates were 1 mil per year or less for Carpenter 20 Cb-3, Hastelloy C-276, Incoloy 825, Inconel 625, and
