# Above Ground Gamma Ray Logging of Edgemont, South Dakota and Vicinity

Jack E. Thrall\*  
Joseph M. Hans, Jr.\*  
Vonni Kallemeyn\*\*

February 1980

\*U.S. Environmental Protection Agency  
Office of Radiation Programs  
Las Vegas Facility  
Las Vegas, Nevada 89114

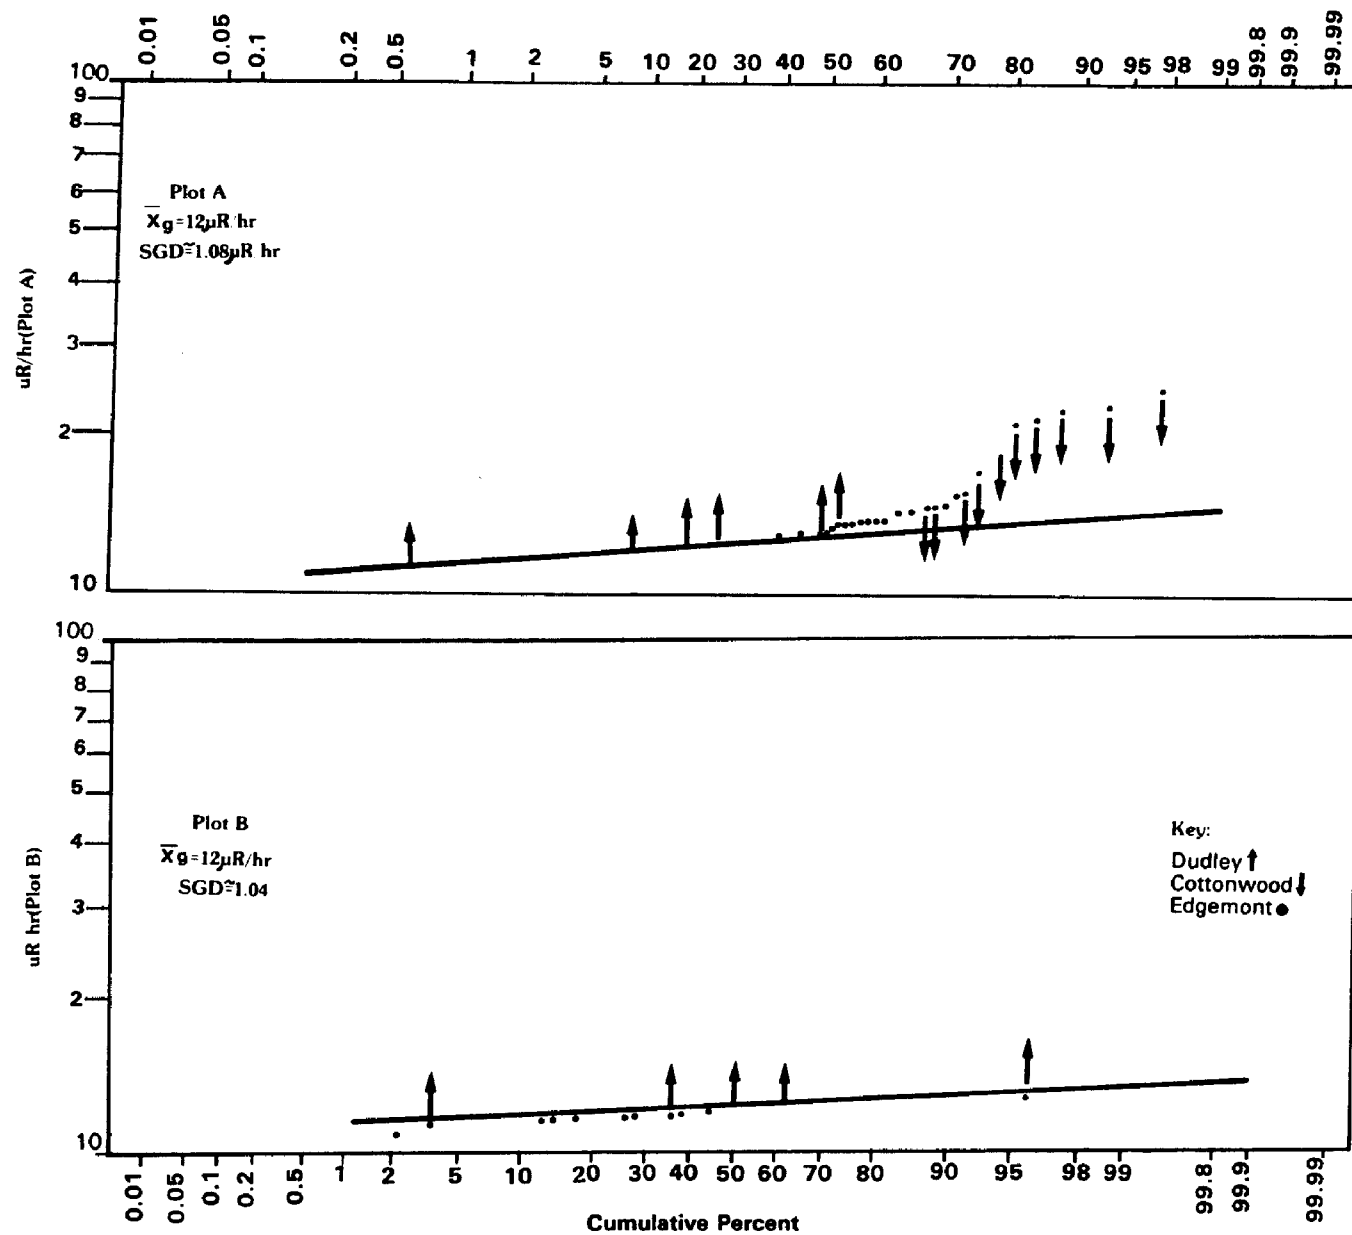
Figure 3. Log-Probability Plot of PIC Measurements

All corrected exposure rates are plotted on log-probability paper to determine their distribution characteristics (Figure 3, Plot A). The data on plot A belongs to two distributions which end and begin near the 70 percentile line. All data below the 74 percentile line were ranked and plotted (Plot B). The slope or Standard Geometric Deviation (SGD) of Plot B is 1.04 and strongly indicates that the data in this group indicates background conditions (Denham, 1975). A relatively uniform deposition of mill wastes over the Edgemont area would also produce a similar SGD. The geometric average ( $\bar{X}_g$ ) or 50 percentile value for Plot B is about 12  $\mu\text{R/hr}$ . Therefore, the ambient gamma radiation background in Edgemont and Dudley was about  $12 \pm 1 \mu\text{R/hr}$  at the 95 percent confidence level. The geometric average compares well with the arithmetic average of 12.4  $\mu\text{R/hr}$  computed in Table 3.

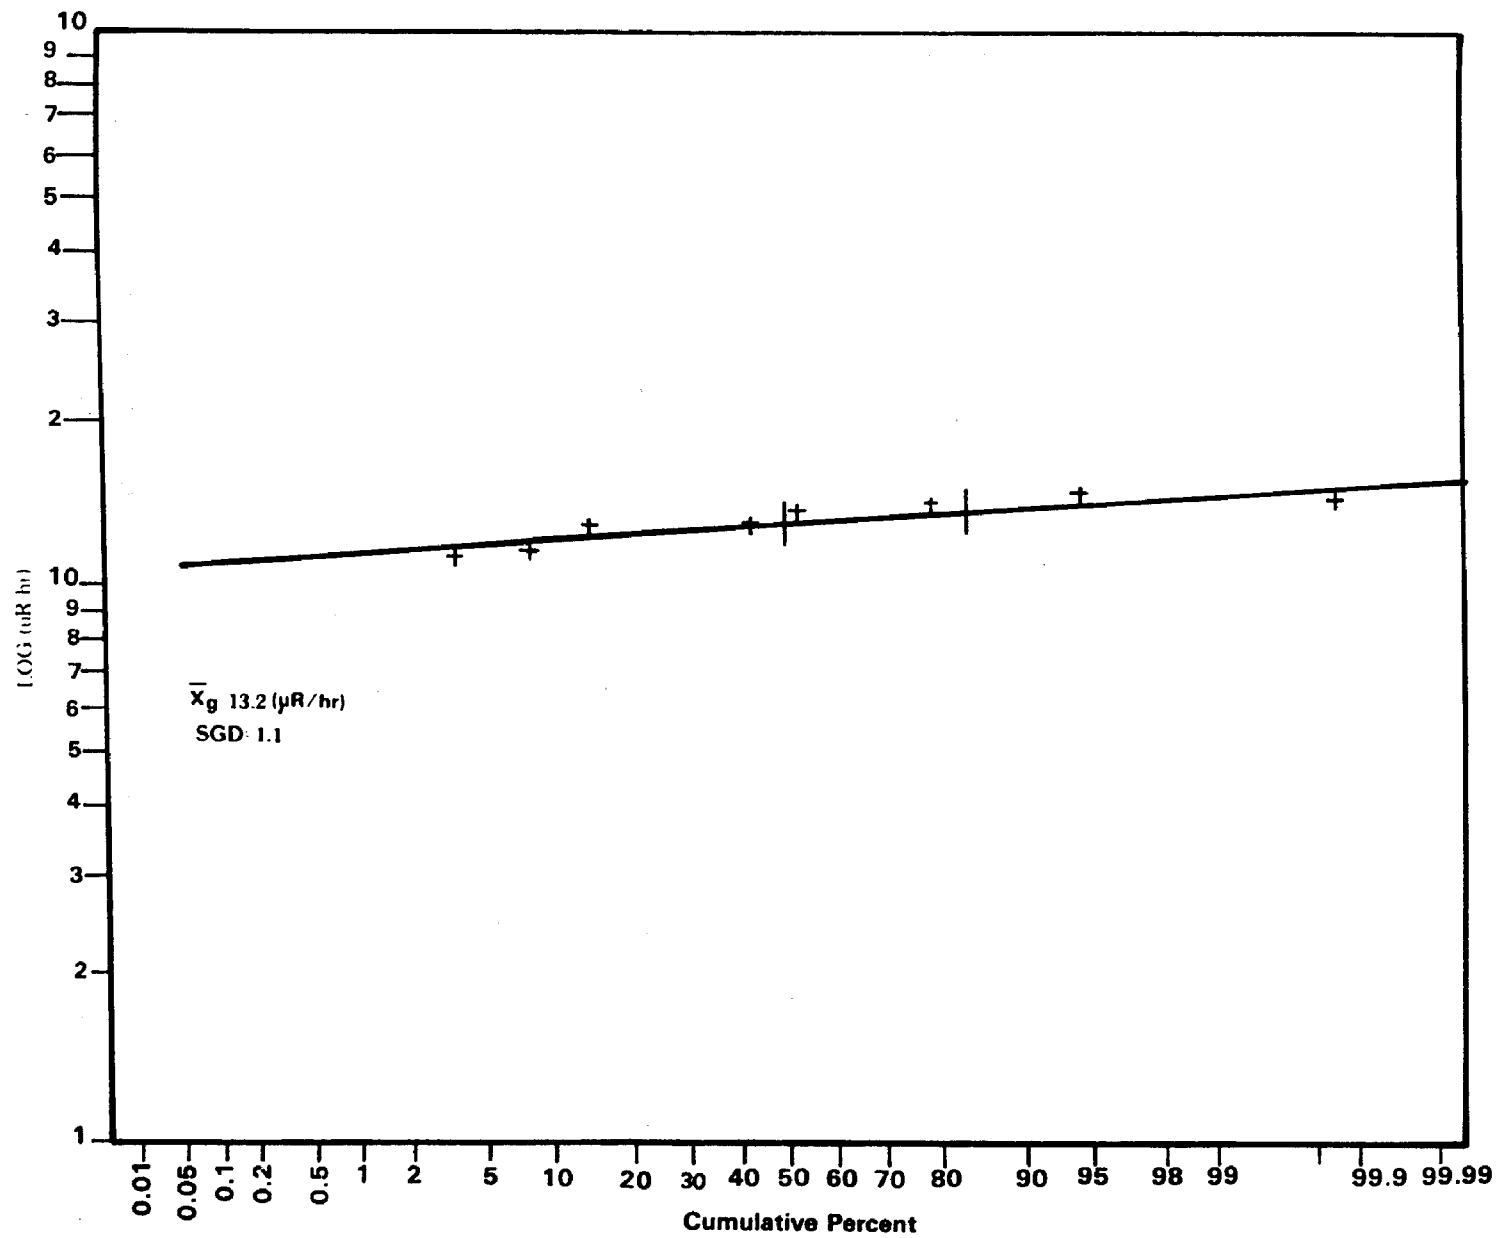
Figure 4. Log-Probability Plot of (LOG) Scintillometer Measurements

Since nearly all of the PIC measurements were made on streets, there is a possibility that the measurements may be lower than adjoining areas. This is because the streets are paved or dirt and would have less retention of airborne deposition of mill wastes. In order to compare on and off-street exposure rate levels, all low outside gamma (LOG) measurements made at non-tailings locations during the 1978 survey were tabulated and ranked in Table 4. Like values were grouped and plotted on a log-probability graph (Figure 4). The data points appear to fall in one distribution and have a slope or (SGD) of 1.1 indicating that they are ambient background measurements. The geometric average, or 50 percent percentile value, of the data points is about  $13 \mu\text{R/hr}$  with a SGD of  $1.1 \mu\text{R/hr}$ . There appears to be no statistical difference between the PIC measurements made on the streets and the corrected scintillometer measurements made in off-street areas.

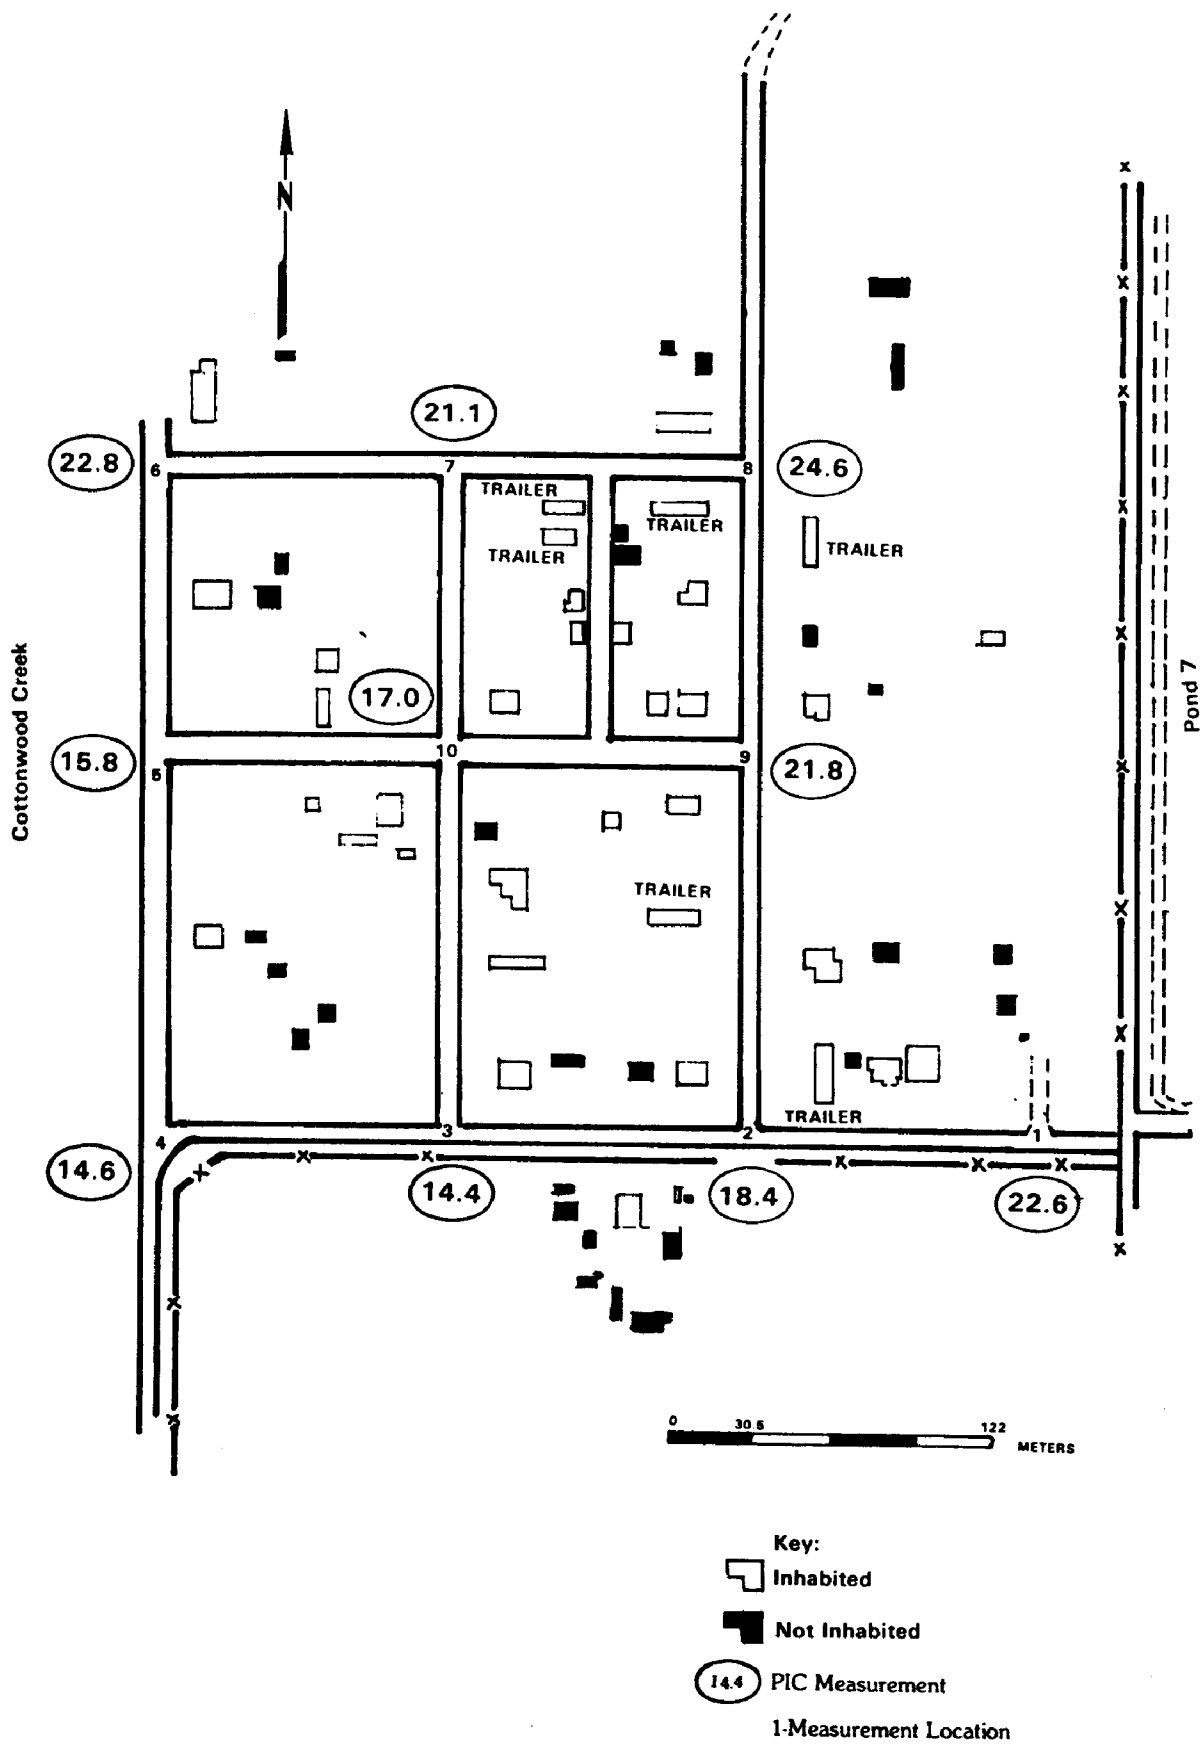
Figure 5. Gross Corrected PIC Measurements in Cottonwood

All of the PIC measurements made in Cottonwood are not in the background distribution. These measurements are discussed later in this report.

measurement of 4 for local natural soils, the net average  $\Delta$  value for the Cottonwood area would be 8. This net  $\Delta$  value of 8 corresponds to an estimated surface contamination of 50 pCi/cm<sup>2</sup> for radium-226 (derived from measurements made at other mill sites). Assuming a soil density of 1.6 g/cm<sup>3</sup> and the contaminants averaged over a depth of 5 cm, the radium-226 surface contamination would be equivalent to a net radium-226 concentration in the soil equal to 6 pCi/g. The net average above ground exposure rate estimated for the surface deposition is about 11  $\mu$ R/hr. This agrees reasonably well with the average net corrected scintillometer measurements of 18  $\mu$ R/hr for the Cottonwood area (i.e., 30  $\mu$ R/hr - 12  $\mu$ R/hr). It appears that most of the above ground exposure rates in Cottonwood result from surface deposition. The difference of 7  $\mu$ R/hr between the estimated exposure rate from the average net corrected exposure rate minus the exposure rate from deposition may be due from "shine" from the adjacent tailings piles.

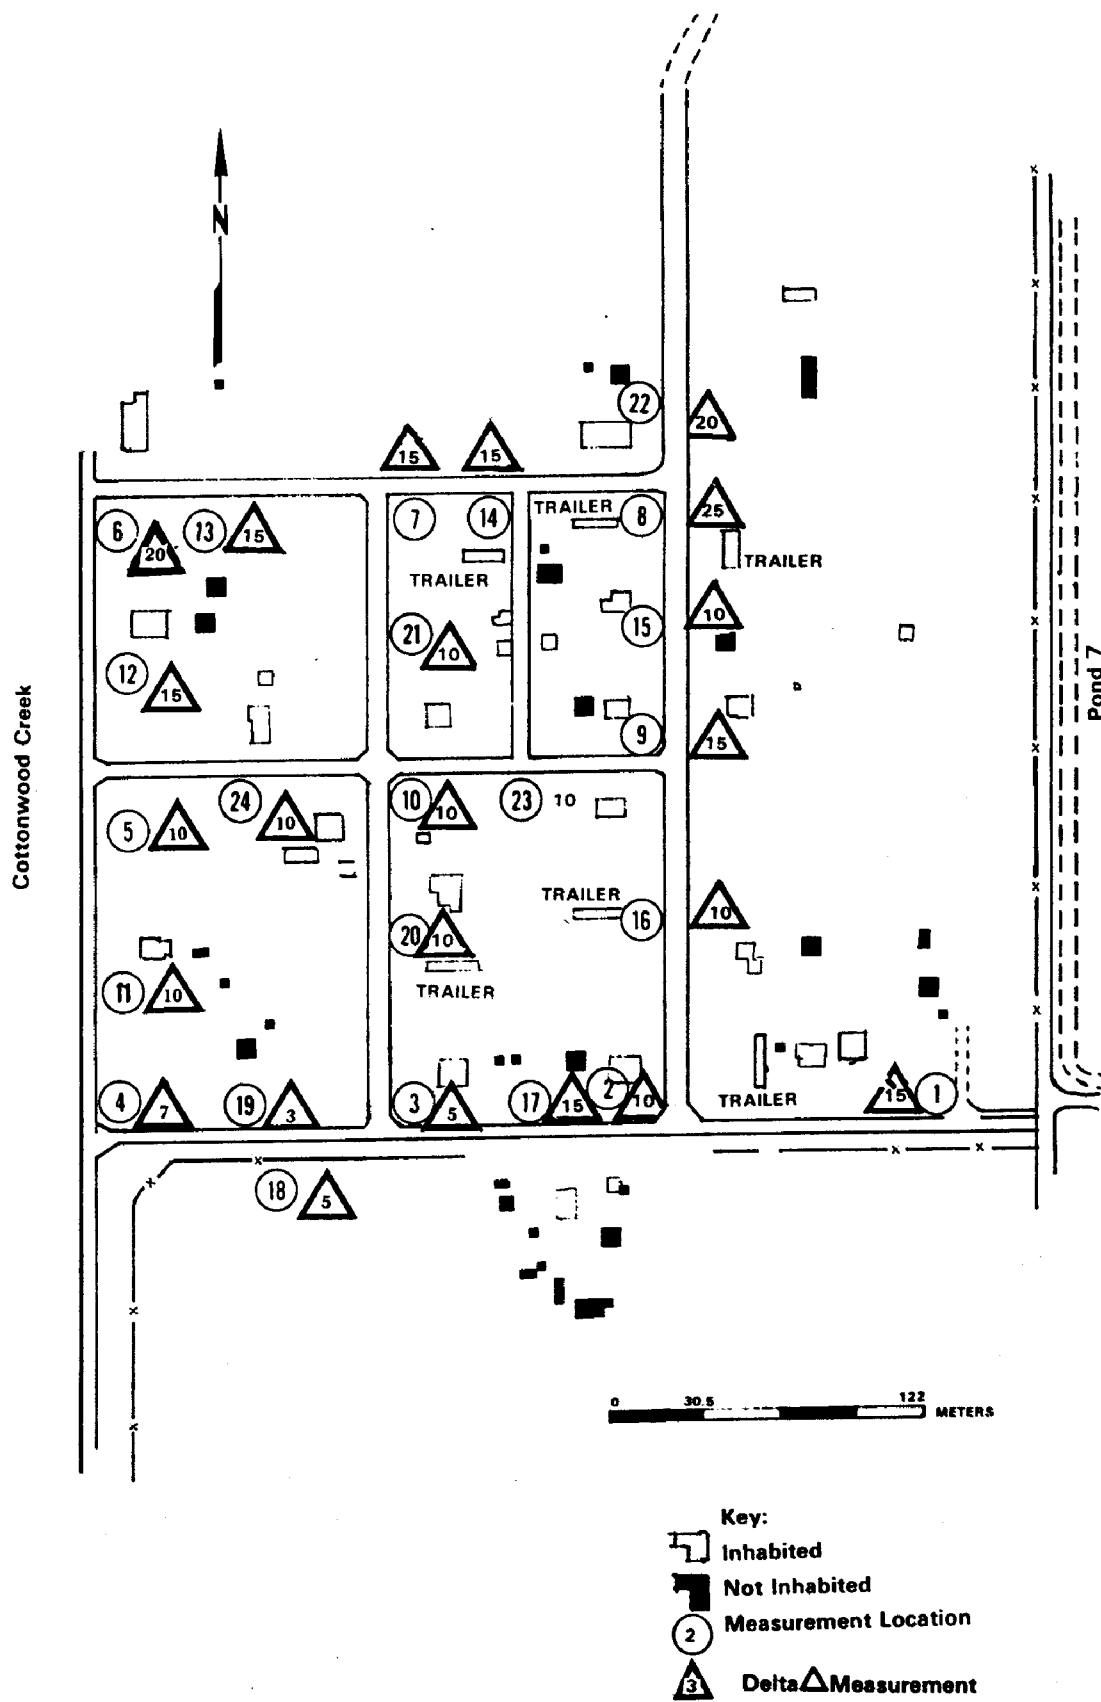
The arithmetic average of the net above ground exposure rates based on the corrected scintillometer measurements is 18  $\mu$ R/hr. This amounts to an average annual exposure of 158 mR ranging from 53 to 412 mR for the Cottonwood area.
