A STUDY OF COASTAL WATER QUALITY IN THE
VICINITY OF SAN JUAN, PUERTO RICO, JANUARY
13-31, 1971

Environmental Protection Agency
Water Quality Office
Southeast Water Laboratory
Technical Services Program
Athens, Georgia

February 1971

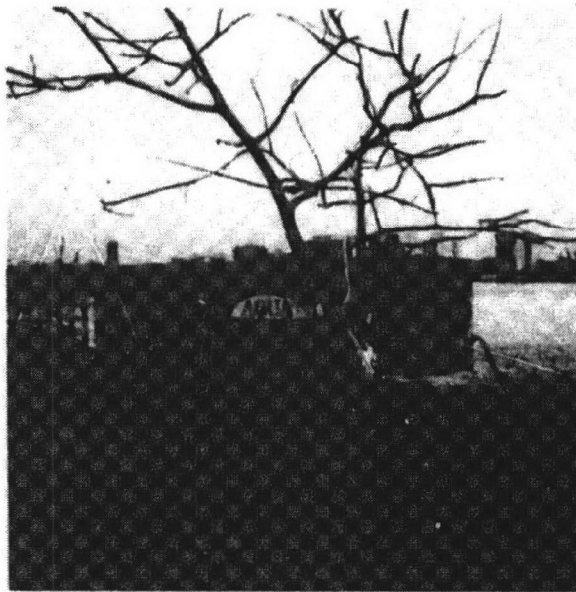
January 1971
Operational Site of EPA Mobile Lab
Southeast Shore of Condado Lagoon
Adjacent to Power Company

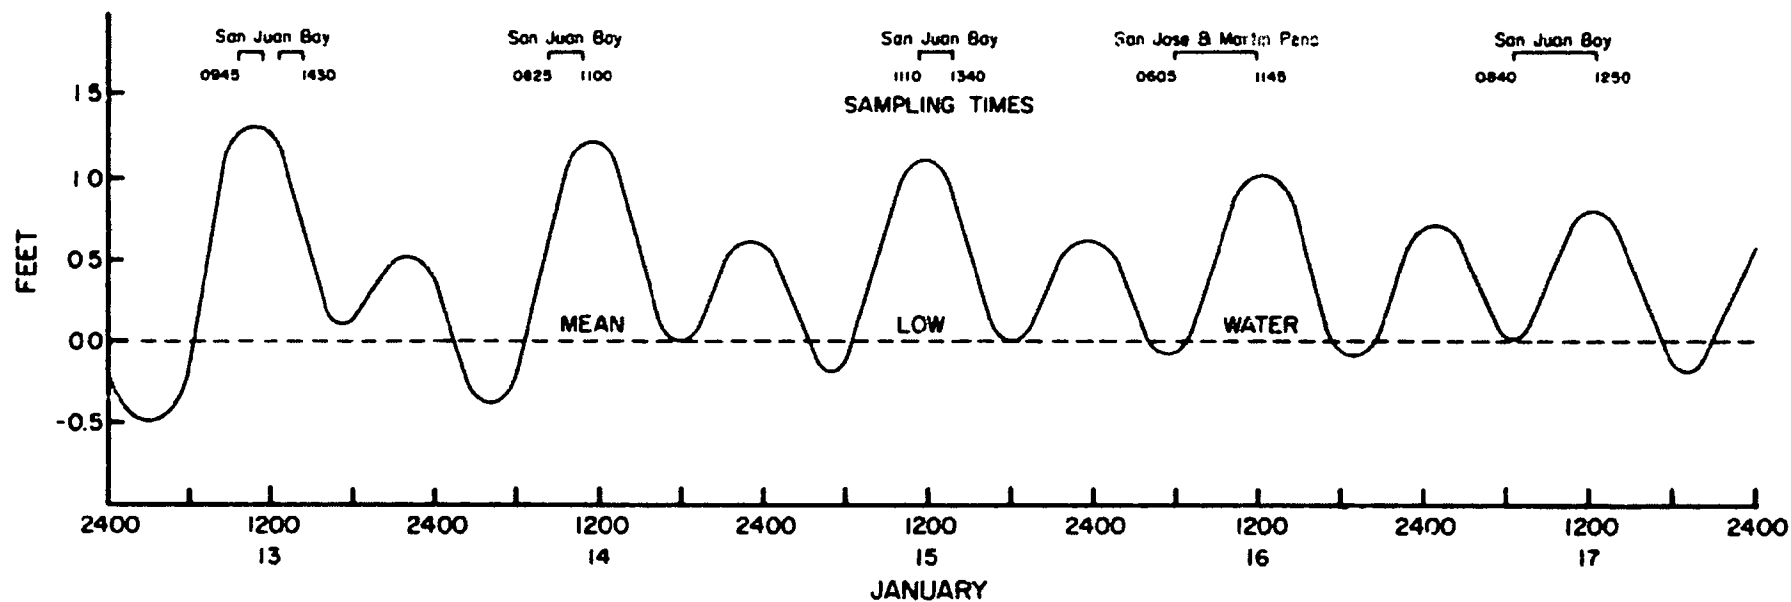
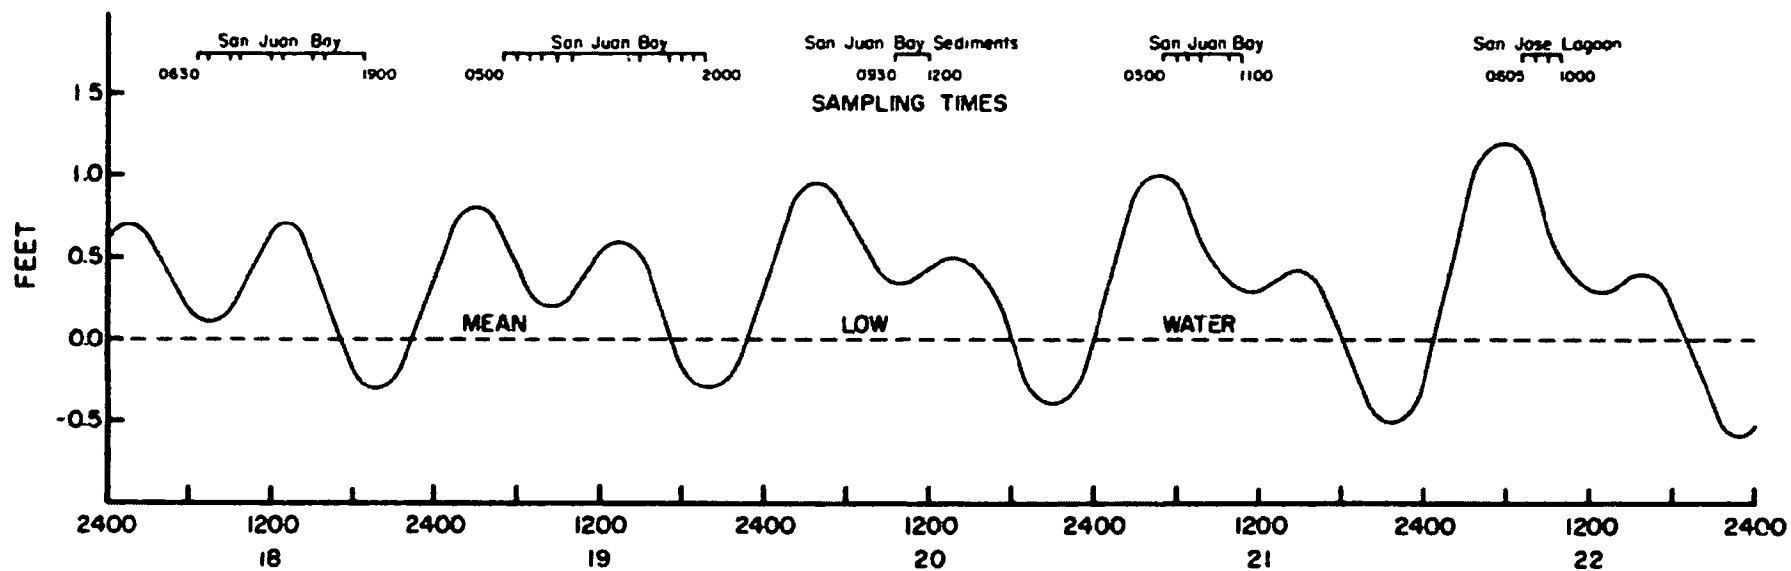
FIGURE 2
TIDAL CYCLES AND SAMPLING SCHEDULE
SAN JUAN BAY & COASTAL WATERS
JANUARY 13-22, 1971

Tidal variations during sampling periods in San Juan Bay were determined from tide tables and are shown in Figure 2.

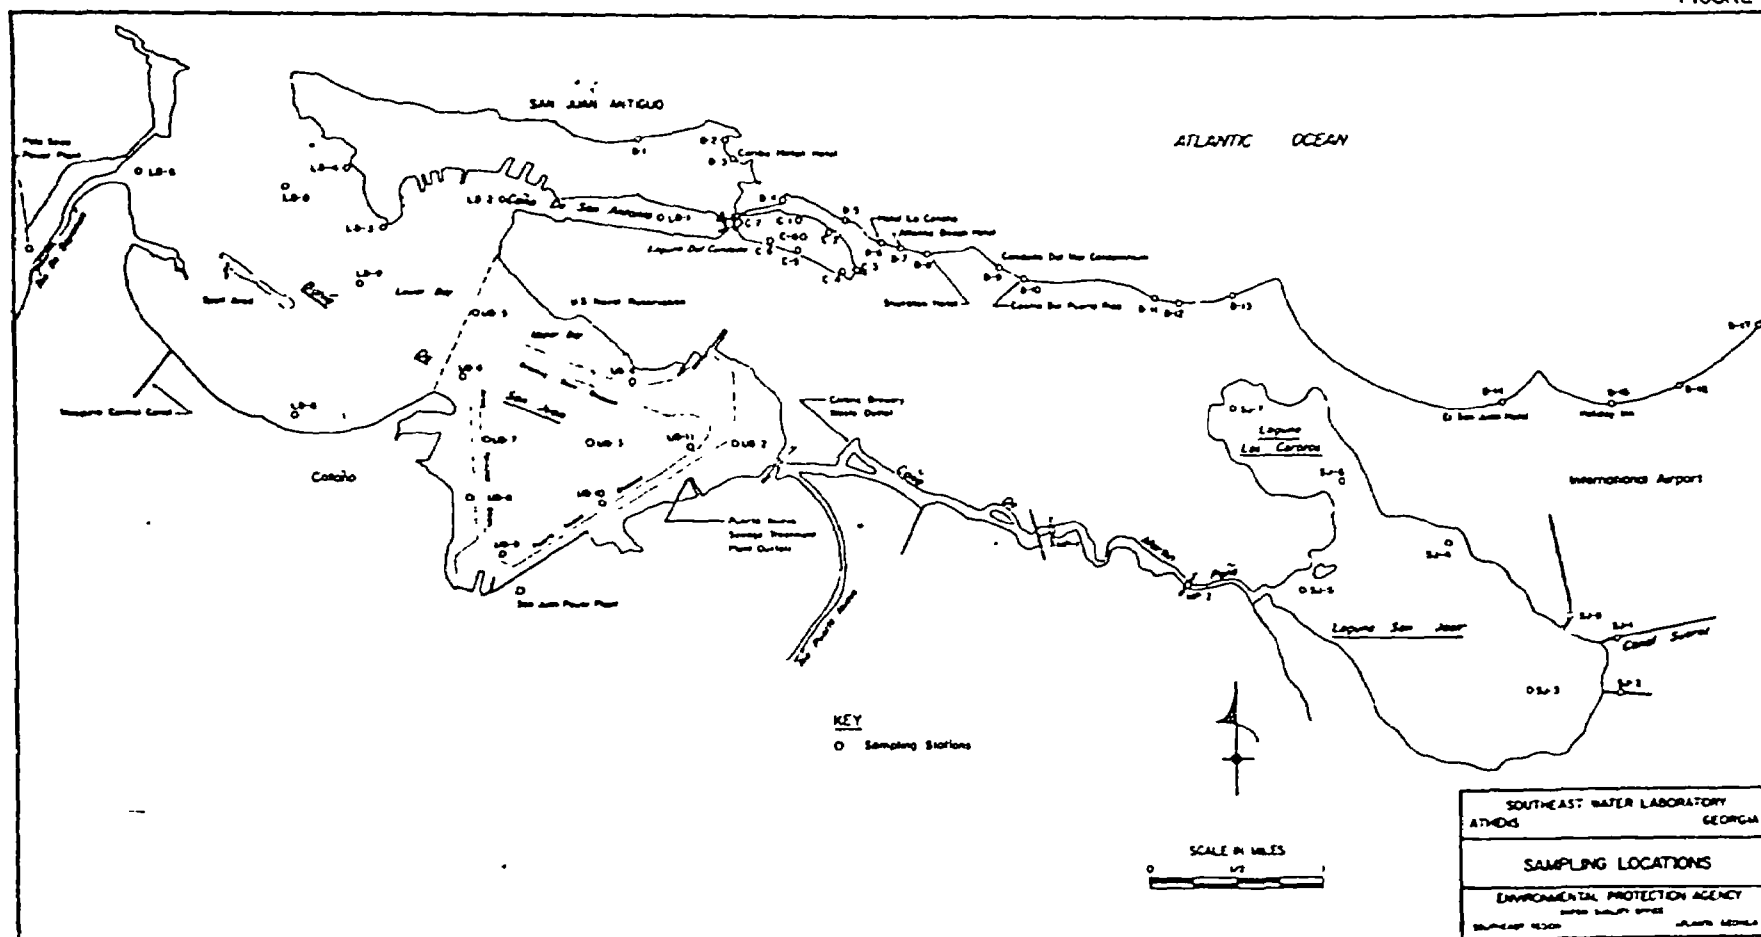
FIGURE 1

A description of sampling stations in the first three areas is found in Table I. Stations in Condado Lagoon and along the beaches were established primarily for bacteriological studies and are described in a later section. Figure 1 (rear of report) shows the study area and location of all sampling stations.

Wastes from the Gulf Caribbean refinery are discharged into the mosquito control canal which enters San Juan Bay near Cataño (see Figure 1). Zero dissolved oxygen conditions were found at the mouth of the canal. Large quantities of oil also enter the bay from the canal.
