SUMMARY

Since the Mines Development, Inc., uranium mill located at Edgemont, South Dakota, began commercial operation in 1956, the resultant impact of waste management practices on environmental radiation levels has been the subject of several State and Federal studies. The first set of post-operational samples were collected during June, 1957. During the latter part of July, 1957, an intensive in-plant study was conducted to characterize the mill process and liquid effluents. Water quality studies conducted during September, 1966, and July, 1971, showed that process and waste liquors were being lost by seepage from mill ponds and entering surface waters - Cottonwood Creek and the Cheyenne River. Soil and bottom sediment samples collected during the 1971 study confirmed the loss of unstabilized sand tailings to the water environment by wind and water erosion.

The mill was revisited October 3, 1972, to discuss the efforts undertaken by Mines Development, Inc., to abate radiological pollution and to assess the progress achieved in the year following the 1971 Conference. To eliminate seepage from mill ponds, the Company had instituted a program of operating the ponds at lower fluid

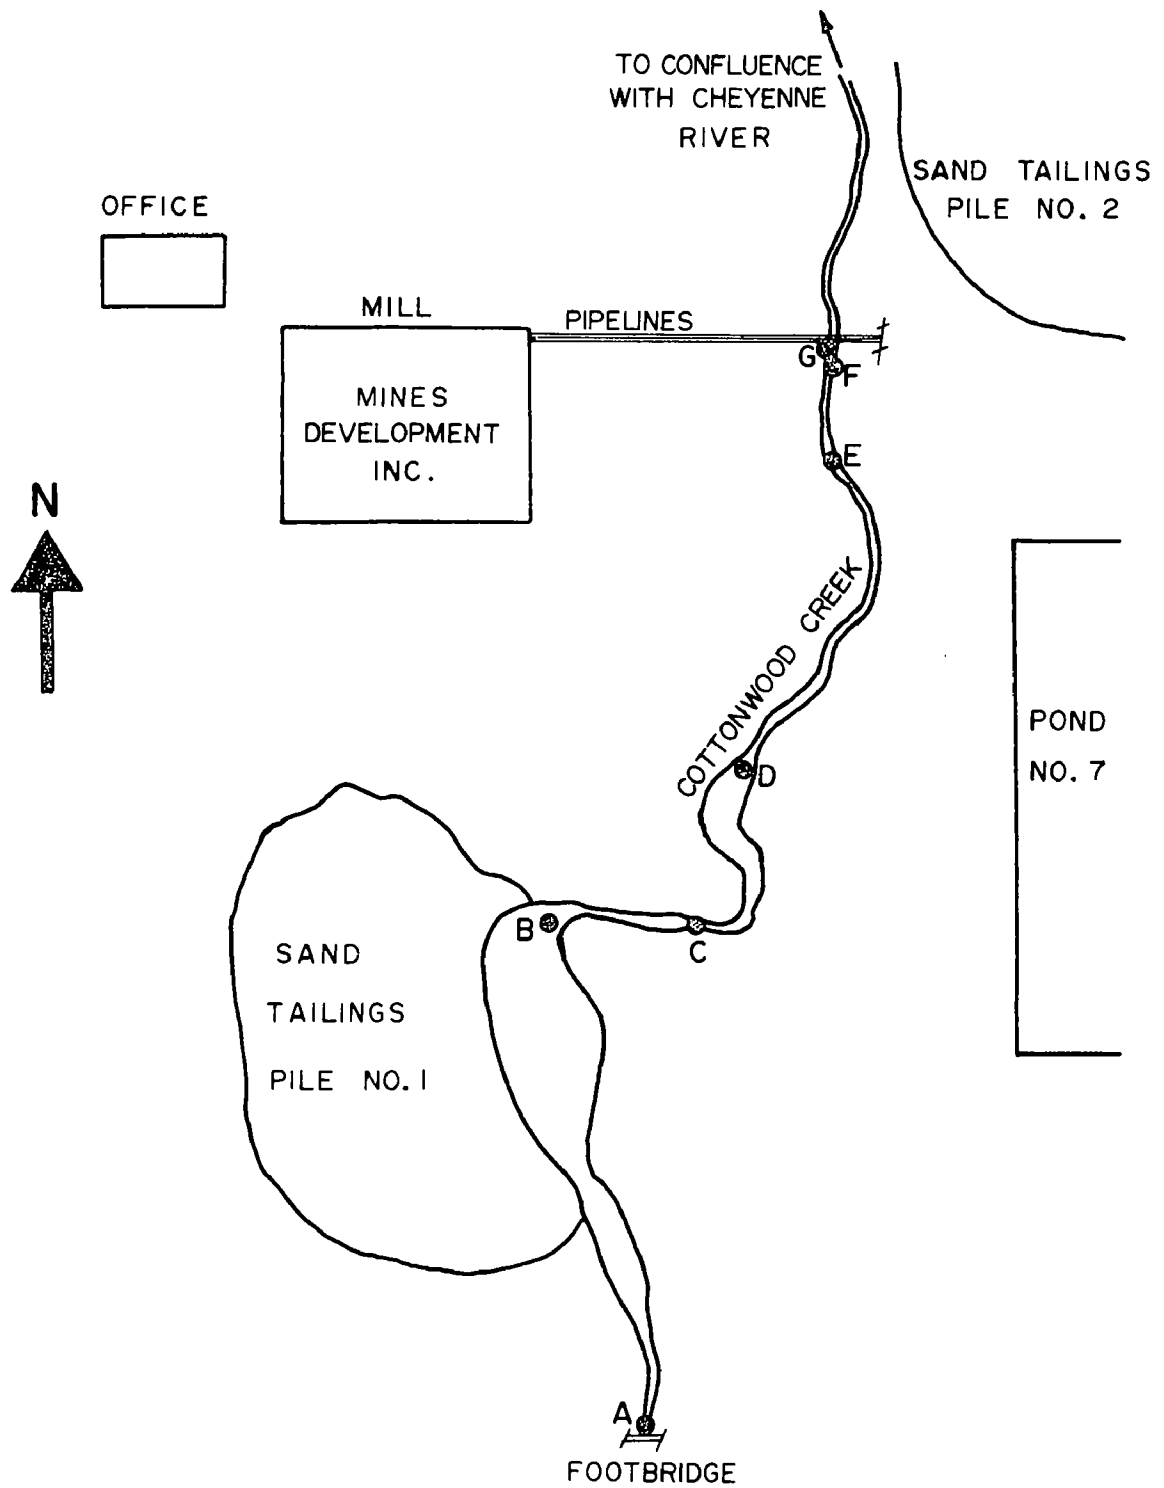
FIGURE III  
COTTONWOOD CREEK  
BOTTOM SEDIMENT SAMPLING STATIONS

As was the case in previous studies, the sediment sample collected at the pedestrian bridge across Cottonwood Creek (Station A) contained radium-226 at a concentration slightly greater than the background level. The possible explanations are a natural source (spring flow) or periodic contamination of the site by windblown sand tailings from pile No. 1 (located several hundred feet downstream). Since the sediment was stained at this

The field study eliminated any question regarding the transport of sand tailings from pile No. 1 into Cottonwood Creek by erosive action during periods of high runoff and/or wind action. Such transport was documented by the analysis of bottom sediment samples as well as visual observation of the common boundary between the creek and the tailings pile for a distance of several hundred feet. One small section of this common boundary is shown in Figure IV (photograph taken on October 3, 1972 - low flow condition). Similar documentation was obtained for the loss of sand tailings from the Pond No. 2 storage area. Soil samples collected at thirteen locations on the Cheyenne River bank and the dry stream bed adjacent to Pond No. 2 (Figure V) showed that sand tailings had breached the security fence and were beginning to migrate down the slope. Radium-226 concentrations in samples collected just outside the fence - Stations S1, S2, S3, and S4 - were indicative of sample compositions approaching 25 to 50% sand tailings (Table X). Along the line marking the sharp increase in bank slope - Stations S5, S6, S7, S8, and S9 - background concentrations of radium-226 were found. These data suggested that a loss of solids to the river had and continues to take place, but the magnitude of the loss has not been large. Slightly elevated radium-226 concentrations in the dry stream bed - Stations S11 and S12 - were probably caused by seepage as opposed to sand tailings.
