CASE STUDIES OF
RADON REDUCTION RESEARCH
IN 13 SCHOOL BUILDINGS

PB94-130010
4. TITLE AND SUBTITLE Case Studies of Radon Reduction Research in 13 School Buildings	5. REPORT DATE December 1993

6. PERFORMING ORGANIZATION CODE	
7. AUTHOR(S) Bobby E. Pyle and Ashley D. Williamson	8. PERFORMING ORGANIZATION REPORT NO. SRI ENV-92-766-7400.10	
9. PERFORMING ORGANIZATION NAME AND ADDRESS Southern Research Institute P. O. Box 55305 Birmingham, Alabama 35255-5305	10. PROGRAM ELEMENT NO.

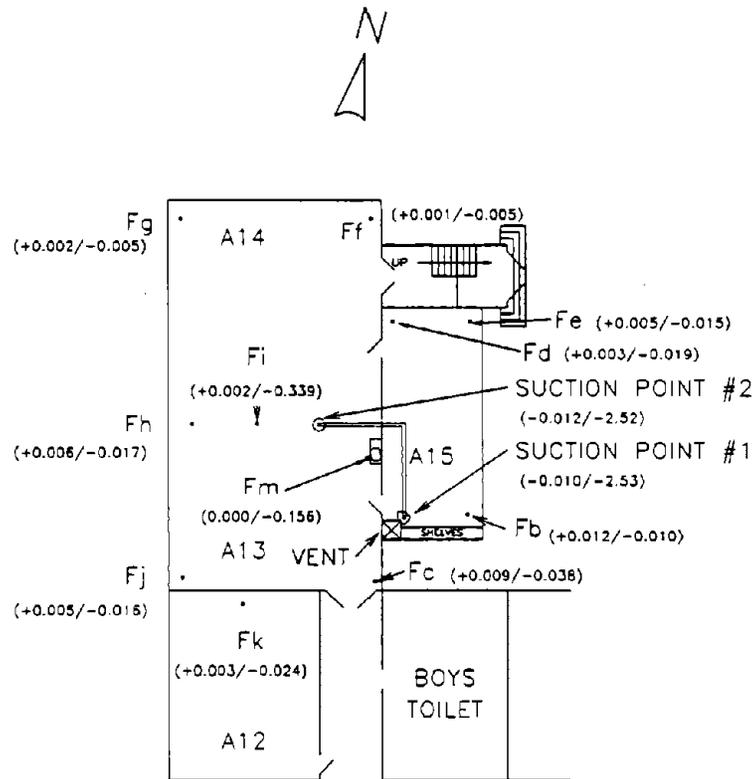
Figure 5.1.2 Location of mitigation system installed and subslab communication test results in the NW wing of Sanford Middle School, Sanford, ME (in.W.C.-fan off/in.W.C.-fan on).

After the ASD system was installed, subslab PFE was measured using the fan and two suction points of the ASD system as the suction source. The results are shown in Figure 5.1.2, where the values on the left of the "/" were measured with the ASD system installed but with the fan turned off and the values to the right were made with the ASD fan running. From the values measured at the two suction points, it appears that a significant stack depressurization effect was produced by the PVC piping. This passive soil depressurization (PSD) may lower the subslab radon levels in the immediate vicinity of the suction points but as the data show, no depressurization could be measured at any of the other, more distant, test points drilled through the slab. In fact, the static pressures under the slab at most of the test points were positive as shown in Figure 5.1.2. This may have resulted from depressurization of the basement rooms by the open vent stack running from the basement to the roof.

Due to the lack of other options, it was concluded that an ASD system was the logical choice. Because of the possibility of subslab flow obstruction caused by the footer between rooms A13/14 and A15, a suction point was installed in each room. The suction points were connected to a common suction pipe that ran up through the two floors above and out the roof of the building. On the roof, a single fan was used to provide suction to both points in the basement. The ASD system was constructed using schedule 40 PVC pipe as shown in Figure 5.1.2. The suction pits under the slab were excavated to a depth of about 12 in. and a diameter of about 36 in. The fan installed on the roof of the building had a flow capacity of 230 cfm at a static pressure of 1 in.W.C. The location of the fan on the roof of the building is shown in Figure 5.1.3.

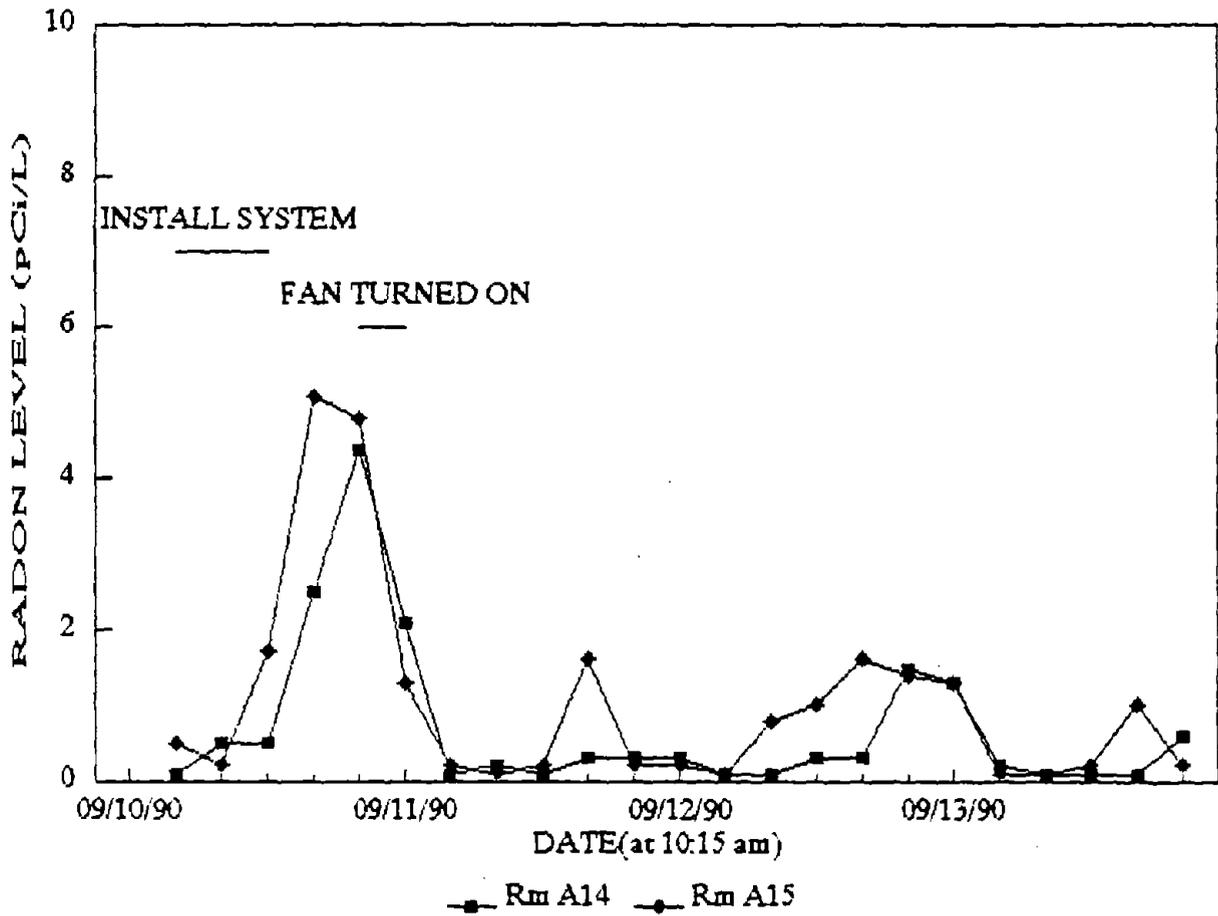
Figure 5.1.4. Tentative results of the mitigation system installed in Sanford Middle School, Sanford, ME.

Post-mitigation radon measurements were taken using Honeywell continuous radon monitors. The results are shown in Figure 5.1.4. For these data, the monitors were started at 1015 hours on September 10, 1990 and recorded the radon level at 4 hour intervals through 1000 hrs on September 14, 1990. The monitors were located in rooms A14 and A15. Installation of the ASD systems began on Monday 10 September at around 1200 hrs and continued through 2000 hrs on the same day. Installation continued on Tuesday morning 11 September and the ASD fan was turned on at approximately 1300 hrs. The communication measurements were made at approximately 1600 hrs on Tuesday 11 September 1990. From the radon levels shown in Figure 5.1.4 it would appear that the ASD mitigation system will keep the levels in the basement below 2 pCi/L.

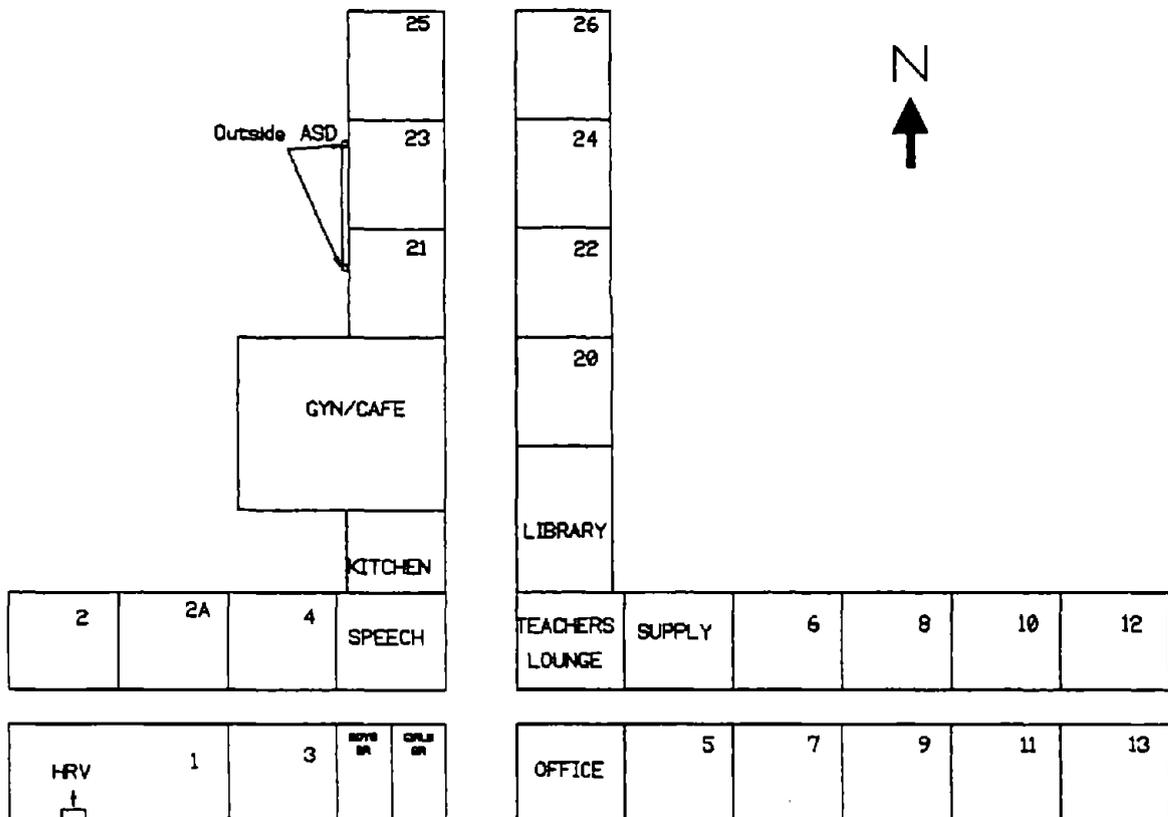
Figure 5.2.1 Plan view of Russell Elementary, Gray, ME.

The West wing was an obvious choice to test the effectiveness of increased ventilation on total indoor air quality through the use of a heat recovery ventilator (HRV). A local ventilation contractor was hired by the SEP group (6) to install an HRV in one (room 1 of Figure 5.2.1) of five rooms in that wing. The unit was installed near the middle of the outside wall of that room. No electric reheat was included to limit energy usage. The discharge was ducted to four 8 in. circle diffusers in the ceiling. Return air was taken in at the bottom of the unit. Total design air delivery was 450 cfm on low speed and close to 600 cfm on high speed.

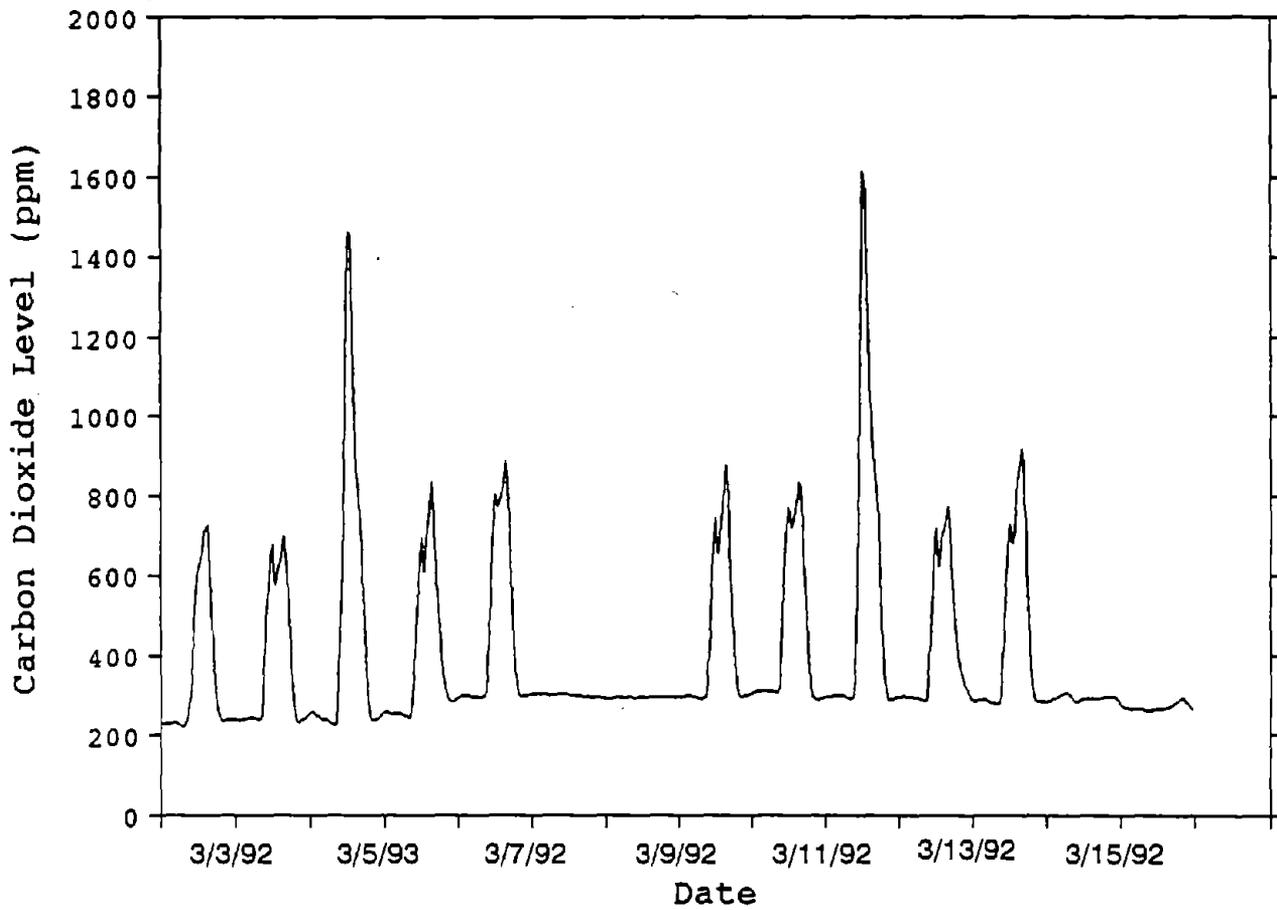
Figure 5.2.4. Continuous CO2 levels in HRV room at Russell Elementary, Gray, ME.

The data stations were modified for the second year by adding a commercial data logger which included a modem for direct data transfer to remote computers. In conjunction with the indoor air studies conducted at the school, continuous CO₂ monitors were added in a few rooms. The HRV data shown in Figure 5.2.4 shows levels less than 1000 ppm except Wednesdays when the readings doubled. This is probably due to increased activities of the children which increased their respiration rate.

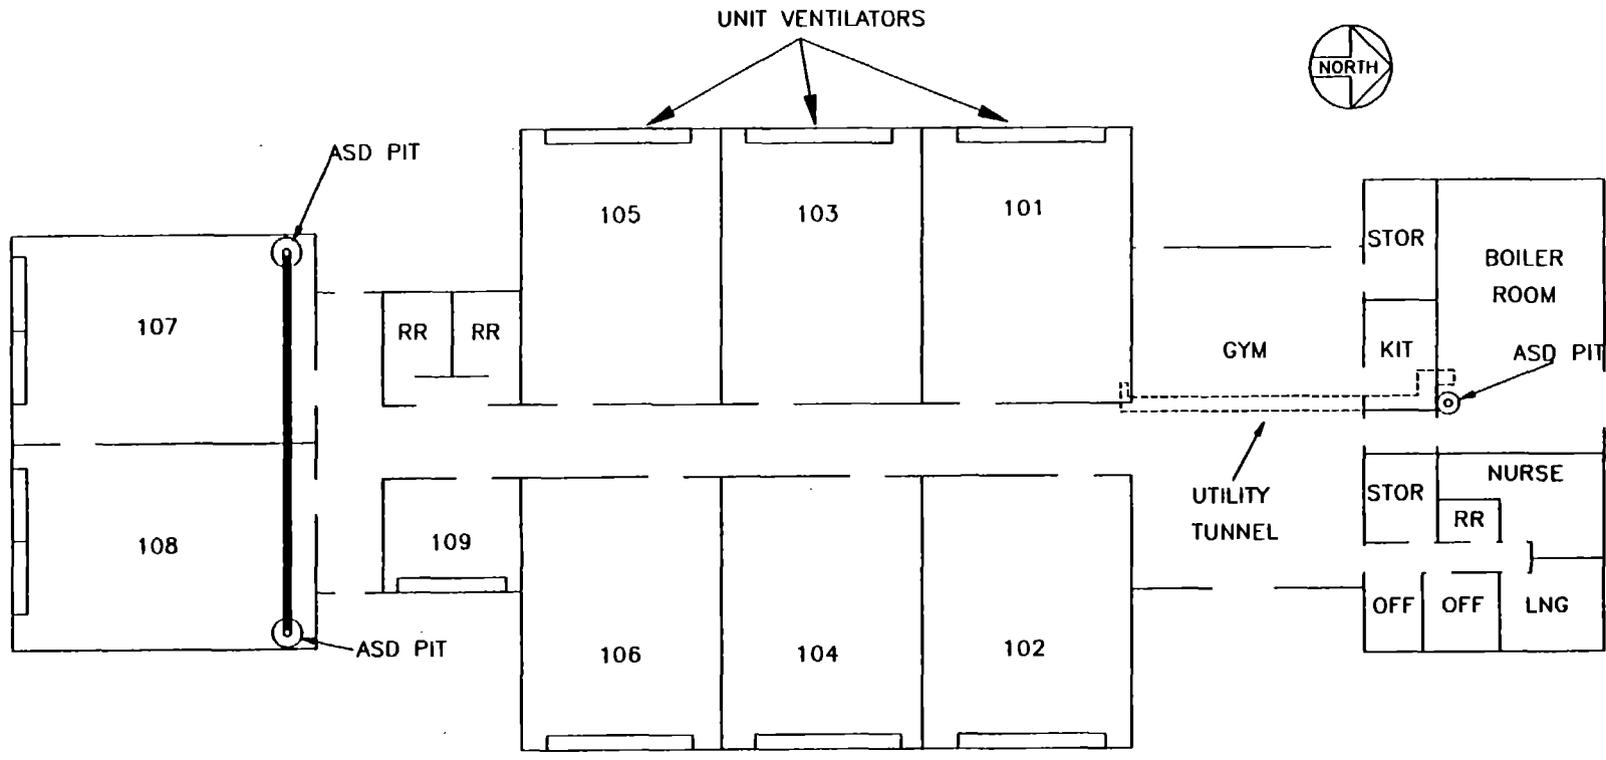
Figure 6.1.1. Floor plan of Nokomis Elementary School, St. Paul, MN, showing radon mitigation system locations.

The floor plan of Nokomis is shown in Figure 6.1.1. The total floor area is around 15,000 ft². The nature of the subslab footings is not available at the time of this report. The subslab material is packed sand.

installed in each of the two closets. The pipes from each point were connected and run to a single, roof-mounted, exhaust fan capable of moving 420 cfm at 0 in. W.C. and about 180 cfm at 1.6 in. W.C. The locations of the ASD points are shown in Figure 6.1.1.

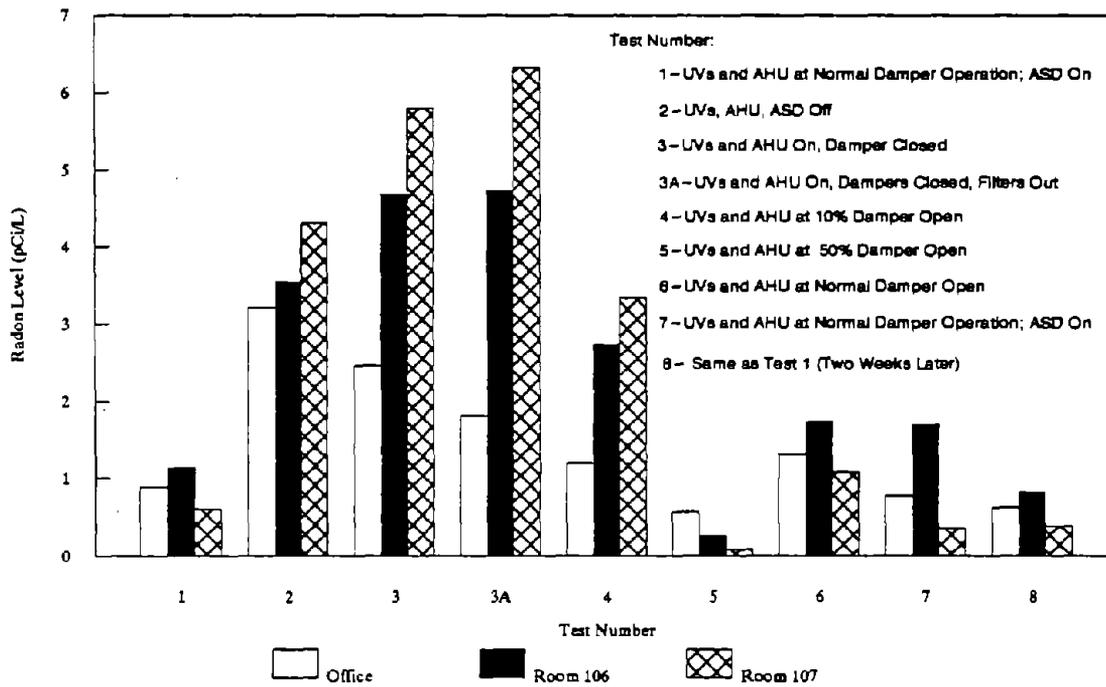
Figure 6.1.2. Radon levels during the testing period at Nokomis Elementary School.

The results of the nine initial tests are shown in Figure 6.1.2 and the three additional tests in Figure 6.1.3. The average radon levels for the principal's office, room 106, and room 107 are plotted for each of the test conditions (except for the three additional tests shown in Figure 6.1.3 where the radon monitor in room 106 lost power). Radon levels increase from Test 1 to 2 because of stack effect induced radon entry. With the ASD systems operating (Test 1), the stack effect is reversed. The operation of the UVs with OA also helps to reduce the stack effect.
