EPA/600/R-09/066
August 2009

Arsenic Removal from Drinking Water by Iron Removal U.S. EPA Demonstration Project at Vintage on the Ponds in Delavan, WI Final Performance Evaluation Report

Battelle
Columbus, OH 43201-2693

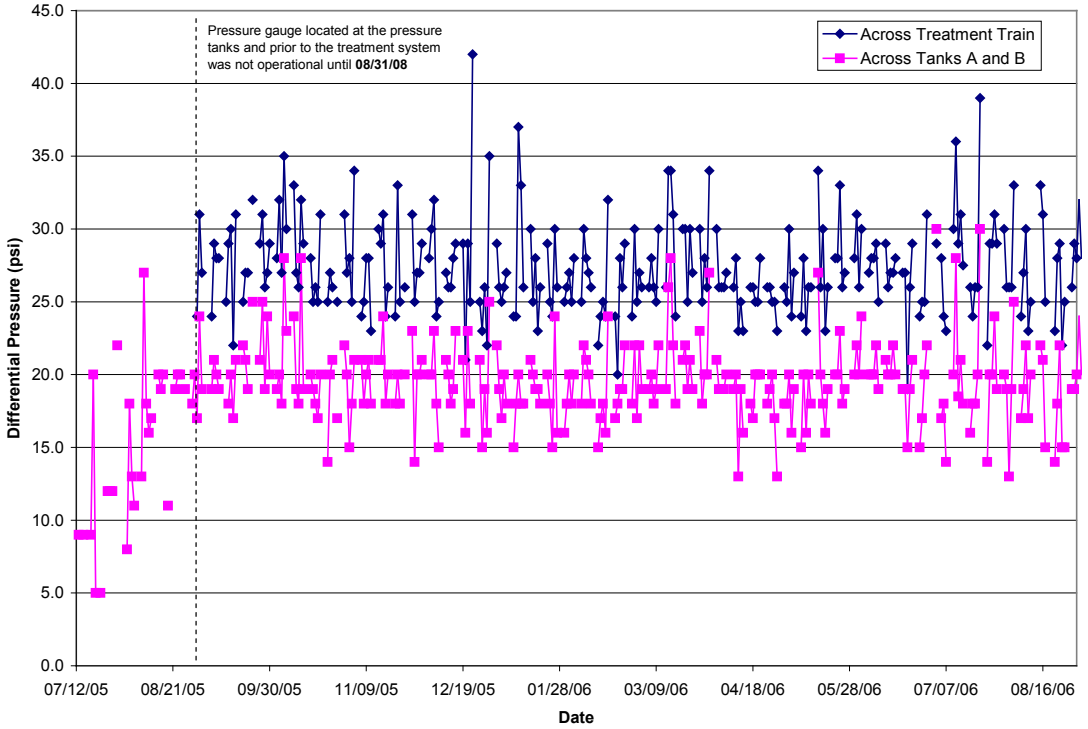
Figure 4-12. Δp Across Vessels A and B and Entire System

At flowrates of less than 20 gpm, system inlet pressure readings to the system ranged from 42 to 60 psi, which, as expected, were within the operating range of 40 to 60 psi for the pressure tanks. System outlet pressure readings to the downstream softener units ranged from 10 to 40 psi. Differential pressure (Δp) readings across Vessels A and B ranged from 5 to 30 psi (excluding two readings at 1 and 33 psi). As shown in Figure 4-12, Δp readings across Vessels A and B rose gradually from 5–9 psi immediately after system startup and were stabilized at about 15–25 psi approximately one month into system operation. Because the Δp readings were recorded at different stages of various service cycles, the spikes shown in the figure most likely represent the times when the filters were about to be backwashed. Δp readings across the system ranged from 19 to 42 psi.

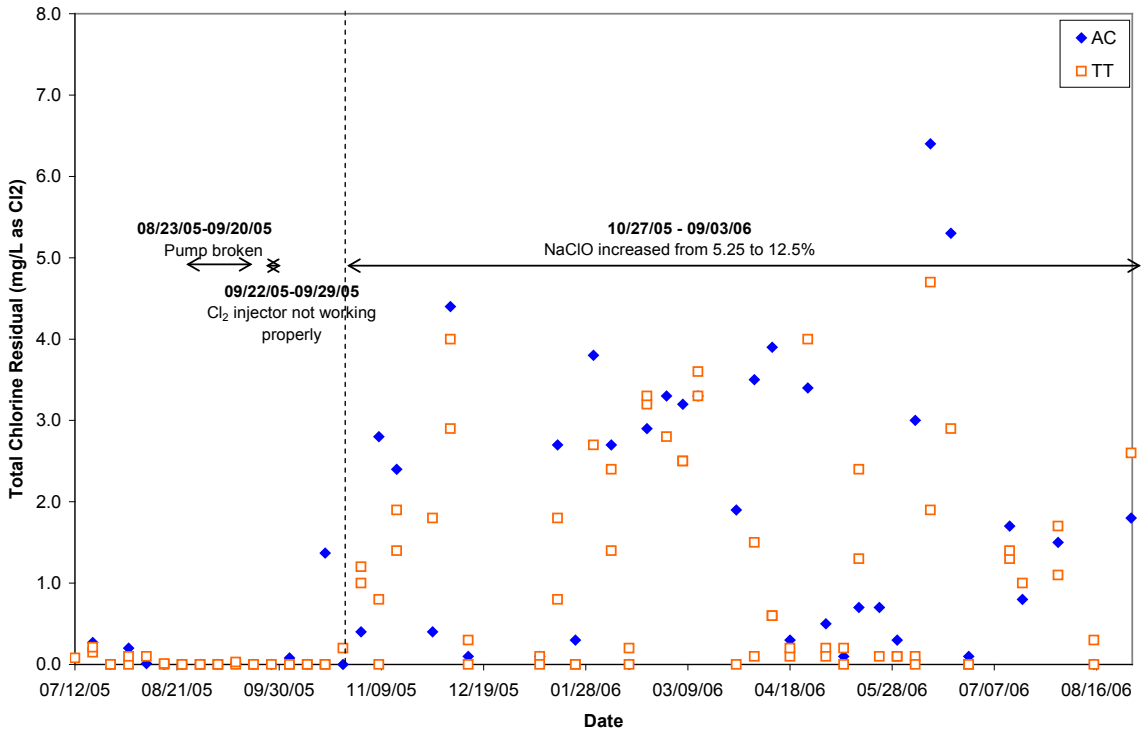
Figure 4-13. Total Chlorine Residuals at AC and TT Locations

For the first three months of system operation through October 2005, except for a few occasions, little or no chlorine residuals were measured after the contact tank and in the system effluent. Failures to detect chlorine residuals were attributed to factors such as problems with the chlorine test kit, chlorine feed pump, and chlorine injector, and insufficient chlorine dosage with the use of a 5.25% NaClO solution. Initial attempts to correct the problems included replacing a potentially malfunctioning N,N diethyl-p-phenylene diamine (DPD) reagent dispenser with DPD pillows for chlorine residual measurements and increasing the chlorine injection rate by stepping up the stroke length of the chlorine feed pump from 70 to 83.5%. Since August 23, 2005, the operator noticed no change in the chlorine tank level, indicating no chlorine addition. A broken compression fitting on the chlorine feed pump was later identified as the root cause and replaced on September 19–20, 2005. Two days later, the chlorine injection point was relocated from before to after the pressure tanks to prevent the butyl rubber diaphragms in the pressure tanks from being damaged. After relocation, the chlorine injector did not bleed properly and had to be repaired by the vendor's subcontractor a week later.

After switching to a 12.5% NaClO solution on October 27, 2005, both chlorine dosages and chlorine residuals were increased significantly, as shown in Figure 4-13. The actual chlorine dosages based on chlorine tank level measurements ranged from 1.3 to 5.9 mg/L (as Cl_2). With approximately 1 mg/L (as Cl_2) of chlorine demand for Fe(II), Mn(II), and As(III) and an unknown amount for the organic matter in raw water, total chlorine residuals in the treated water should have been no more than 0.3 to 4.9 mg/L (as Cl_2), a range that covered the majority of the measured residual data points as shown in Figure 4-13. It is suspected that the measured total chlorine residual data might be somewhat higher than the actual concentrations due to the inadvertent use of high range (HR) test kits designed for a higher concentration range (i.e., from 0.1 to 8.0 mg/L [as Cl_2]). During a site visit in July 2006, a Battelle staff member measured a set of samples using both the high and low range (designed for 0.02 to 2.0 mg/L [as Cl_2]) test kits and obtained 0.2–0.3 and 0.4–1.4 mg/L (as Cl_2) of total chlorine residuals, respectively. Therefore, the use of HR test kits could have skewed the test results to some extent.

Leaks were developed after switching from 5.25 to 12.5 % NaClO solution due to incompatibility of the plumbing material with the stronger NaClO solution. A leak was first discovered between the ½-in copper chlorine injector and 2-in copper "tee" on November 4, 2005. After being patched, the leak continued at the 2-in copper "tee". The ½-in copper chlorine injector and 2-in copper "tee" were then replaced with the equivalent PVC parts on November 7, 2005. A leak was discovered again on the 2-in PVC "tee" on November 11, 2005, caused by a cracked plastic fitting, and was fixed on the same day. Since then, no more repairs have been performed on the chlorine addition system, except for the pump's (losing prime) periodically due to airlocks, causing little or no consumption of the chlorine solution.

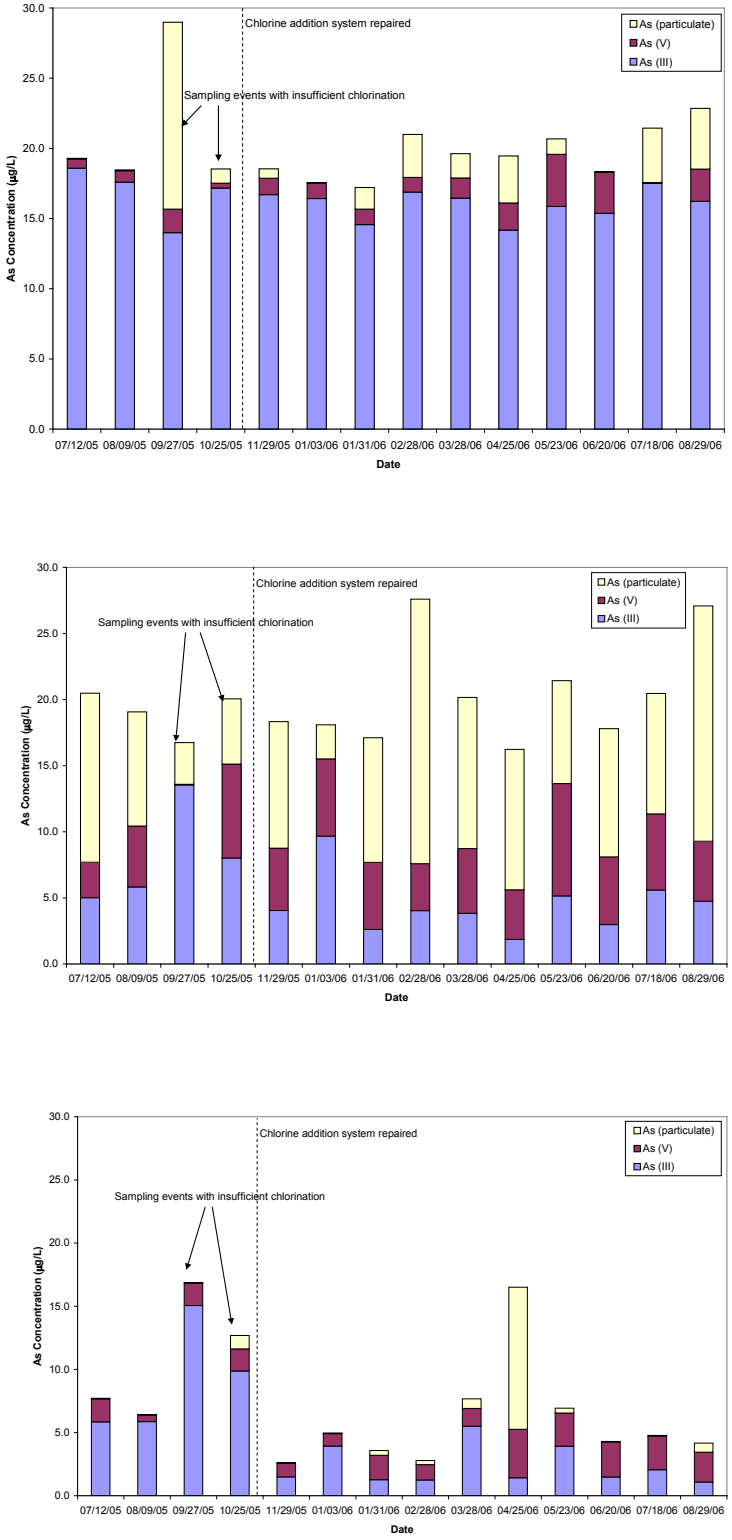
Figure 4-14. Concentrations of Arsenic Species at IN, AC, and TT Sampling Locations

As shown in Figure 4-14, for the 14 speciation sampling events, 11 TT samples were below 10 µg/L of arsenic. For the other three events, the two on September 27 and October 25, 2005, had insufficient chlorine addition due to problems with the chlorine addition system, as discussed in Section 4.4.2, and the one on April 25, 2006, had particulate arsenic breakthrough due to failure to backwash at the specified throughput setting caused by malfunctioning of Vessel B, as discussed in Section 4.4.4. Problems with the chlorine addition system resulted in elevated soluble As(III) and iron concentrations in the treated water. For example, total arsenic concentrations at the TT location were 16.6 and 12.7 µg/L, respectively, with most existing as As(III) at 15.1 and 9.9 µg/L, respectively (data shown in parentheses in Table 4-7). The corresponding total iron concentrations were 1,596 and 834 µg/L, with most existing in the soluble form at 1,417 and 832 µg/L, respectively. These elevated results were consistent with the results of five of six other regular sampling events taking place on August 30, September 6 and 13, and October 4, 11, and 18, 2005 (Figures 4-15 and 4-16) when insufficient chlorine was added due to the problems with the

chlorine injection system. For these five events, total arsenic concentrations ranged from 9.4 to 21.0 μg/L and total iron concentrations ranged from 856 to 1,525 μg/L at the TA, TB, and TT sampling locations.

Decreases in As(III) concentration after the contact tank were not as significant as those observed at many other demonstration sites, where As(III) was almost completely converted to either As(V) and particulate arsenic (Condit et al., 2006). Most of these sites had little or no ammonia in raw water, suggesting that presence of ammonia in the Vintage's raw water impacted As(III) oxidation. Ghurye and Clifford (2001) reported that pre-formed monochloramines were ineffective for As(III) oxidation and that limited oxidation could be achieved when monochloramine was formed in situ. The injected chlorine probably reacted with both As(III) and ammonia before being quenched by ammonia to form chloramines.

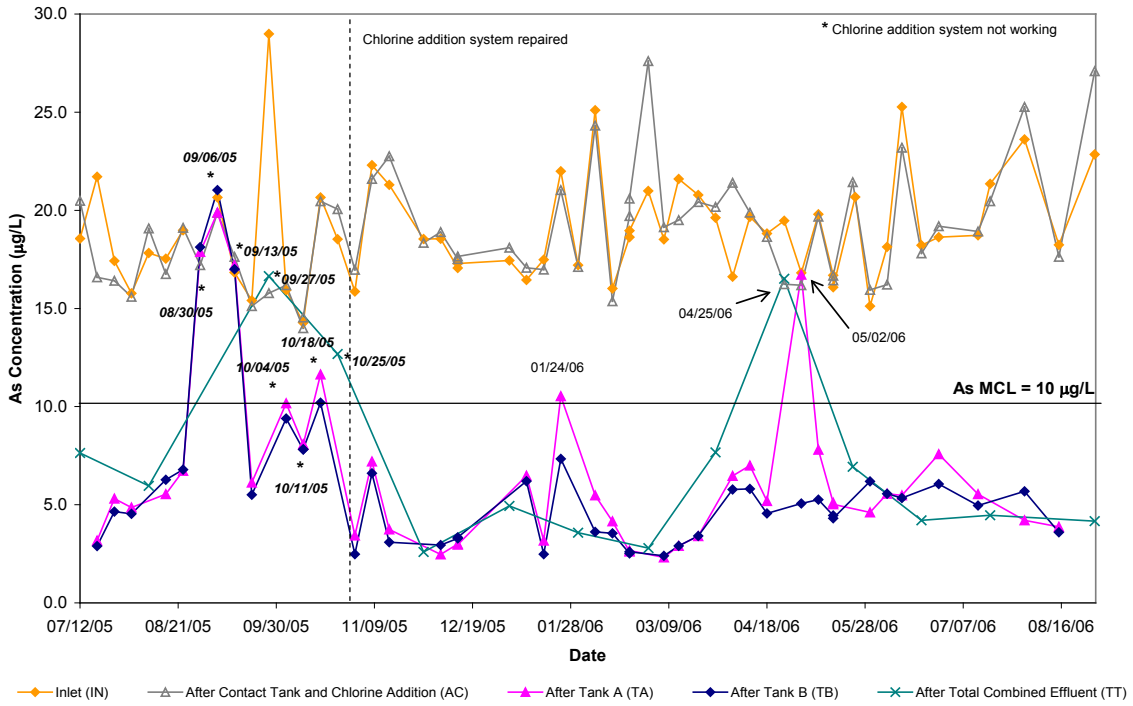
Figure 4-15. Total Arsenic Concentrations at IN, AC, TA, TB, and TT Sampling Locations

For the 12 speciation sampling events having sufficient chlorine addition (including the one with particulate breakthrough on April 25, 2006), As(III) concentrations were reduced from an average of 16.3 μg/L in raw water to 4.6 μg/L after the contact tank. Correspondingly, particulate arsenic concentrations were increased from an average of 2.4 to 10.8 μg/L. This, along with the moderate increase in As(V) concentration following the contact tank (i.e., from 1.4 to 4.9 μg/L), confirmed that As(V) formed via oxidation of As(III) adsorbed onto and/or co-precipitated with iron solids and formed arsenic-laden particles. As(III) concentrations after the pressure filters averaged 2.9 μg/L, suggesting additional As(III) oxidation through the filters. As(V) concentrations after the filters were further reduced to 1.9 μg/L, suggesting additional As(V) removal via adsorption onto iron solids intercepted by the filters. Particulate arsenic levels after the pressure filters averaged 1.2 μg/L, indicating effective particulate removal by the filters. Note that, in addition to the April 25, 2006 speciation sampling event mentioned above, two other regular sampling events on January 24 and May 2, 2006 (after the chlorine addition system had been fixed), also had higher than 10-μg/L arsenic breakthrough in the filter effluent (Figure 4-15). In each event, a high total iron concentration was measured (Figure 4-16), indicating particulate breakthrough from the filters.

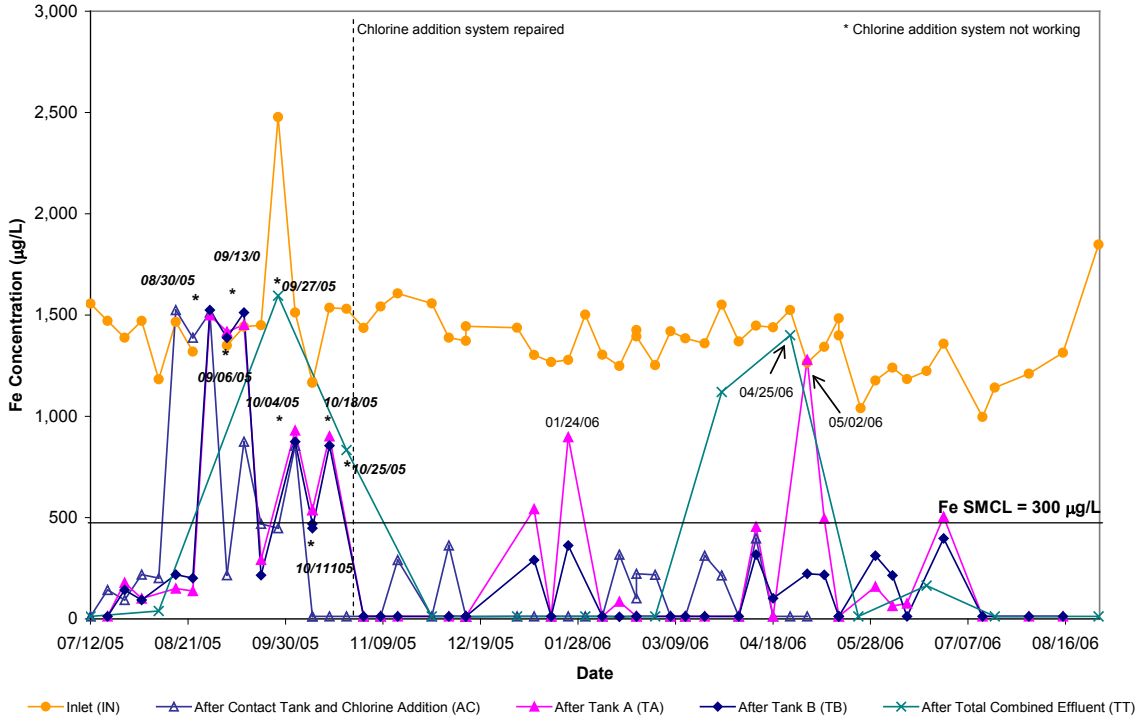
Figure 4-16. Total Iron Concentrations at IN, AC, TA, TB, and TT Sampling Locations

Incomplete iron oxidation also was observed after the contact tank. For the 12 speciation events where sufficient chlorine was added, as much as 429 μg/L of dissolved iron (on average) was measured after chlorine addition and contact tank. The chlorine added might have reacted with both soluble iron and ammonia before being quenched by ammonia to form chloramines. Soluble iron concentrations were reduced to an average of 39 μg/L after the pressure filters, suggesting more complete oxidation of soluble iron with prolonged contact times (Vikesland and Valentine, 2002). After filtration, total iron concentrations ranged from <25 to 1,400 μg/L (not including data in parentheses in Table 4-7) and averaged 158, 100, and 235 μg/L at the TA, TB, and TT sampling locations, respectively. As discussed above, particulate iron breakthrough was observed in a number instances as evidenced by the spikes shown in Figure 4-16.

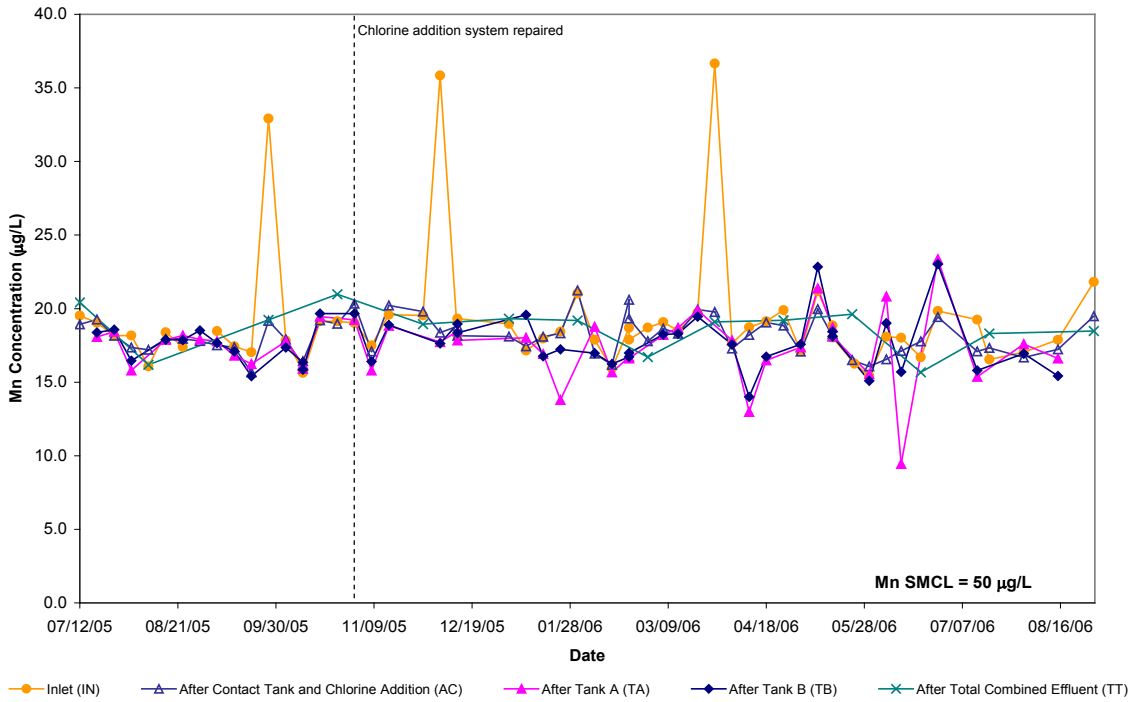
Figure 4-17. Total Manganese Concentrations at IN, AC, TA, TB, and TT Sampling Locations

Manganese. Total manganese levels in source water ranged from 15.5 to 36.7 μg/L and averaged 19.2 μg/L (Table 4-7), which were below the Secondary Maximum Contaminant Level (SMCL) of 50 μg/L. Manganese in source water existed almost entirely in the soluble form at levels ranging from 17.0 to 32.4 μg/L and averaging 20.1 μg/L. For the two speciation events without sufficient chlorine addition, soluble manganese concentrations after the contact tank ranged from 11.8 to 18.7 μg/L and averaged 15.2 μg/L. For the 12 speciation events with sufficient chlorine addition, soluble manganese concentrations after the contact tank were at similar levels, ranging from 16.1 to 20.8 μg/L and averaging 18.1 μg/L. Chloramines formed during prechlorination apparently were ineffective at oxidizing Mn(II). Manganese after chlorination remained in the soluble form, which was not filtered out by the pressure filters. Soluble manganese in the treated water averaged 20.8 and 18.8 μg/L for the sampling events without and with sufficient chlorine addition (Figure 4-17).
