Innovative Internal Camera Inspection and Data Management for Effective Condition Assessment of Collection Systems

Kathy Martel, P.E., and Mary Ellen Tuccillo, Ph.D.
The Cadmus Group, Inc.

National Risk Management Research Laboratory
Office of Research and Development
U.S. Environmental Protection Agency
Cincinnati, OH 45268

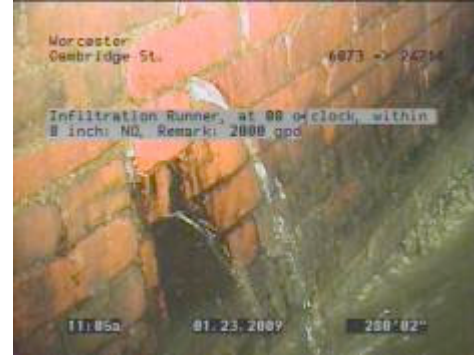
Figure 2-2. Example of infiltration. Image courtesy of RedZone Robotics, Inc.

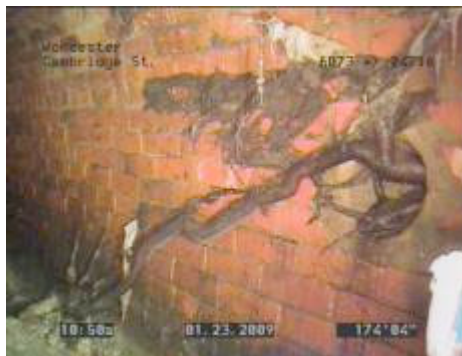
Figure 2-3. CCTV image of roots in lateral. Image courtesy of RedZone Robotics, Inc.

Figure 2-3 provides an example of a CCTV image that documents root intrusion. As noted above, CCTV technology has limitations because it can only provide a visual representation of the inside surface of a pipe above the waterline. Furthermore, the quality of defect identification and pipe condition assessment using CCTV is highly dependent on

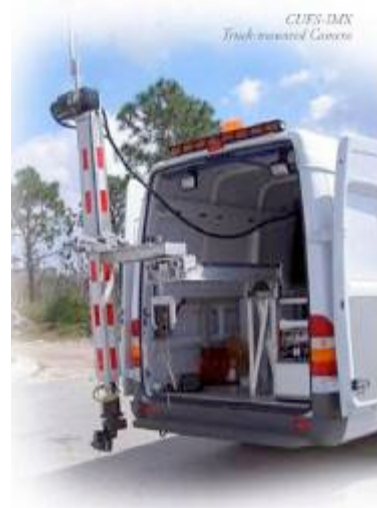
Figure 2-5. CUES-IMX truck-mounted zoom camera. Source: CUES, Inc. (2009). Reprinted with permission.

The CUES-IMX truck-mounted zoom camera (Figure 2-5) has a total effective zoom ratio of 300:1 including a 25:1 optical zoom range. The camera is stabilized and remotely controlled by a telescopic boom. It is equipped with high-intensity lights. The camera mounting fork is designed to pan the camera head 360° continuously, tilt mechanically 45° up or 90° down and tilt optically 166°. The camera system can be mounted within an inspection van, all-terrain vehicle or trailer. The camera housing is a damage-resistant, waterproof enclosure 7 in. in diameter and 16 in. in length. The CUES-IMX zoom camera system is equipped with data collection software, GIS software and global positioning system (GPS) equipment. The GIS software and GPS equipment are used to create sewer maps in the field and to create an asset management database for the system. Defects detected during the inspection can be stored in a database along with photos and video clips. All data are geo-referenced to the field-collected GPS coordinates. This is common in the industry and the subject of further discussion in Chapter 3.

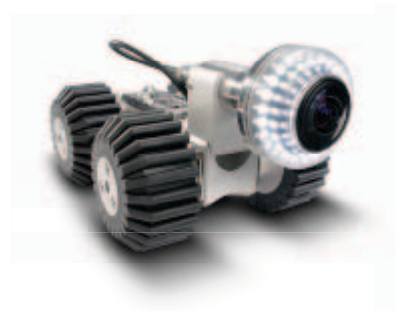
DigiSewer uses one high-resolution photo camera with a 180° wide-angle fisheye lens integrated into the front of the rover crawler (Figure 2-11). According to the vendor, DigiSewer can scan 6-in. to 32-in. diameter pipes at a scan speed of 70 ft per minute and can scan pipes approximately 650 ft in length.

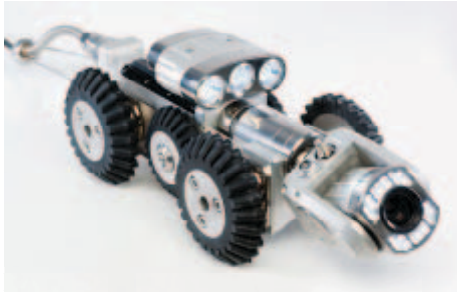
Figure 2-13. Mobile robot inspection system. Source: iPEK International GmbH (2009). Reprinted with permission.

In CCTV inspection, cameras are deployed into pipelines in a variety of ways. Mobile robots called crawlers or tractors (e.g., Figure 2-13) are available in a variety of sizes and configurations, enabling their use in various pipes sizes. These robots are typically introduced into the sewer via a manhole. Cameras can also be mounted on float rigs (Figure 2-14) for inspecting large-diameter pipes that are partially filled with water. Pushrod cameras are typically used in smaller diameter pipes (6 in. and less) such as service laterals and are typically introduced into the sewer through a cleanout.

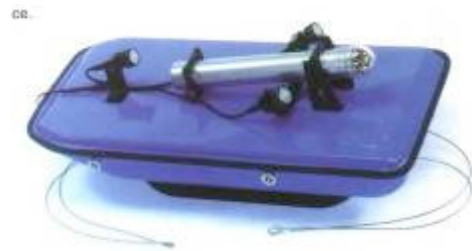
Figure 2-14. CUES camera float. Source: CUES, Inc. (2009). Reprinted with permission.
