EPA-450/3-76-001

**RELIABILITY STUDY
OF VAPOR
RECOVERY SYSTEMS
AT SERVICE STATIONS**

R.J. Bryan, L.G. Wayne, and R.L. Norton

**Pacific Environmental Services, Inc.
1930 11th Street
Santa Monica, California 90404**

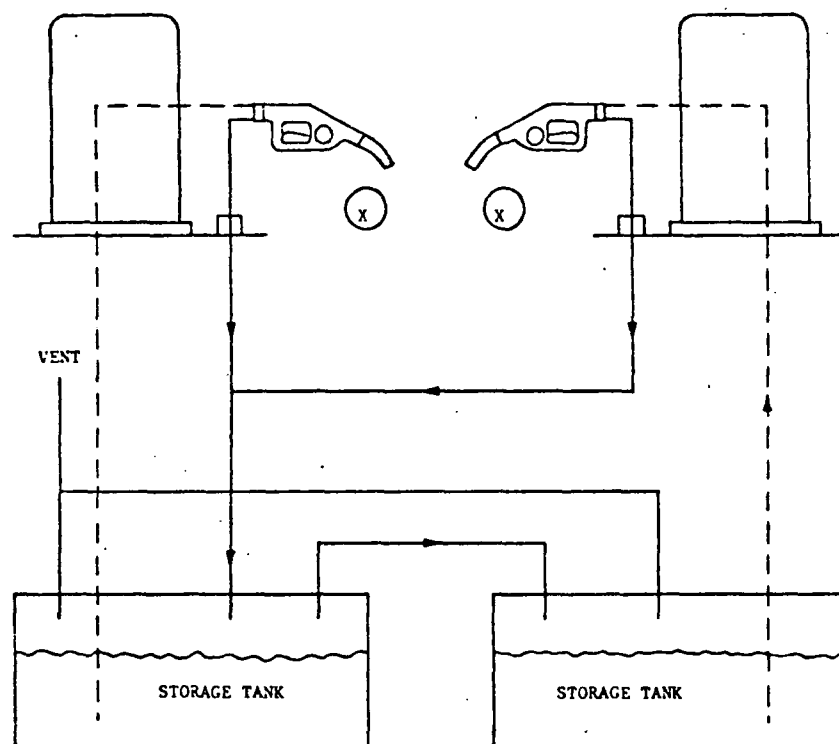
Figure 1A. SCHEMATIC DIAGRAM OF
MANIFOLDED BALANCE
SYSTEM

The simplest vapor recovery systems are the vapor-balance systems, which operate on the principle of a simple exchange of materials between the vehicle tank and the service station storage tank. As liquid gasoline is withdrawn from the underground storage tank and pumped into the vehicle tank, it displaces an equivalent volume of vapor-laden air, which either enters the underground tank through a return line to replace the liquid removed or leaks to atmosphere. In principle, with tight connections, such systems might operate indefinitely without loss of hydrocarbons. Achieving such operation is difficult, however, because in practice it is difficult to obtain a tight seal between the nozzle and the fill-neck for all vehicles. Therefore, leakage at this point is frequently encountered. Figure 1 illustrates a typical balance system.

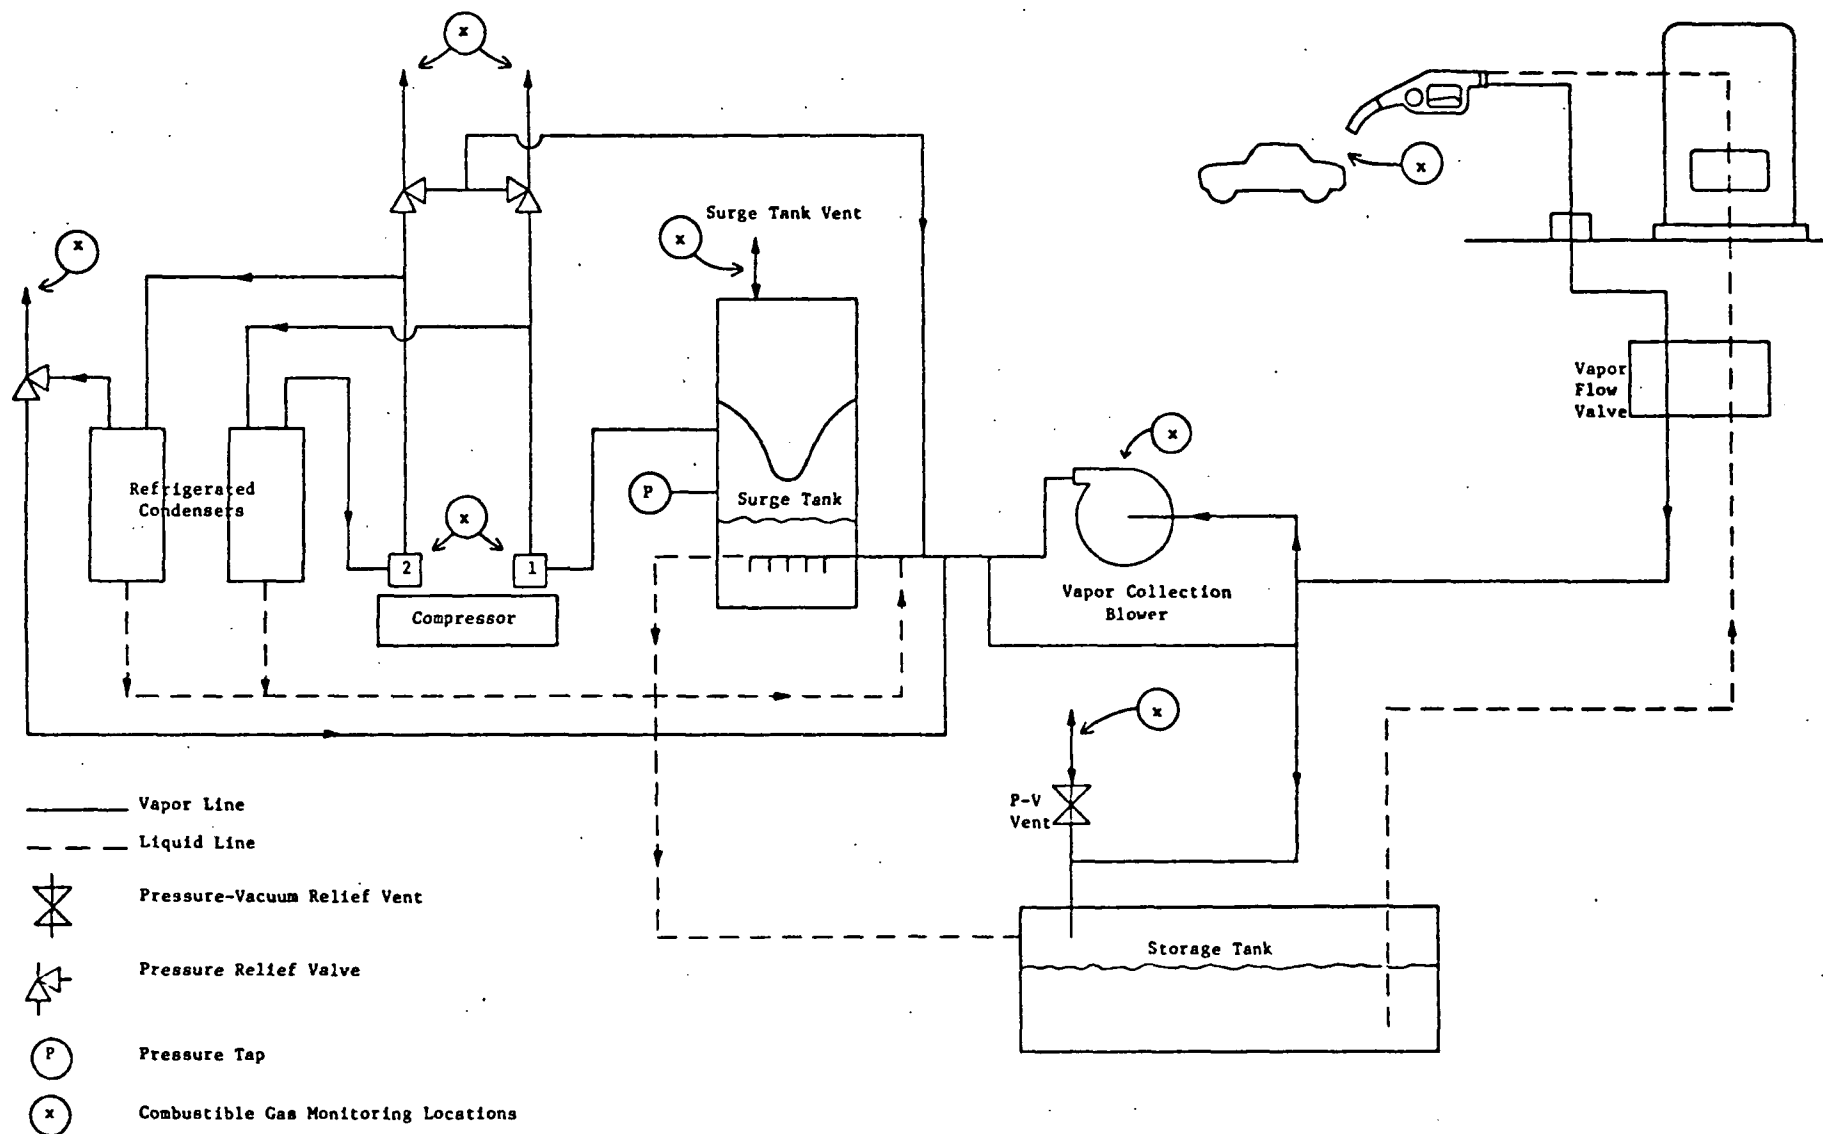
Figure 2. SCHEMATIC DIAGRAM OF INTERMARK SYSTEM (MARK I)

Figure 2 is a schematic diagram of the Intermark Mark I system. Vapors are drawn from the nozzle by a blower; a tee provides for the return of vapor to the underground tank. Vapor laden air passing through the blower bubbles through liquid gasoline in the surge tank. This causes further gasoline evaporation if the air is not initially saturated. Within the tank, a flexible bladder moves a switch, activating the compressor of a refrigeration unit when a predetermined position is reached. Air and vapor are withdrawn from the surge tank, compressed and refrigerated, condensing the hydrocarbons to a liquid which is returned to the surge tank and thence to the storage tank.

Figure 2 also indicates the locations of points (x) which were monitored by the study team to detect possible leakage of hydrocarbon vapors, and the location of a pressure tap (p) which was installed to permit checking the bladder tank pressure at which the compressor was activated. New features since the TRW study were the addition of a vapor flow control valve and use of a different model compressor.

For each of the vacuum-assist systems, pressures within the system were measured at strategically located pressure taps as indicated in the schematic diagrams, Figures 2 to 6. Magnehelic gauges having a sensitivity of 0.01 inch of water were used, with self-sealing, quick-connecting Imperial Eastman fittings. With two of the systems, temperatures were also determined. For this purpose thermocouples were used, and the potentials generated were measured with a portable potentiometer (Thermo-Electric Co., Model 31101, "Minimite").

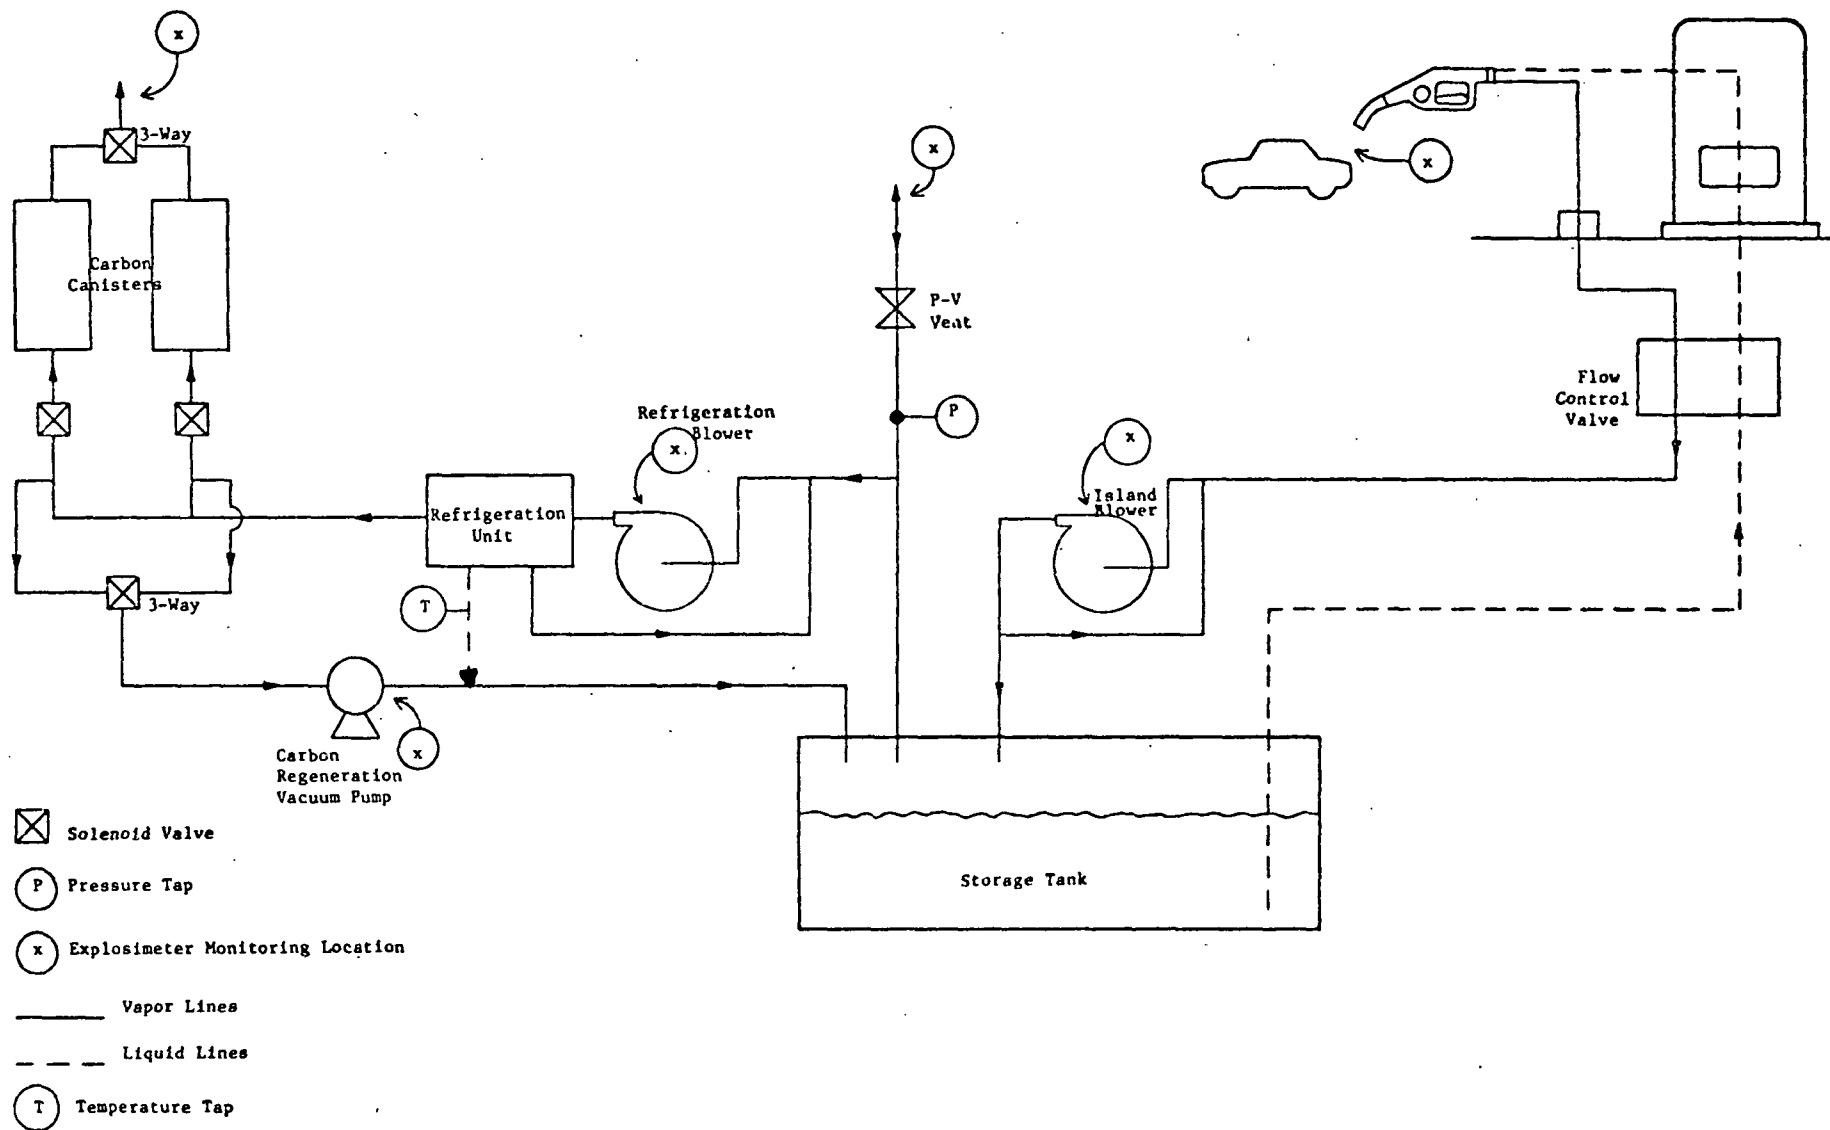
Figure 3. SCHEMATIC DIAGRAM OF PROCESS PRODUCTS SYSTEM

A system developed by Process Products, Inc. processes the vapor-laden air, first by condensation, then by adsorption. Figure 3 shows a schematic diagram of this system. Vapor-laden air is collected by means of a blower, located at the pump island, and is delivered to the underground storage

tank. When the pressure in the tank reaches a predetermined value, a second blower is activated, moving air from the tank to a refrigeration unit, from which condensate flows back to the storage tank. As shown in the schematic this model incorporates partial recirculation through the refrigeration unit. The air then passes through carbon beds, which remove much of the remaining hydrocarbons before venting to the atmosphere. When the tank pressure is reduced to another predetermined value, or after thirty minutes, the refrigeration blower is deactivated.

Figure 3 also indicates the locations of points monitored by the study team to detect possible leakage of hydrocarbon vapors, and the locations of pressure and temperature taps installed to determine tank pressure and condensate temperature. Information provided by the manufacturer indicated that the blower serving the refrigeration unit should be automatically activated when the tank pressure (gauge) reaches one inch of water, and deactivated when tank pressure falls to one half inch.

The condensate temperature is expected to be about 20°F. Modifications to this system since the TRW study consist of the replacement of the belt-driven blower by a direct drive blower and the routing of the refrigerated gas stream directly through the carbon canisters to the atmosphere instead of recycling to the underground tank.

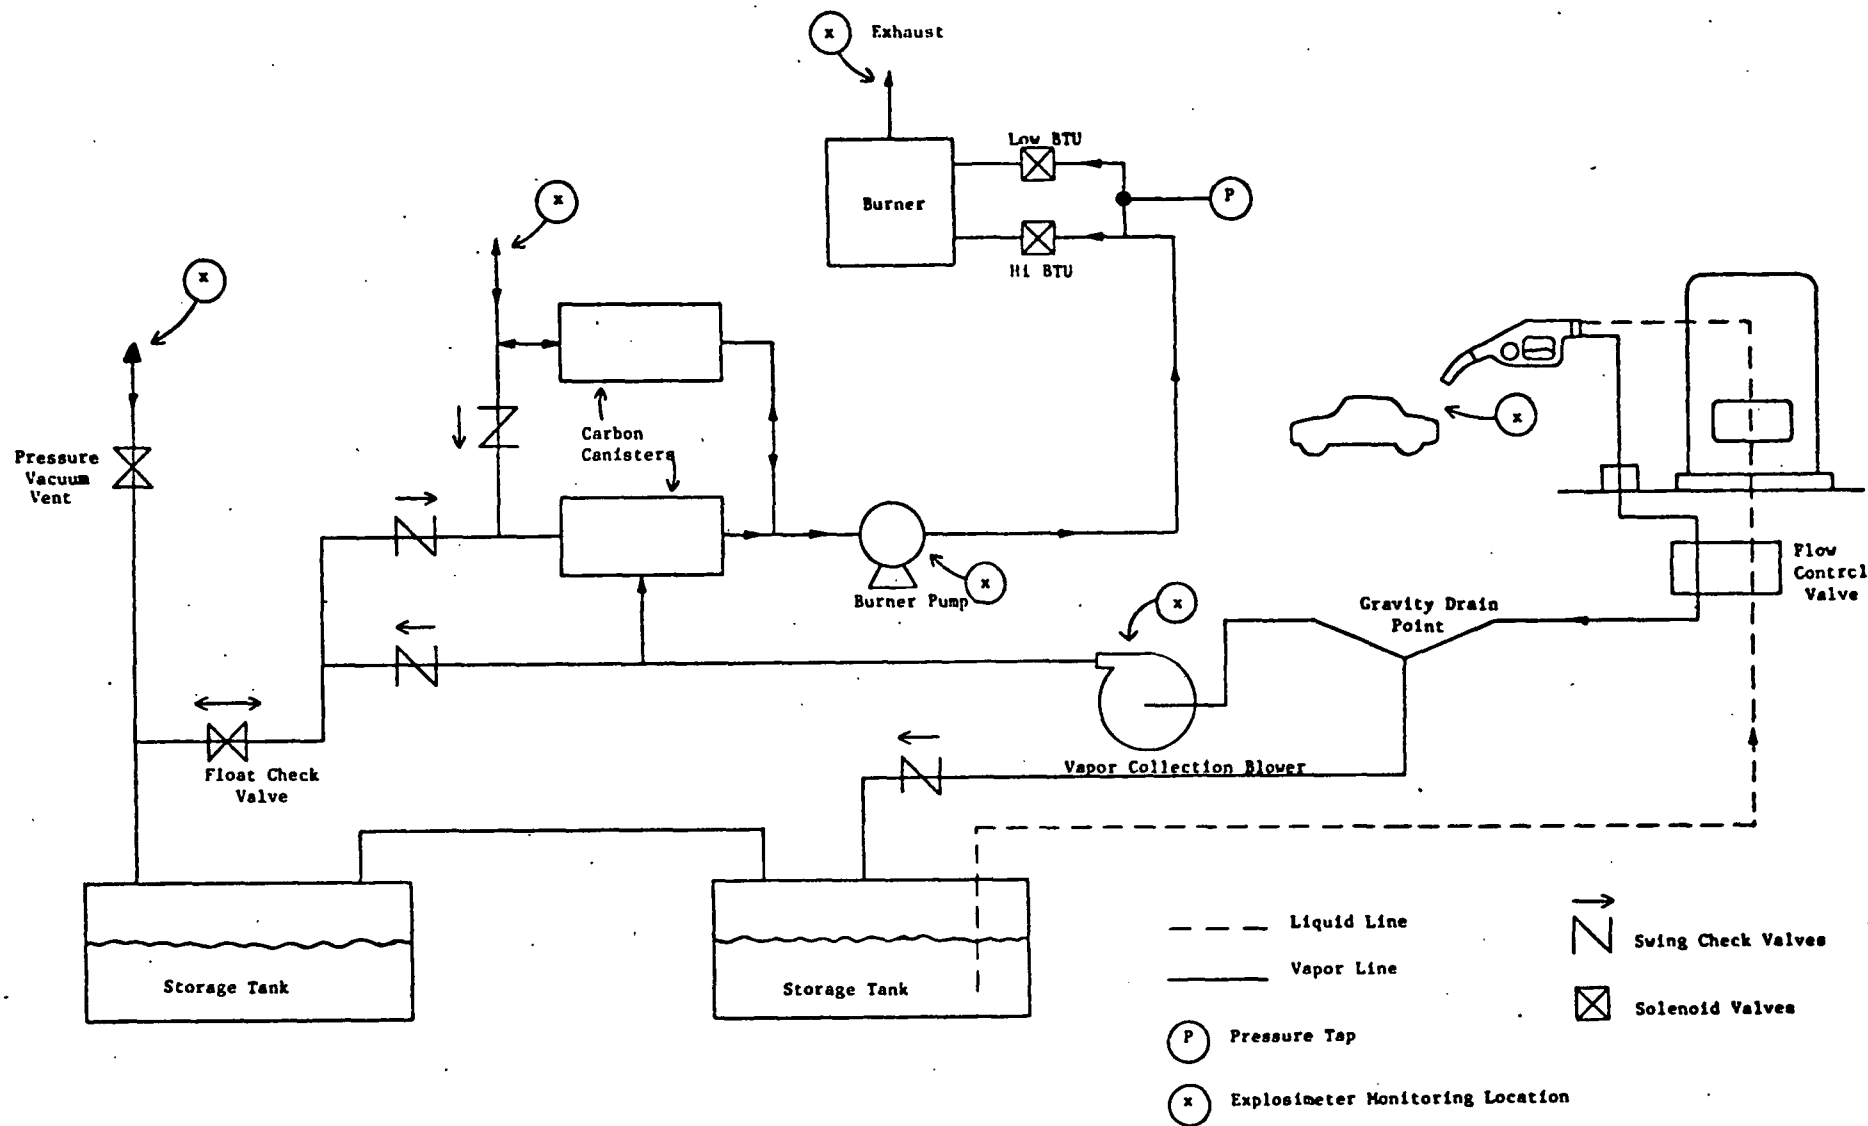
Figure 4. SCHEMATIC DIAGRAM OF CLEAN AIR ENGINEERING SYSTEM
(Model 5000B)

A system developed by Clean Air Engineering Inc. employs carbon canisters to adsorb vapors and direct flame burners to dispose of the hydrocarbons released when the sorbent is regenerated. A schematic diagram of the clean air model 5000B is shown in Figure 4. Vapor-laden air is collected by means of a blower and delivered to the processing unit. A tee connector ahead of the blower provides for drainage of any entrained liquid back to the storage tank. A second tee after the blower directs part of the vapor-laden air to the underground tank and the remainder to the processing unit. In the processing unit, activated carbon adsorbs hydrocarbons and the stripped air is vented. After 30 seconds of operation in this mode, a second blower is activated, which draws fresh air through the carbon canisters, delivering the desorbed hydrocarbons to a set of burners, where they are destroyed. Two stages of combustion are employed; the burning continues until the rate of desorption becomes too low to support combustion at either stage, at which time the second blower is deactivated.

Figure 4 also shows the locations of points monitored by the study team to detect possible leakage of hydrocarbon vapors, as well as the location of a pressure tap which was installed to permit checking pressures in the burner manifold. According to the manufacturer, this pressure should normally be maintained at 5 to 5 1/2 inches of water. The modification to this system since the TRW study consists of the replacement of the gasoline engine (which burned the vapors) by a direct-flame, two-stage burner.

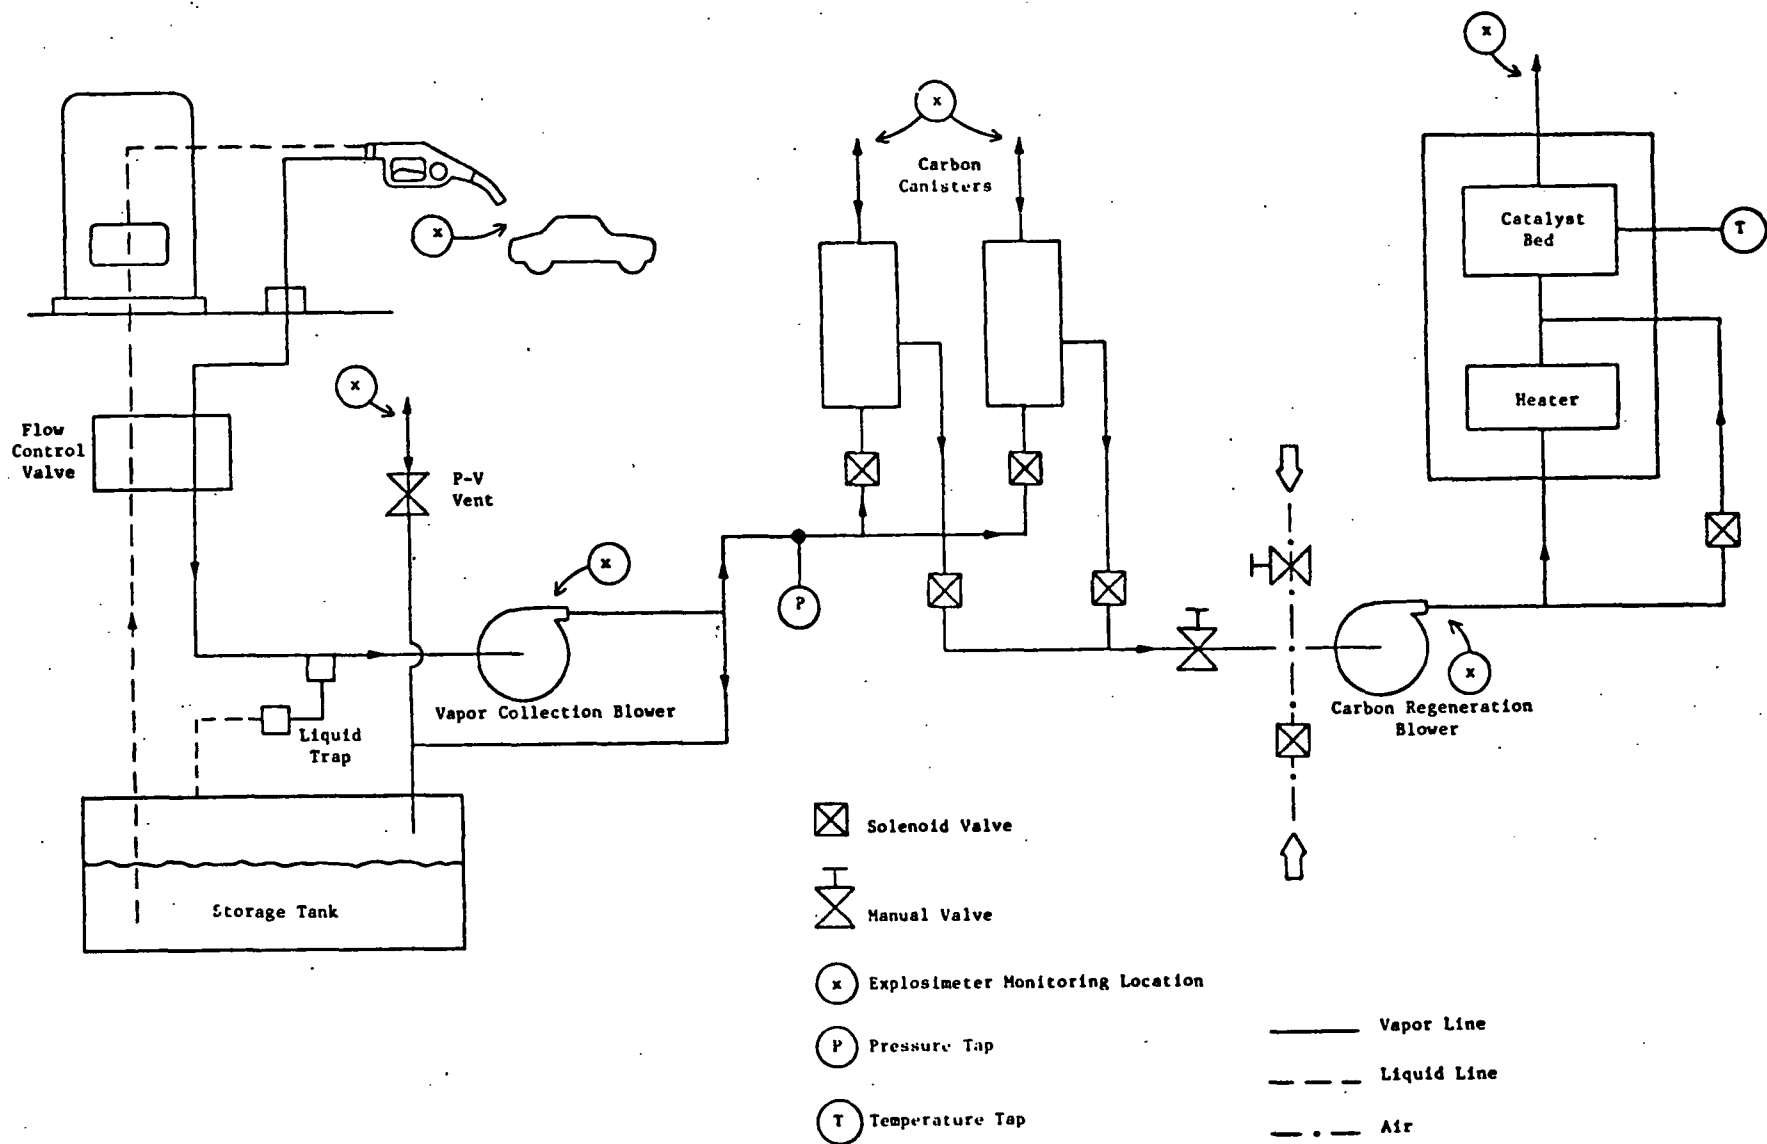
Figure 5. SCHEMATIC DIAGRAM OF ENVIRONICS SYSTEM (MODEL A-3000)

schematic diagram of the Environics Model A-3000 is shown in Figure 5. Vapor-laden air is collected by means of a blower and delivered to the underground tank and to the processing unit. (Entrained liquid is trapped and drained to the storage tank).

The reactor is designed to operate at temperatures between 900° and 1200°F. Preheating with an electric element initiates combustion when the unit is activated. When the feed becomes so lean that a temperature of 900°F cannot be maintained, the flushing is terminated. A temperature override switch is also provided, which deactivates the unit in case of overheating; this is set for a limiting temperature of 1300°F.

Figure 5 also shows the locations of points monitored by the study team to detect possible leakage of hydrocarbon vapors, as well as the locations of pressure and temperature taps installed to facilitate observation of the operating parameters of the system. According to information supplied by the manufacturer, a pressure-activated switch allowing the vapor-laden air to enter the carbon canisters should open when the pressure reaches 3 1/2 inches of water. The modifications to this system since the TRW study consist of: 1) the addition of a vapor flow control valve, 2) the rerouting of most of the vapors to the underground tank, and 3) the addition of a thermal overload switch to the reactor.

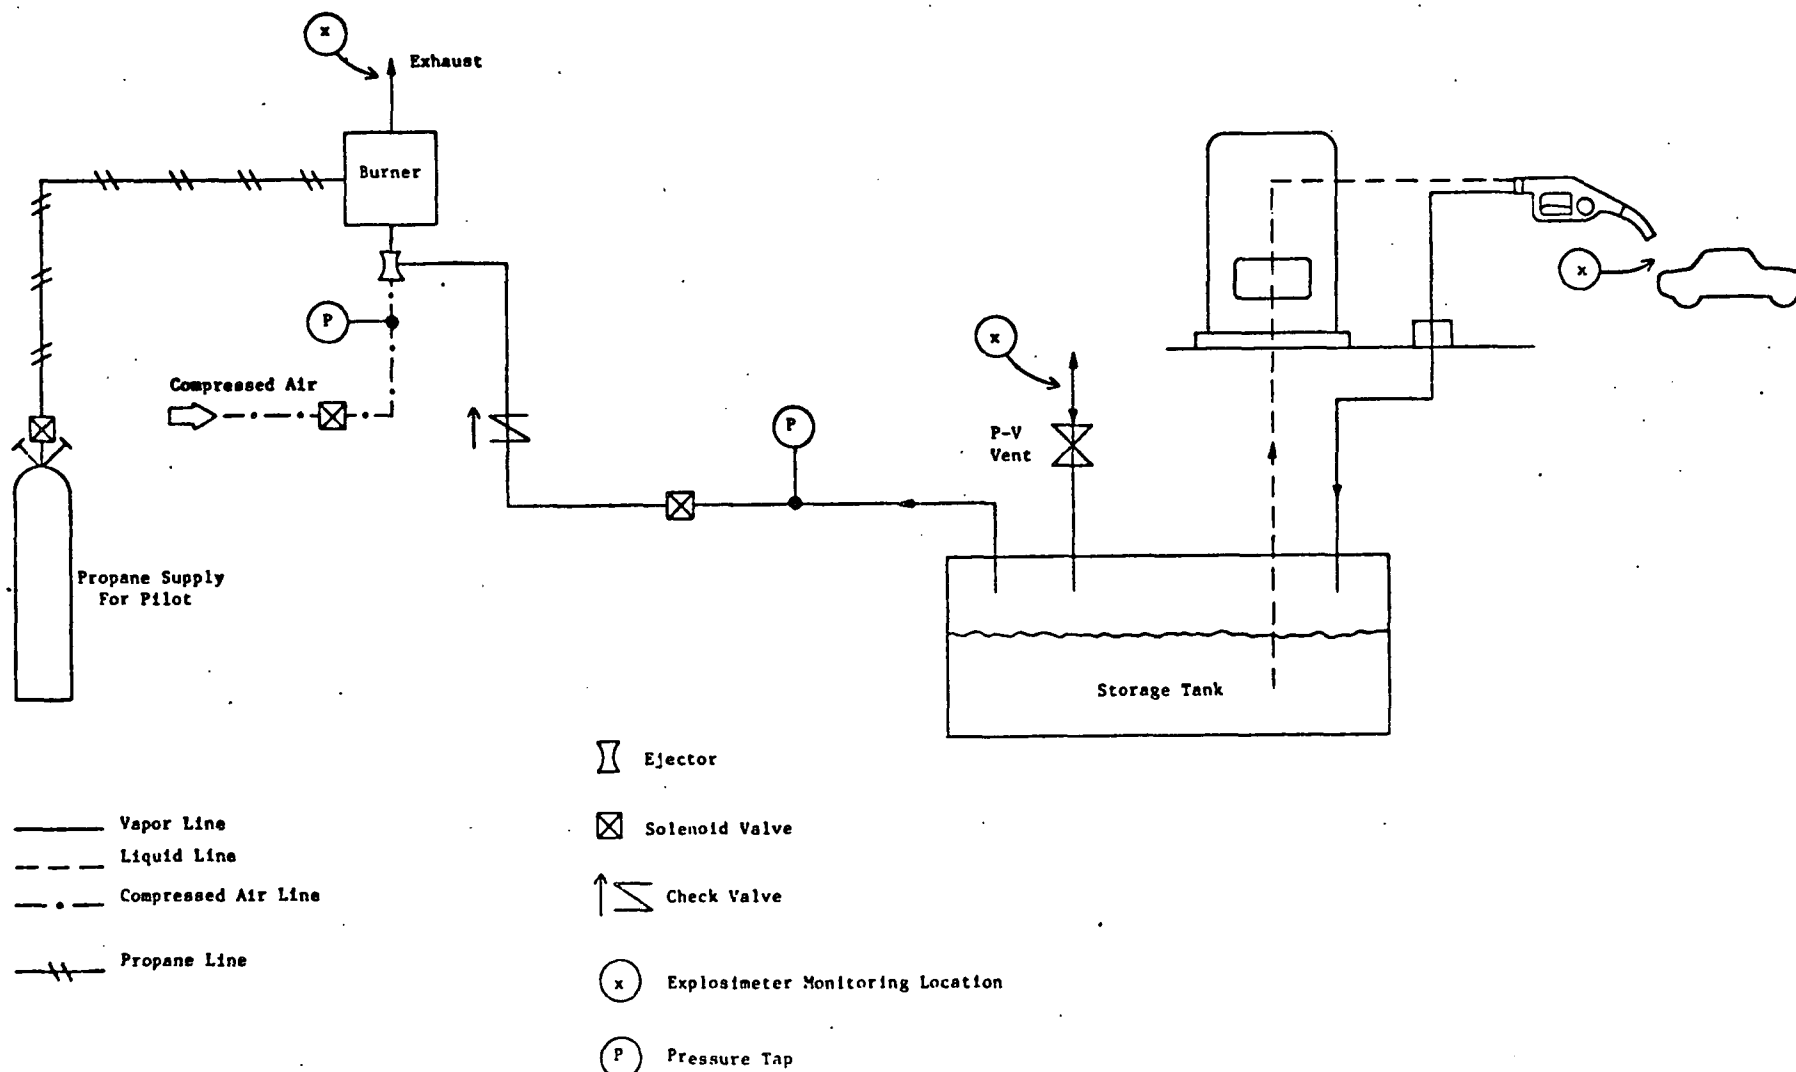
Figure 6. SCHEMATIC DIAGRAM OF HIRT SYSTEM

A system developed by Hirt Combustion Engineers employs an air-actuated ejector to maintain negative pressure in the underground storage tank and burners to destroy the hydrocarbons which are carried through the system. A schematic diagram is shown in Figure 6.

Flow of compressed air is initiated whenever the absolute pressure (for clarity of discussion, performance in terms of absolute pressures is used; in practice, differential pressure actuators are used) in the tank rises above a pre-determined absolute value. The air flows to a set of burners, entraining vapor-laden air from the tank. Combustion is initiated by a pilot light, fueled by propane; an alarm system notifies the station operator in case the pilot flame should fail. The compressed air flow is automatically halted when the absolute pressure in the underground tank falls below a preset value.

Figure 6 also shows the locations of points monitored by the study team to detect possible leakage of hydrocarbon vapors, as well as the locations of existing pressure taps which were used to check on pressures in the storage tank and in the compressed air system. In the single system observed in this study, the preset levels were -0.58 inches of water to activate compressed air flow, and -0.61 inches to deactivate it. This system was designed and built since the TRW study.
