June 1988 EPA-700/8-88-052

# Hazardous Waste Ground-Water Task Force

## Evaluation of Wyman-Gordon Company North Grafton, Massachusetts

## UPDATE OF THE HAZARDOUS WASTE GROUND-WATER TASK FORCE EVALUATION OF WYMAN-GORDON COMPANY

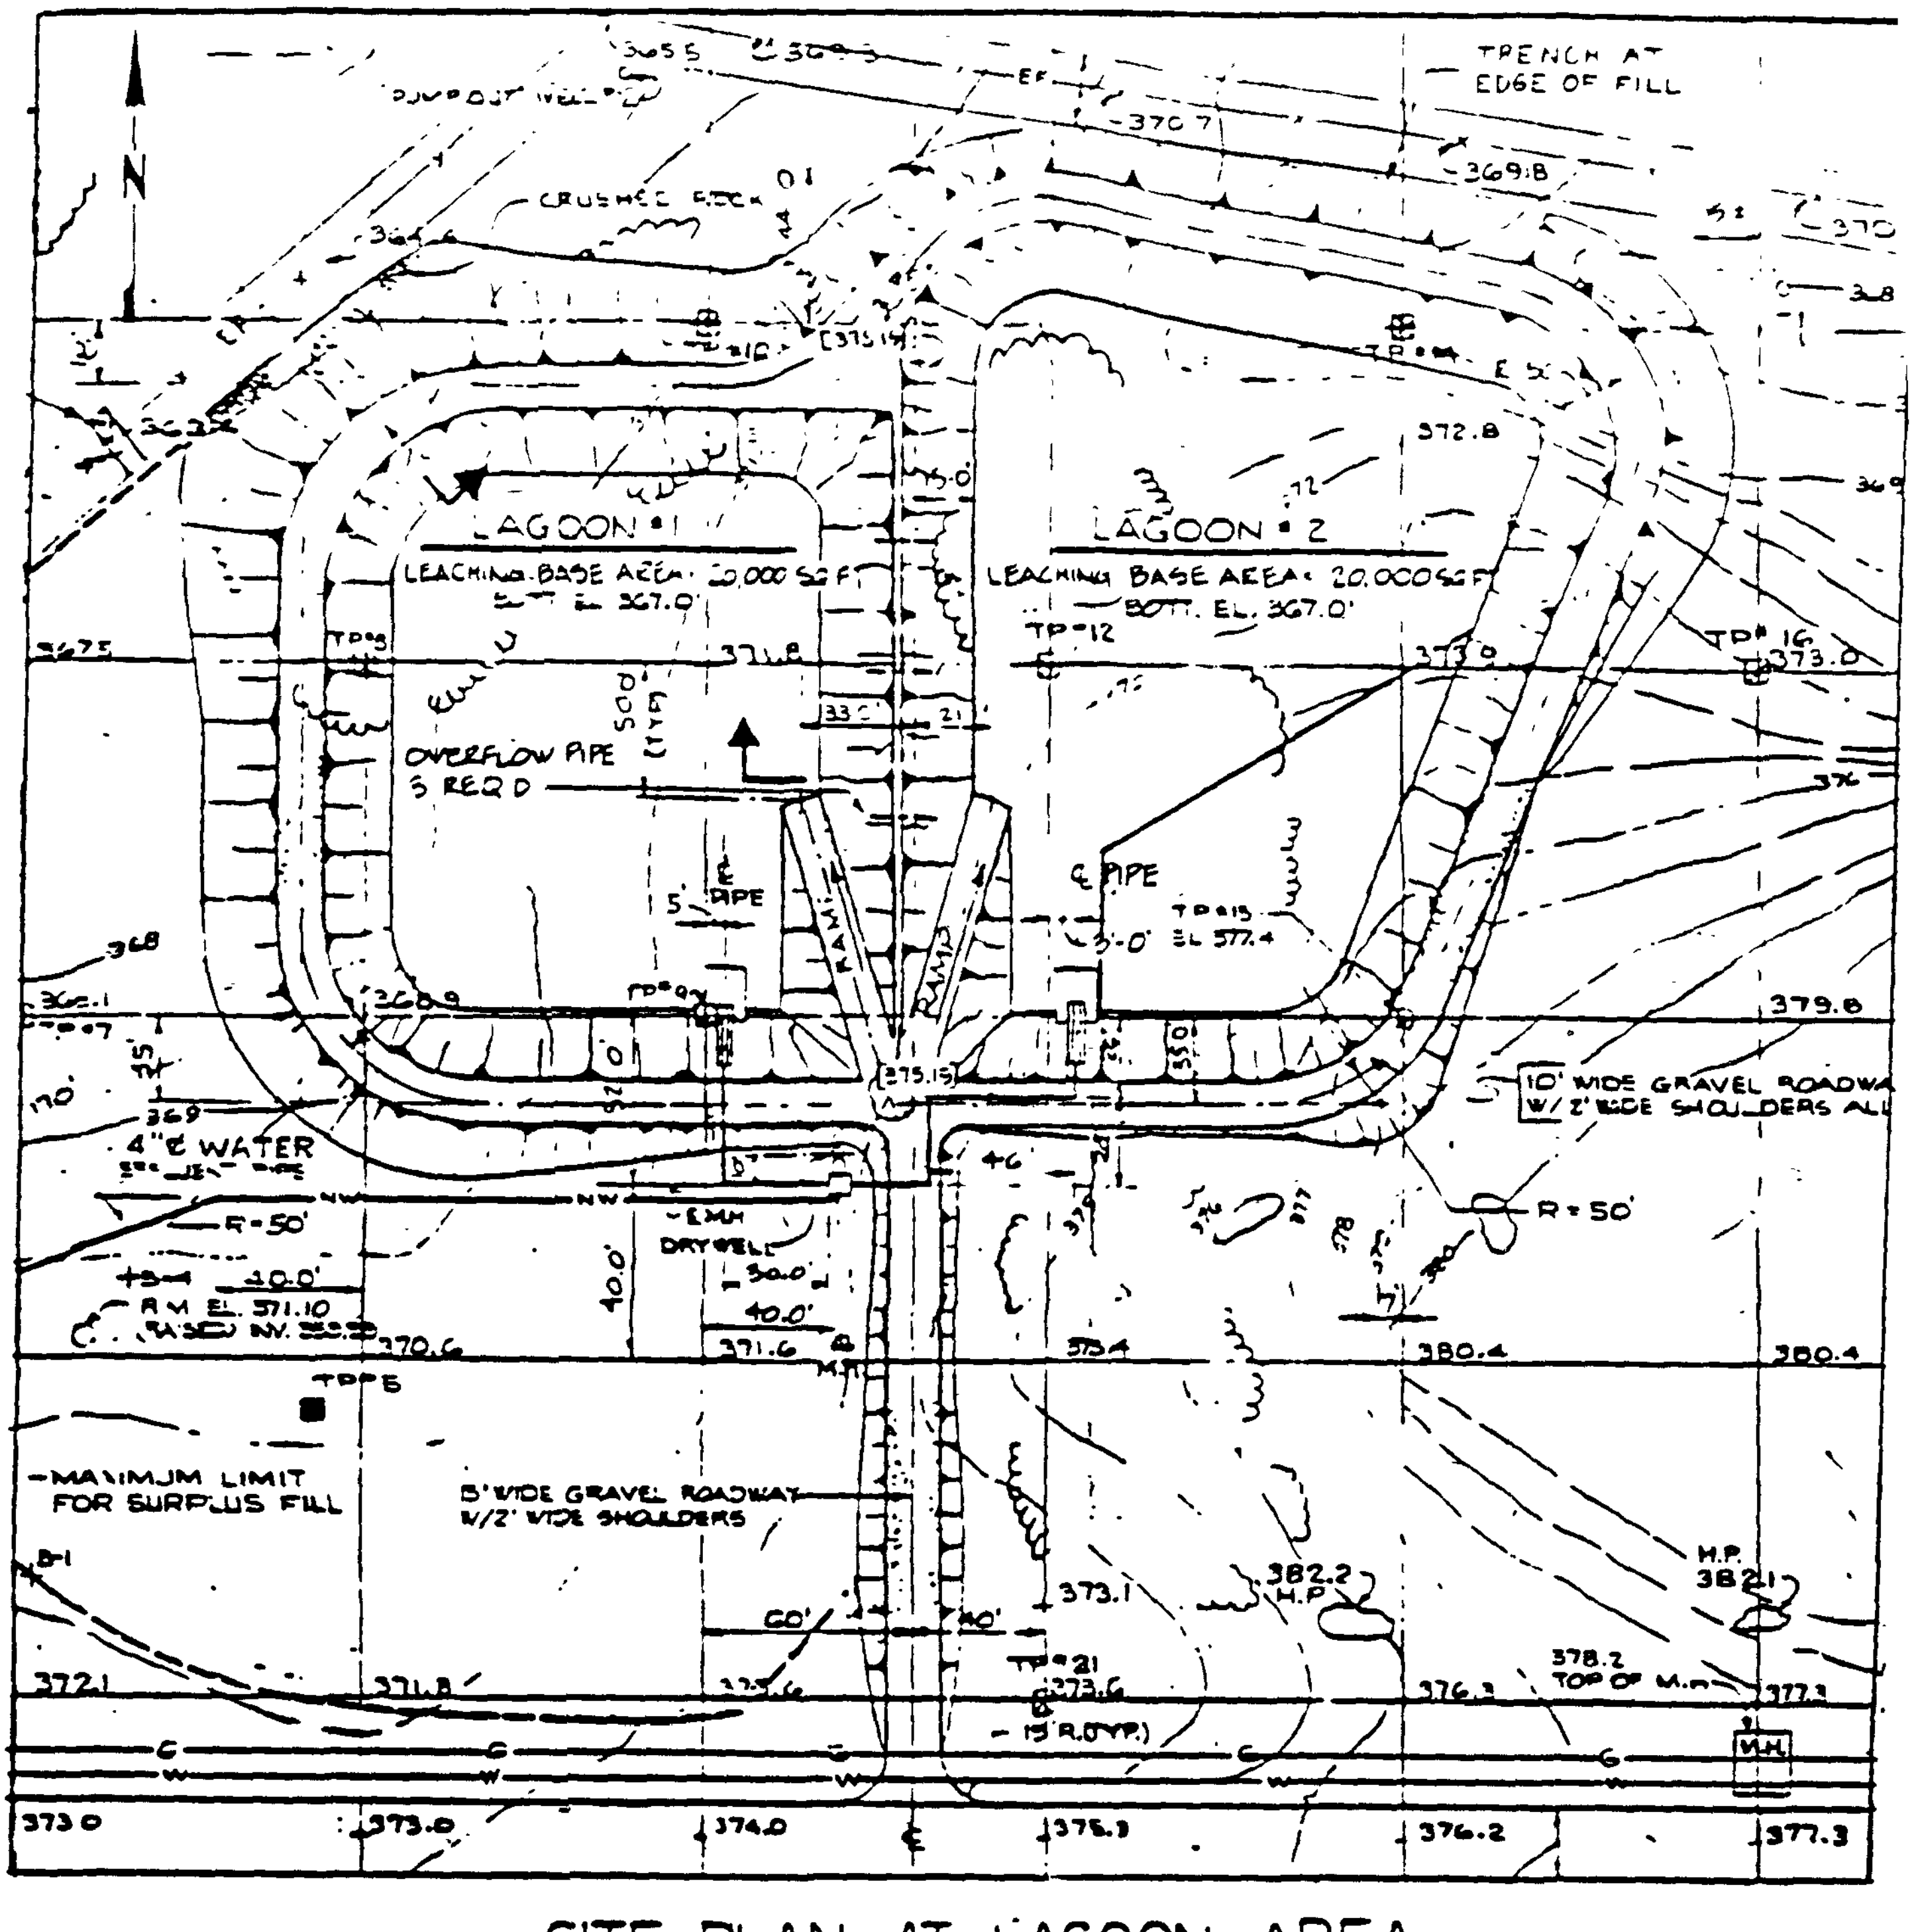
FIGURE 3

Two RTF lagoons exist at the Wyman-Gordon facility, the North lagoon and the South lagoon (see Figure 3). The lagoons were constructed in 1973 as percolation lagoons in a fill area in the southeast corner of the facility (known as the "East Side"), adjacent to a wetland and a stream known as East Brook. The South lagoon has a surface area of approximately 32,000 square feet and an average depth of 4 to 5 feet; it is capable of holding 960,000 to 1,200,000 gallons of liquid. The North Lagoon is connected to the South lagoon via three clay pipes. The North lagoon receives overflow from the South lagoon when the water level in the South lagoon exceeds an elevation of +373 feet. A berm surrounds the two lagoons (Wyman-Gordon, 1985).

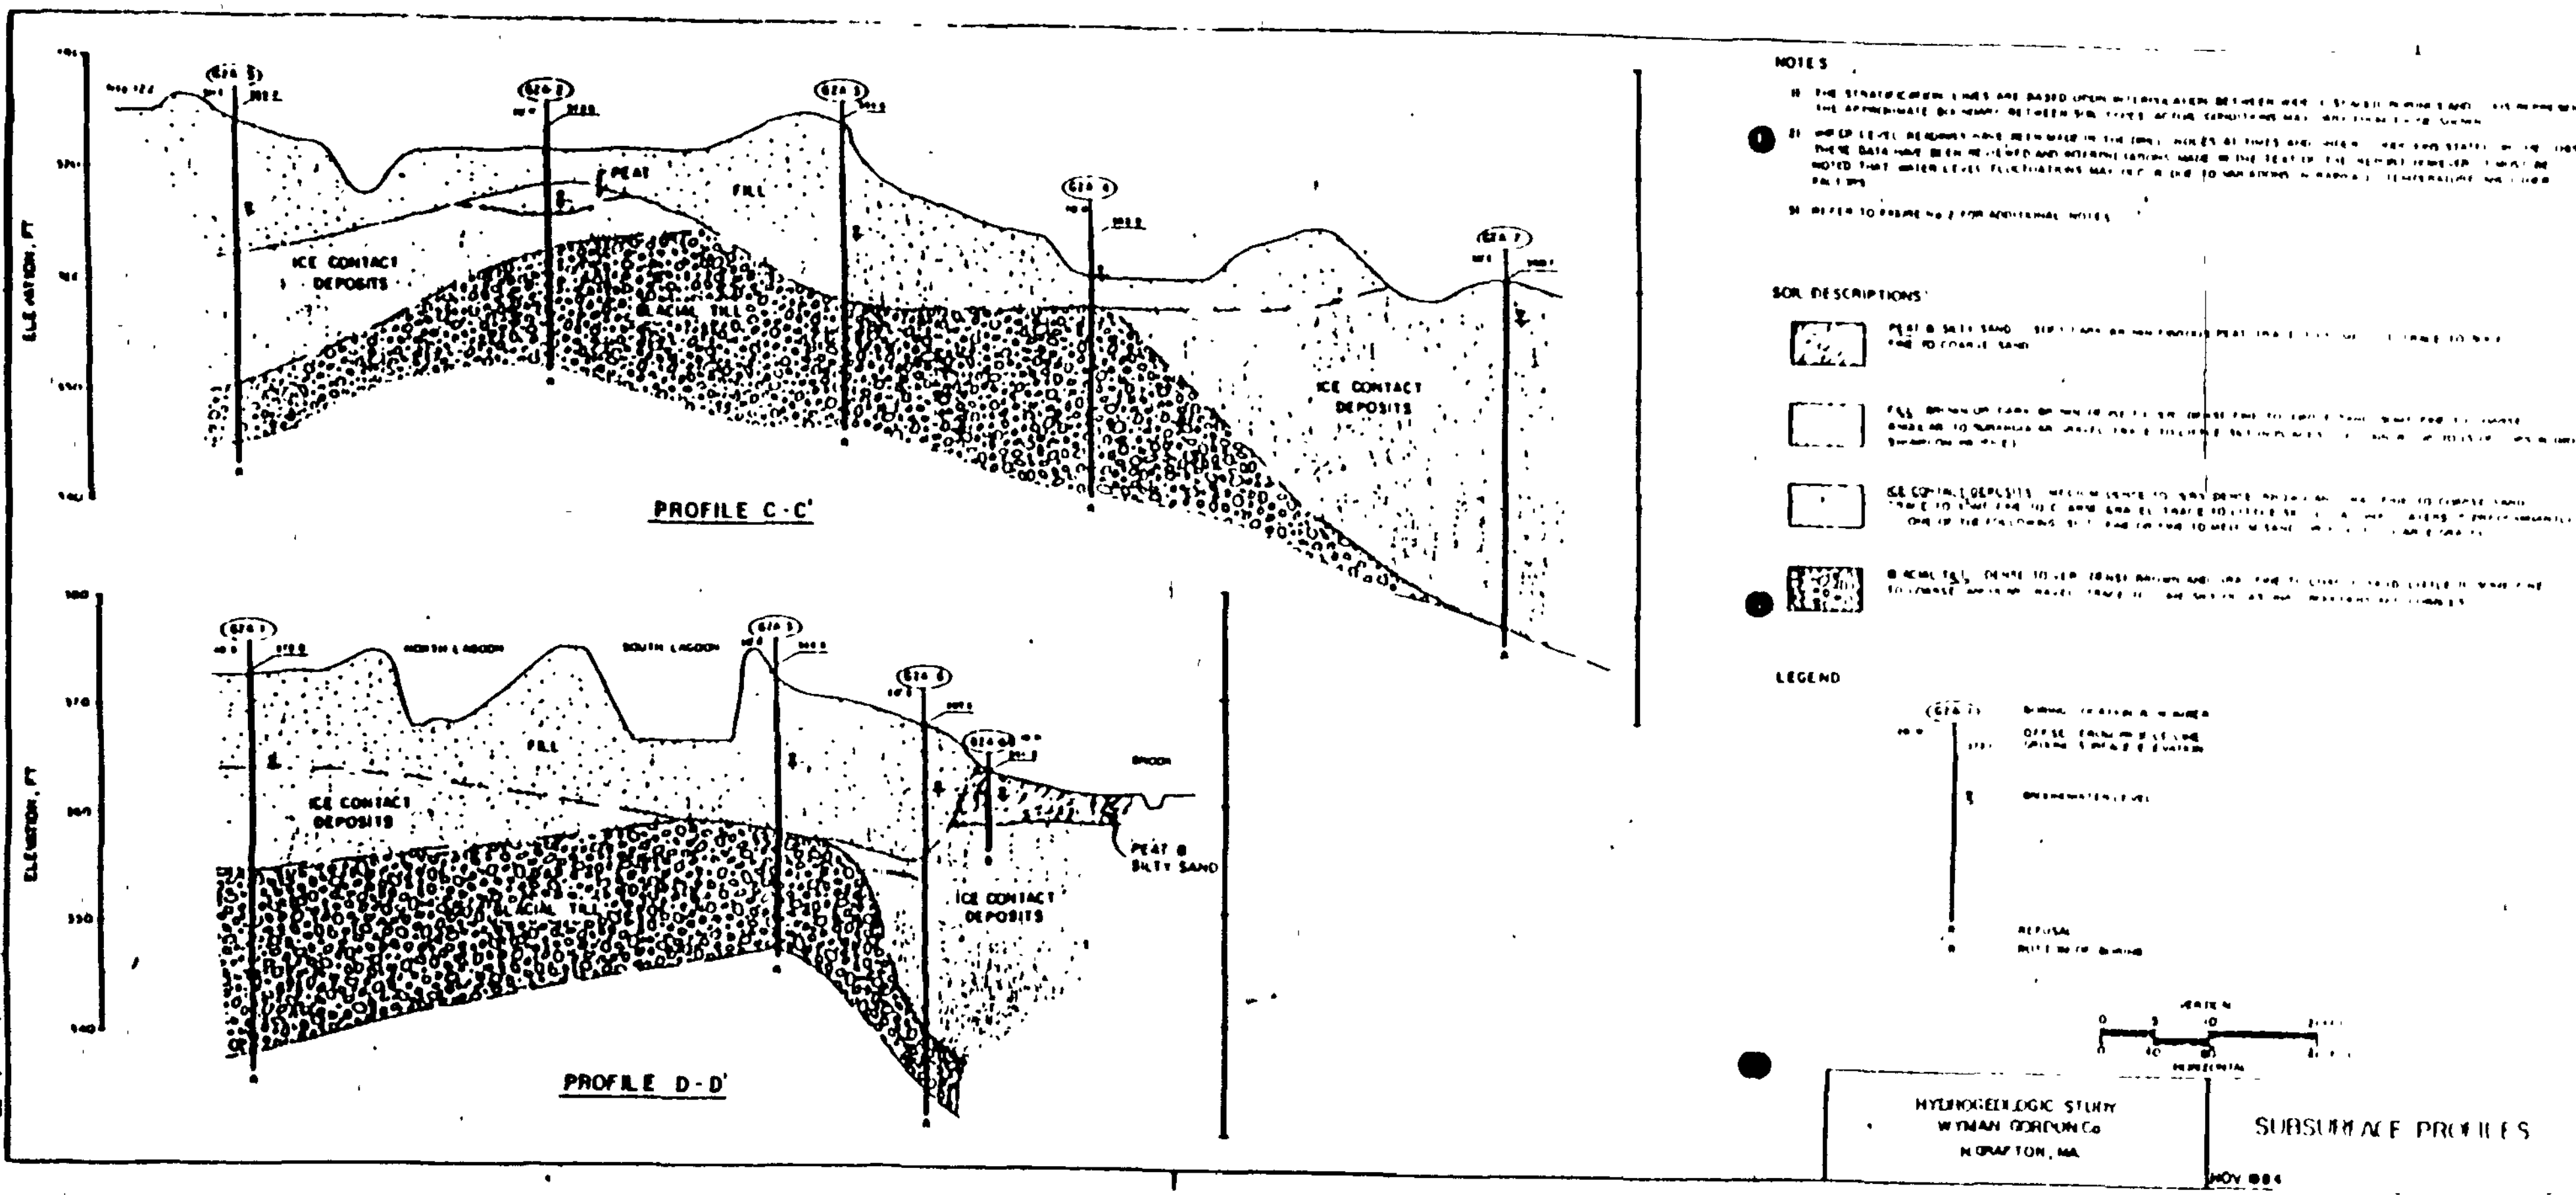
**FIGURE 4**
**GEOLOGIC CROSS-SECTION**

As the ice advanced, glacial till was deposited over bedrock in most of the area. As the ice retreated, a variety of meltwater-laid sediments were deposited over the till in valleys and other low-lying areas. In low-lying, poorly drained areas, swamp deposits have accumulated over glacial deposits since the retreat of the ice sheet. In recent years, fill has apparently been placed in some areas. Profiles of typical conditions from GZA boring data are depicted in Figure 4.

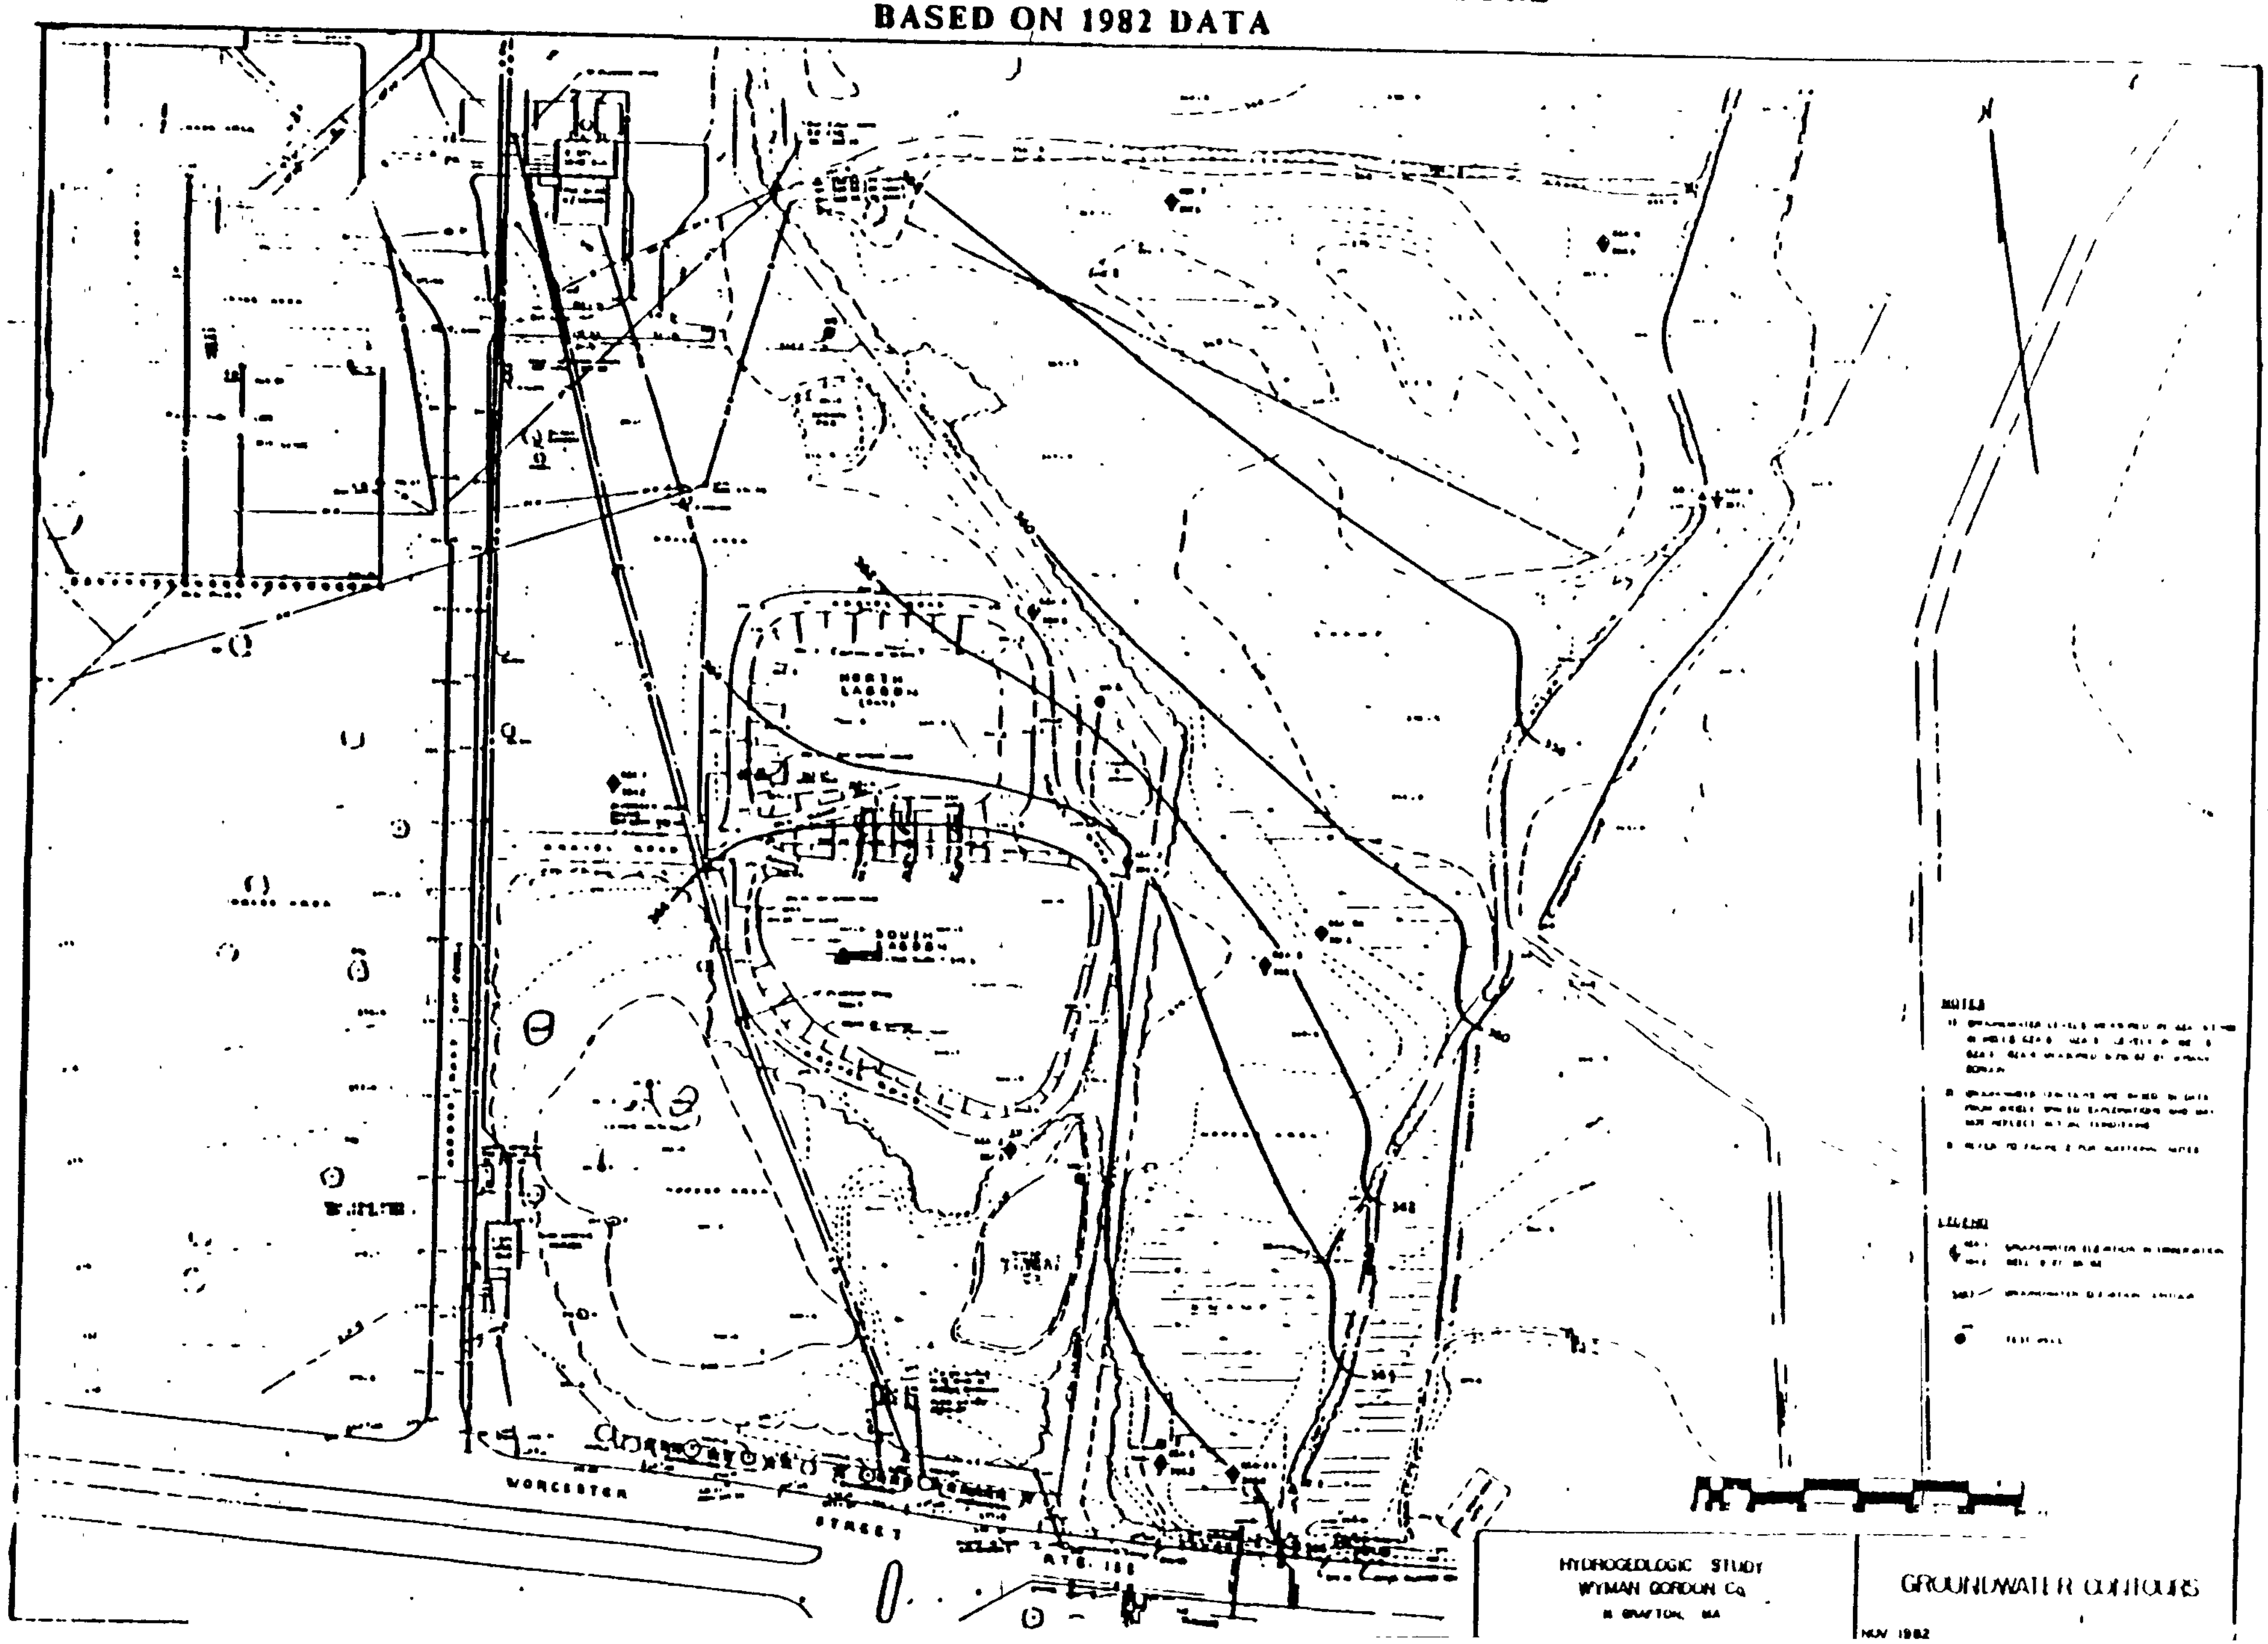
**FIGURE 5**
**INTERPRETATION OF GROUND-WATER CONTOURS**
**BASED ON 1982 DATA**

The ground-water elevations observed in September 1982 were used to develop the contours shown on Figure 5. As indicated on Figure 5, the apparent direction of ground-water flow across the study area is northeasterly. However, recharge from the South lagoon apparently resulted in ground-water mounding in the vicinity of the lagoons. Thus, ground water may flow radially from the lagoons, not only to the northeast, but toward the northwest and southeast; a westerly flow component from the lagoons could affect water

however, and distorted flow paths eventually merge into the regional northeasterly flow pattern. East Brook may represent the eventual discharge point for ground water moving through the Wyman-Gordon facility area.

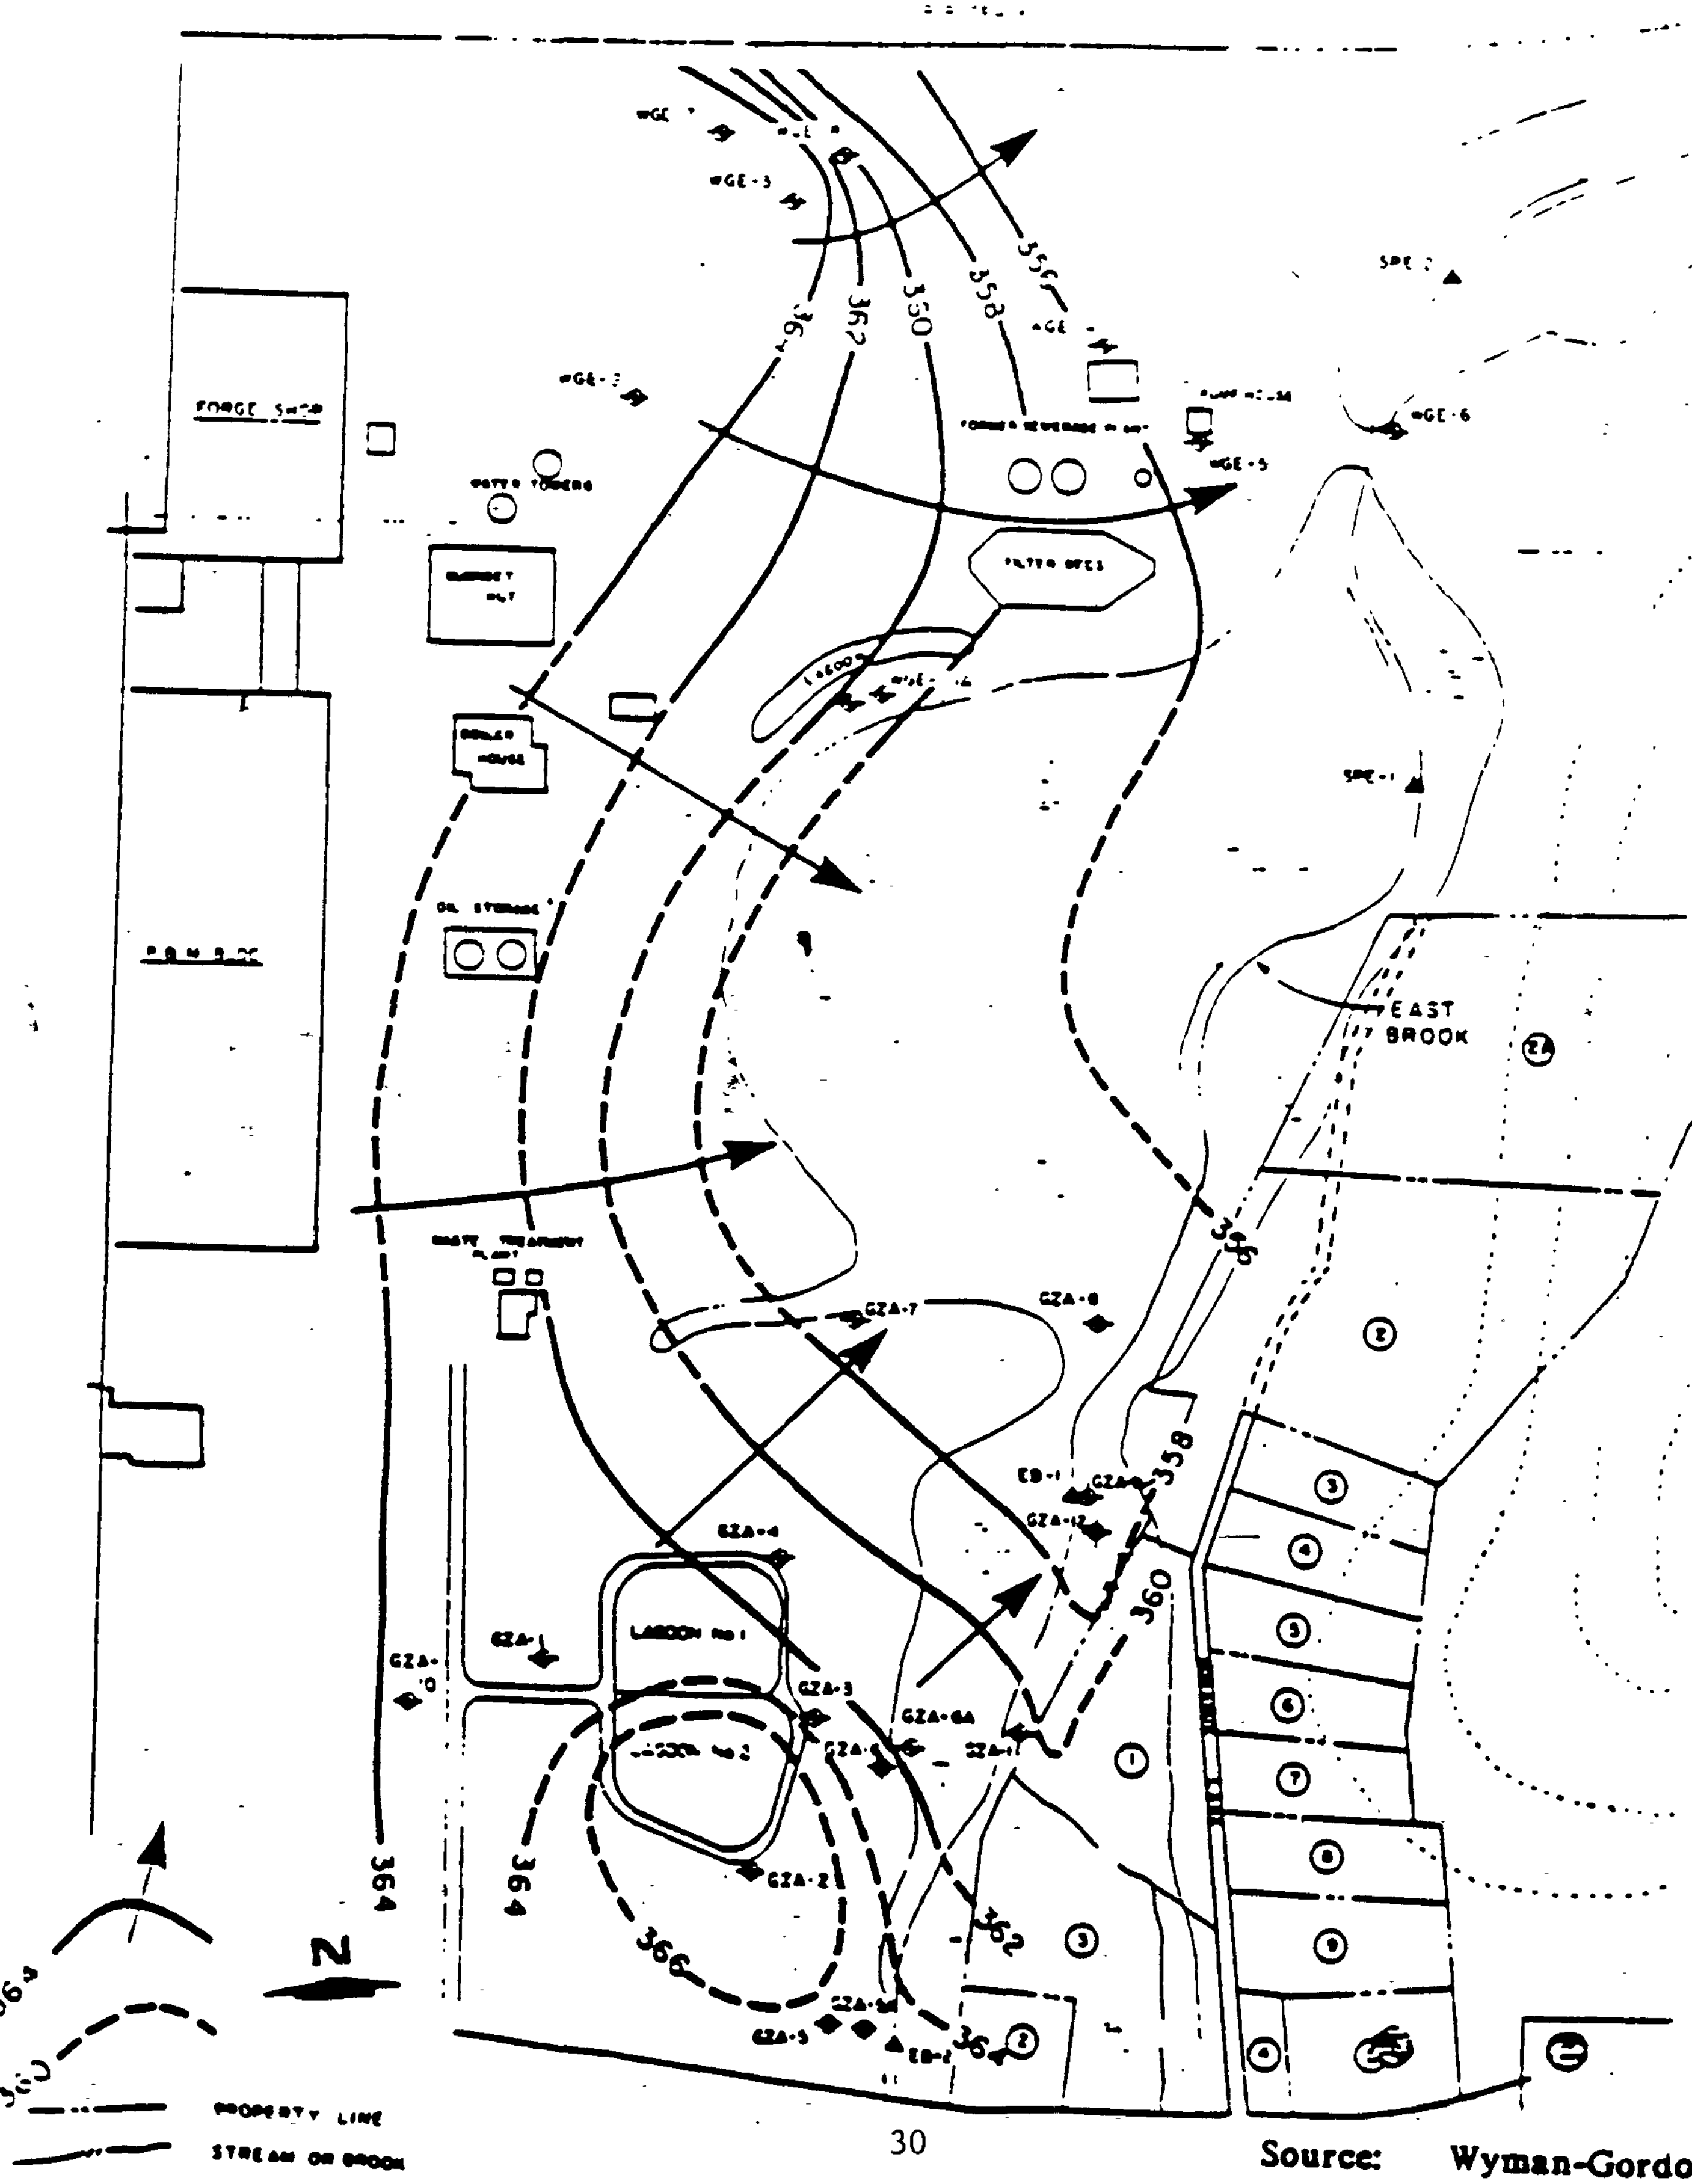
FIGURE 6
GROUND-WATER CONTOURS NORTH OF THE IMPOUNDMENTS

Wyman-Gordon suggests that ground-water flow is predominantly easterly toward the wetland and East Brook, based on ground-water elevation data from north of the immediate facility area (Wyman-Gordon, 1985). Figure 6 depicts ground-water contours constructed in the area east of the main plant based on data recorded in July and September 1984. These contours reflect the regional flow toward East Brook from the Wyman-Gordon property and the course of the brook prior to its discharge into Hovey Pond. It is important to note that these flow directions are indicative only of generalized regional flow. The elevation data were not obtained on the same day; however, it is not known whether this would have influenced the results.
