A Study of Mandatory Engine Maintenance for Reducing Vehicle Exhaust Emissions

Volume V. Experimental Investigation of Service Organization Maintenance Performance

Year End Report July 1972

APRAC Project Number CAPE-13-68

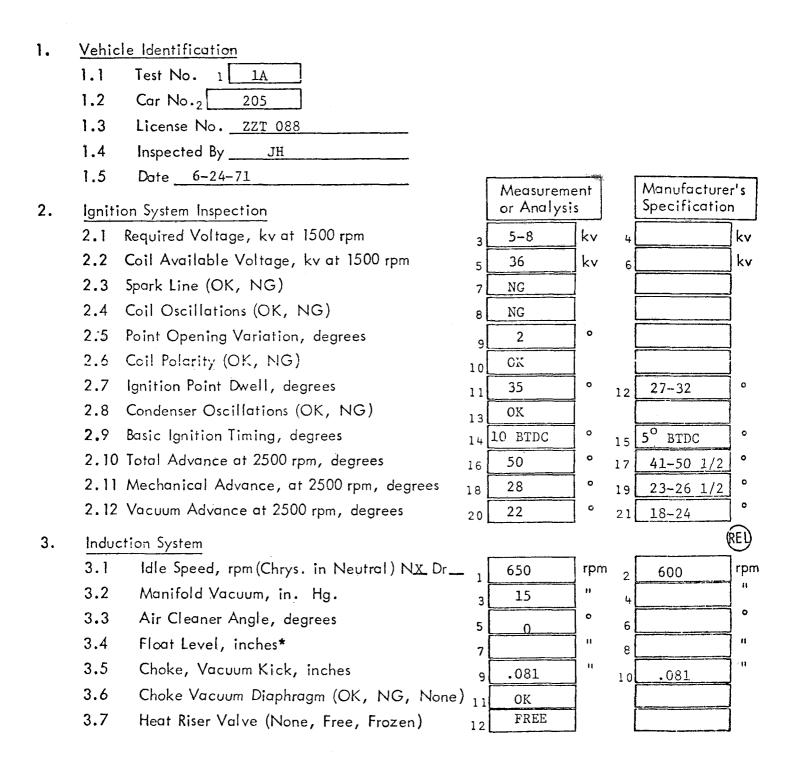
Figure 4.1 Engine Parameter Inspection Summary

Engine Parameter Inspection Performed By SCOTT RESEARCH LABORATORIES, INC.

The inspection sheet used for recording deviations is shown in Figure 4.1, Engine Parameter Inspection Summary. All required repairs or adjustments were performed, including inspection and maintenance of crankcase oil, transmission fluid and cooling system, to put the vehicles in factory specification operating condition. The vehicles were then ready for the

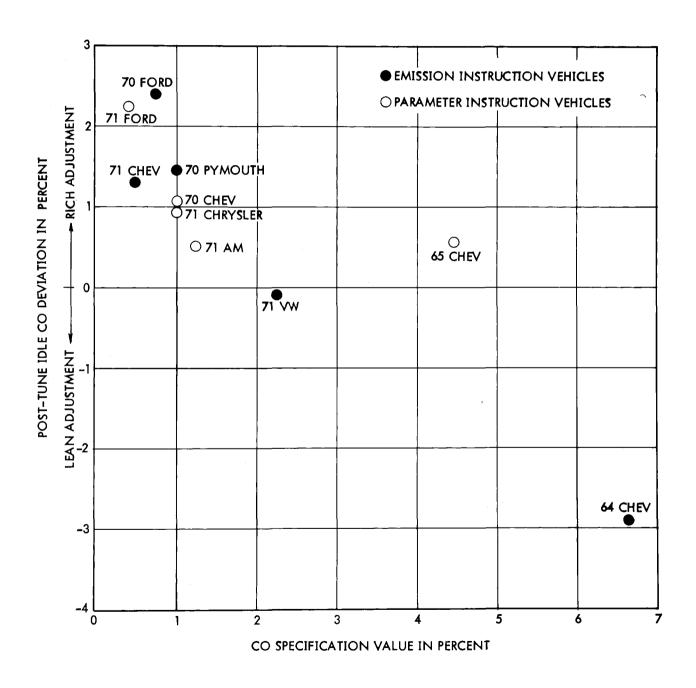
Figure 5.2

MEAN POST-TUNE IDLE CO DEVIATION AS A FUNCTION OF IDLE CO SPECIFICATION VALUE

The question arises as to what aspect of the vehicles was responsible for this highly significant effect. The mean idle CO deviation for each vehicle plotted as a function of the idle CO specification value for that vehicle is shown in Figure 5.2. The correlation between the idle CO deviations and the absolute value of idle CO specification is negative and significant (r = -0.54; df = 232; Q > 0.99). This relationship accounts for 29% of the variance in CO deviations. This correlation suggests that vehicle with lean idle specifications are not satisfactorily adjusted to specification with service organizations erroring in a direction to increase CO and HC exhaust emissions. Further, there is a tendency to over lean older vehicles. It would be significant in the implementation of an inspection program to determine whether this tendency is an equipment or procedural problem. The relationship between idle CO deviations and idle CO specification values explains more of the variance in afterrepair measures than any of the other factors the study was designed to investigate.

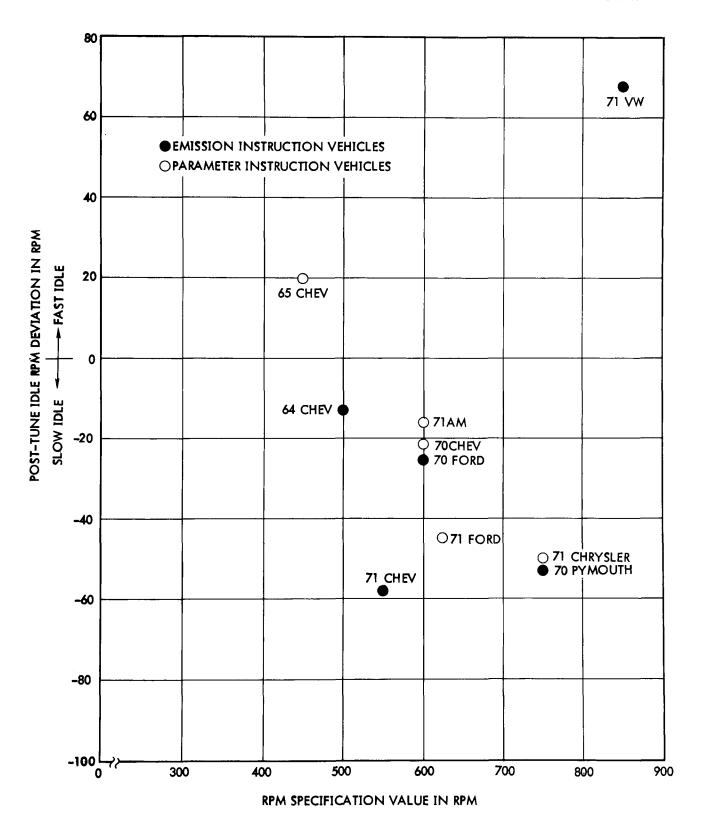
Figure 5.3

MEAN POST TUNE IDLE RPM DEVIATION AS A FUNCTION OF IDLE RPM SPECIFICATION VALUE

The mean post-tune idle rpm deviation for each vehicle was plotted as a function of its idle speed specification, Figure 5.3. With the notable exception of the VW, there is an inverse relationship between the post-tune idle rpm deviation and the idle rpm specification value. Omitting the VW data resulted in a significant, negative correlation (r = -0.25; df = 214; Q >0.99) between post-tune rpm deviation and its specification value which accounts for 6.4% of the variance.
