A STUDY OF PNEUMATIC SOLID WASTE COLLECTION SYSTEMS AS EMPLOYED IN HOSPITALS

ROSS HOFMANN, ASSOCIATES

ENVIRONMENTAL PROTECTION AGENCY

1974

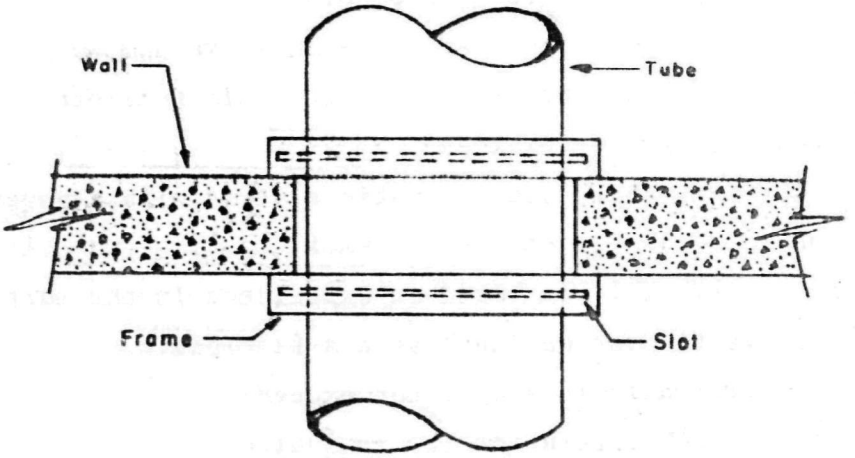
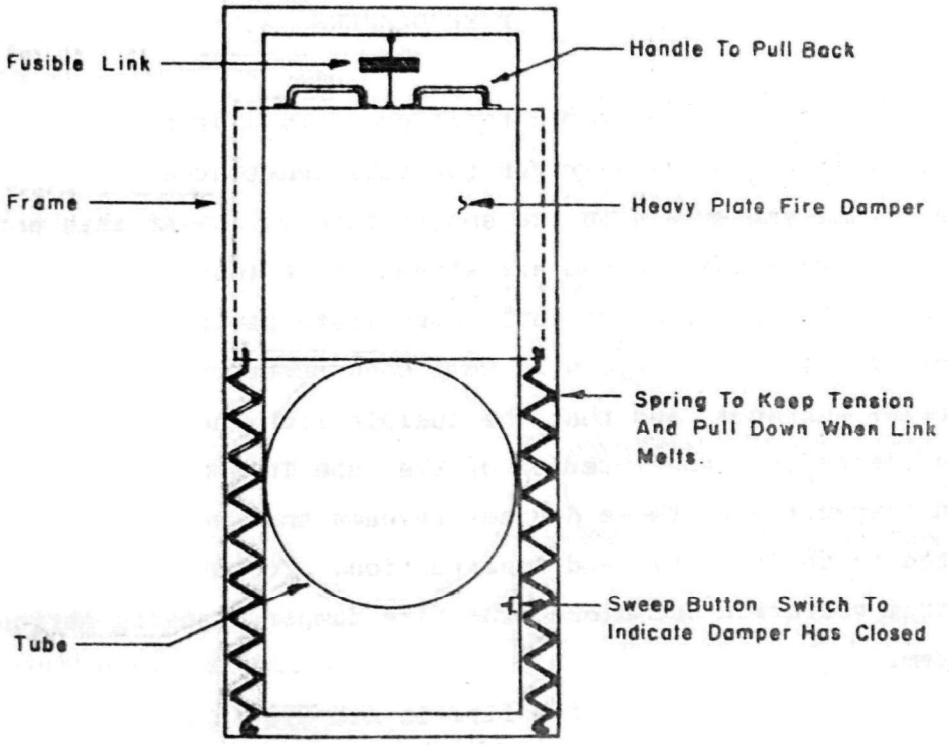
FIGURE 5. FIRE DAMPER DESIGN

One part of the tube system still presents a problem. Codes require fusible link fire dampers wherever the tube penetrates a fire wall. This means an actual gap exists in the smooth tube wall. At this point, a turbulence is always created in the air stream which instantaneously balloons out the transport bag or tends to hurl loose waste particles in the opening. It is essential that such dampers be well constructed, with no sharp corners in the interior surfaces, and that the fusible link and damper holding device in no way projects into the interior of the tube in a way that could rip a waste bag. An inspection of these devices reveals that much further thought should be devoted to their design and construction. Too often the latches have broken from vibration and closed the fire damper, causing serious plugging of the system.

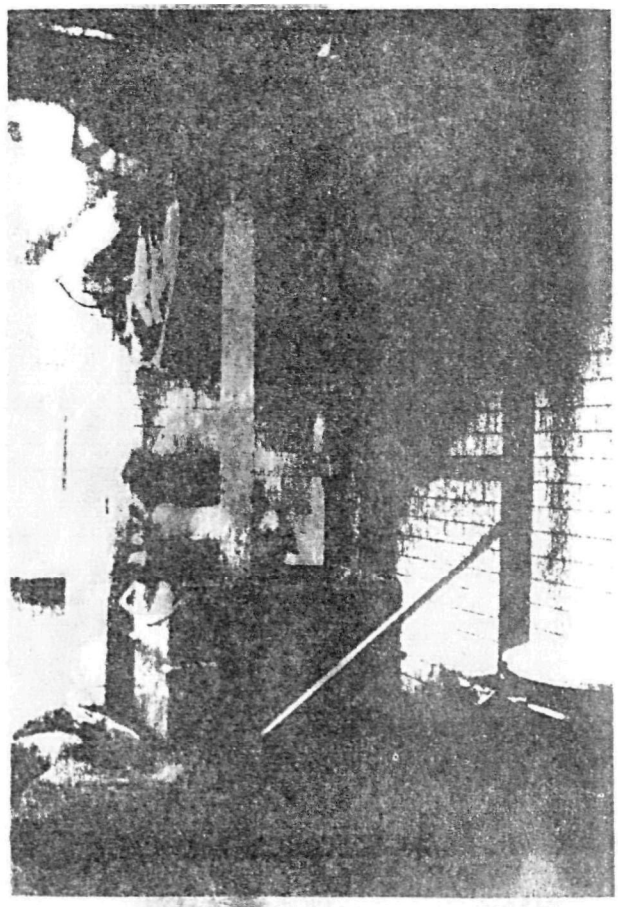
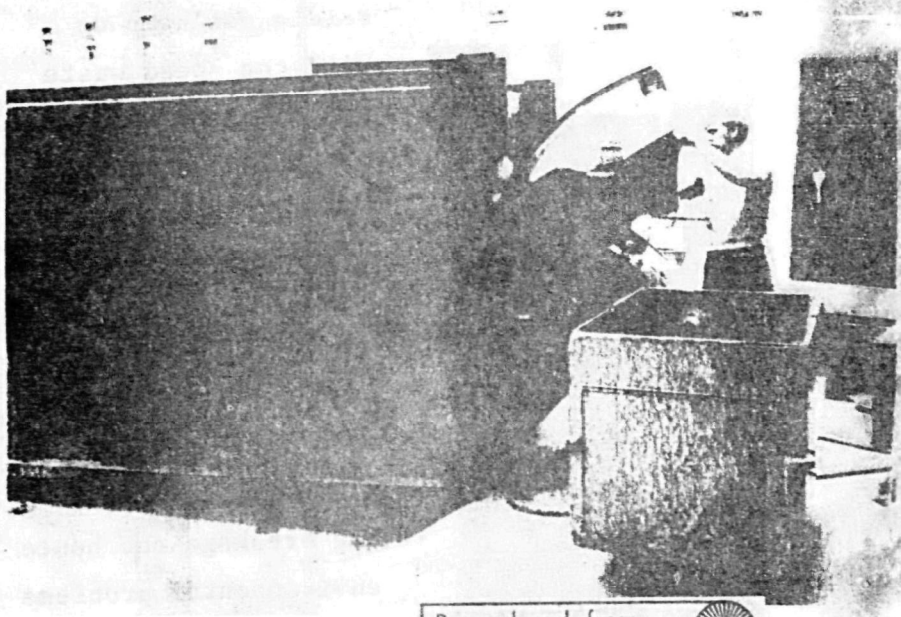
Above: Views of the box type soiled laundry and solid waste collectors at the end of the line at St. Mary's Hospital. The waste must be hand carted from the waste collector to the compactor located in the Service Building court yard.

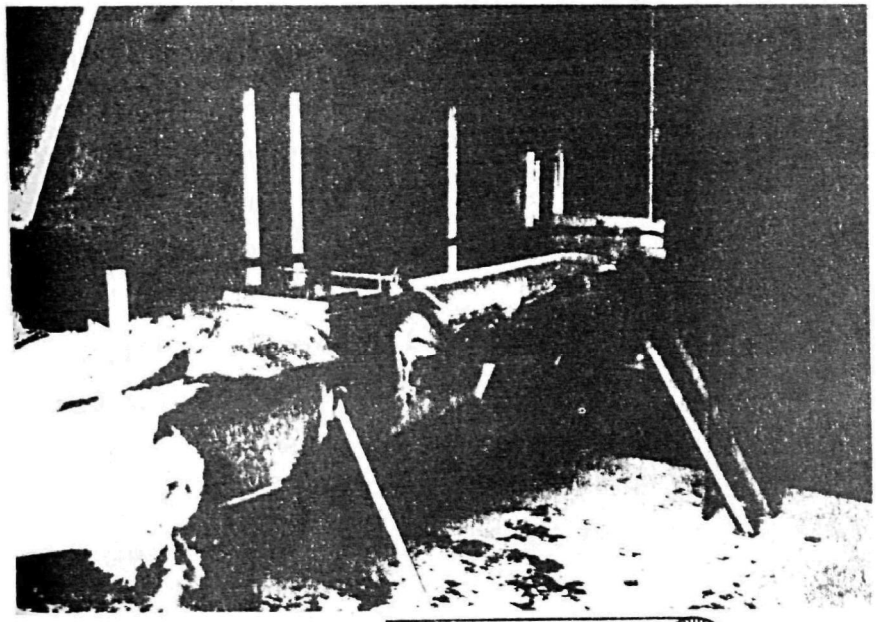
Left: The fan room equipment is unsophisticated and quite lightly constructed in this system, using an open type materials handling fan and a simple exhaust duct type sound attenuator. High level vacuum protection is obtained by a gate valve before the fan.

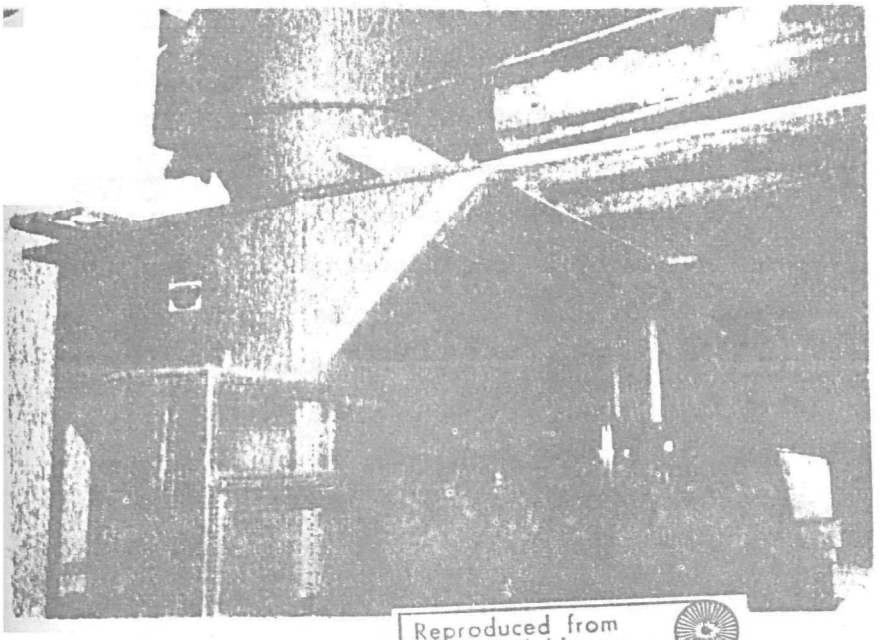
Top left and lower left: The cyclone collector used for waste is designed to receive rapid and continuous loading. Note that most bags are ripped by the time they emerge from the collector. The entrance to the compactor is not close coupled to the collector and presents serious aerosol possibilities with broken bags.
