Assessment of Synthetic Membrane Successes and Failures at Waste Storage and Disposal Sites

EPA/600/2-85/100
August 1985

Arthur D. Little, Inc.
Cambridge, MA 02140

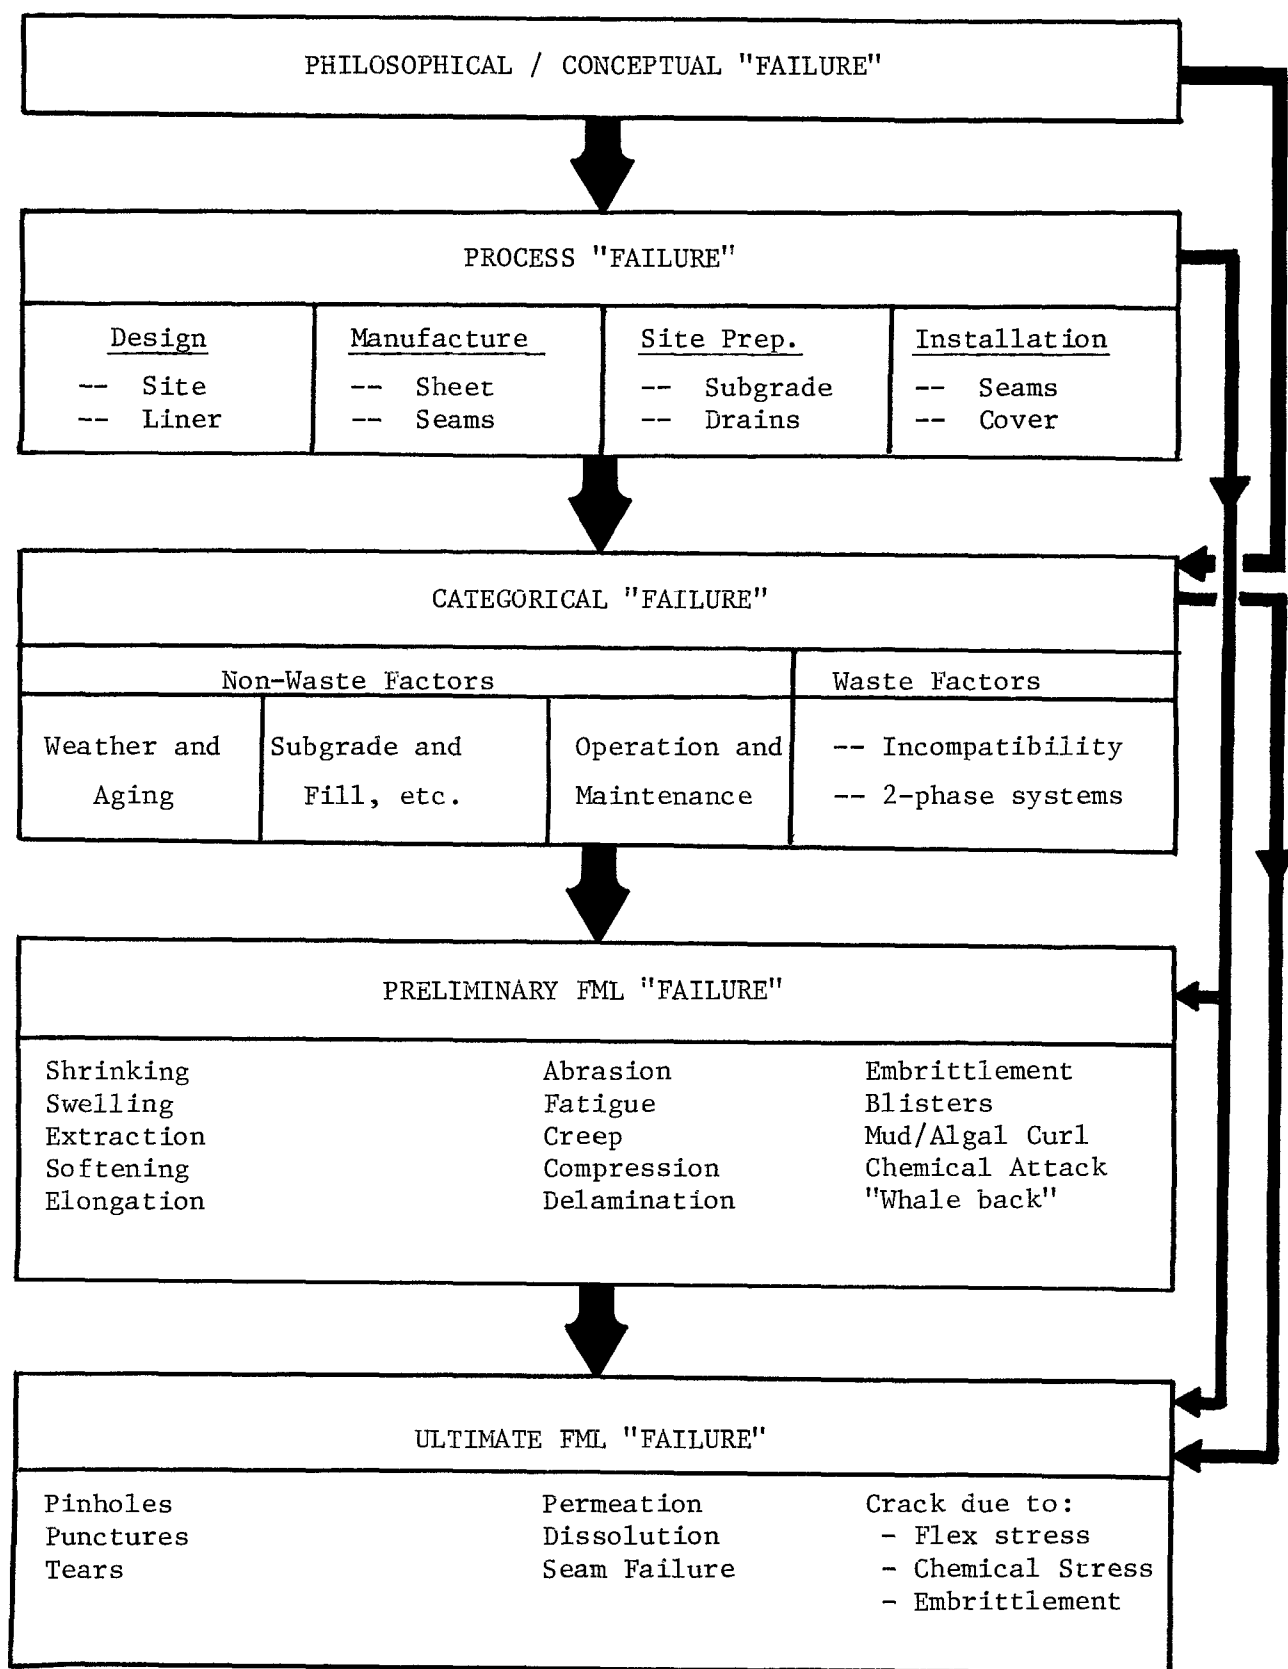
Figure 1. Hierarchy of Failure Modes

However, our previous study of liner failures (Lyman et al., 1983) showed that the question of failure mode could be given a much broader definition. The definition encompasses all of the actions and processes that lead to ultimate failure and leakage. This approach thus recognizes various stages of preliminary failure including, for example, poor materials, poor workmanship (especially during liner installation) and poor design. Philosophical failures, relating to a variety of misconceptions (about liners) and motives, were also recognized as being potential forerunners of ultimate failures. A diagram showing such a hierarchy of failure modes is shown in Figure 1. The downward-pointing arrows between boxes in the Figure imply a connection between types of failure, i.e., one type of failure leading to another, a propagation of errors.

to prior failure modes. At site V2-1, for example, an ultimate failure reported was the permeation and/or dissolution of the liner at the air-liquid interface of the impoundment. This was attributed to chemical attack (preliminary failure) by an oil-based defoamer discharged to the system without prior evaluation of the possible consequences (operational failure). There may have been conceptual failures here in that the designers and operators of the system were insufficiently sensitive to the need to consider appropriate designs and operational controls that would have prevented the harmful chemical from entering the impoundment in the first place.

Other categorization schemes used in discussion of liner failure modes are shown in Tables 3, 4 and 5. Table 3 shows the scheme used by Kays (1977) in his discussion of cut and fill reservoirs; some of the items listed in this table belong in the "categorical failure" category shown in Figure 1. Kays dedicates a whole chapter of his book to the discussion of liner failure mechanisms; the reader is referred to this work for further information.

First, success is more likely to follow if the responsible individuals have the proper philosophical and conceptual approach (cf. Figure 1). If they understand that what they are doing is important and that the process of designing, installing and using a lined facility involves many technical factors that will likely present problems, then they are more likely to proceed with due diligence. A key element of the proper philosophical approach is indeed: (1) to assume that there will be problems; (2) to examine the possible consequences of those problems and/or "failures"; and then (3) to take the appropriate steps (e.g., design changes, quality control procedures) to avoid or minimize the problems.

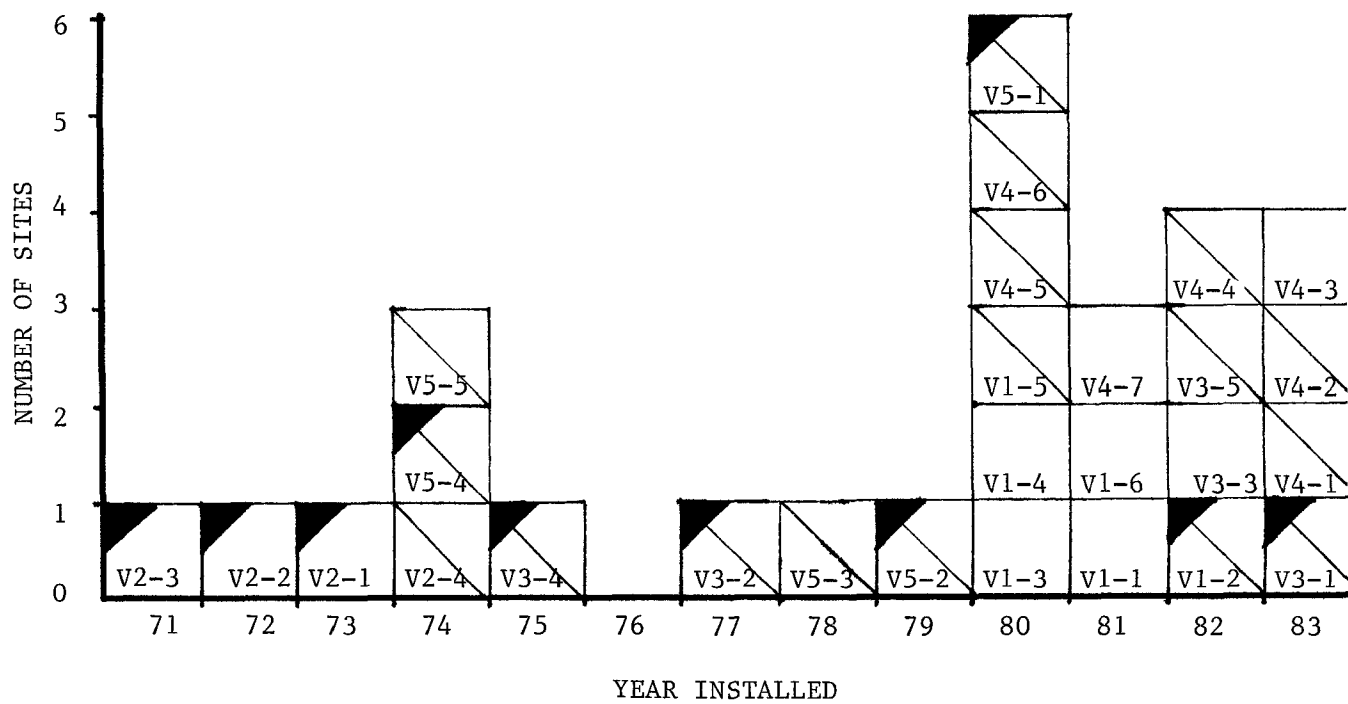
FIGURE 4
CORRELATION OF FACILITY AGE WITH FAILURES

Vn-m = site identification number

It is not clear that failures correlated with facility age in the sites studied although, as seen in Figure 4, there were failures at 3 of the oldest facilities, and at 7 of the 10 facilities installed prior to 1980. It is possible that this higher tendency for failures at older sites can be attributed: (1) to the (assumed) use of less appropriate designs, materials and installation practices at older sites; (2) to the (assumed) paucity of related experience by the manufacturing and installing companies in those early years; and/or (3) just to the fact that there has been more time for failures to show up.

Seventeen (17) of the 27 sites had some form of monitoring system to detect failures in the primary liner. Figures 4 and 5 indicate the sites with monitoring. Seven of the sites with monitoring systems had failures, but, as noted above (see Table 6), the monitoring system was involved in the identification of the failure at only 5 sites. Still, it is possible that if our vendors had selected a higher percentage of sites with monitoring systems, more failures might have been identified. In any case, the necessity for some type of monitoring system at RCRA-permitted sites is quite clear.
