An Evaluation of Sealed Idle Mixture
Adjustment on 1977 Buicks

November 1980

Test and Evaluation Branch
Emission Control Technology Division
Office of Mobile Source Air Pollution Control
Office of Air, Noise, and Radiation
U. S. Environmental Protection Agency

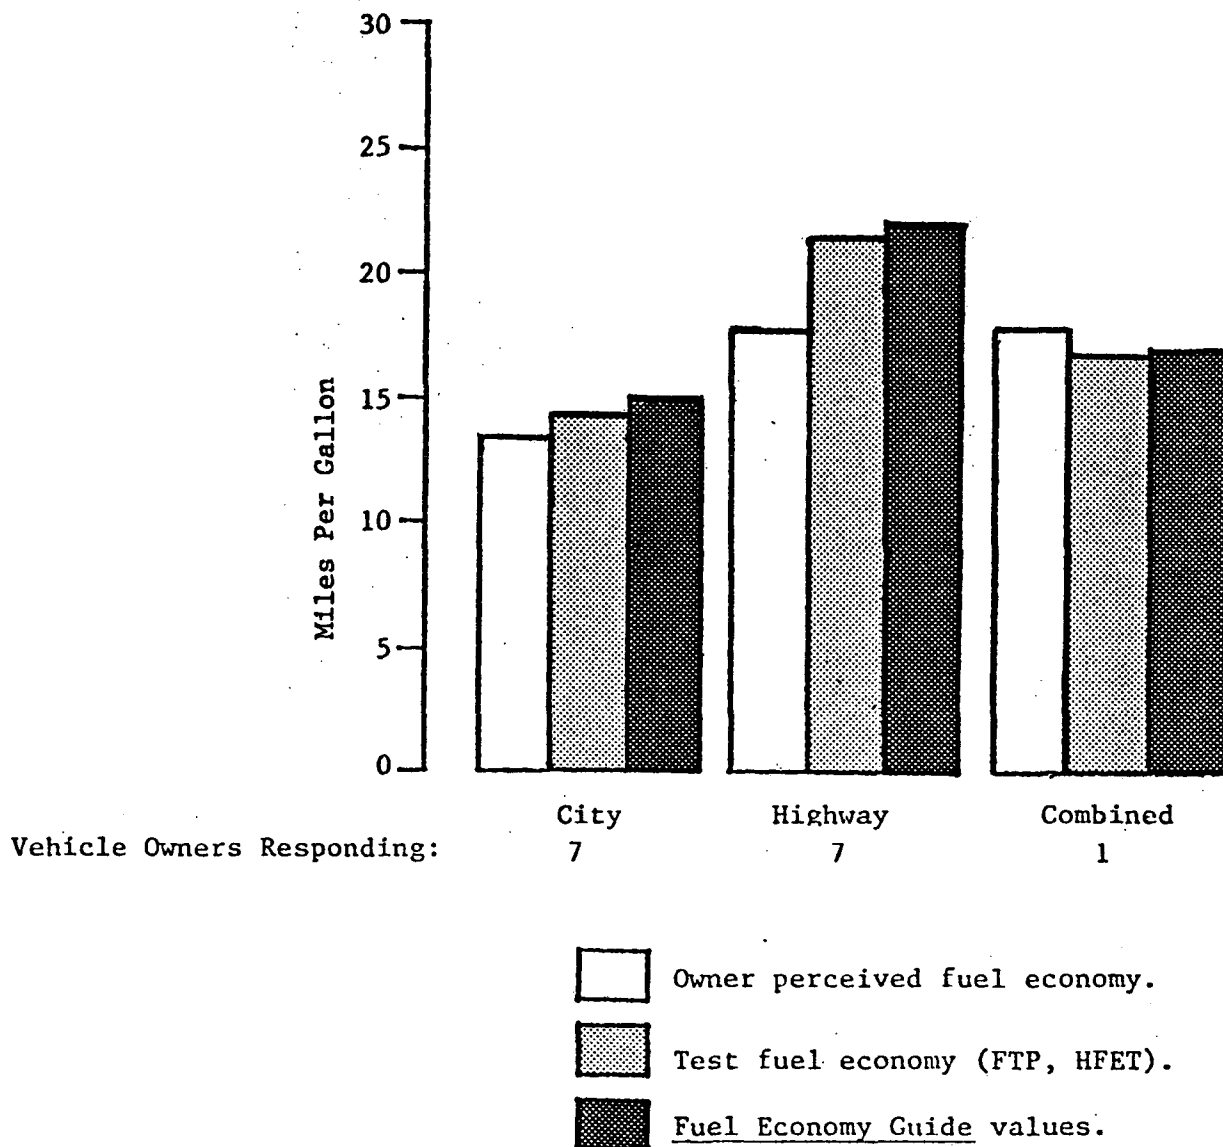
Comparison of Owner Perceived MPG to
Test and Fuel Economy Guide Values
