Insulation and Testing of Indoor Radon
Reduction Techniques in 40 Eastern
Pennsylvania Houses

INSTALLATION AND TESTING OF
INDOOR RADON REDUCTION TECHNIQUES
IN 40 EASTERN PENNSYLVANIA HOUSES

A. G. Scott
A. Robertson
W. O. Findlay

AMERICAN ATCON INC.
1105 North Market Street
P.O. Box 1347
Wilmington, DE 19899

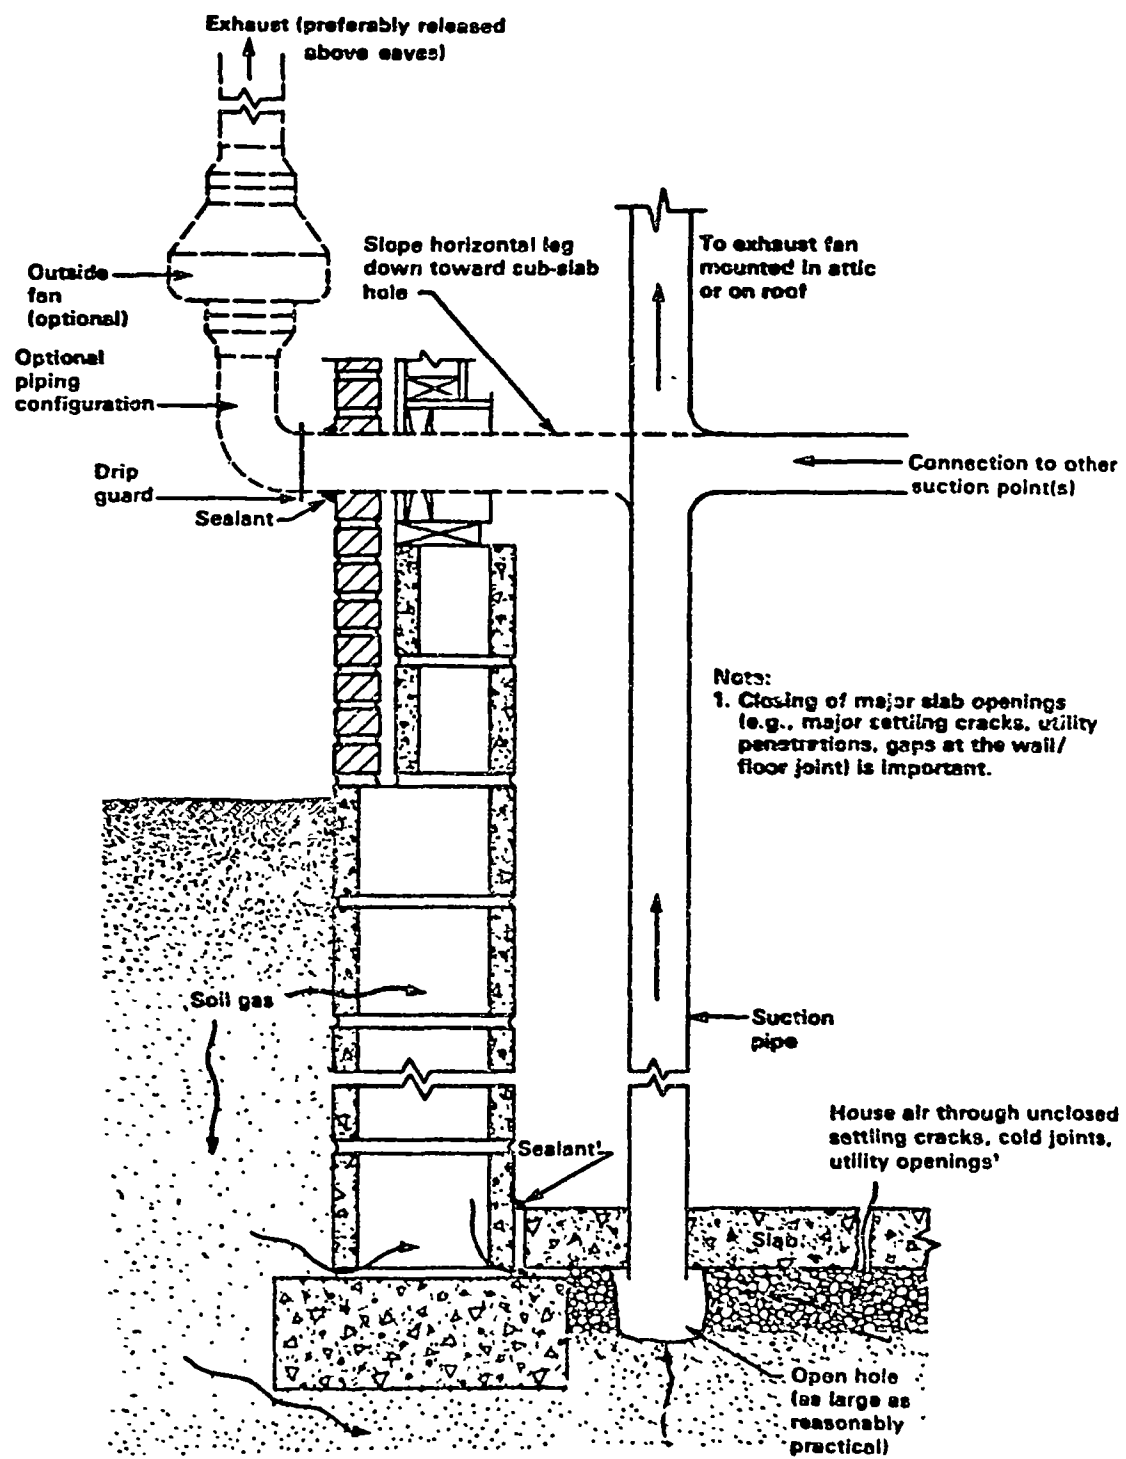
FIGURE 1 TYPICAL SUB-SLAB VENTILATION INSTALLATION

Figures 1 through 5 present generic illustrations of these types of active soil ventilation systems. These figures are taken from the second edition of EPA's "Radon Reduction Techniques for Detached Houses: Technical Guidance". Most of the installations made under this project differ in some details from these generic figures. In fact, the testing under this project helped lead to some of the design refinements which are incorporated into these figures from EPA's guidance document.

An illustration of a typical sub-slab ventilation system is shown in Figure 1.

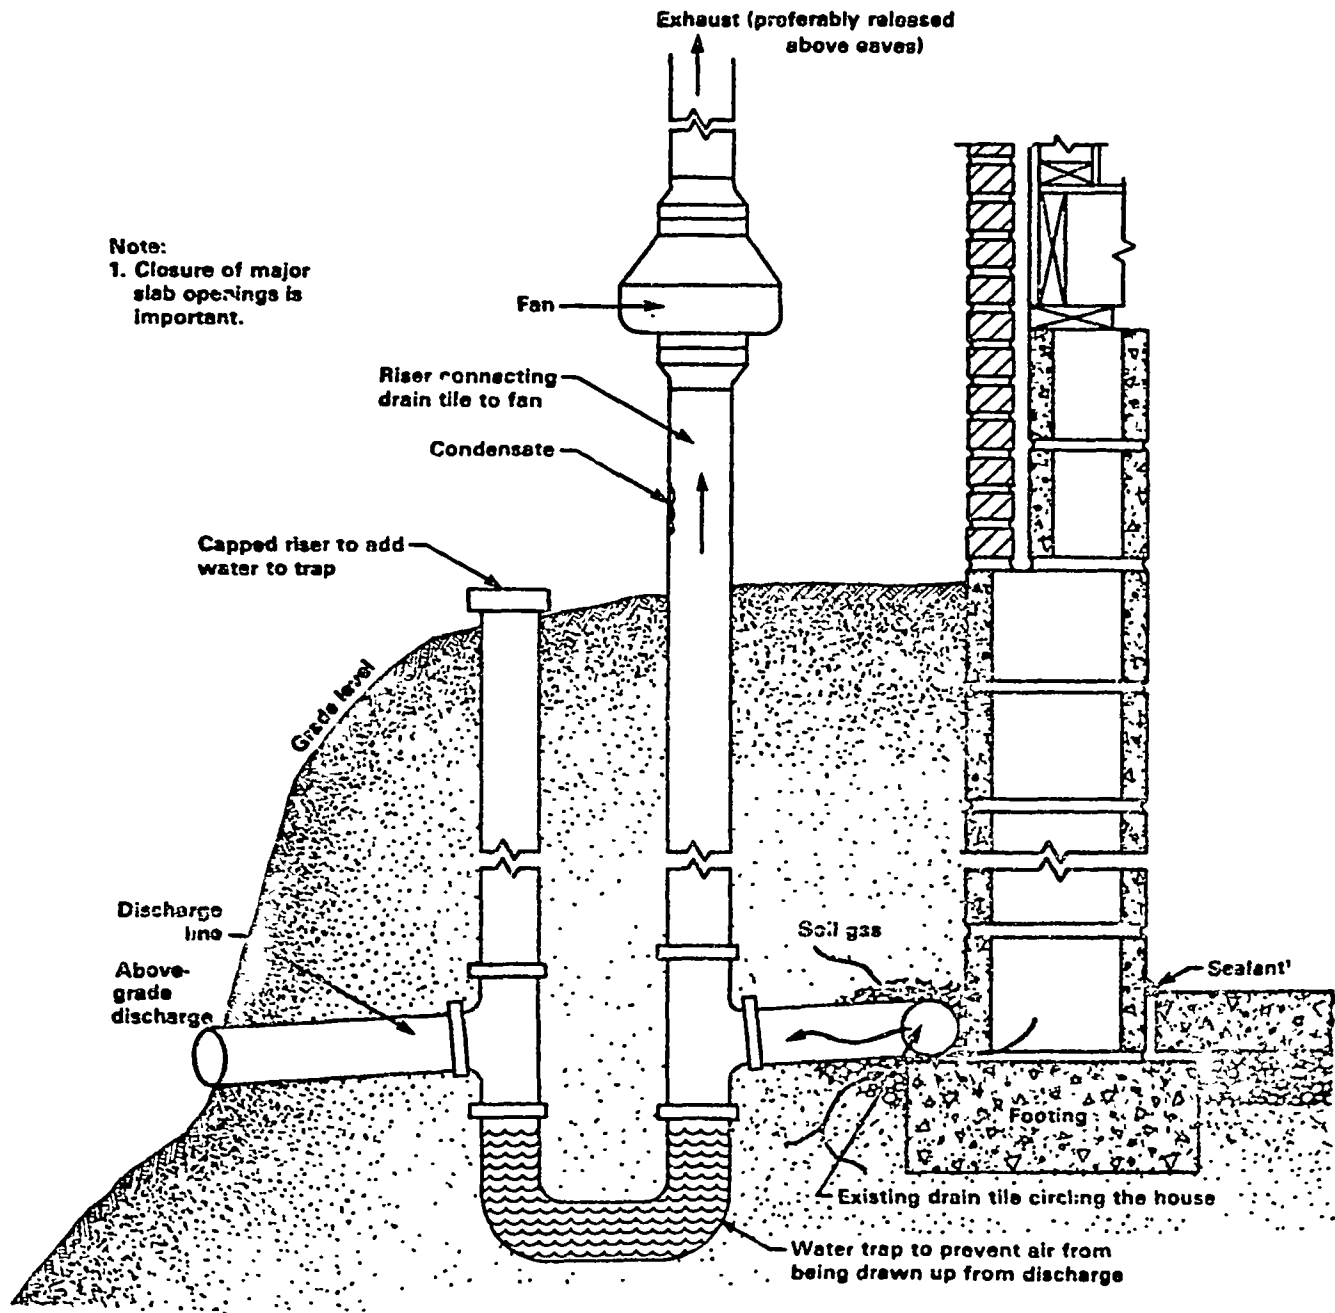
FIGURE 2 TYPICAL DRAIN TILE VENTILATION SYSTEM
(ABOVE-GROUND DISCHARGE)

The drain tile installations tested during this study were of two types. Where the tiles drained to an above-ground discharge, the system resembled that shown in Figure 2. Where they drained to an internal sump, the system resembled that shown in Figure 3.

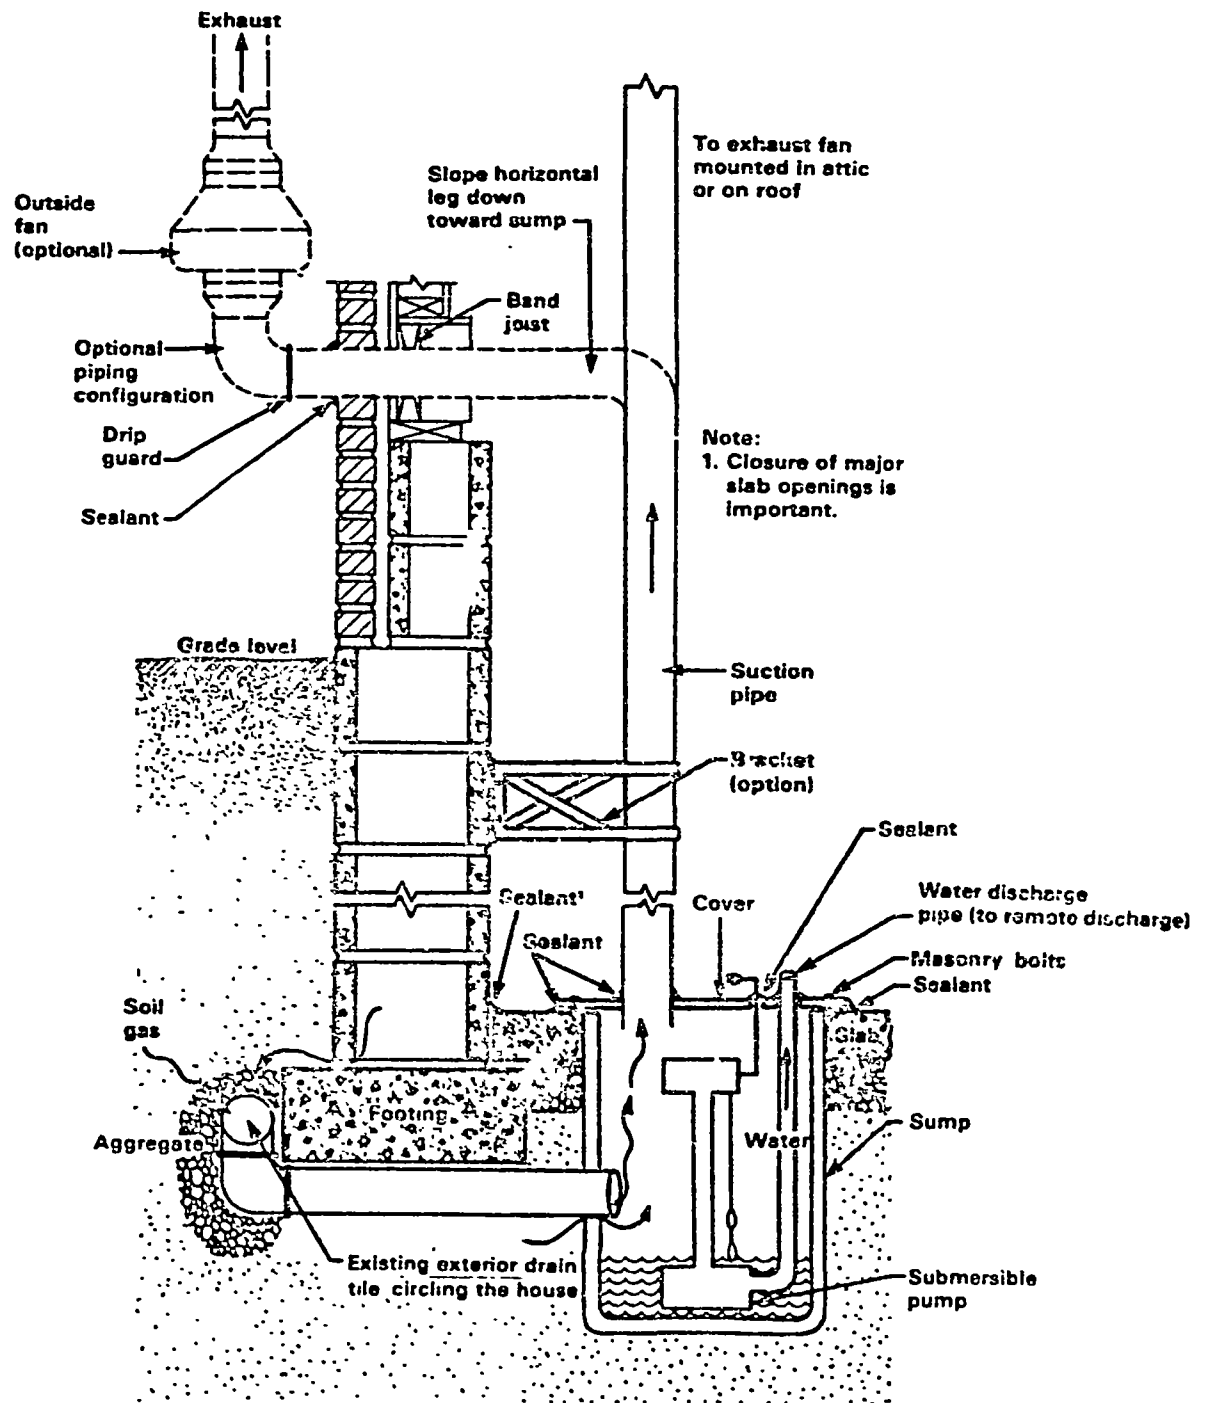
FIGURE 3 TYPICAL DRAIN TILE VENTILATION SYSTEM
(INTERNAL SUMP DISCHARGE)

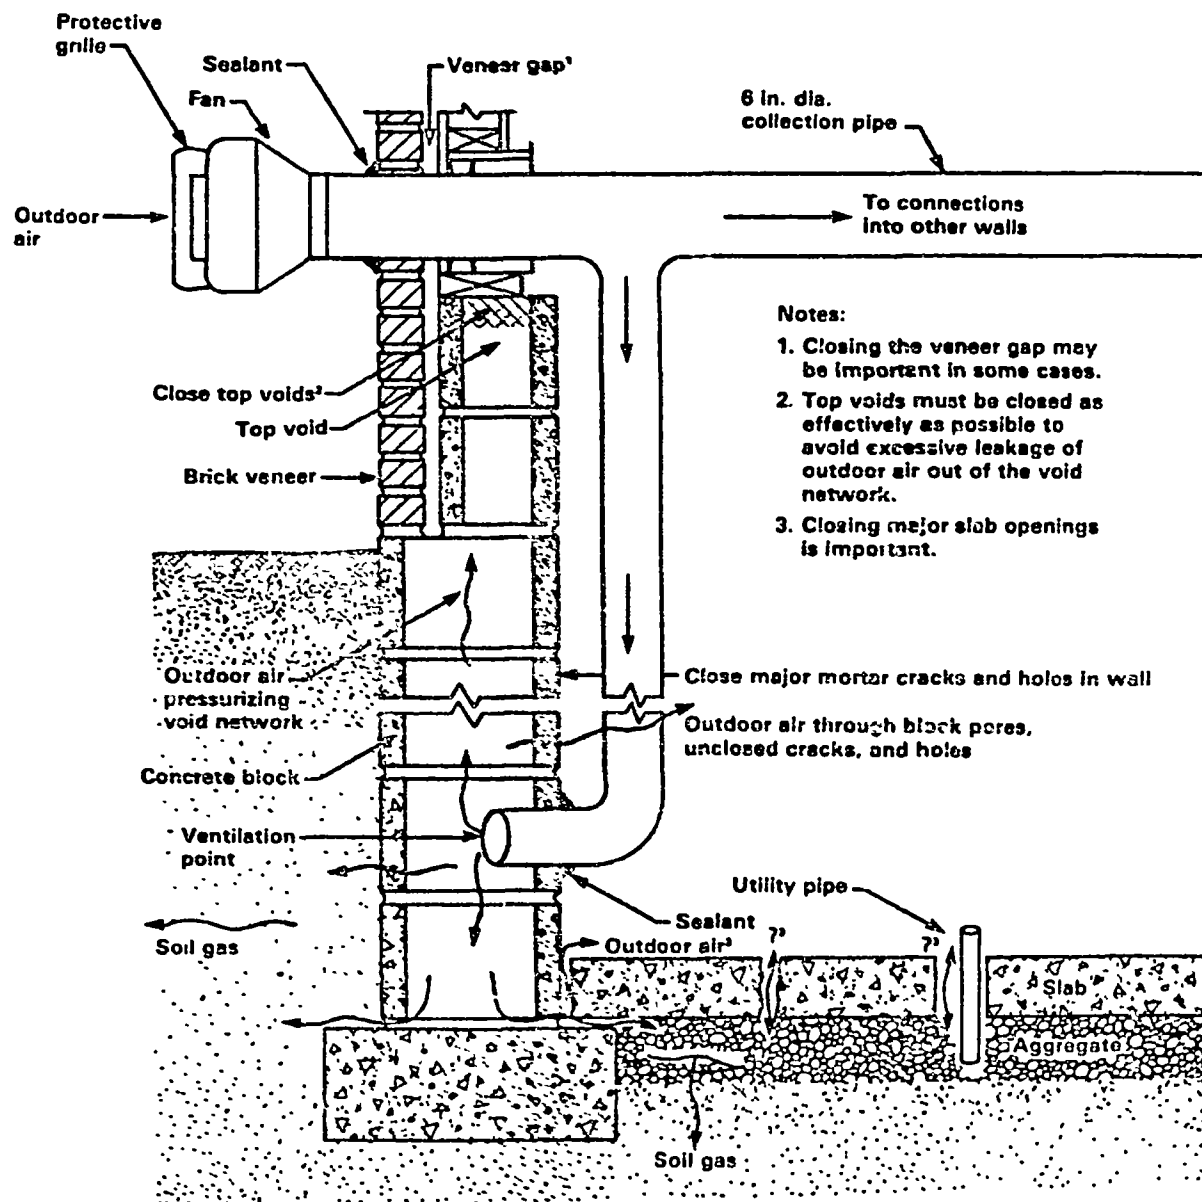
FIGURE 4 TYPICAL WALL VENTILATION SYSTEM

A typical wall ventilation system is shown in Figure 1.

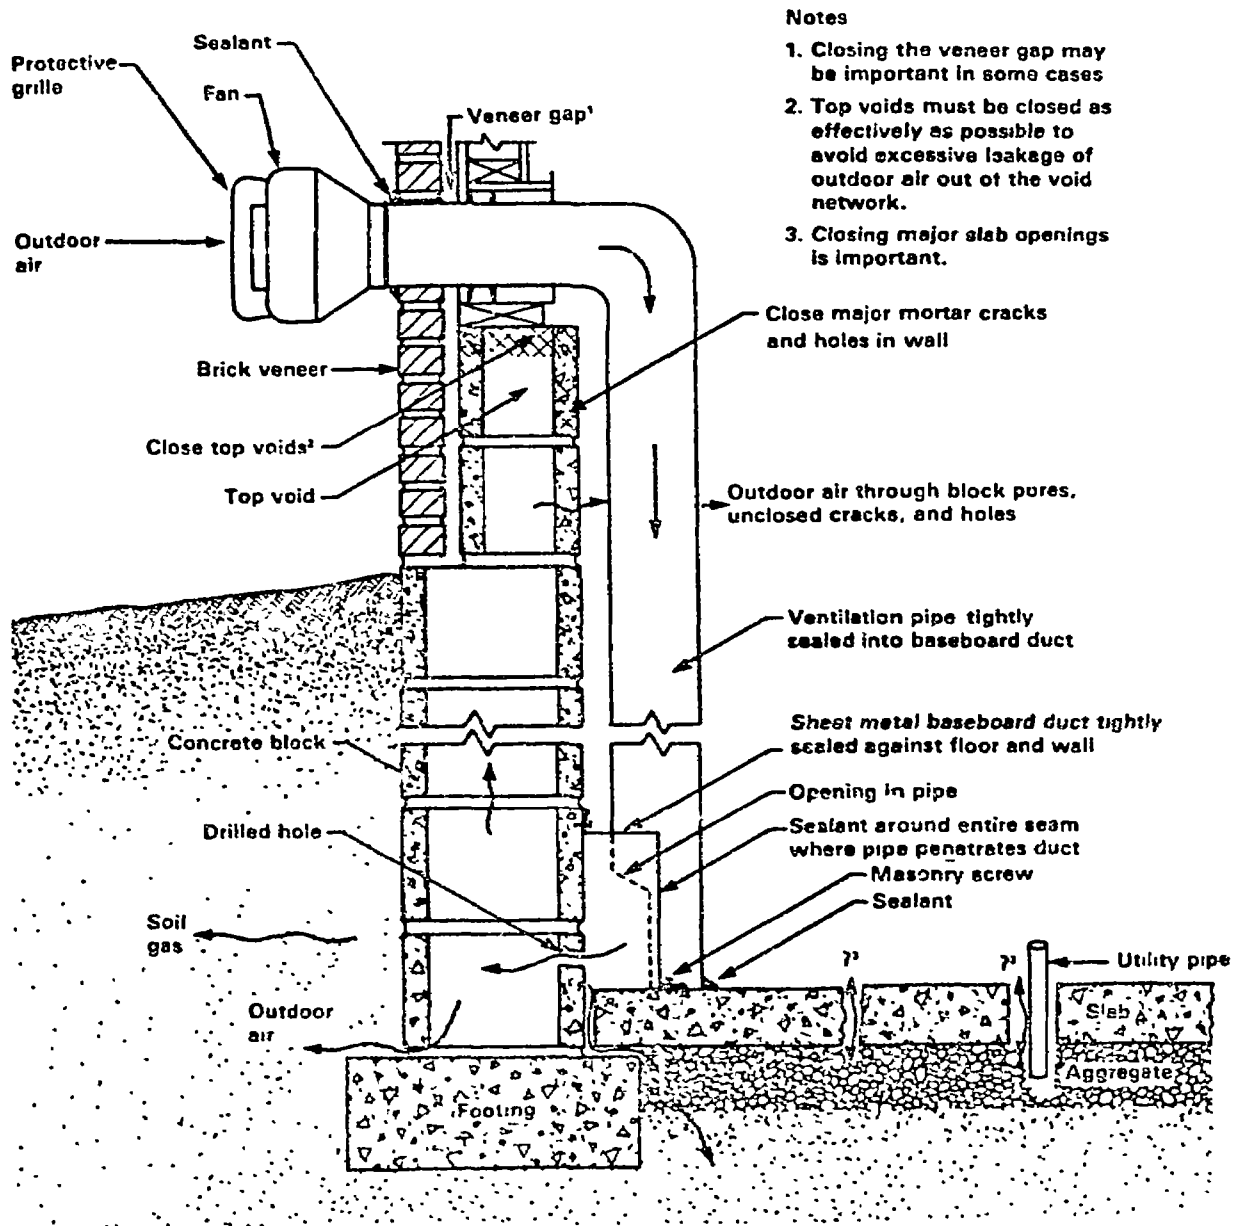
FIGURE 5 TYPICAL "BASEBOARD DUCT" INSTALLATION

Two methods of combined wall plus sub-slab ventilation were tested in this project. The first involved drilling holes into the lowest course of the block wall, and placement of a "baseboard duct" to cover the holes and the wall/floor junction. This duct then ventilated both the wall and the sub/slab space. A typical baseboard duct installation is shown in Figure 5. The second method involved placement of individual suction pipes into both the wall and the sub-slab space - a simple combination of the wall and sub-slab ventilation methods described in Sections 7 and 9.

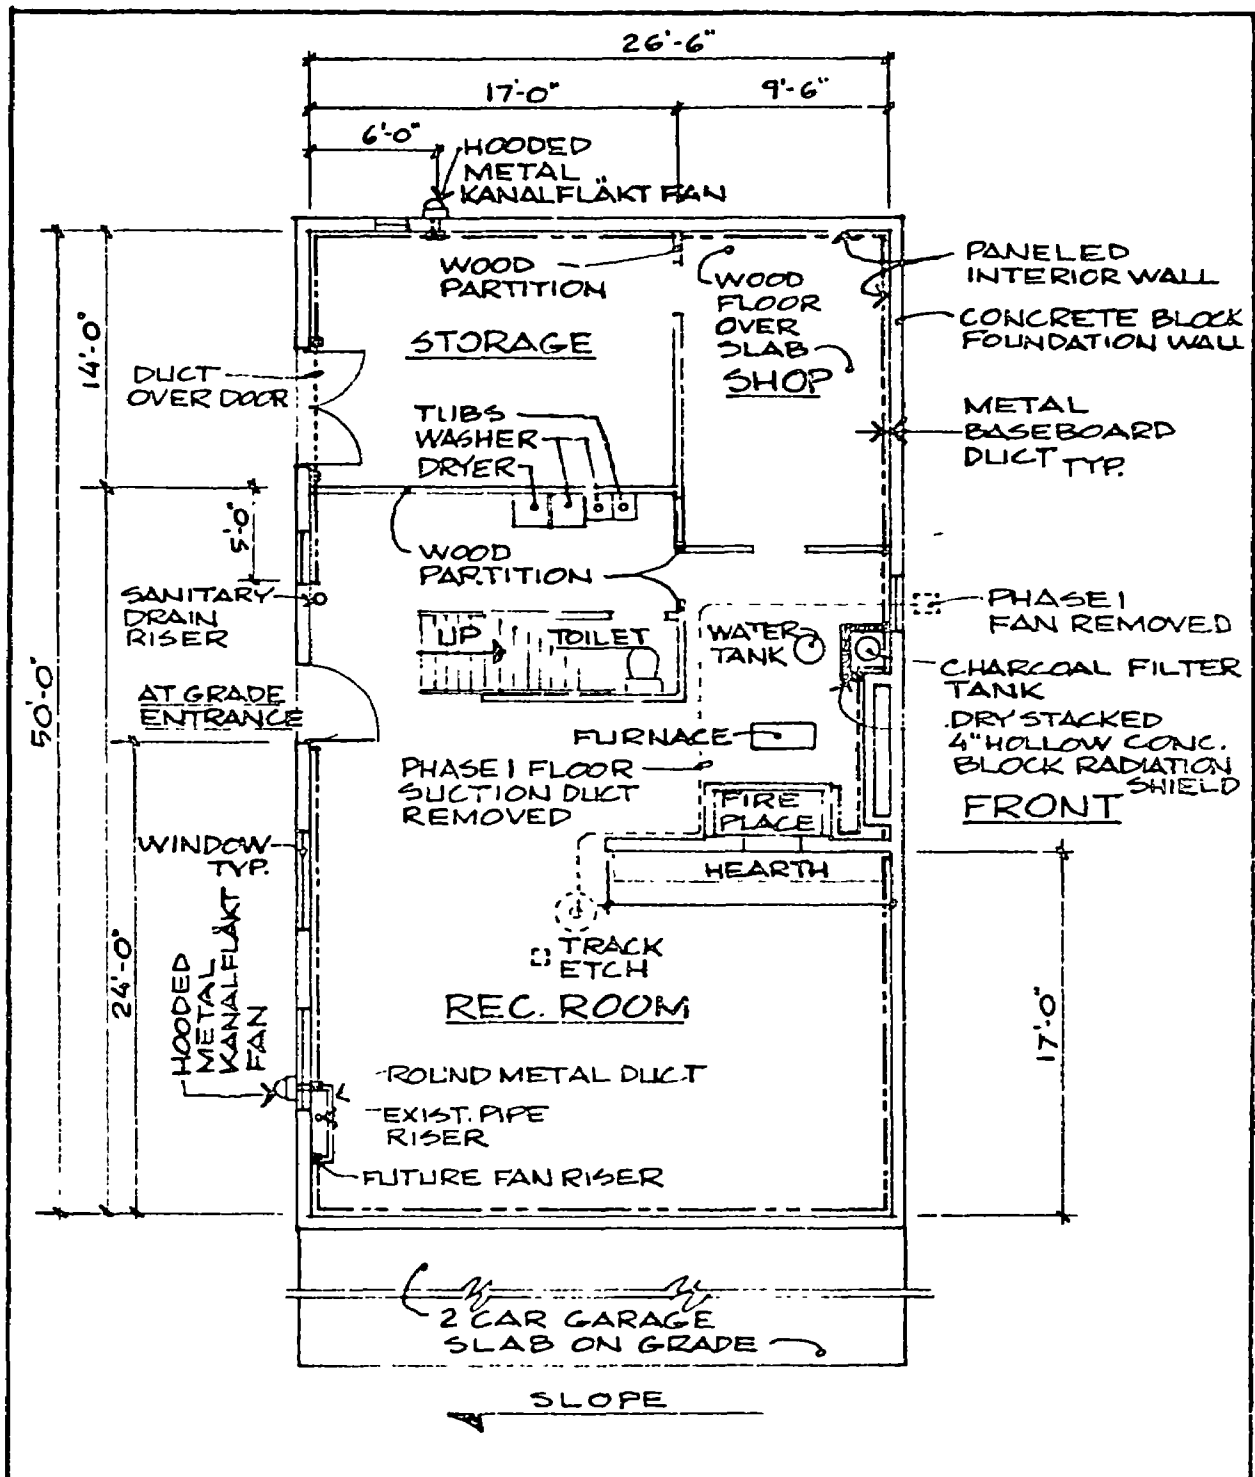
LOW COST REDUCTION OF INDOOR RADON		HOUSE NUMBER
	FOUNDATION PLAN		Date: 12/1/86
	Mitigation system: BASEBOARD TYPE WALL/SLAB SUCTION		PHASE: 1 THRU FINAL
			2

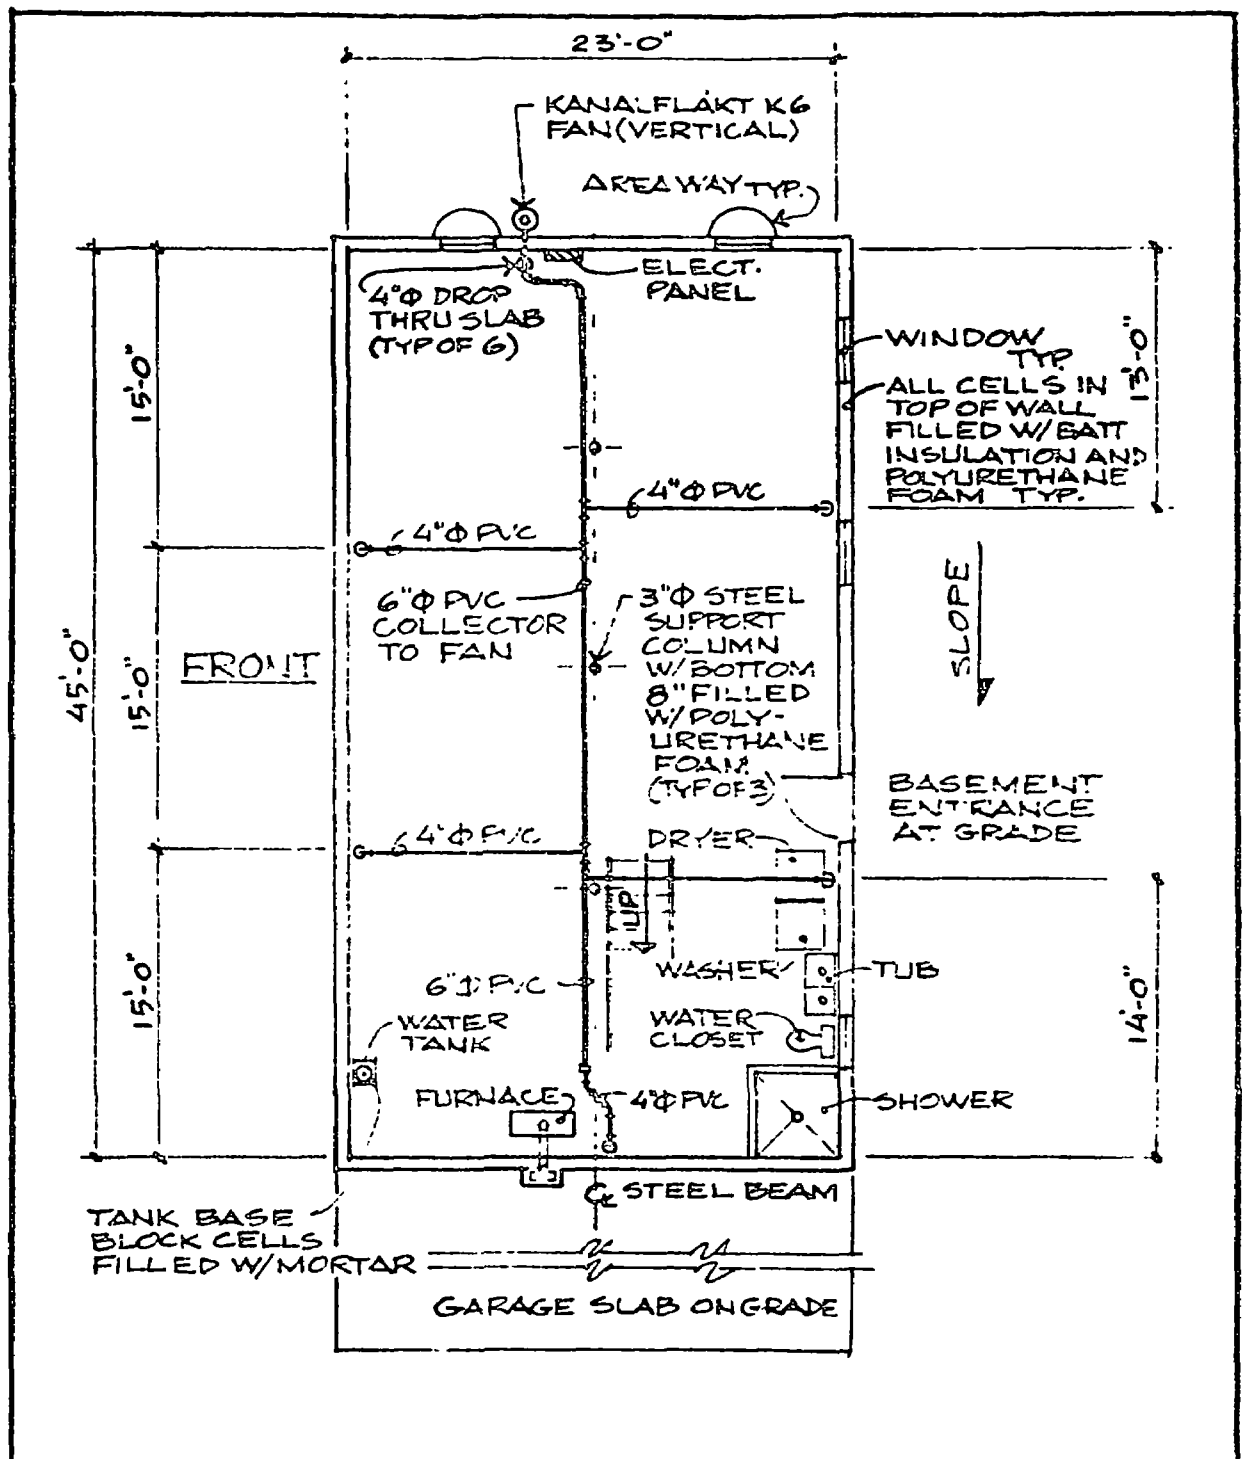
<small>ACRES</small> <small>ADVISORY CORPORATION</small>	LOW COST REDUCTION OF INDOOR RADON		HOUSE NUMBER
	FOUNDATION PLAN		Date: 12/11/86
	Mitigation system: SUBSLAB SUCTION		PHASE: FINAL
			4

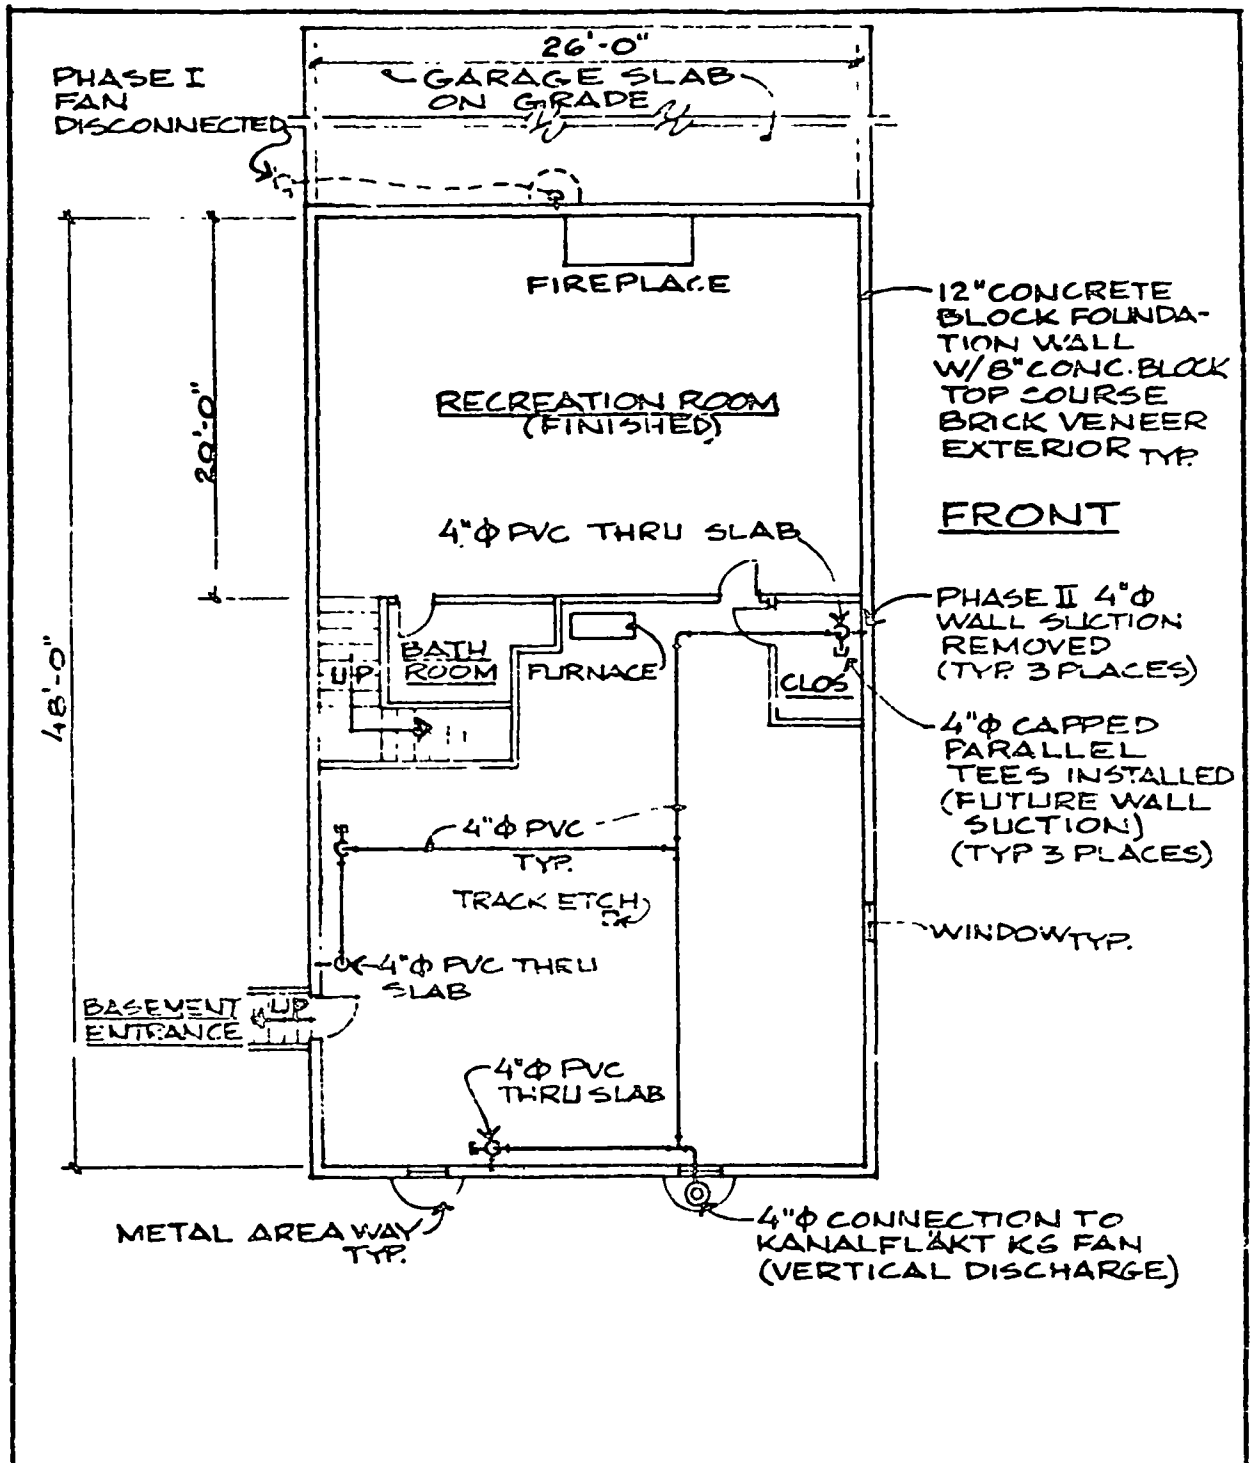
LOW COST REDUCTION OF INDOOR RADON		HOUSE NUMBER
	FOUNDATION PLAN		Date: 12/10/64
	Mitigation system: SUBSLAB SUCTION		PHASE: I THRU FINAL

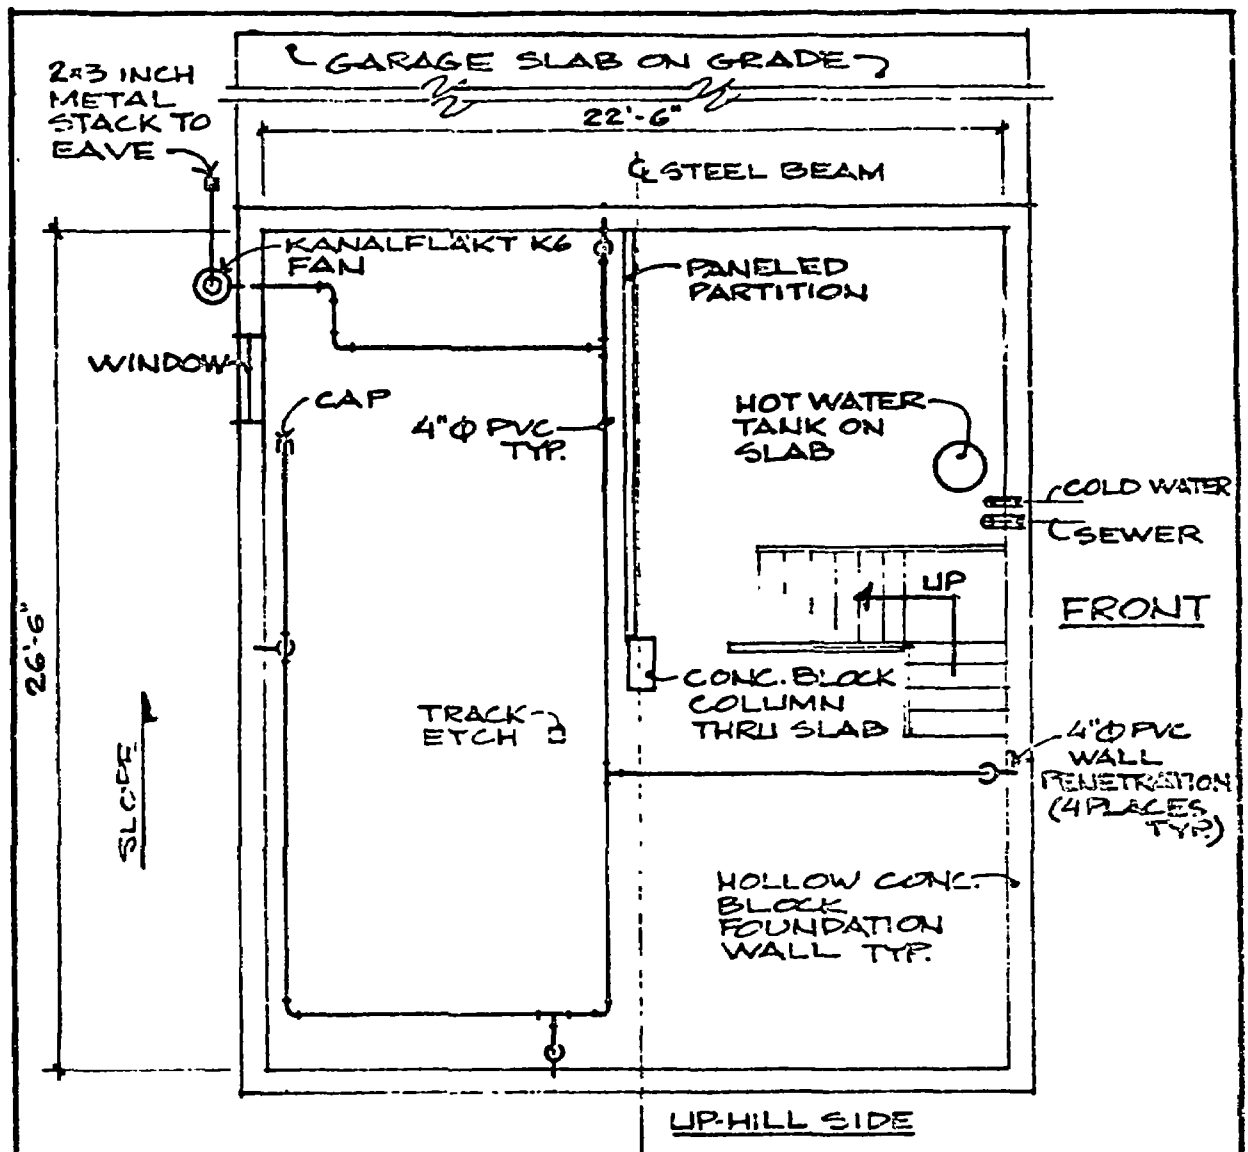
- NOTES: 1. SIDE WALLS MORTARED ON TOP TO FILL TOP COURSE CAVITIES.
2. BACK AND FRONT WALL CAVITIES OF TOP COURSE SEALED AT SILL PLATE WITH TAR-BASED SEALANT
3. SOME FOAMING TRIED, BUT WITHOUT MUCH SUCCESS, AT BLOCK CAVITIES. FOAM APPLIED AT ELECTRICAL PANEL, SEWER OUTLET AND AS FILL FOR SMALL HOLES.

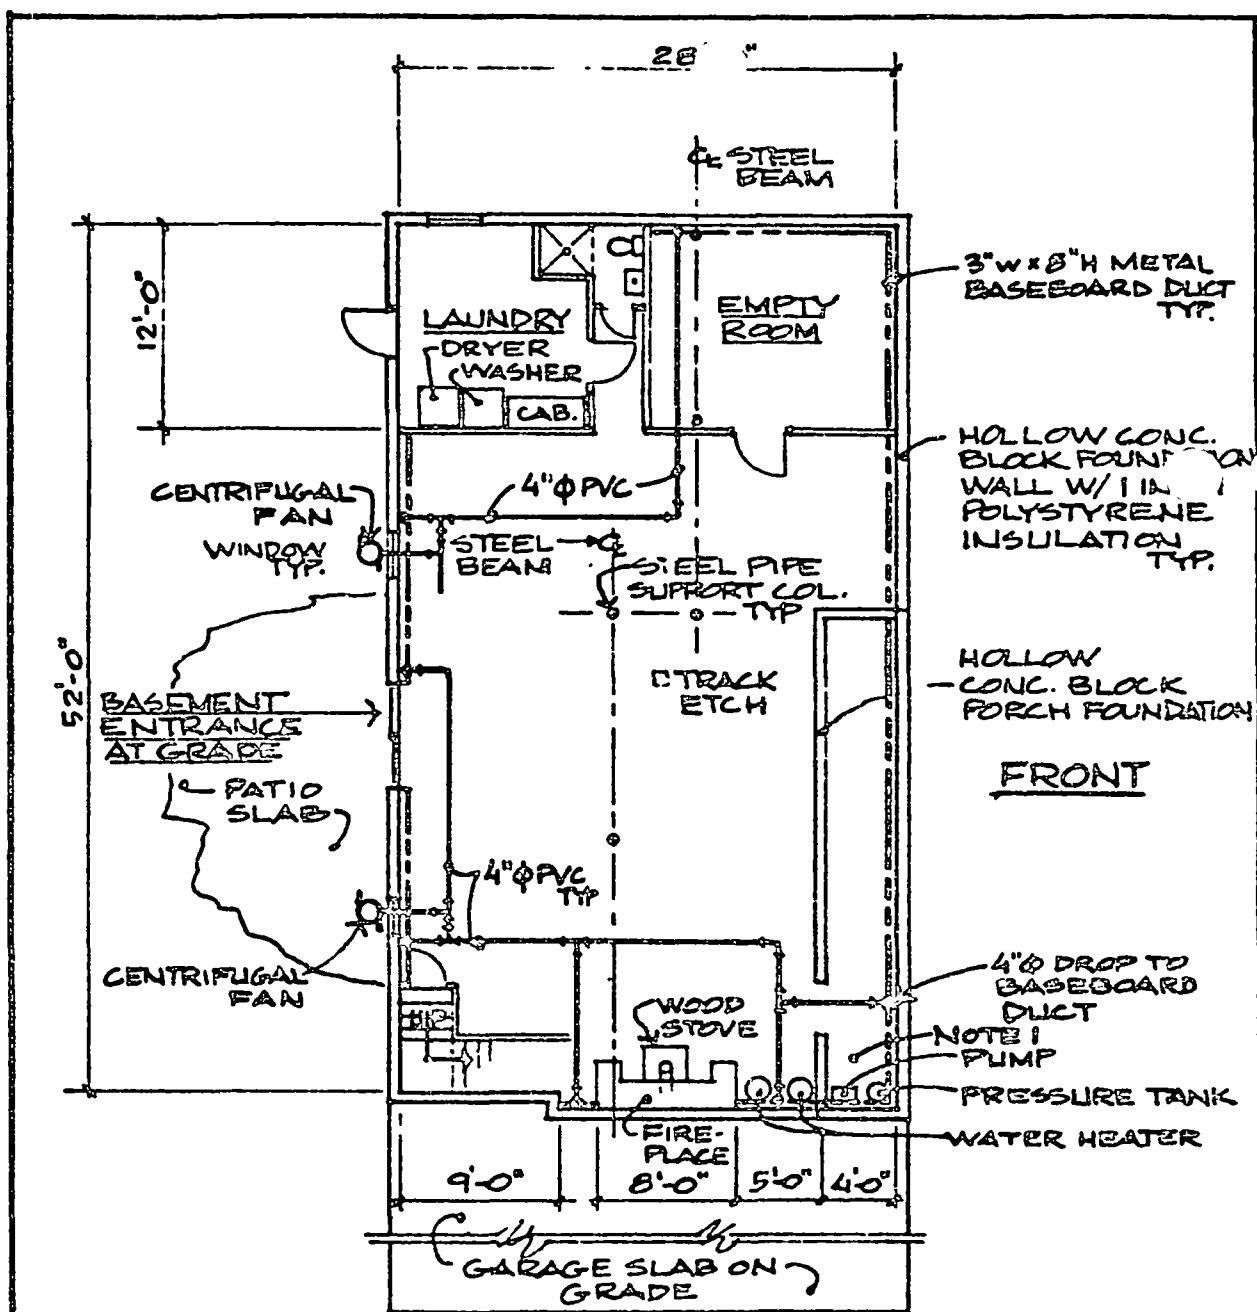
9

NOTES: 1. ROOFING FELT INSTALLED UNDER BRICK FLOOR THIS AREA

LOW COST REDUCTION OF INDOOR RADON		HOUSE NUMBER
	FOUNDATION PLAN		Date: AUG. '86
	Mitigation system: BASEBOARD TYPE WALL/SLAB PRESSURIZATION		PHASE: 1

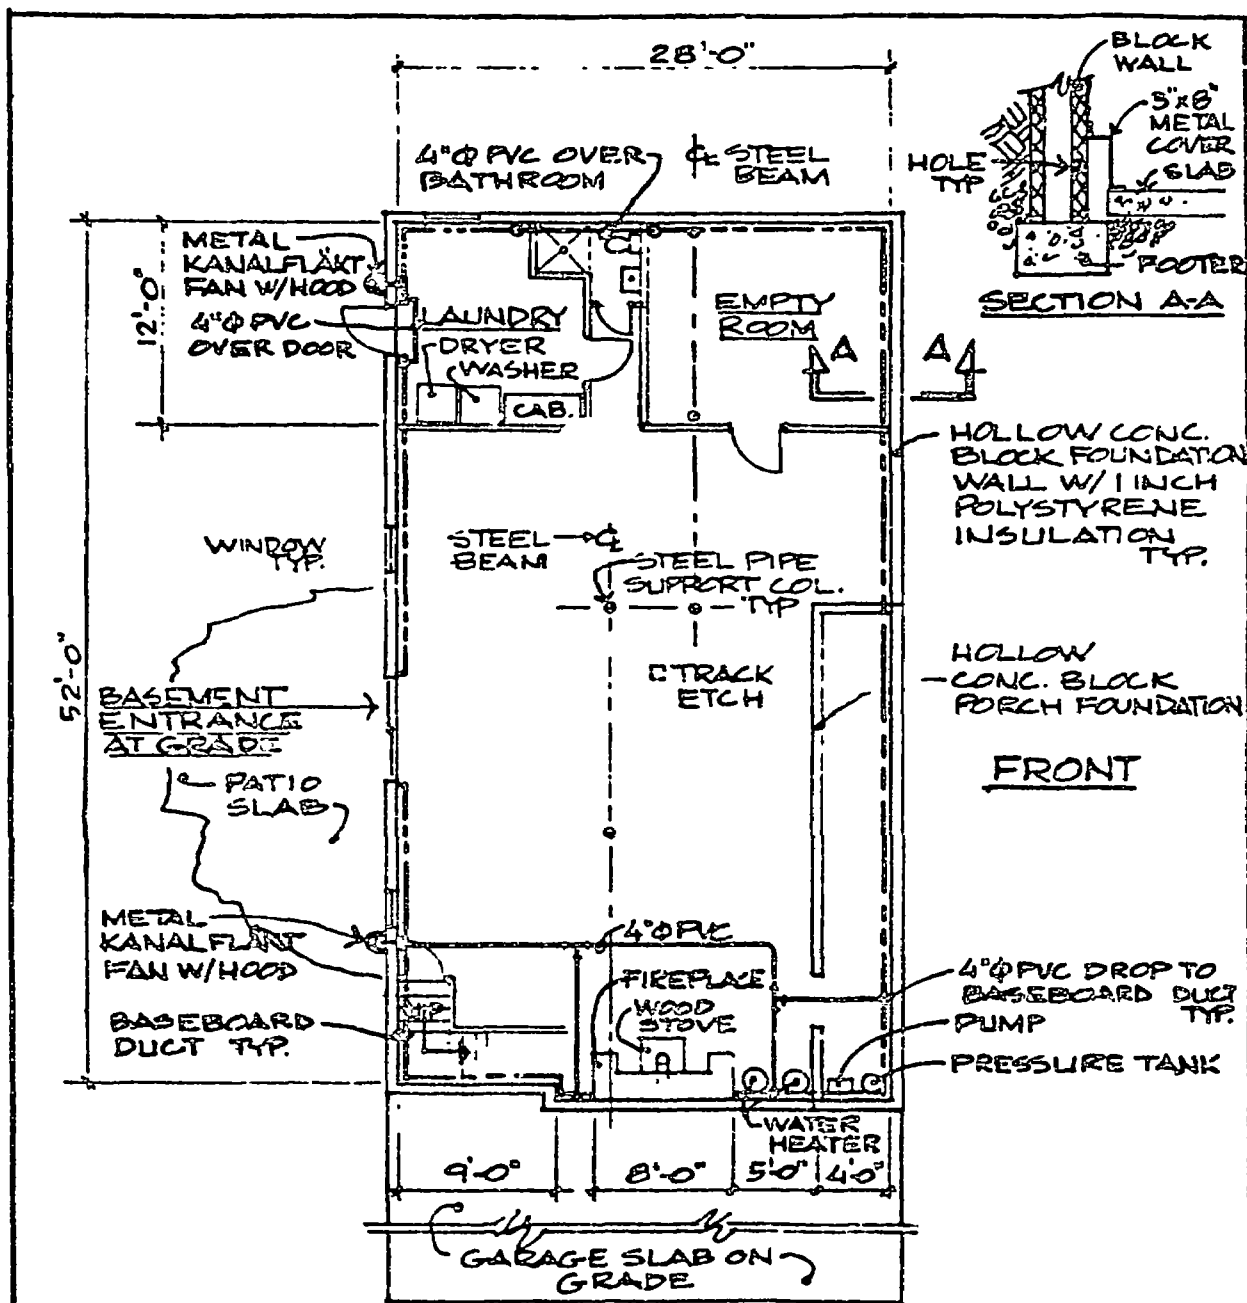
LOW COST REDUCTION OF INDOOR RADON		HOUSE NUMBER
	FOUNDATION PLAN		Date: 5/6/86
	Mitigation system: BASEBOARD TYPE WALL/SLAB PRESSURIZATION	PHASE: 2 AND FINAL	9

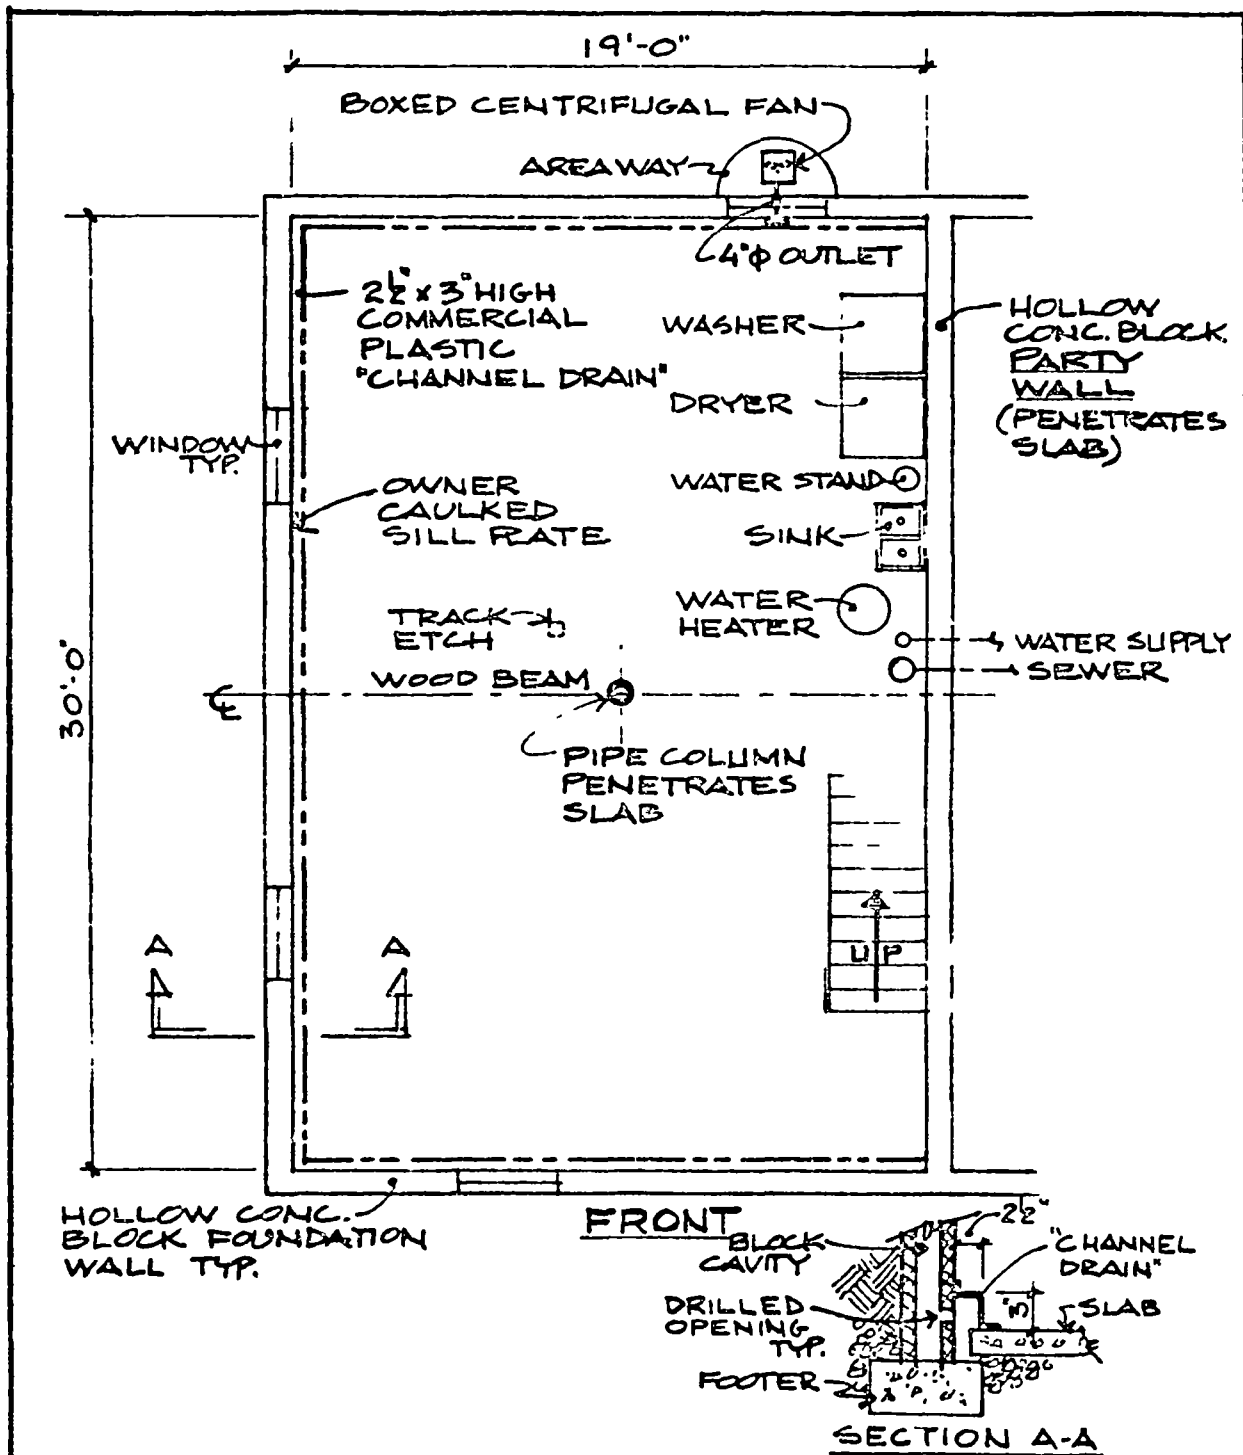
<small>ASHEE American Society of Heating, Refrigerating and Air-Conditioning Engineers</small>	LOW COST REDUCTION OF INDOOR RADON		HOUSE NUMBER
	FOUNDATION PLAN	Date: 10/20/86	11
	Mitigation system: BASEBOARD TYPE WALL/SLAB SUCTION	PHASE: FINAL

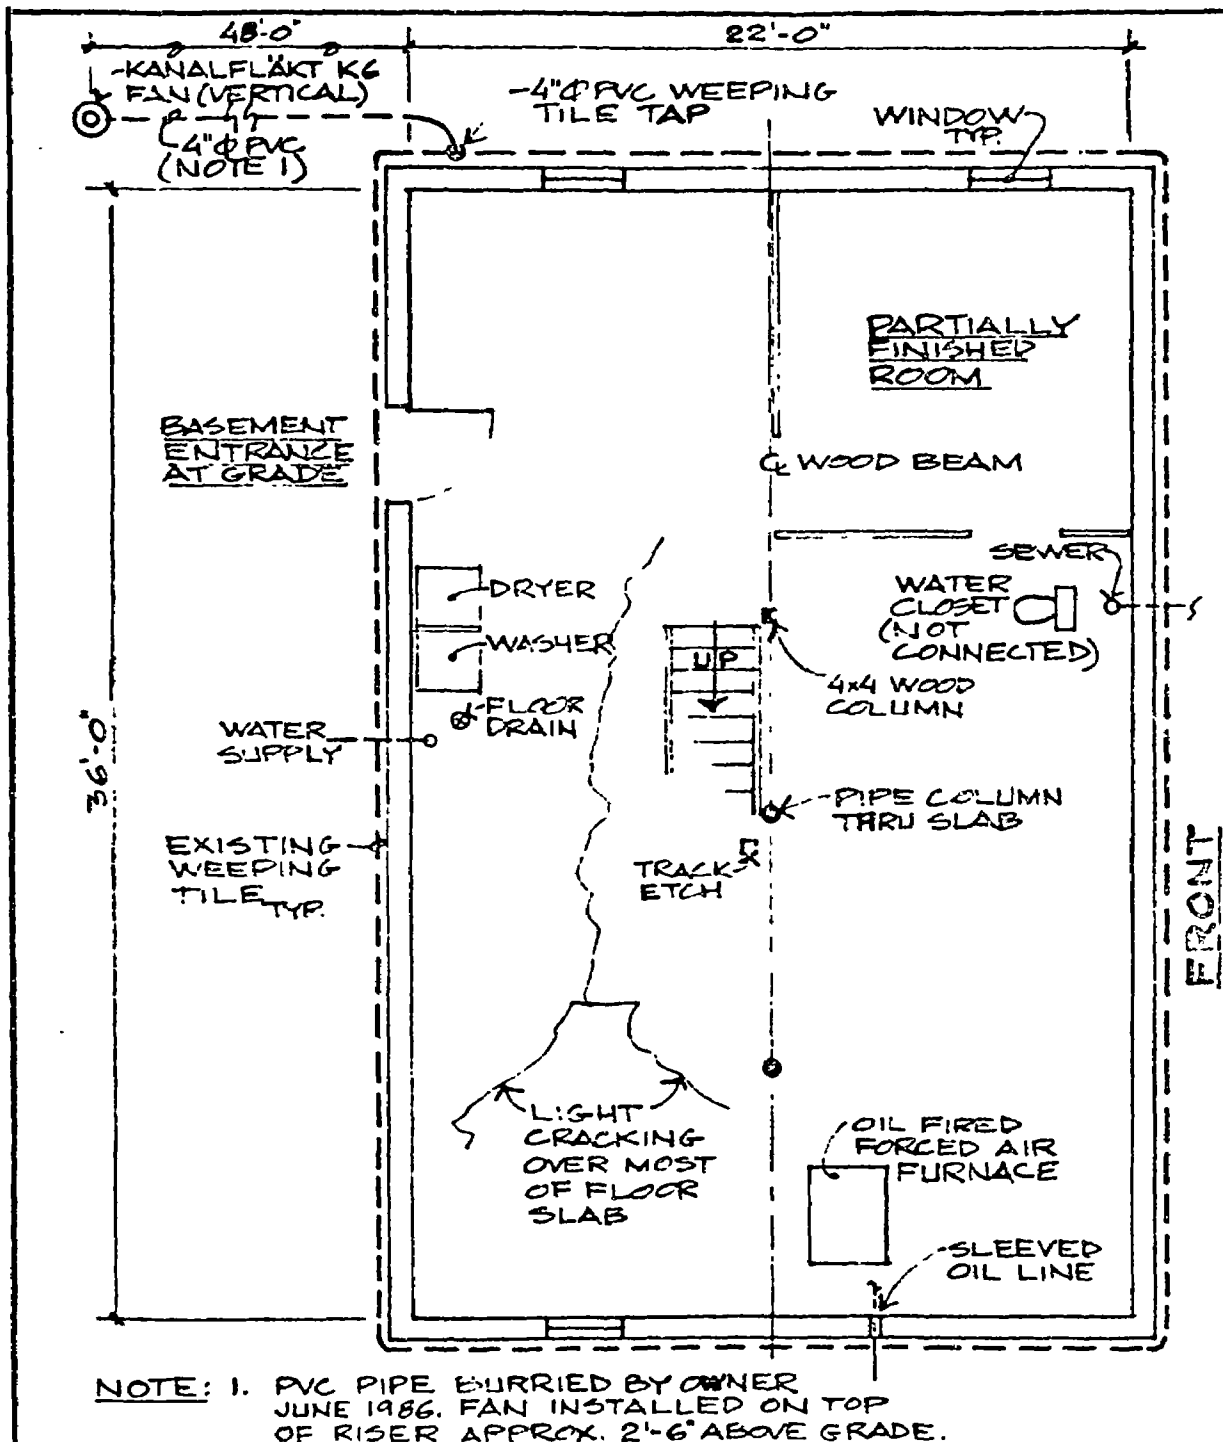
LOW COST REDUCTION OF INDOOR RADON		HOUSE NUMBER
	FOUNDATION PLAN		Date: 10/20/86
	Mitigation system: WEEPING TILE SUCTION	PHASE: FINAL	12
