Insulation and Testing of Indoor Radon
Reduction Techniques in 40 Eastern
Pennsylvania Houses

INSTALLATION AND TESTING OF
INDOOR RADON REDUCTION TECHNIQUES
IN 40 EASTERN PENNSYLVANIA HOUSES

A. G. Scott
A. Robertson
W. O. Findlay

AMERICAN ATCON INC.
1105 North Market Street
P.O. Box 1347
Wilmington, DE 19899

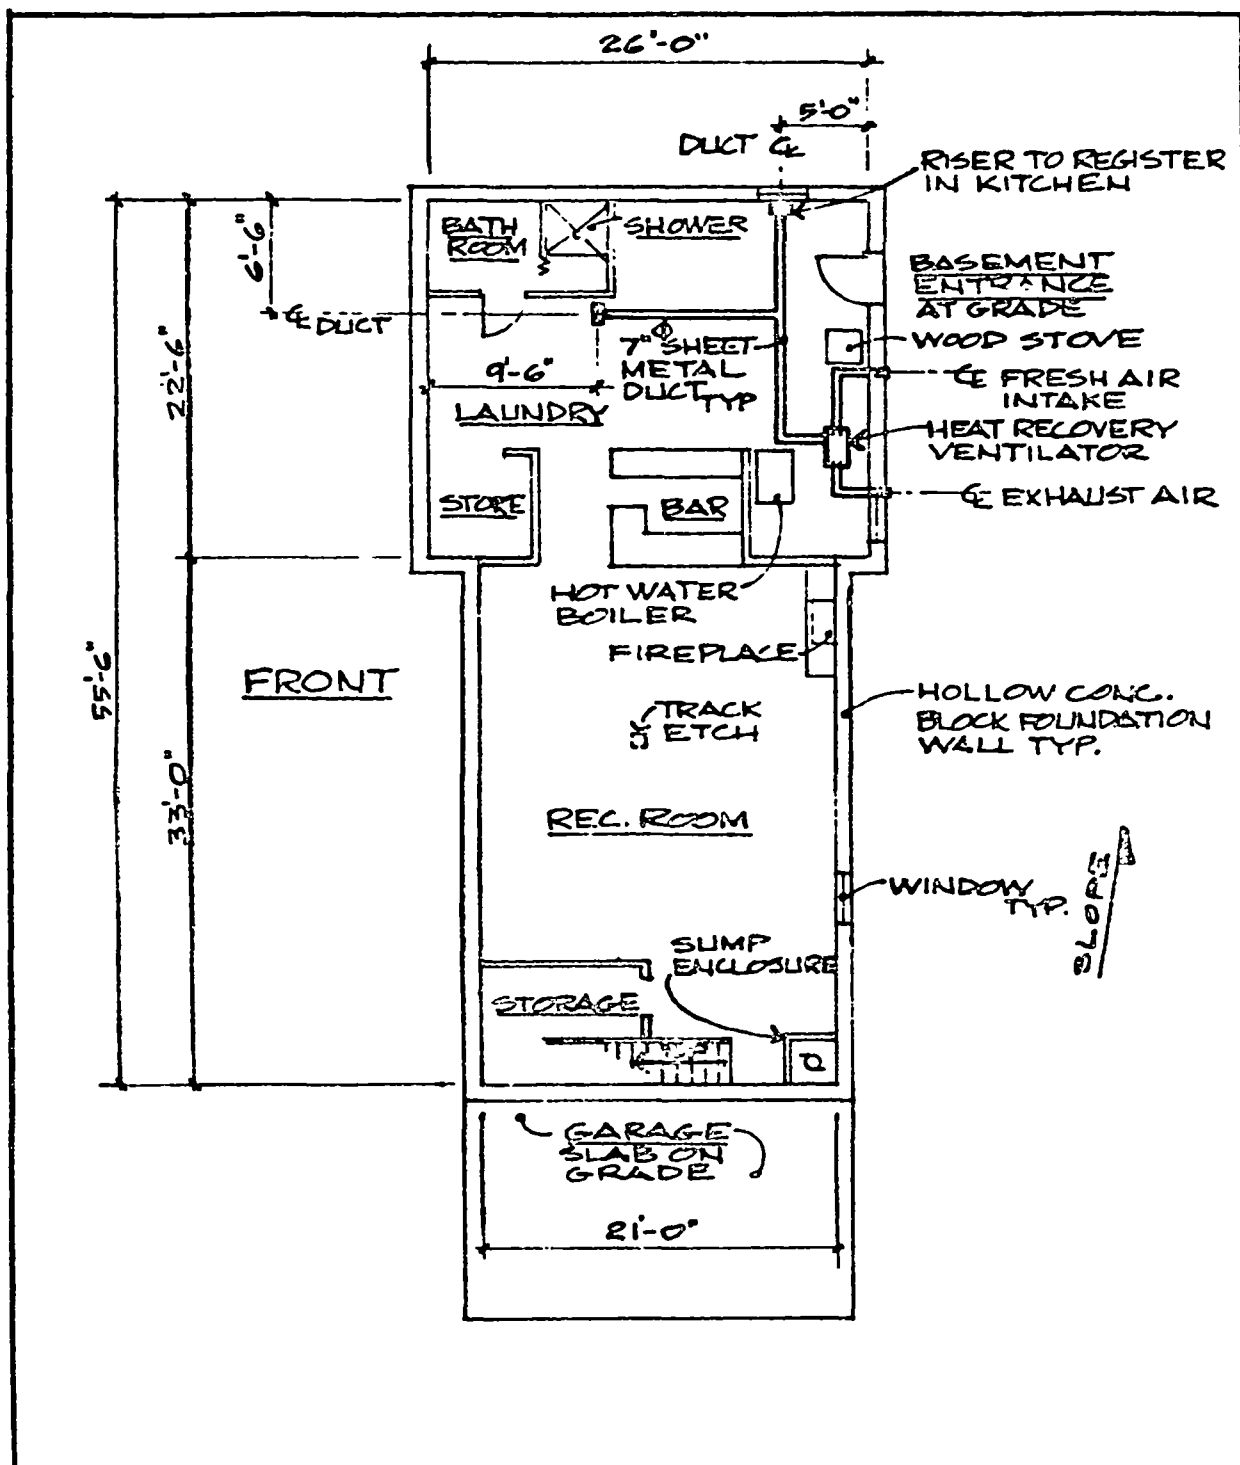
LOW COST REDUCTION OF INDOOR RADON		HOUSE NUMBER
	FOUNDATION PLAN		Date: 2/16/86
	Mitigation system: COMMERCIAL HEAT RECOVERY VENTILATOR	PHASE: FINAL	17

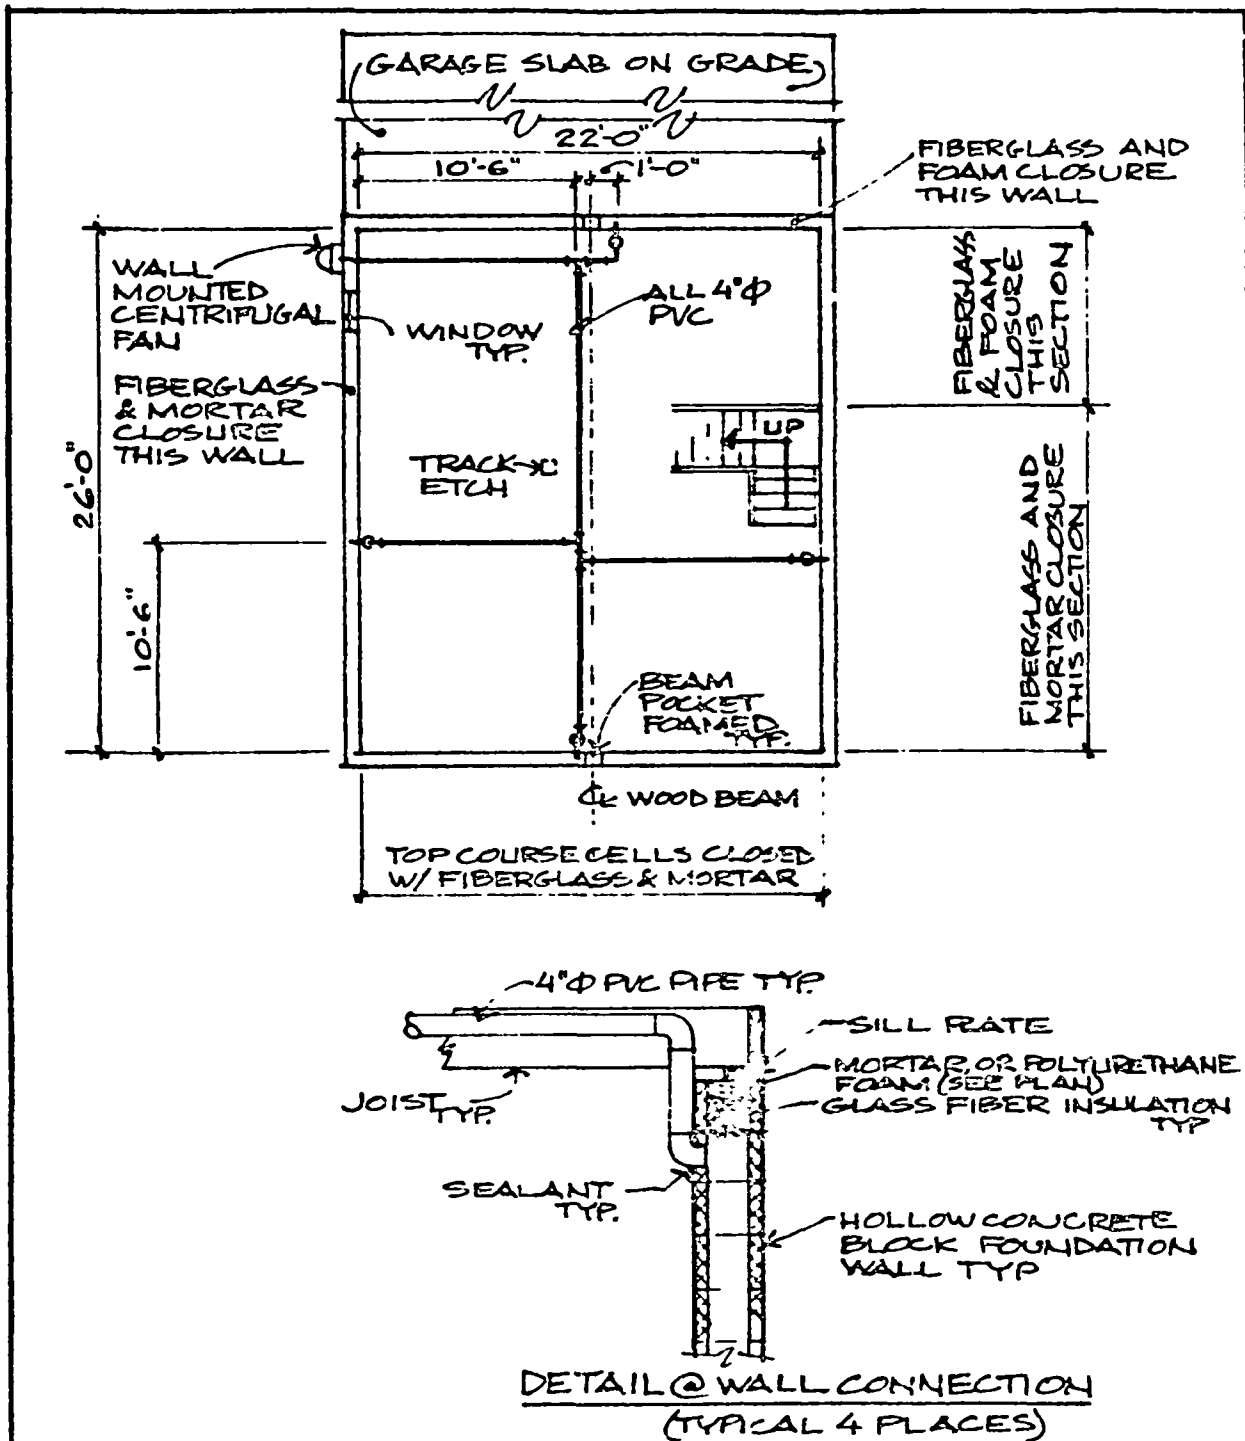
LOW COST REDUCTION OF INDOOR RADON		HOUSE NUMBER
	FOUNDATION PLAN		Date: 4/11/88
	Mitigation system: WALL SUCTION	PHASE: FINAL	19

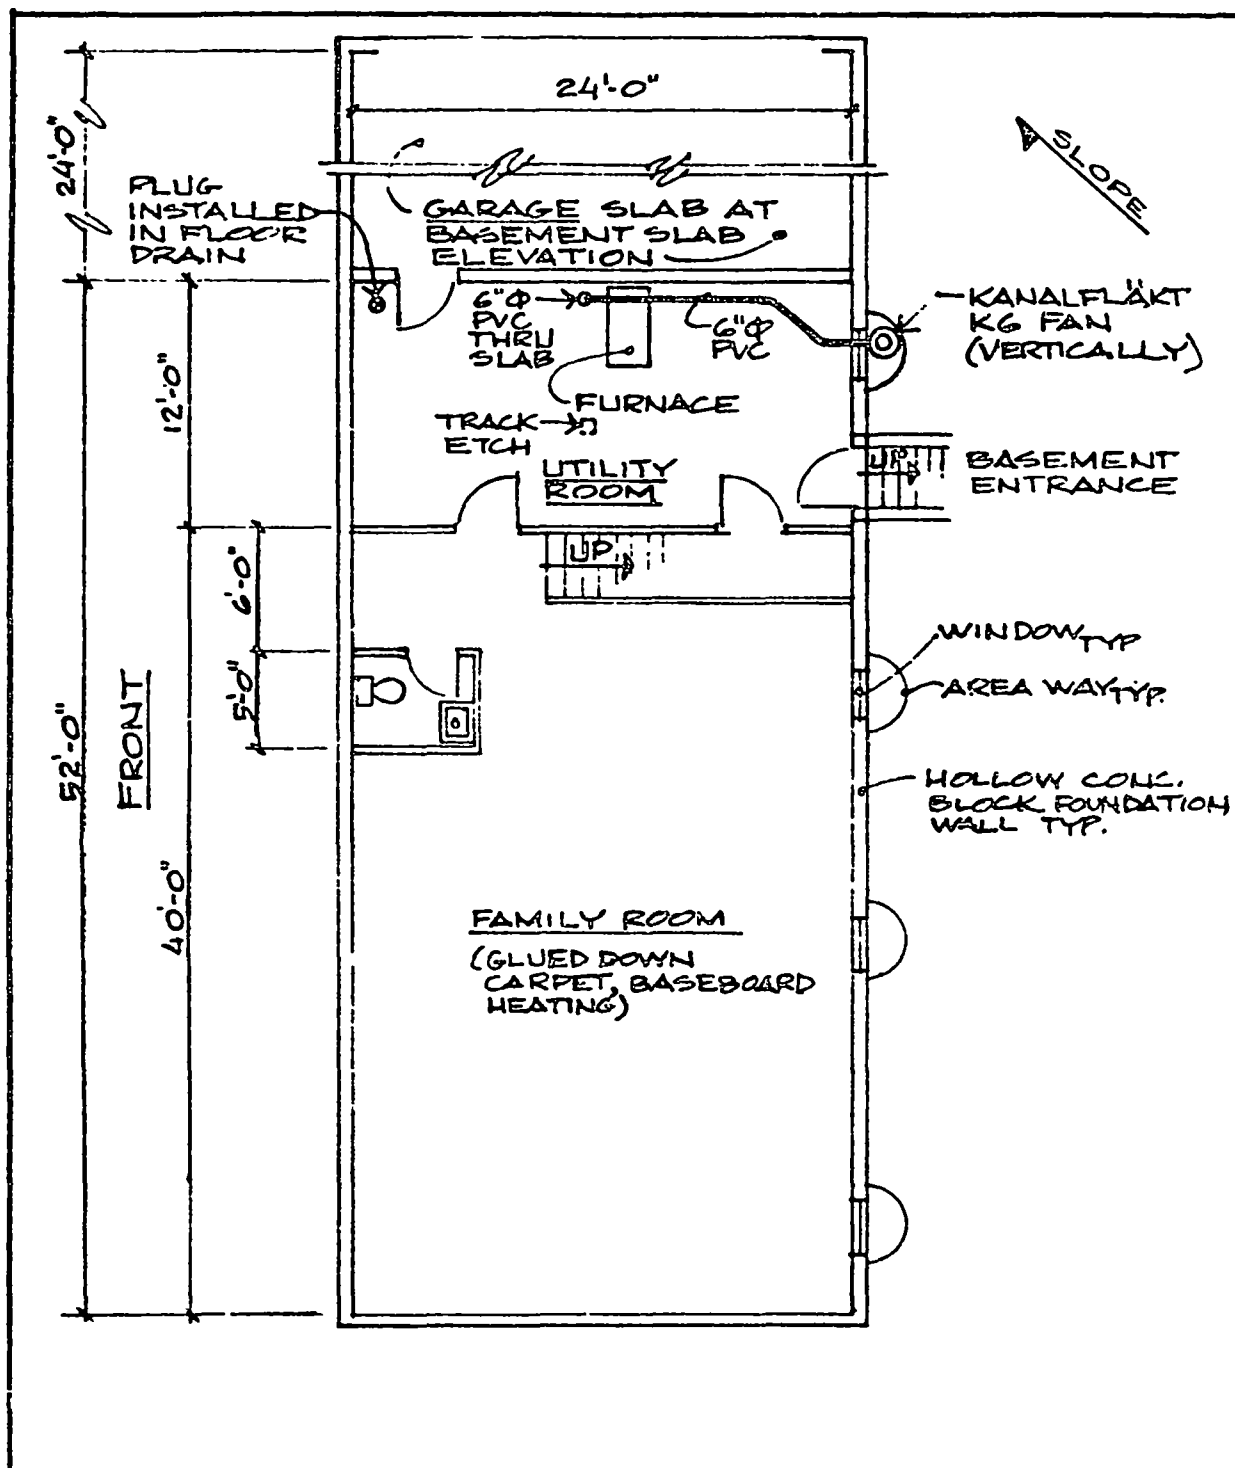
LOW COST REDUCTION OF INDOOR RADON		HOUSE NUMBER
	FOUNDATION PLAN		Date: NOV, 86
	Mitigation system: SUB-SLAB SUCTION	PHASE: 2 THRU FINAL	21

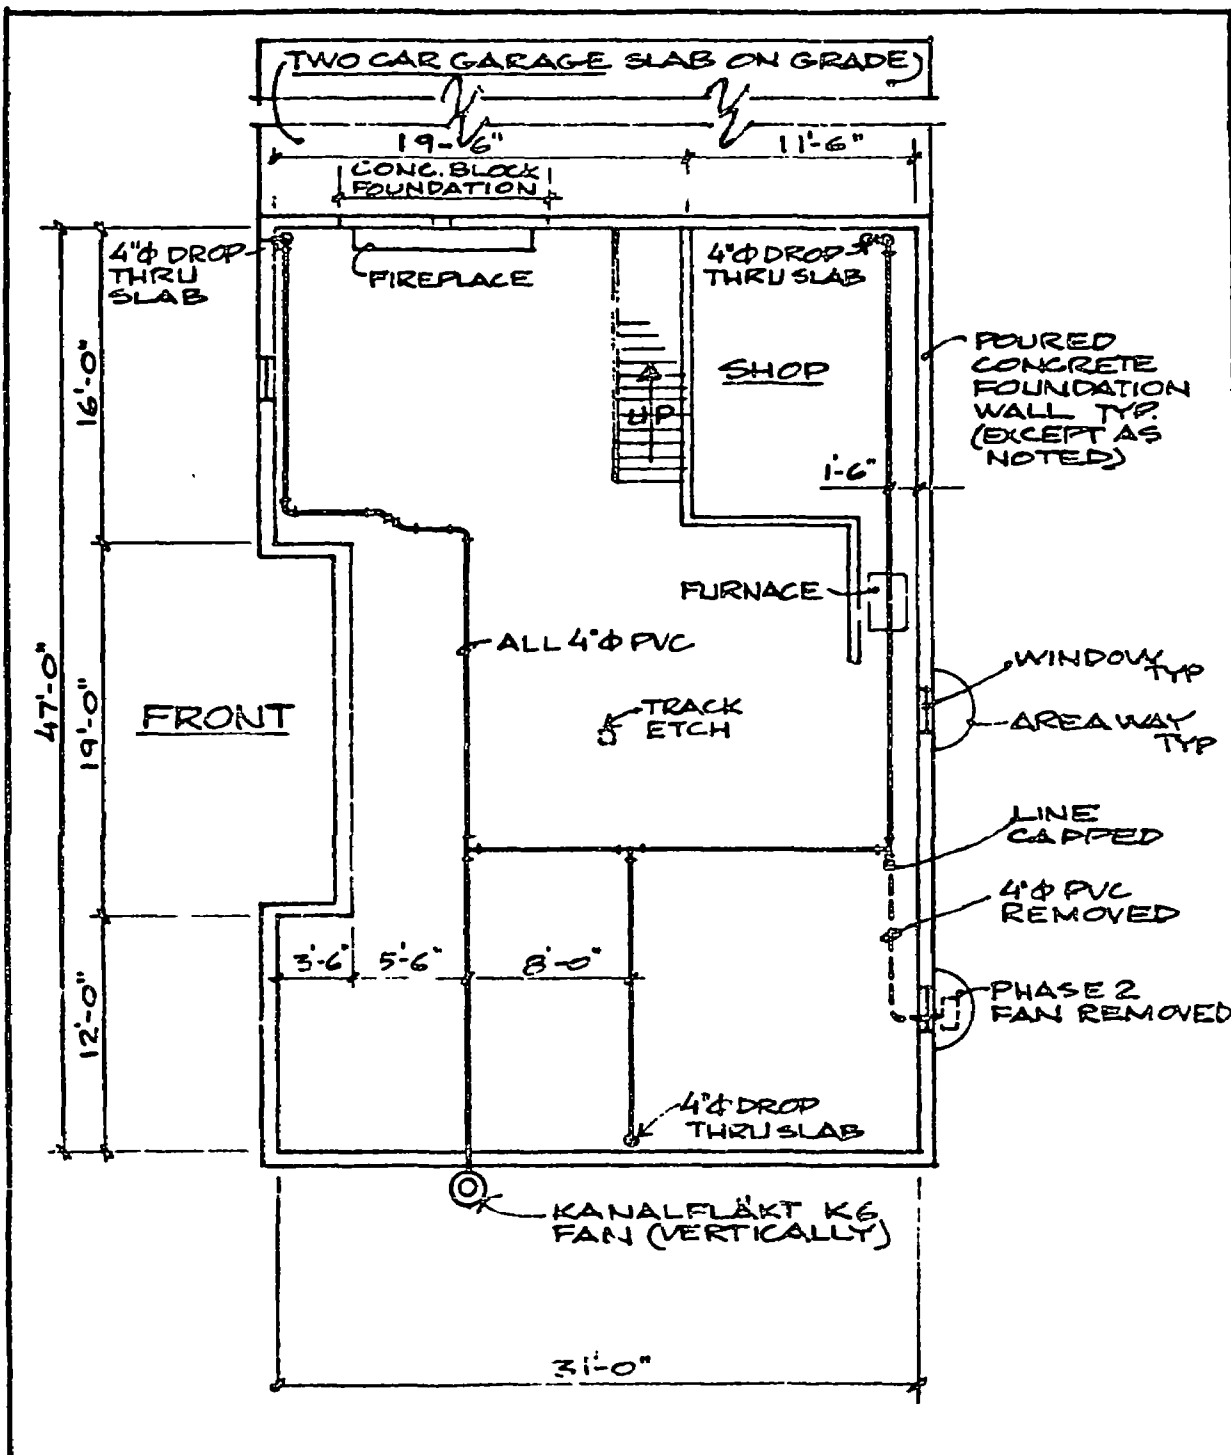
Leg 1: near fireplace
Leg 2: rear wall
Leg 3: end wall

LOW COST REDUCTION OF INDOOR RADON		HOUSE NUMBER
	FOUNDATION PLAN		Date: 2/24/87
	Mitigation system: SUB-SLAB SUCTION	PHASE: 2 AND FINAL	24

Holes were drilled through the floor slab at the agreed locations with a concrete coring machine. At the corner near the fireplace the footing extended 30 cm from the wall, and several overlapping cores had to be taken to connect to the sub-slab fill of 5 to 8 cm of crushed stone. At the other locations the hole entered the sub-slab fill directly. The pipes were linked to a single 50 L/s centrifugal fan via a length of flex hose passed through a sheet of plywood placed in a basement window opening at the rear of the house.

System measurements found suction flows and radon concentrations in the pipes were; fireplace 100 Pa, 3.5 L/s at 2 100 pCi/L; rear wall 100 Pa, 9 L/s at 270 pCi/L; end wall 80 Pa, 8 L/s at 550 pCi/L. The highest concentration was found in the pipe by the fireplace. Smoke testing at that time indicated general suction at the open perimeter wall/floor joint.

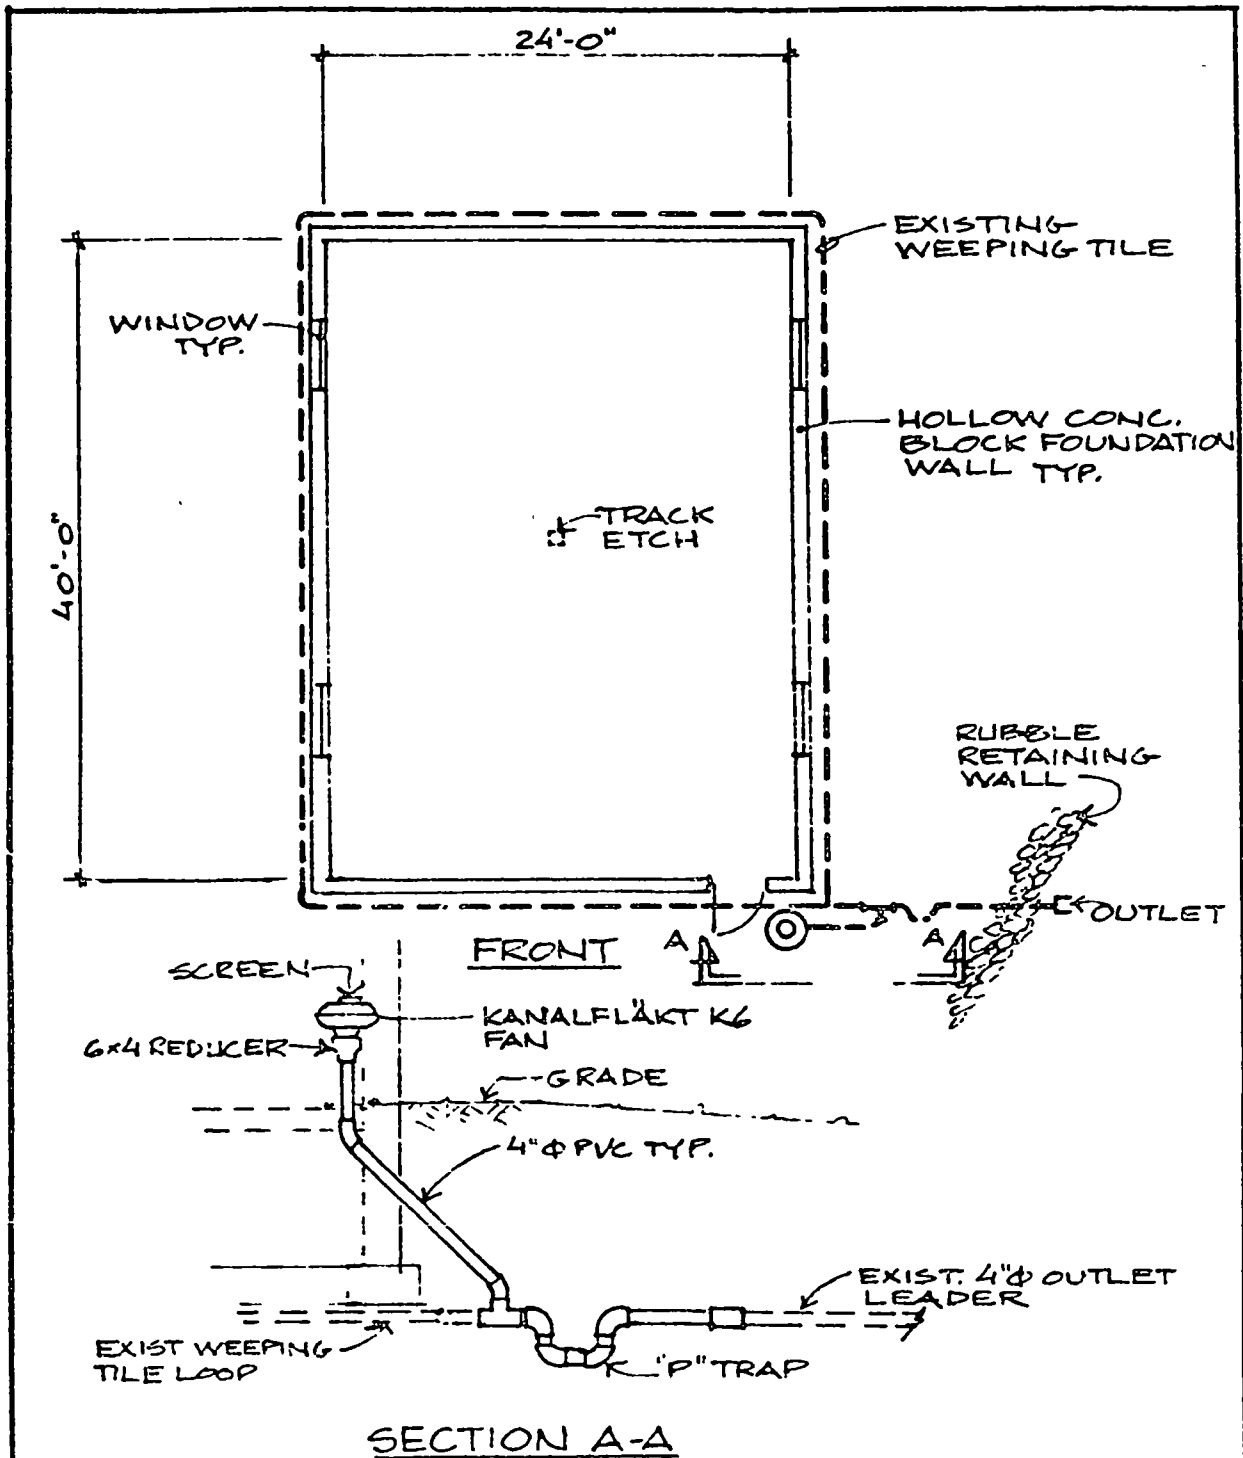
LOW COST REDUCTION OF INDOOR RADON		HOUSE NUMBER
	FOUNDATION PLAN		Date: DEC. 86
	Mitigation system: WEEPING TILE SUCTION	PHASE: FINAL	27

PHASE	MITIGATION SYSTEM	DATE	SYSTEM MEASUREMENTS			COMMENTS
			PRESSURE Pa	FLOW (L/s)	RADON (pCi/L)	
2	Drain tile ventilation; 50 L/s axial fan	04/86	35	27	800	In riser
3	Axial replaced by 150 L/s centrifugal	12/86	325	100	500	In riser

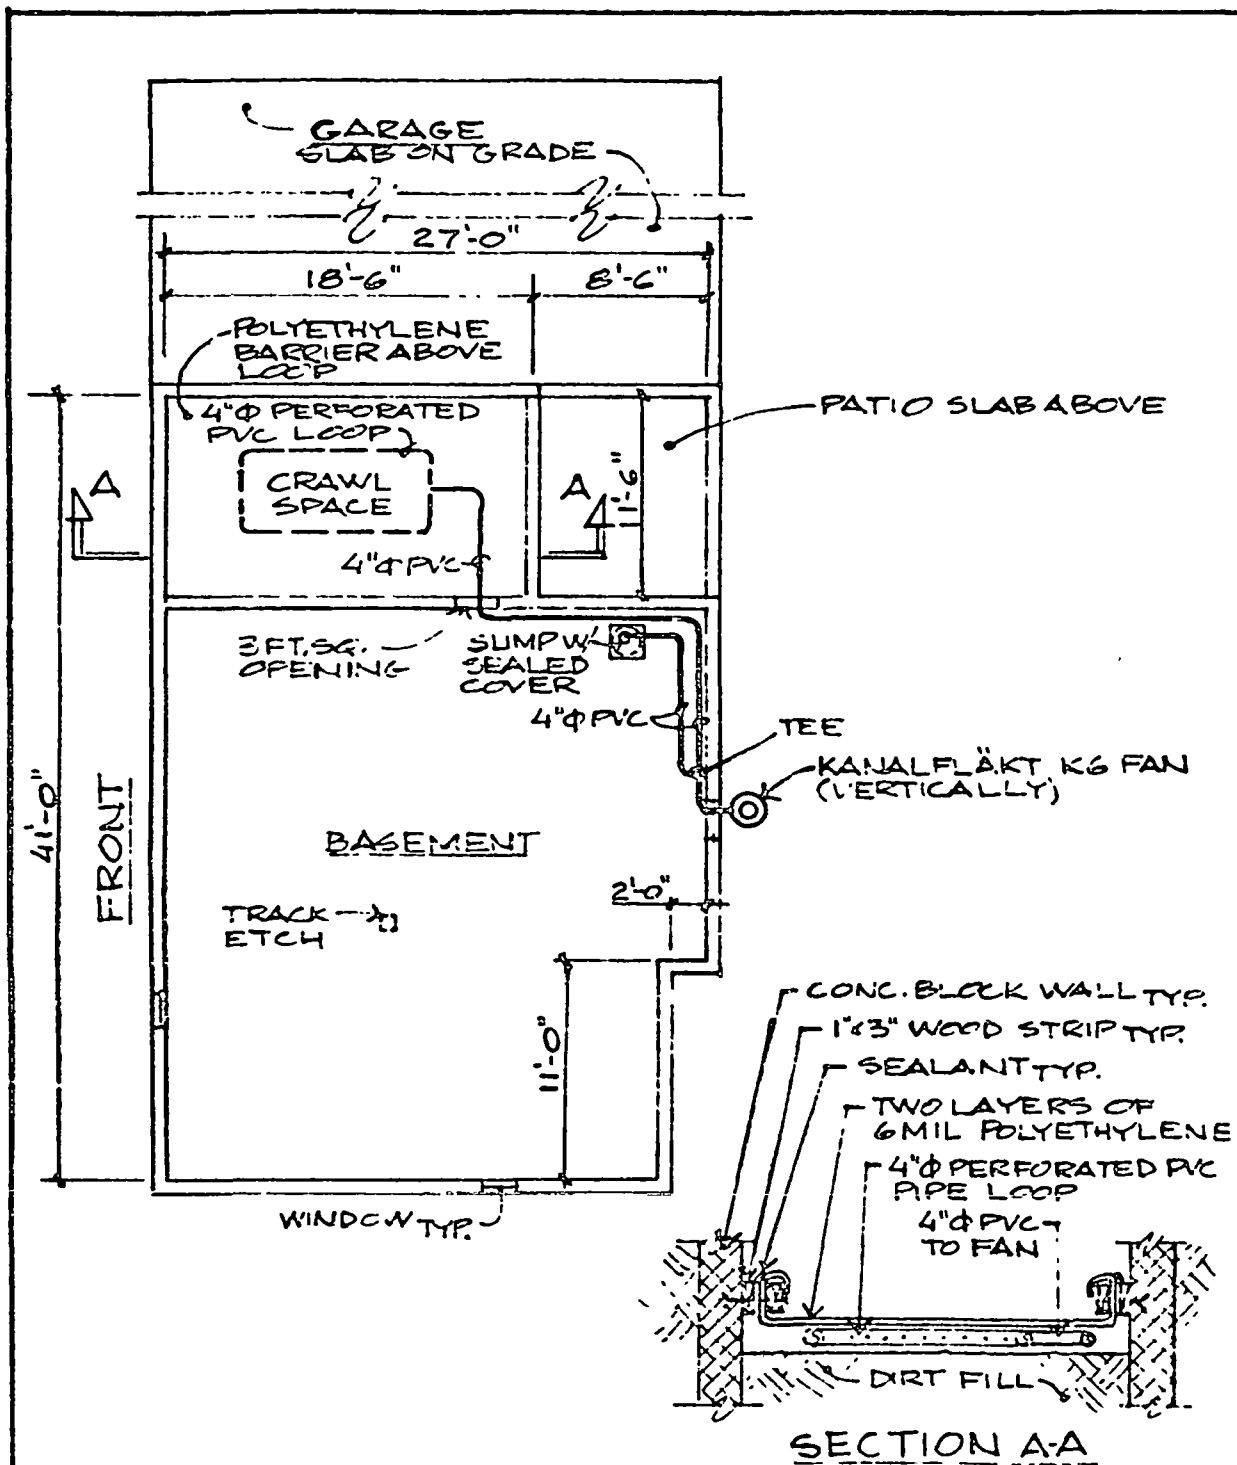
LOW COST REDUCTION OF INDOOR RADON		HOUSE NUMBER
	FOUNDATION PLAN		Date: JAN. 87
	Mitigation system: PERFORATED LOOP AND SUMP SUCTION		PHASE: FINAL

PHASE	MITIGATION SYSTEM	DATE	SYSTEM MEASUREMENTS			COMMENTS
			PRESSURE Pa	FLOW (L/s)	RADON (pCi/L)	
2	Sump +crawl-space ventilation; two 50 L/s axials on	01/86	60	8	1 000	Sump fan line
			20	25	10	Crawl-space line
					12	Basement air
					17	Floor drain
3	Lines teed; fans replaced by 150 L/s centrifugal	02/87	120	15	600	Sump line
			95	60	13	Crawl-space line

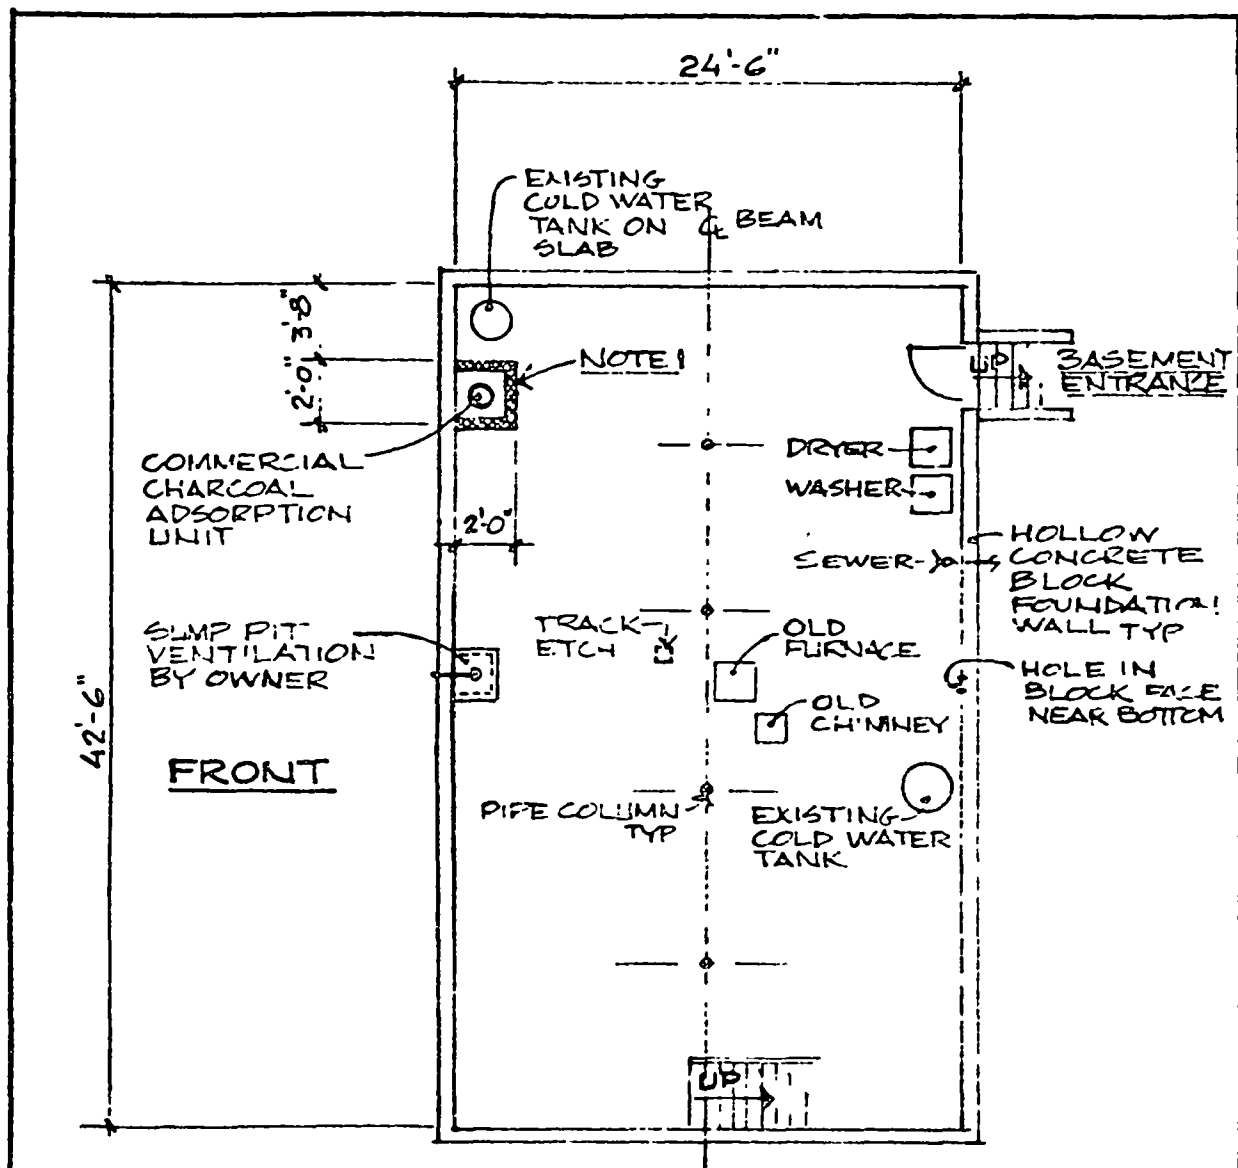
NOTES: 1. FOUR INCH NOMINAL HOLLOW CONCRETE MASONRY UNITS LAID AND MORTARED IN RUNNING BOND. MASONRY STRAP ANCHORS EVERY SECOND COURSE AT WALL JOINTS. COVER CONSISTS OF TWO INCH NOMINAL SOLID CONCRETE MASONRY UNITS OVER 1" WIDE STEEL BARS. VOID BETWEEN FILTER AND MASONRY FILLED WITH SAND.
