Evaluation of Ground-Water Extraction Remedies: Phase II

Volume 2 Case Studies and Updates

Volume 2 Case Studies

Office of Emergency and Remedial Response
U. S. Environmental Protection Agency
Washington, D.C.

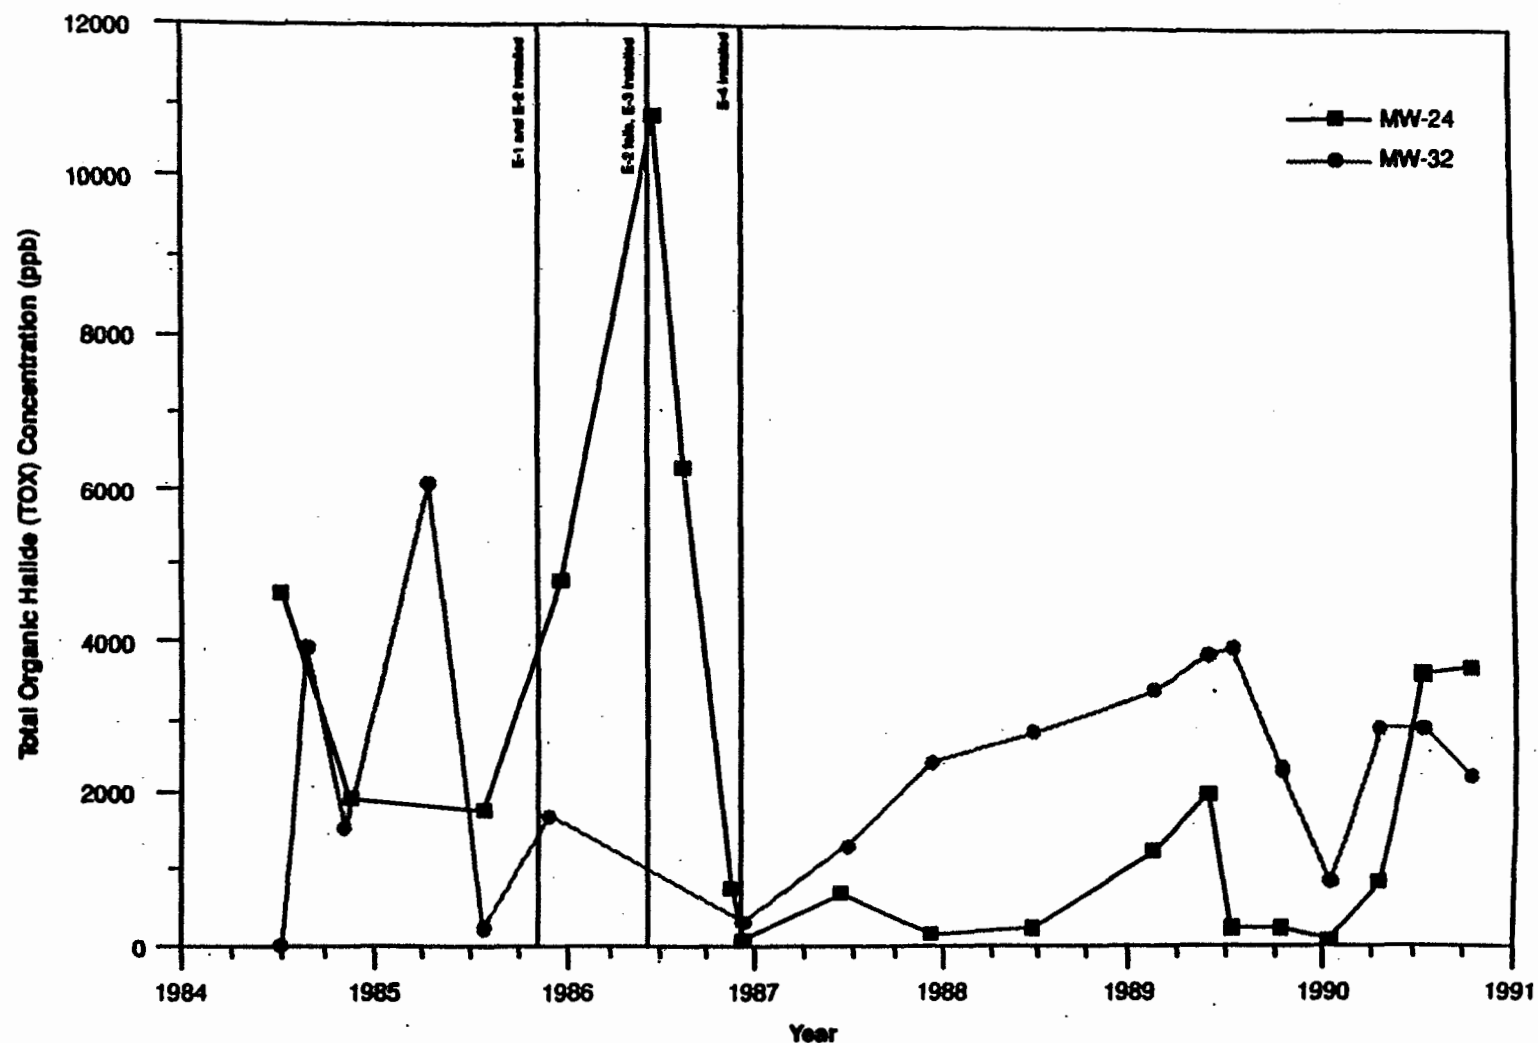
Figure 3
TOTAL ORGANIC HALIDE
CONCENTRATIONS FOR TWO WELLS
INSIDE THE PLUME
DU PONT - MOBILE SITE

Note: The two most recent data points were not validated.

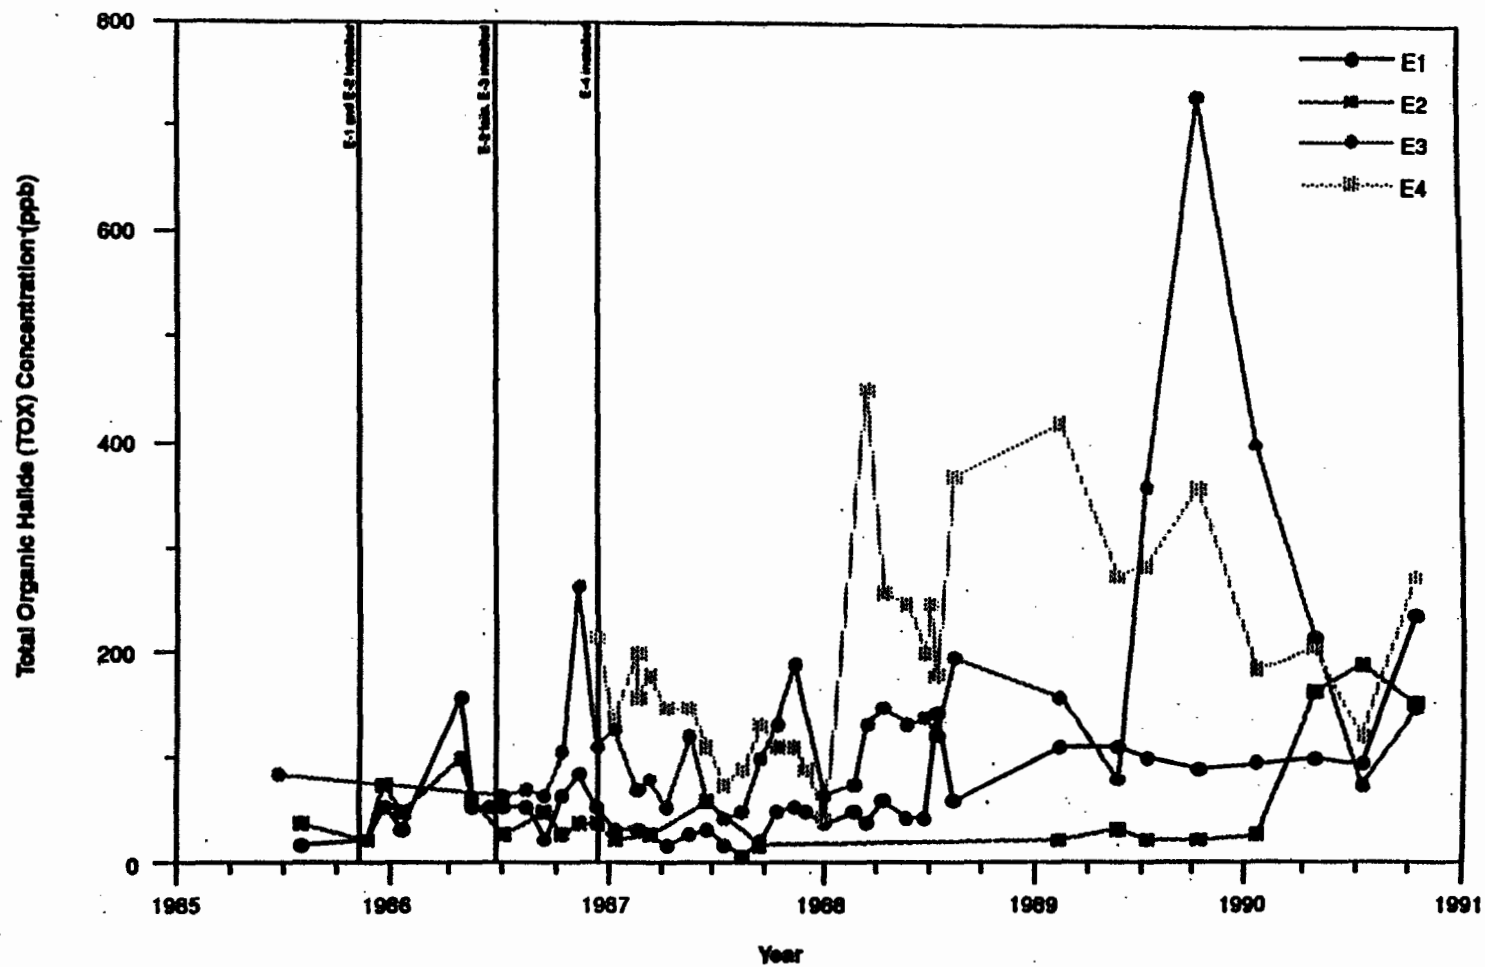
Figure 4
TOTAL ORGANIC HALIDE
CONCENTRATIONS FOR FOUR
EXTRACTION WELLS
DU PONT - MOBILE SITE

Note: The two most recent data points were not validated.

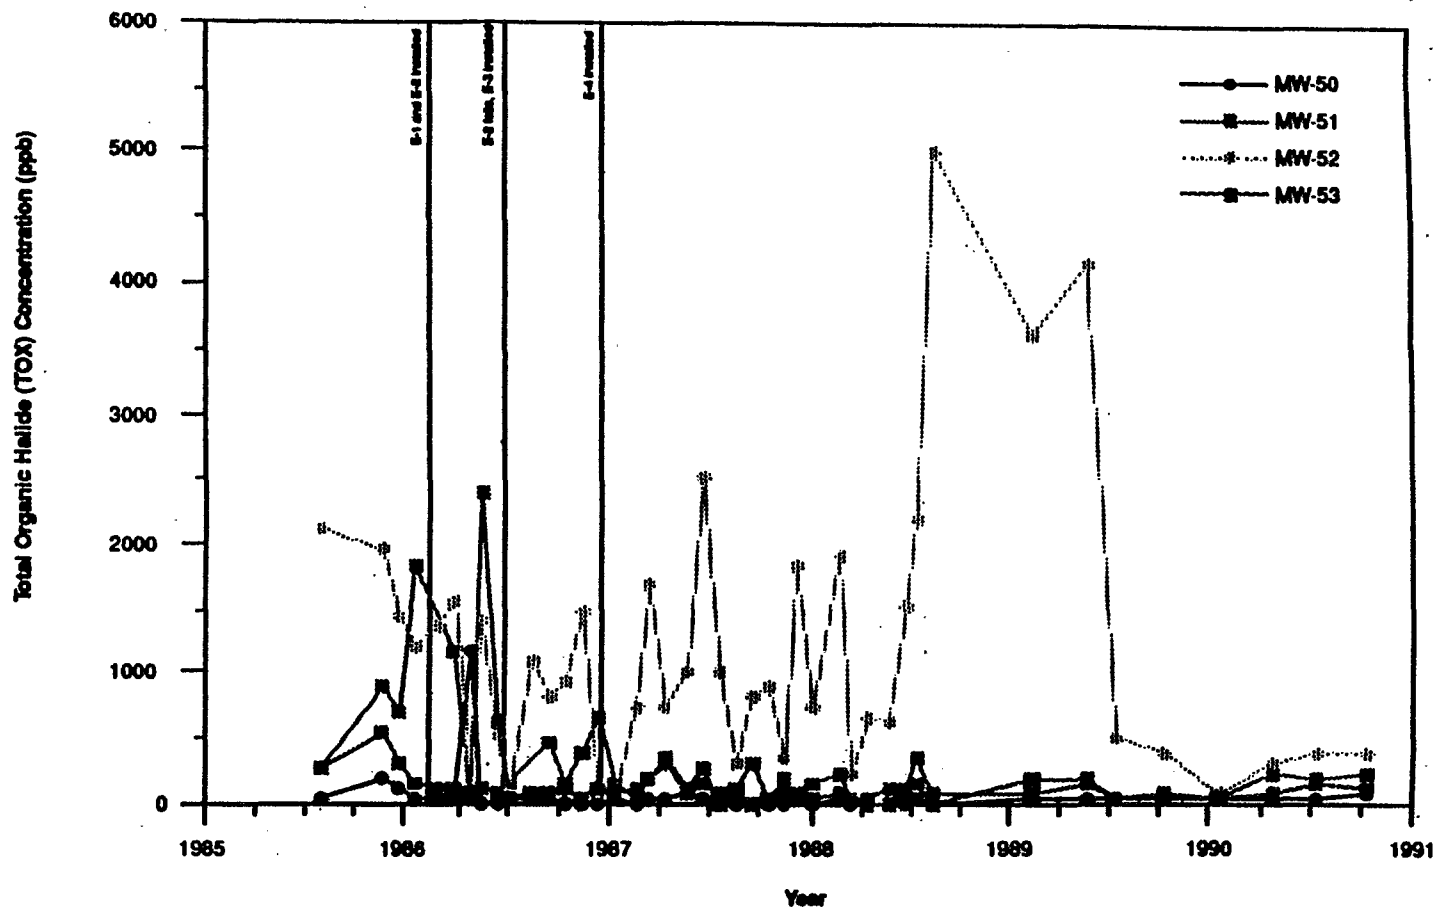
Figure 5
TOTAL ORGANIC HALIDE CONCENTRATIONS
FOR FOUR MONITORING WELLS UPGRADIENT
FROM EXTRACTION WELLS
DU PONT - MOBILE SITE

Note The two most recent data points were not validated.

Figure 5 shows the measured TOX concentrations in the monitoring wells MW-50, MW-51, MW-52, and MW-53, located north of the line of extraction wells. Elevated concentrations of halogenated organic substances were measured in these wells, with the greatest levels found in MW-51 and MW-52. The detection of organics in these wells indicates that contaminants have moved north of the line of extraction wells at the site boundary. However, these contaminants may still be within the capture zone of the extraction wells. Because of the lack of water-level information to the north of this area, the extent of the capture zone cannot be accurately determined.

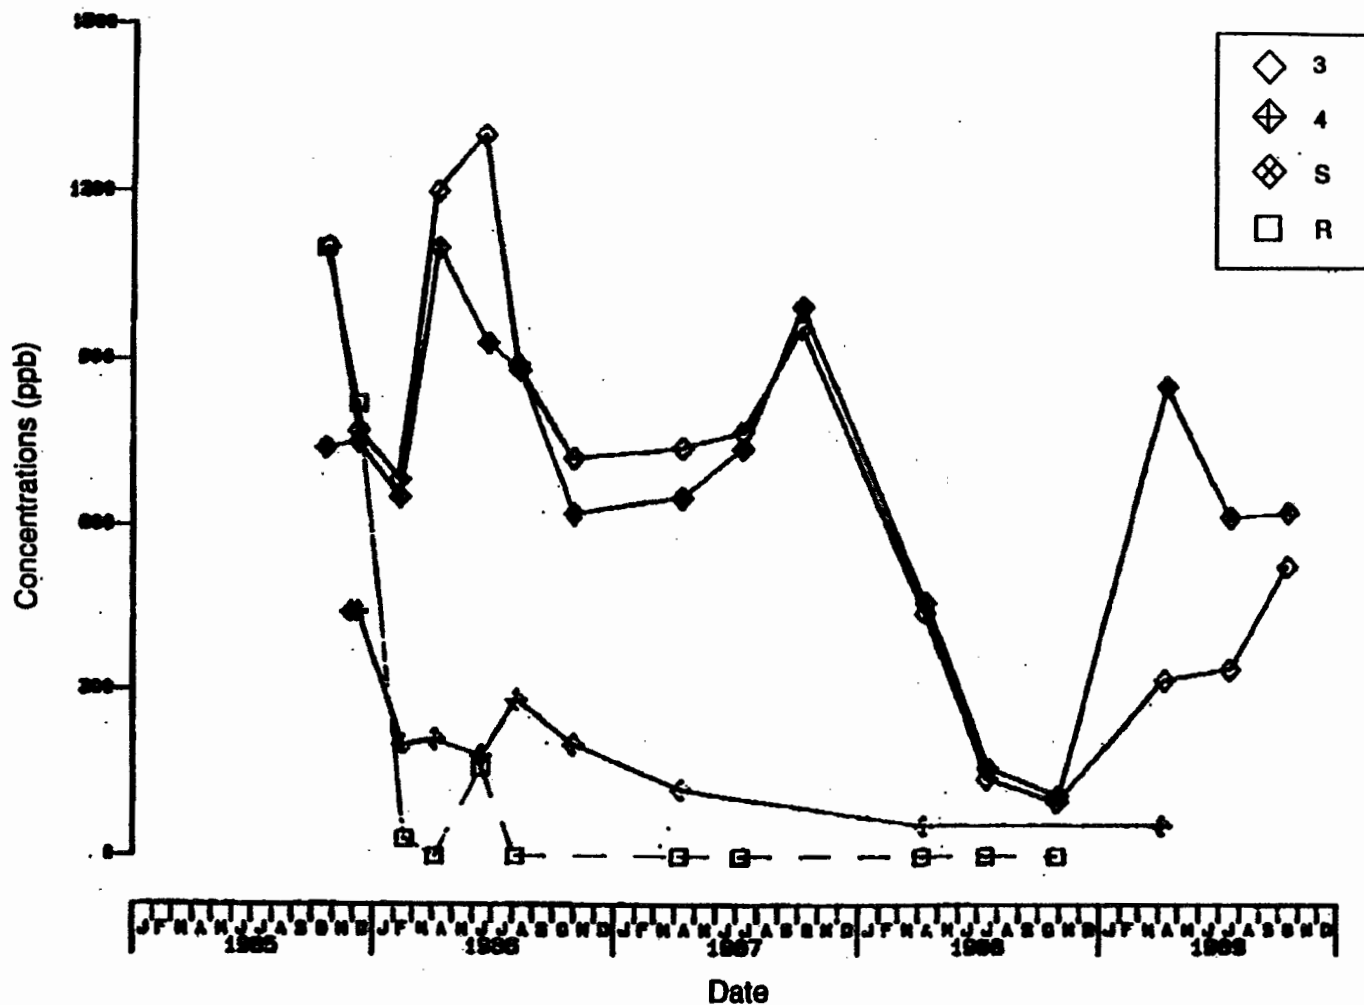
Figure 5
HISTORY OF TCE CONCENTRATION VARIATIONS IN
SHALLOW AQUIFER WELLS 3,4,S AND R
GENERAL MILLS SITE

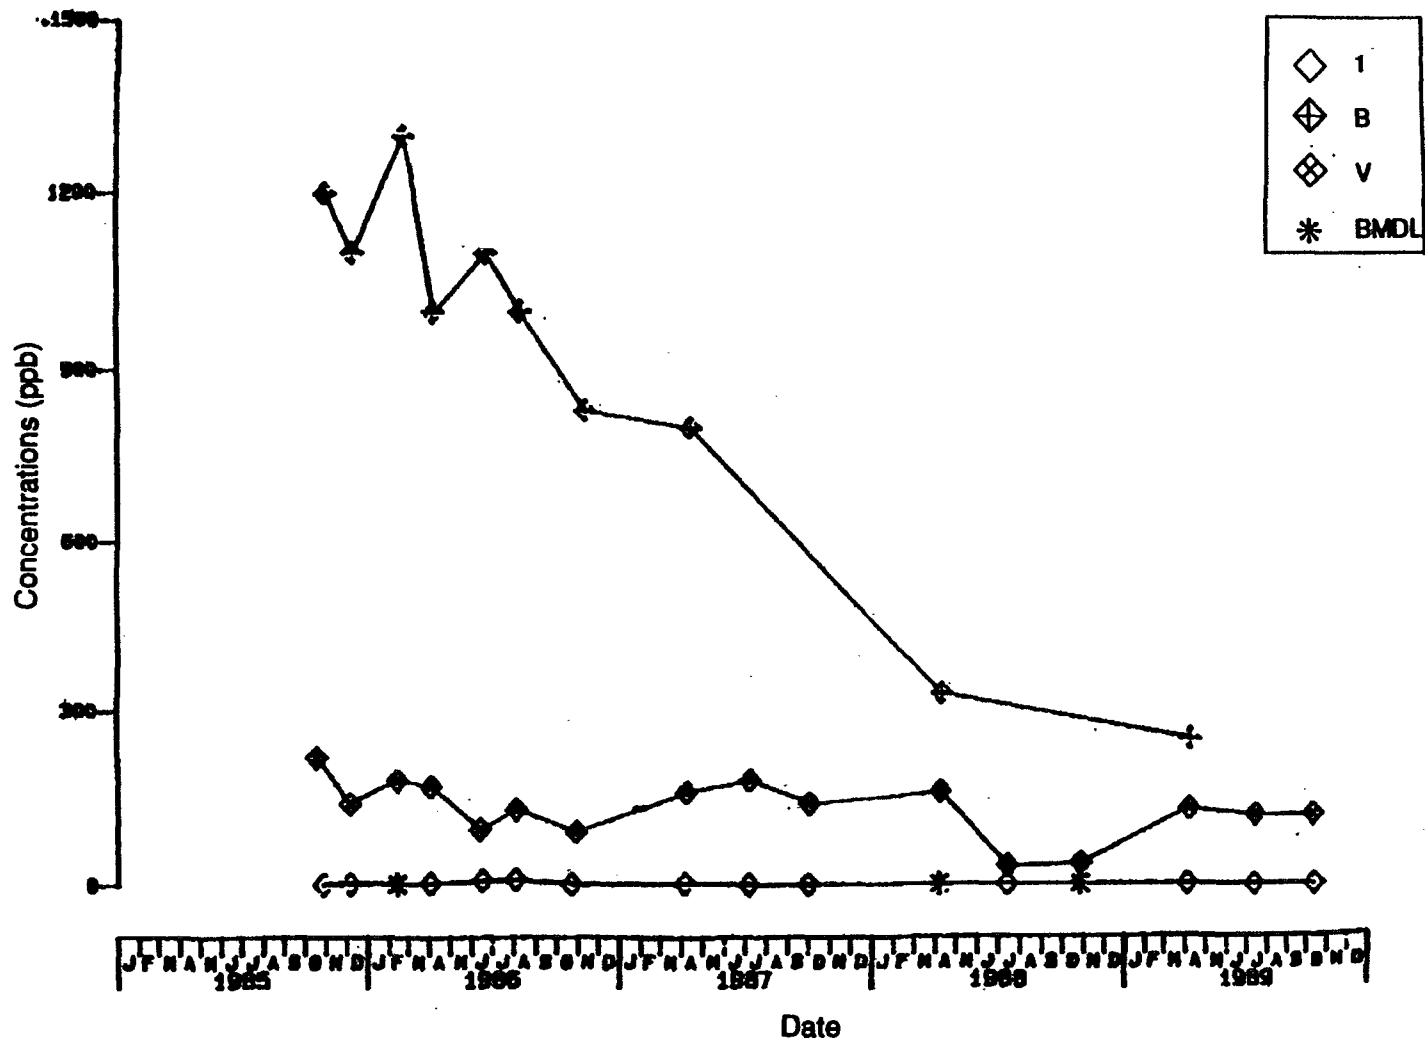
Figure 6
HISTORY OF TCE CONCENTRATION VARIATIONS
IN SHALLOW AQUIFER WELLS 1, B, AND V.
GENERAL MILLS SITE

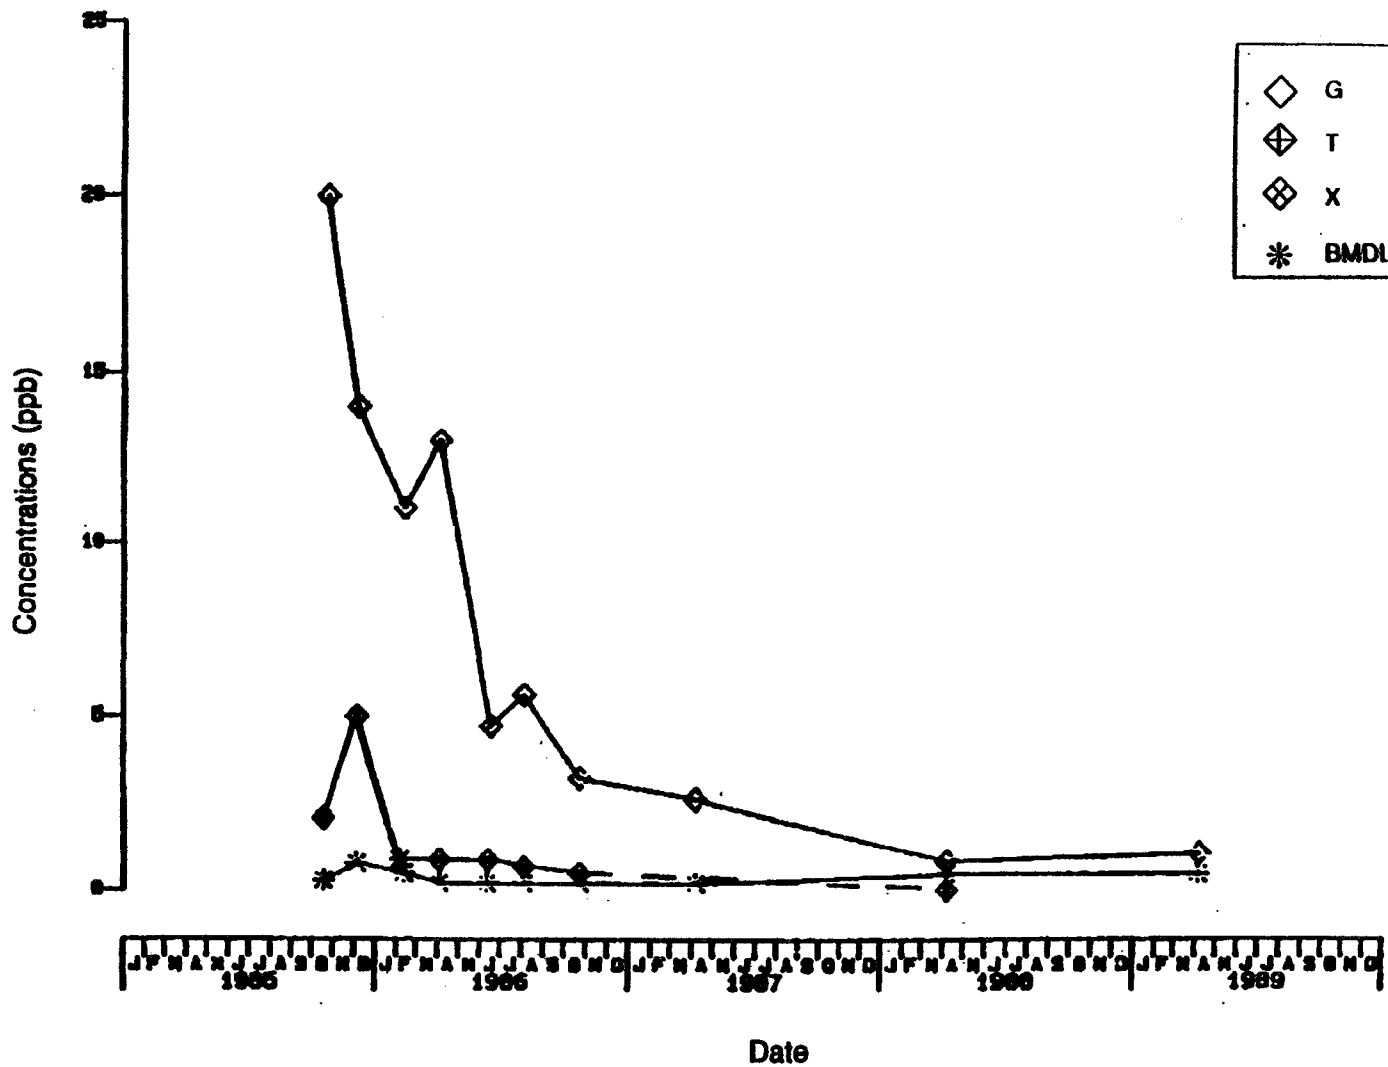
FIGURE 7
HISTORY OF TCE CONCENTRATION VARIATIONS
IN SHALLOW AQUIFER WELLS G, T, AND X.
GENERAL MILLS SITE

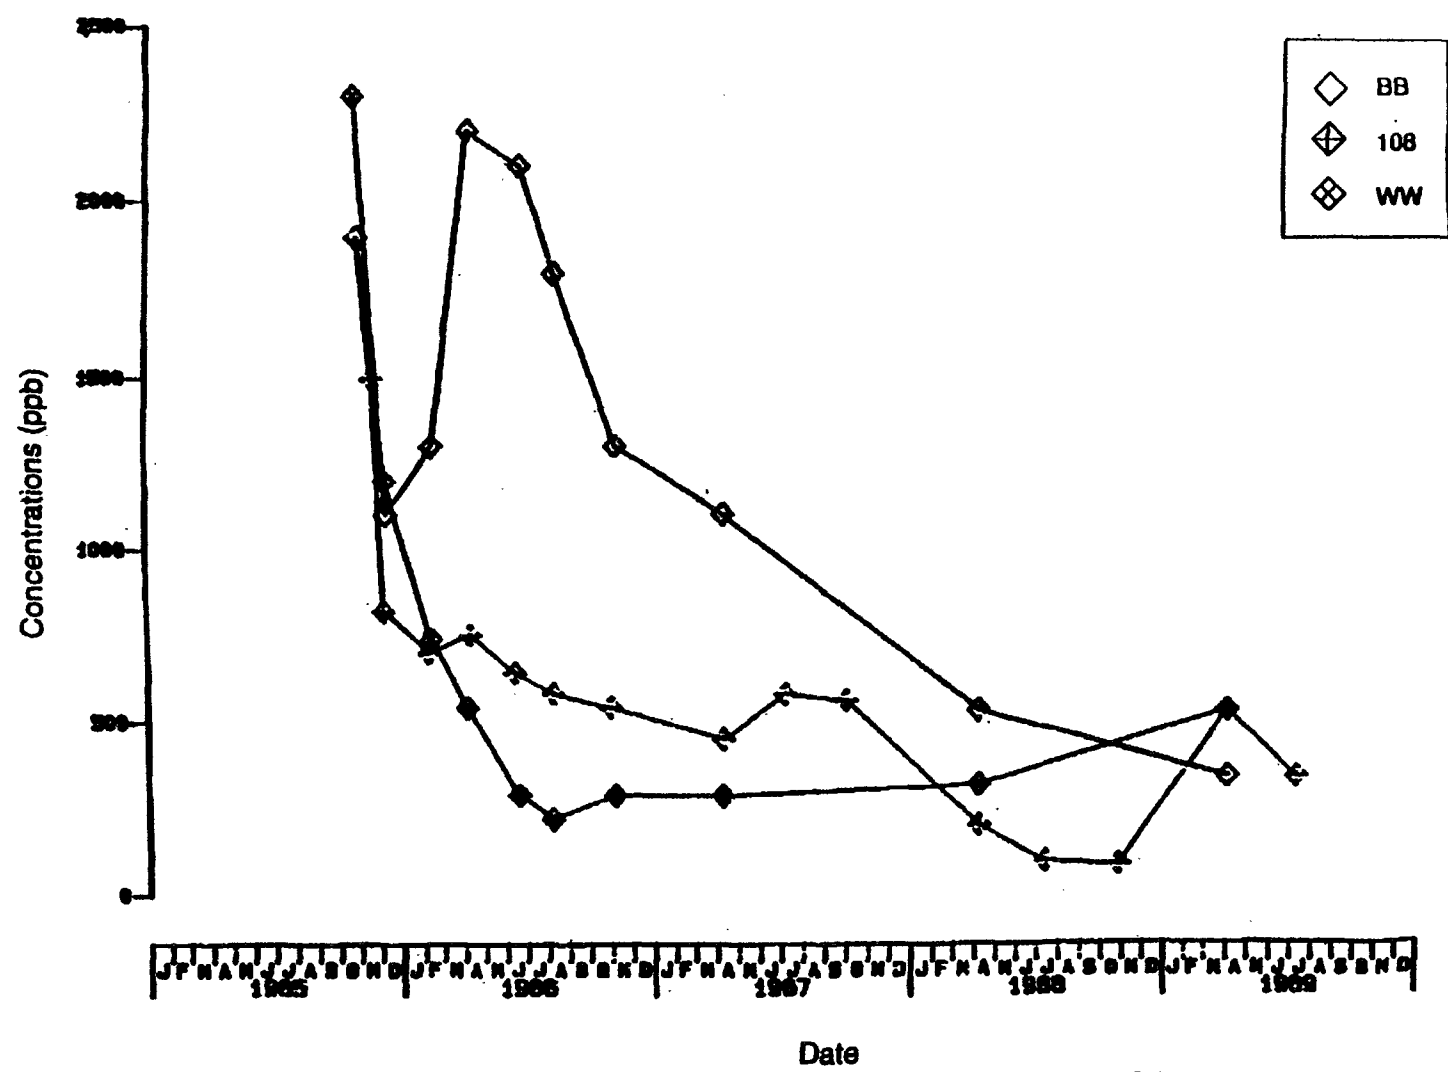
FIGURE 8
HISTORY OF TCE CONCENTRATION
VARIATIONS IN CARIMONA MEMBER
WELLS BB, 108, AND WW.
GENERAL MILLS SITE

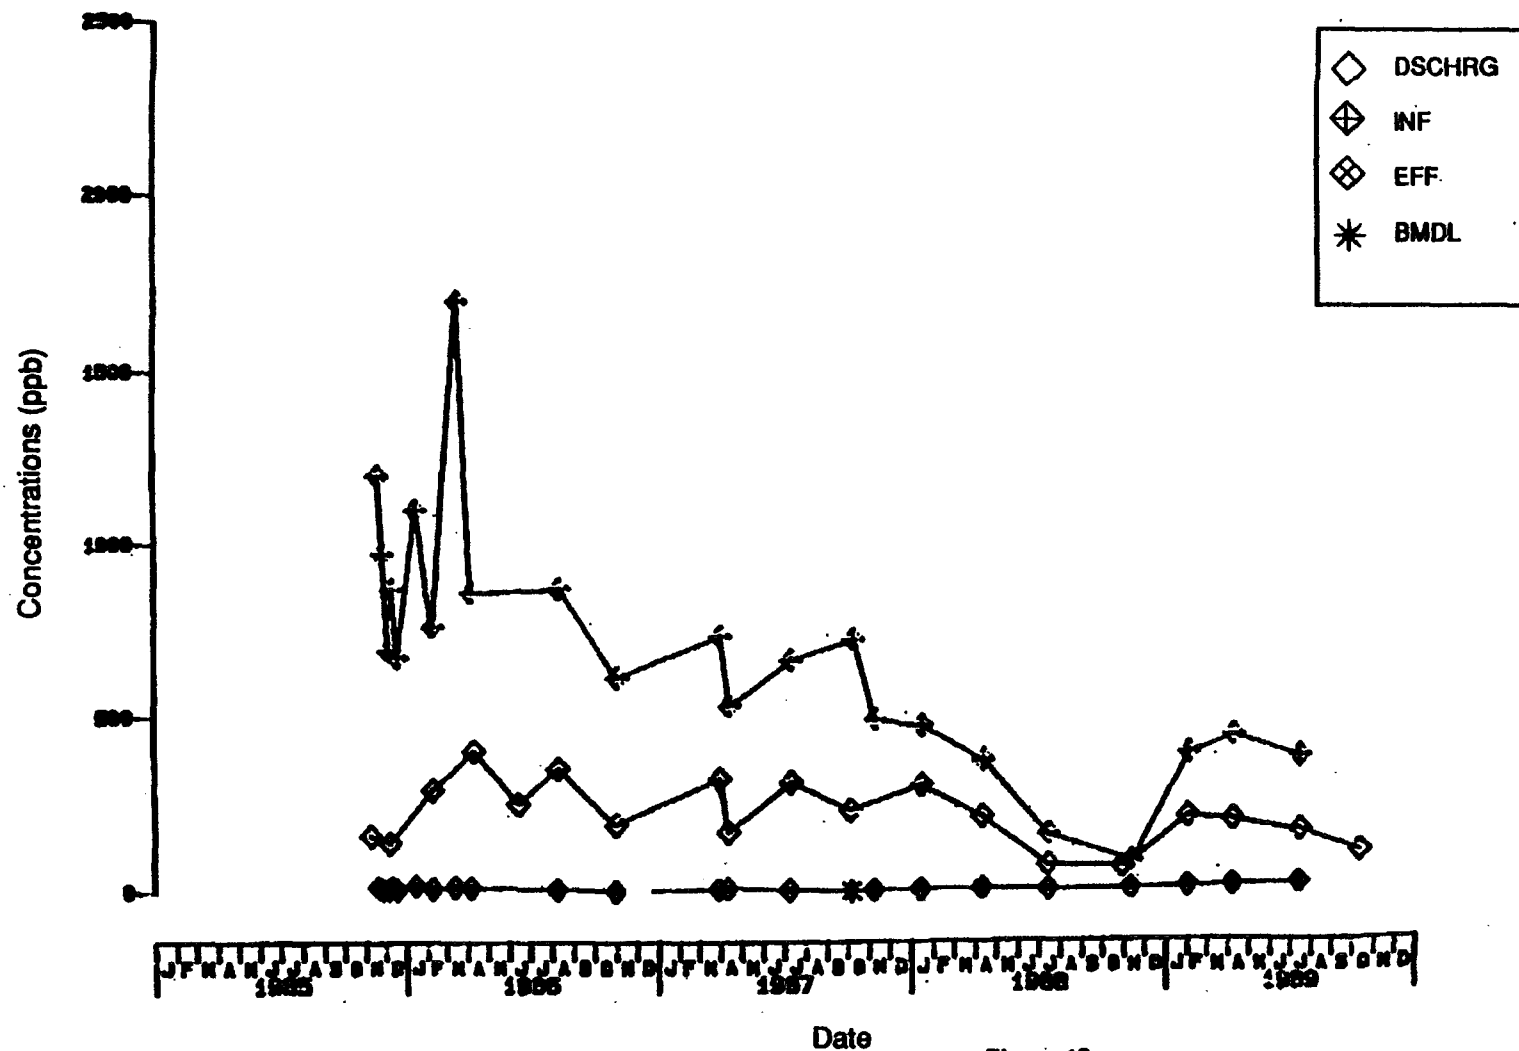
Figure 10
HISTORY OF TCE CONCENTRATION VARIATIONS IN
THE SOURCE-AREA TREATMENT SYSTEM INFLUENT
AND EFFLUENT
GENERAL MILLS SITE

Table 3 lists the TCE concentrations detected in 1989 and early 1990 in the influent to effluent from the source-area treatment system. These data show that influent concentrations were stable during this period, except for December 1989 when influent levels decreased to below effluent levels (General Mills, 1991). In the first three quarters of 1989, the effluent released after treatment by air stripping was consistently below 27 ppb, a 96 percent average treatment efficiency for total VOCs. Due to electrical and mechanical failures in the Well 108 (Carimona Member) pump, system operators recorded 46 days of downtime in the last 3 months of 1989. Total VOC levels in the effluent rose from 20 ppb in the third quarter to 200 ppb in the fourth quarter. Additional sampling in January 1990 revealed 96 ppb TCE, which is still above the NPDES

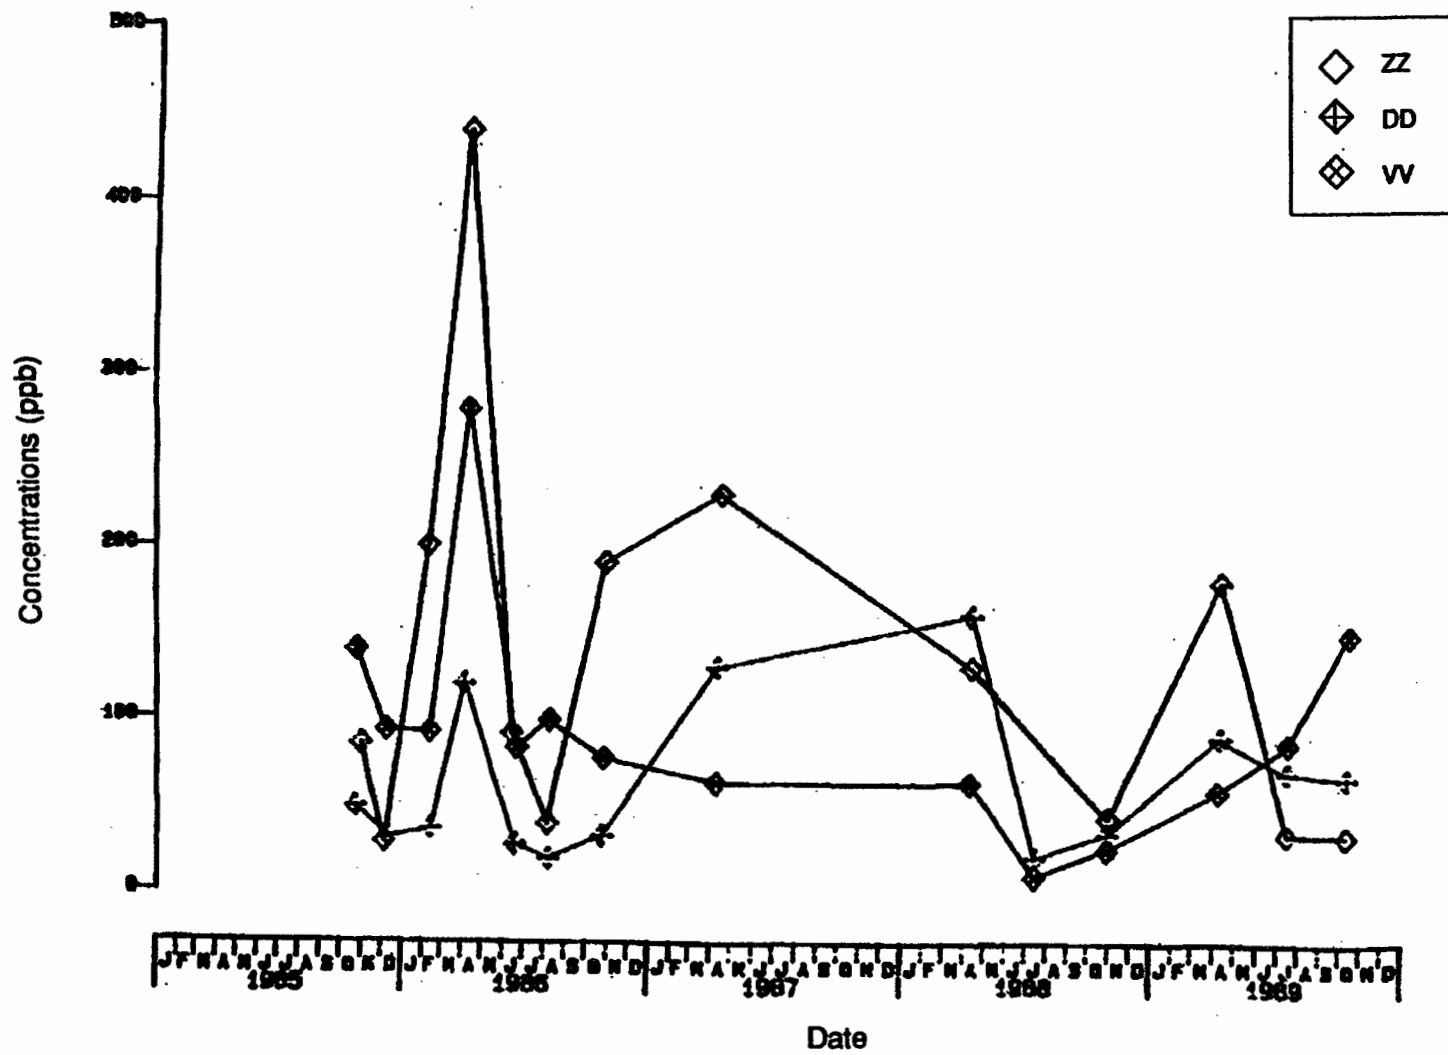
Figure 11
HISTORY OF TCE CONCENTRATION
VARIATIONS IN THE MAGNOLIA WELLS
ZZ, DD, AND VV
GENERAL MILLS SITE

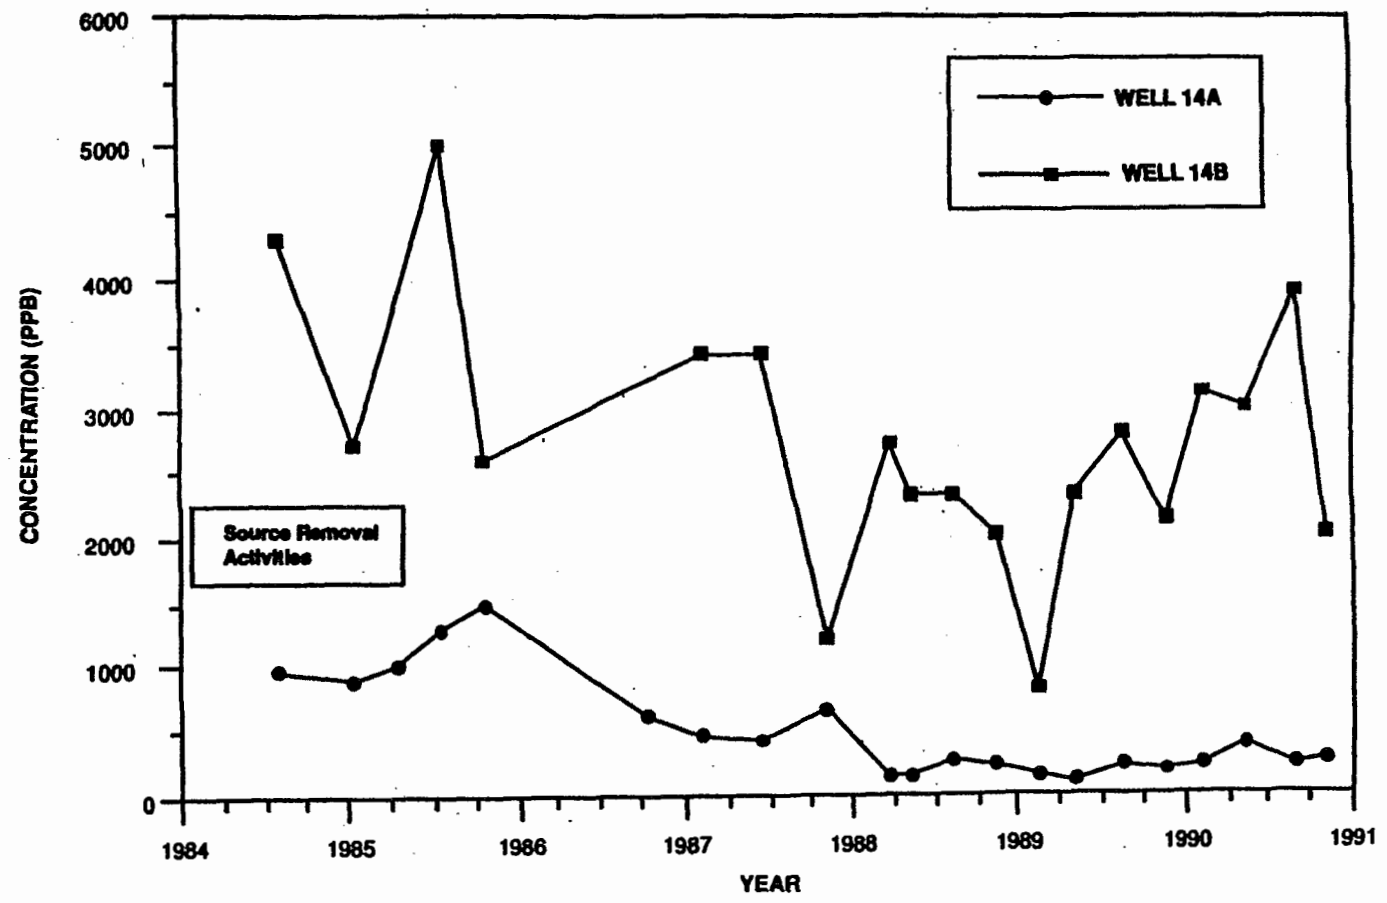
Figure 6
CONCENTRATION OF TCE IN G-III-14A
AND G-III-14B (NORTH PLUME)
GENRAD SITE

Figure 6 shows the concentration of TCE in north plume wells G-III-14A and G-III-14B from mid-1984 through November 1990. This well pair is located on the south bank of Great Brook near bedrock well G-VI-2 at the downgradient eastern tip of the 500-ppb plume. The figure shows that the concentration of TCE in shallow well G-III-14A decreased steadily from the time of source removal in 1984 through early 1988, and then remained steady from early 1988 through late 1990. The overall decrease may be due to the relatively efficient discharge of the shallow ground water to Great Brook.

Figure 6 also shows that the concentration of TCE in deep well G-III-14B decreased from 1984 to early 1989, and then increased from early 1989 through late 1990. This later increase may be due to the migration of the highly contaminated center of the plume toward Great Brook. The increases seen in the spring sampling periods in 1988, 1989,

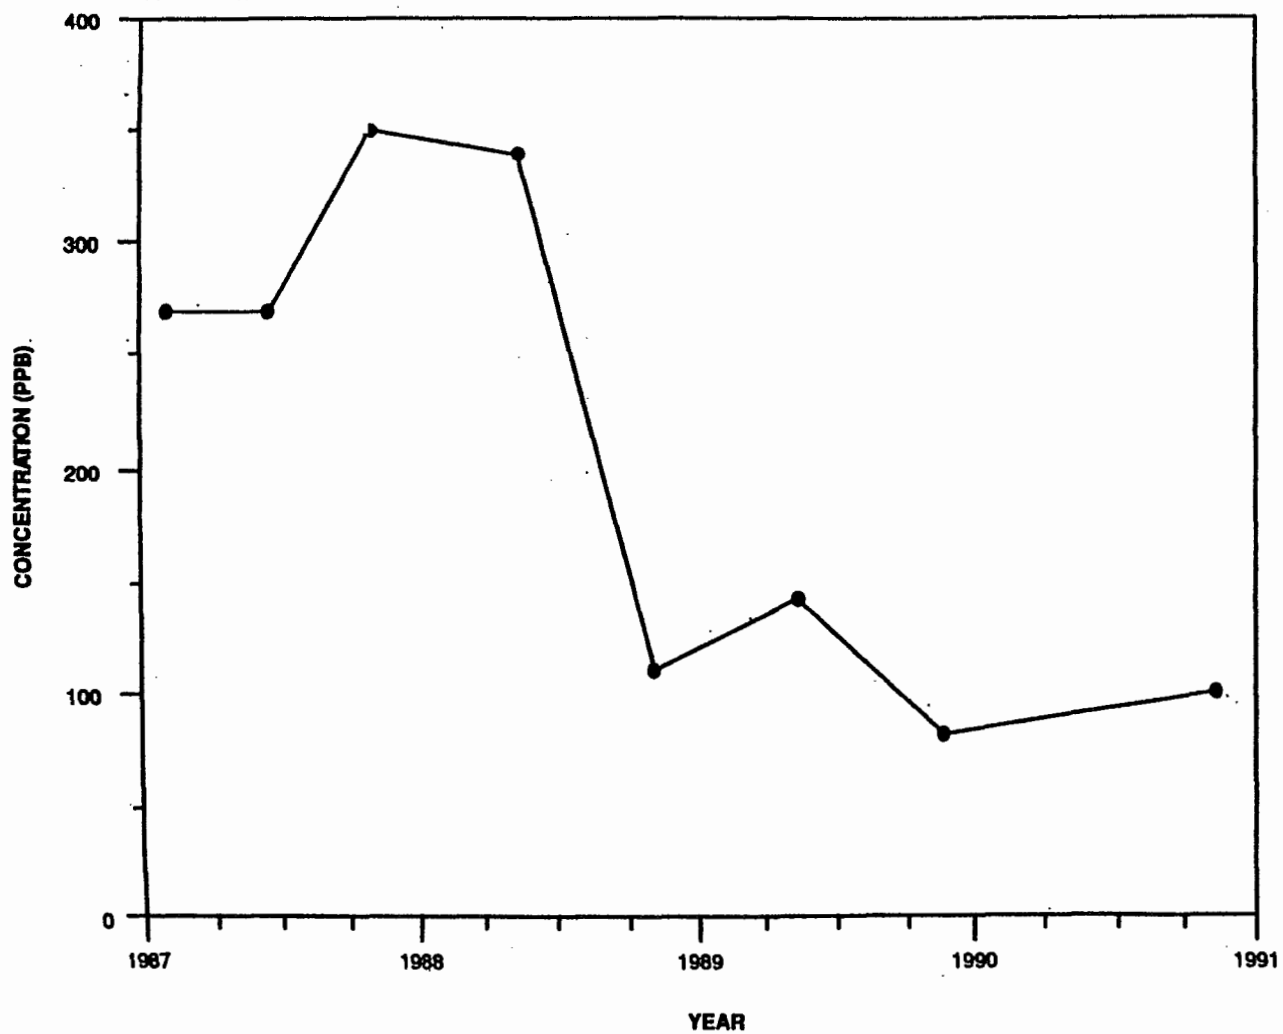
Figure 7
CONCENTRATION OF TCE IN PT-4 (EAST PLUME)
GENRAD SITE

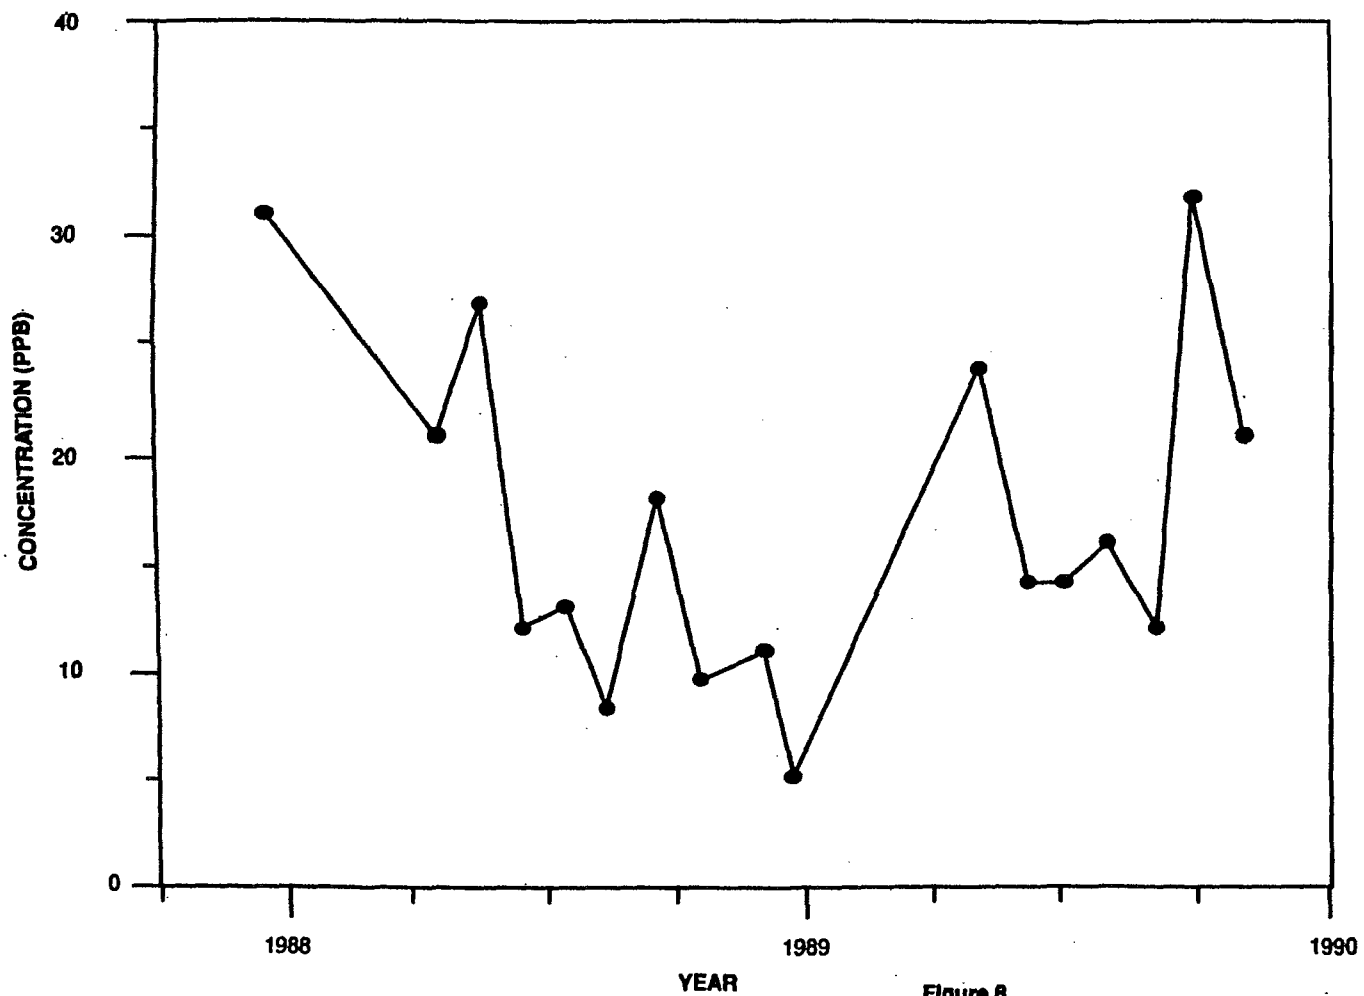
Figure 8
CONCENTRATION OF TCE IN THE INFLUENT TO
THE AIR STRIPPER
GENRAD SITE

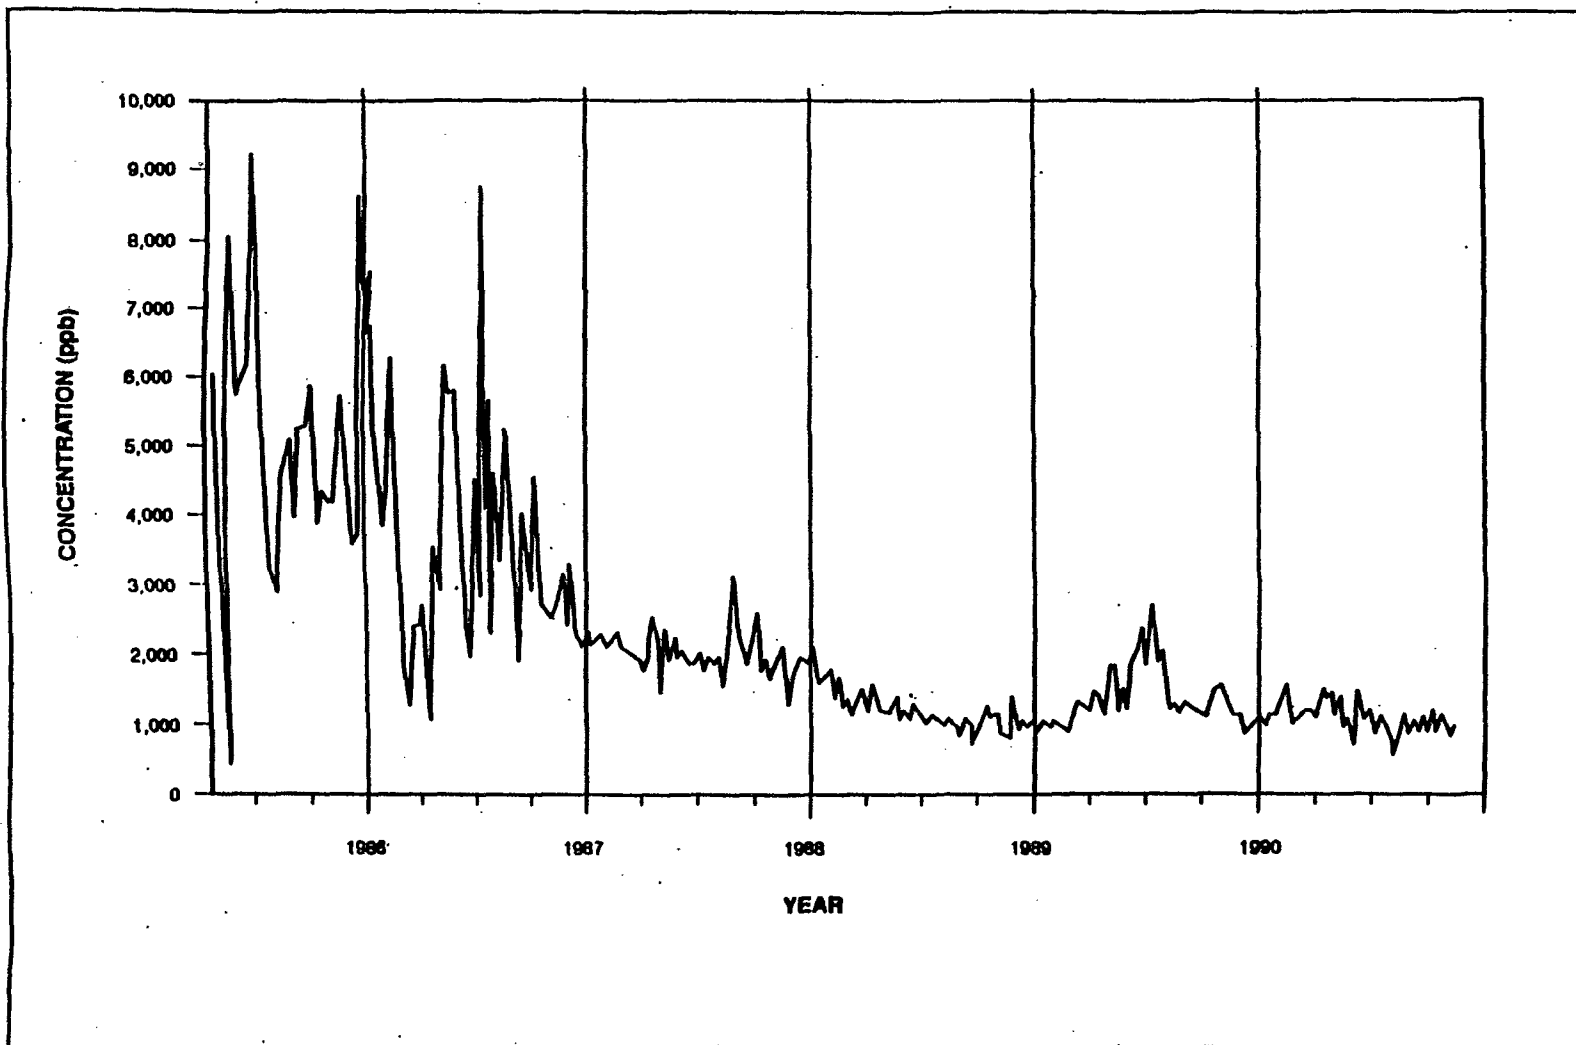
Figure 5
CONCENTRATIONS OF TOTAL VOCs IN THE INFLUENT
TO THE HARRIS SOUTH CAMPUS AIR STRIPPER
HARRIS CORPORATION SITE

Figure 5 is a time series plot of the concentrations of total VOCs in the influent to the Harris south campus air stripper from early May 1985 through October 1990. These data show a significant decrease in total VOC concentrations from 1985 to the end of 1988. Concentrations from early 1988 through late 1990 were essentially stable except for a concentration peak in mid-1989. Approximately 80 percent of the increase in total VOC loading in mid-1989 can be attributed to the central control wells (GS-37S, GS-37D, GS-43S, and GS-43D) but some increased loading was also observed in the barrier wells (Geraghty & Miller, November 30, 1989). This increase may have been caused by system shutdowns for a combined total of 2 1/2 months in March, April, and May 1989. The fact that little actual downgradient plume migration has occurred since startup, as shown by comparison of early plume maps (not shown) with Figures 3 and 4, suggests that the increase was not due to plume migration during shutdown. The repair of the pump in GS-43D in May 1989, after a period of minimal pumping of the highly contaminated central plume area, may have contributed to the increase.

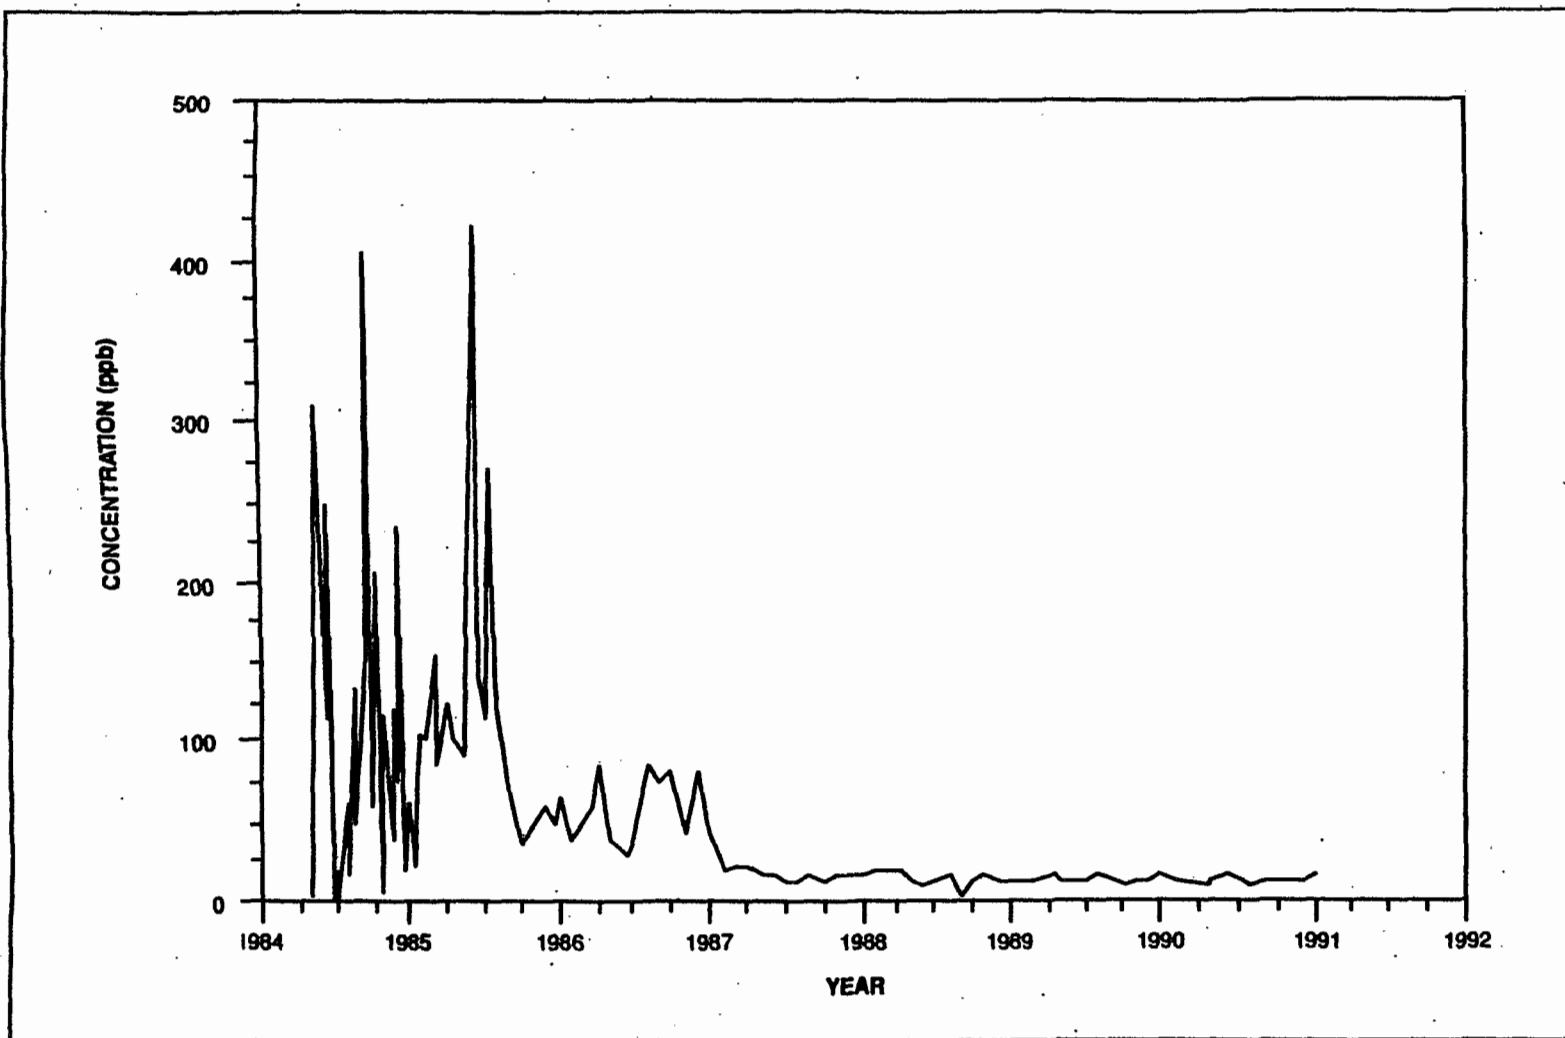
Figure 6
CONCENTRATIONS OF TOTAL VOCs IN THE INFLUENT
TO THE GDU AIR STRIPPER
HARRIS CORPORATION SITE
