Evaluation of Ground-Water Extraction Remedies: Phase II

Volume 2 Case Studies and Updates

Volume 2 Case Studies

Office of Emergency and Remedial Response
U. S. Environmental Protection Agency
Washington, D.C.

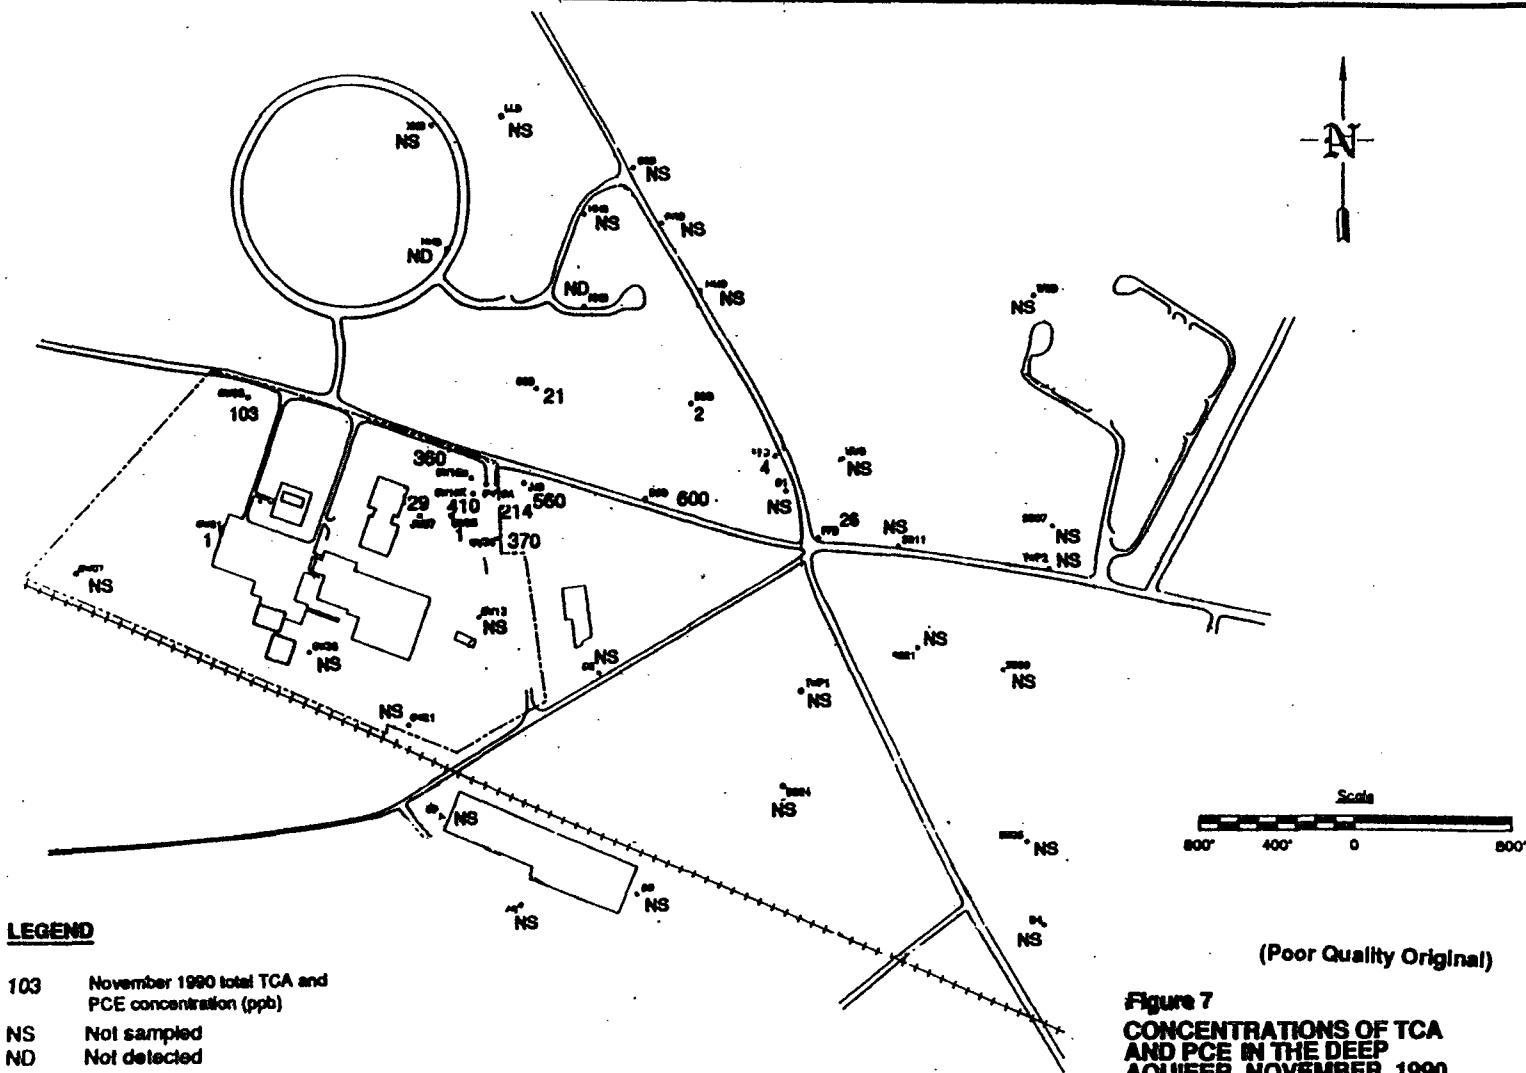
Figure 7
CONCENTRATIONS OF TCA
AND PCE IN THE DEEP
AQUIFER, NOVEMBER 1990
IBM-DAYTON SITE

Figures 6 and 7 show the areal distribution of the summed TCA and PCE concentrations measured in the two aquifers in November 1990, shortly after the migration-control system began operating. The summed concentrations are not

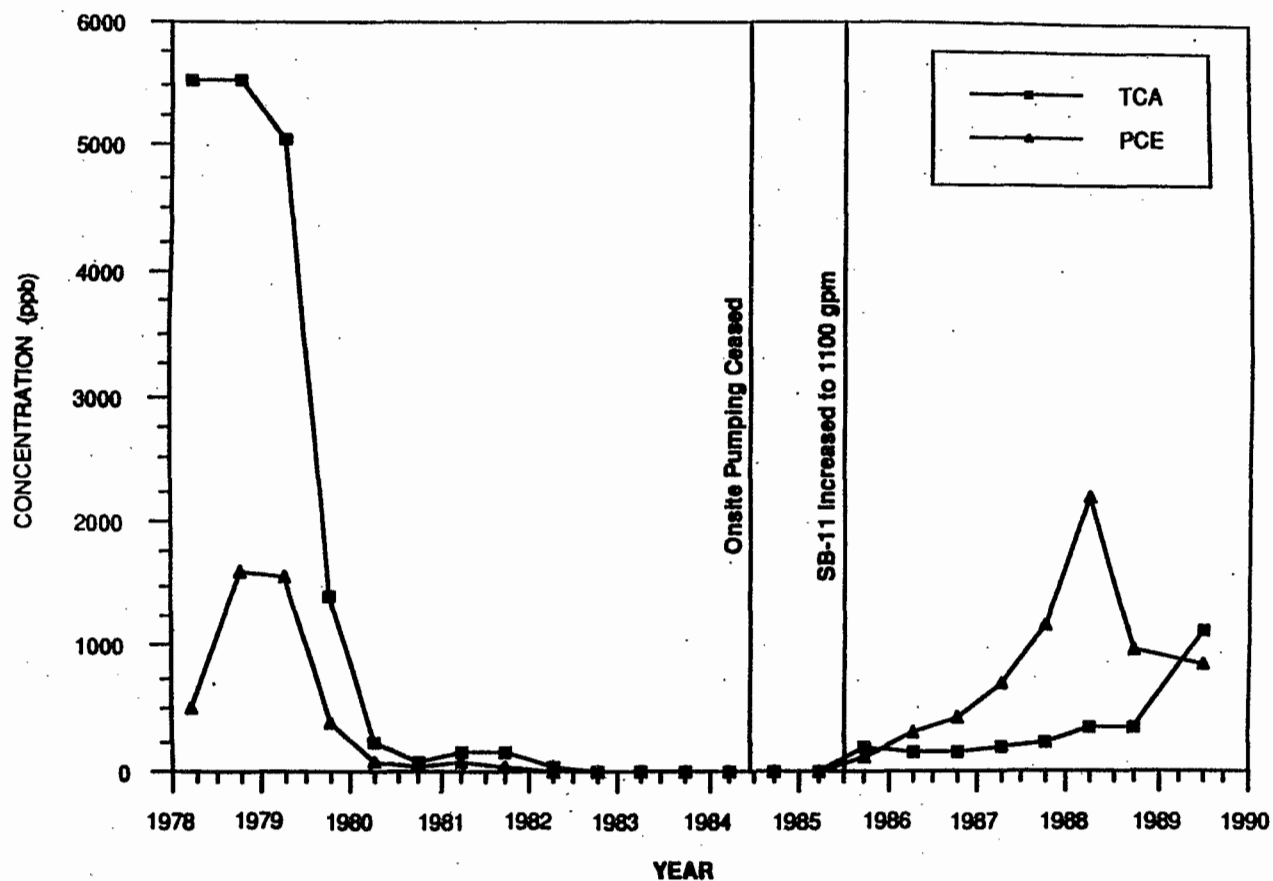
Data reported as 6-month average concentrations in ppb.
Data compiled from various sources.

Figure 8
HISTORY OF TCA AND PCE
VARIATIONS IN EXTRACTION
WELL GW-16B
IBM-DAYTON SITE

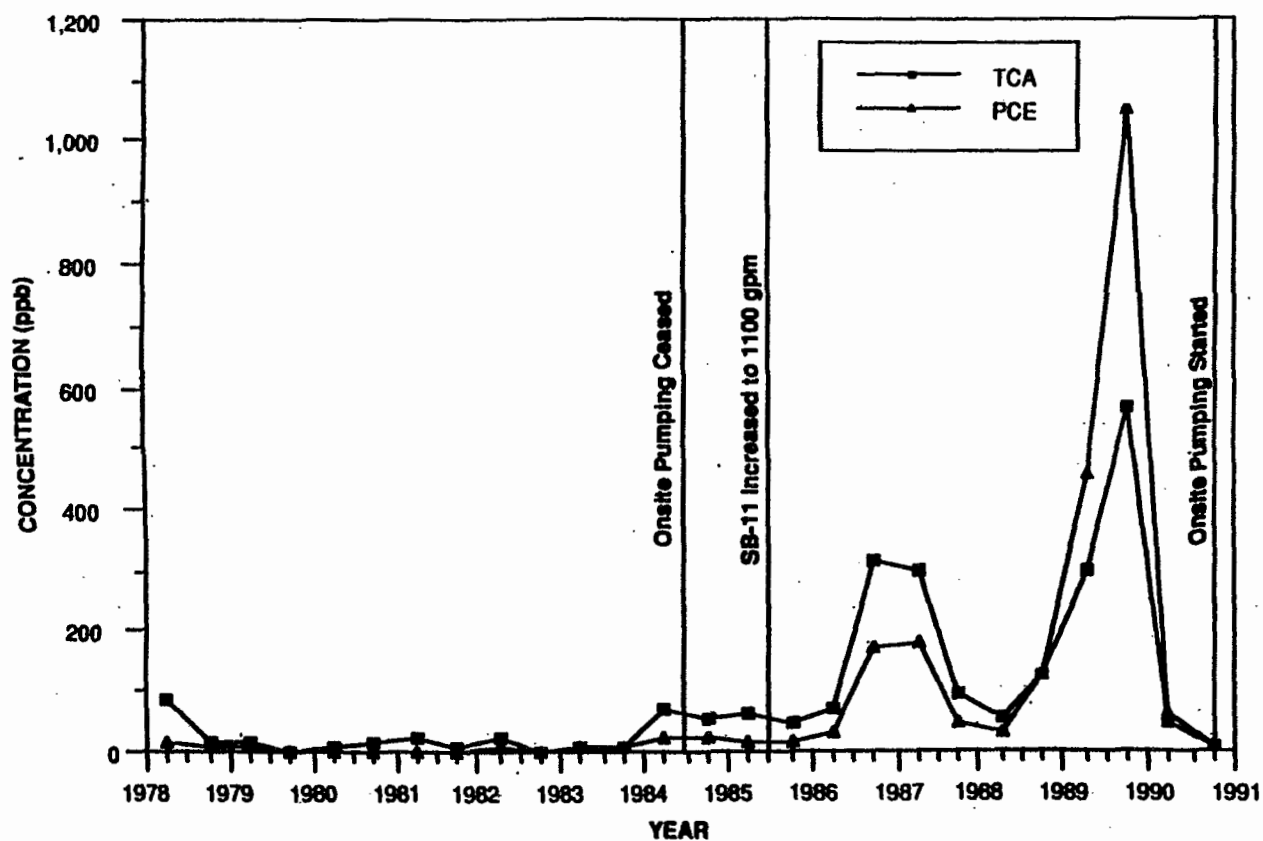
Data reported as 6-month average
concentrations in ppb
Data compiled from various sources

Figure 9:
HISTORY OF TCA AND PCE
VARIATIONS IN MONITORING
WELL GW-25
IBM-DAYTON SITE

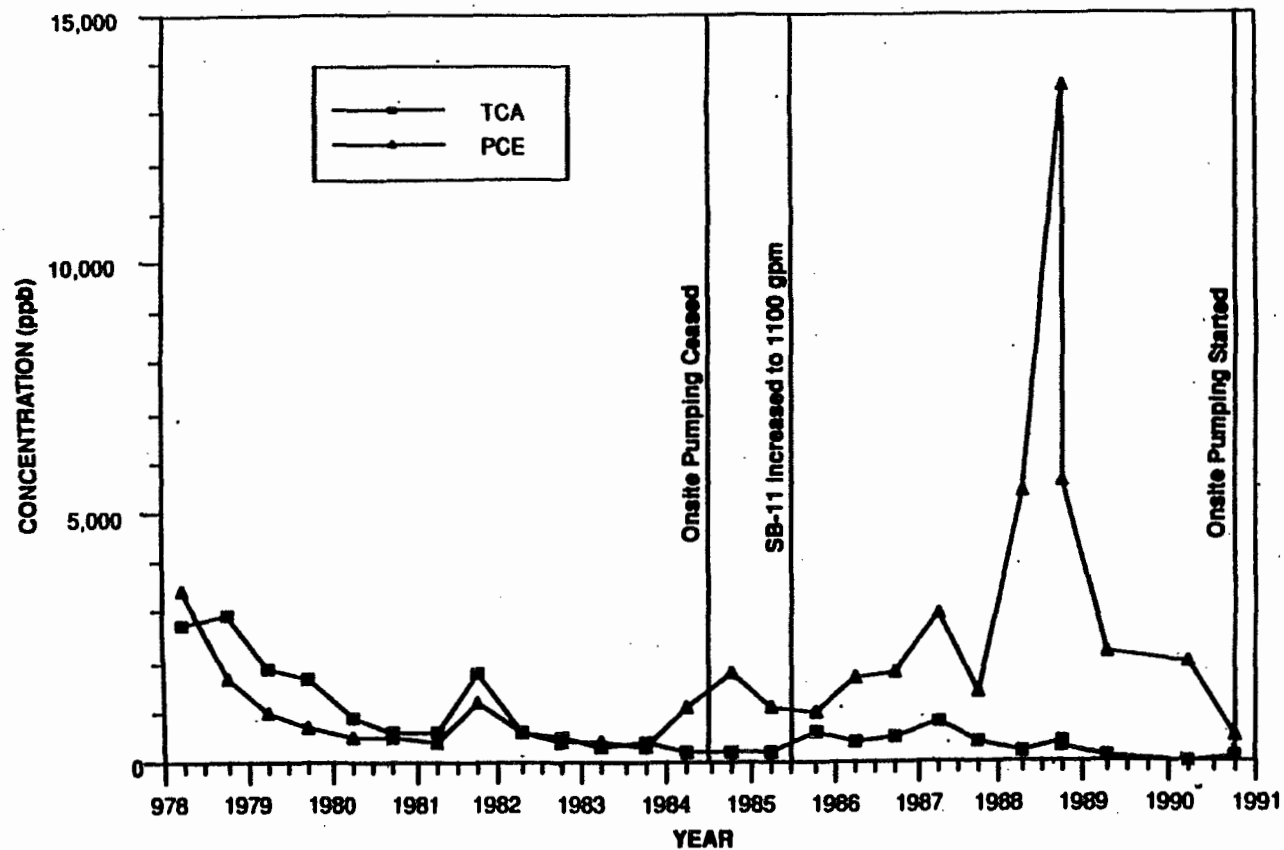
Data reported as 6-month average
concentrations in ppb.
Data compiled from various sources.

Figure 10
HISTORY OF TCA AND PCE
VARIATIONS IN EXTRACTION
WELL GW-32
IBM-DAYTON SITE

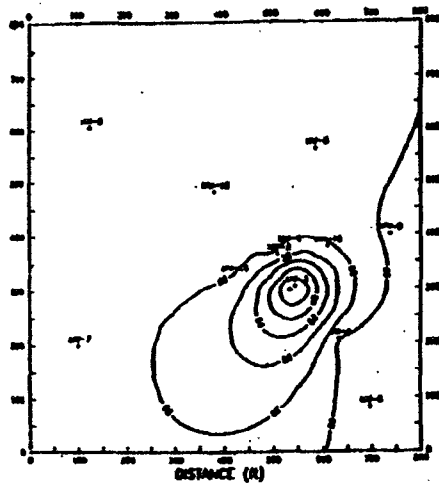
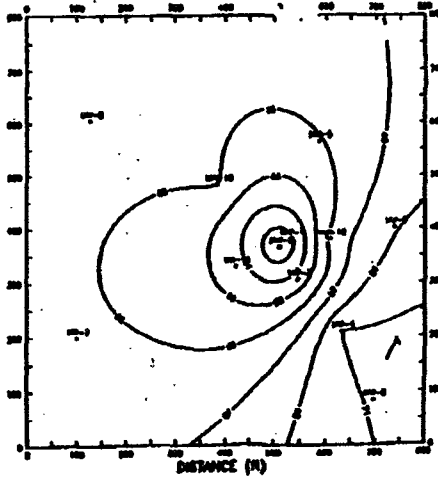
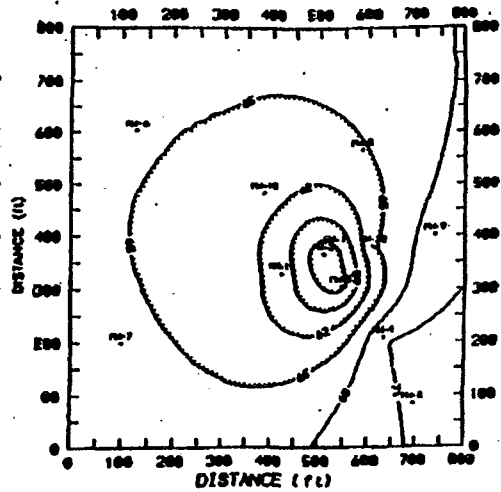
Potentiometric surface 01/03/89 (ft above msl)
MW-3 Pumping 60 gpm

Potentiometric surface 07/13/89 (ft above msl)
MW-3, MW-11, and MW-2
Pumping Total of 60 gpm

Potentiometric surface 06/21/90 (ft above msl)
MW-3, MW-11, MW-1, and MW-2
Pumping Total of 36 gpm

Figure 6
POTENTIOMETRIC SURFACE IN RESPONSE
TO DIFFERENT PUMPING CONFIGURATIONS
NICHOLS ENGINEERING SITE

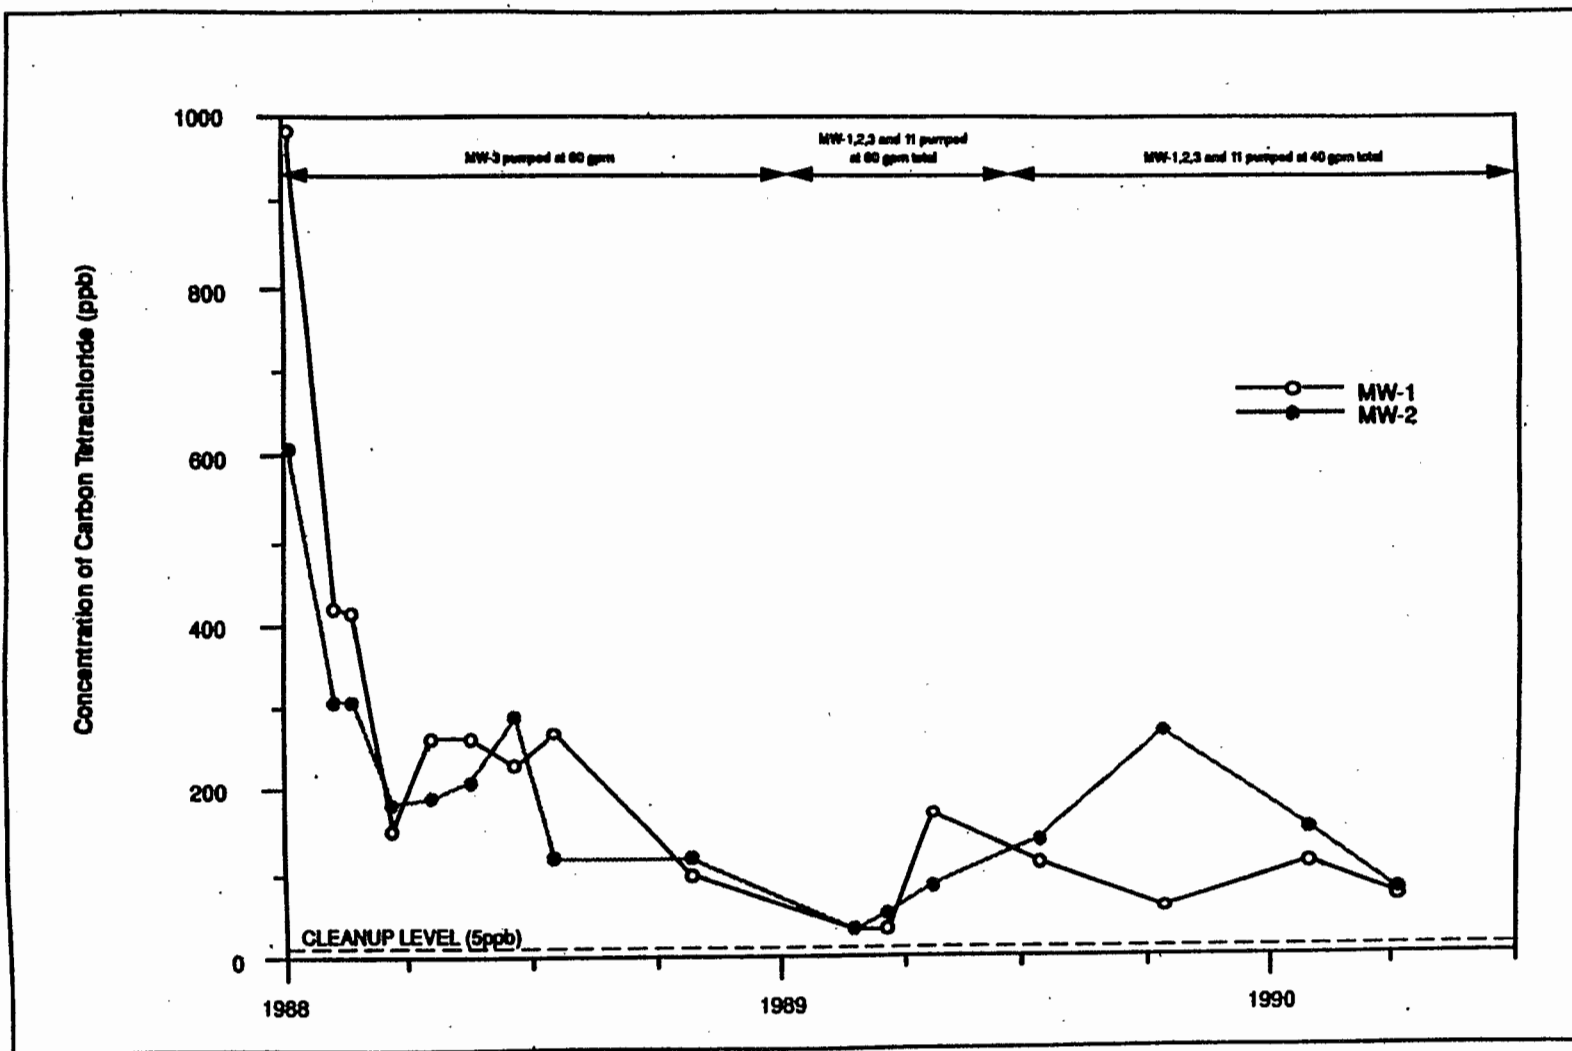
Figure 7
CCl₄ CONCENTRATION OVER TIME
IN MW-1 AND MW-2
NICHOLS ENGINEERING SITE

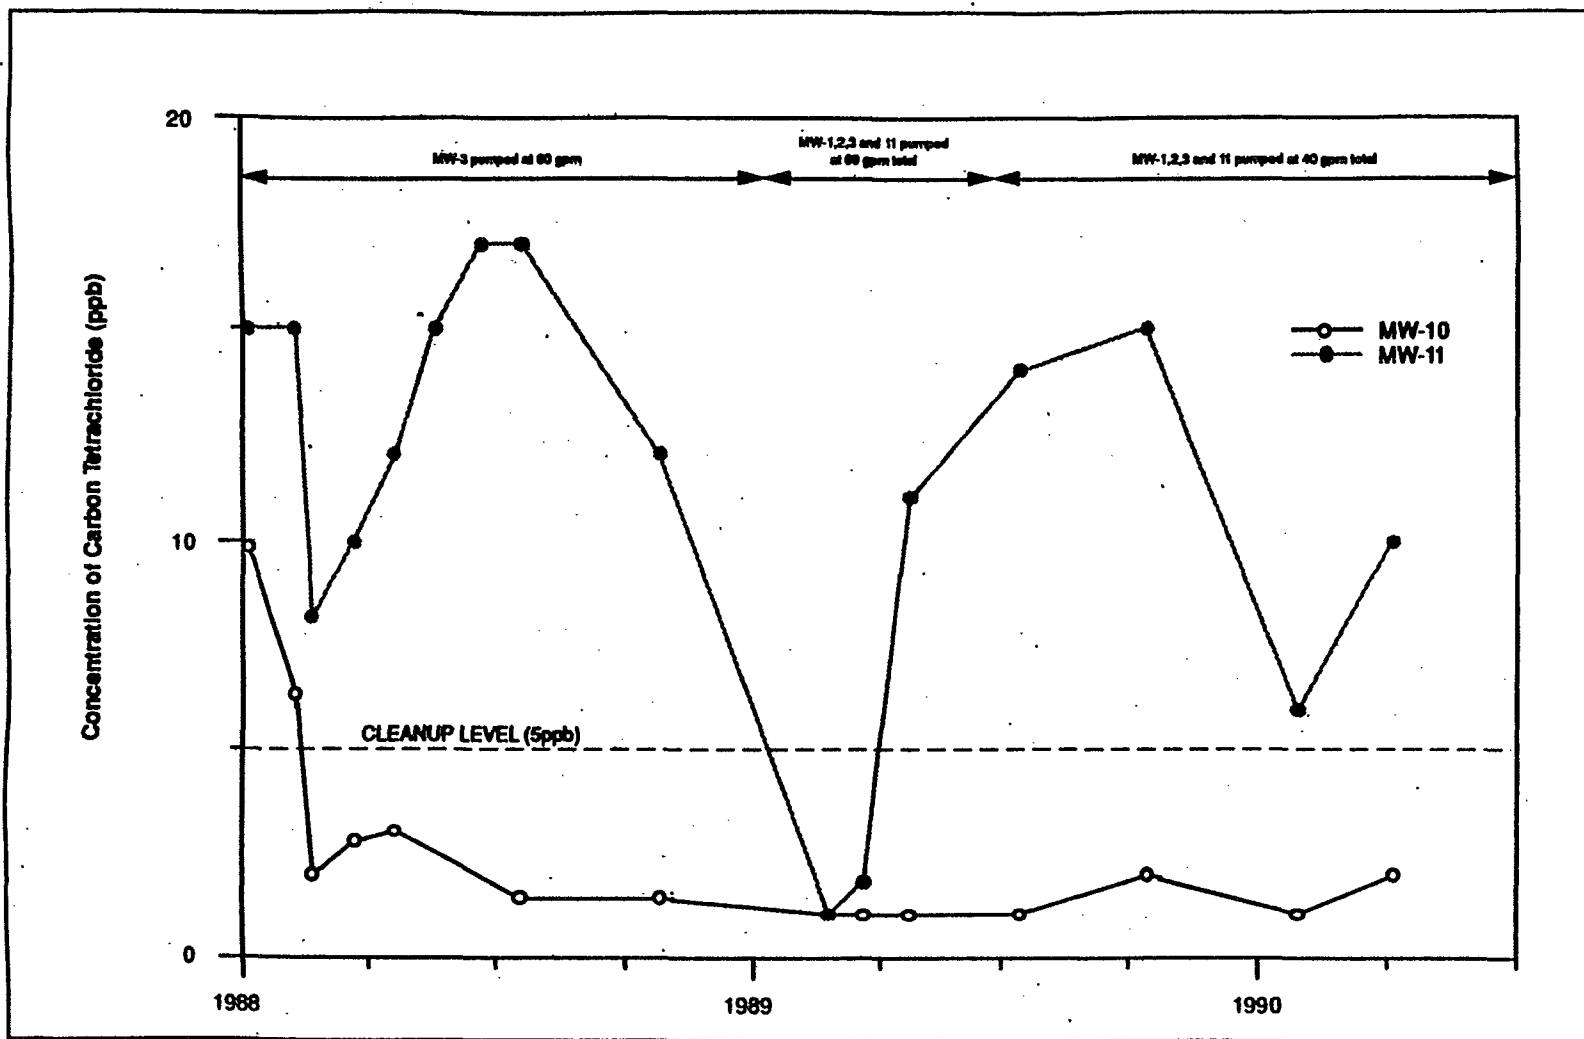
Figure 8
CCl₄ CONCENTRATION OVER TIME
IN MW-11 AND MW-10
NICHOLS ENGINEERING SITE

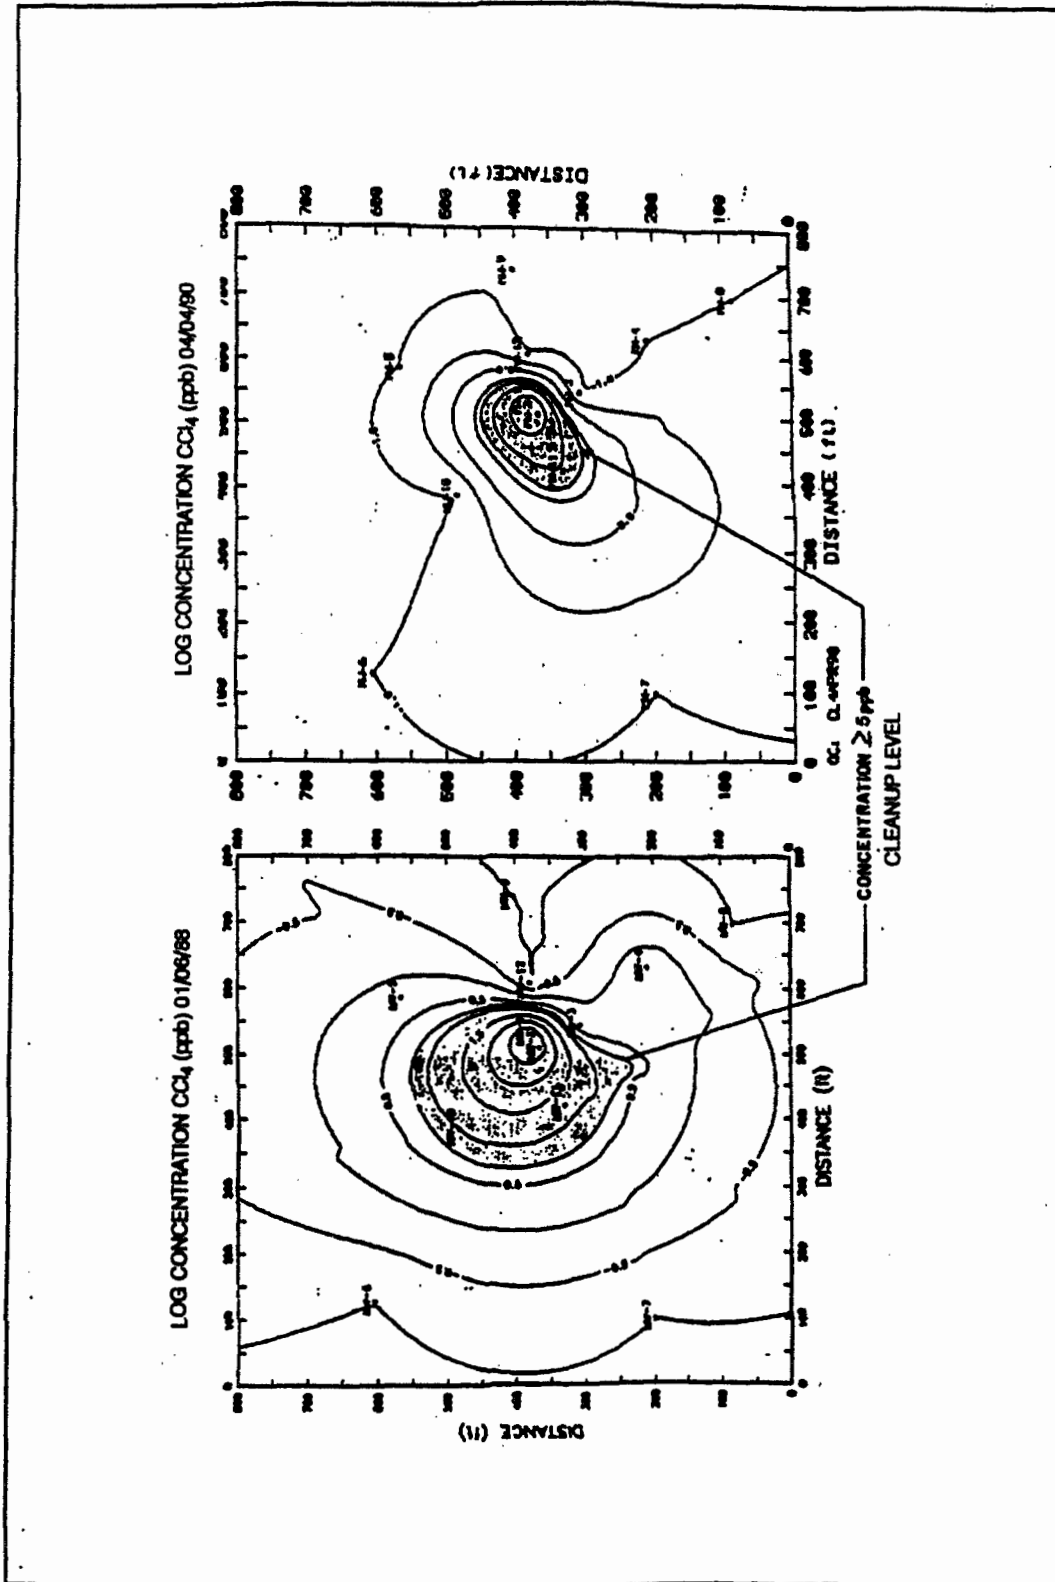
Figure 9
 CCl_4 ISOPLETH
 NICHOLS ENGINEERING SITE

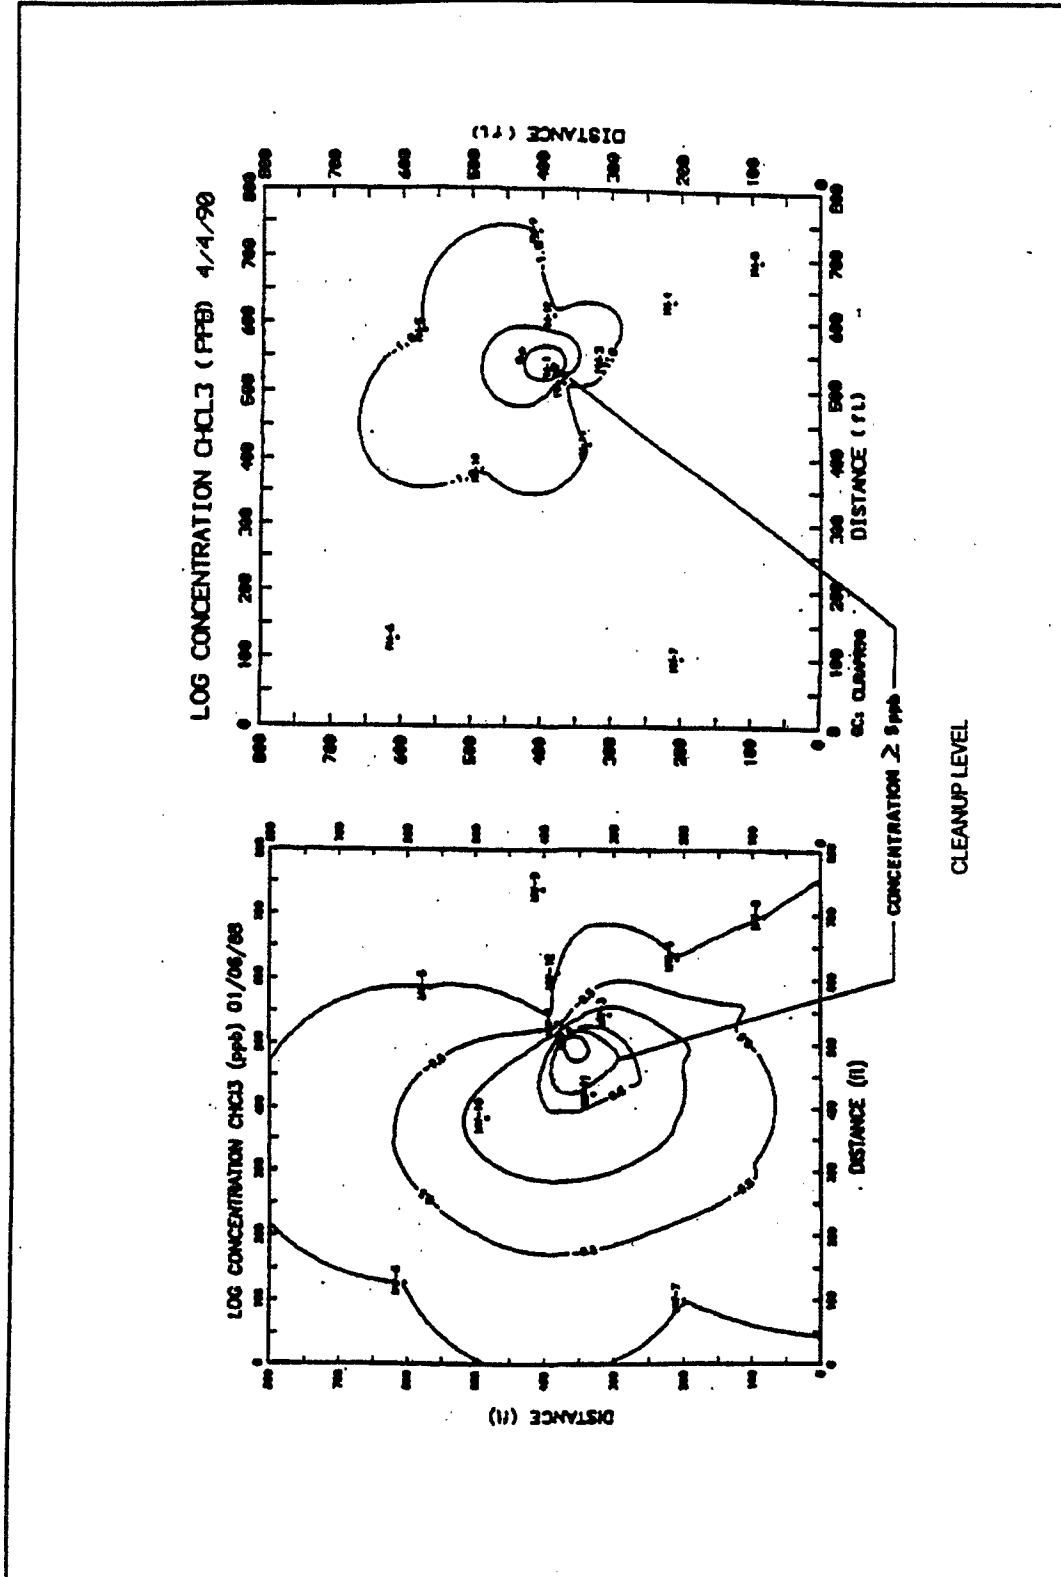
Figure 10
CHCl₃ ISOPLETH
NICHOLS ENGINEERING SITE

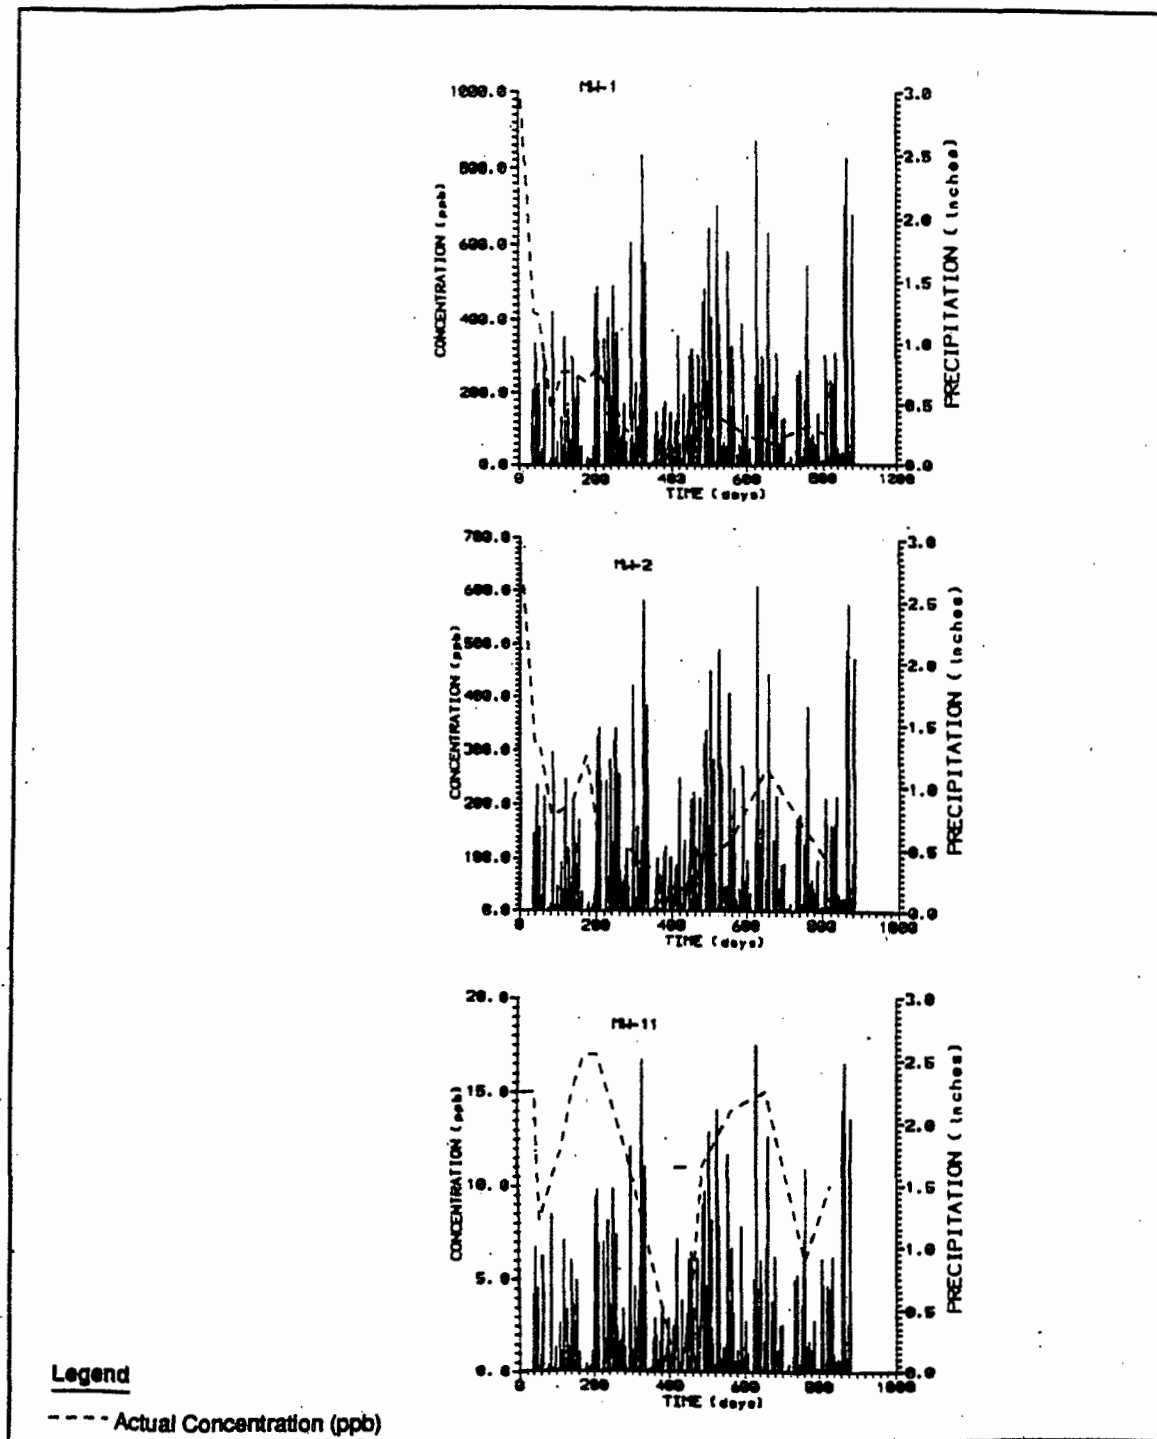
Figure 11
 CCl₄ CONCENTRATION VS
 PRECIPITATION
 IN MW-1, MW-2, MW-11
 NICHOLS ENGINEERING - *E

affect the removal of CCl_4 from this zone. Alternatively, the treated ground water could be recharged to the surface of the site to infiltrate through the unsaturated zone and leach out the CCl_4 . The apparent correlation between precipitation and elevated levels of CCl_4 in the ground-water suggests that this would be effective.

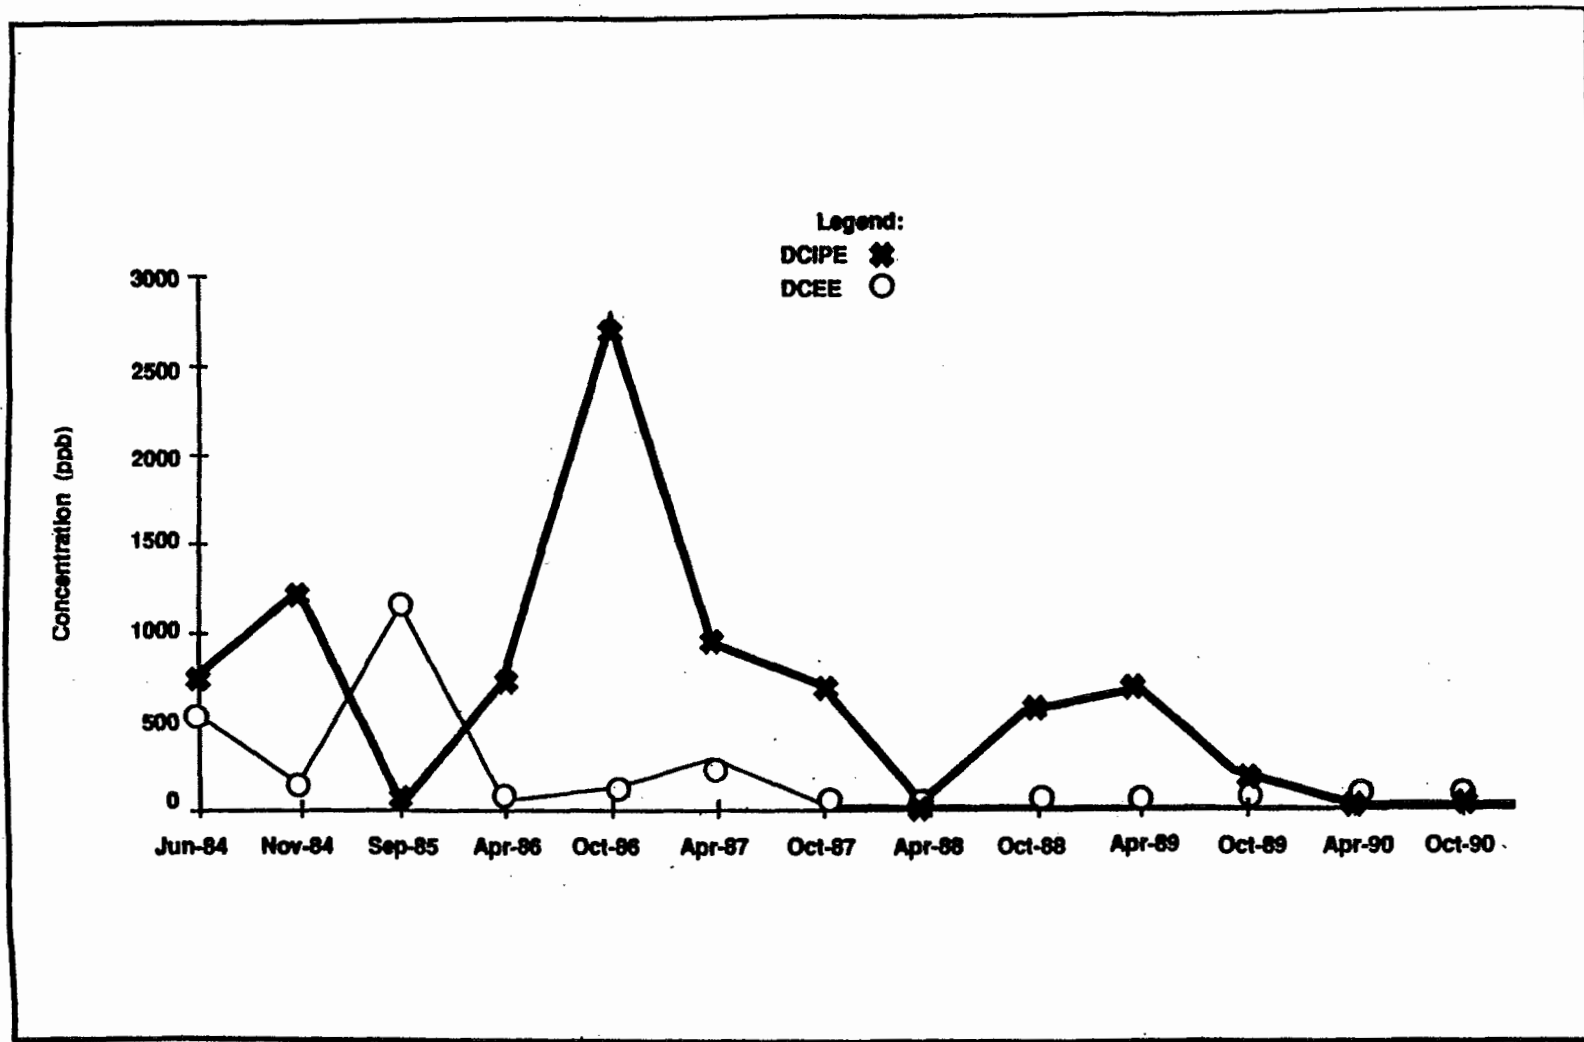
Figure 3
ETHER CONCENTRATIONS IN MW-7
OLIN CHEMICALS GROUP
DOE RUN PLANT

DCIPE concentrations in ground-water samples from Well MW-7, which is located directly downgradient from the off-gas burners, have decreased from an October 1986 high of almost 3,000 ppb to below detection levels by October 1990. DCEE concentrations have continued to stabilize at or near the low levels achieved in 1987. The continuation of low detection levels in MW-7 suggests that the contaminant plume reached and passed this well.

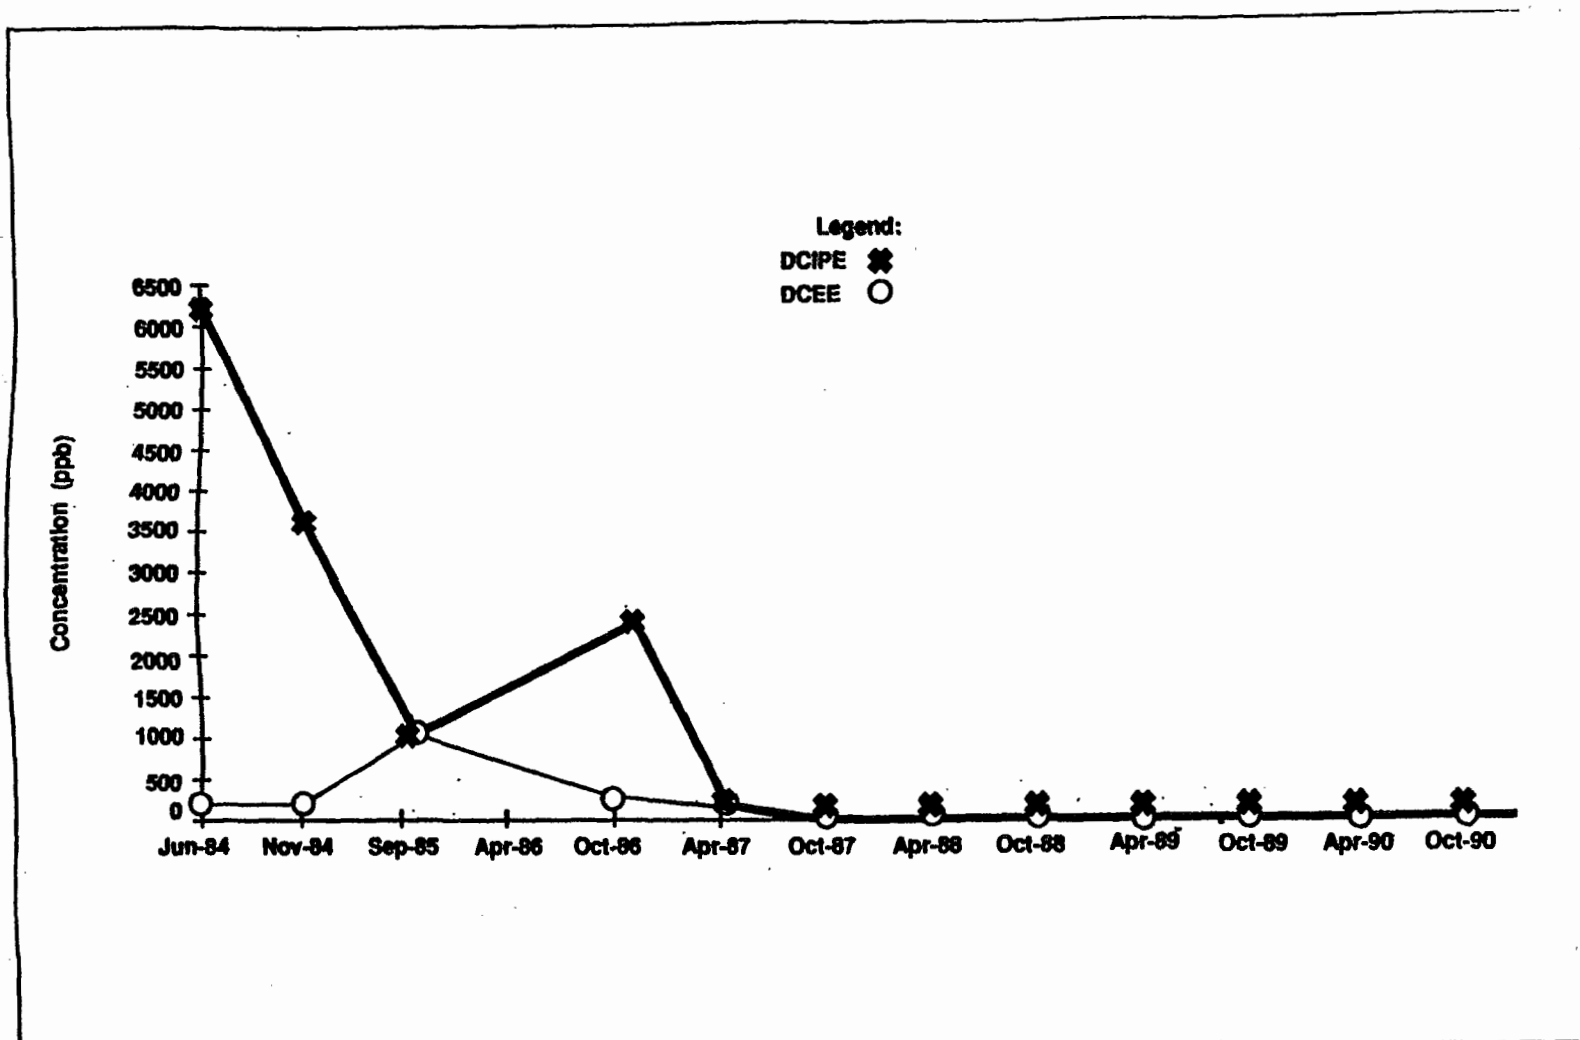
Figure 4
ETHER CONCENTRATIONS IN BH-1
OLIN CHEMICALS GROUP
DOE RUN PLANT

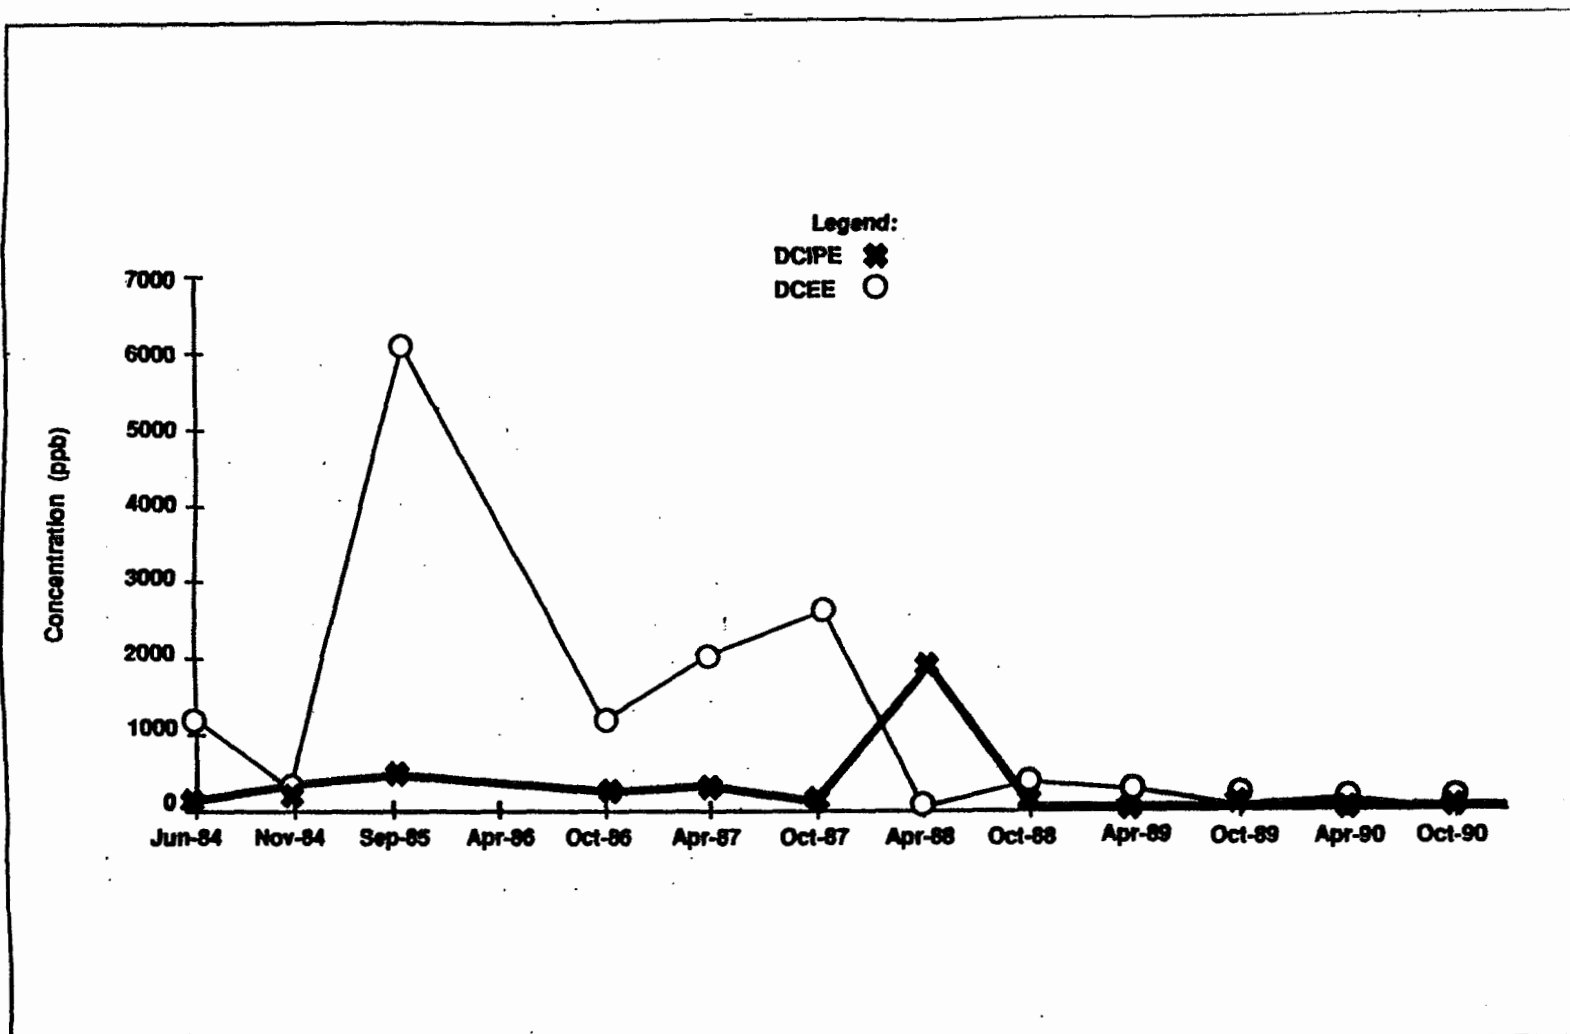
Figure 5
ETHER CONCENTRATIONS IN MW-2
OLIN CHEMICALS GROUP
DOE RUN PLANT

MW-2, which is located between Ranney Wells 2 and 3, has also undergone intermittent fluctuations in concentration levels since the system began operation. DCEE concentrations were as high as 6,000 ppb in 1985, and DCIPE levels were greater than 1,000 ppb. Concentrations of both contaminants, however, were markedly reduced by October 1988 and were below detection levels by October 1990.

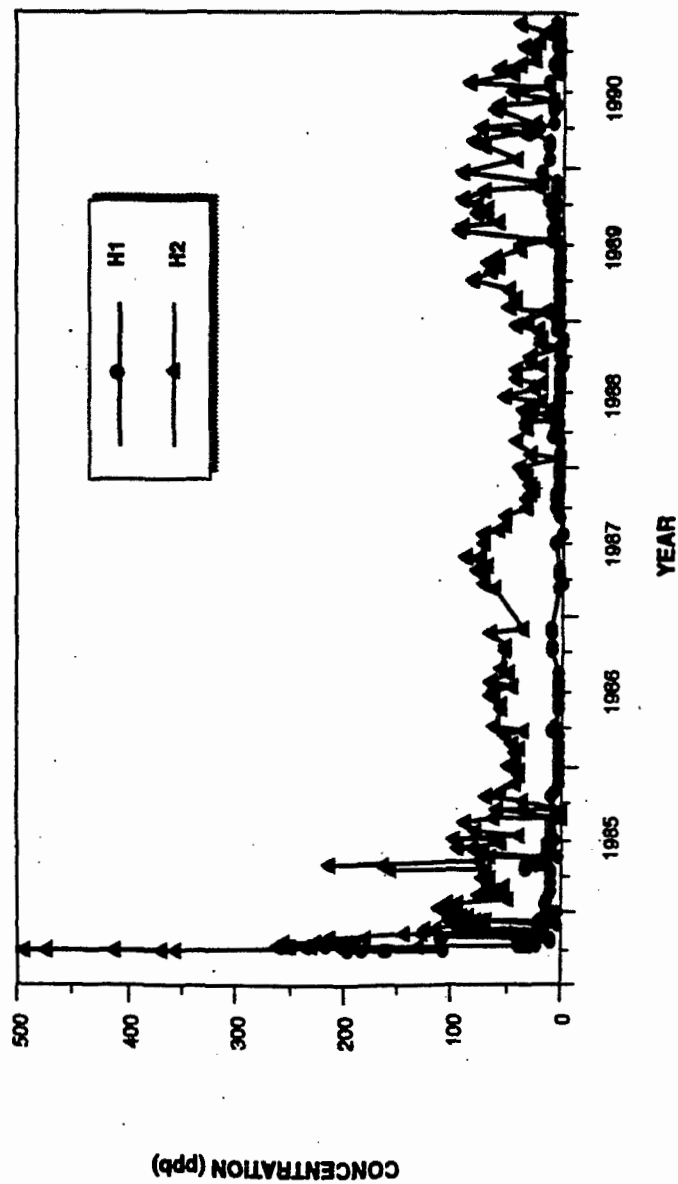
Figure 3
PCE CONCENTRATION IN WELLS H1 AND H2
PONDERS CORNER SITE

Figures 3 and 4 are time-series graphs of the PCE and TCE concentrations measured in flows from production Wells H1 and H2. Figure 3 shows that the PCE concentration in well H2 peaked at 492 ppb in September 1984 and that, after an initial sharp decrease, it has remained fairly stable at between 30 and 100 ppb since early 1985. The PCE concentration appears to have risen slightly during 1989 and to have decreased slightly in 1990. This may have been due to increased recharge during the rainy season of late 1989 and early 1990. The PCE concentration in Well H1 seems to show a similar rise and fall during late 1989 and early 1990.

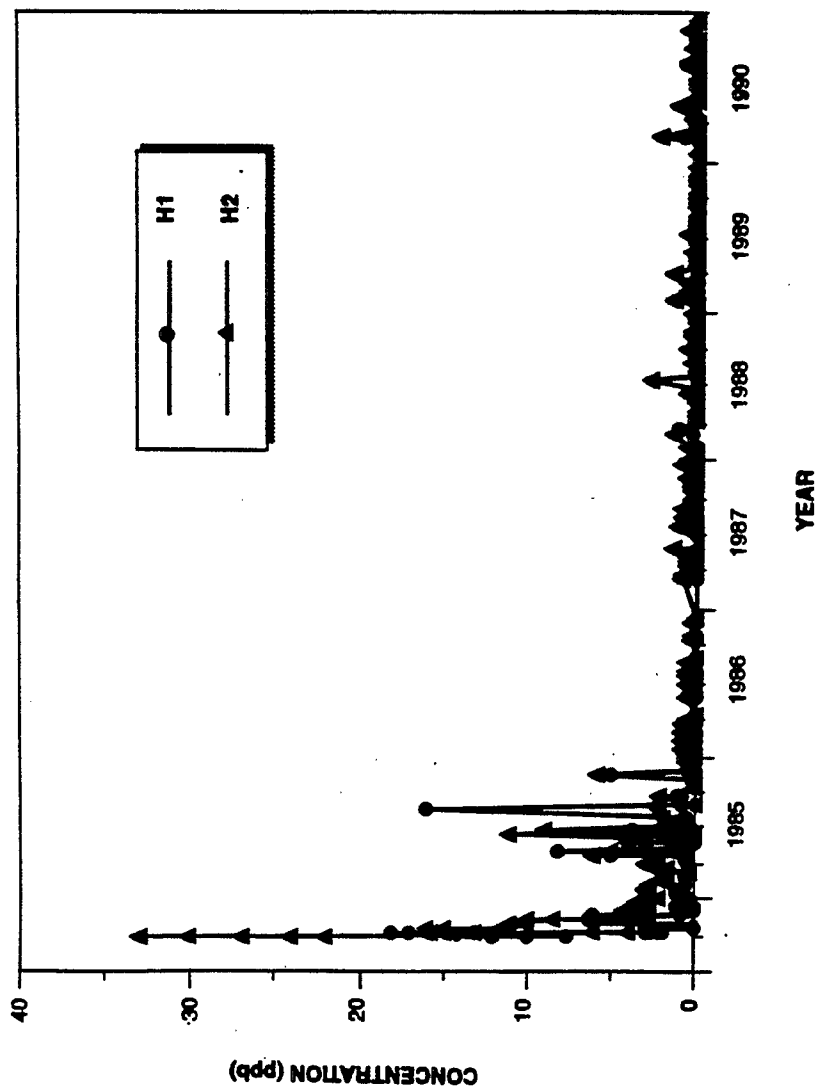
Figure 4
TCE CONCENTRATION IN WELLS H1 AND H2
PONDERS CORNER SITE

Figure 4 shows that the TCE concentration in both wells has been consistently near or below detection limits since late 1985. Small peaks in the TCE concentration were observed in the first quarters of 1988, 1989, and 1990.
