Evaluation of Ground-Water Extraction Remedies: Phase II

Volume 2 Case Studies and Updates

Volume 2 Case Studies

Office of Emergency and Remedial Response
U. S. Environmental Protection Agency
Washington, D.C.

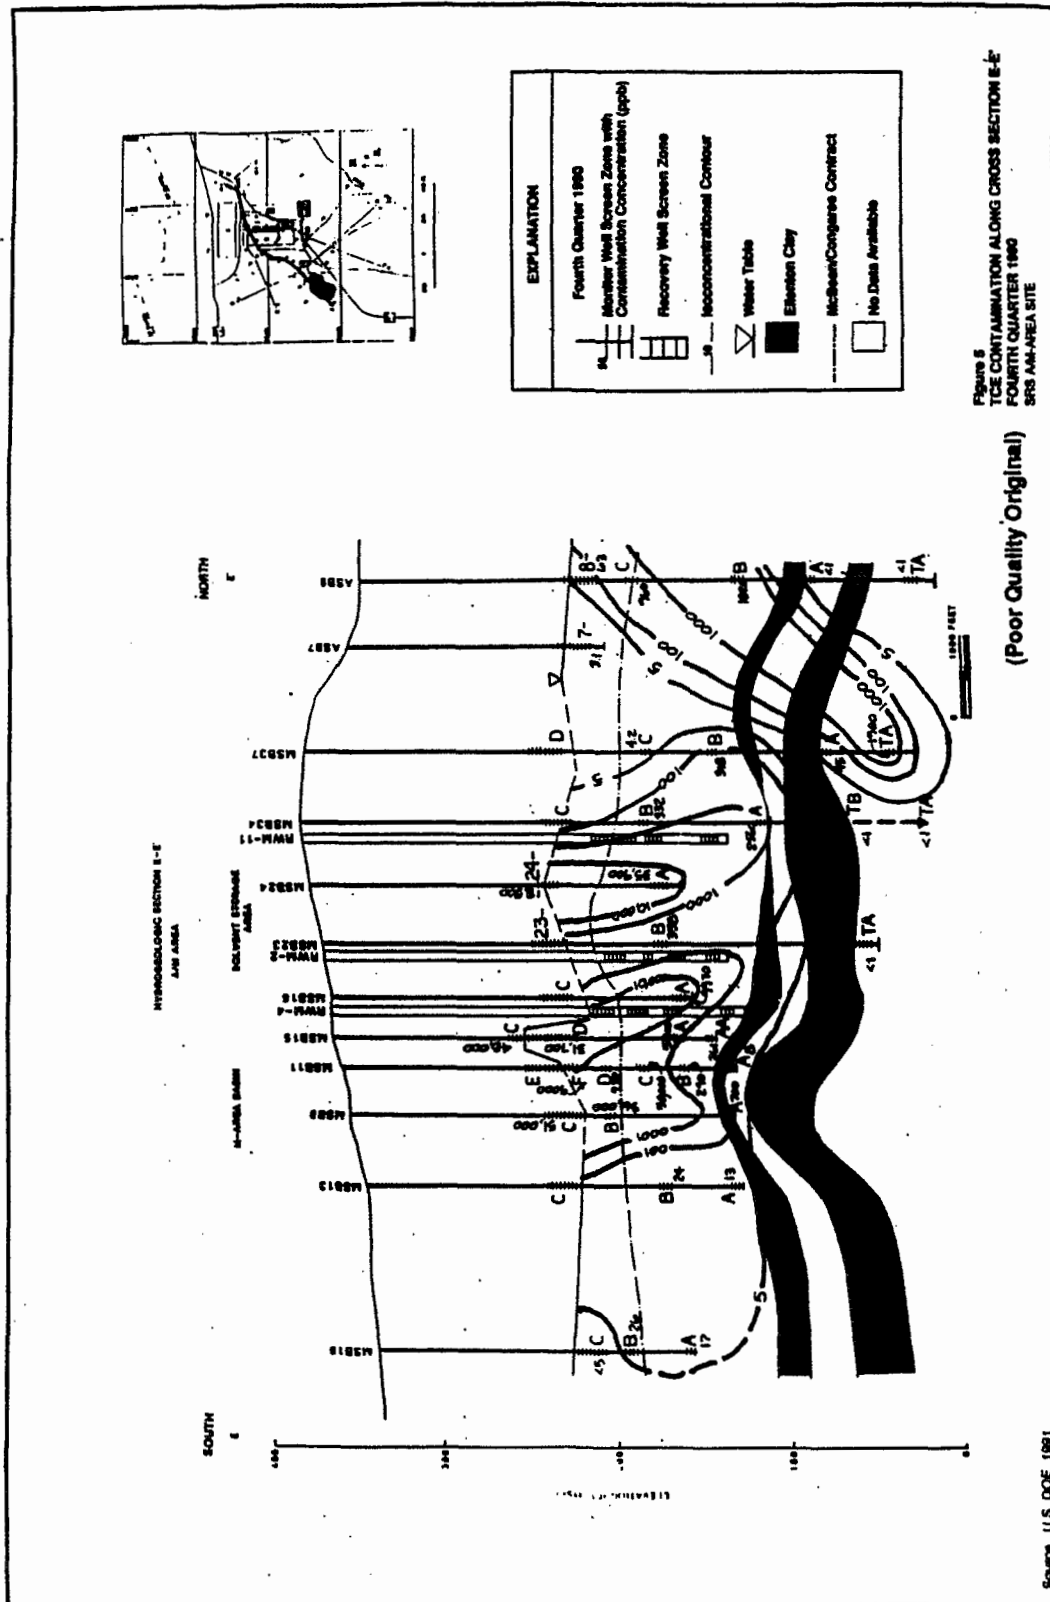
Figure 8
TCE CONTAMINATION ALONG CROSS SECTION E-E
FOURTH QUARTER 1990
SRS AM-AREA SITE

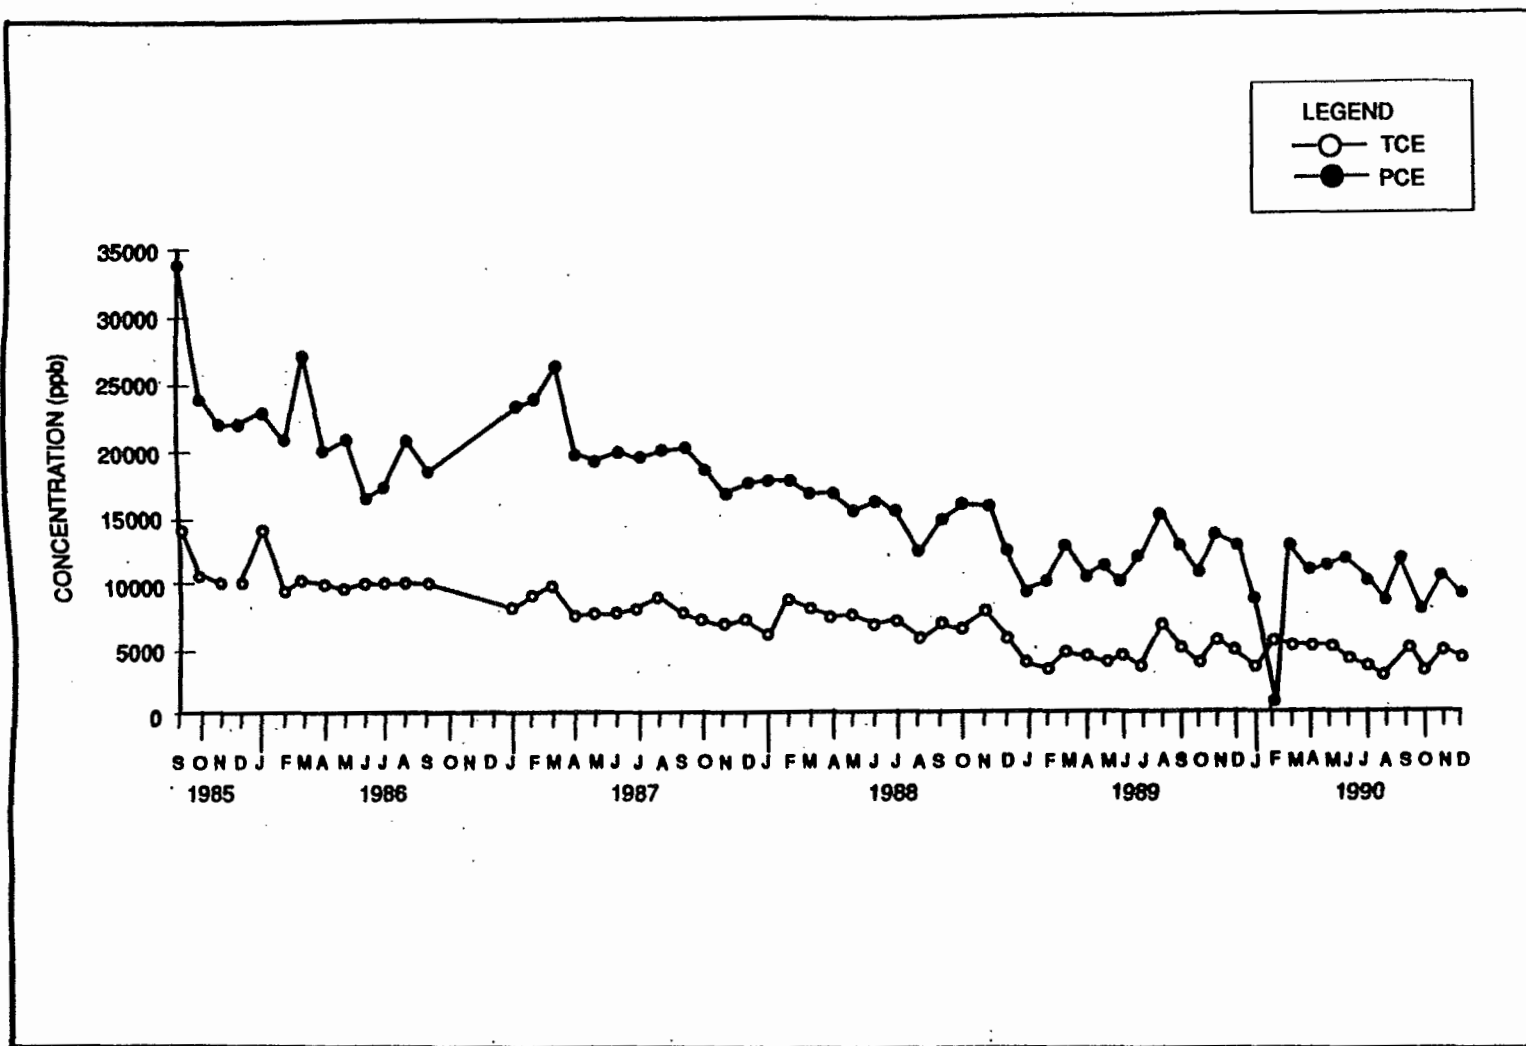
Figure 7
TIME SERIES PLOT OF TCE AND PCE
CONCENTRATIONS IN THE AIR STRIPPER INFLUENT,
SEPTEMBER 1985 TO DECEMBER 1990
SRS AM-AREA SITE

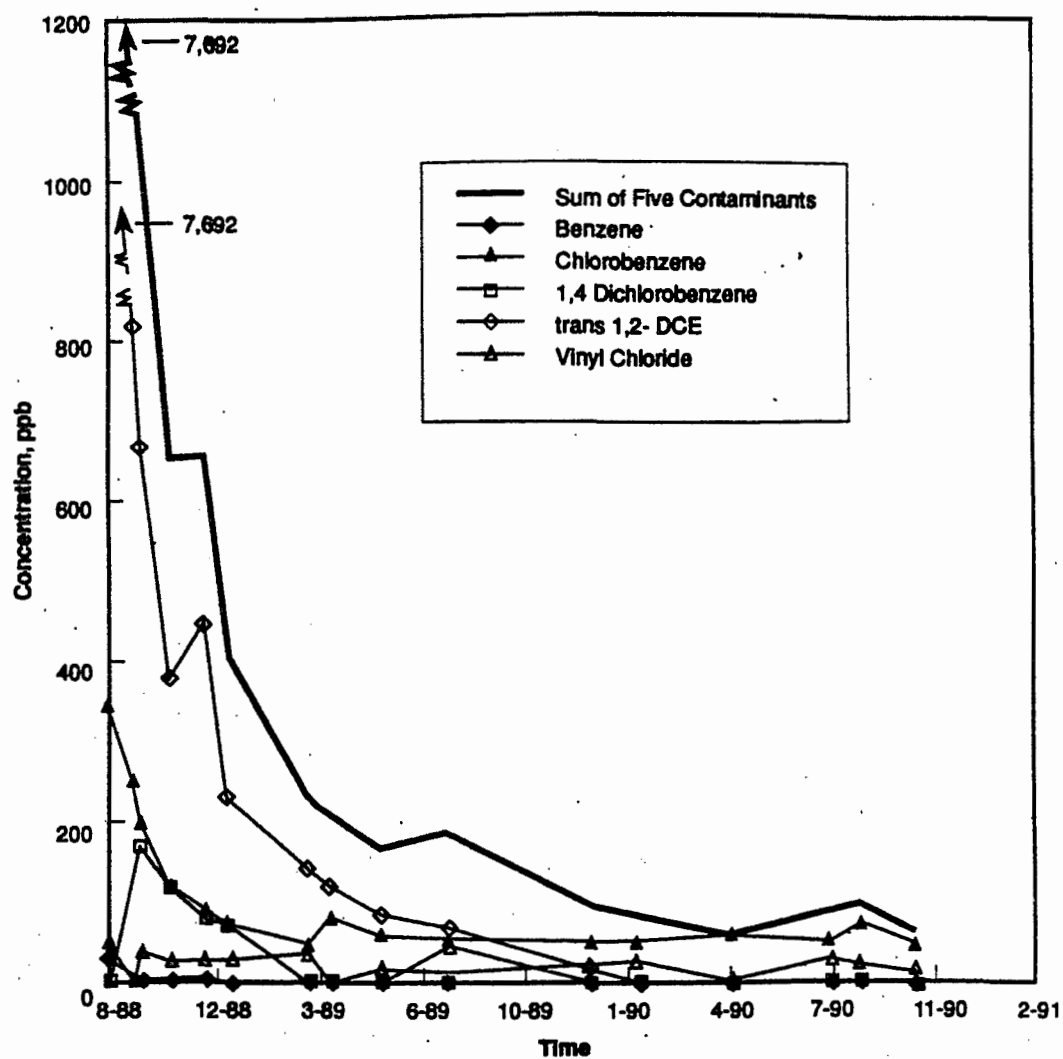
Figure 3
TEMPORARY AIR STRIPPER INFLUENT
CONTAMINANT CONCENTRATIONS AT SITE A
FROM AUGUST 1988 TO OCTOBER 17, 1990

In the original case study, total VOCs in air stripper influent were reported to be at concentrations above 10,000 ppb for the first 10 days after start-up. The highest total VOCs concentration, 24,001 ppb, was recorded on

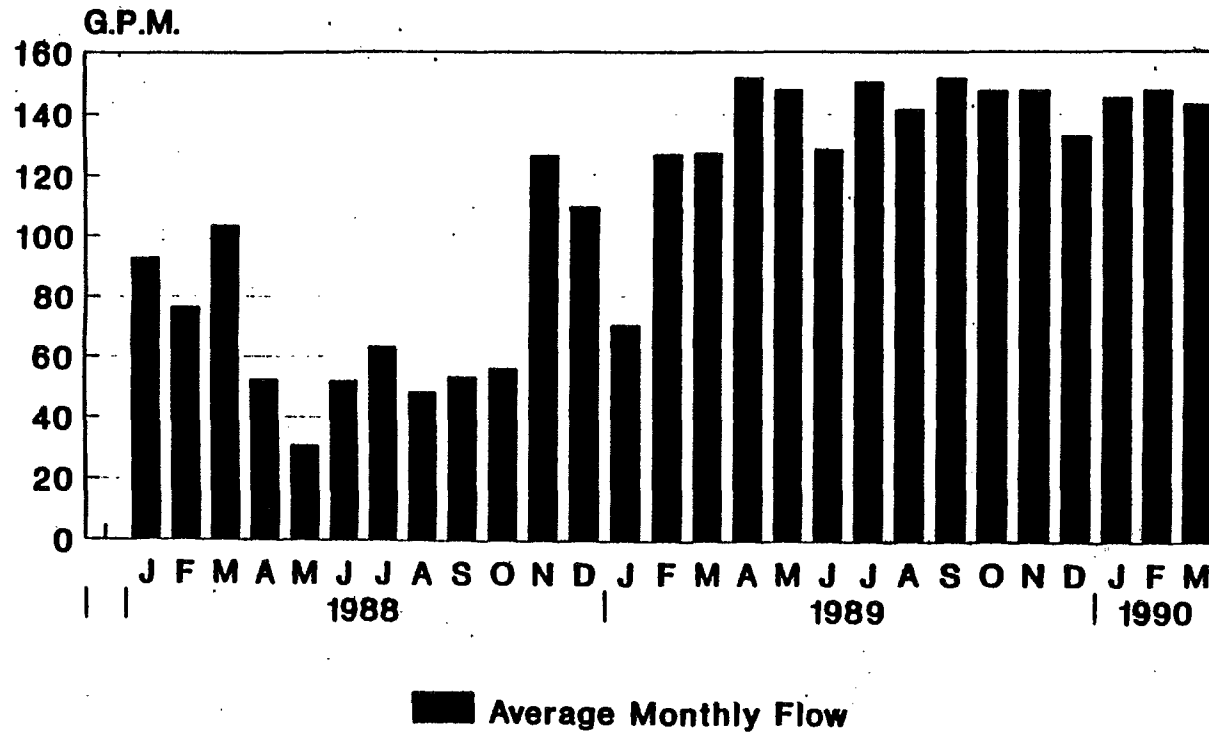
Figure 4
COMBINED AVERAGE MONTHLY PUMPING
RATE OF EXTRACTION SYSTEM
JANUARY 1988 TO MARCH 1990
UTAH POWER AND LIGHT SITE

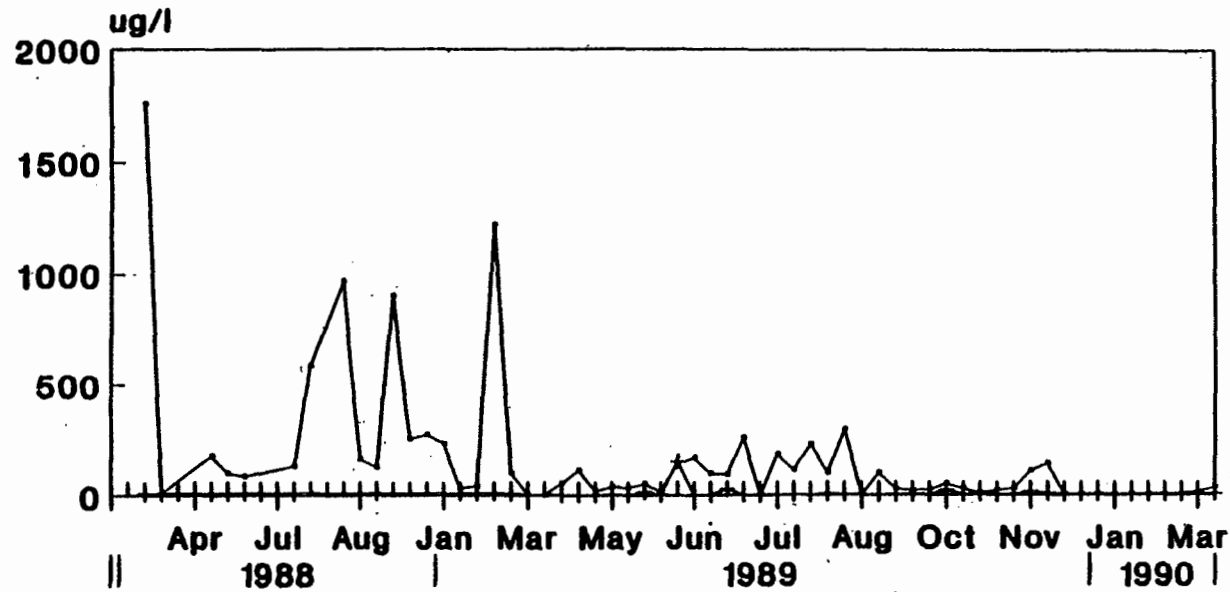
Total PAHs

— Influent + Effluent

Influent - Combined Input From Wells
Effluent - Treated Discharge From Plant

Since remediation began in 1985, the concentration of total PAHs in the influent to the treatment system has decreased substantially. There are still strong concentration peaks of total PAHs, believed to be caused by slugs of free-product creosote being drawn into the extraction system, but the magnitude of these peaks has decreased substantially since remediation began. The remediation system is clearly removing both dissolved constituents and free-product creosote from the subsurface. However, because of the presence of creosote, it appears unlikely that the aquifer can be restored to health-based levels with the current system. Because of the density of creosote, it may also be difficult to achieve vertical containment of the contamination.

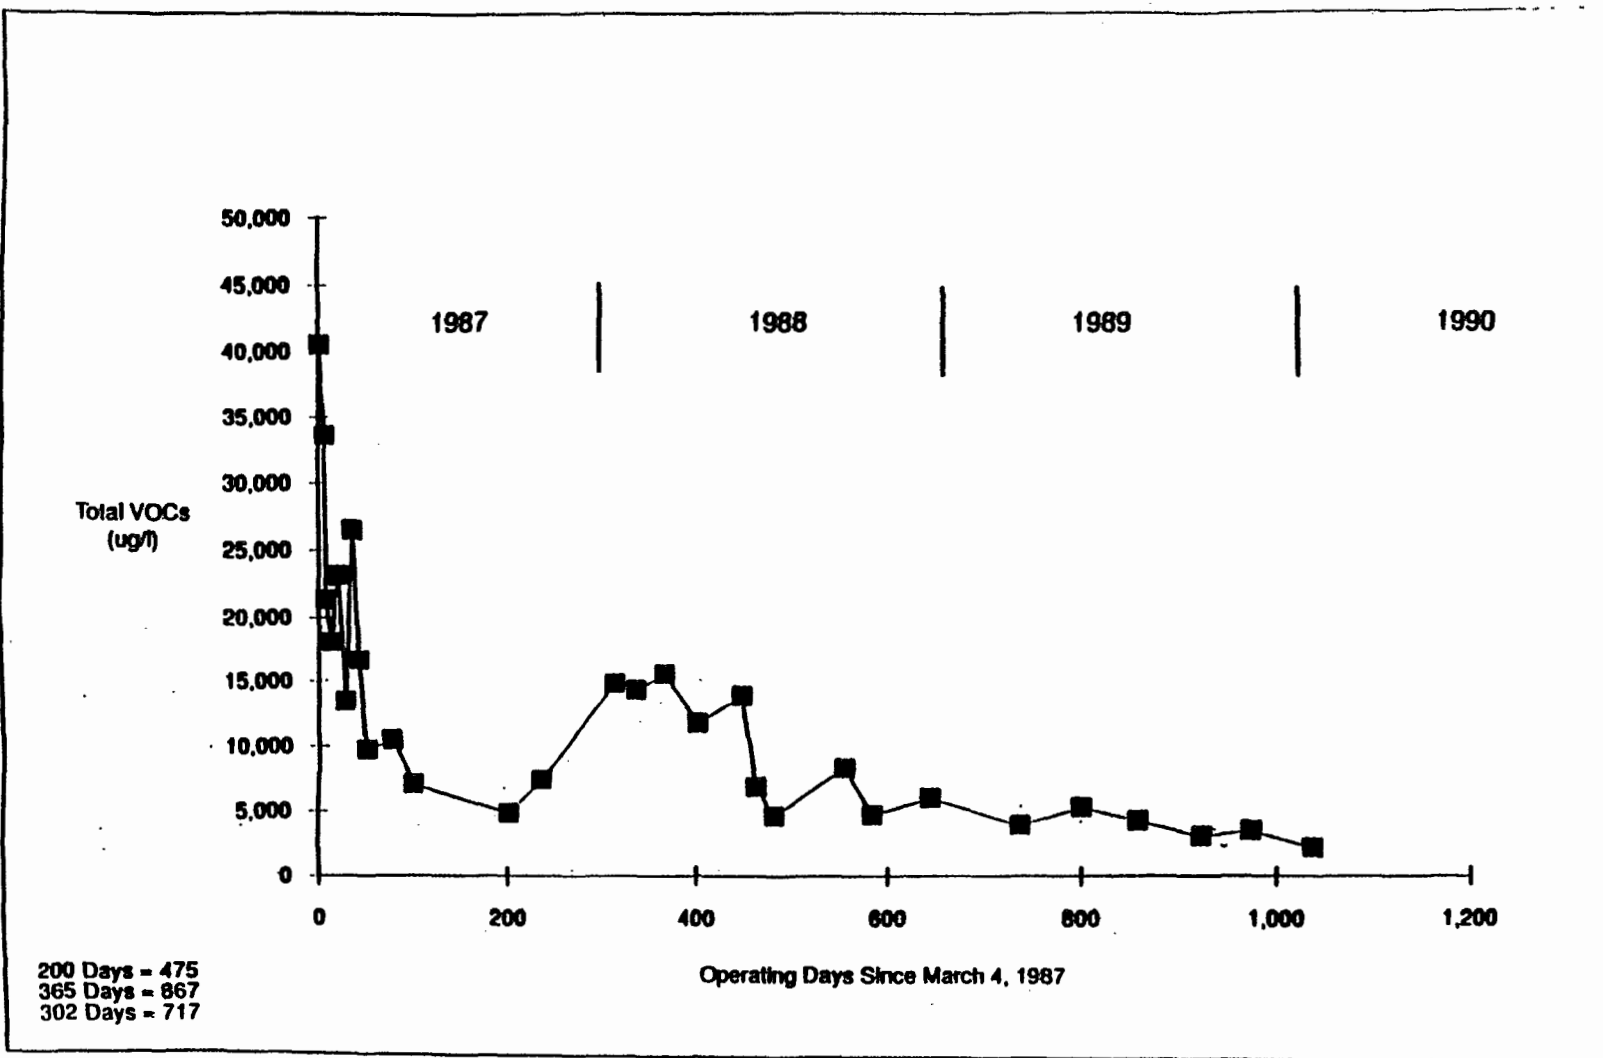
Figure 9
RECORD OF TOTAL VOC
CONCENTRATIONS IN EXTRACTION
WELL EW-8
VERONA WELL FIELD SITE

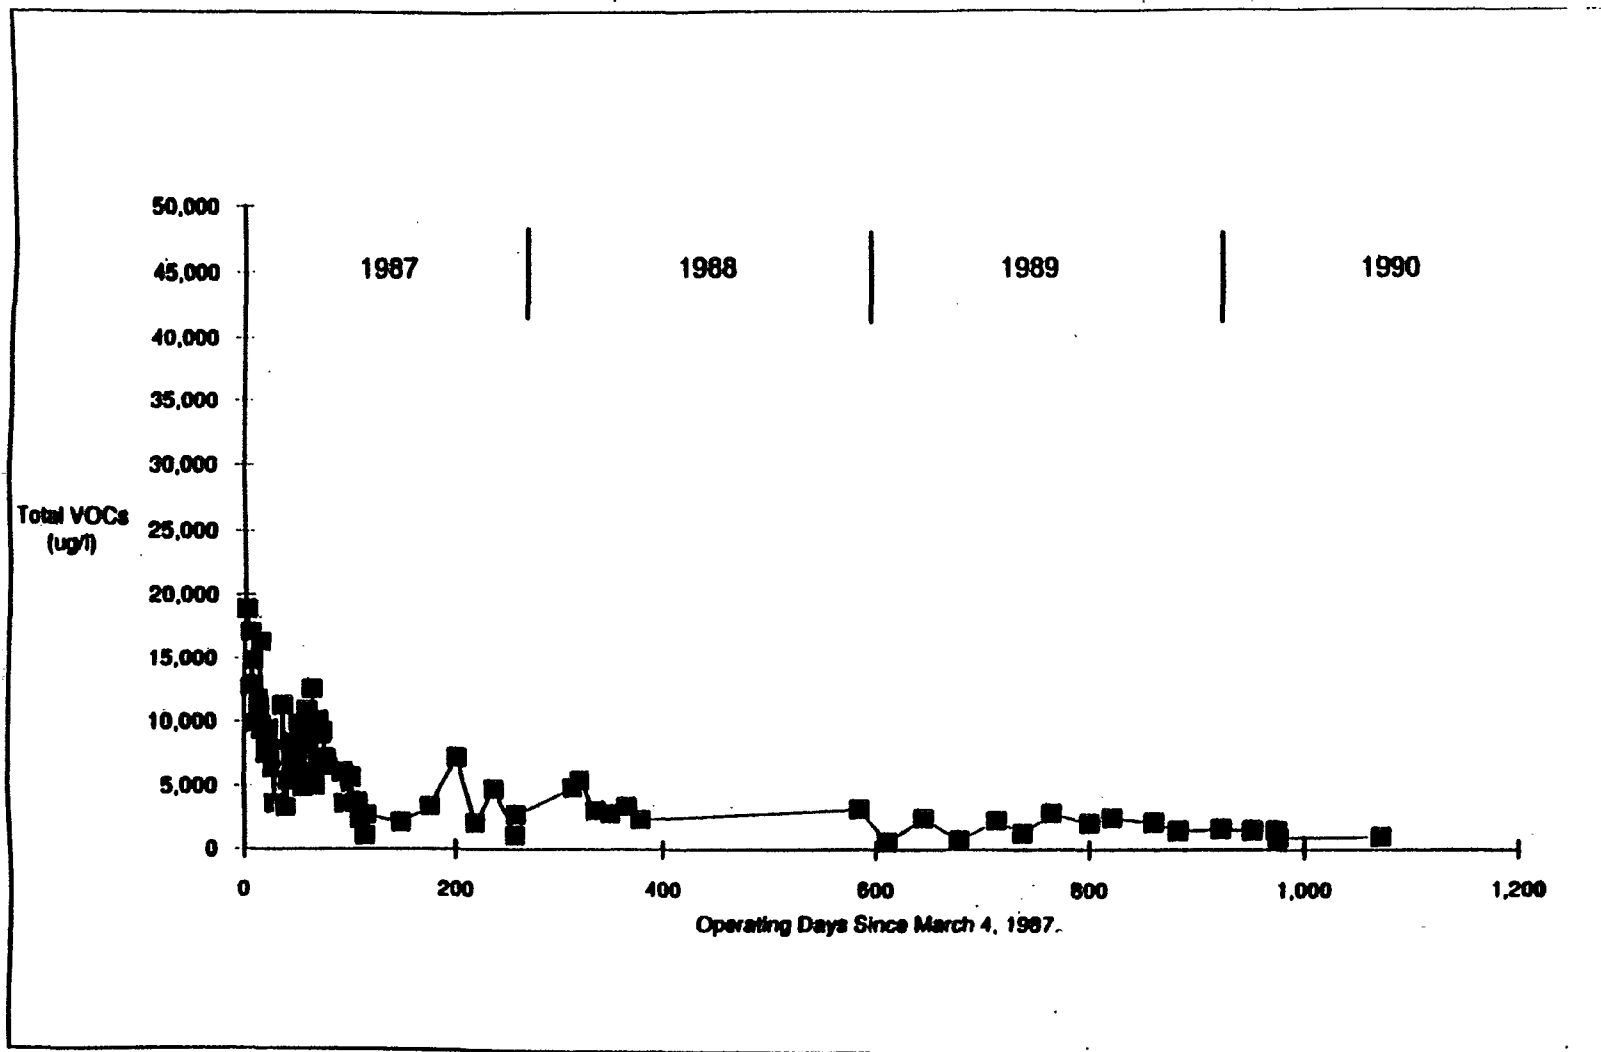
Figure 10
RECORD OF TOTAL VOC
CONCENTRATIONS IN COMBINED
EXTRACTION WELL FLOW
VERONA WELL FIELD SITE

Figure 10 shows the record of total VOC concentrations in the combined flow stream from the extraction well system. The concentrations, which were originally as high as 19,000 ppb, showed a rapid decline in the first half of the year and have stabilized at less than 3,000 ppb. Over the last two years a very slow declining trend can be observed.

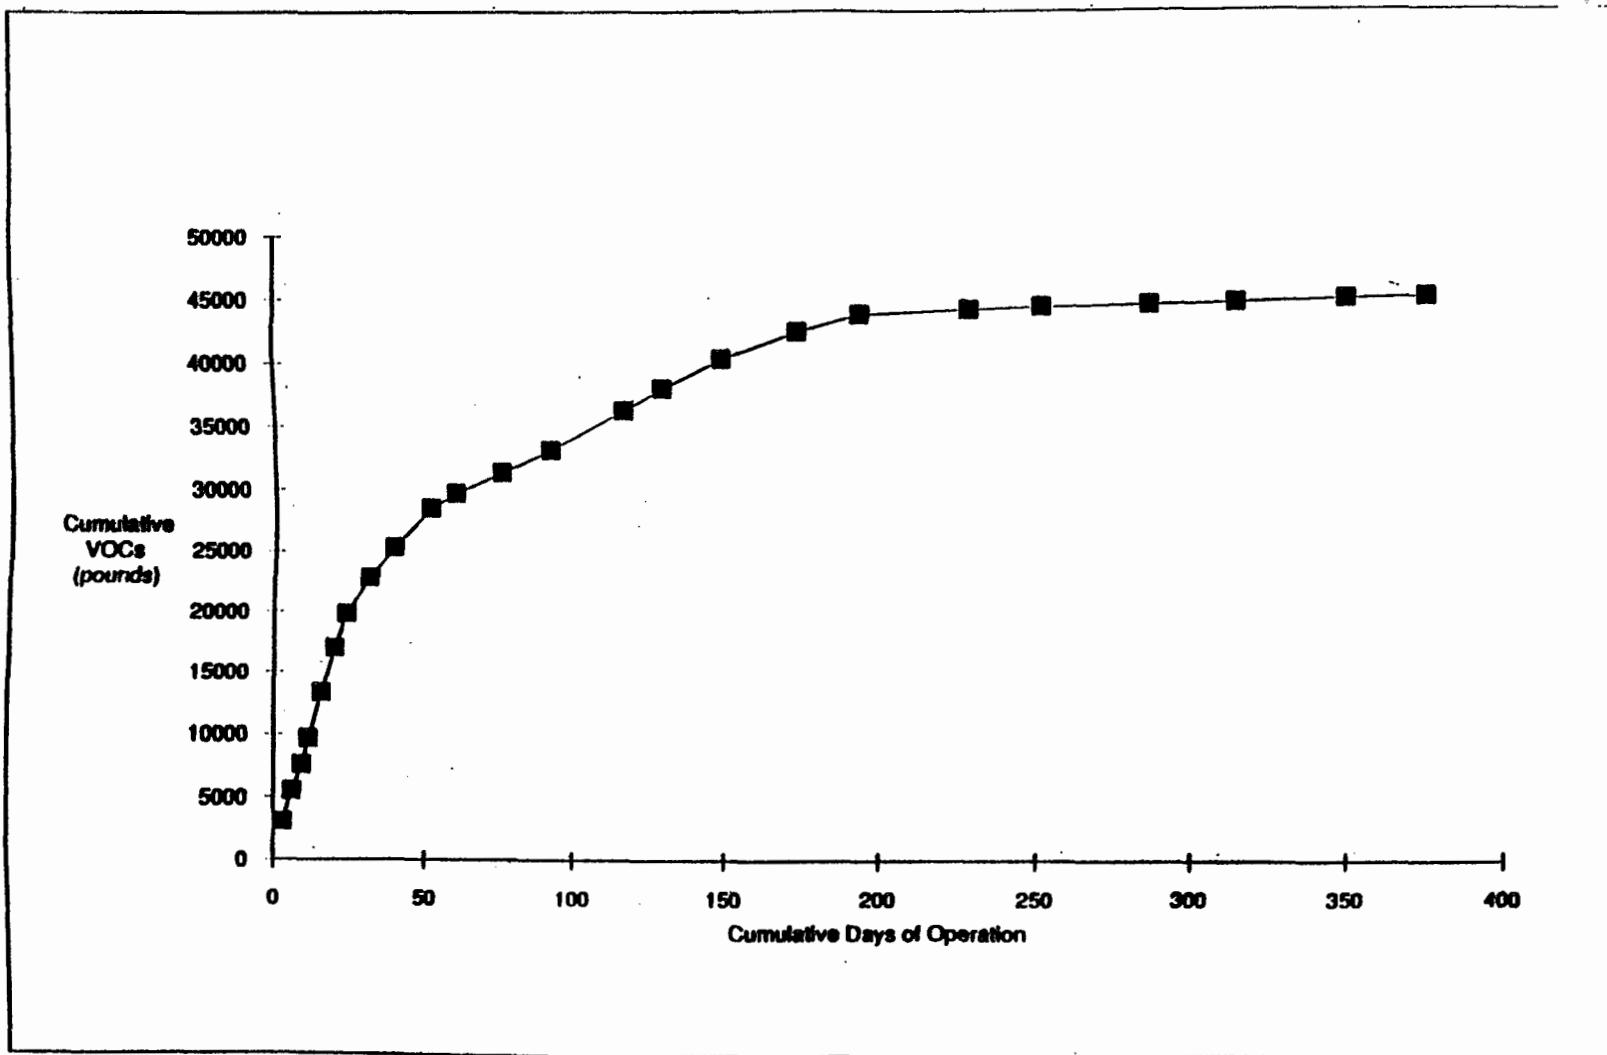
Figure 11
RECORD OF CUMULATIVE VOC
REMOVAL BY THE SOIL VAPOR
EXTRACTION SYSTEM
VERONA WELL FIELD SITE

Approximately 45,000 pounds of VOCs have been removed by the soil vapor extraction system since it began operating in November 1987. Figure 11 shows the record of cumulative VOC removal for the vapor extraction system. Approximately 95 percent of the contaminant removal was achieved during the first 200 days of the 400-day operating record shown. During the second half of 1990 the system's production rate was consistently less than 10 pounds per day. This is in contrast to the first half year of system operation, when production rates were commonly between 600 and 1000 pounds per day. In late 1990, it was estimated that approximately 1000 pounds of VOC remained in the vadose zone soils.

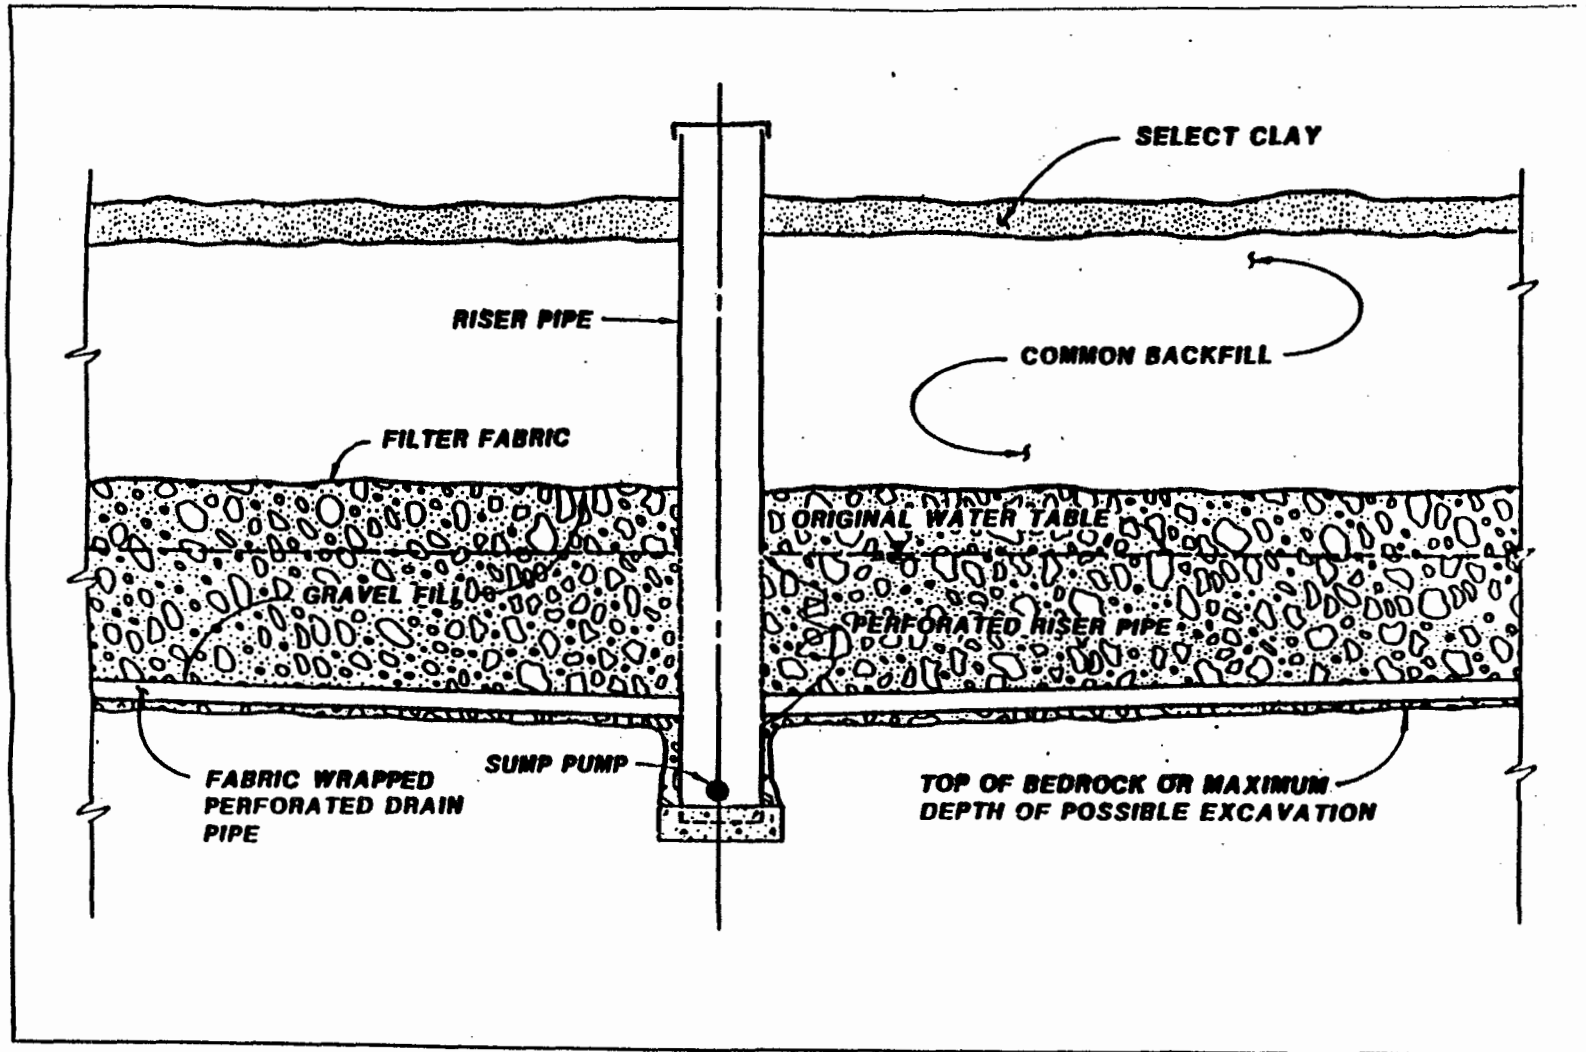
Figure 10
CROSS SECTION OF GROUND-WATER
RECOVERY SYSTEM
MID-SOUTH WOOD PRODUCTS SITE

The final ground-water recovery system, which began operating in the summer of 1989, was designed to remove contaminated ground water from several locations throughout the site and treat the contaminated water to NPDES permit concentrations. To recover contaminated ground water, eight French drains and 15 recovery wells were installed. Nine of the recovery wells are within the sumps of the French drains, and six others are isolated, deep extraction wells. French drains were chosen to recover contaminated ground water because the fractured nature of the bedrock below the site would result in low yields from a system composed only of drilled extraction wells. The French drains are located at the CCA plant, around the tanks and pressure chamber of the old plant, along the perimeter of the old pond, and in line with the northwest-southeast fault zone. The French drain trenches were excavated to the depth of backhoe refusal at the top of the bedrock--a depth of approximately 15 feet. The system was designed to collect contaminated ground water from shallow depths where flow and contaminant concentrations were expected to be greatest. Figure 10 is a cross section of a typical drain.

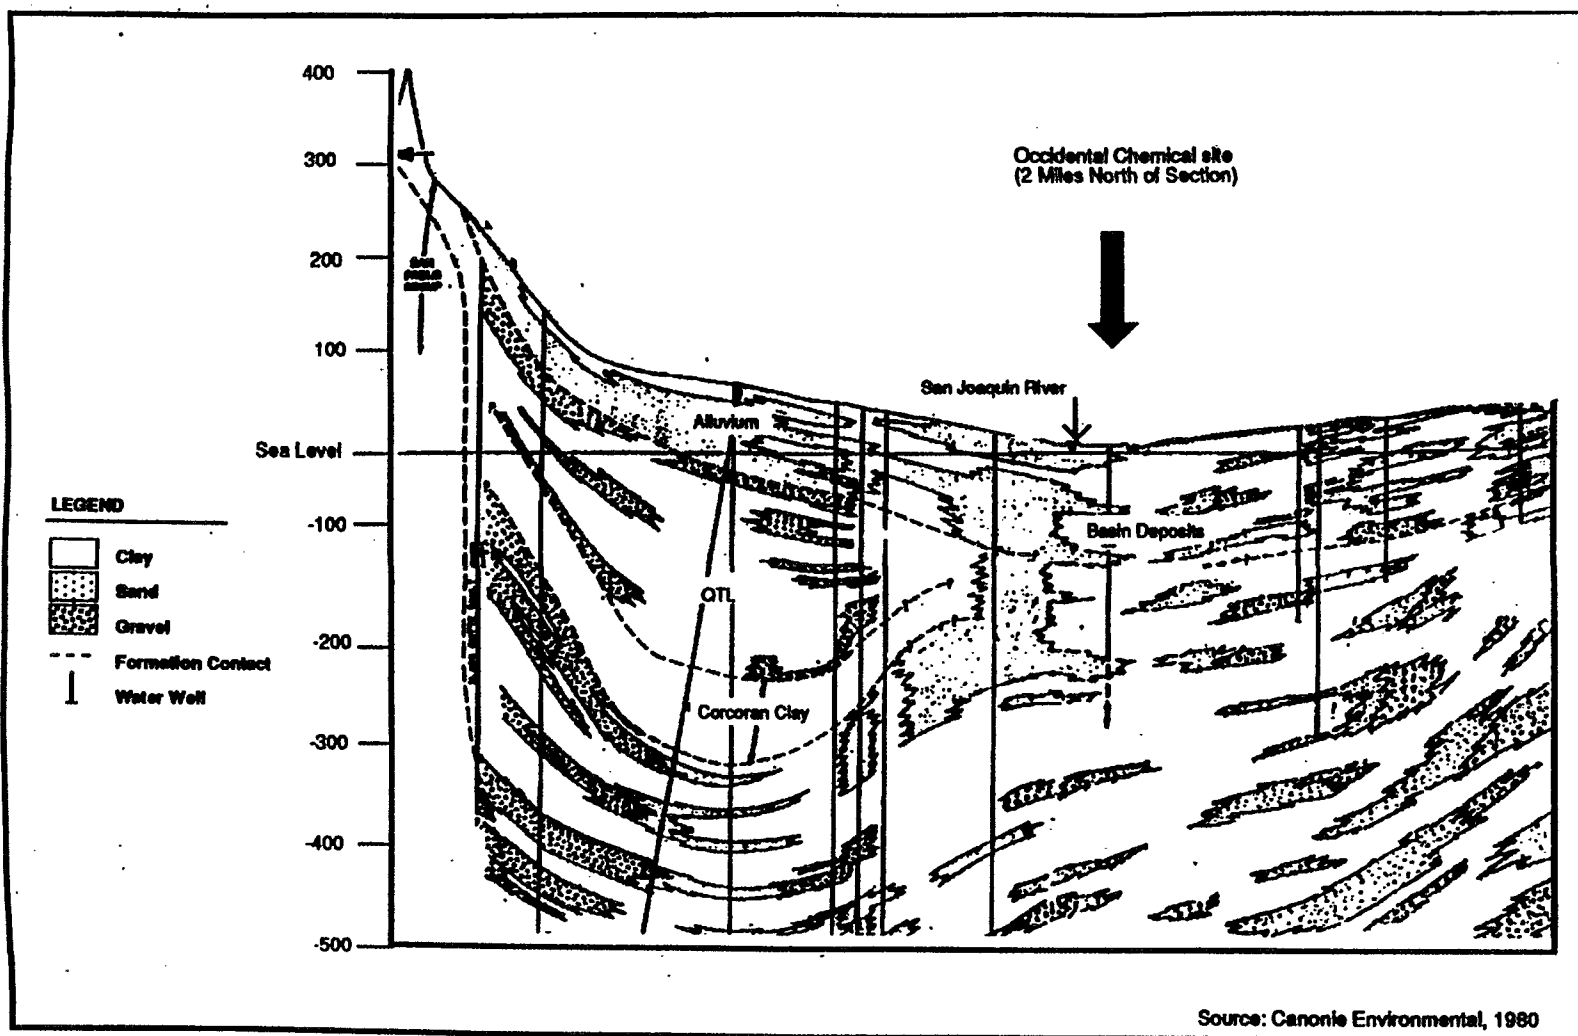
Figure 3
EAST-WEST CROSS SECTION
THROUGH THE CENTRAL VALLEY
TWO MILES SOUTH OF THE SITE
OCCIDENTAL CHEMICAL SITE

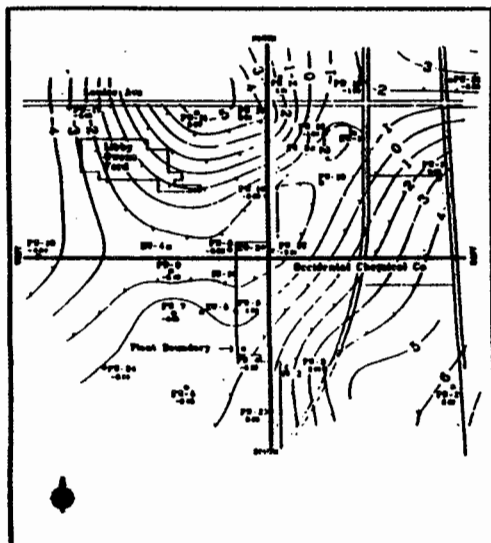
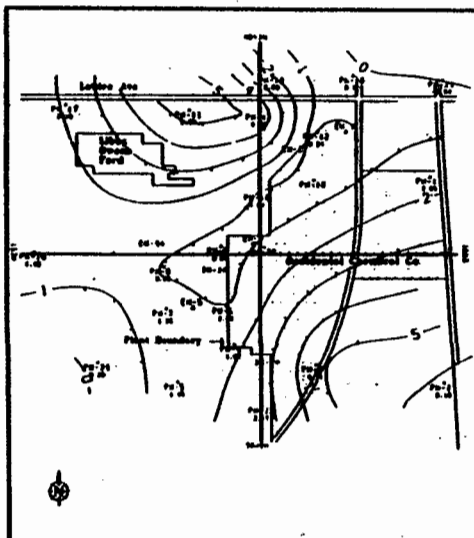
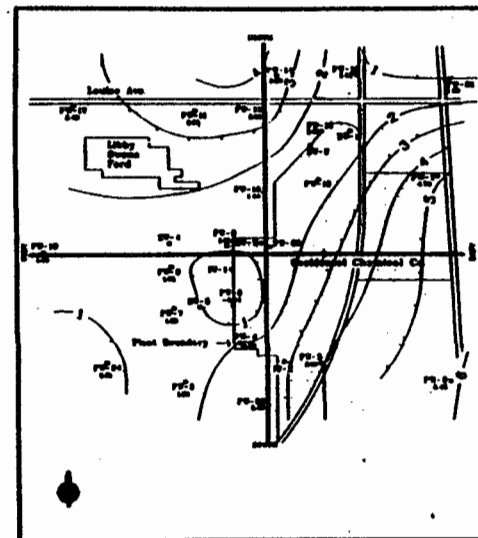
Figure 8
CONTOUR PLOTS OF WATER LEVEL ELEVATIONS
IN THE SHALLOW ZONE, 1989 AND 1990
OCCIDENTAL CHEMICAL SITE

Considerable variability in pesticide concentrations was observed between sampling events at a few individual locations in the monitoring network, notably in the shallow well at PW-22. Other examples of variable concentrations, especially along the western border of the site, can be seen in the 1989/1990 data presented in Figures 7, 8, and

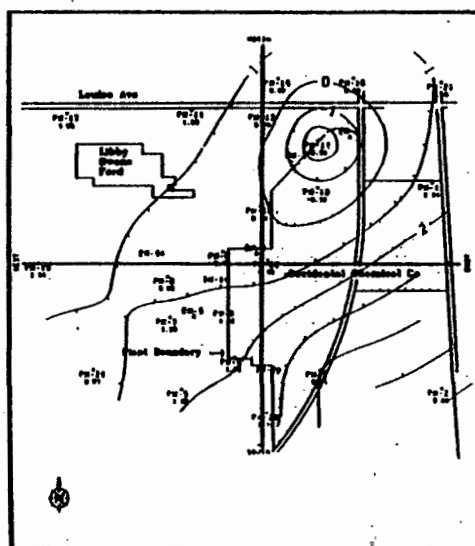
Figure 10
CONTOUR PLOTS OF WATER LEVEL ELEVATIONS
IN THE DEEP ZONE, 1989 AND 1990
OCCIDENTAL CHEMICAL SITE

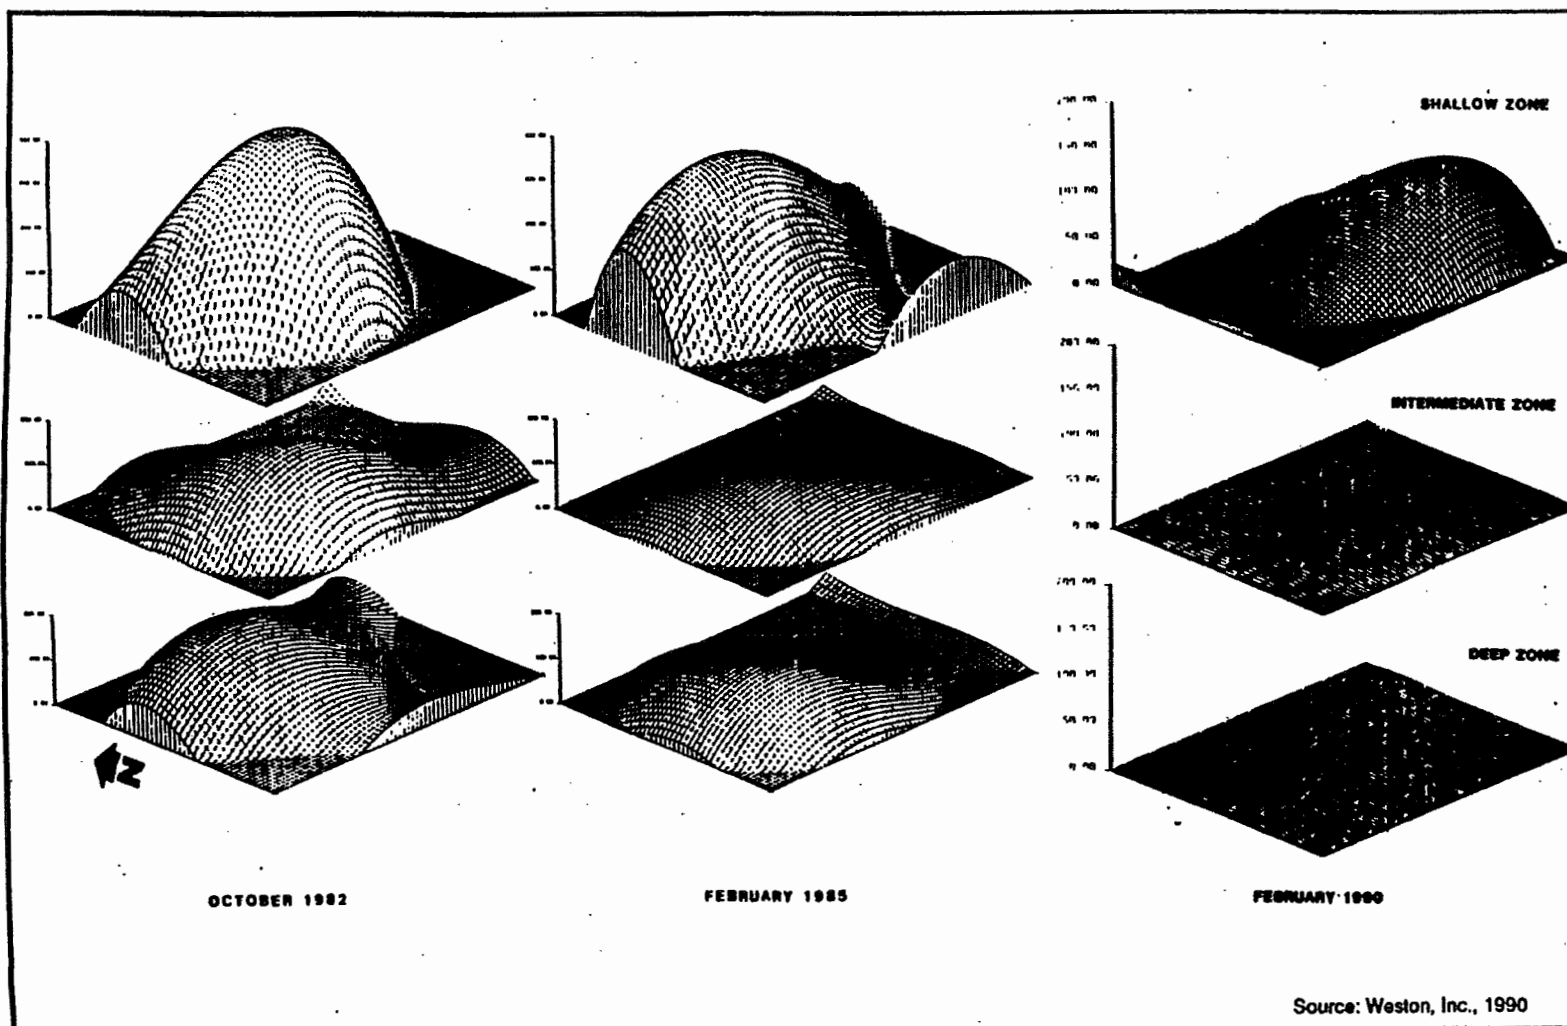
Figure 12
TREND SURFACE OF DBCP CONCENTRATIONS IN THE
CENTER OF THE SITE, OCTOBER 1982 TO FEBRUARY 1990
OCCIDENTAL CHEMICAL SITE

Figure 12 is a three-dimensional plot of the trend surface of DBCP concentrations in the three zones from October 1982 to February 1990. This figure clearly shows that the concentration of DBCP has decreased substantially since 1982. Note that the vertical scale used for the February 1990 data is twice that used in the other two plots, so reductions are even greater than they appear.

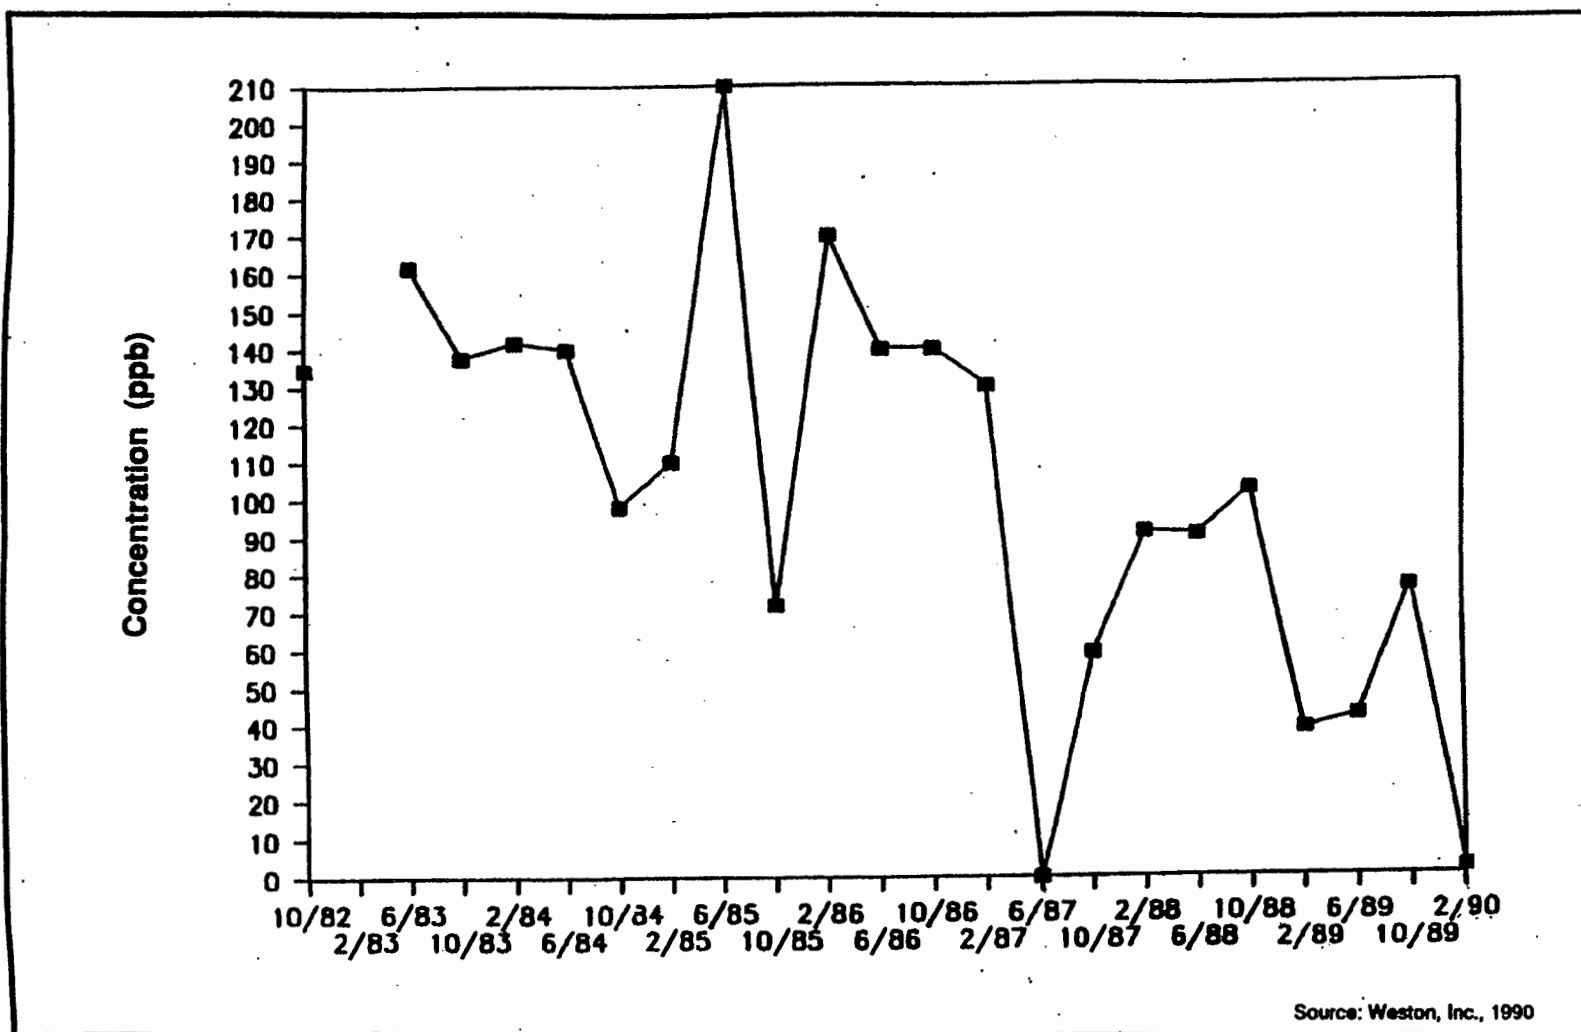
Figure 13
CONCENTRATION OF DBCP IN PW-6-197,
OCTOBER 1982 TO FEBRUARY 1990
OCCIDENTAL CHEMICAL SITE

Figures 13, 14, and 15 show the trend in DBCP concentrations from October 1982 to February 1990 in monitoring Wells PW-6-197, PW-8-150, and PW-22-71, respectively. Well PW-6-197 is the deep zone monitoring well at PW-6, located along the western boundary of the plant. Figure 13 shows a steep initial drop in DBCP concentrations followed by a steady decrease through the end of 1986. Concentrations in PW-6-197 appear to have stabilized at approximately 10-15 ppb since the end of 1986. This pattern of steep initial decreases followed by more gradual reductions was observed in many of the monitoring wells. The concentrations of DBCP in several cells decreased to below detection limits by the end of 1986.

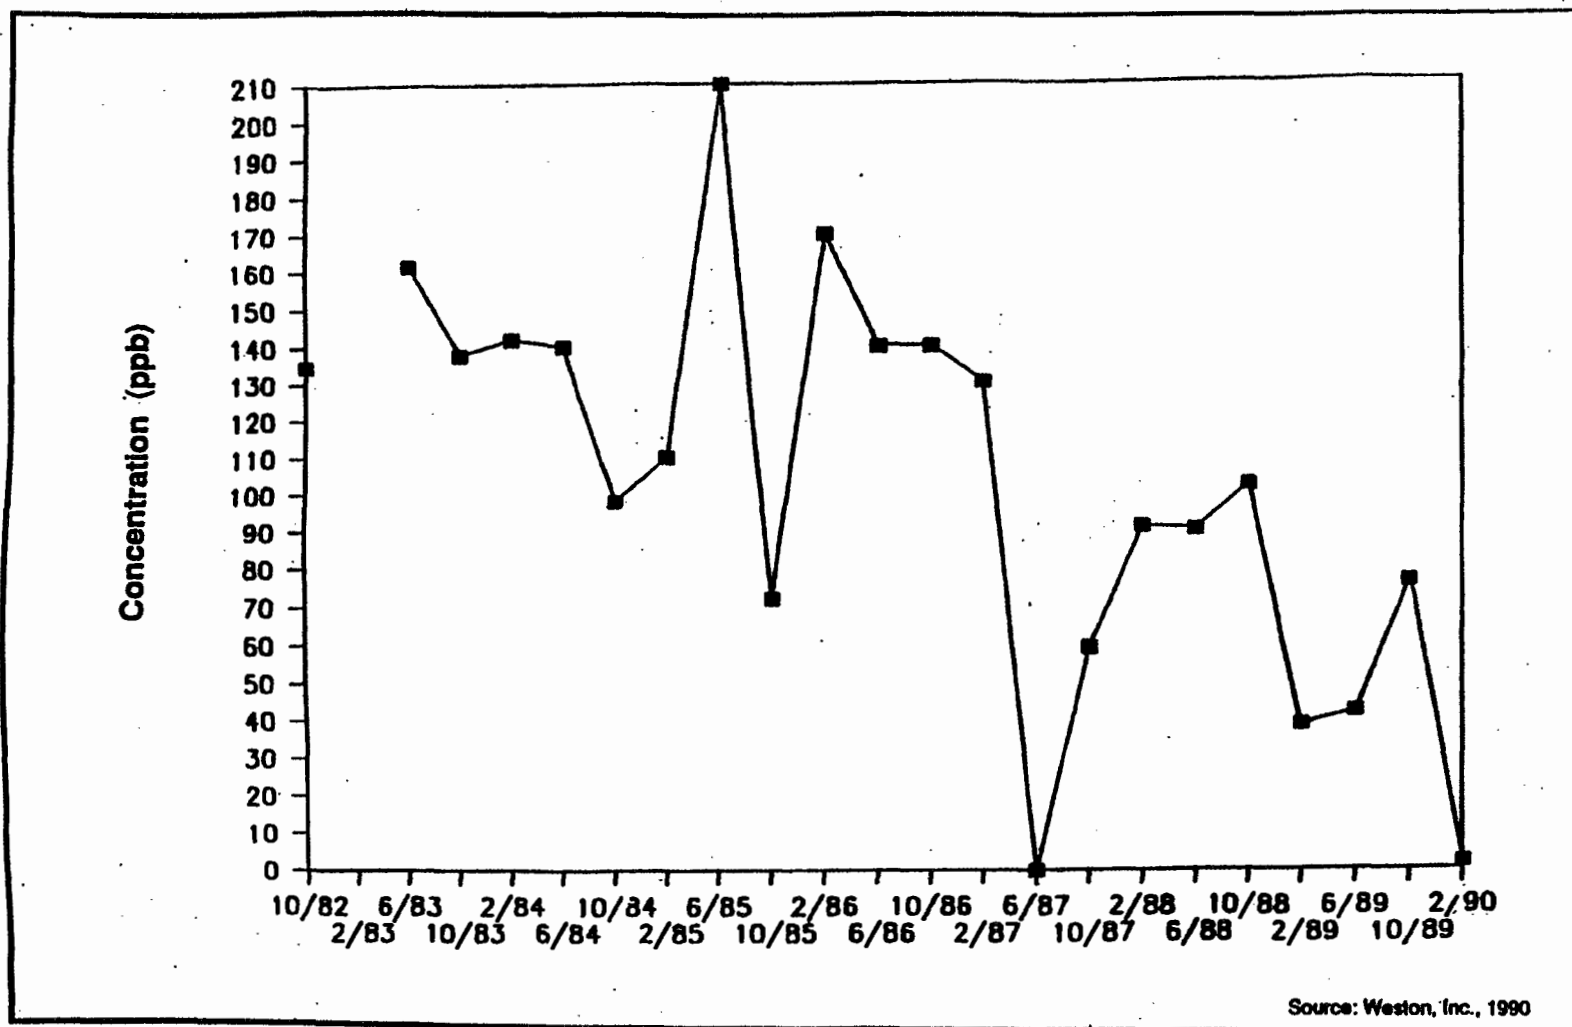
Figure 14
CONCENTRATION OF DBCP IN PW-8-150,
OCTOBER 1982 TO FEBRUARY 1990
OCCIDENTAL CHEMICAL SITE

Other wells have shown a more gradual decrease and greater variability in DBCP concentrations since 1982 than PW-6-197. An example of this trend is the data from PW-8-150 shown in Figure 14. PW-8-150 is the intermediate zone monitoring well at PW-8, located on the northwest corner of the former Western Storage area. The DBCP concentration in PW-8-150 decreased from approximately 150 ppb in early 1983 to approximately 30 ppb at the end of 1989. The reason for the sharp increases and decreases seen in the concentration trend is not known. However, the increases and decreases appear to be seasonal. Overall, the plots display general decreasing groundwater contamination levels.
