Evaluation of Ground-Water Extraction Remedies: Phase II

Volume 2 Case Studies and Updates

Volume 2 Case Studies

Office of Emergency and Remedial Response
U. S. Environmental Protection Agency
Washington, D.C.

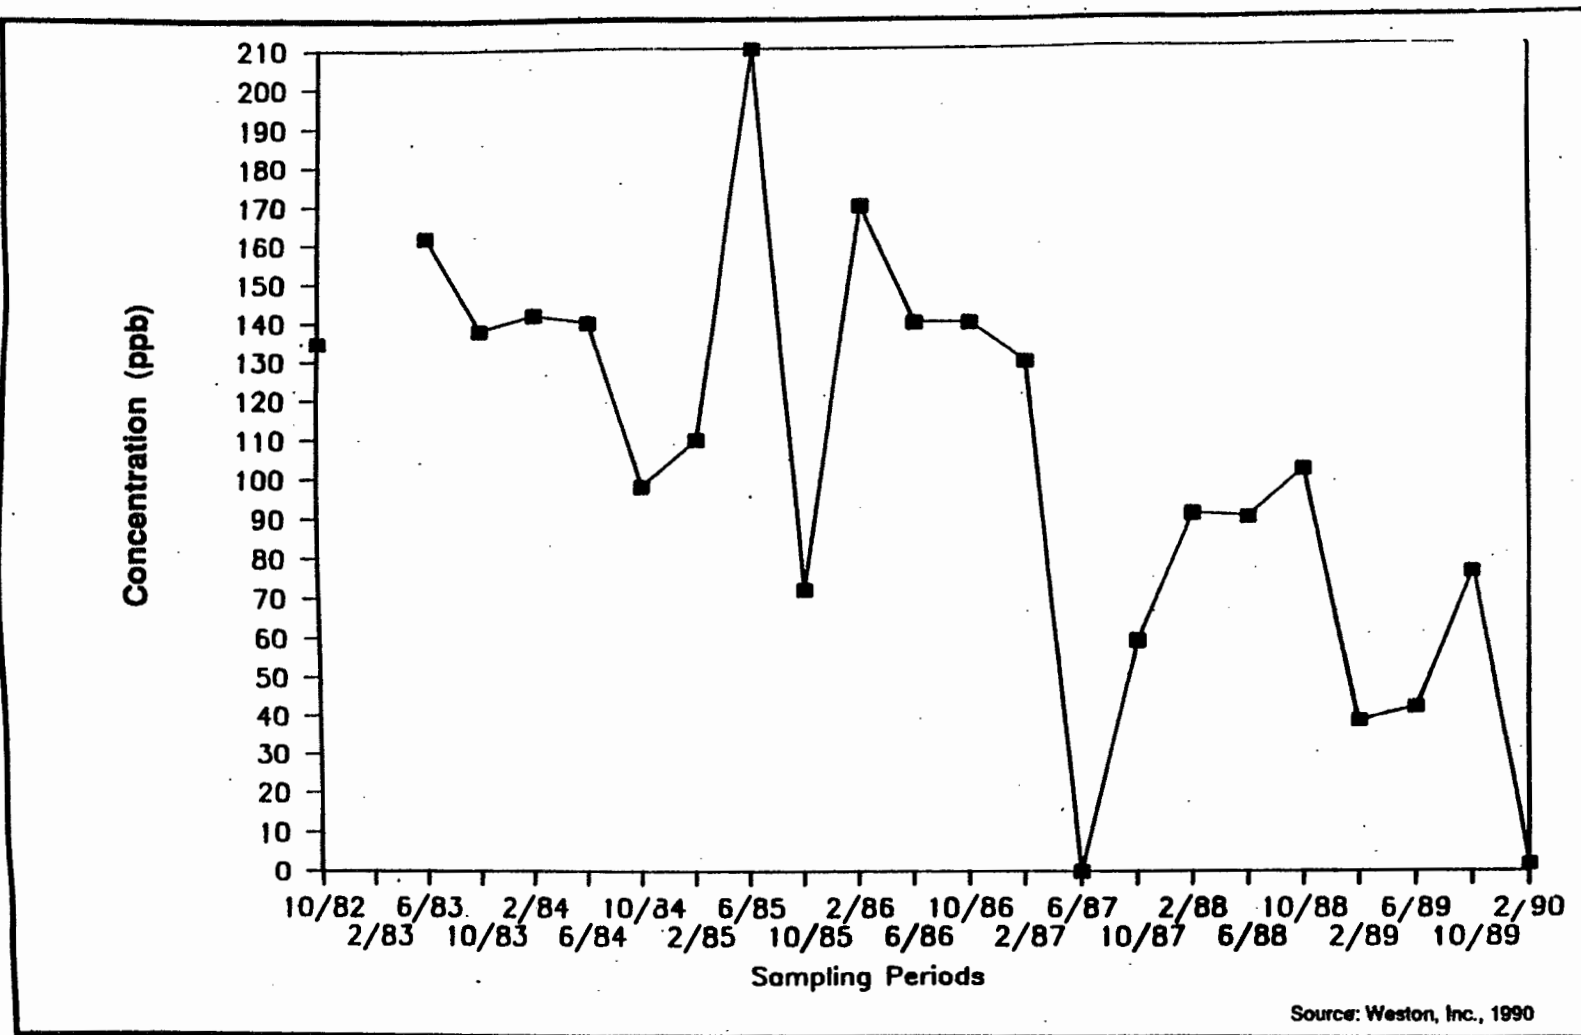
Figure 15
CONCENTRATION OF DBCP IN PW-22-71
OCTOBER 1982 TO FEBRUARY 1990
OCCIDENTAL CHEMICAL SITE

The concentration trend in PW-22-71 has been extremely variable since late 1982, as shown in Figure 15. PW-22-71 is the high-concentration monitoring well that was converted to use as an intermittent extraction well in December 1989. The reason for the high variability and long term stability in DBCP concentrations is not clear, however, the proximity of this well to the Western Storage area suggests that the stability and variability may be the result of a residual source of DBCP in the soil.

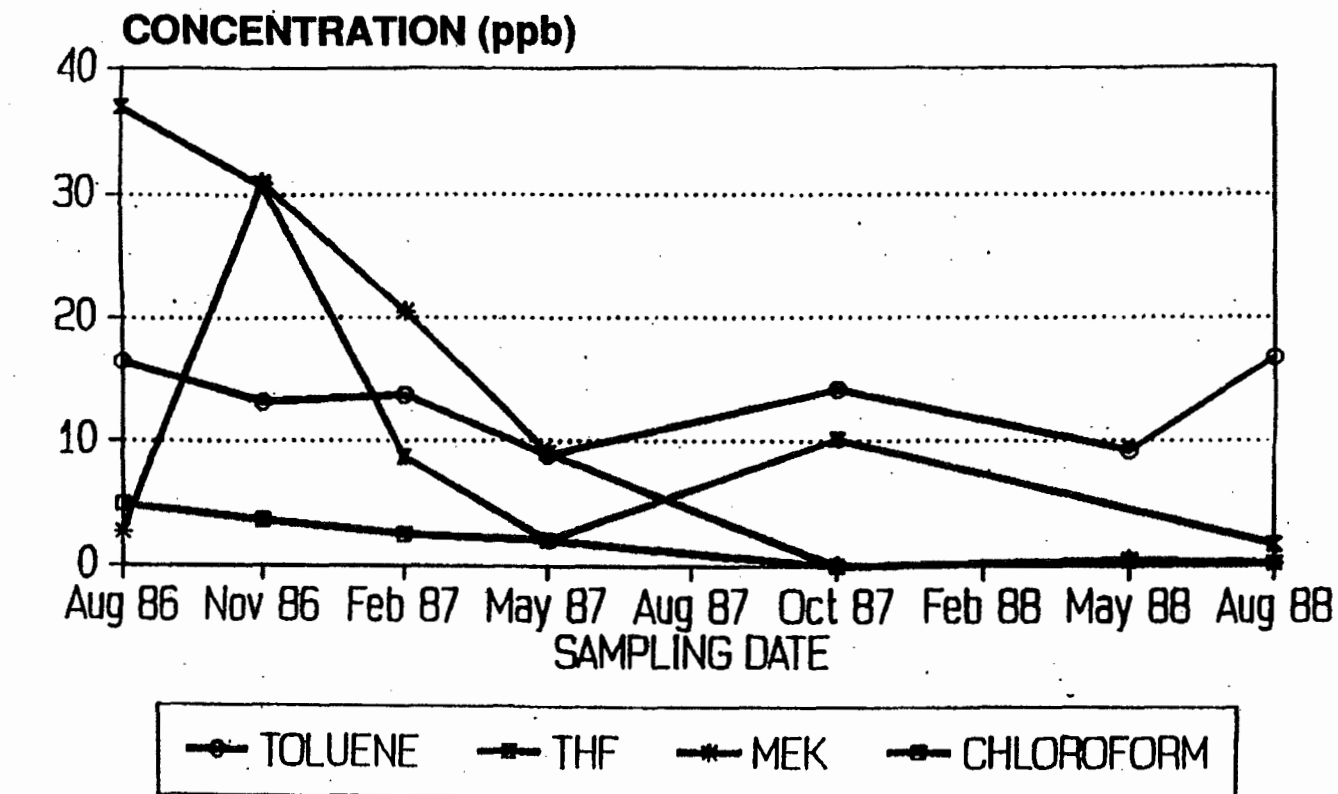
GILSON ROAD SITE, NASHUA, NH
DATA FROM M&E, ECJ, & STATE LAB

Figure 9
SELECTED VOCs IN TREATMENT
PLANT INFLUENT
SYLVESTER/GILSON ROAD SITE

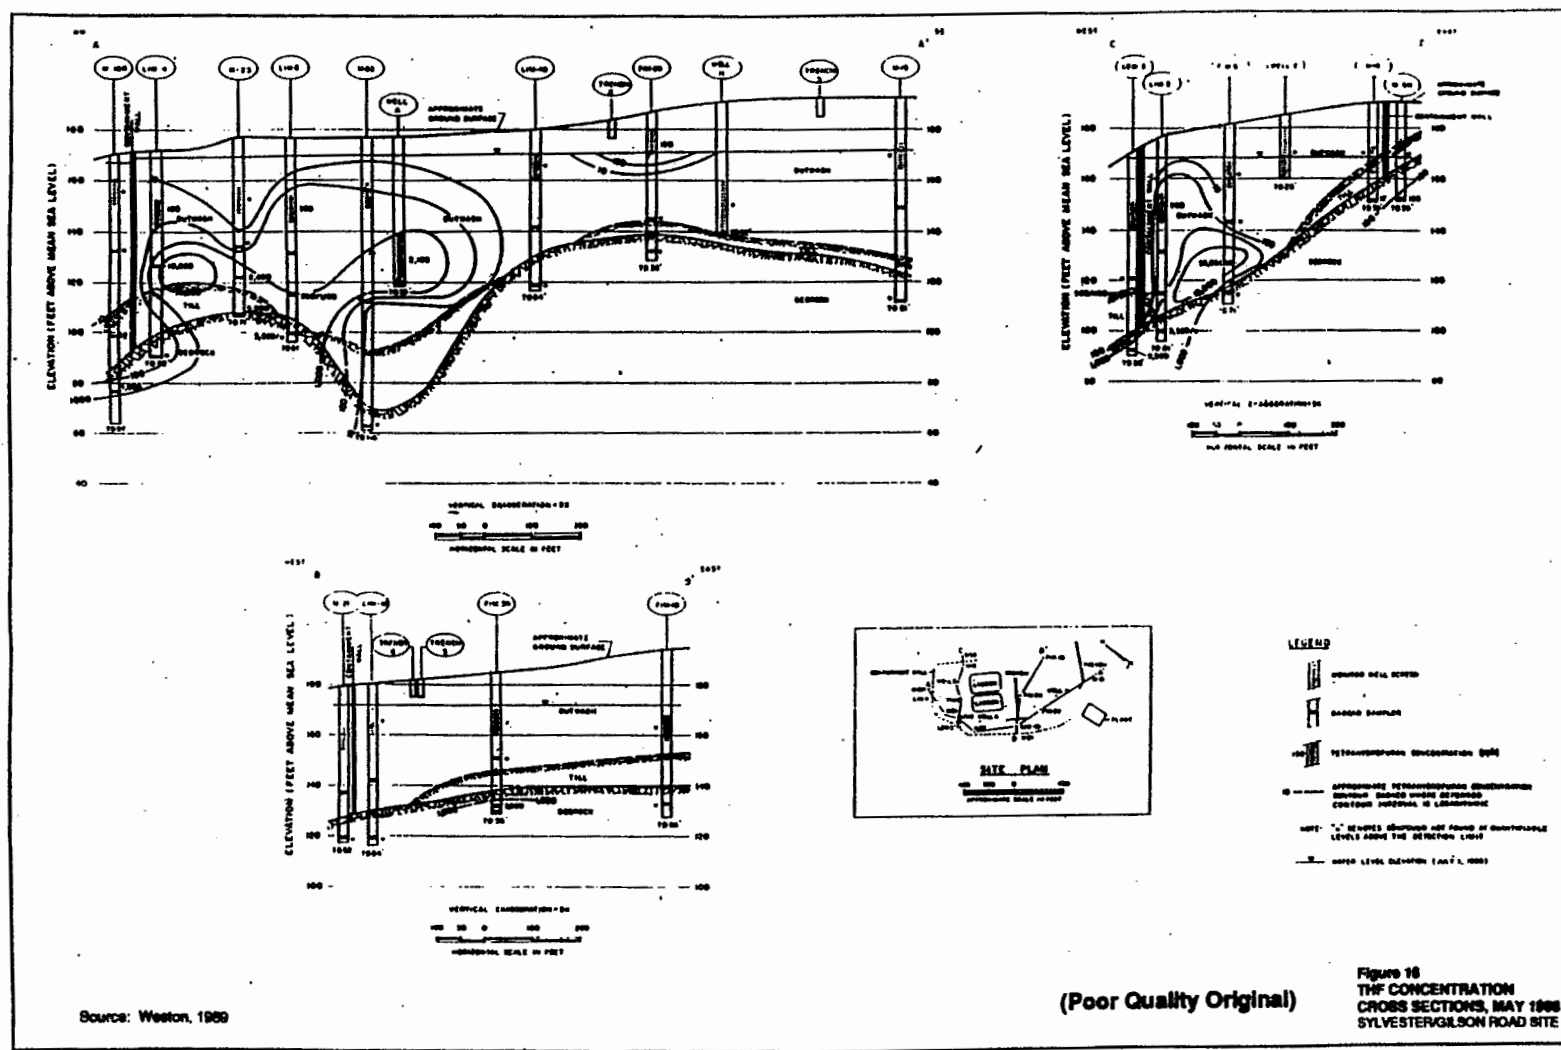
Figure 16
THF CONCENTRATION
CROSS SECTIONS, MAY 1988
SYLVESTER/GILSON ROAD SITE

Contour maps of THF concentrations and 1,1-DCA concentrations in May 1988 are presented in Figures 14A, 14B, 15A, and 15B. Cross-sections of THF concentrations are presented in Figure 16. Areas with high THF concentrations do not correspond to areas with high VOC concentrations in 1988 as they did in 1980. THF is no longer the dominant plume contaminant. Areas of high 1,1-DCA concentration appear to correspond with areas of high toluene concentrations. Both 1,1-DCA and toluene have relatively low water solubility.

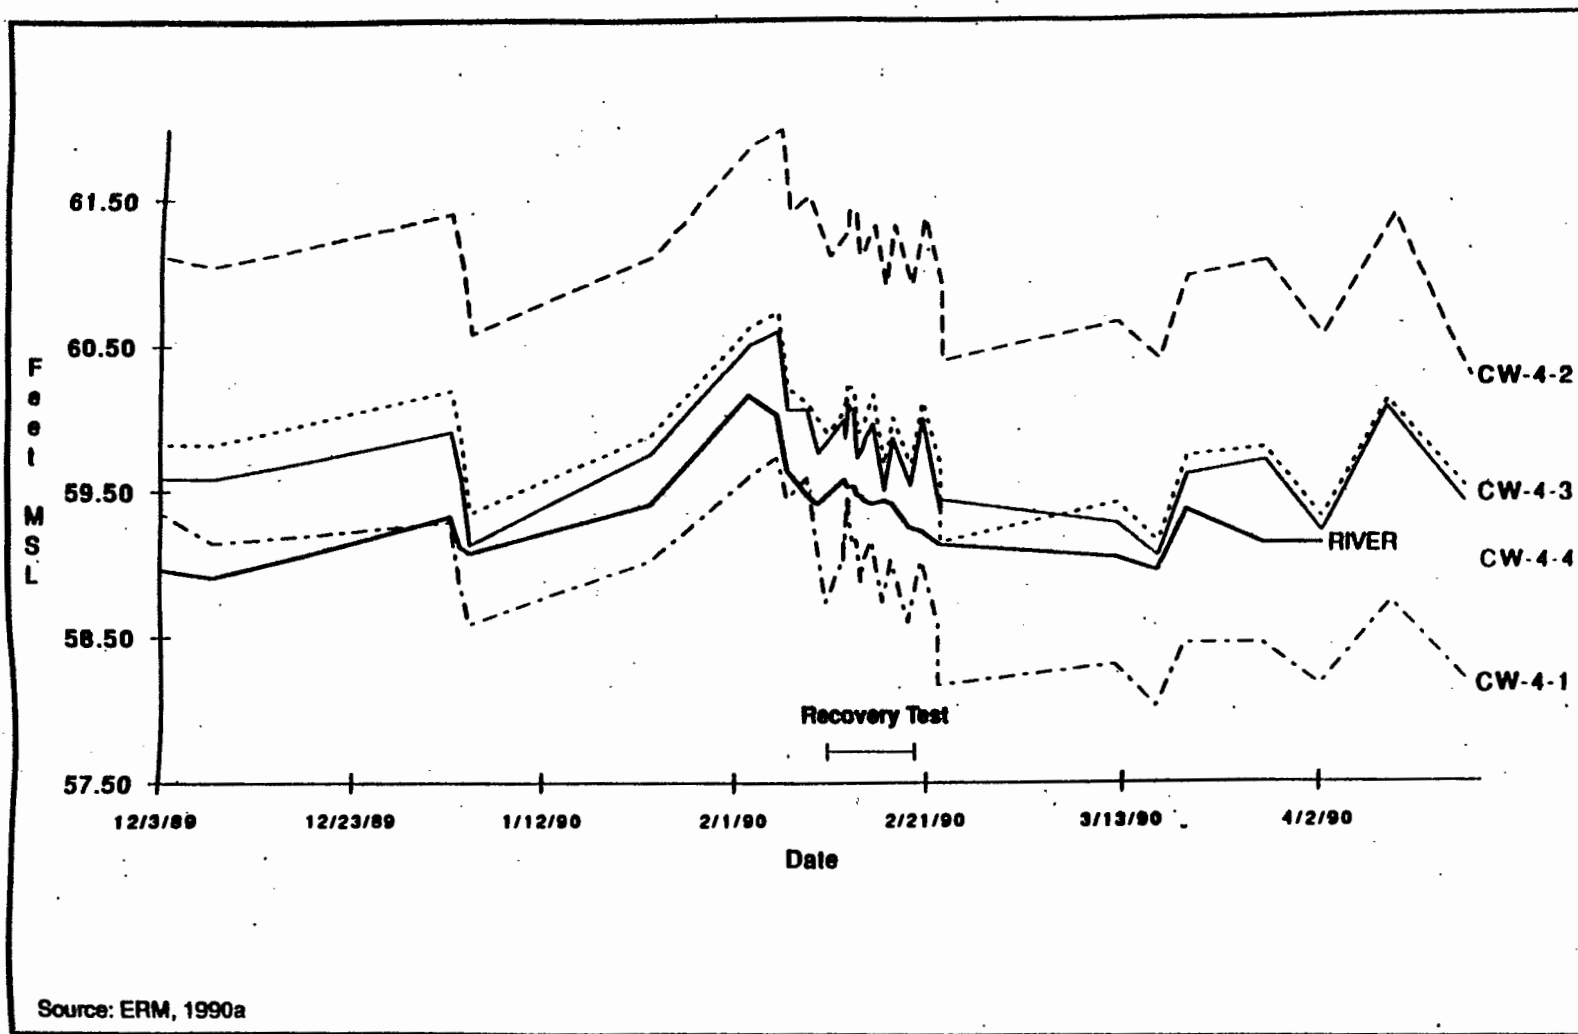
Figure 8
RESPONSE OF WELL CLUSTER CW-4
TO CHANGES IN RIVER LEVEL AND TO
THE FEBRUARY 1990 RECOVERY TEST
TYSON'S DUMP SITE

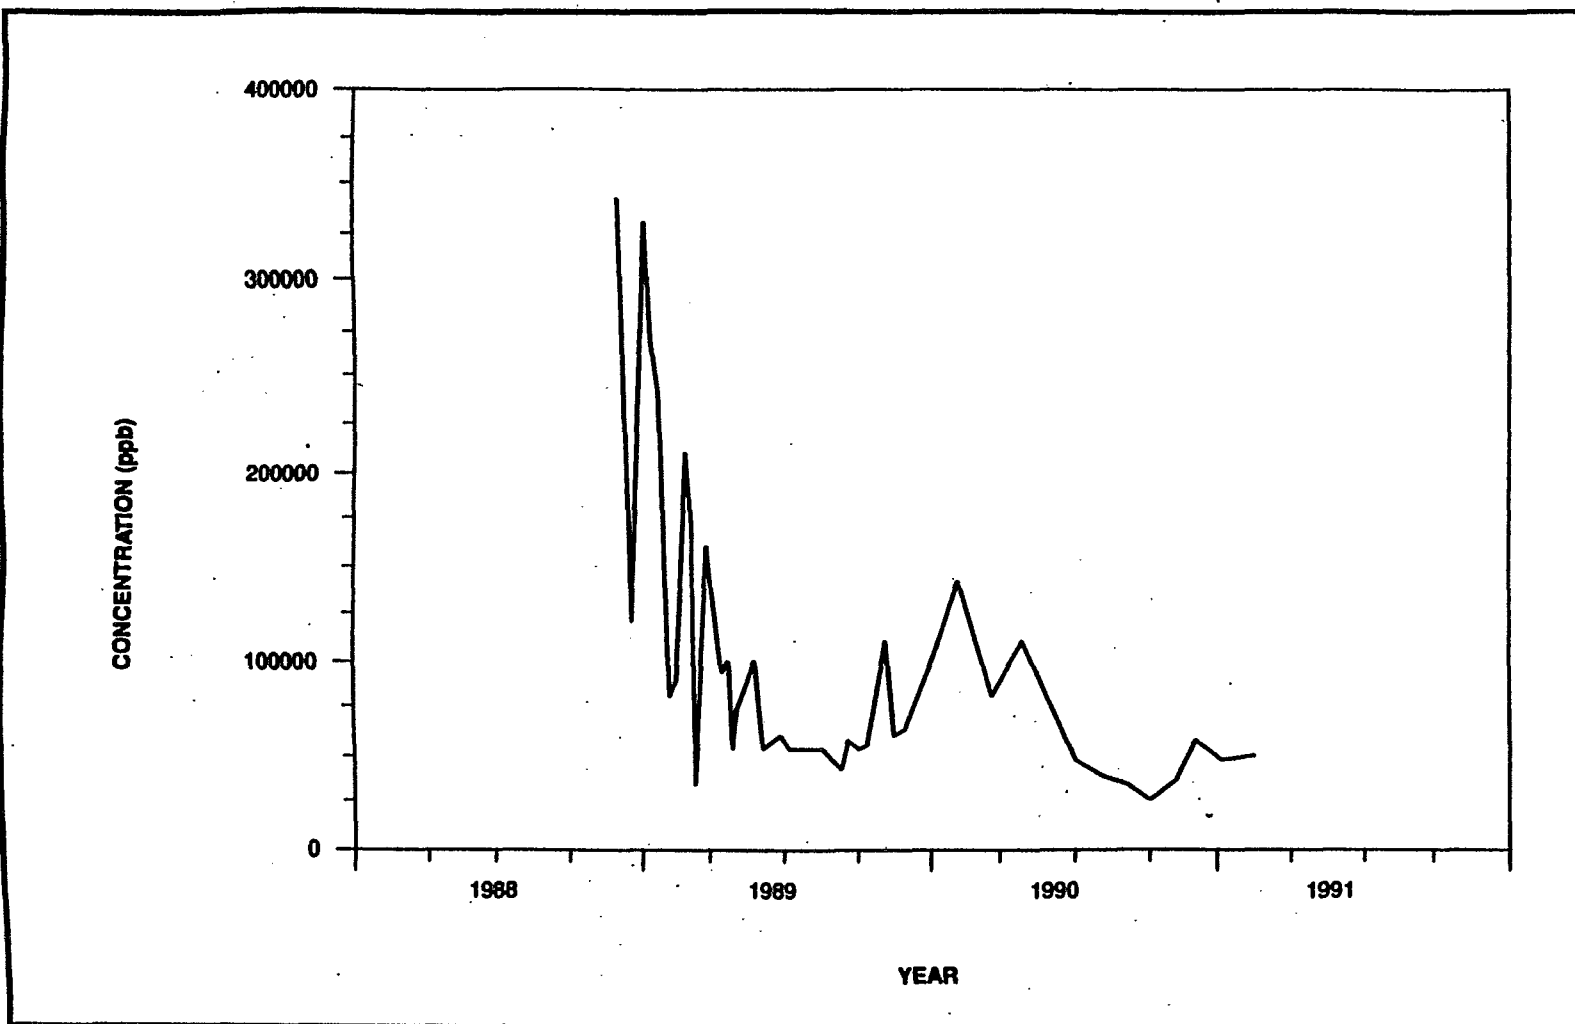
Figure 23
CONCENTRATION OF 1,2,3-TRICHLOROPROPANE
IN THE INFLUENT TO THE GROUND-WATER
TREATMENT SYSTEM
TYSON'S DUMP SITE

observed after even brief shutdown of the extraction system (ERM, 1991b). The concentrations of 1,2,3-TCP in the influent to the ground-water treatment system shown in Figure 23 also shows that the concentration of 1,2,3-TCP entering the extraction system along the river front has decreased since startup.

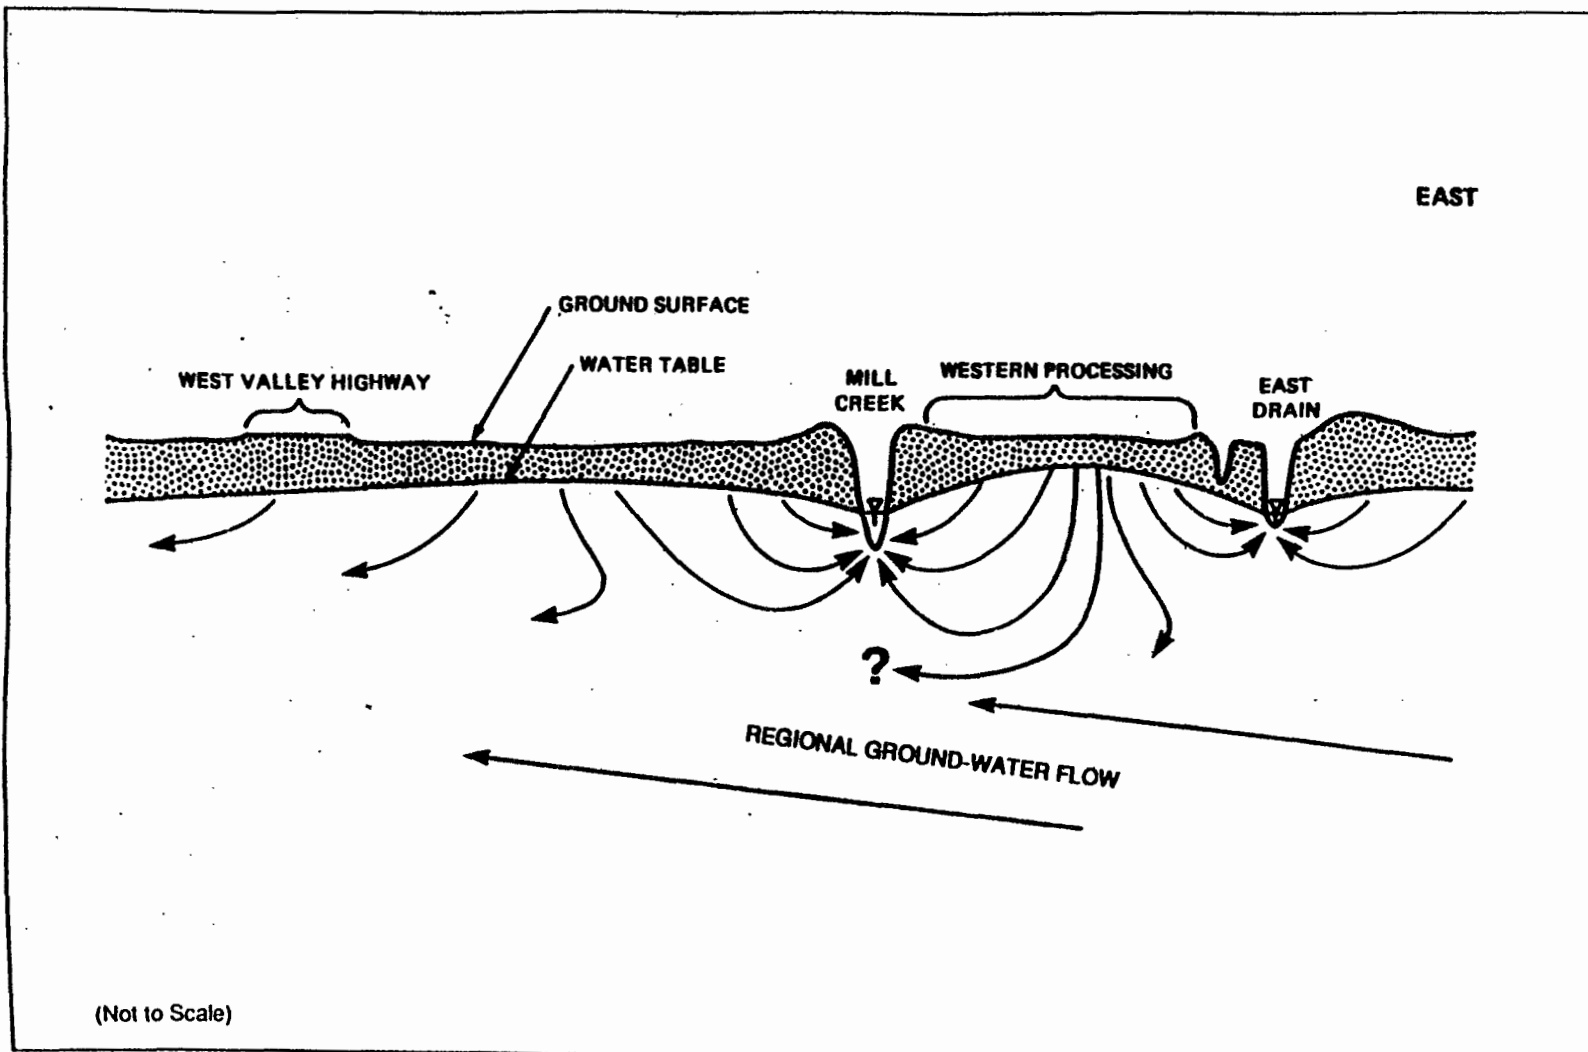
Figure 4
SCHEMATIC REPRESENTATION OF LOCAL
GROUND-WATER FLOW SYSTEM
WESTERN PROCESSING SITE

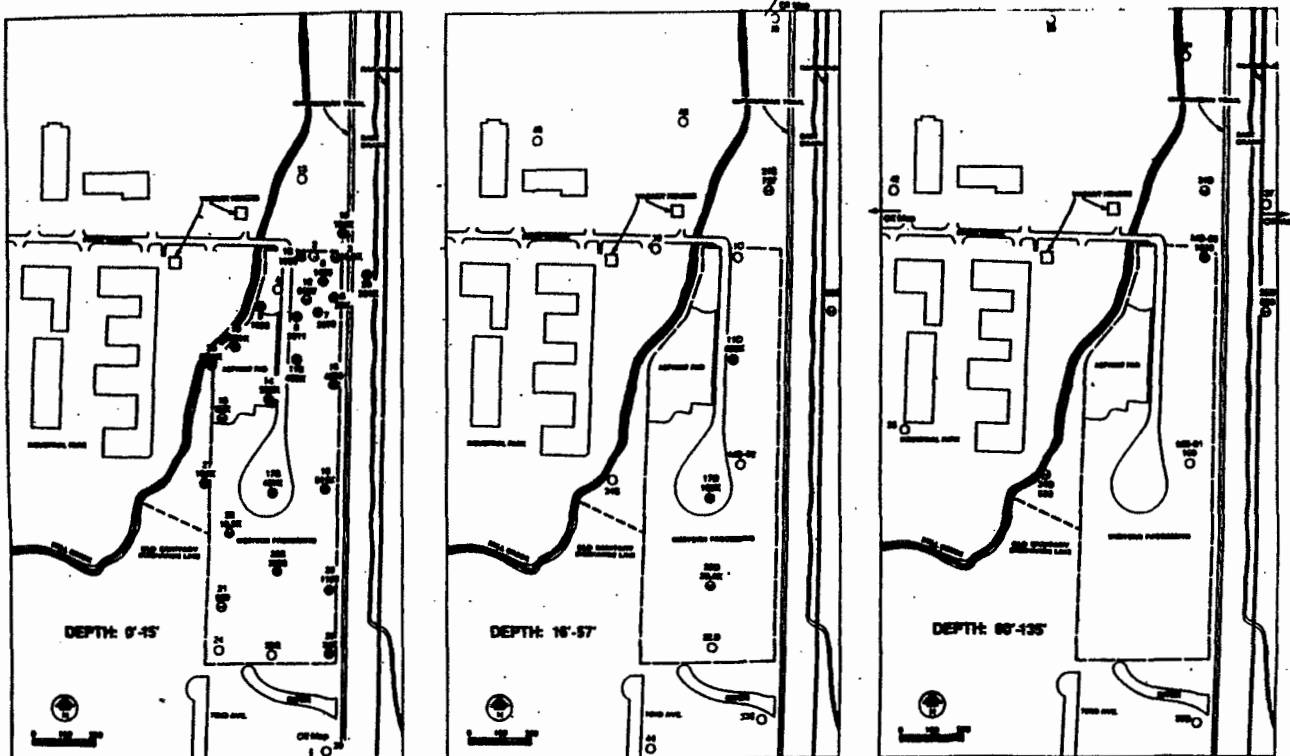
Figure 6
INDICATOR PRIORITY POLLUTANT
METALS IN GROUND WATER
WESTERN PROCESSING SITE

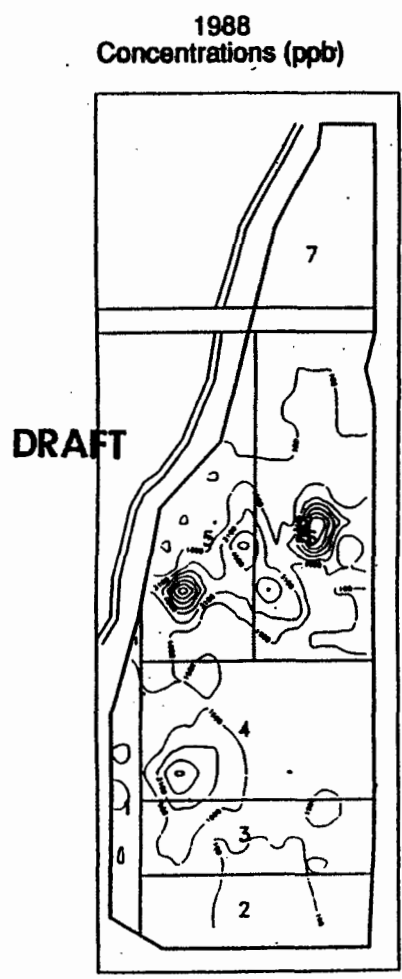
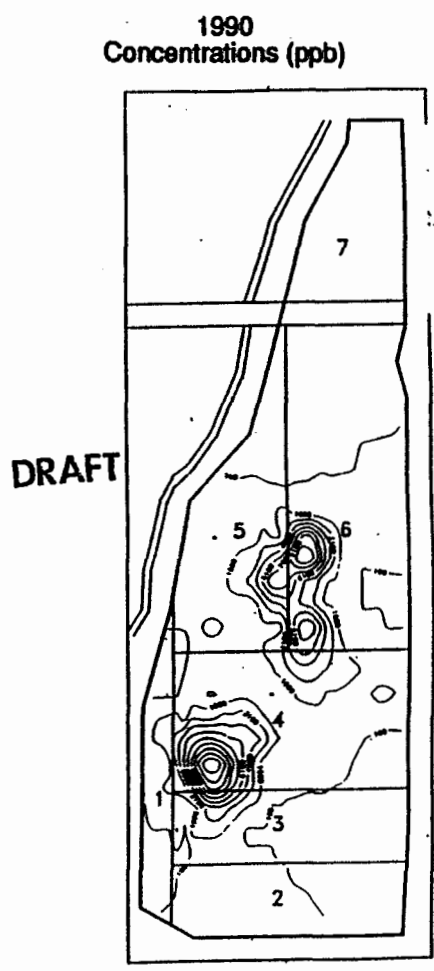
Figure 11
CHLOROFORM WELL POINT
CONCENTRATION CONTOUR MAPS
1988 AND 1990
WESTERN PROCESSING SITE

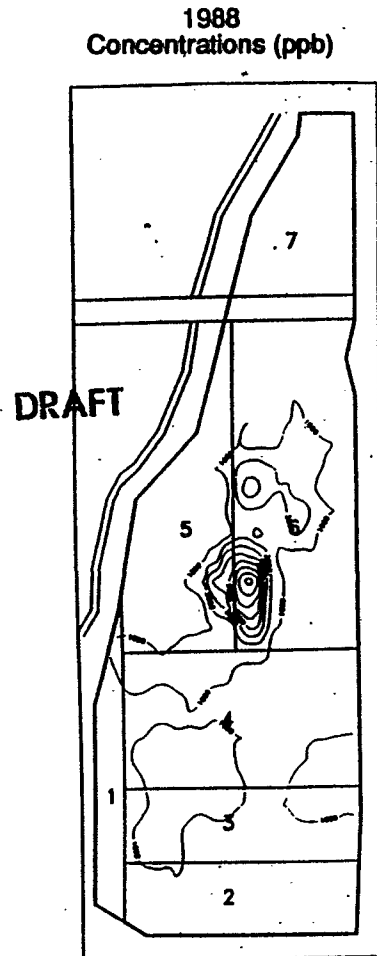
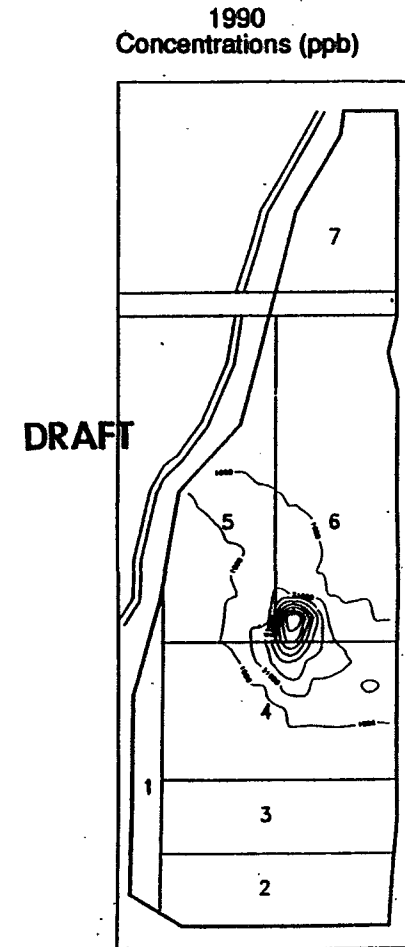
Figure 12
TOLUENE WELL POINT
CONCENTRATION CONTOUR MAPS
1988 AND 1990
WESTERN PROCESSING SITE

Figure 12 shows well point concentration maps for toluene in 1988 and 1990. In 1988, the toluene plume extended throughout the central portion of the site with a maximum concentration of 12,000 ppb. No concentrations in excess of 1,000 ppb were observed at the northern end of the site as they had been in 1984. In 1990, considerably higher concentrations were observed in the central site with a maximum of 180,000 ppb. Toluene has a specific gravity of 0.87 and lower aqueous solubility (515 mg/l) than most indicator organics.

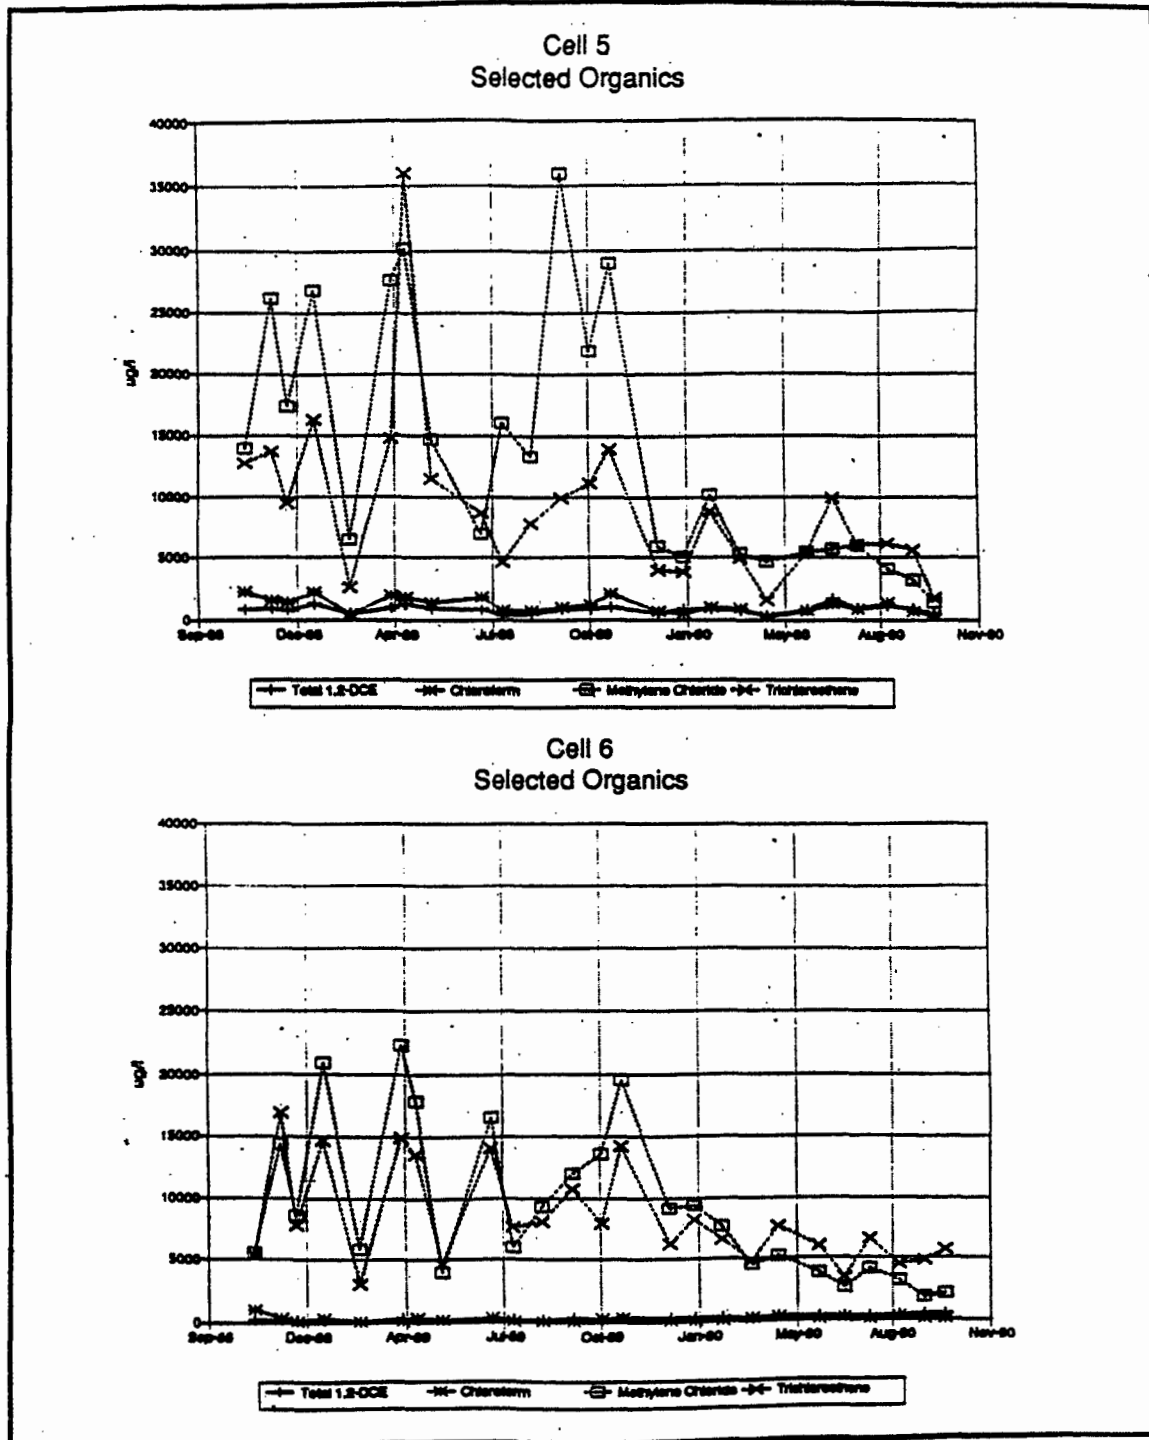
**Figure 14
SELECTED ORGANICS
CONCENTRATIONS
IN GROUND WATER EXTRACTED FROM
CELLS 5 AND 6
WESTERN PROCESSING SITE**

Samples of extracted ground water in well point cell headers have been analyzed for indicator compounds since the extraction system began operating. Plots of concentrations versus time are presented in Figure 14 for total 1,2-DCE, chloroform, methylene chloride, and TCE. Figure 14 presents data from Cells 5 and 6, which are two of the most highly contaminated cells. The plots show highly variable, but declining,

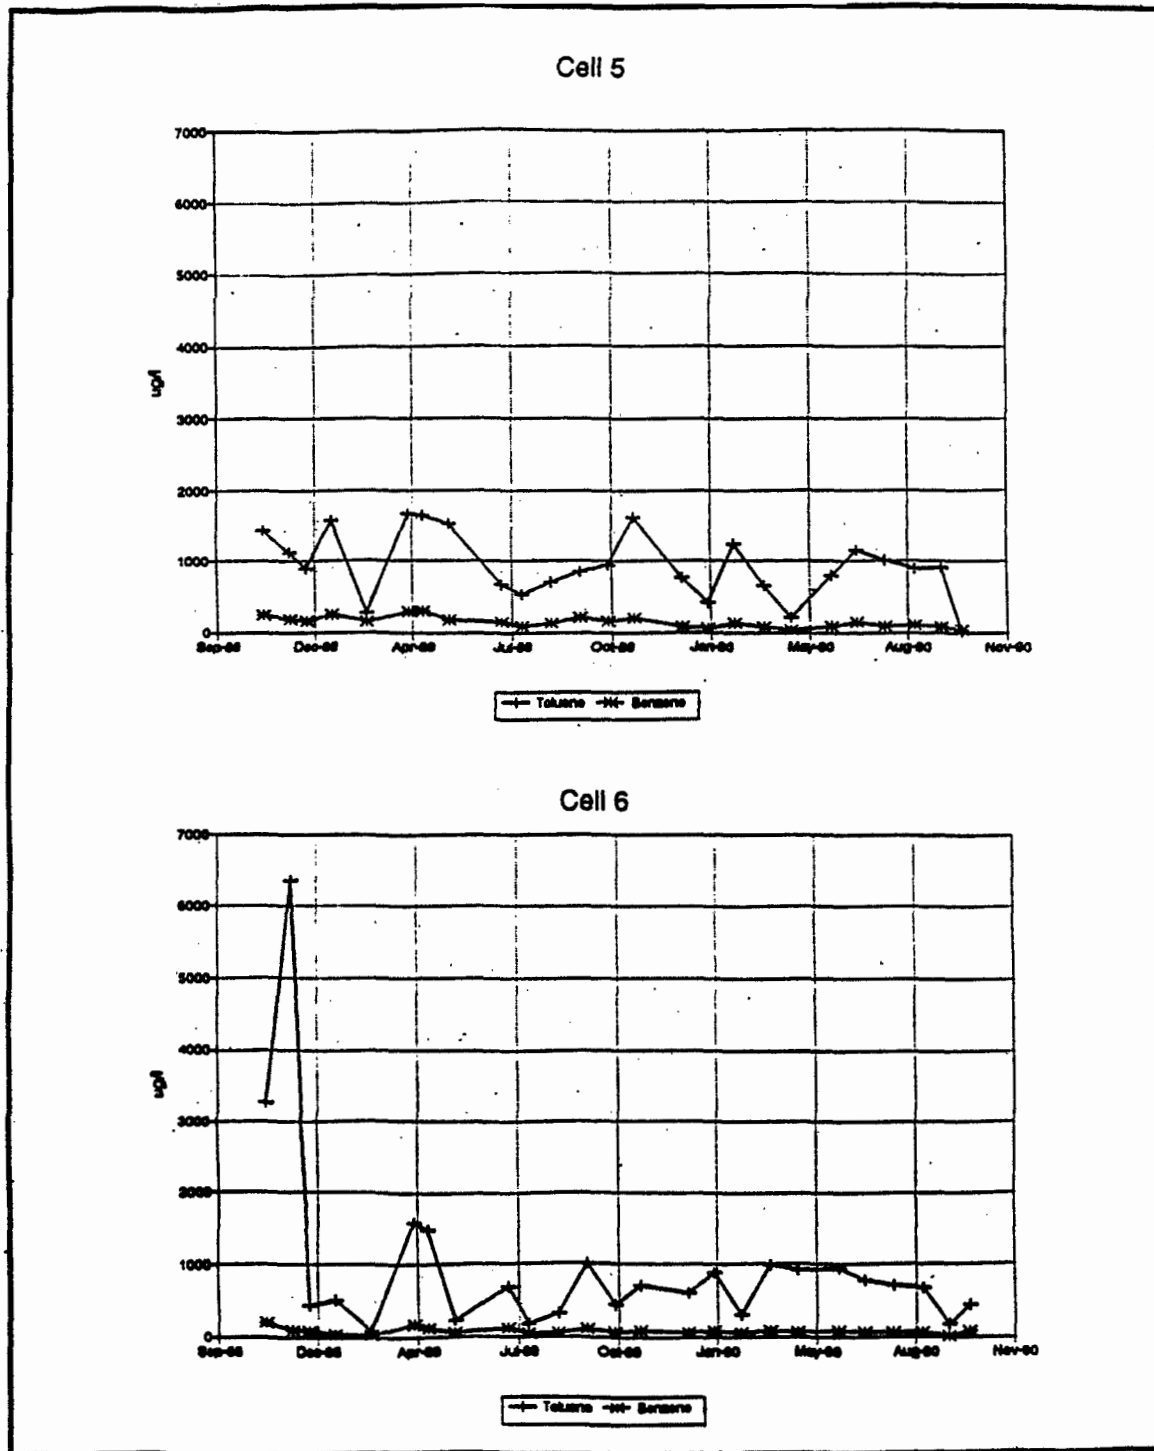
Figure 15
BENZENE AND TOLUENE
CONCENTRATIONS IN GROUND WATER
EXTRACTED FROM CELLS 5 AND 6
WESTERN PROCESSING SITE

methylene chloride and TCE concentrations from late 1988 to late 1990. Figure 15 presents well point cell header concentrations for benzene and toluene over time in Cells 5 and 6. In Cell 5, a small declining trend in benzene concentration is evident; however, no long-term trend is evident in the toluene plot. In Cell 6, there is a significant decline in toluene concentrations from October 1988 to July 1989, but no long-term trend is evident.

Ground-water concentrations of toluene were not particularly high when measured during the remedial investigation in 1984. In 1990, however, after two years of ground-water remediation, concentrations as high as 180,000 ppb were recorded. This is approximately 34 percent of the aqueous solubility of toluene. High toluene concentrations were not measured in the early ground-water samples possibly because the monitoring wells were screened below the water table, which was only a few feet below the ground surface. When the water table was drawn down by extraction from the well points, a floating layer of toluene would be drawn down with it, and higher concentrations might be measured. The records of blended toluene concentrations for Cells 5 and 6, shown in Figure 15, show little or no
