Performing Onboard Diagnostic System Checks as Part of a Vehicle Inspection and Maintenance Program

David Sosnowski
Edward Gardetto
Transportation and Regional Programs Division
Office of Transportation and Air Quality
U.S. Environmental Protection Agency

June 2001

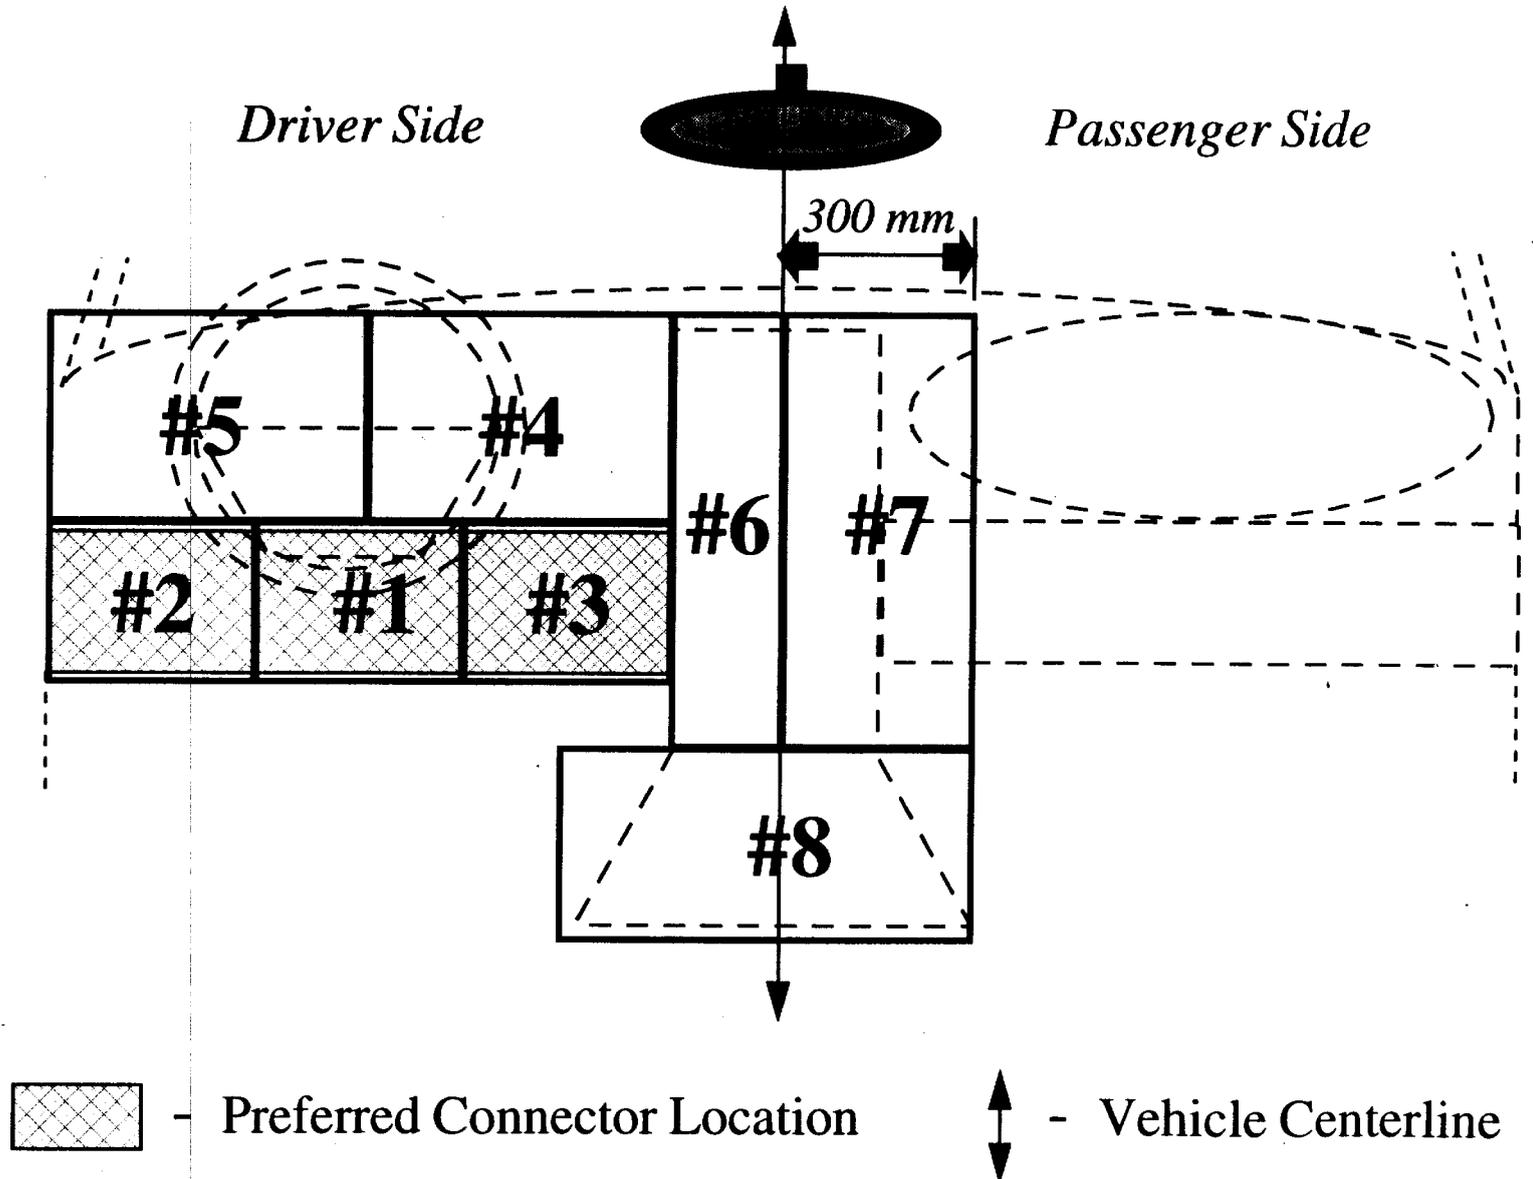
Diagnostic Link Connector Mapping Diagram

Diagnostic Link Connector (DLC) Mapping Diagram Explanation

The mapping diagram of DLC locations contains a divided instrument panel (IP) with numbered areas. Each numbered area represents specific sections of the IP where manufacturers may have located DLCs. This document briefly clarifies the numbered locations on the mapping diagram. Areas 1-3 fall within the preferred DLC location while the remaining areas, 4-8, fall into the allowable DLC location according to EPA requirements. Areas 4-8 require that manufacturers label the vehicle in the preferred location to notify parties of the alternate connector location.

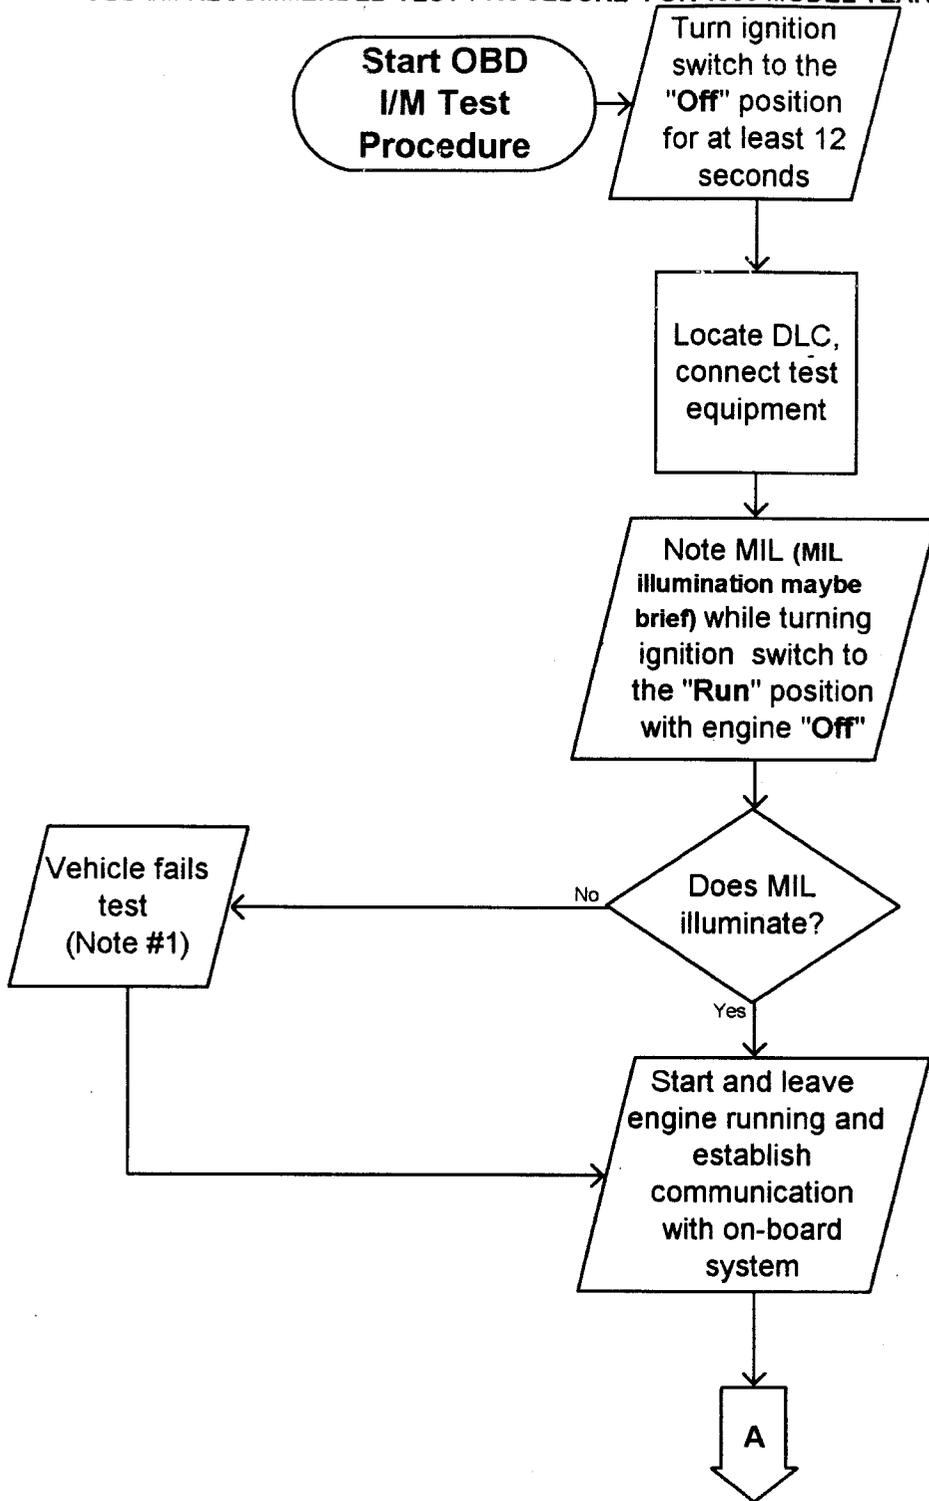
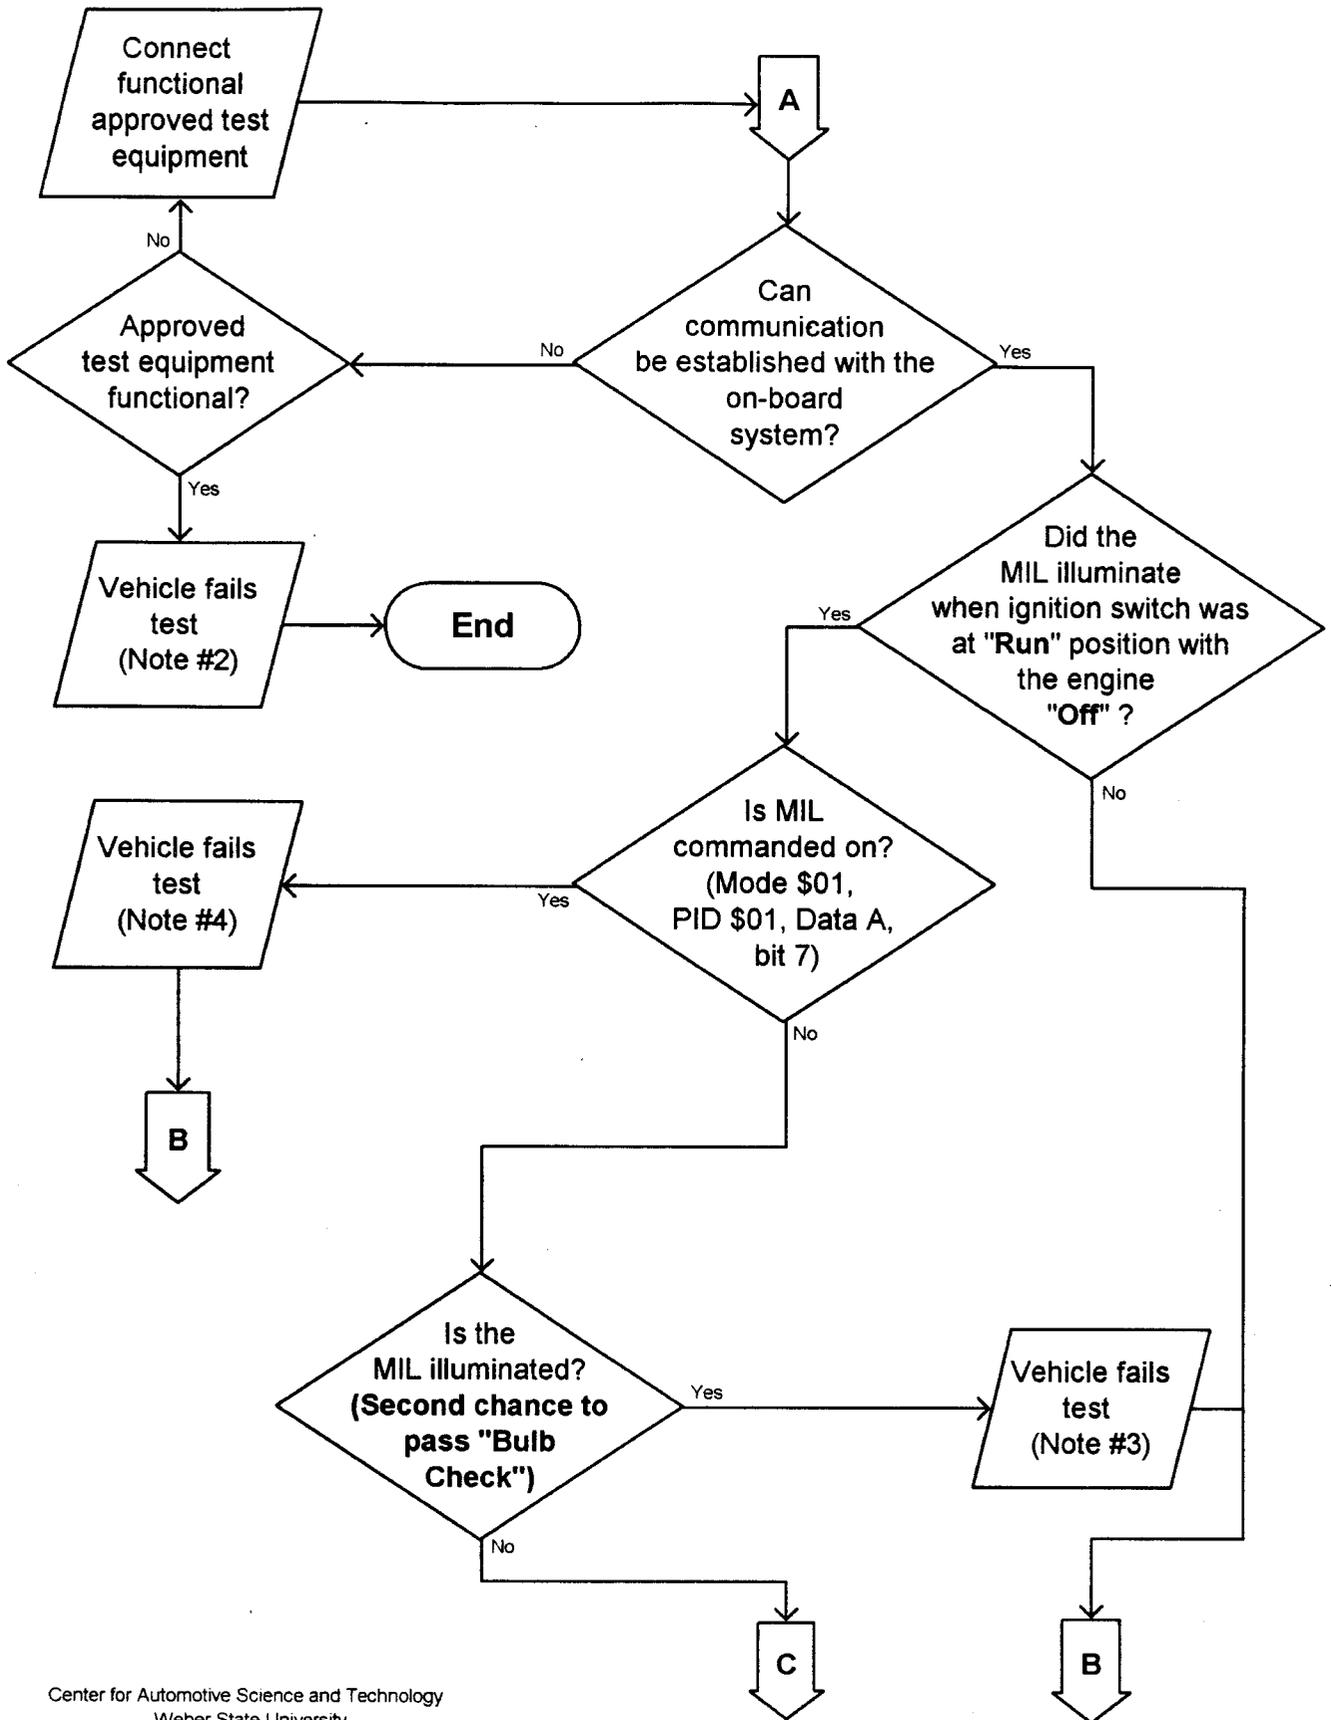
OBD I/M RECOMMENDED TEST PROCEDURE FOR 1996 MODEL YEAR AND NEWER VEHICLES

OBD-I/M Test Procedure Flow Chart

Notes on flow chart:

- Note 1:** The purpose of this step is to verify the On-Board Diagnostic (OBD) system has control of the Malfunction Indicator Light (MIL) and the MIL is functional. Operation of the MIL varies between vehicle manufacturers. Key On Engine Off (KOEO) typically results in the MIL on steady, however, there are systems which will illuminate the MIL only briefly during KOEO. In either situation MIL presence and illumination capability has been established. If the vehicle fails the I/M test at this point, the vehicle inspection report should indicate the MIL problem should be repaired and also include information gathered during the remaining I/M test steps.

- Note 2:** It is important for the I/M testing personnel to verify proper diagnostic equipment operation before failing the vehicle. If the diagnostic equipment is functional then the vehicle's communication problem must be resolved. Without communication between the OBD system and the test equipment the I/M test must be ended and the problem resolved before further interrogation of the vehicle can be performed. This step includes identification of Data Link Connector (DLC) tampering, serial data circuit problems and any other condition that would prevent the OBD system from communicating with the test equipment.

- Note 3:** I/M test failure is a result of MIL illumination even though the OBD system has not commanded the MIL on, or has stored any Diagnostic Trouble Codes (DTCs); e.g., a serial data line failure between the OBD computer and the Instrument Panel.

- Note 4:** I/M test failure is a result of both the actual and commanded state of the MIL. DTCs should be stored since the MIL is commanded on. A vehicle **should not** fail an I/M test when DTCs are stored but there is no MIL on; e.g., the DTC was stored by a loose gas cap which was subsequently tightened.

- Note 5:** Readiness Code status must be identified at this stage in the I/M test to determine whether or not all emission control systems have been tested by the OBD system. If any one (or more) Readiness Code(s) are not set ("ready") the OBD system has not yet completed testing of the system(s) and failures may be present but not yet identified. It is important to understand that the vehicle **does not** fail the I/M test at this point; no emission related faults have been identified. The current state of the vehicle's emission control system is **undetermined**.
The emission control systems and related components are tested under specific vehicle operating conditions. Therefore, to set the Readiness Codes the vehicle must be operated within these specific conditions (commonly referred to as "enable criteria") for the OBD system tests to be performed. Once testing of an emission control system is complete, the related Readiness Code will be set ("ready"). When all Readiness Codes are set, the vehicle is ready for further I/M testing.

It will be at the states discretion whether to recommend the customer drive the vehicle to set the Readiness Codes or to take the vehicle for service. The state may also choose to use a dynamometer drive cycle.

Note 6: EPA has revised the current readiness code requirement to allow states to complete the testing process on model year 1996 thru 2000 vehicles with two or fewer unset readiness codes; for model year 2001 and newer vehicles, the testing process could still be complete provided there is no more than one unset readiness code. It is important to understand that the vehicle **does not** fail the I/M test because an unset readiness code is not itself an indication of an emission problem with the vehicle.
