PCBs, MINING, AND WATER POLLUTION

Dan W. Bench Region 8 PCB Coordinator U.S. Environmental Protection Agency 999 18th Street Denver, Colorado 80202-2466 (303) 312-6027

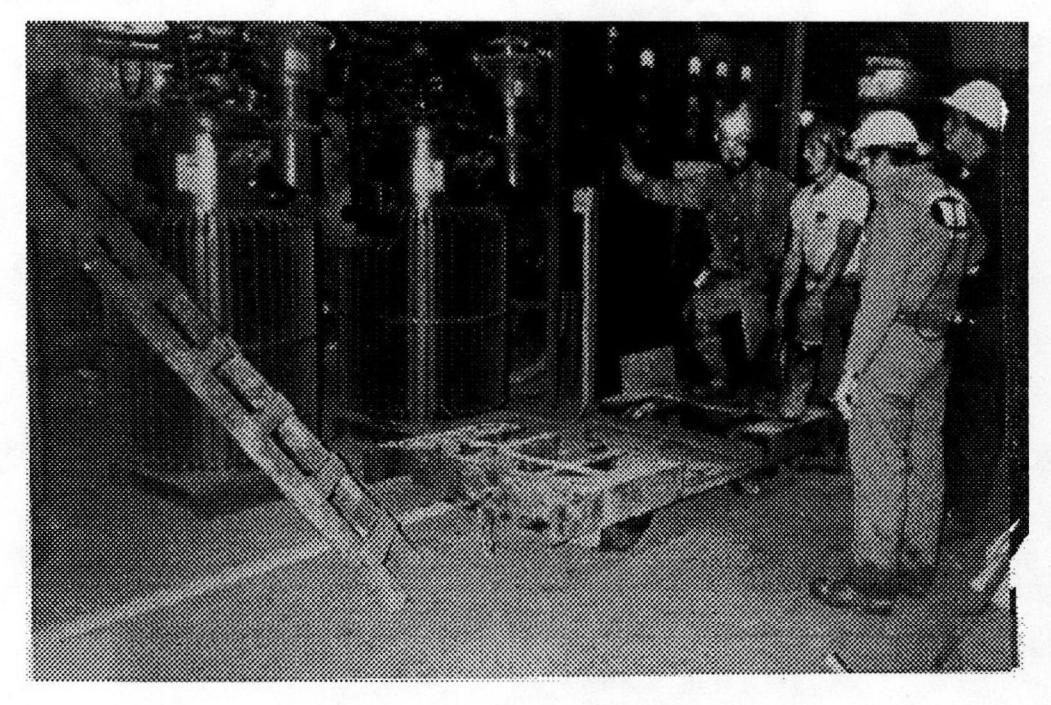
Fig. 1. 76 Gallon PCB Transformers (Cylindrical Objects with Cooling Fins) with PCB Marks

In the following discussion, underground mines are emphasized because abandoned PCB-containing equipment is likely to cause water pollution for which there may be no solutions. This can affect the environment and the health of down stream human and wildlife populations. PCBs are most likely to be in transformers as shown in Fig. 1., drums of used transformer oils, and capacitors as shown in Fig. 2. Transformers may be grouped in permanent substations, located singly, or mounted on mine cars that can be transported throughout the working areas of the mine. The regulations require these items to be identified by PCB marks if they contain 500 ppm (0.05%) or more PCBs. Transformer oils have been used for lubrication, dust suppression, or as fuels. Capacitors occur in similar locations to transformers; in addition, PCB-containing capacitors have been found in electric locomotives. In coal mines, capacitors are often in wheel or skid mounted power centers as shown in Fig. 3.

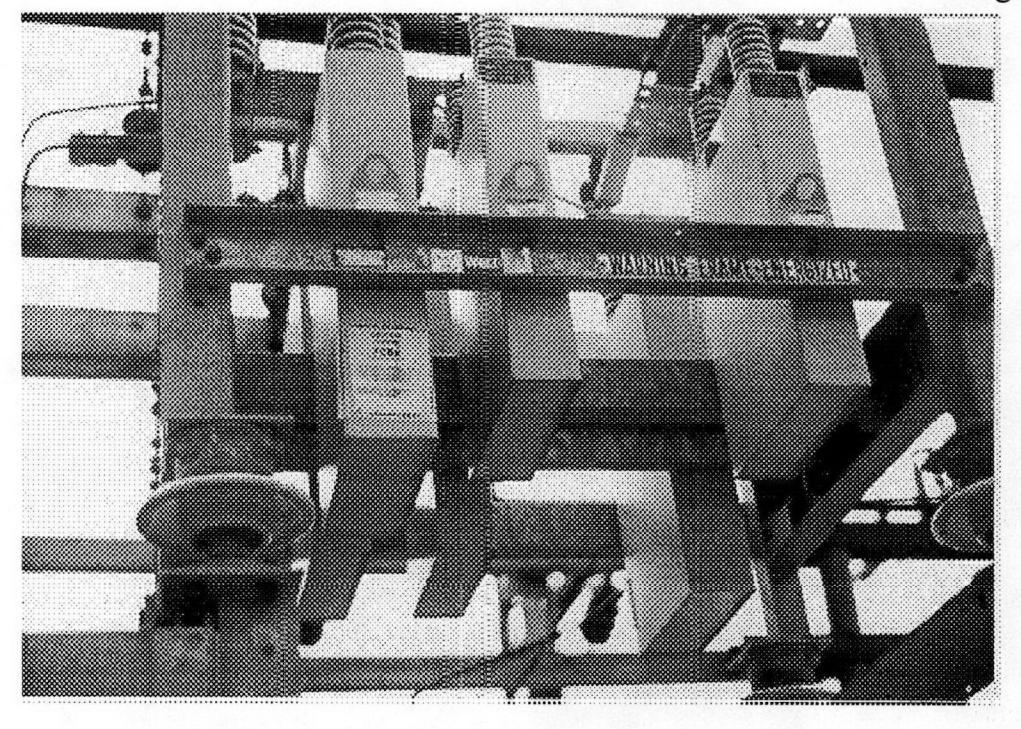
Fig. 2. Looking up at a PCB Marked Capacitor on the left

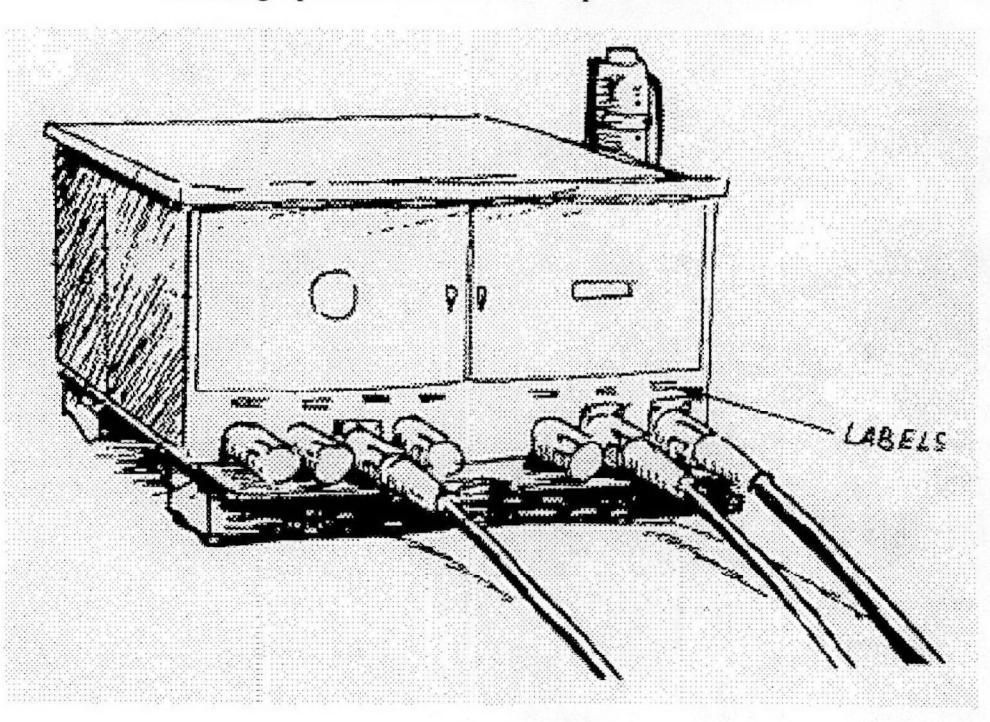
Fig. 3. Mine Power Center that Commonly Contains Capacitors

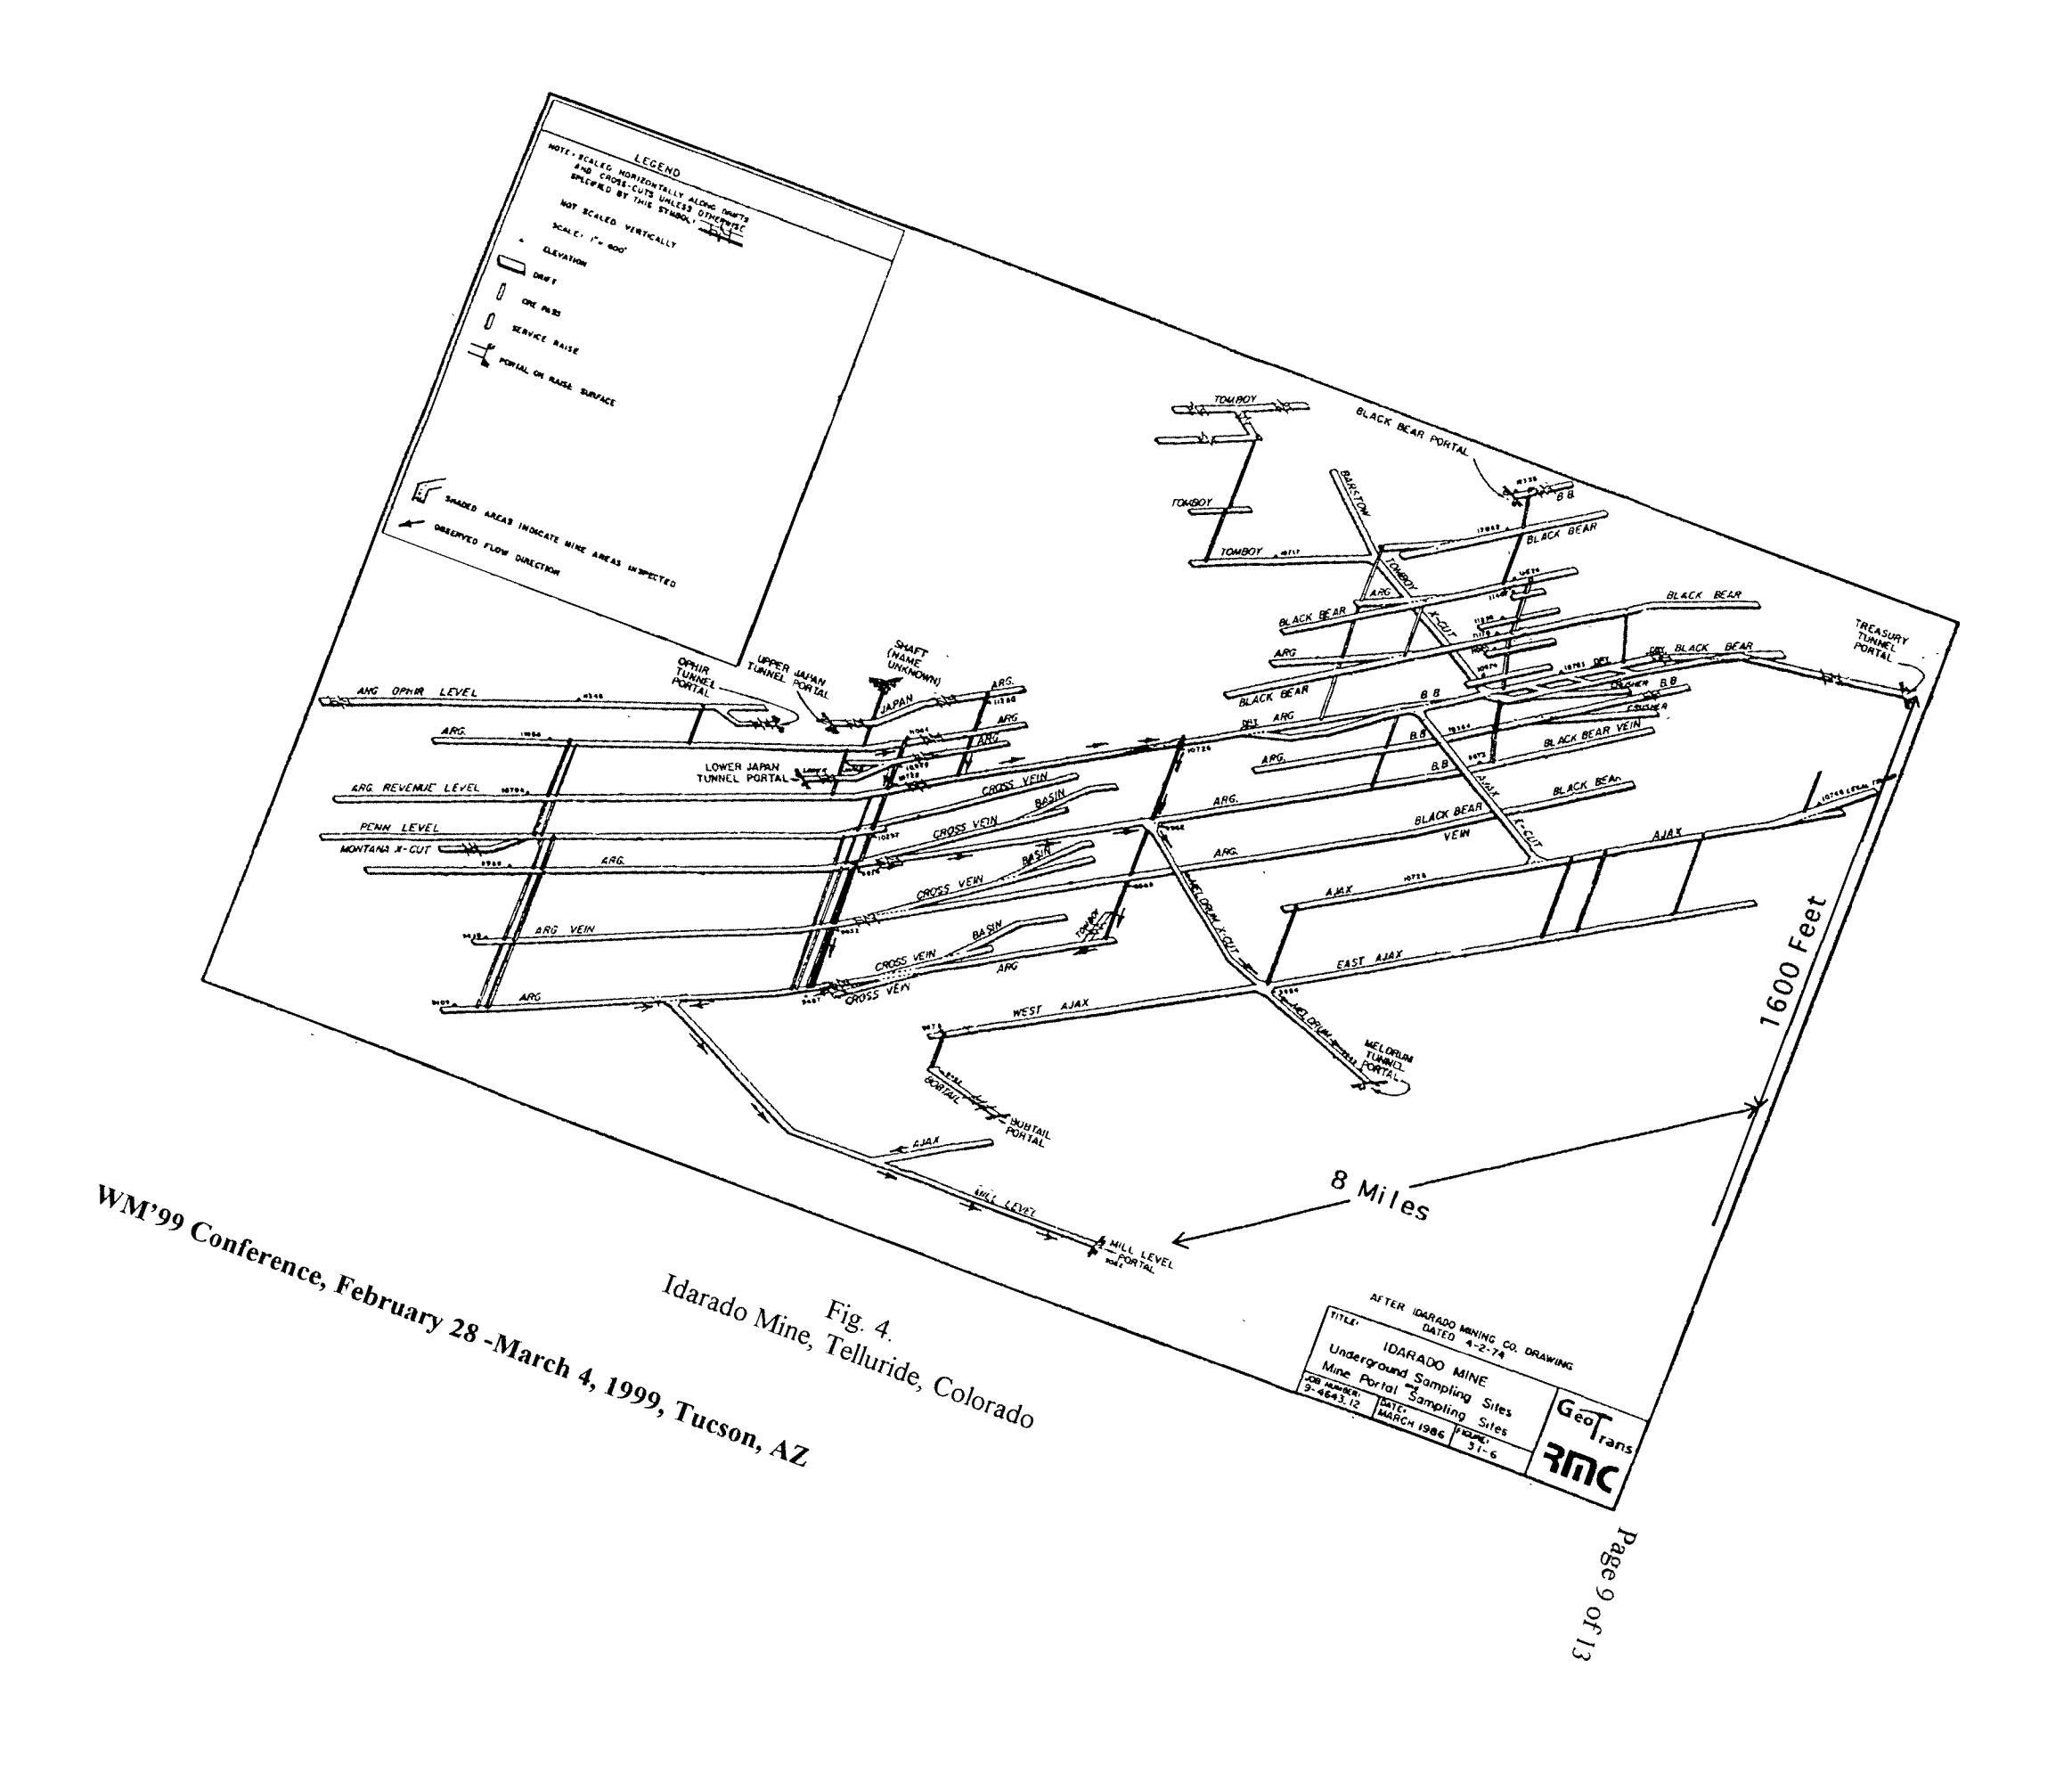
Mines can be very extensive and complex. To illustrate this, Fig. 4. is a map of the Idarado Mine at Telluride, Colorado. The distance "as the crow flies" between the Treasury Tunnel.Portal, at the top of Red Mountain Pass on the Million Dollar Highway, in the upper right-hand corner, and the Mill Level Portal at Telluride, near the bottom center, is about eight miles. Only entries, major haulage drifts, and winzes appear on the map. The mining areas are not shown. This mine was confirmed to have PCB-containing electrical equipment underground by an EPA inspection in 1984.
