# Arsenic and Nitrate Removal from Drinking Water by Ion Exchange U.S. EPA Demonstration Project at Vale, OR Final Performance Evaluation Report

This demonstration study was divided into three periods: Study Periods I and II and an interim period between the two. Study Period I (extending from September 19, 2006, through January 14, 2008) evaluated the originally proposed Purolite Arsenex II anion exchange (AIX) resin. Because of its deteriorating performance due to organic fouling and difficulties in restoring its exchange capacity after resin cleaning, a dual resin approach was identified and implemented in the interim period to address the relevant issues. In February 2009, Arsenex II resin was replaced with Purolite PFA300E resin, which was overlain with an organic scavenger, Purolite A850END. The performance of PFA300E/A850END was evaluated in Study Period II from February 10, 2009, through March 22, 2010.

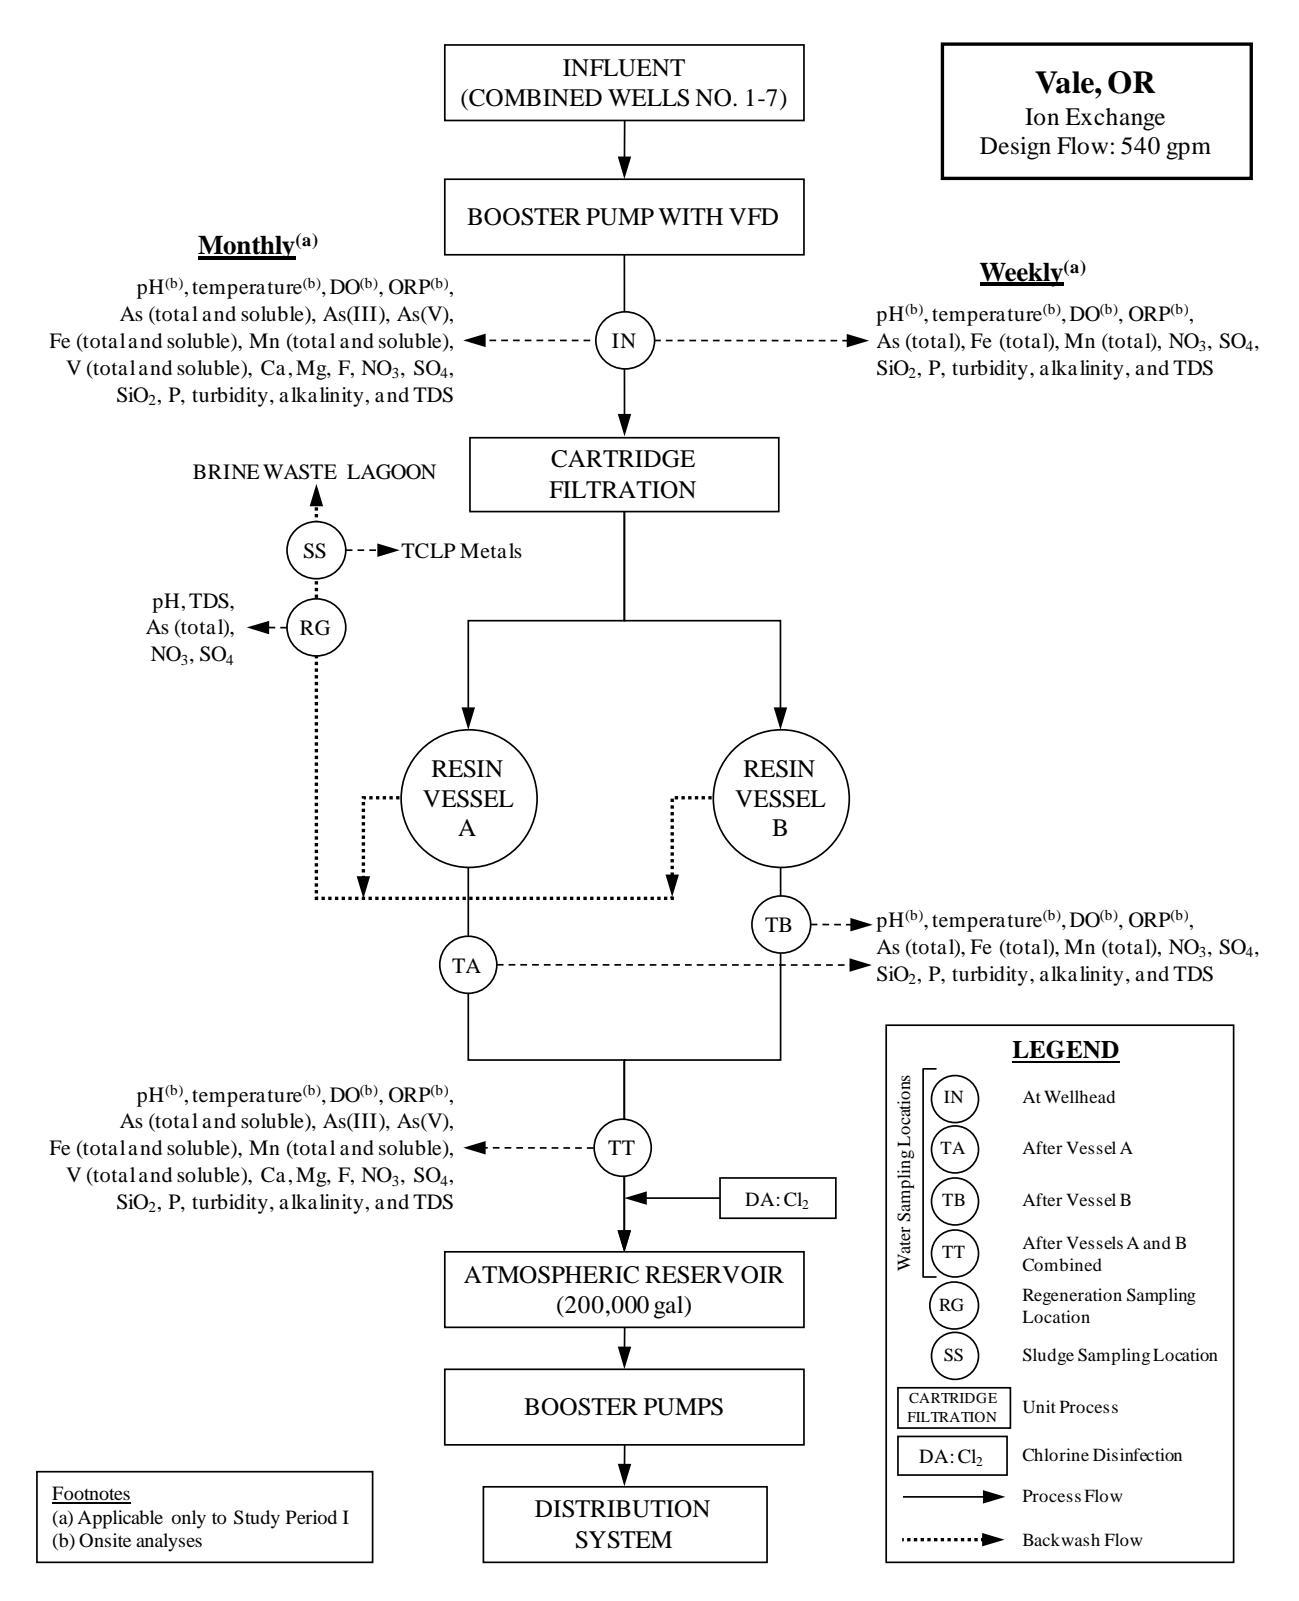
Figure 3-1. Process Flow Diagram and Sampling Locations/Analyses for Vale IX System

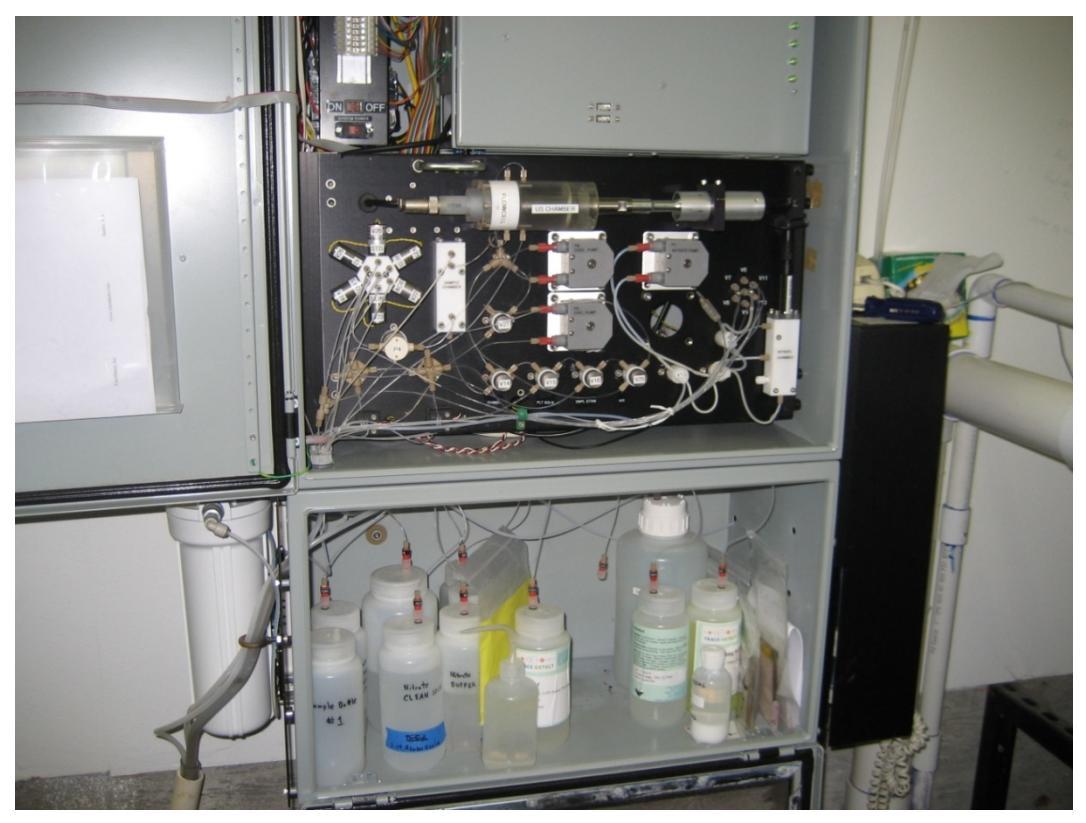
ArsenicGuard<sup>TM</sup> utilizes an electrochemical plating and stripping technique to measure part-per-billion (ppb) quantities of arsenic. The treated sample as mentioned above is drawn into a measurement cell, which houses a sensor along with a reference and an auxiliary electrode. The voltage of this electrochemical cell is manipulated so that arsenic is first plated onto the tip of the sensor during an

Figure 3-2. Real-Time Arsenic Analyzer – ArsenicGuard<sup>TM</sup>

accumulation phase, and then stripped off the sensor during a stripping phase. The duration of the accumulation phase is adjusted to ensure a good stripping signal, i.e., high concentrations are measured using a short accumulation time and low concentrations using a longer accumulation time. The sensing action occurs during the stripping phase of the measurement, during which the voltage of the electrochemical cell is ramped from the accumulation potential, due to the release of the stripping potential of arsenic. When arsenic is stripped off the sensor, it dissolves back into the test solution. This stripping process releases three electrons per arsenic atom and, therefore, the amount of arsenic accumulated on the tip of the sensor is proportional to the current measured during the stripping operation. This current is recorded for the treated sample as well as for the spiked sample in order to calculate the arsenic concentration in the original sample stream.

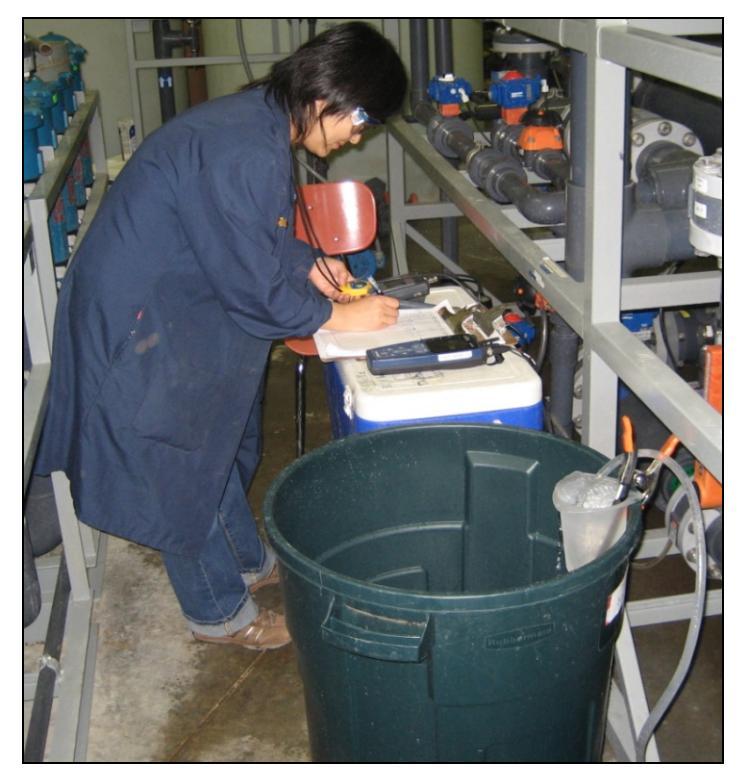
The IX resin vessels were set to regenerate for a volume throughput of 600,000 gal in a service cycle. Regeneration consisted of brine draw, slow rinse, and fast rinse with one vessel being taken offline for regeneration while the other remained in service. An 8% brine solution (specific gravity of 1.06) was used for brine draw. Raw water was used for slow and fast rinse. Figure 3-3 shows the experimental setup, including the use of a flow-through cell, for the elution study. A side stream of spent brine/rinse water was directed from the regeneration waste discharge line via a piece of <sup>3</sup>/<sub>8</sub>-in Tygon tubing to an 800-mL plastic beaker, or a flow-through cell, in which a Hanna HI 9635 conductivity/TDS probe (Hanna Instruments, Inc., Woonsockett, RI) and a VWR pH probe were placed (after calibration) for continuous measurements of TDS and pH. Because the flow-through cell was secured using a 3-in spring clamp just inside the rim of a 32-gal plastic container, the solution that overflowed the flow-through cell was collected into the plastic container. Upon completion of one regeneration step, the flow-through cell was immediately transferred to another 32-gal plastic container for continuing measurements. This process continued until all three regeneration steps were complete. A stopwatch was used to measure elapsed time. Table 3-5 lists the number of samples collected and analyzed during each regeneration step.

Figure 3-3. Regeneration Monitoring Setup

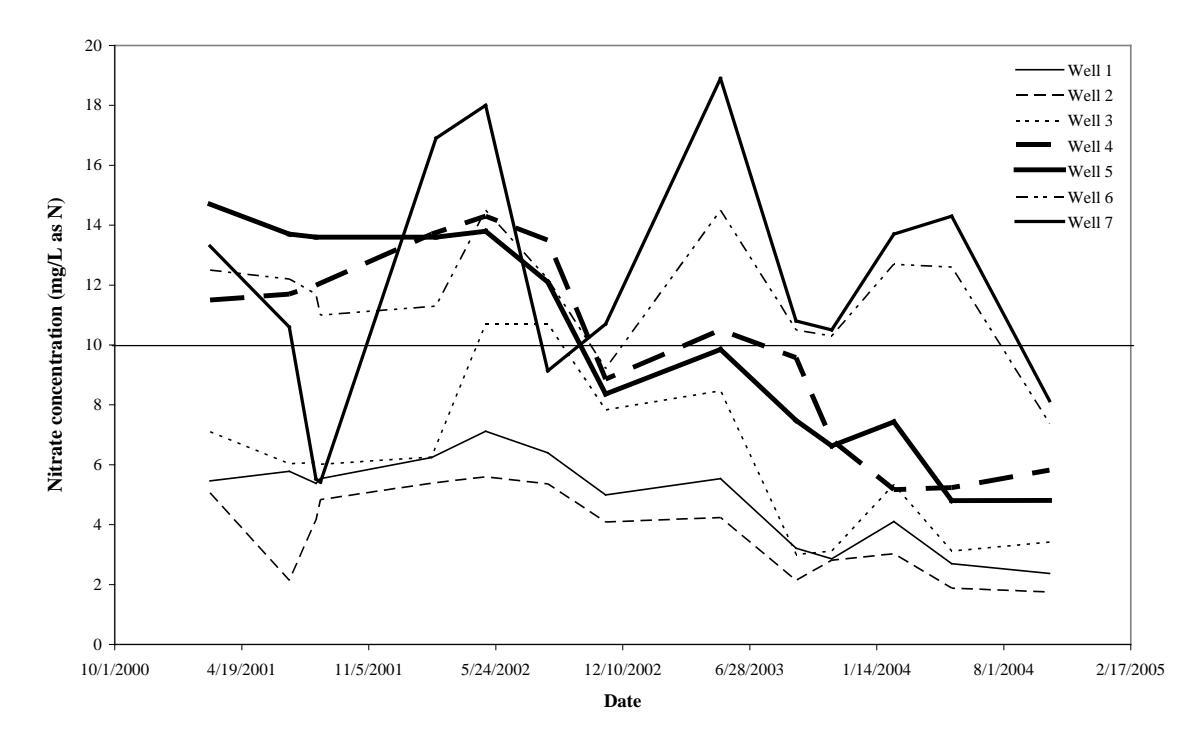
*Nitrate*. The City blended source water from various wells to minimize nitrate concentrations in the blended water to below the 10 mg/L MCL. As shown in Table 4-5 and Figure 4-3, nitrate concentrations in Wells No. 1 and No. 2 were less than 7.1 mg/L (as N) and exhibited a decreasing trend starting from 2002. Nitrate concentrations in Well No. 3 peaked at 10.7 mg/L (as N) and then decreased to just over 3.0 mg/L (as N) by 2004. Wells No. 4 to No. 7 had historical nitrate levels mostly over 10 mg/L and as high as 18.9 mg/L (as N). Concentrations in wells No. 4 and No. 5 also showed a significant decreasing trend with concentrations measured at 4.8 to 5.8 mg/L (as N) by October 2004. Concentrations in Wells No. 6 and No. 7 remained elevated from 2000 through 2004; the measurements made in October 2004 were less than 10 mg/L (as N) for both wells. Combined source water values were 8 to 12 mg/L (as N) from the facility and 4.1 mg/L (as N) from Battelle (Table 4-2). Similar to arsenic, the water treatment process relied upon the exchange of nitrate in source water with chloride on the resin.

Figure 4-3. Historic Nitrate Data from Wells No. 1 Through No. 7

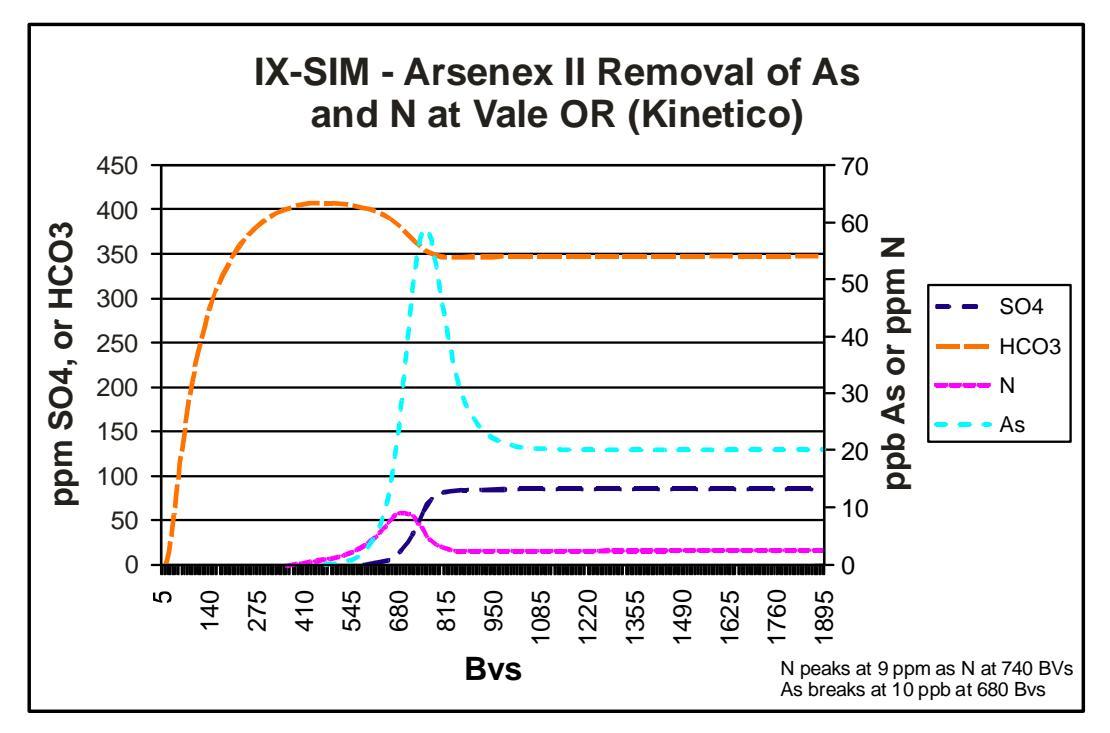
Figure 4-4. Simulation of Arsenex II Resin Run Length

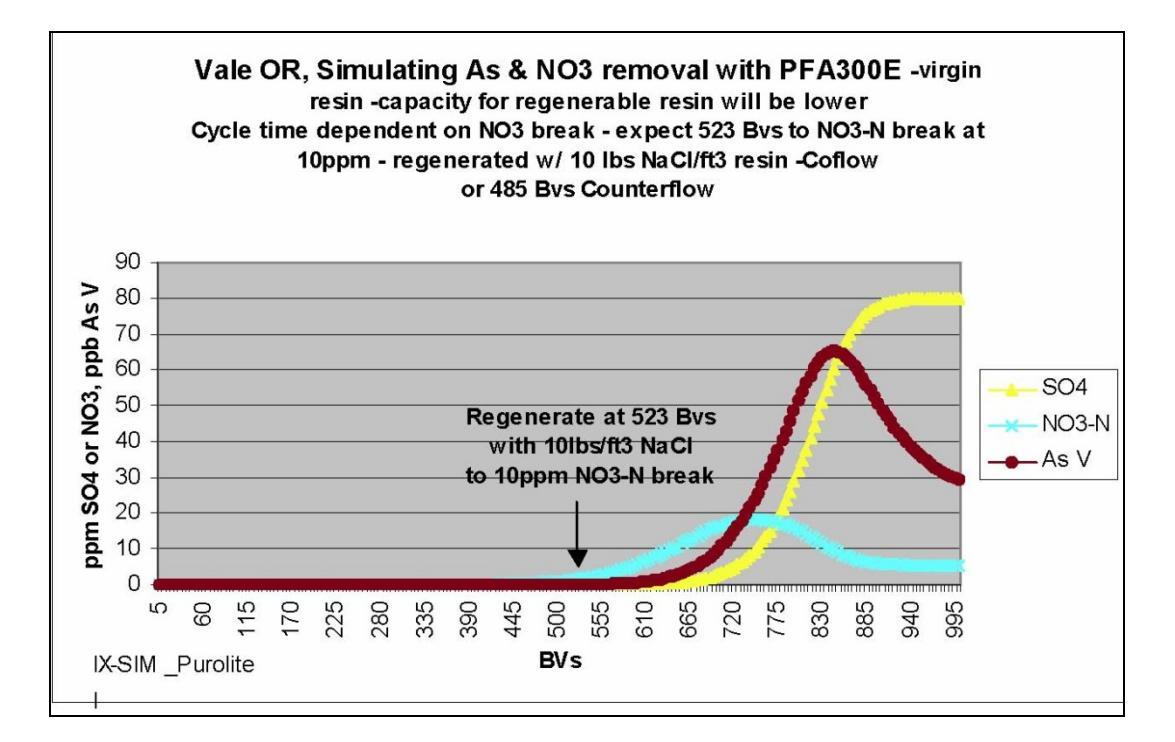
Figure 4-5 presents results of a simulation for PFA300E done in June 2008. Similar to the simulation for Arsenex II, nitrate breaks first, followed by arsenic and sulfate. But unlike Arsenex II, nitrate breakthrough at 10 mg/L (as N) would occur first at approximately 650 BV followed by arsenic breakthrough to 10  $\mu$ g/L at approximately 700 BV. The vendor recommended regenerating at 523 BV with 10 lb/ft<sup>3</sup> of salt. In January 2009, Purolite updated the run length simulation after receiving additional source water quality data for Vale. The updated run length to 10-mg/L nitrate (as N) breakthrough was 604 BV, corresponding to 993,940 gal of throughput (1 BV = 220 ft<sup>3</sup>).

Figure 4-5. Simulation of A850END/PFA300E Resin Run Length (June 2008)

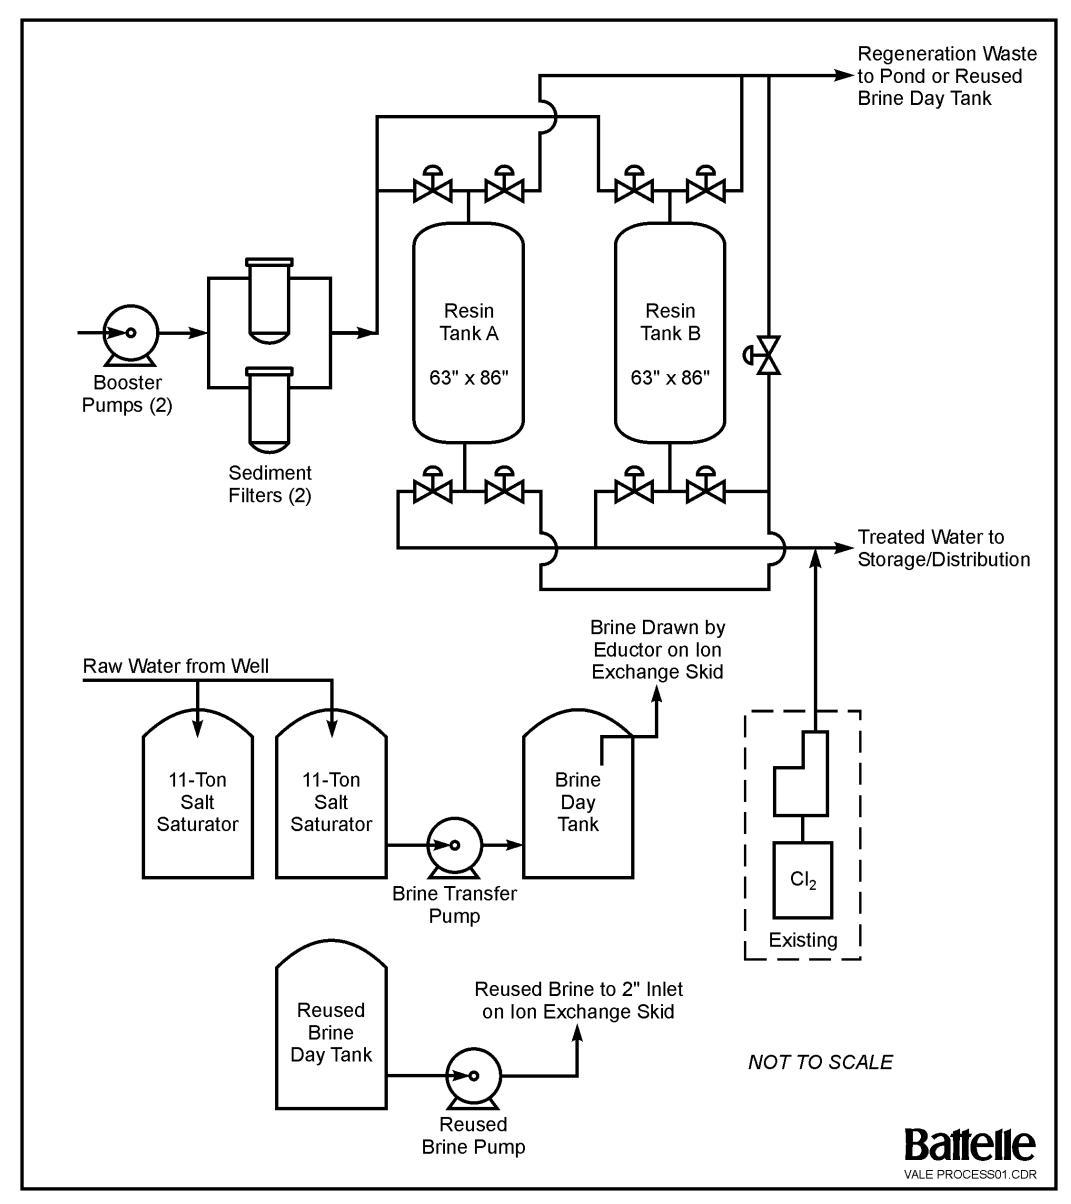
**4.2.2 Treatment Process**. The Vale IX system utilized the packed-bed anionic IX technology to remove arsenic and nitrate from source water. Figure 4-6 is a process schematic of the treatment system. The process equipment included two banks of five skid-mounted bag filters, two skid-mounted resin vessels, two salt saturators, two brine day tanks, three pre-wired brine transfer/injection pumps, one air compressor, one post-chlorination system, as well as associated valves, sample ports, pressure gauges, and flow elements/controls. The IX system was fully automated and controlled by a central control panel consisting of a programmable logic control (PLC), a touch screen operator interface panel (OIP), and a data communication modem. The OIP allowed the operator to monitor system flowrate and volume throughput since last regeneration, change system setpoints, and check the status of alarms. The modem allowed the vendor to remotely dial in for monitoring and troubleshooting. All pneumatic valves were constructed of PVC and all plumbing was Schedule 80 PVC solvent bonded. Table 4-7 summarizes the design specifications of the IX system.

Figure 4-6. Schematic of Kinetico's IX-263 As/N Removal System for Vale, OR

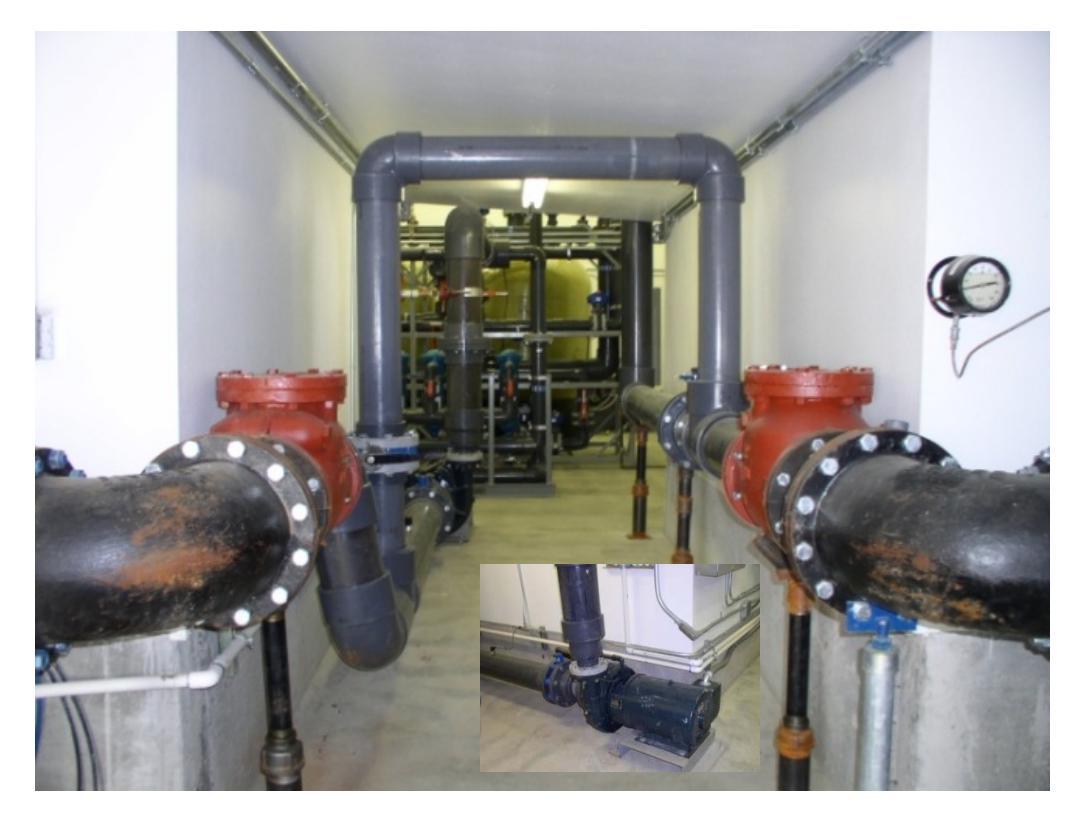
• Intake. Raw water from Wells No. 1 through 7 was pumped to the treatment building and then combined at a common header. To overcome the anticipated headloss from the treatment system, the incoming water was boosted by a 25-horsepower (hp) booster pump to meet the minimum influent pressure requirement of the IX system. Two booster pumps (one on standby), each rated for 600 gpm at 130 ft H<sub>2</sub>O head (or 56 psi), and a three-phase Danfoss VLT8000 series variable frequency drive (VFD) were installed at the common header. System inlet piping and a booster pump is shown in Figure 4-7.

Figure 4-7. System Inlet Piping and Booster Pump

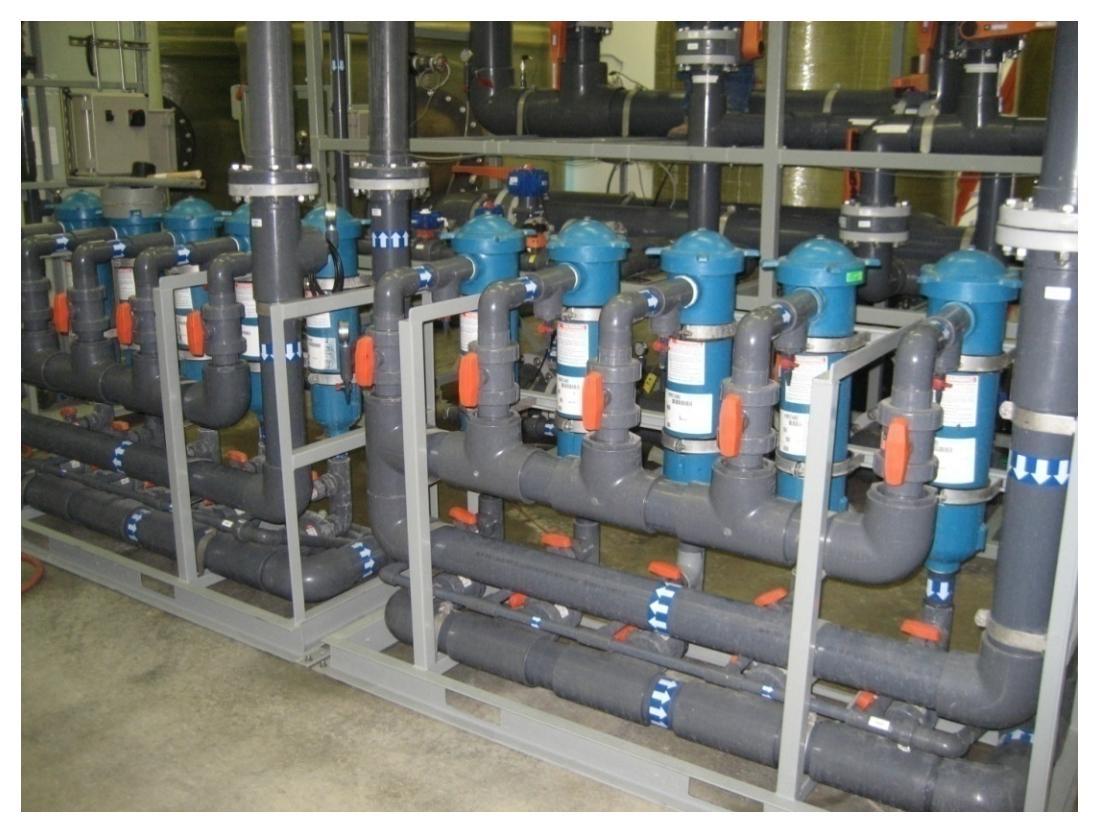
• Sediment Filtration. Prior to entering the IX resin vessels, raw water was filtered through two parallel, skid-mounted bag filter assemblies to remove sediment. Each assembly consisted of five parallel FSI X100 polypropylene housing units, each lined with a 20- $\mu$ m (in Study Period I) or 5- $\mu$ m filter bag (in Study Period II). Each filter was rated at 65 gpm, giving a total capacity of 325 gpm per assembly or 650 gpm for both. Filter bags in the two assemblies were cleaned or replaced when headlosses across each assembly had reached 10-to 15-lb/in<sup>2</sup> (psi) levels. Figure 4-8 presents a photograph of the bag filter assemblies. This filtration step was used to prevent the resin beds from being clogged and/or fouled by particulates.

Figure 4-8. Photograph of Two Banks of Cartridge Filters

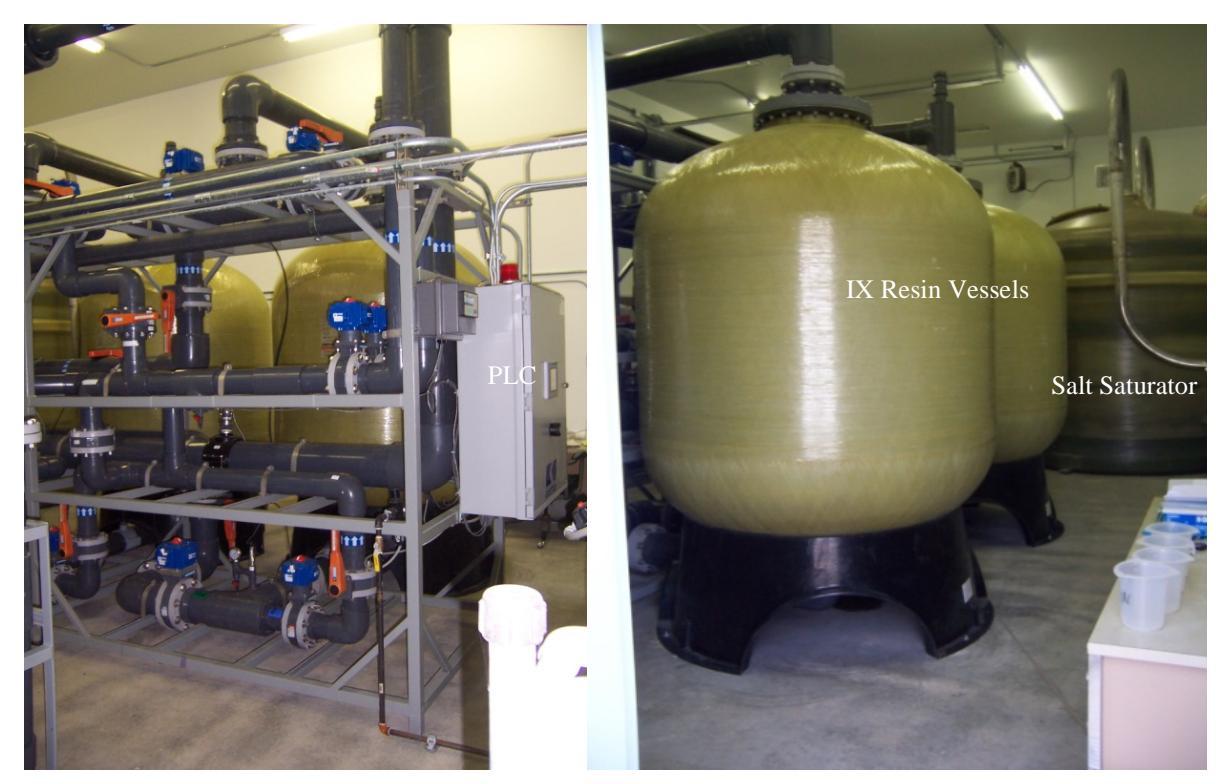
The IX system was designed for 540 gpm, yielding a hydraulic loading rate of 12.5 gpm/ft<sup>2</sup> and an empty bed contact time (EBCT) of 3 min. Each vessel was equipped with a 270-gpm flow restrictor on the effluent piping to help balance the flow between the two vessels and prevent overrun during regeneration. An insertion-type paddle wheel flow element was installed on the combined effluent line to register flowrate and throughput of the product water since last regeneration. When a pre-determined throughput setpoint was reached, Vessel A was automatically taken out of service for regeneration, whereas Vessel B remained online for treatment. Once Vessel A regeneration was complete, the totalizer was automatically reset to zero and began to register the water treated by Vessel A. Meanwhile, Vessel B was taken out of service for regeneration. After Vessel B regeneration was complete, the totalizer registered the amount of water treated by both vessels.

Figure 4-9. Photographs of Arsenic/Nitrate Removal IX System at Vale, OR

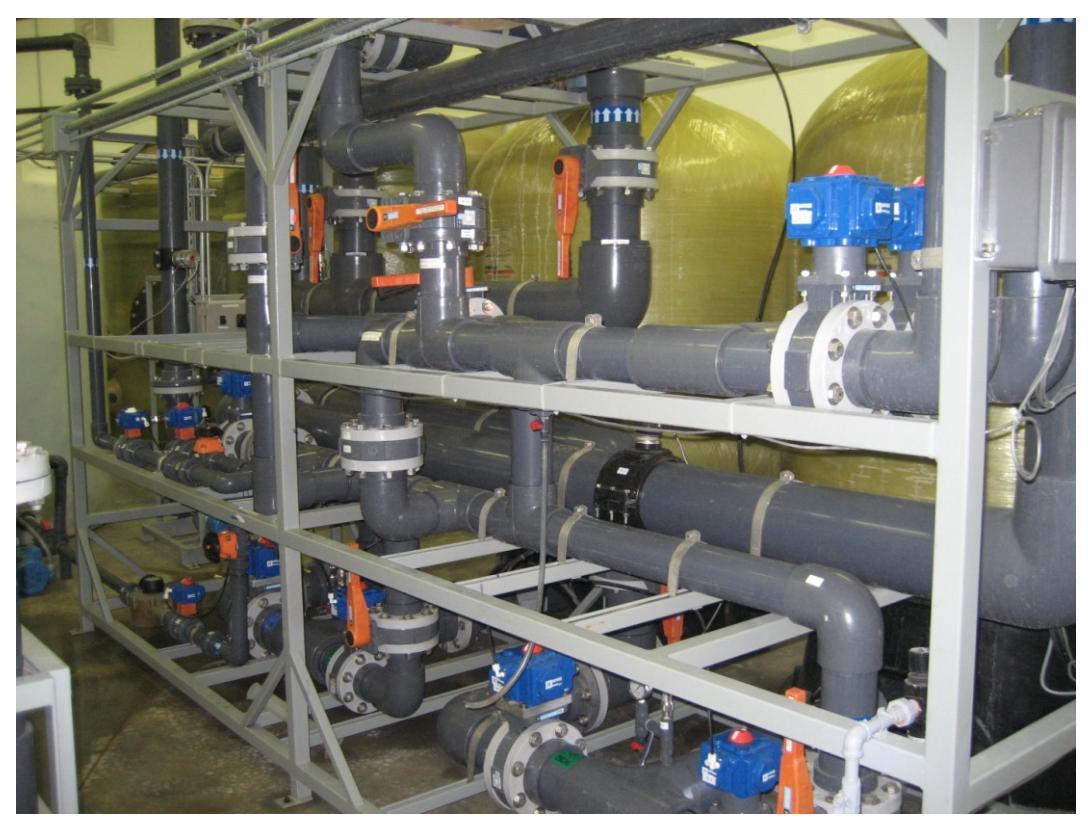
Figure 4-10. Skid-Mounted Piping/Valving Rack

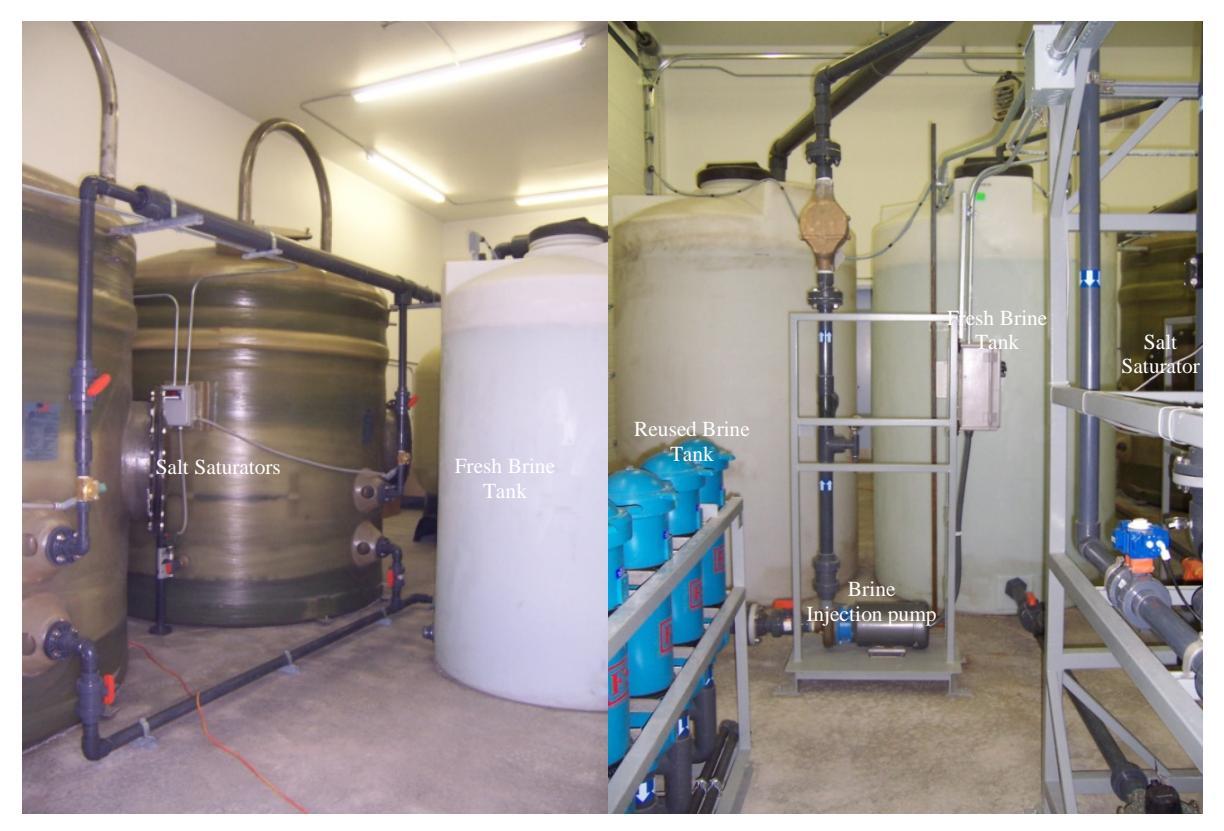
**Step 1. Spent Brine Draw** – The treatment system was originally designed with a brine reclaim feature to minimize salt usage and brine waste. During the first half of brine draw, a spent brine solution with a concentration of 9 to 10% was pumped from a 1,050-gal day tank at approximately 50 gpm for 15 min using a 5-hp centrifugal pump. The entire volume of waste produced during spent brine draw was discharged to an evaporation pond. The volume of spent brine was tracked by a 2-in mechanical totalizer installed on a brine feed line. The use of spent brine could reduce the brine waste volume by 137 gal/vessel and the corresponding salt consumption by 885 to 758 lb/vessel, or 14%. The brine reclaim, however, was discontinued on December 10, 2007, due to concerns that DOM might accumulate in spent brine and would increase the resin fouling (Section 4.4.3).

Figure 4-11. Photographs of IX Regeneration System at Vale, OR

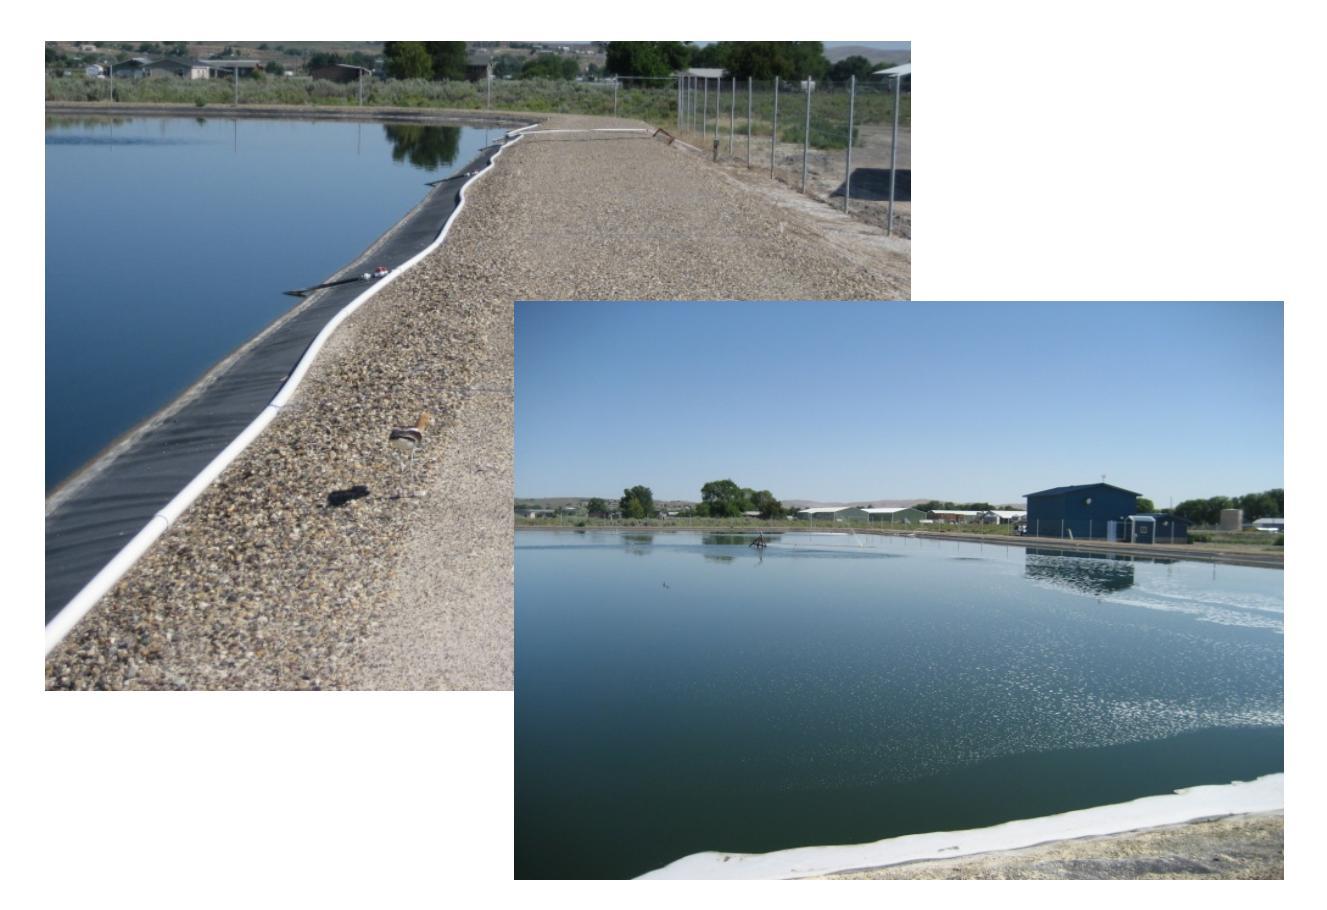
Figure 4-13. Wastewater Evaporation Pond

Construction of the evaporation pond didn't begin until the ground dried out for earthwork, was interrupted by the weather in April, and was completed in late May 2005, just before system startup. The pond consisted of an evaporation basin and a drying bed. A 40-mil textured HDPE liner was installed in the evaporation basin and drying bed to prevent any leakage to groundwater. An 8-ft tall exterior fence consisting of steel posts, wire mesh, and an access gate was installed surrounding the pond. Figure 4-16 is a photograph of the evaporation pond under construction; photographs of the completed pond are presented in Figure 4-13.

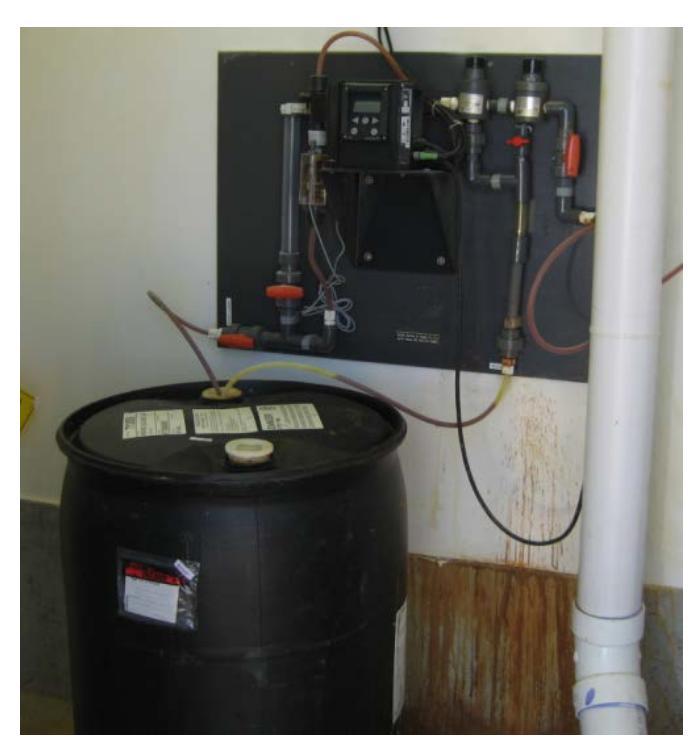
As part of the pond design, ferric chloride (FeCl<sub>3</sub>) was added to spent brine prior to being discharged to the pond (see Figure 4-14). Specifically, 0.25 gal of a commercial grade FeCl<sub>3</sub> solution (40% with specific gravity of 1.4) was fed to the waste brine stream at a rate of 1.0 gph for 15 min. Based on the design brine draw rate of 50 gpm, the iron dosage would be approximately 63 mg/L (as Fe). Because FeCl<sub>3</sub> was fed in a batch mode into a total waste volume of 7,250 gal (per vessel), the average iron dosage was only 6.65

Figure 4-14. Ferric Chloride Addition to Treat Spent Brine

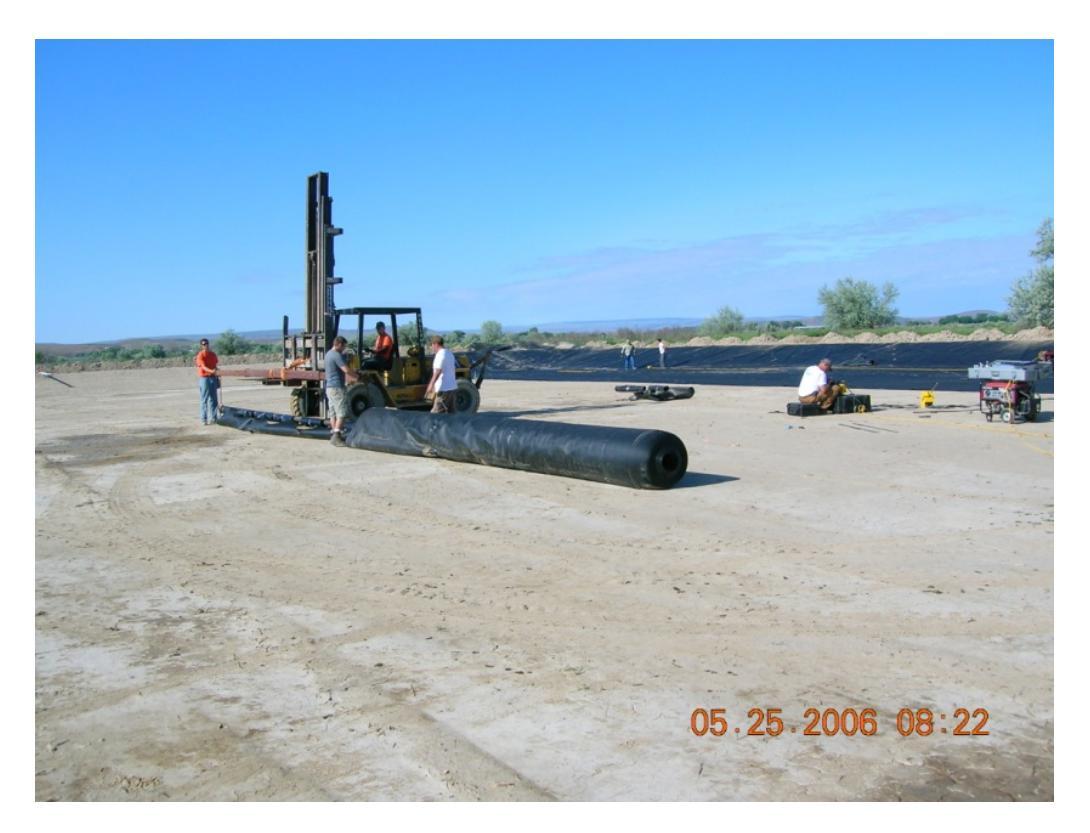
Figure 4-16. Installation of HDPE Liner in Evaporation Pond

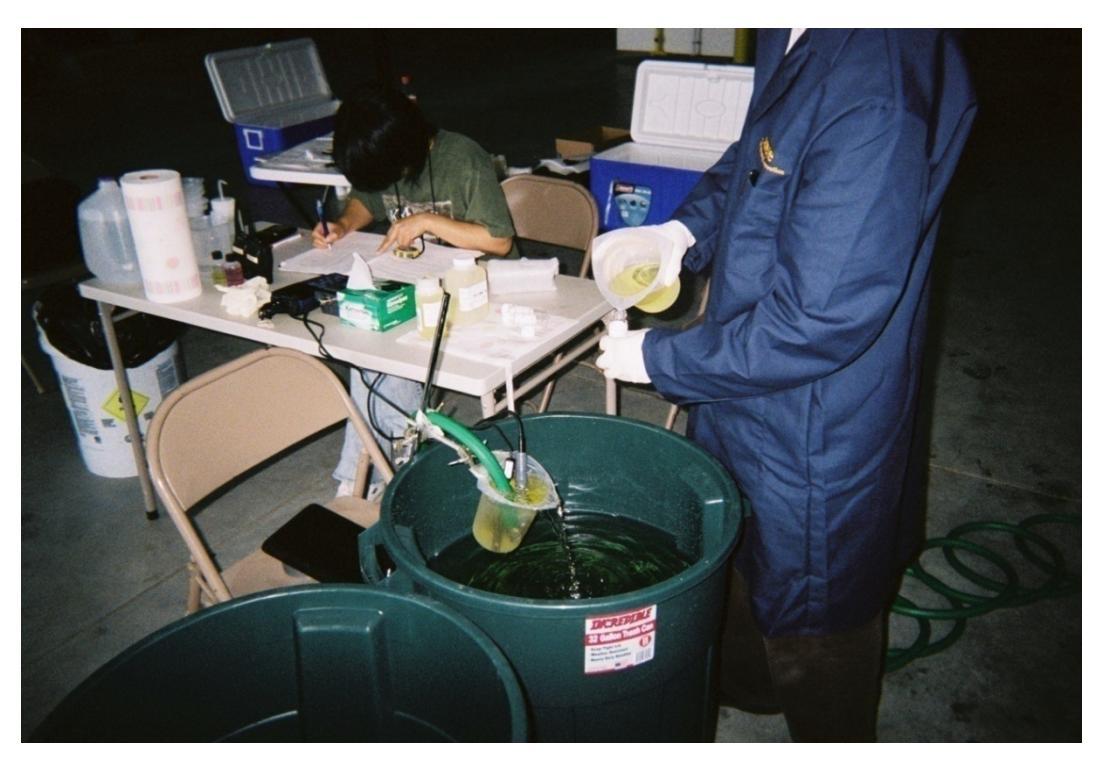
A complete regeneration and service cycle of one anion vessel (i.e., Vessel 5) was monitored in a two-day period. Grab and composite samples were collected from each step of the regeneration cycle (see Figure 4-20). Following regeneration, time-series influent and effluent samples were collected during the Vessel 5 service cycle. In addition, a resin core sample was collected from a freshly regenerated Vessel 6 for visual inspection and analysis.

Figure 4-20. Sample Collection and pH/TDS Monitoring during Regeneration of AIX Vessel 5 at McCook, NE

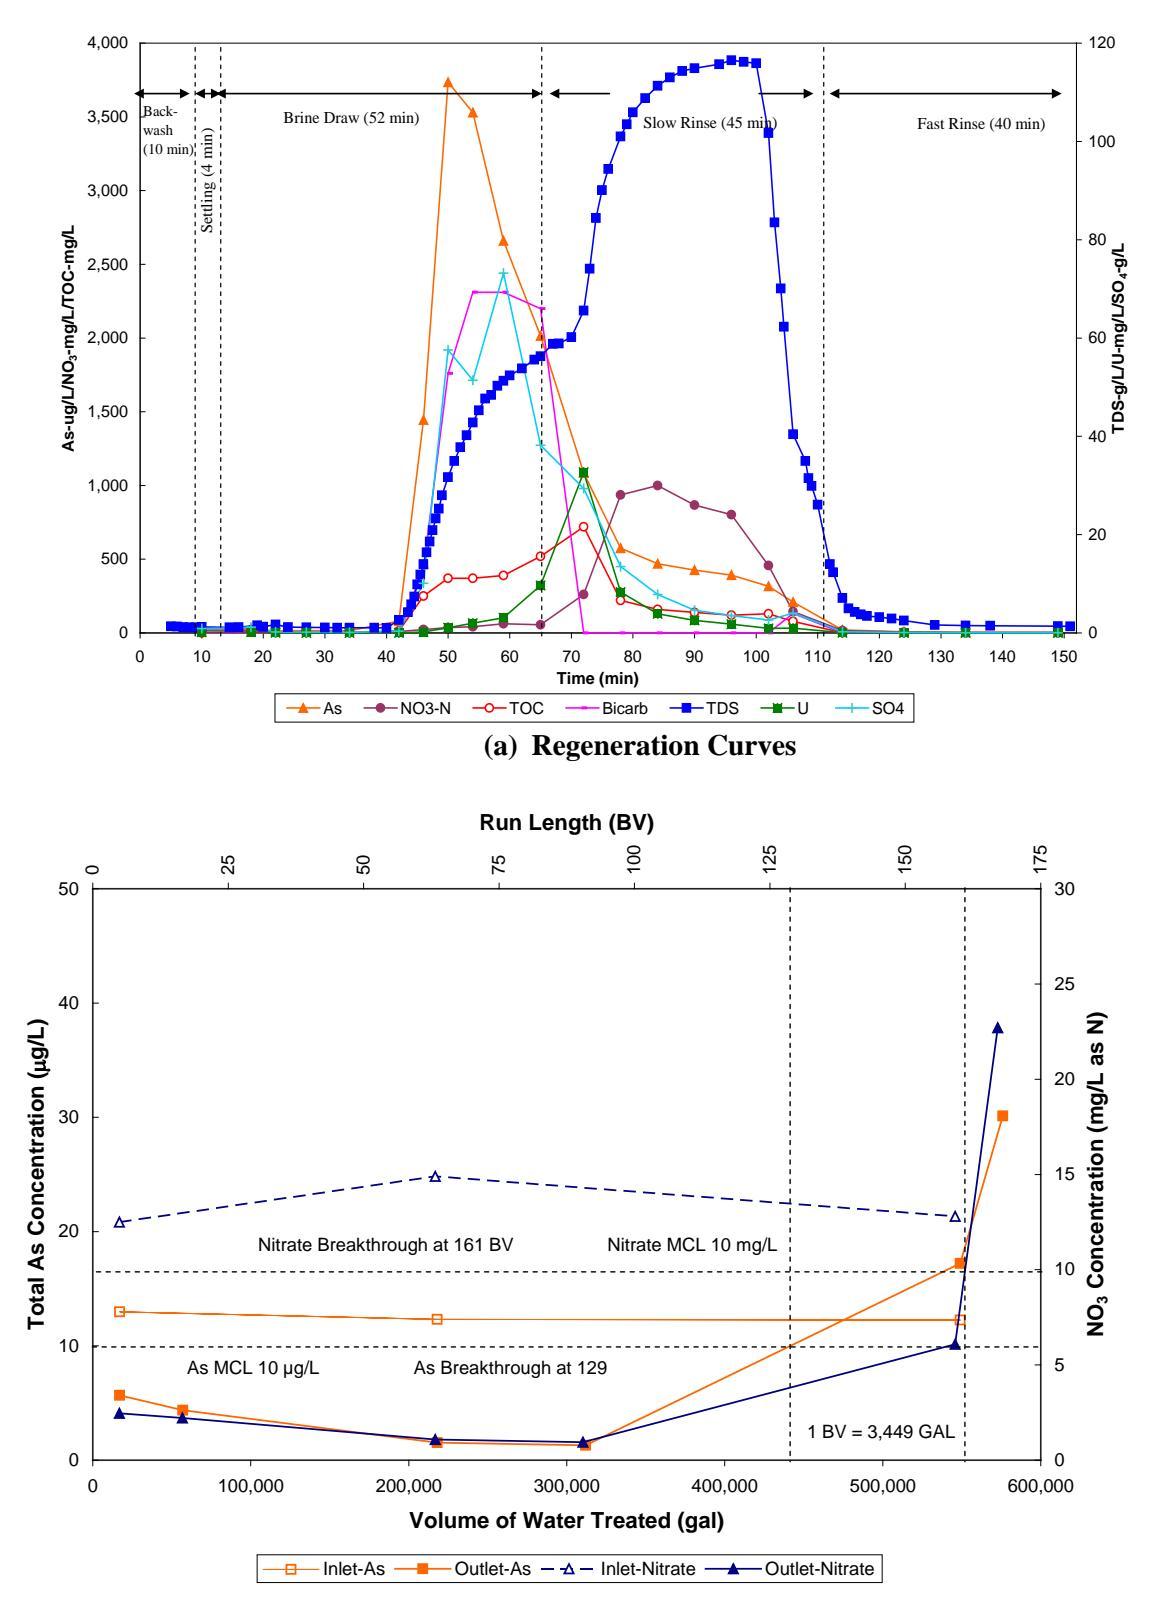
- Due to the long freeboard over the resin bed (i.e., 8 to 9 ft), it took over 40 min for brine to emerge from the vessel to the discharge line, as indicated by TDS reading. TDS readings reached the maximum level of 117 g/L approximately 10 min before the end of the slow rinse.
- Resin regeneration achieved 99% recovery for TOC, 86% for arsenic, 130% for uranium, and 55% for nitrate. The spent brine had a distinctive yellowish or tea color, indicating the presence of DOM.
- TOC levels in the effluent water were below detection during the run length study (576,000 gal). Arsenic and nitrate breakthrough at their respective MCLs occurred at 445,000 gal (129 BV) and 550,000 gal (161 BV), respectively. Uranium was almost completed removed.

(b) Exhaustion Curves Figure 4-21. Results of McCook AIX Vessel 5
