# Arsenic and Nitrate Removal from Drinking Water by Ion Exchange U.S. EPA Demonstration Project at Vale, OR Final Performance Evaluation Report

This demonstration study was divided into three periods: Study Periods I and II and an interim period between the two. Study Period I (extending from September 19, 2006, through January 14, 2008) evaluated the originally proposed Purolite Arsenex II anion exchange (AIX) resin. Because of its deteriorating performance due to organic fouling and difficulties in restoring its exchange capacity after resin cleaning, a dual resin approach was identified and implemented in the interim period to address the relevant issues. In February 2009, Arsenex II resin was replaced with Purolite PFA300E resin, which was overlain with an organic scavenger, Purolite A850END. The performance of PFA300E/A850END was evaluated in Study Period II from February 10, 2009, through March 22, 2010.

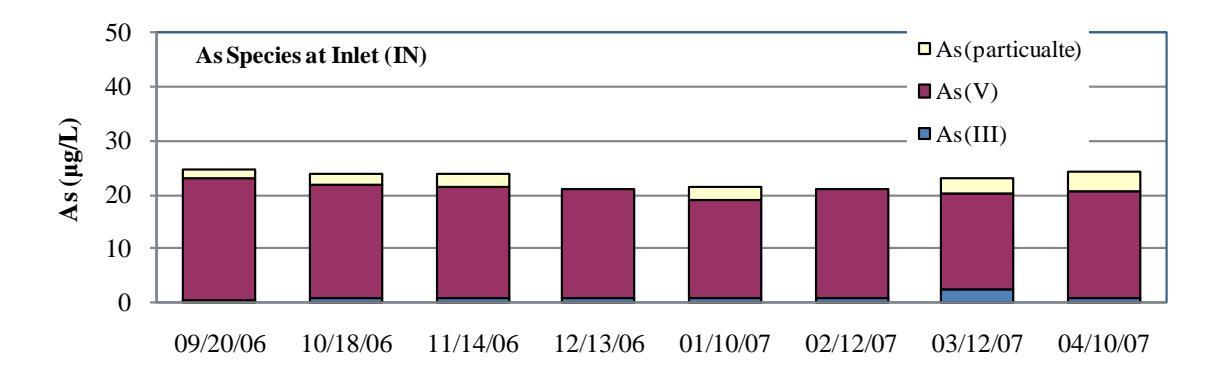
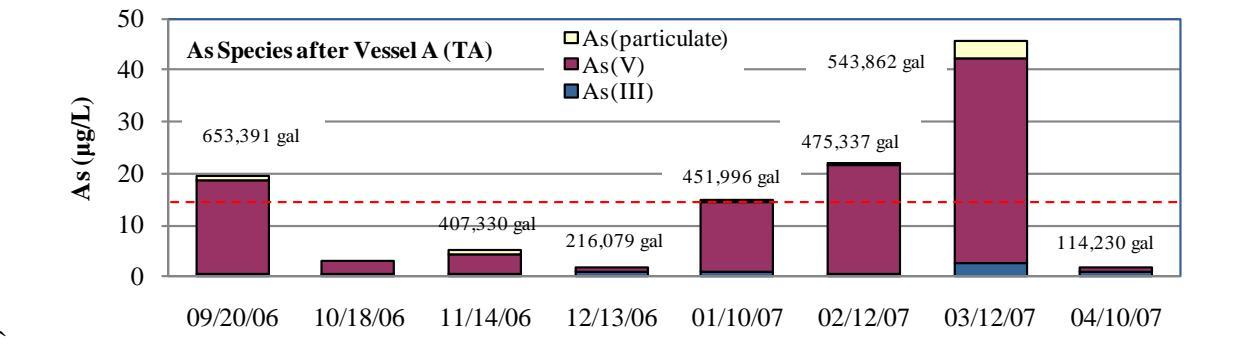
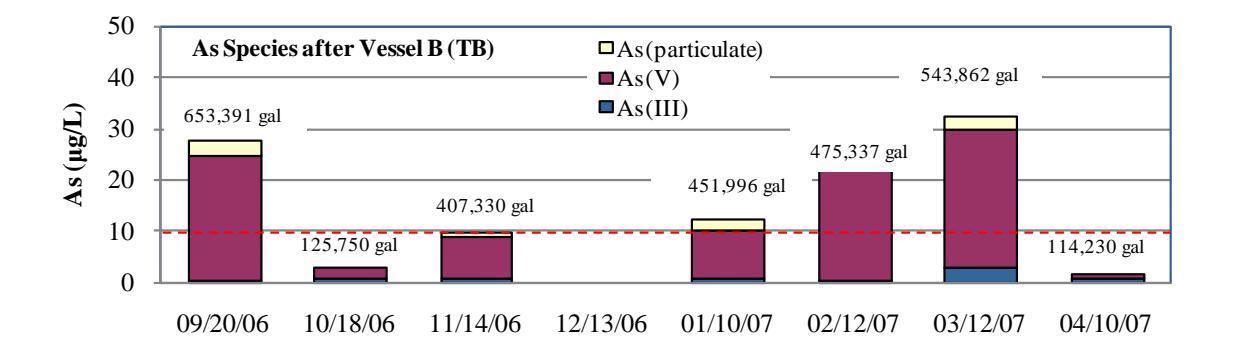
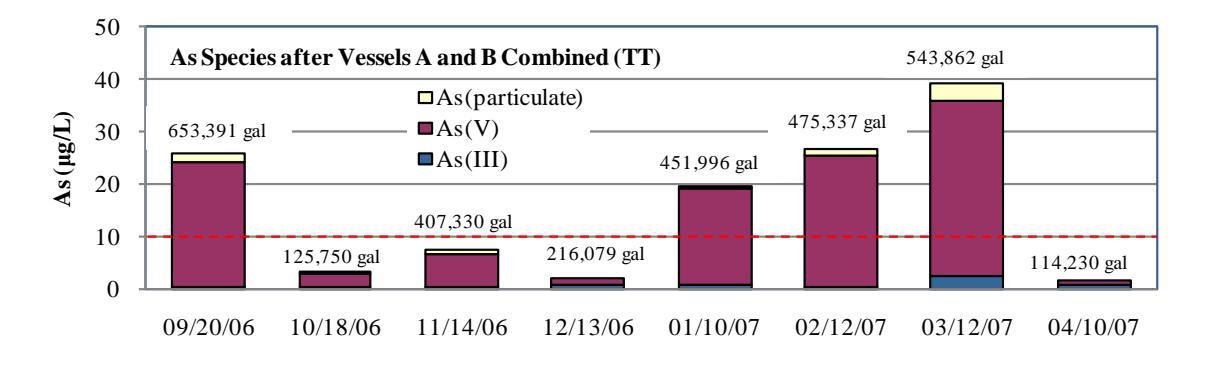
**4.5.1.1** Arsenic Speciation. Eight speciation sampling events were conducted in Study Period I. Figure 4-22 presents arsenic speciation results at the IN, TA, TB, and TT sampling locations. Soluble As(V) was the predominant species in raw water, ranging from 17.8 to 22.5  $\mu$ g/L and averaging 20.0  $\mu$ g/L (Table 4-16). Trace amounts of particulate As and soluble As(III) also existed with concentrations

Figure 4-22. Concentrations of Arsenic Species across Treatment System

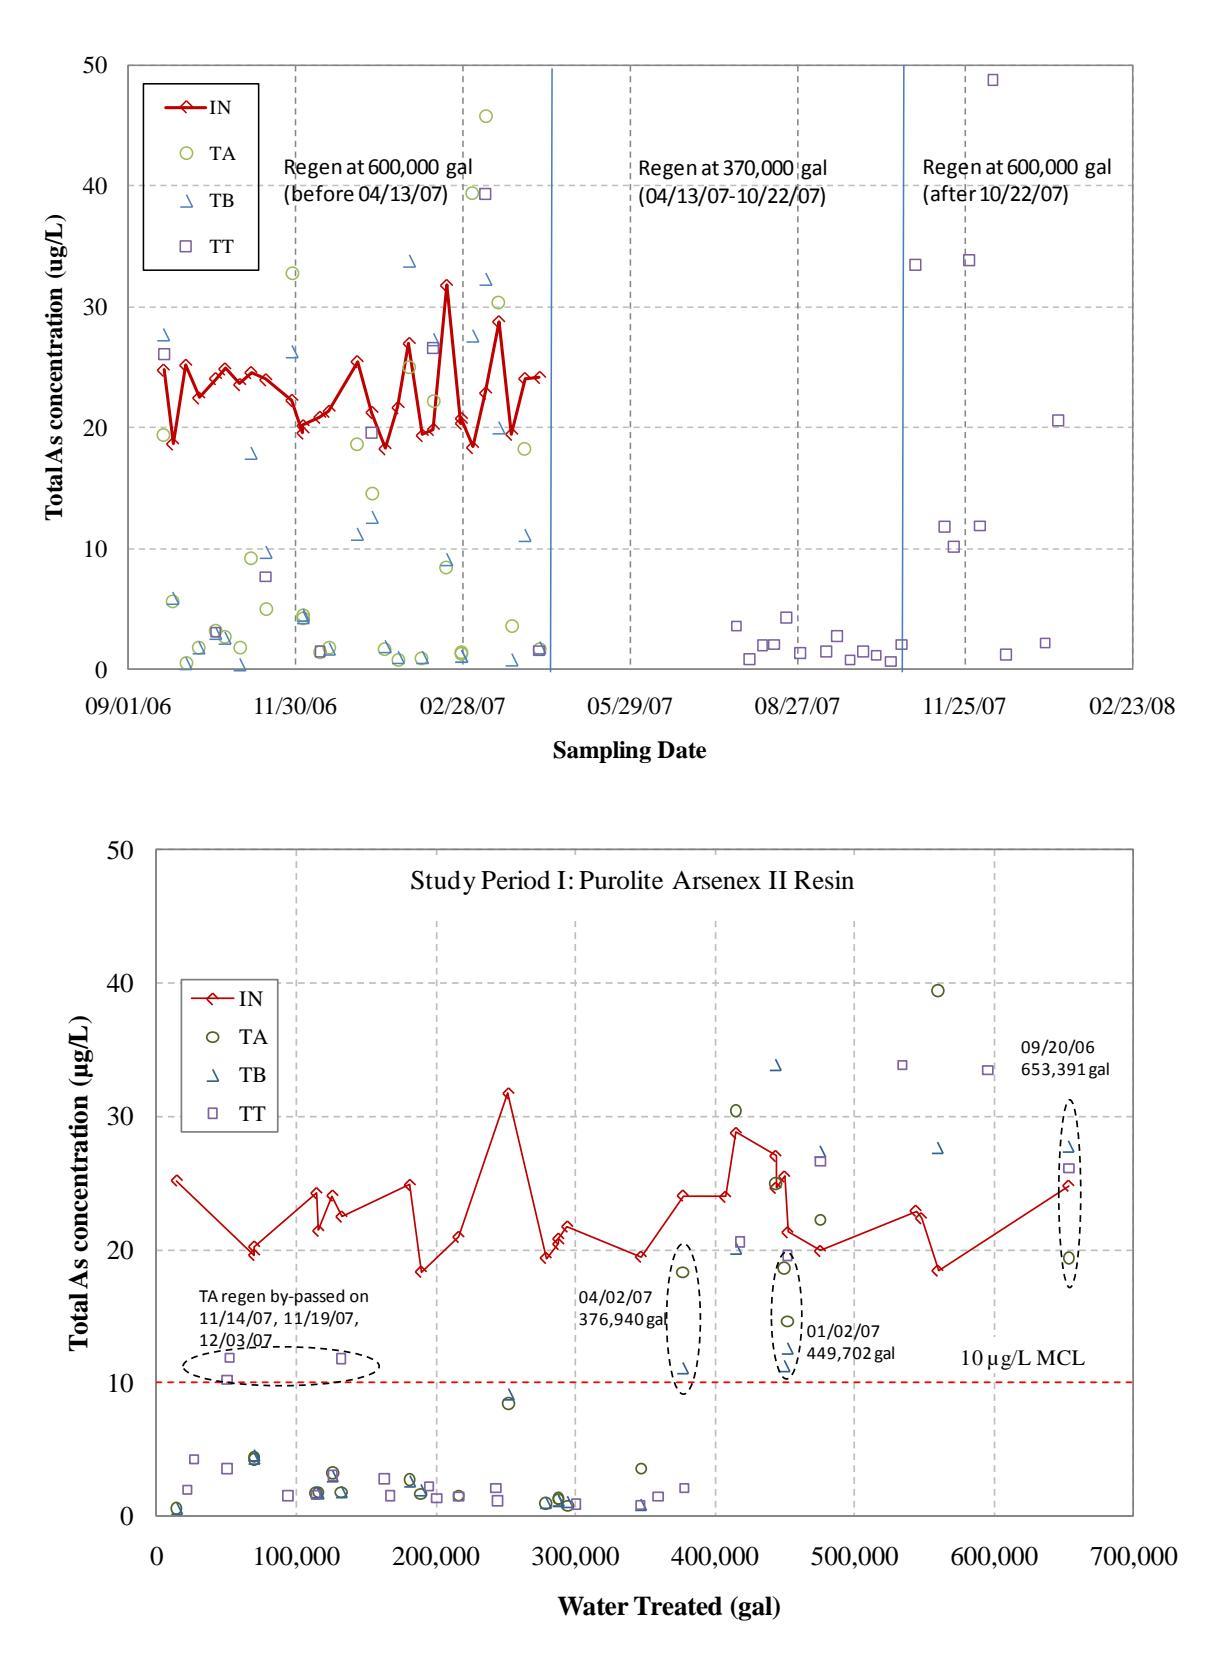
The IX system performance was deteriorating with time as evidenced by the weekly arsenic monitoring data and special run length study results. The run length to  $10-\mu$ g/L arsenic breakthrough was reduced from 562,300 gal at startup in September 2006 to 449,702 gal in early January 2007, and then to 376,940

Figure 4-23. Total Arsenic Concentrations Measured During Study Period I (a) Temporal Plot; (b) Reconstructed Breakthrough Curves

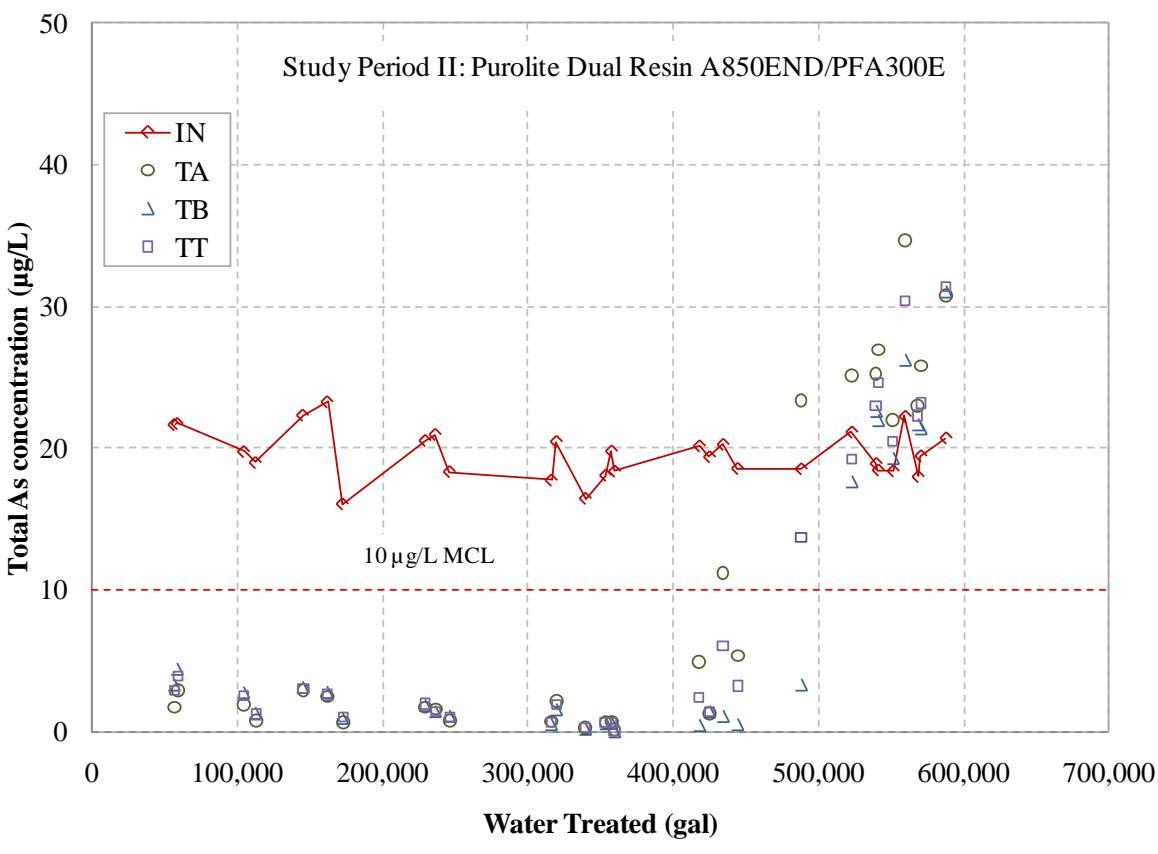
Figure 4-24. Total Arsenic Concentrations Measured During Study Period II

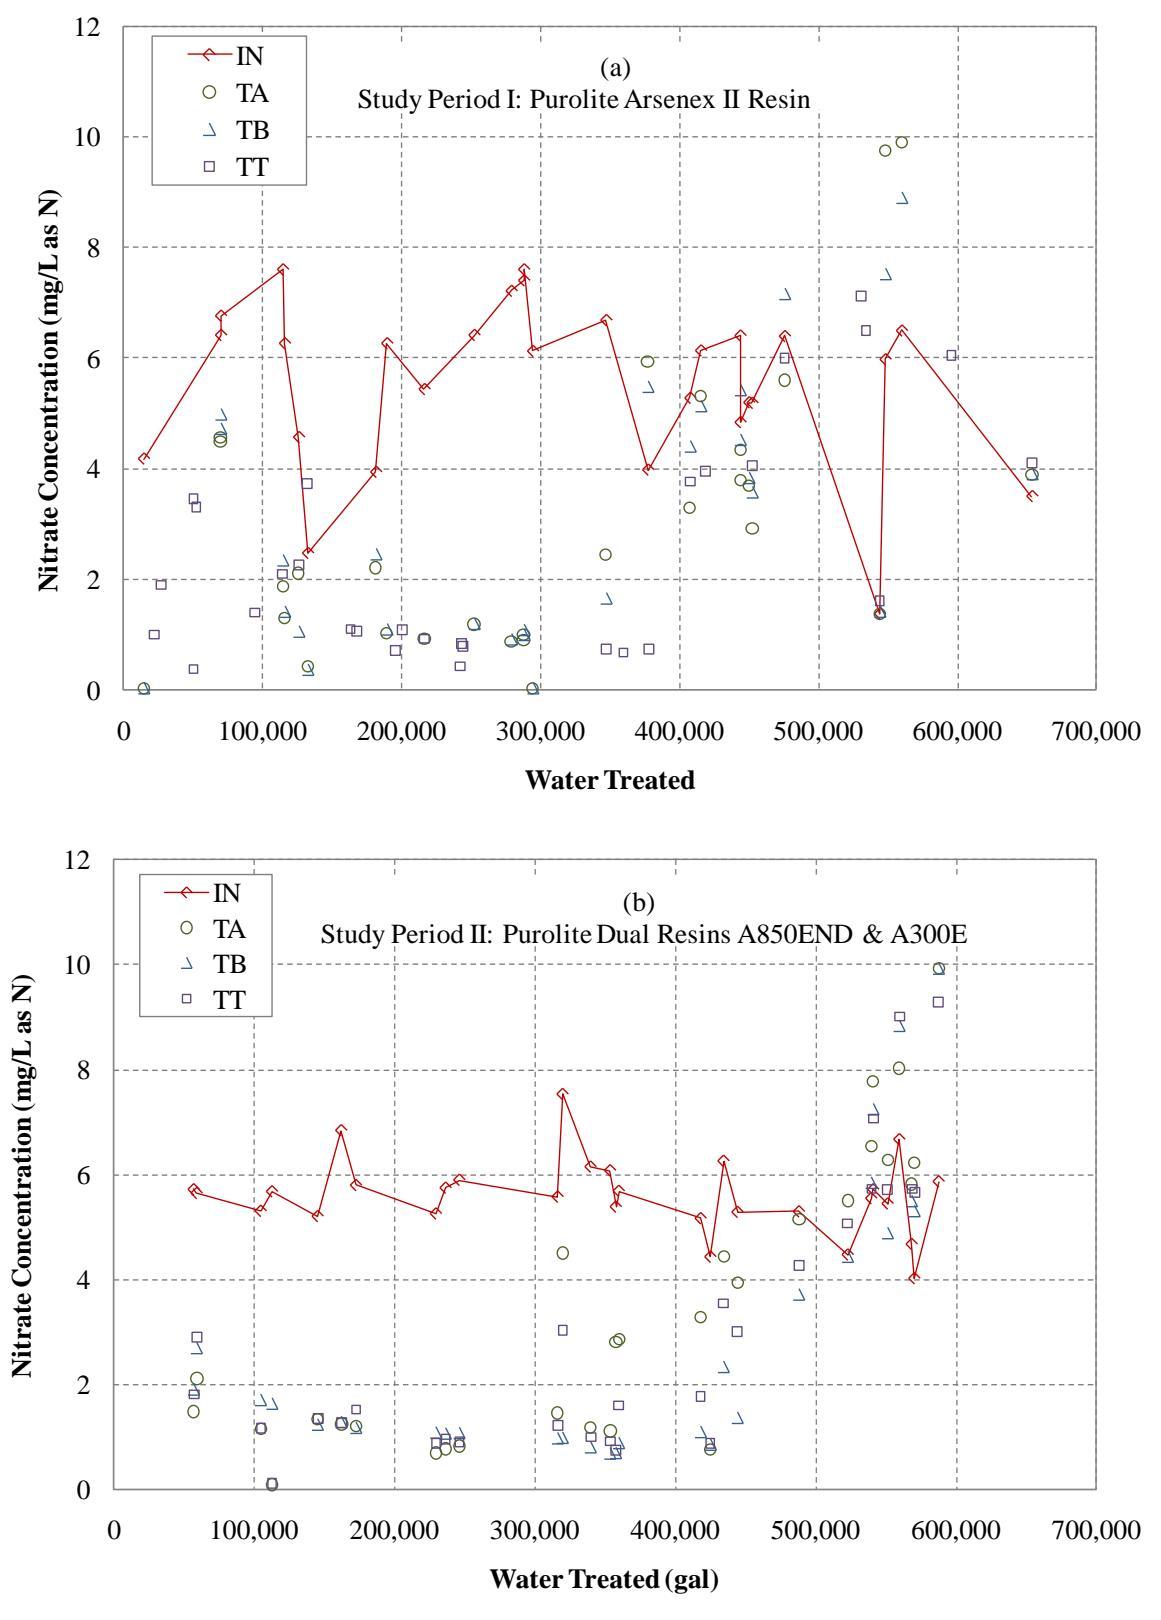
The original intent of system design was to control system operations based on nitrate breakthrough because it was easier and cheaper to monitor nitrate using a Hach test kit and because the regular resin is cheaper than the nitrate selective resin. The facility reported a higher nitrate concentration of 8 to 12 mg/L (as N) for technology selection and computer simulation. The facility also indicated that it preferred the IX system over other technologies because of its ability to remove both arsenic and nitrate.

Figure 4-25. Reconstructed Breakthrough Curves for Nitrate (a) Study Period I; (b) Study Period II

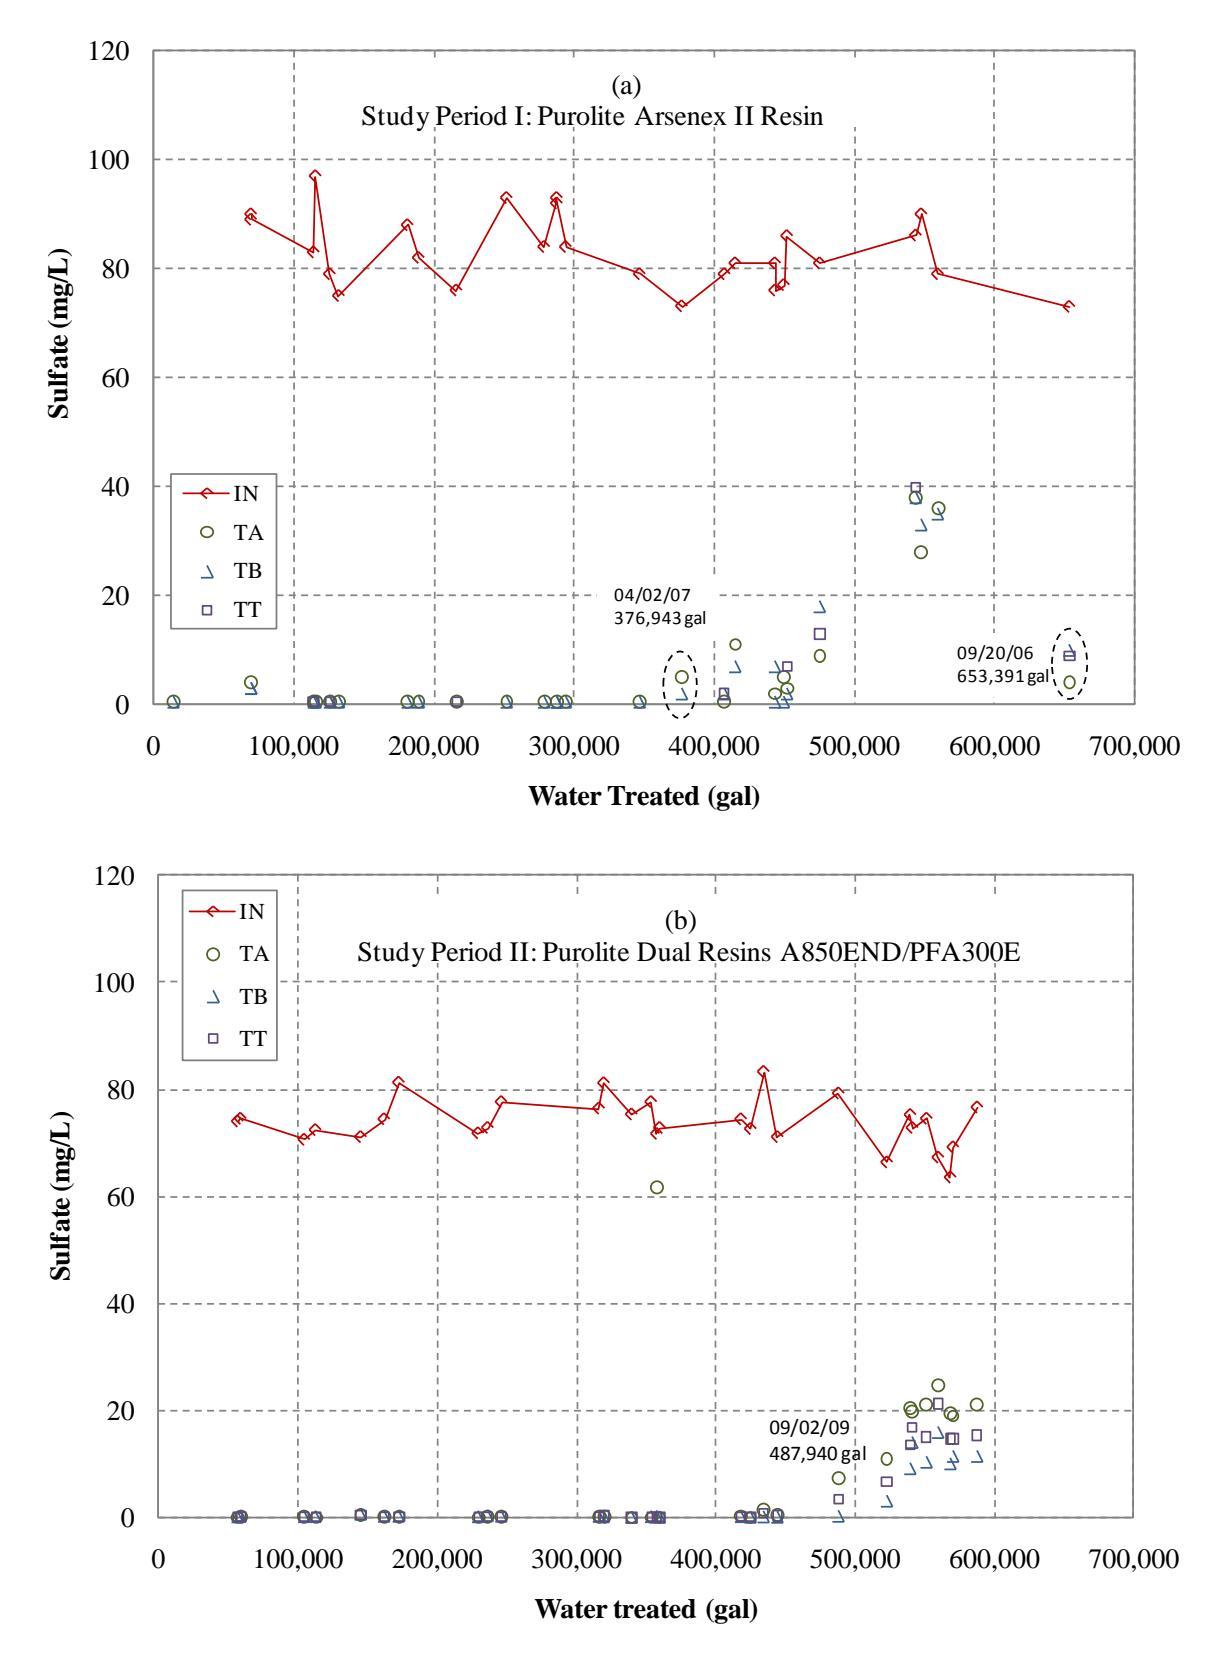
Figure 4-26. Reconstructed Breakthrough Curves for Sulfate (a) Study Period I; (b) Study Period II

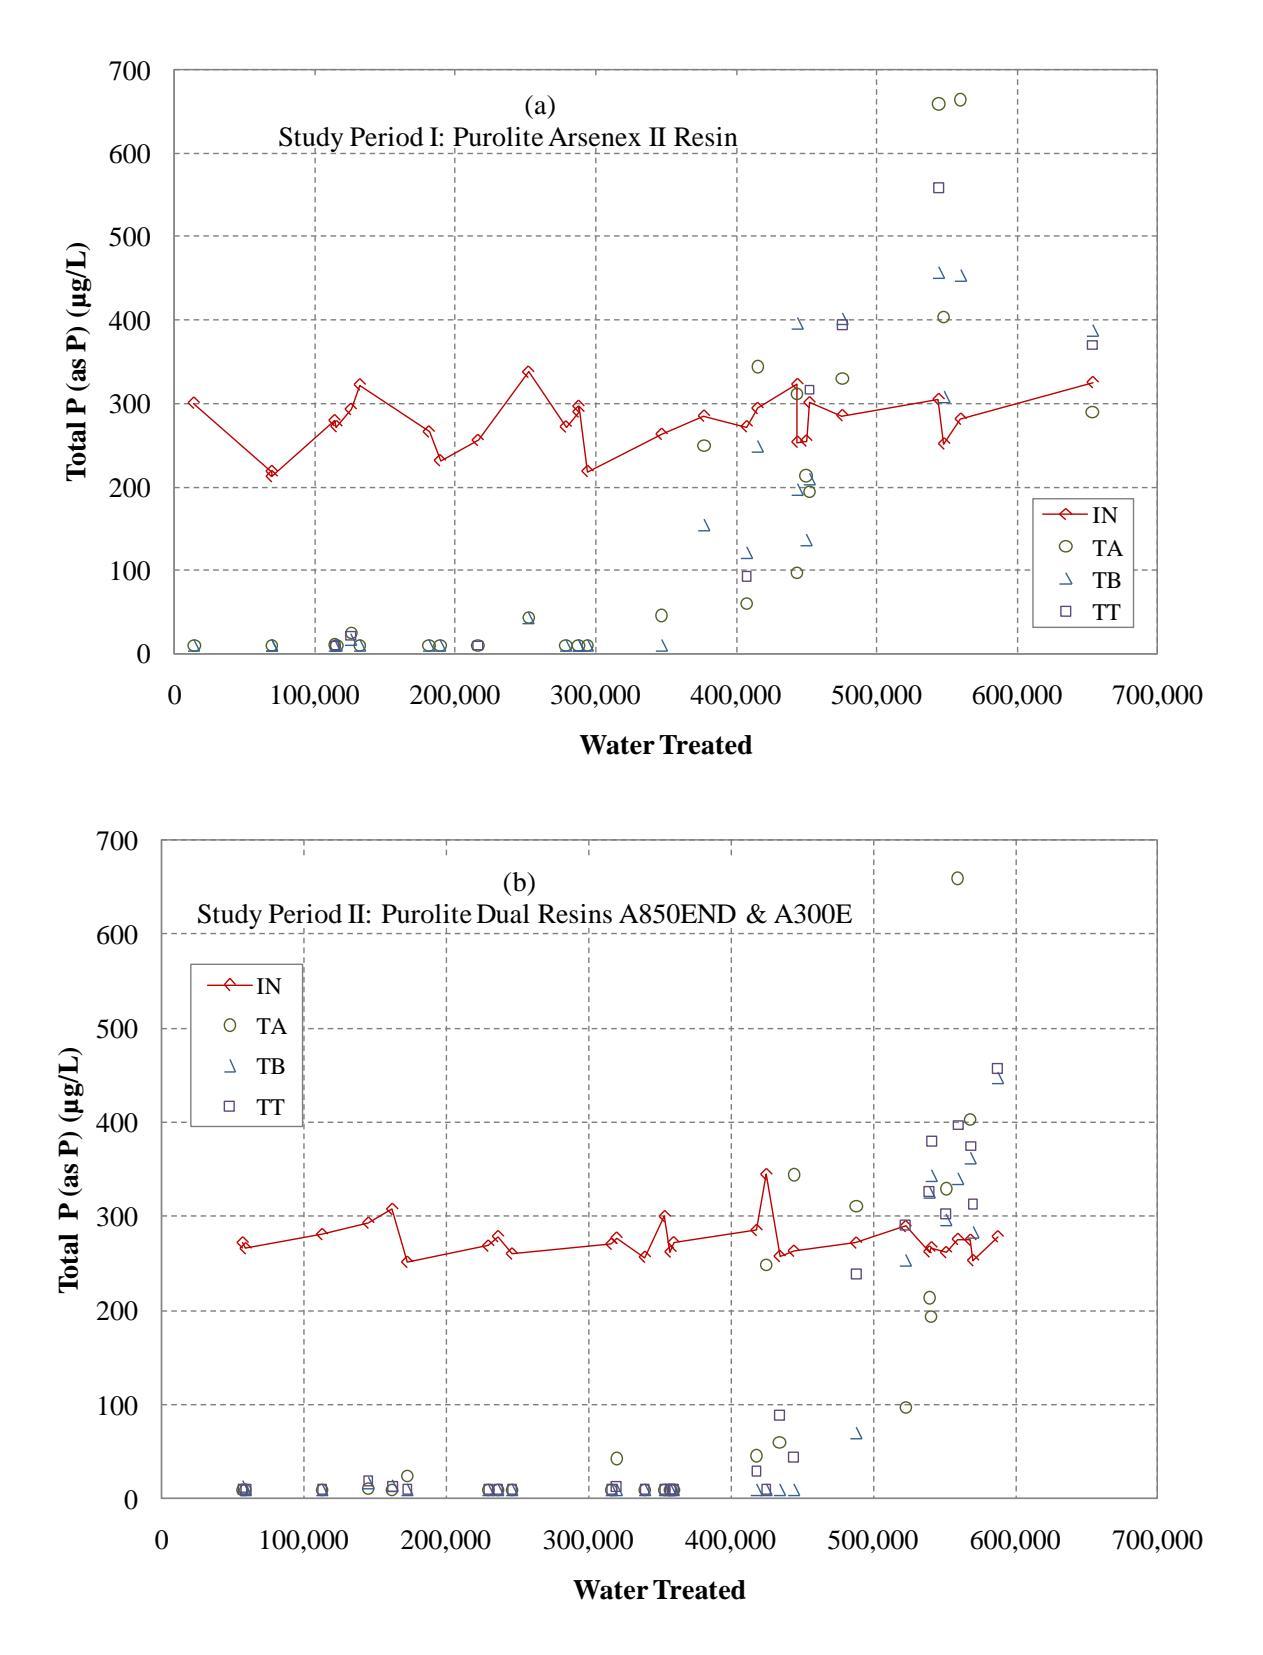
Figure 4-27. Reconstructed Breakthrough Curves for Total Phosphorus (a) Study Period I; (b) Study Period II

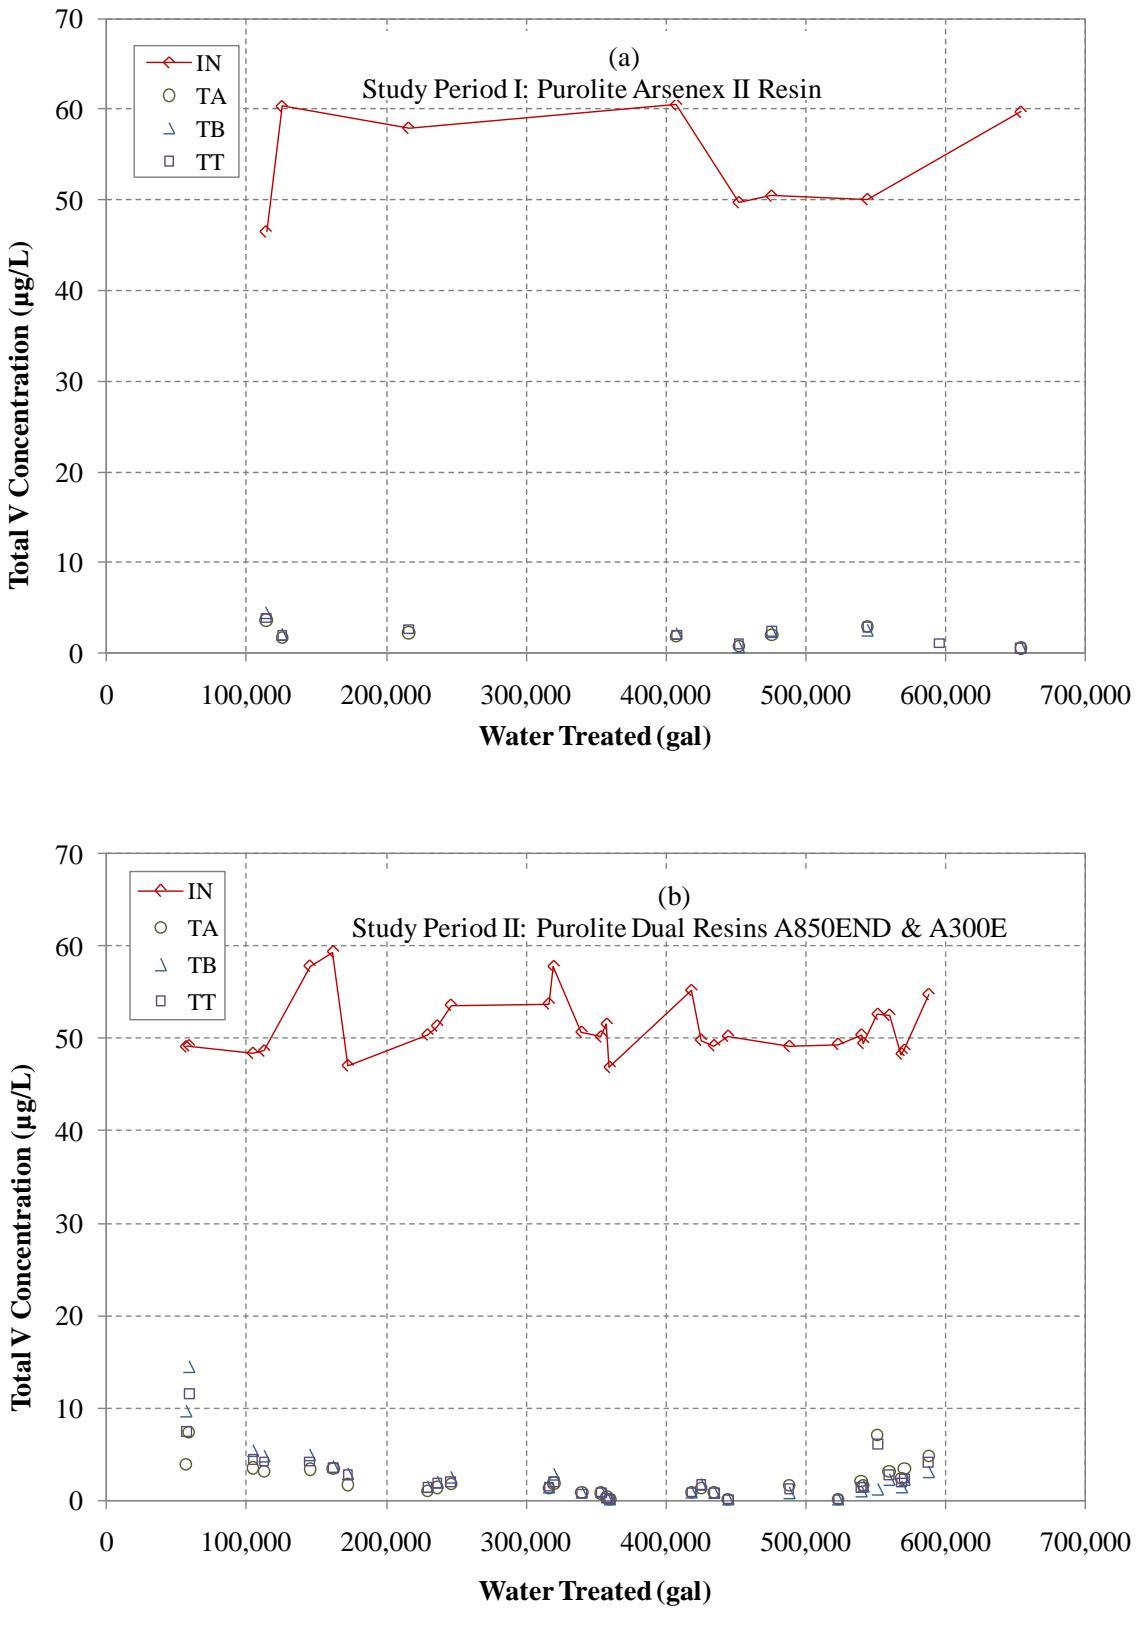
Figure 4-28. Reconstructed Breakthrough Curves for Total Vanadium (a) Study Period I; (b) Study Period II

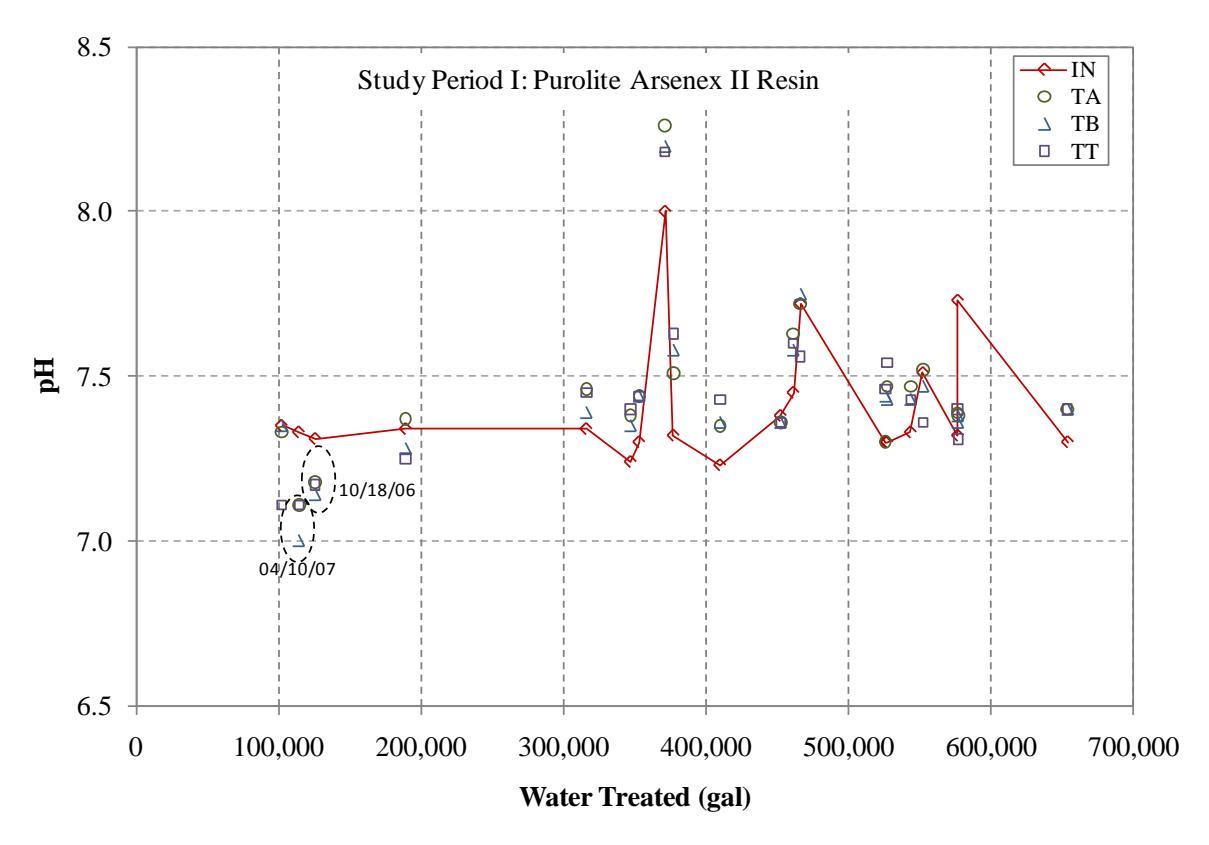
**4.5.1.5** *Other Water Quality Parameters*. Figures 4-29 and 4-30 present a "reconstructed pH plot" and "reconstructed breakthrough curves" for pH and total alkalinity, respectively. Raw water pH values ranged from 7.2 to 8.0 and averaged 7.4 in Study Period I. pH was not measured in Study Period II. Total alkalinity concentration in raw water ranged from 254 to 358 and averaged 329 mg/L (as CaCO<sub>3</sub>) in Study Period I; and ranged from 279 to 346 and averaged 309 mg/L (as CaCO<sub>3</sub>) in Study Period II.

Figure 4-29. pH Measured During Study Period I

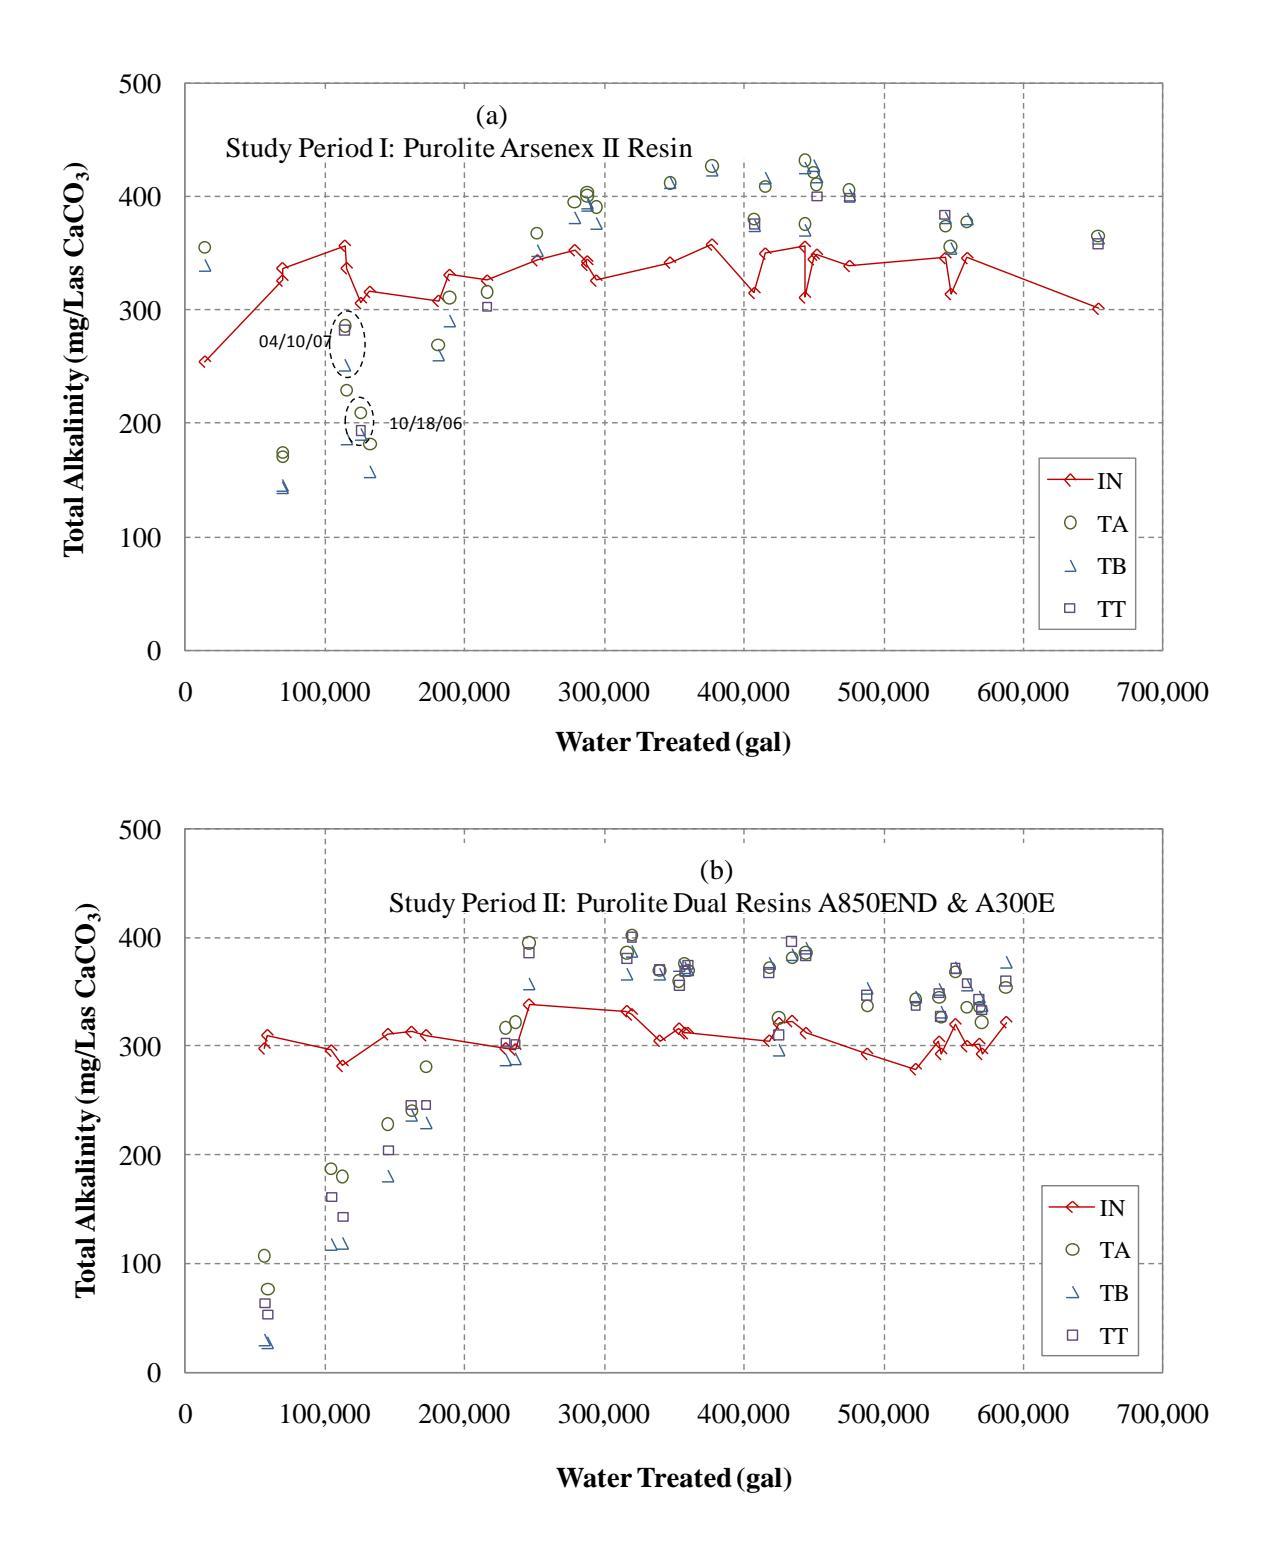
The reduction in pH and alkalinity immediately after regeneration was attributed to the removal of bicarbonate ions by the AIX resin. As reported in the literature, one disadvantage of the IX process is the production of low pH and corrosive water during the initial 50 to 100 BV of a service cycle (Clifford, 1999). Afterwards, the pH value of treated water returned to the raw water level due to the complete breakthrough of bicarbonate ions, which had a lowest selectivity by the SBA AIX resin.

Figure 4-30. Reconstructed Breakthrough Curves for Total Alkalinity (a) Study Period I; (b) Study Period II

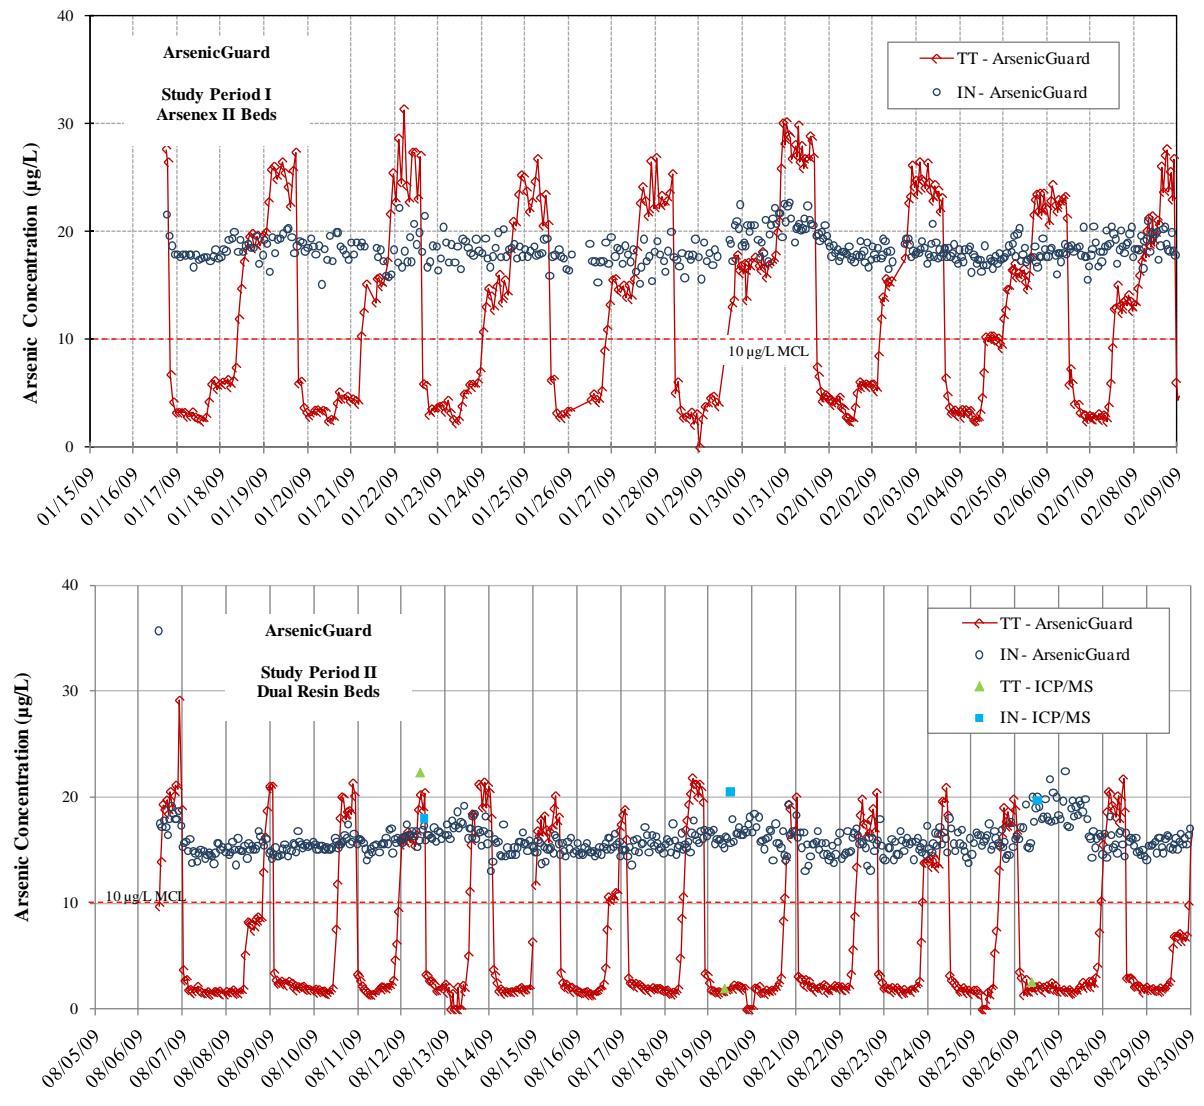
4.5.2 **Real-Time Arsenic Monitoring by ArsenicGuard<sup>TM</sup>.** The ArsenicGuard<sup>TM</sup> analyzer was installed on November 19, 2008, to provide real-time monitoring of arsenic in raw and treated water. ArsenicGuard<sup>TM</sup> took one measurement every 45 min (even when the well pump was off and the system was not in operation) with data displayed as strip charts, which can be downloaded from the computer for further processing. Figure 4-31 shows two examples of real-time total arsenic plots using data downloaded from ArsenicGuard<sup>TM</sup>. The top graph plotted data from January 16 through February 9, 2009, right before Arsenex II replacement in February 2009. The bottom graph plotted data from August 6 through 30, 2009, after dual resins installation. The plots clearly showed reoccuring service/ regeneration cycles as arsenic concentrations in system effluent cycled between a few  $\mu$ g/L and higher than corresponding influent concentrations. As shown in Table 4-11, system regeneration was set at a volume throughput of 600,000 gal during applicable operating periods shown in Figure 4-31 (under Setting 6 in Study Period I and Setting 7 in Study Period 7). Arsenic breakthrough to 10 µg/L occurred before reaching 600,000 gal for both Arsenex II and PFA300E/A850END and continuing operations resulted in arsenic dumping in every regeneration cyle. Because ArsenicGuard<sup>™</sup> continued analyzing "samples" even when the system was not in operation, the plots shown in Figure 4-31 do not represent actual arsenic breakthrough curves or reflect actual run lengths.

Figure 4-31. Examples of Real-Time Arsenic Monitoring by ArsenicGuard<sup>TM</sup>

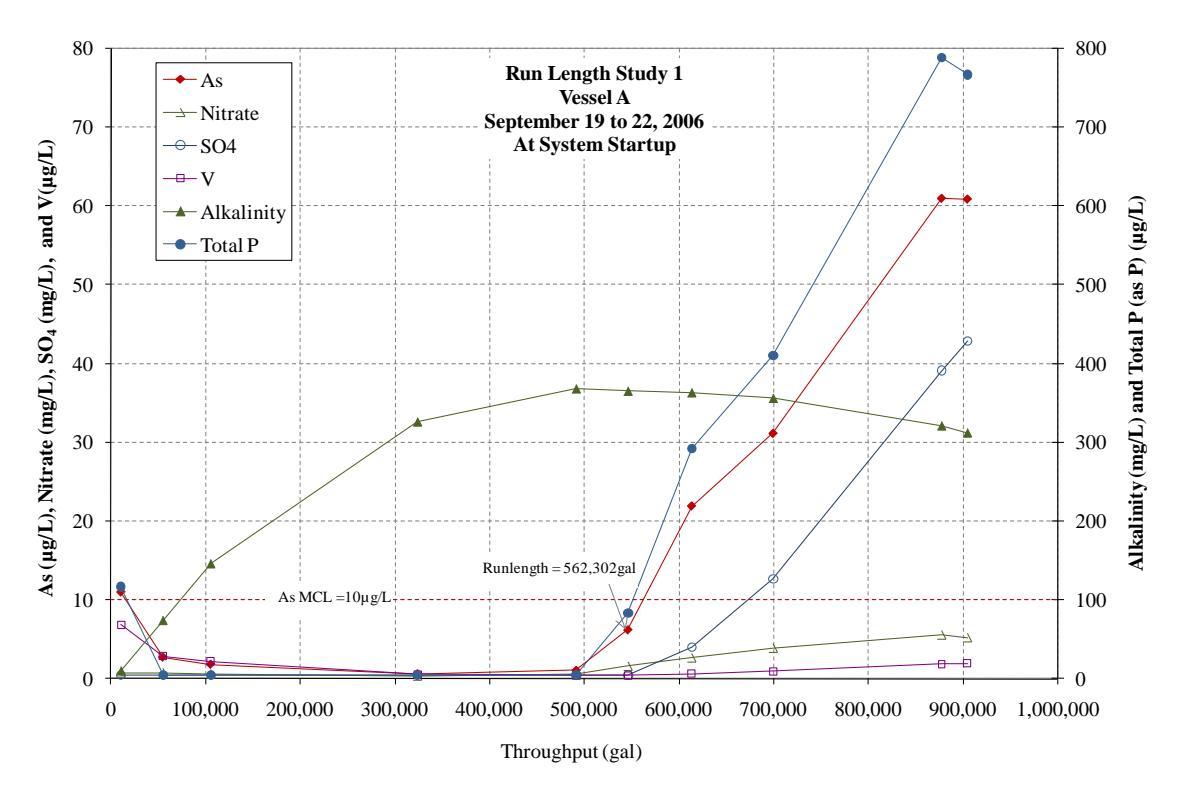
Figure 4-32. Vessel A Breakthrough Curves from Run Length Study 1

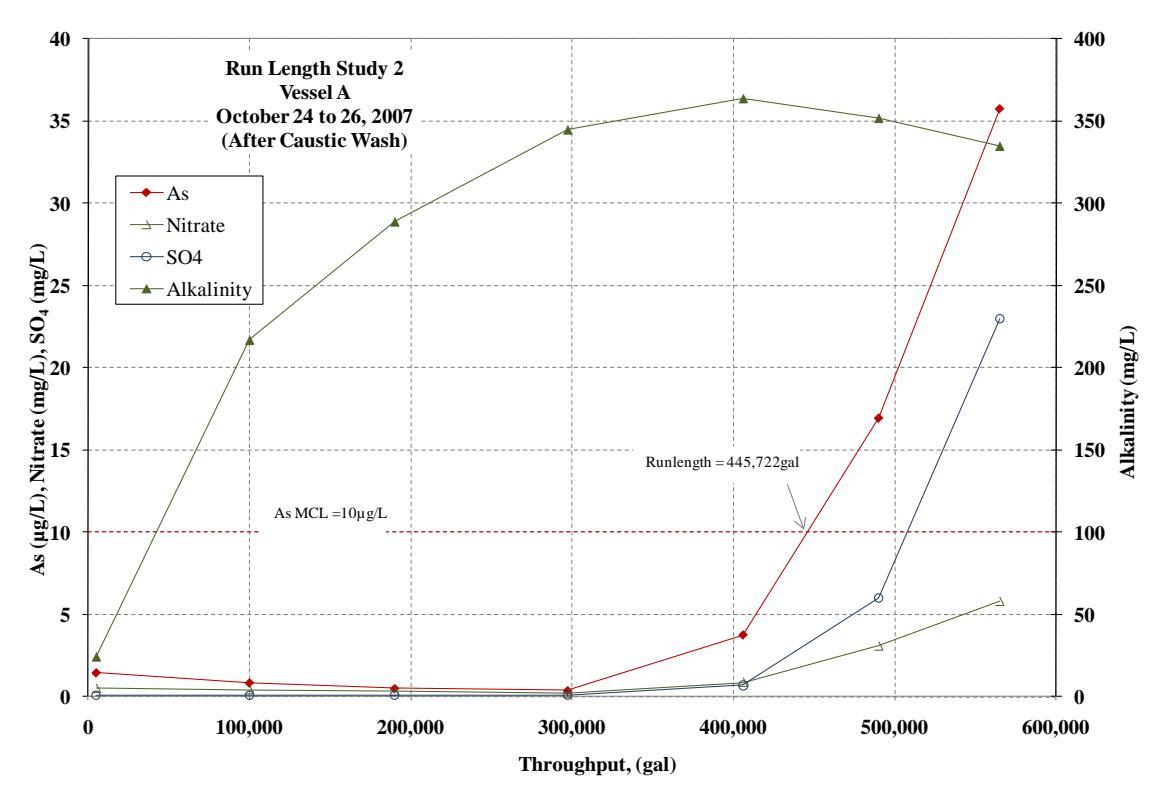
*Run Length Study 2 (October 24 to 26, 2007)*. Run Length Study 2 was conducted on Vessel A two days after resin cleaning using a mixture of 5% caustic/10% brine in October 2007 to assess the effectiveness of the cleaning. Figure 4-33 presents total arsenic, nitrate, sulfate, and total alkalinity breakthrough curves, which are similar to those shown in Figure 4-32, except that the first breakthrough point for total As, nitrate, and sulfate occurred at approximately 400,000 gal, shorter than the 550,000 gal observed in Run Length Study 1. The run length to  $10-\mu g/L$  of arsenic breakthrough was approximately 445,720 gal, which was 20% more than the pre-cleaning level, but only 80% of the baseline level. The highest arsenic

Figure 4-33. Vessel A Breakthrough Curves from Run Length Study 2

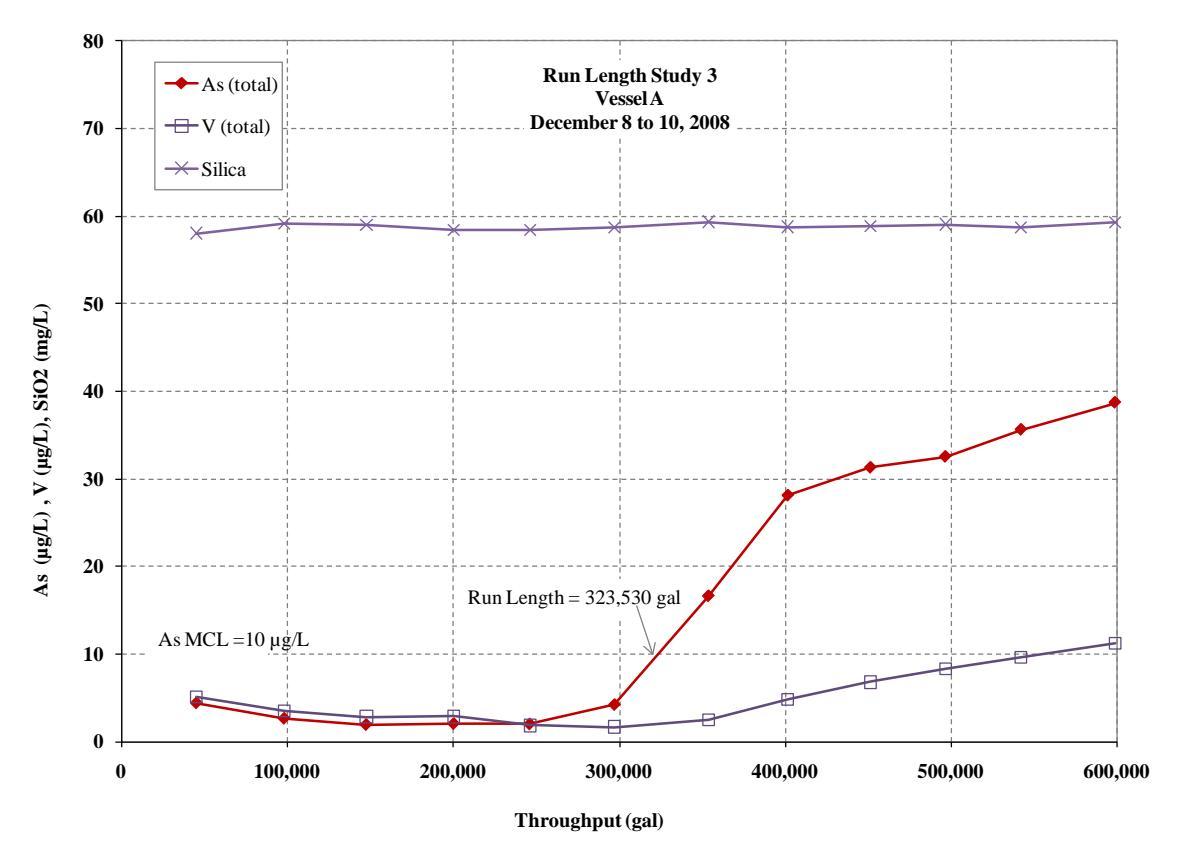
*Run Length Study 3 (December 8 to 10, 2008)*. Run Length Study 3 was conducted on Vessel A to assess the condition of the resin following nine months of system operation after the October 2007 caustic/brine cleaning. Raw water samples collected at the beginning of the study contained 24.0 µg/L of total arsenic, 53.3 µg/L of total vanadium, and 57.7 mg/L (as SiO<sub>2</sub>) of silica. As shown in Figure 4-34, the run length to 10-µg/L of arsenic breakthrough was shortened significantly from the previous 445,720 gal to approximately 323,530 gal. The deteriorating performance also was reflected by the total vanadium breakthrough curve, which showed a concentration of 11.3 µg/L at 600,000 gal, compared to <1 µg/L in both Run Length Studies 1 and 2. Silica concentrations stayed constant throughout this special study, ranging from 58.0 to 59.3 mg/L (as SiO<sub>2</sub>).

Figure 4-34. Vessel A Breakthrough Curves from Run Length Study 3
