# Arsenic and Nitrate Removal from Drinking Water by Ion Exchange U.S. EPA Demonstration Project at Vale, OR Final Performance Evaluation Report

This demonstration study was divided into three periods: Study Periods I and II and an interim period between the two. Study Period I (extending from September 19, 2006, through January 14, 2008) evaluated the originally proposed Purolite Arsenex II anion exchange (AIX) resin. Because of its deteriorating performance due to organic fouling and difficulties in restoring its exchange capacity after resin cleaning, a dual resin approach was identified and implemented in the interim period to address the relevant issues. In February 2009, Arsenex II resin was replaced with Purolite PFA300E resin, which was overlain with an organic scavenger, Purolite A850END. The performance of PFA300E/A850END was evaluated in Study Period II from February 10, 2009, through March 22, 2010.

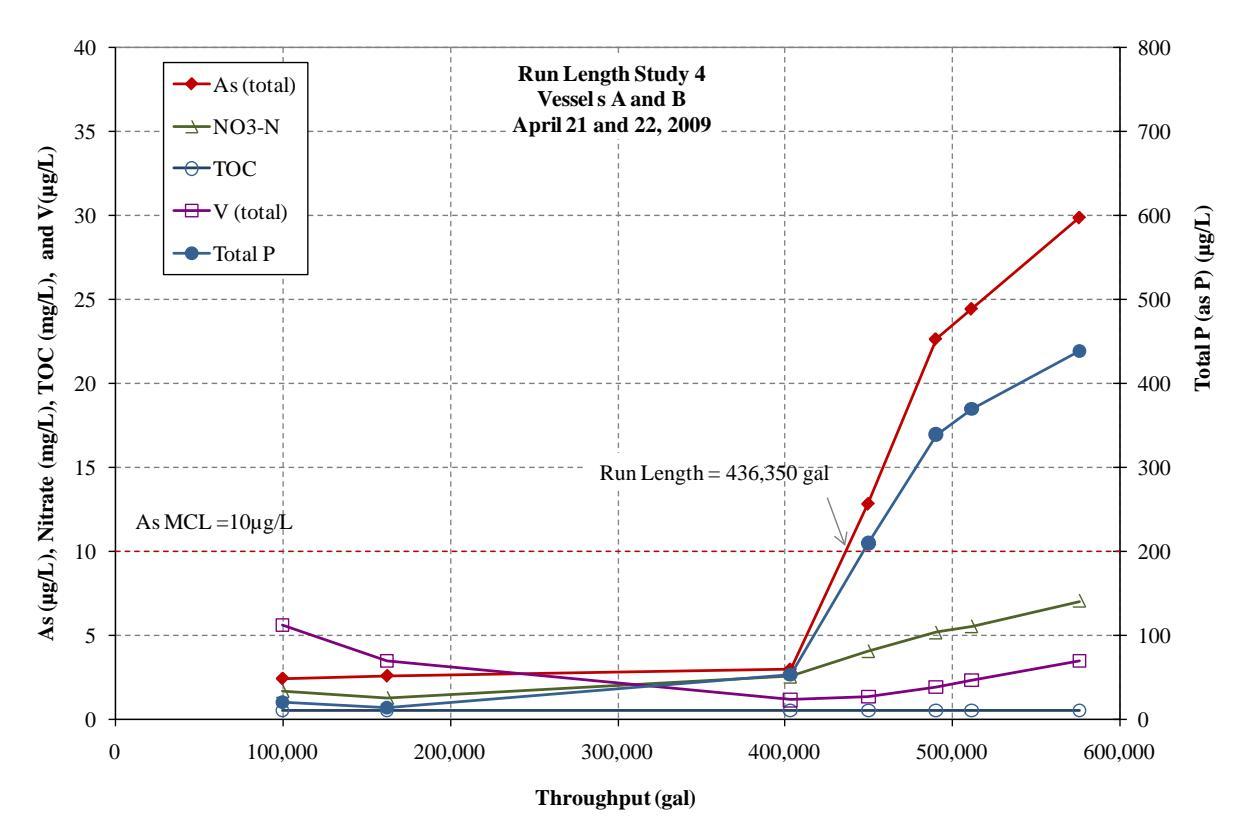
As shown in Figure 4-35, arsenic breakthrough at 10  $\mu$ g/L occurred between 403,000 and 450,000 gal and estimated to be 436,350 gal using linear interpolation, which was consistent with the results of weekly sampling discussed in Section 4.5.1.2 (Figure 4-24). Arsenic peaking occurred after 500,000 gal with the highest concentration measured at 30  $\mu$ g/L. Similarly, total phosphorus began to exceed its influent level around 500,000 gal with the highest concentration measured at 438  $\mu$ g/L. Total vanadium was removed to <5  $\mu$ g/L in all but the first sample. Nitrate was below its MCL for the entire study period, reaching its influent concentration by the end of the study. TOC was removed to below the reporting limit of 1 mg/L consistently throughout, suggesting that A850END had worked well as a TOC scavenger.

Figure 4-35. Combined Effluent Breakthrough Curves from Run Length Study 4

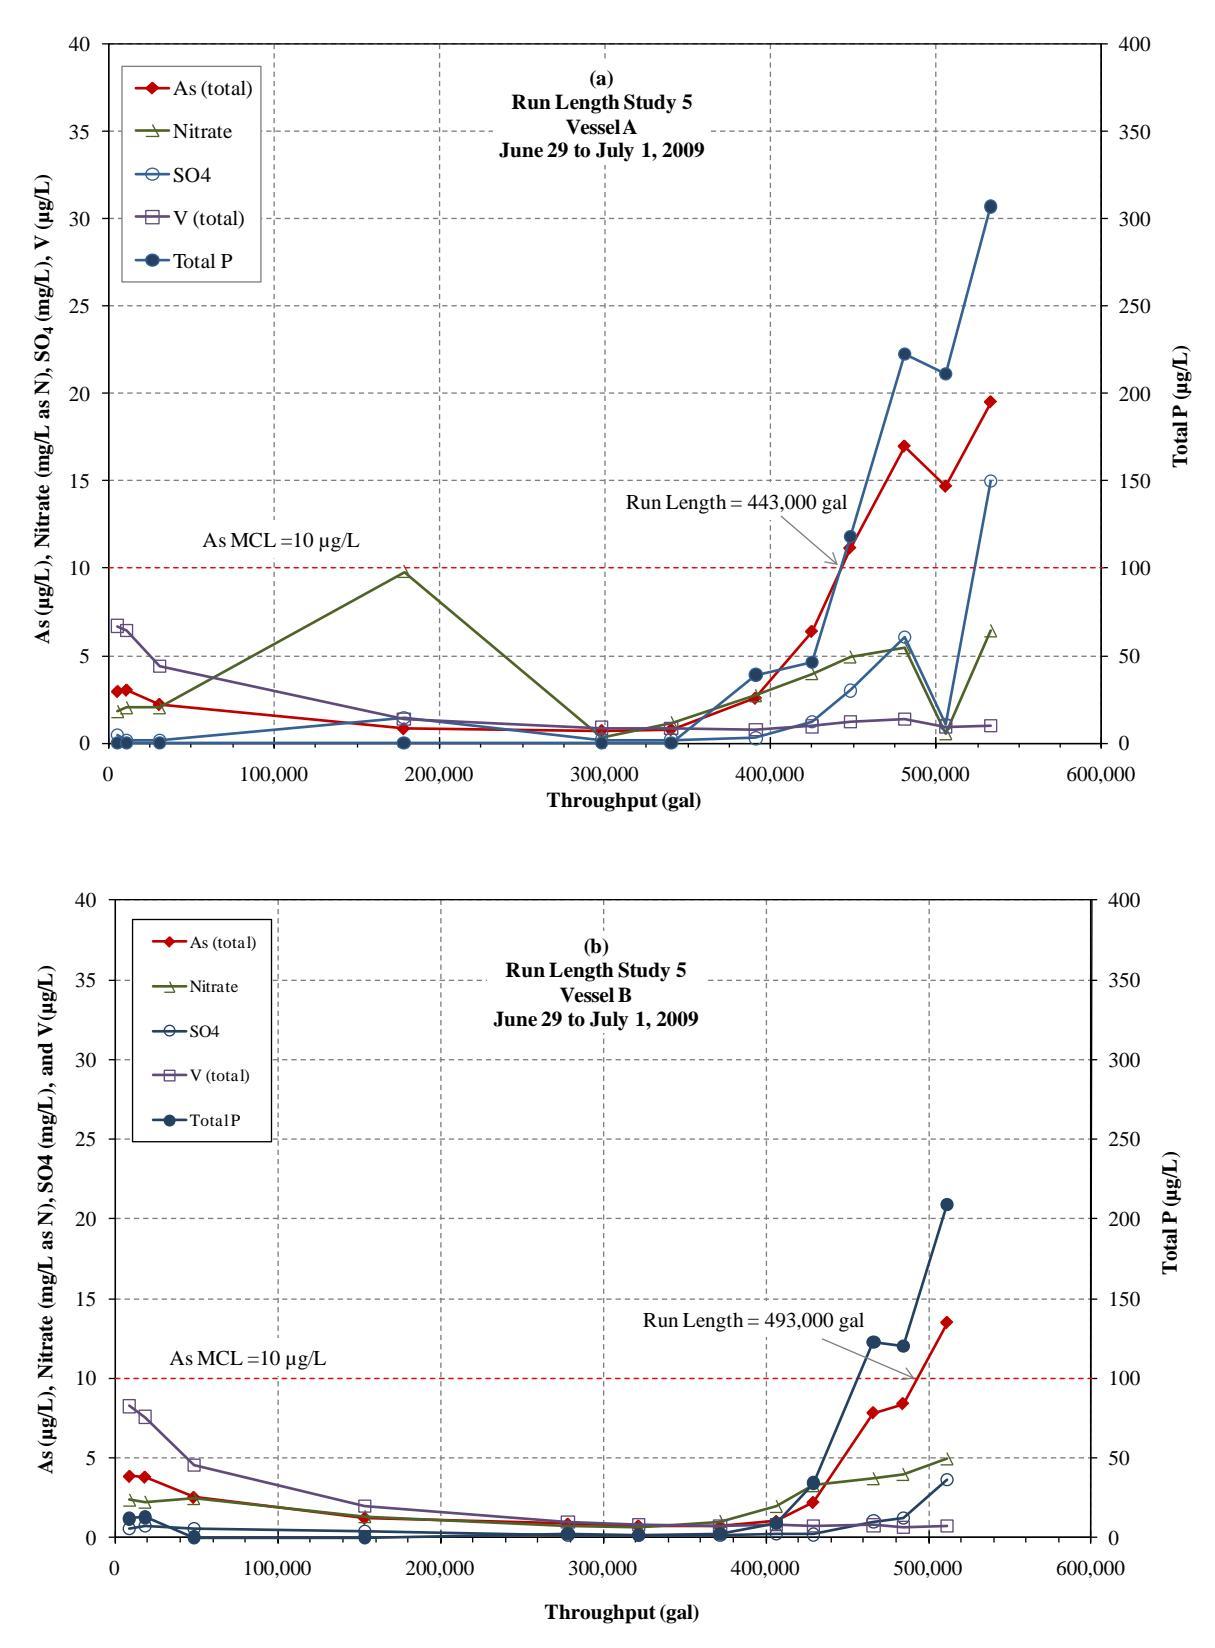
As shown in Figure 4-36, effluent from Vessels A and B reached  $10-\mu g/L$  arsenic breakthrough at approximately 443,000 and 493,000 gal, respectively, or 468,000 gal (on average). Nitrate did not reach the 10 mg/L MCL in either vessel. TOC stayed below the MDL of 1 mg/L throughout the study, indicating good removal by the TOC scavenger. Total phosphorus rose sharply around 400,000 gal for both vessels. Sulfate and total vanadium remained low throughout the study period while silica concentrations in the treated water were similar to the raw water level (i.e., 58.7 mg/L [as SiO<sub>2</sub>]).

Figure 4-36. Breakthrough Curves from Run Length Study 5

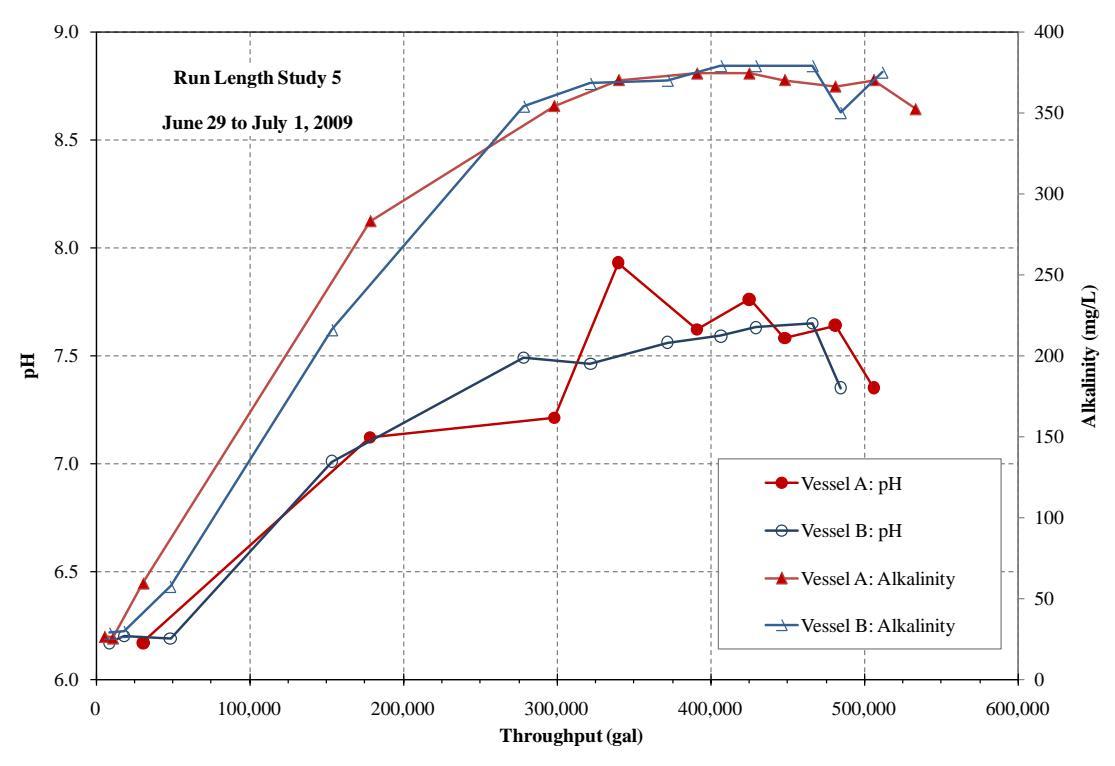
Figure 4-37. pH and Alkalinity Breakthrough Curves from Run Length Study 5

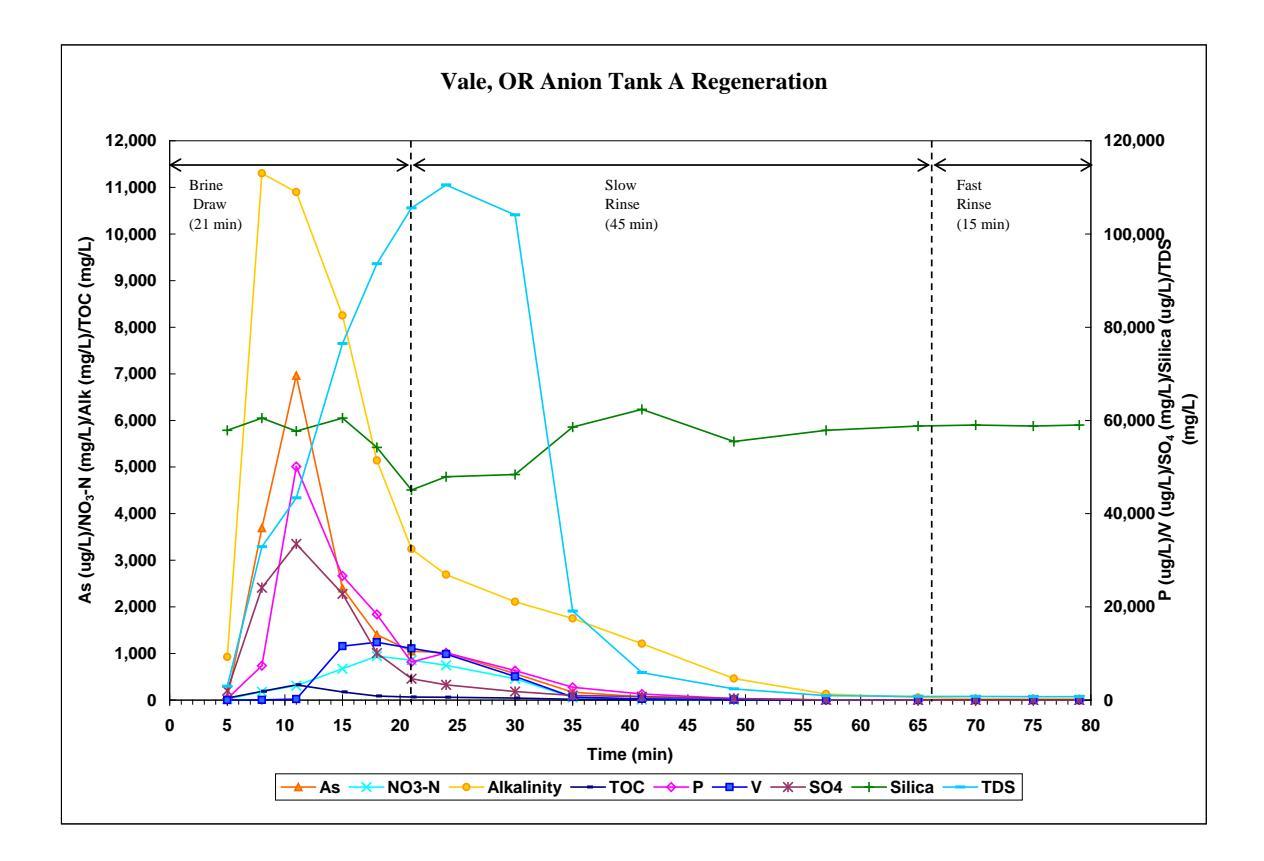
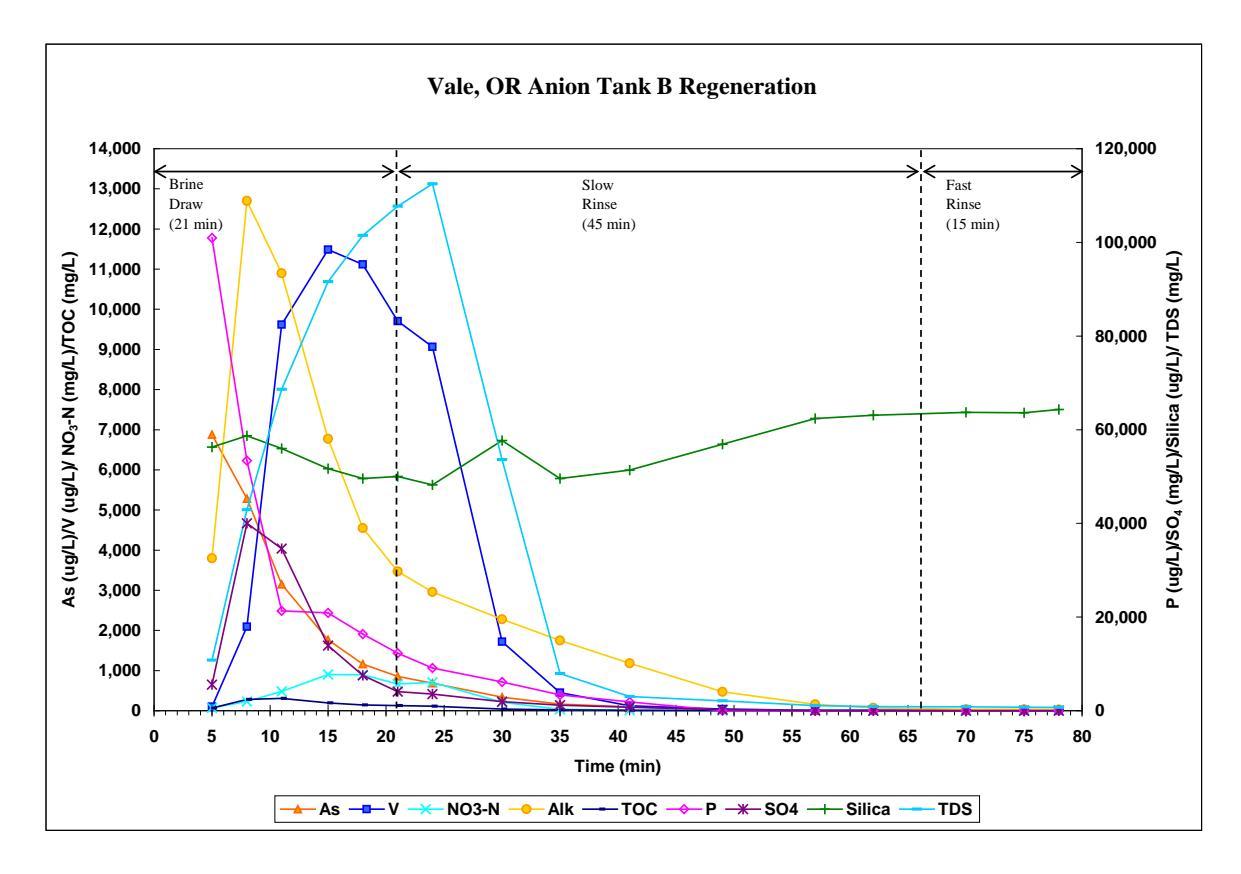
**Elution Curves.** Figure 4-38 presents elution curves of arsenic, nitrate, total phosphorus, alkalinity, sulfate, vanadium, silica, and TOC for Vessels A and B. Figure 4-39 shows similar curves for TDS and pH. All figures have a primary and a secondary y-axis to accommodate all intended analytes on the same graphs. TDS concentration reflects salt concentration in the eluent. As the brine solution entered an IX vessel, arsenic, nitrate, sulfate, TOC, and other analytes of concern on the exhausted resin were displaced into the eluent by highly concentrated chloride ions. The highest concentrations of arsenic, sulfate, and TOC from Vessel A were measured at 6,963 µg/L, 33,560 mg/L, and 327 mg/L, respectively, approximately 11 min into the brine draw step. Nitrate did not peak until 18 min into brine draw at 942 mg/L (as N). Peak concentrations of arsenic, nitrate, sulfate, and TOC from Vessel B occurred between 5 min and 15 min into the brine draw step and were measured at  $6,882 \mu g/L$ , 900 mg/L (as N), 40,000 mg/L, and 308 mg/L, respectively. Maximum TDS concentrations for each vessel occurred approximately 6 min into the slow rinse step. After 41 min into the 45 min slow rinse step, arsenic and nitrate concentrations decreased to below their respective MCLs while TOC was below its detection limit. Sulfate concentrations fell below its secondary MCL (250 mg/L) at 36 and 28 min into the slow rinse step for Vessels A and B, respectively. TDS concentrations for both vessels exceeded its secondary MCL (500 mg/L) during the entire regeneration cycle.

Figure 4-38. Vessels A and B Elution Curves

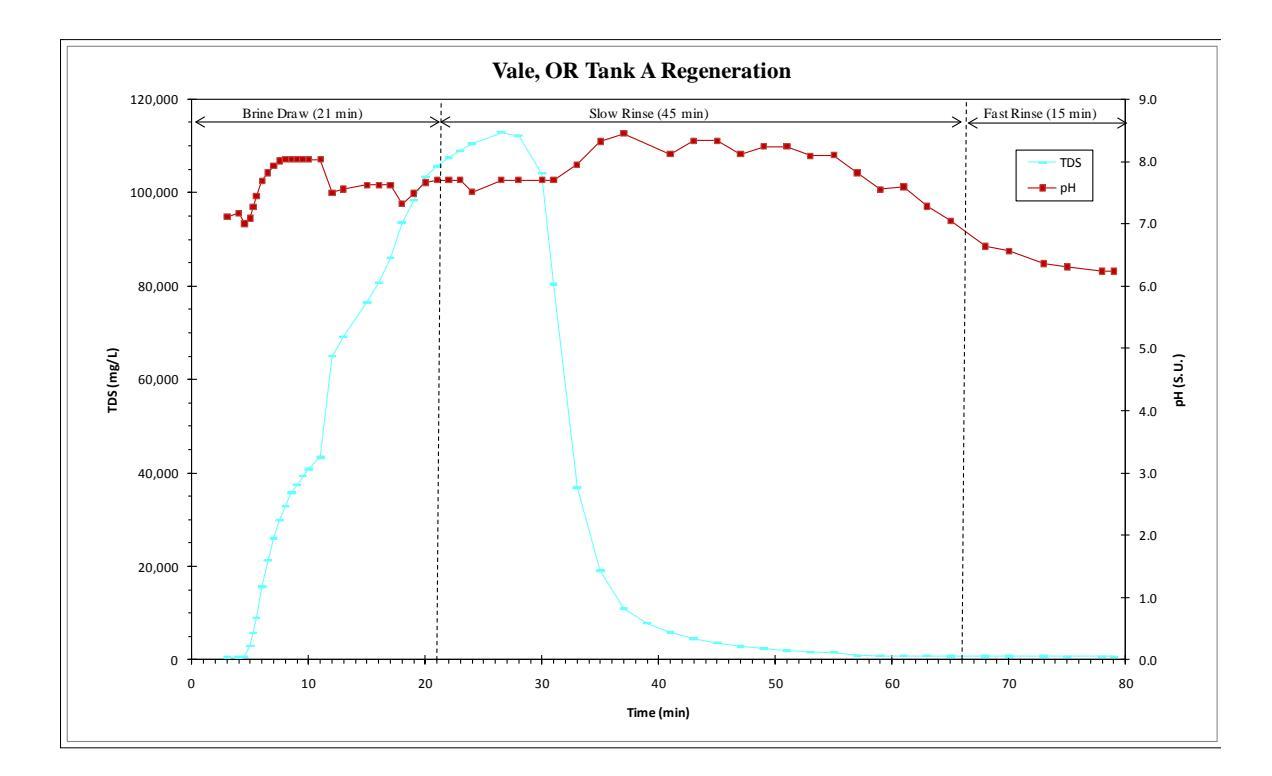
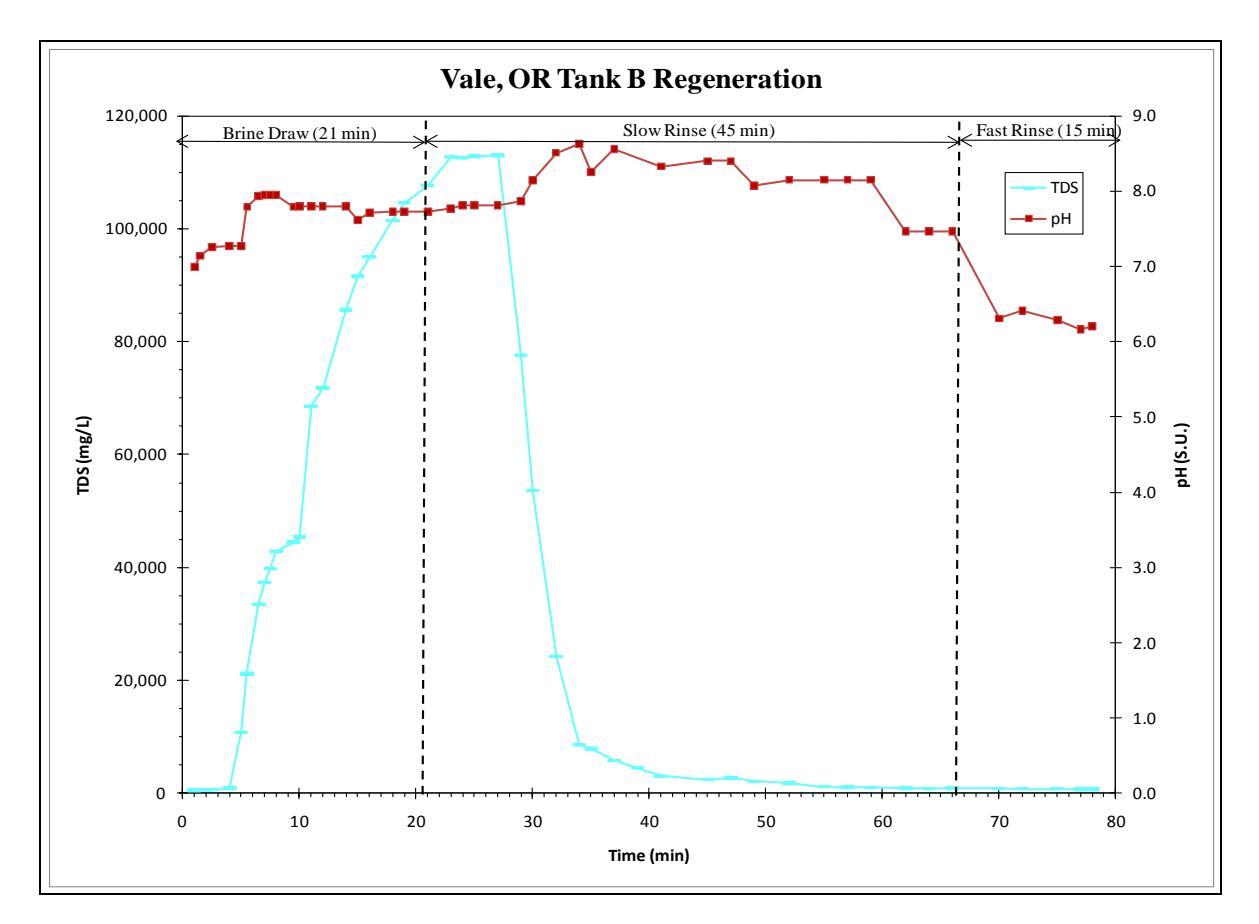
Figure 4-39. Vessels A and B Elution Curves for TDS and pH

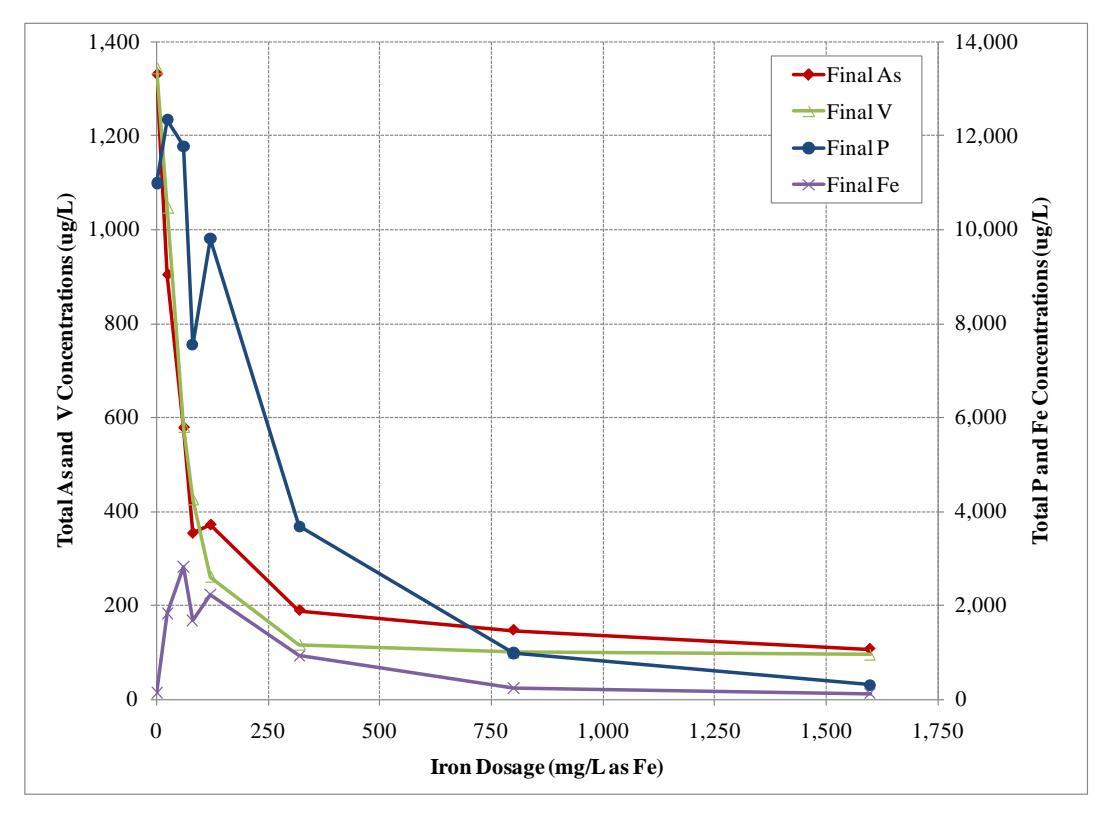
corresponding to Fe to As mass ratios of 15:1 to 1,216:1 at a pH value of 6.9 to 7.2. Analytical results showed that final arsenic concentrations in the supernatant ranged from 106 to 904  $\mu$ g/L and generally decreased with increasing iron dosages, as shown in Figure 4-40. However, the concentration reduction leveled off after the first 320 mg/L of iron addition. Even with the 320 mg/L of iron addition, arsenic in supernatant remained high at 200  $\mu$ g/L, indicating ineffective treatment by FeCl<sub>3</sub>. In contrast, the spent regenerant from an AM system containing up to 200 mg/L of arsenic (but no salt) was effectively treated to below 10  $\mu$ g/L with FeCl<sub>3</sub> at a mere 30:1 Fe/As mass ratio under a neutral pH condition. As shown in Figure 4-40, total phosphorus and total vanadium also were removed, suggesting that these anions might contents along with the presence of competing anions rendered the FeCl<sub>3</sub> treatment of the pond water ineffective.

Figure 4-40. Results of Vale Pond Water Jar Tests
