EVALUATION OF REFRIGERANT FROM MOBILE AIR CONDITIONERS

> EPA Contract 68-02-4285 Work Assignment No. 1/006

EPA Project Officer: Dale L. Harmon

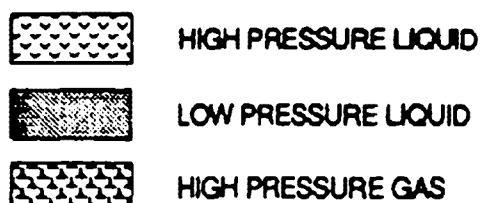
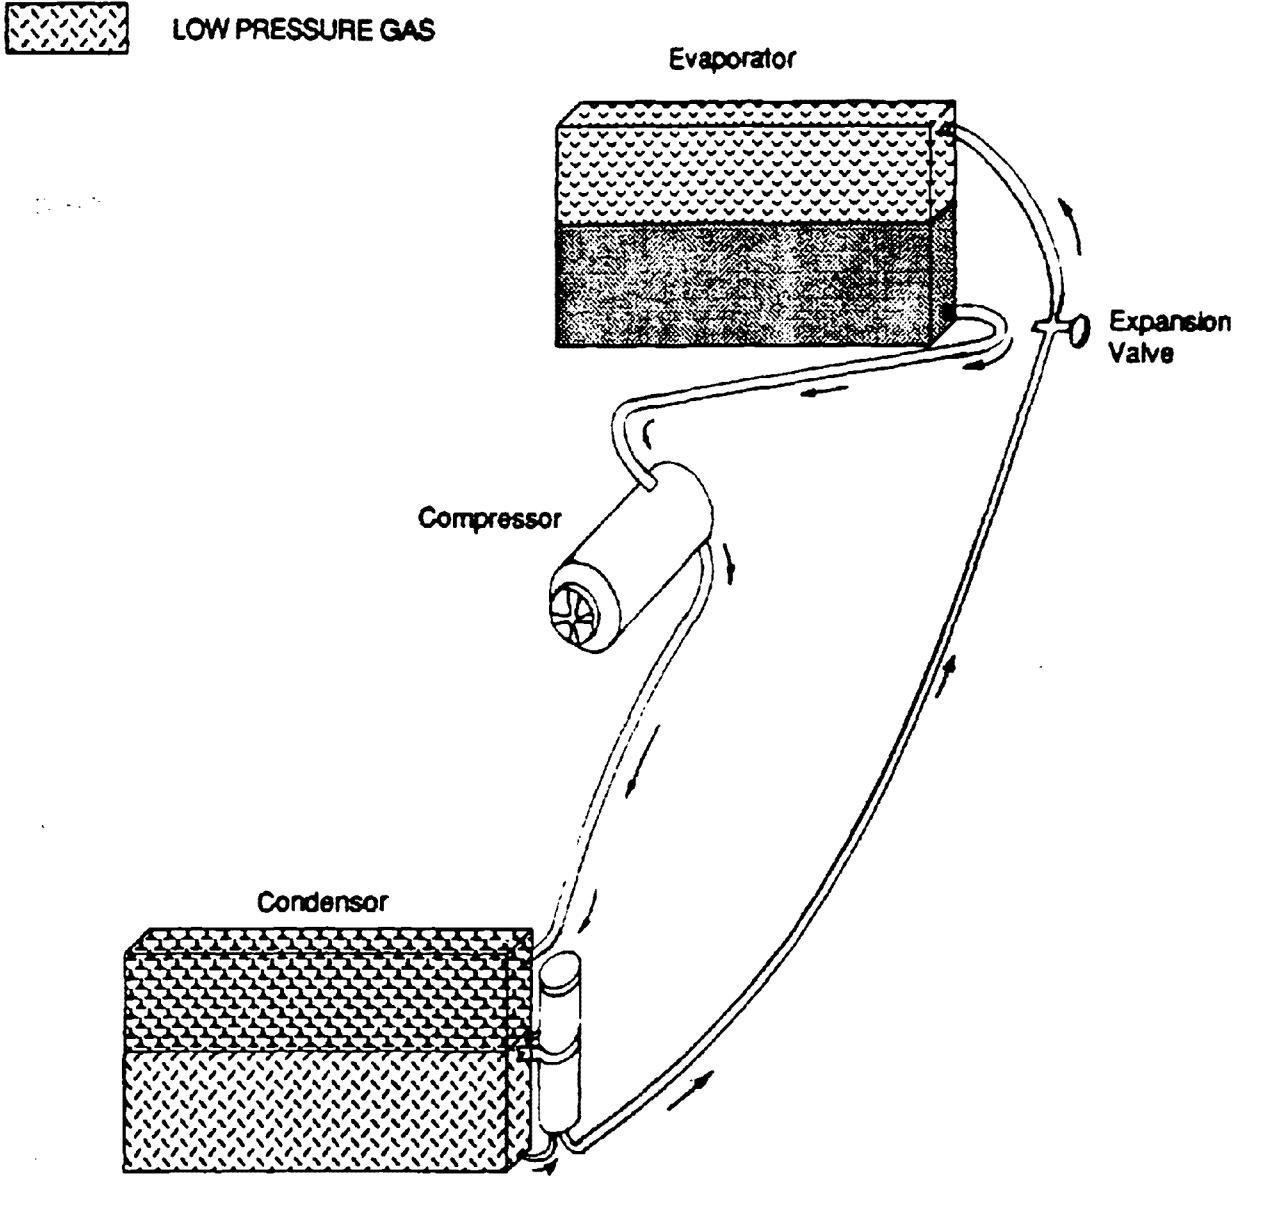
Before further discussion of this program, a brief explanation of mobile refrigeration systems will be presented for background. A typical mobile air conditioner, which is shown in Figure 1-1, consists of a compressor, evaporator, expansion valve, and condenser. Other valves and equipment, which are not shown, are installed in a working system to scavenge trace amounts of moisture and dirt and to ensure that the system functions properly. The condenser and evaporator are heat exchangers, similar in appearance to automotive radiators, that contain the refrigerant. In an automobile, the condenser is mounted in front of the engine fan under the hood where it is cooled by the outside air; the evaporator is mounted in the ventilation system to cool the air inside the car.

The refrigeration cycle works by pumping the working fluid through the compressor to increase its pressure. The refrigerant is a gas at that point; its temperature is well above ambient. The refrigerant flows from the compressor to the condenser where outside air cools the refrigerant to nearly the ambient (outside) temperature, causing the refrigerant to condense into a liquid and releases its heat to the outside air.

The liquid refrigerant flows from the condenser through an expansion valve to the evaporator where the pressure is low enough so that the refrigerant vaporizes. During vaporization, the temperature of the refrigerant drops. Air is blown across the cooled refrigerant tubes of the evaporator and into the passenger compartment. The refrigerant returns to the compressor though the suction throttling valve to repeat the cycle.

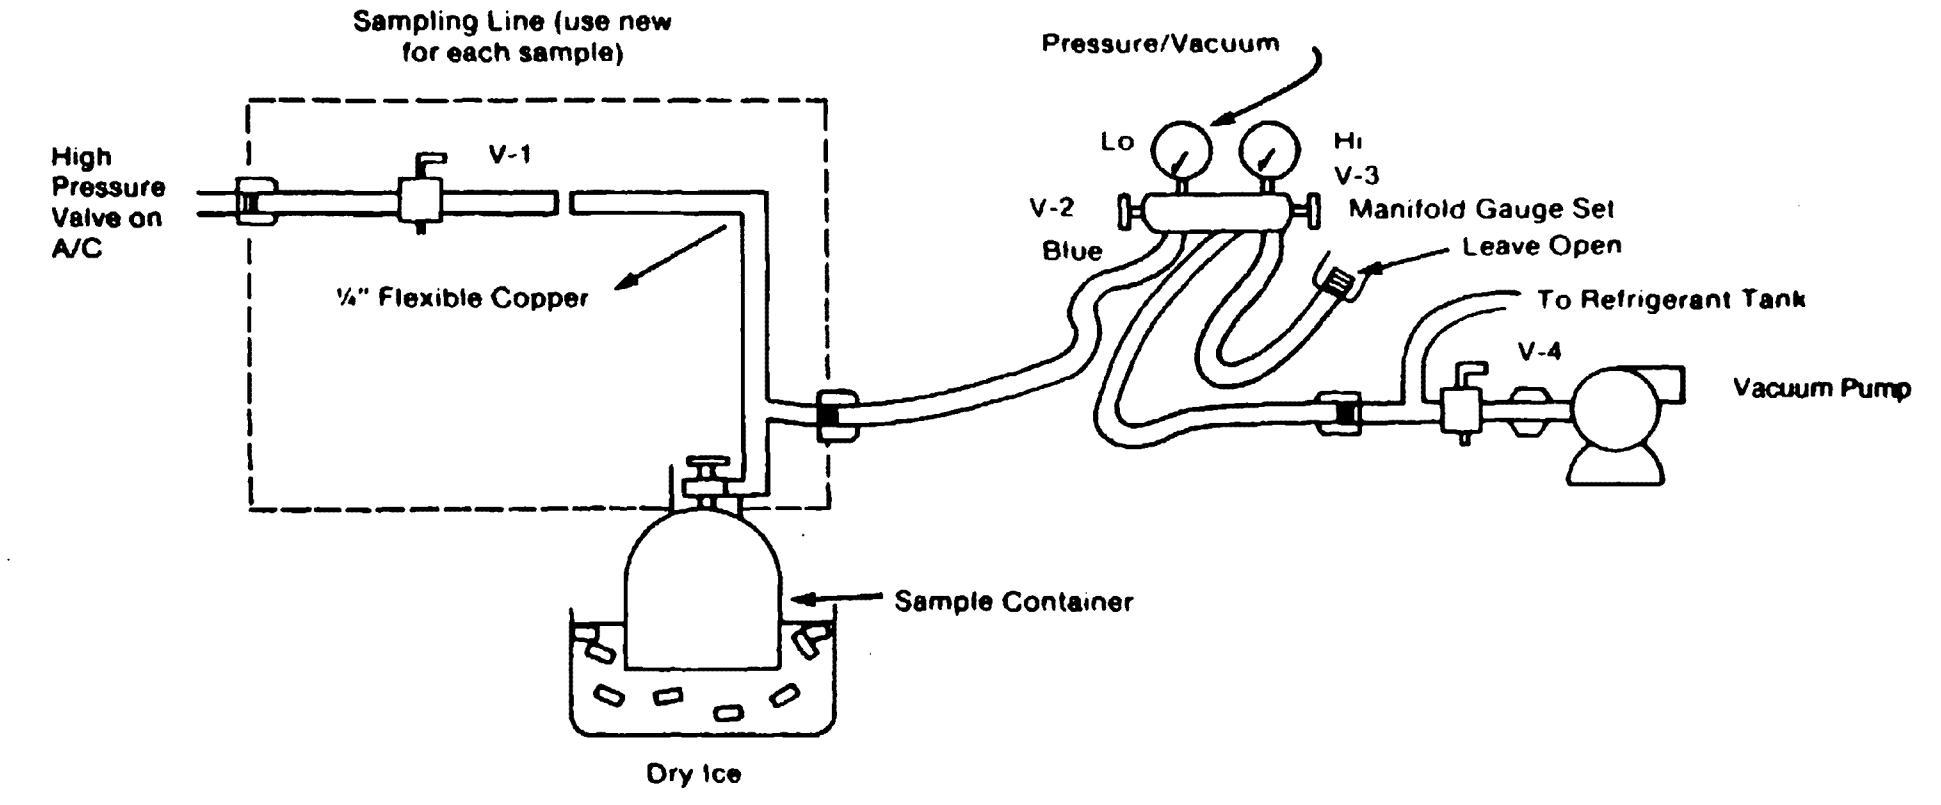
Figure 3-1. Sampling schematic.

The equipment used for sampling the automobile air conditioners, which is shown in Figure 3-1, consists of the following three components:

The sampling line, which is shown in Figure 3-1 as the line within the broken rectangle and which is made of 1/4-in flexible copper tubing, was used only once to prevent the risk of cross-sample contamination. One line was made up for each container and was shipped with it. Prior to shipment, these lines were flushed with CFC-113, blown out with nitrogen, and capped. One in 10 of these lines was tested by filling it with CFC-113 and analyzing the solvent in the same way as the containers were tested.

- 2. Loosely connect a new sampling line to the sample container and the vacuum line as shown.
- 3. Put the sampling container into a pan and cover about two-thirds of the way up with dry ice.

- 4. Make sure that valve V-1 is closed, and then connect the sampling line to the high pressure side of the air conditioner (A/C). The A/C must not be running.
