EPA/540/R-92/015 September 1992

TECHNOLOGY EVALUATION REPORT

SITE PROGRAM DEMONSTRATION OF A TRIAL EXCAVATION AT THE MCCOLL SUPERFUND SITE

RISK REDUCTION ENGINEERING LABORATORY OFFICE OF RESEARCH AND DEVELOPMENT U.S. ENVIRONMENTAL PROTECTION AGENCY CINCINNATI, OHIO 45268

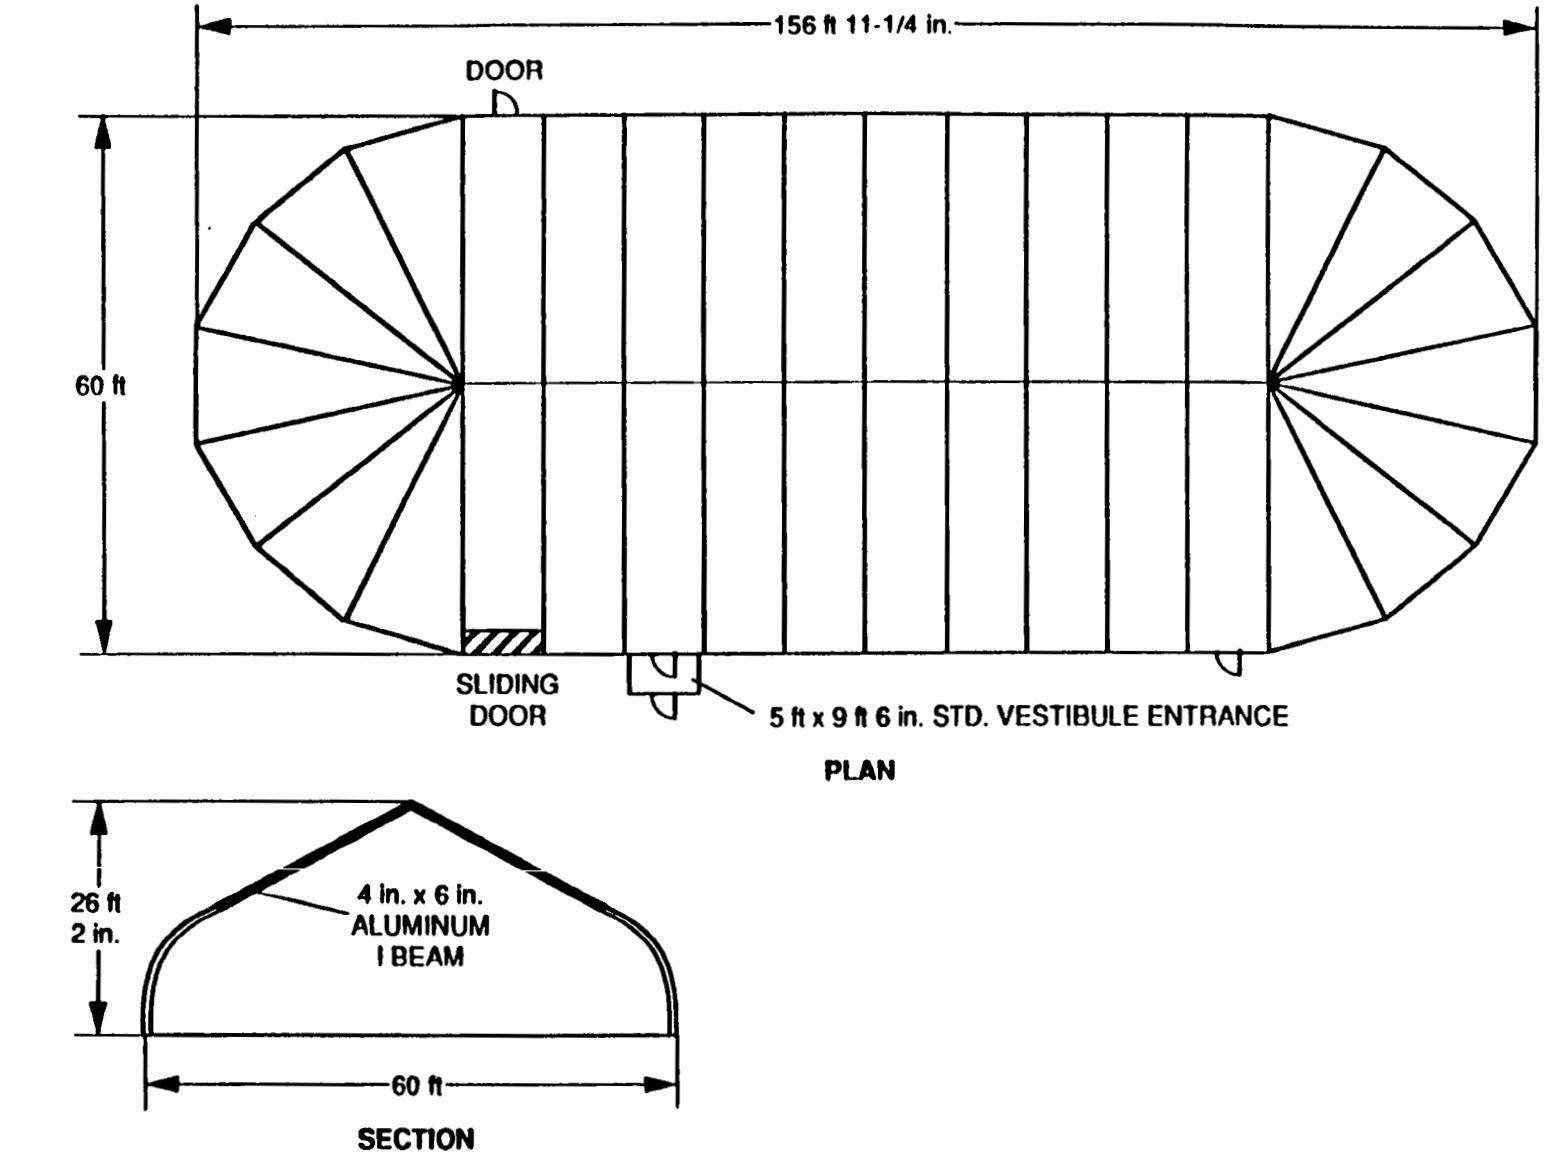
Figure 1. Enclosure plan and section.

A rigid-frame, PVC-covered enclosure structure was erected over part of the L-4 sump and adjoining land prior to the start of excavation. Before its erection, the site was graded to provide a smooth, level area. The enclosure, supplied by Sprung Instant Structures and shown in Figures 1 and 2, was nominally 60 feet wide by 157 feet long, and 26 feet high at the center. The white, opaque PVC cover was 26 mils thick and impervious to gaseous emissions. The lower edge was covered by 12 to 18 inches of soil along the ground level to prevent air leakage. Translucent panels located along the roof peak allowed light to enter. Personnel entry was through an airlock door which minimized fugitive emissions during entry. Equipment was moved inside the enclosure through a sliding door that was 14 feet high and 9 feet, 5 inches wide.

The volume of the enclosure was approximately 192,000 ft^3 and air was drawn through the building at a rate of approximately 1,000 ft^3 /min. This air entered the

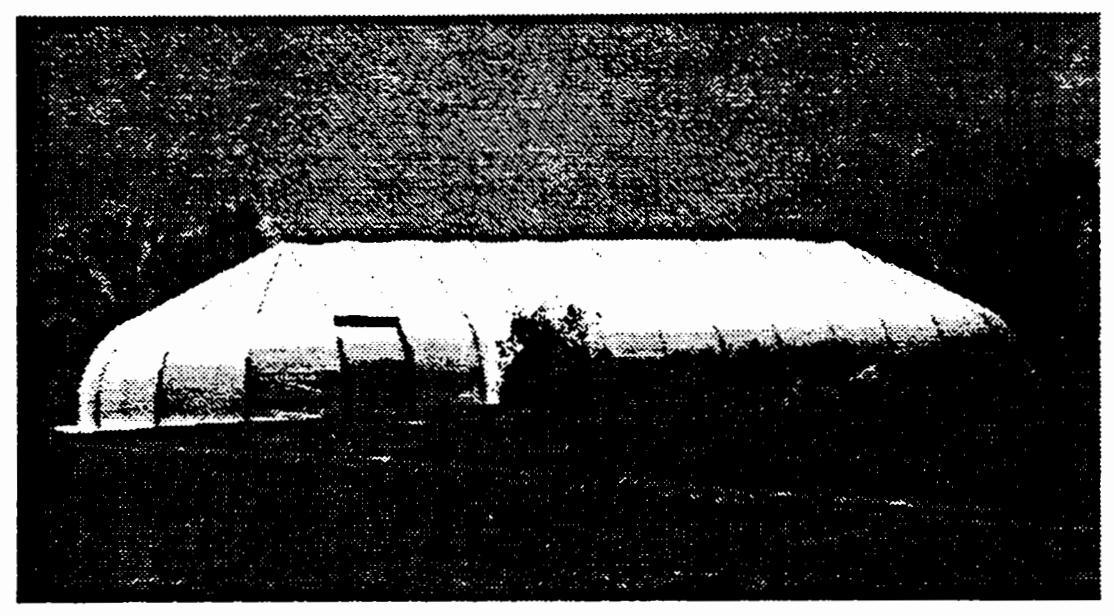
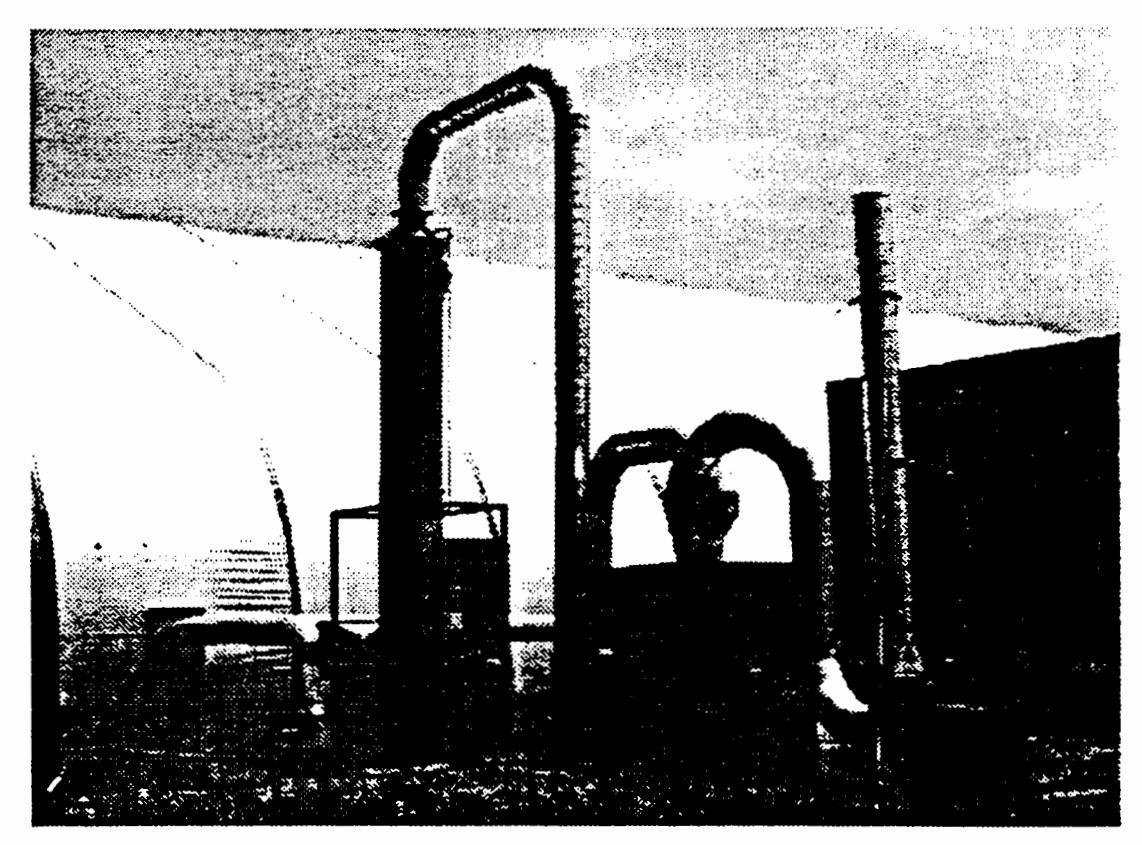
Figure 2. Excavation site enclosure.

View from east side.

View from west side showing air emission control system and monitoring trailer.

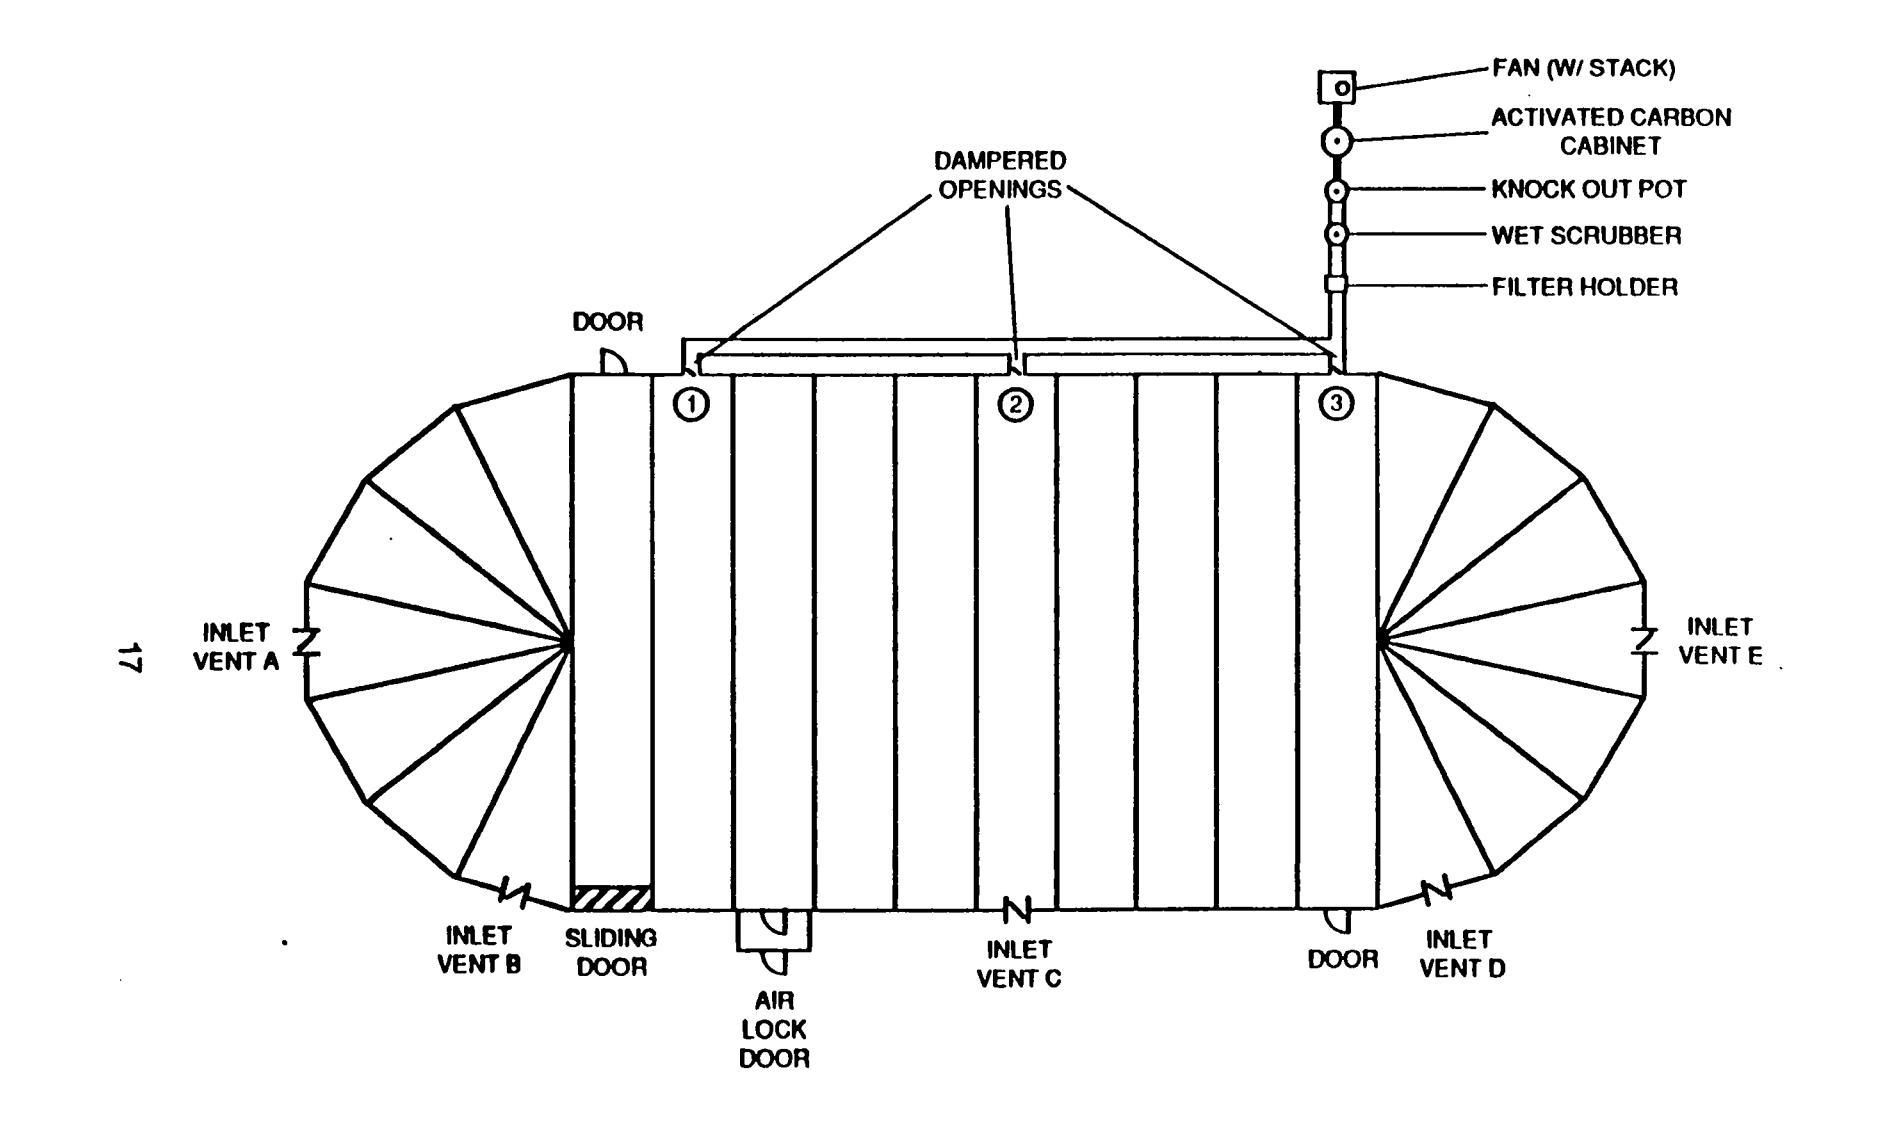
Figure 3. Ventilation air cleaning equipment general arrangement.

To reduce emissions of volatile organic compounds, a granular activated carbon bed was installed after the wet scrubber. A knockout chamber was inserted between the scrubber and carbon bed to trap any liquid carryover from the scrubber. Specifications for this adsorber called for a 95 percent minimum removal of total

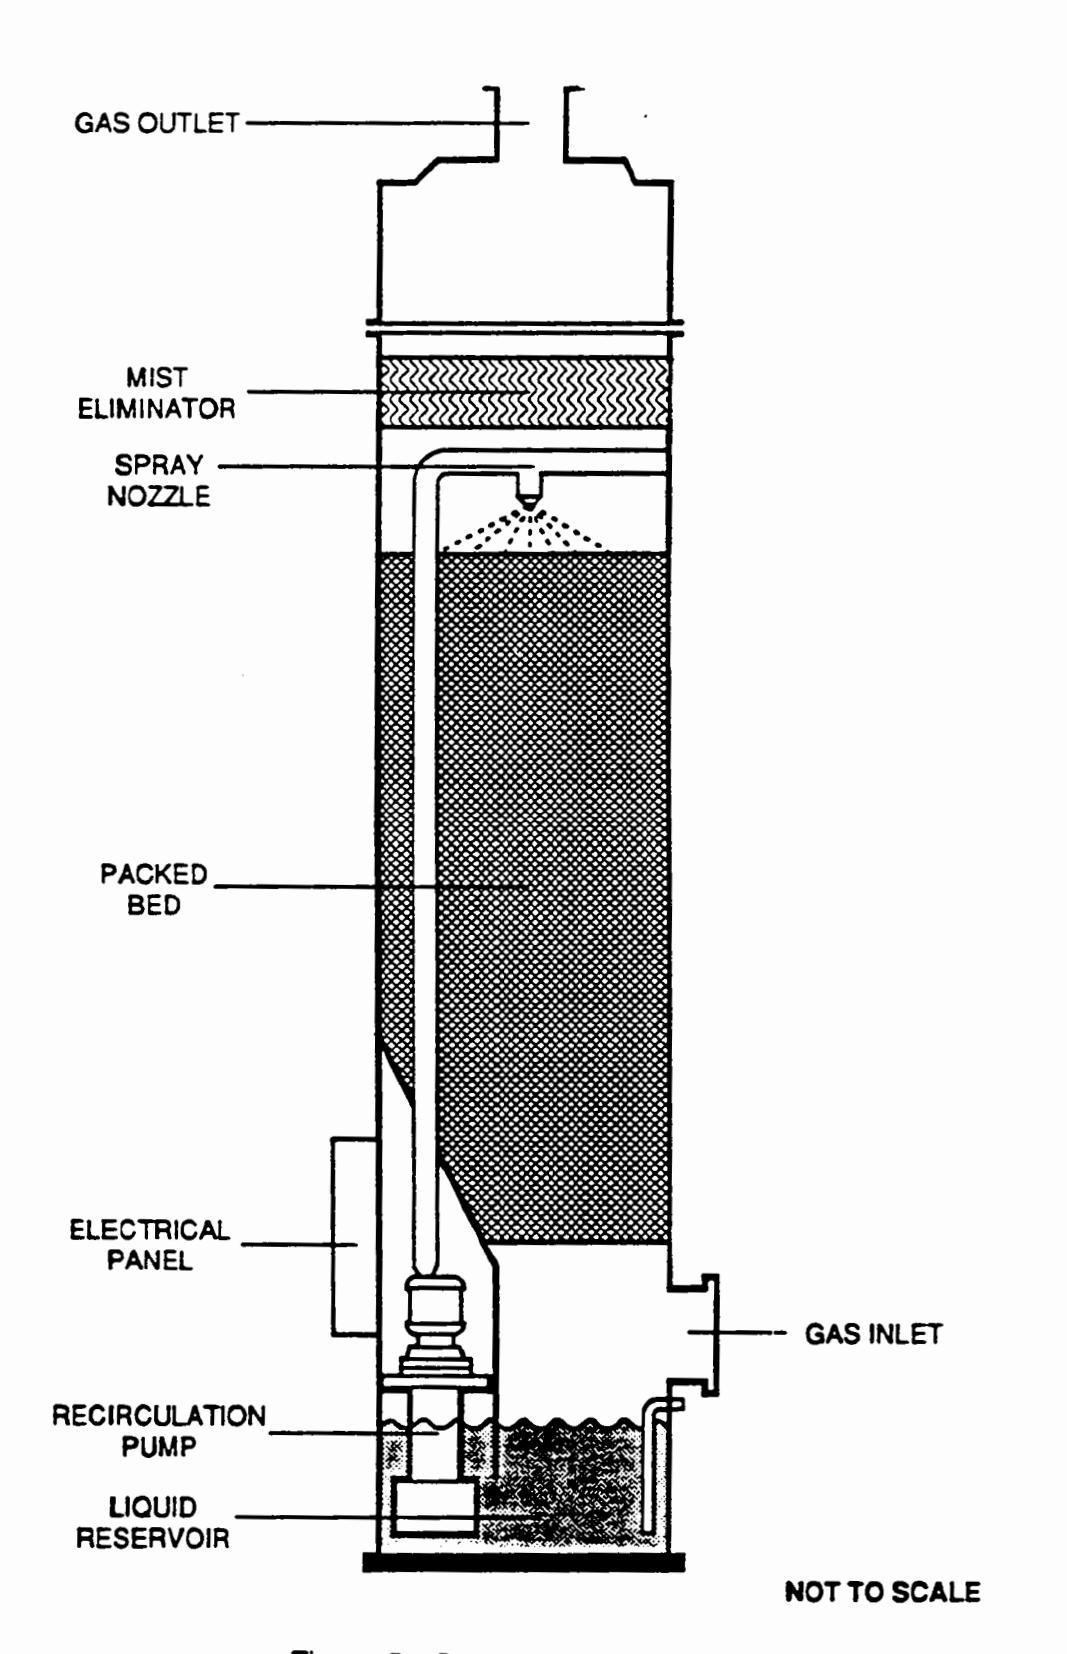
Figure 5. Scrubber cross section.
organics at a flow rate of 1000 ft³/min at 100 • F and a pressure drop not to exceed 5 inches of water.

Scrubber size GWX 1200_ 1,200 ft³/min Design flowrate 24 inches Diameter 190 gallons Sump capacity Circulation rate 25 GPM Pump motor 1.5 hp 2-inch hollow spheres Type of packing Packing height 11 feet Scrubber overall height 17 feet Type of mist eliminator Chevron Empty weight 650 lb Operating weight PURCHASE PRICE 2350 lb \$22,600.00 Fan Material of construction Steel Polyurethane Corrosion resistant coating Gas flowrate (standard air density) 1,200 ft/min Static pressure (Neg/Pos) 20 inches WG Motor rating 7.5 hp PURCHASE PRICE: \$2,200.00

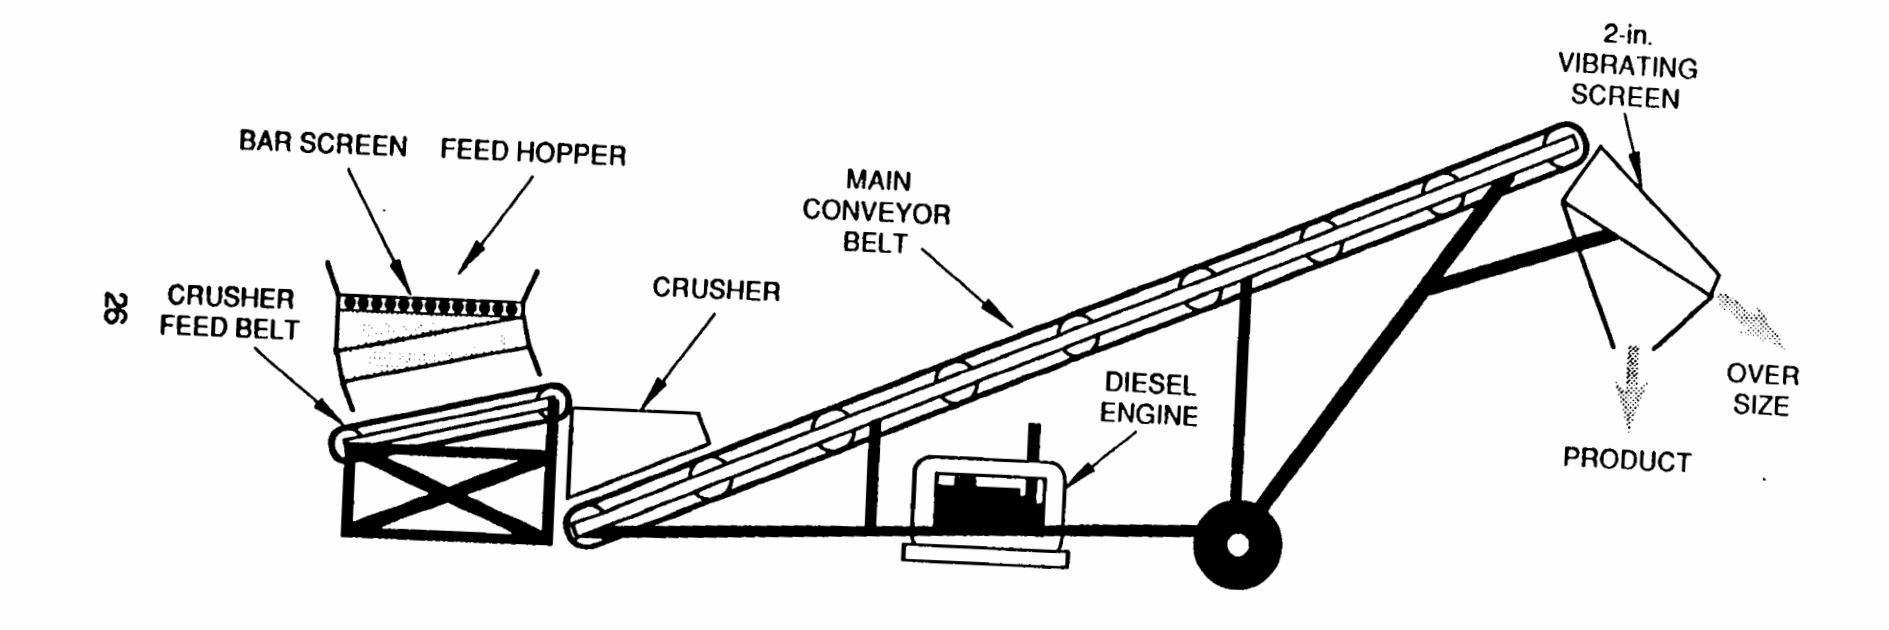
Figure 8. Char/mud crusher schematic.

The crusher was expected to operate on both char alone and a mixture of char and mud. A schematic of the crusher is shown in Figure 8. The overall dimensions of the unit were 51 feet long, 7 feet wide, and 17 feet high.

The objective of the char and mud processing operations planned for this project was to reduce the size of these materials to less than 2 inches so they would be suitable for feed to a thermal destruction system. The crusher brought on site for this purpose was a Masterskreen Explorer, manufactured by M&KK Quarry Plant Ltd. in 1989. With this system, material is dumped into a 4-yd³ tray feed hopper fitted with 6-inch stationary bars. From the hopper, material is transported by a feed belt into the jaws of the crusher. After passing through the crusher, material is picked up by a product conveyor and transported to a vibrating screen with 2-inch square openings. Undersize material passes through the screen to the ground while oversize material rolls off the screen to another pile on the ground. The conveyor belts, crusher, and hydraulic control system were powered by a diesel engine.

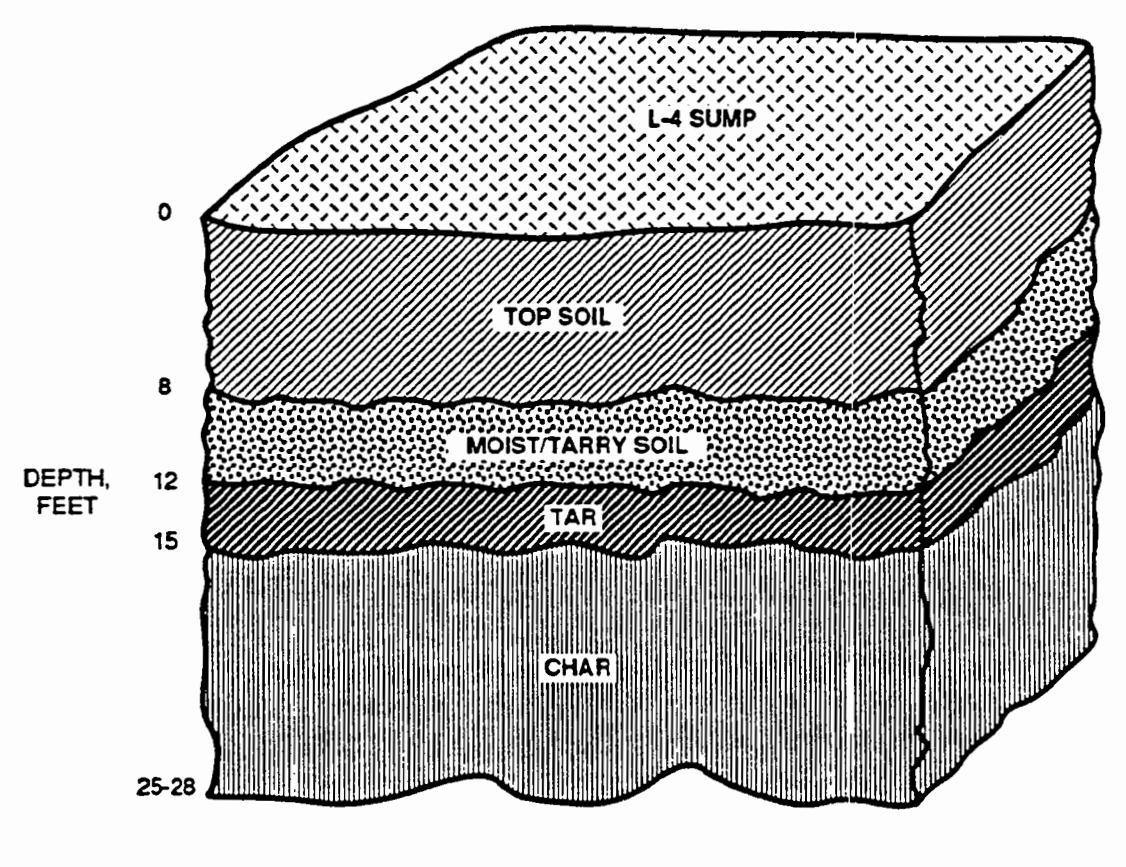
Figure 11. Approximate cross section of L-4 sump based on boring logs (Geotechnical Professionals 1989).

Borings previously made in the L-4 sump showed that both tar and char were present in fairly segregated layers under a layer of moist soil or mud, which was in turn under approximately 8 feet of overburden soil. The anticipated waste configuration based on these boring is indicated in Figure 11; this information was used to plan the excavation work for the study (Geotechnical Professionals 1989).

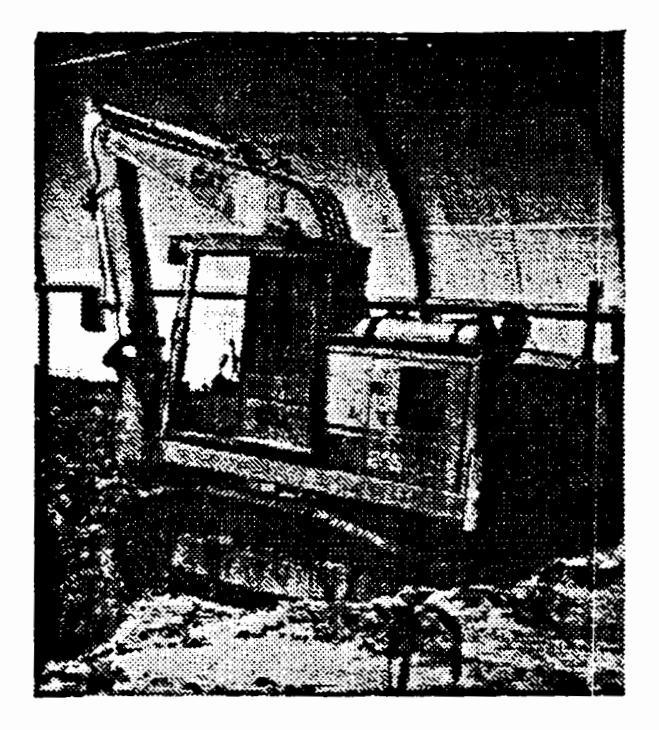
Figure 12. Caterpillar Model 215 DLC trackhoe.

Excavation equipment included a diesel-powered (Caterpillar Model 215 DLC) tractor-mounted backhoe (or trackhoe), shown in Figure 12. This trackhoe was equipped with an extended boom and 1-yd³ bucket. With the extended boom, the trackhoe had an effective digging depth of 20 feet. The trackhoe was used for excavation of overburden, mud, tar, and char. In addition to the trackhoe, the backhoe portion

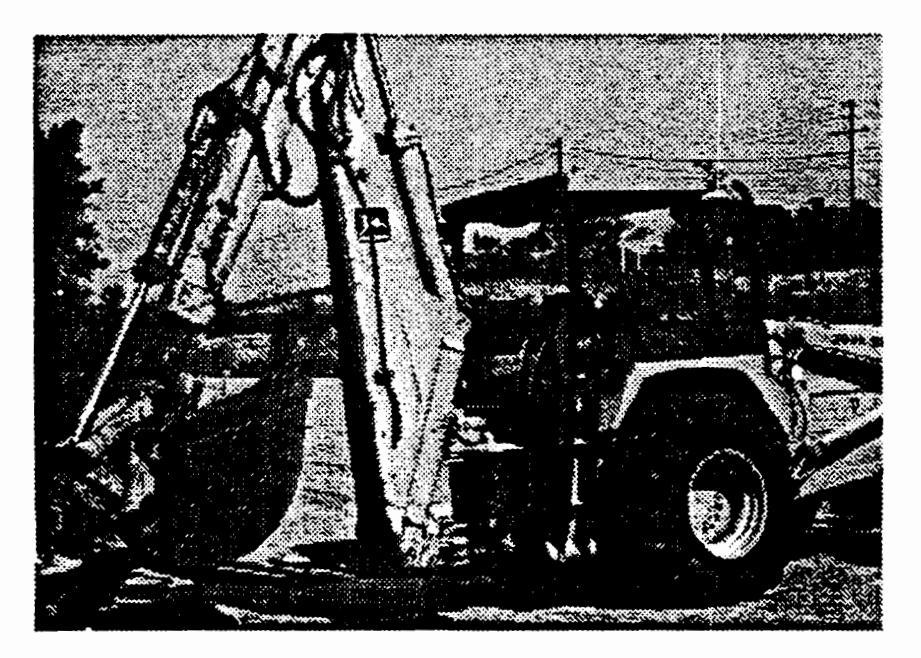
Figure 13. John Deere Model 710 loader/backhoe.

of a diesel-powered (John Deere Model 710) loader/backhoe (see Figure 13) was also used for some excavation operations. At 1/3 yd³, the backhoe bucket was smaller than the trackhoe bucket and was used primarily during placement of the trench shield. The effective digging depth of the wheel-mounted backhoe was about 15 feet.

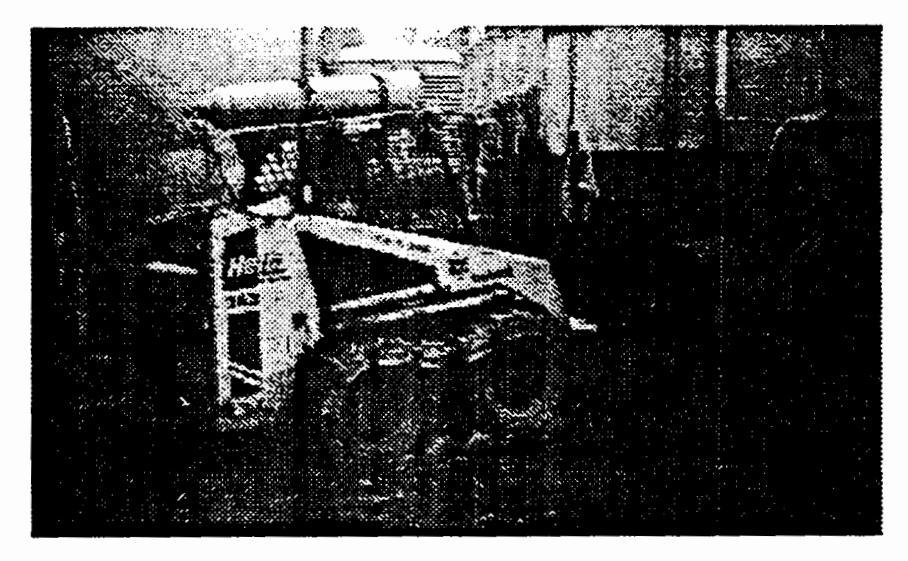
Figure 14. Bobcat Model 743 loader.

The loader portion of the loader/backhoe was used for material transport operations such as carrying excavated waste from the pit staging area to stockpiles. The 1-yd³ loader bucket was approximately 7.5 feet in width. A diesel-powered Bobcat Model 743 loader was also used for materials transport when the floor of the enclosure became too muddy and slippery for the John Deere loader/backhoe to operate properly. The muddy conditions were caused by the water in the foam vapor suppressants and by blowdown water associated with foam application. As shown in Figure 14, the Bobcat was fitted with special chain-like tracks over its wheels to provide adequate traction on the wet floor. The bucket of the Bobcat was 5 feet wide and had a capacity of $1/4 \text{ yd}^3$.

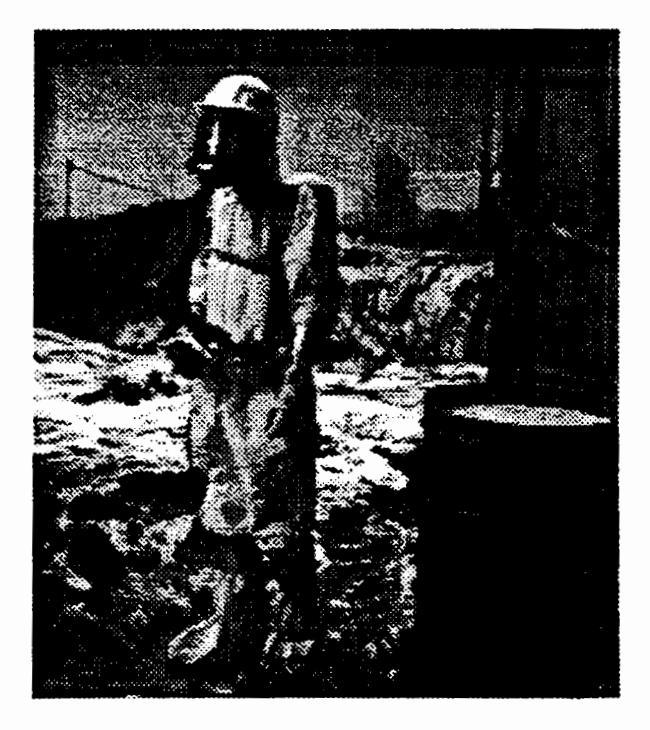
Figure 17. Level B personal protection equipment.

Excavation work inside the enclosure was conducted either in Level B or Level A personal protective equipment. Level B equipment consisted of supplied-air respirators, coated Tyvek overalls, steel-toed boots, inner and outer gloves, and a hard hat. Air bottles were mounted on the trackhoe, loader/backhoe, and Bobcat for operator air supply; other members of the crew used air lines supplied from air cylinders located outside the enclosure. Level A requirements added a totally encapsulated chemical protective (TECP) suit to the preceding equipment list. Air supplies to these suits were either from air lines (as previously discussed) or from

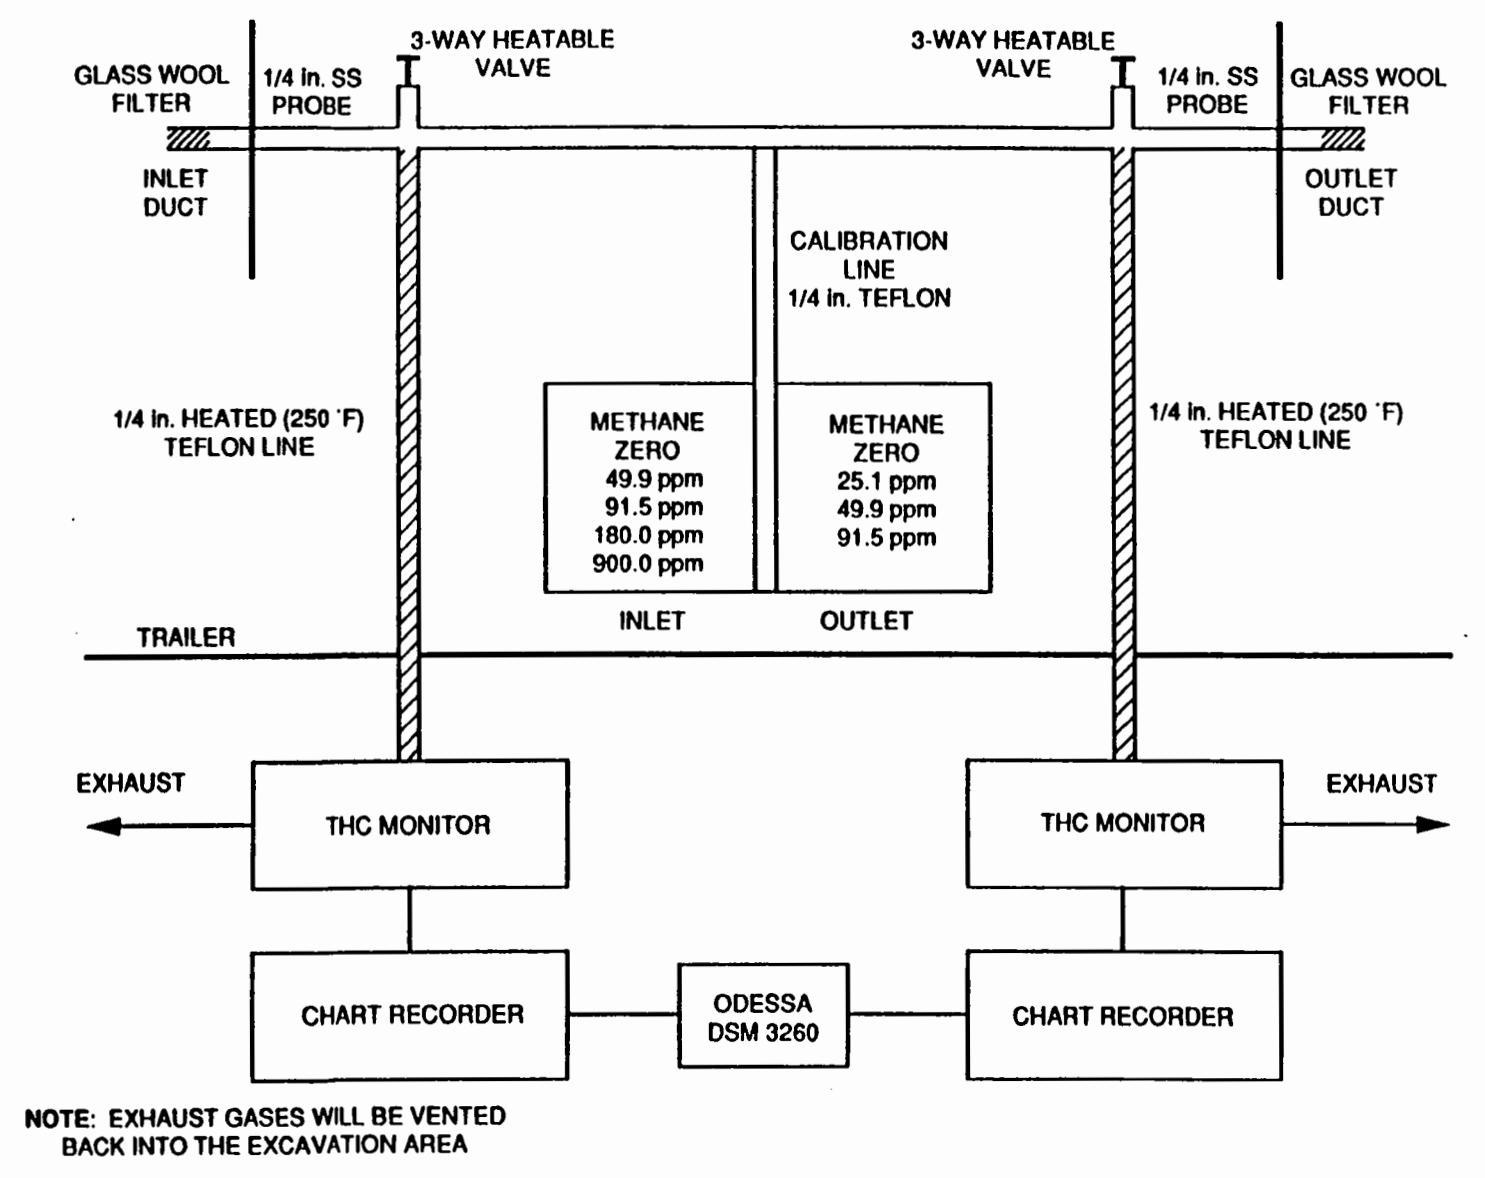
Figure 23. Outlet and inlet THC sample systems.

These monitors and gases were chosen to allow for measurements on a variety of ranges. If instruments went offscale on the original scale, a 900-ppm calibration gas was available to calibrate on higher ranges. Higher concentrations were not expected and additional calibration gases were not available for this study.
