**Arsenic Removal from Drinking Water by Adsorptive Media  
EPA Demonstration Project at Goffstown, NH  
Six-Month Evaluation Report**

**Battelle  
Columbus, OH 43201-2693**

**Contract No. 68-C-00-185  
Task Order No. 0029**

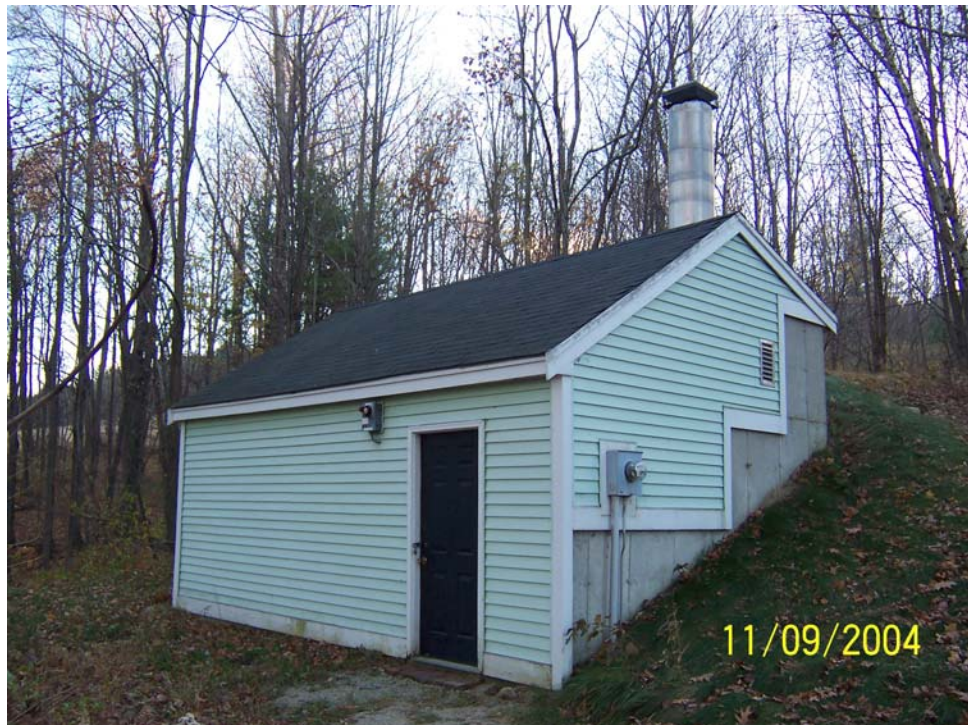
**Figure 4-1. Pre-Existing Treatment Building at Orchard Highlands Subdivision**

The community water system supplies water to 42 homes in the Orchard Highlands Subdivision in Goffstown, NH. Figure 4-1 shows the water treatment building. The water source is a single deep bed-rock well drilled to a depth of approximately 800 ft. The flowrate from this supply well was estimated to be approximately 7.5 gal/min (gpm) based on the pump curve provided by the facility. The actual peak flowrate recorded at the site after the installation of the system was 15 gpm with an average flowrate of 13 gpm. The existing system includes an aeration system for radon treatment (Figure 4-2), a 10,000-gal storage tank (Figure 4-3), two booster pumps (Figure 4-4), and a 2,000-gal hydropneumatic pressure tank (Figure 4-5).

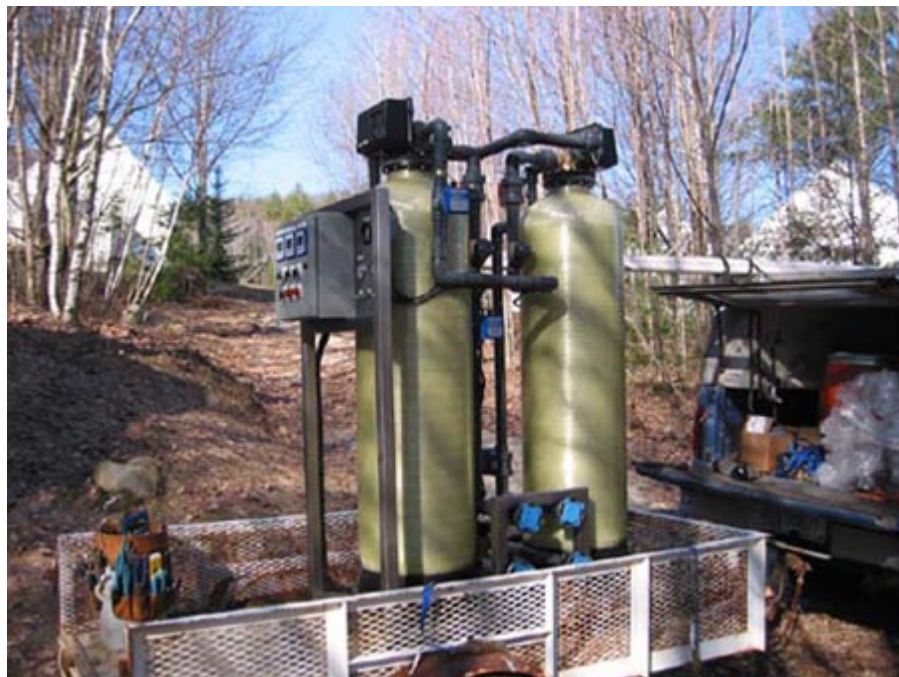
**Figure 4-10. System Being Delivered to Site**

**4.3.3 Installation, Shakedown, and Startup.** The treatment system arrived on-site on April 12, 2005. Figure 4-10 shows a photograph of the system arriving at the site. Several of the PVC connections were damaged during shipping and had to be replaced before system installation. Thursty Water System
